Nature-Based Design Practices Case Study

Preliminary

Popham Beach, Maine

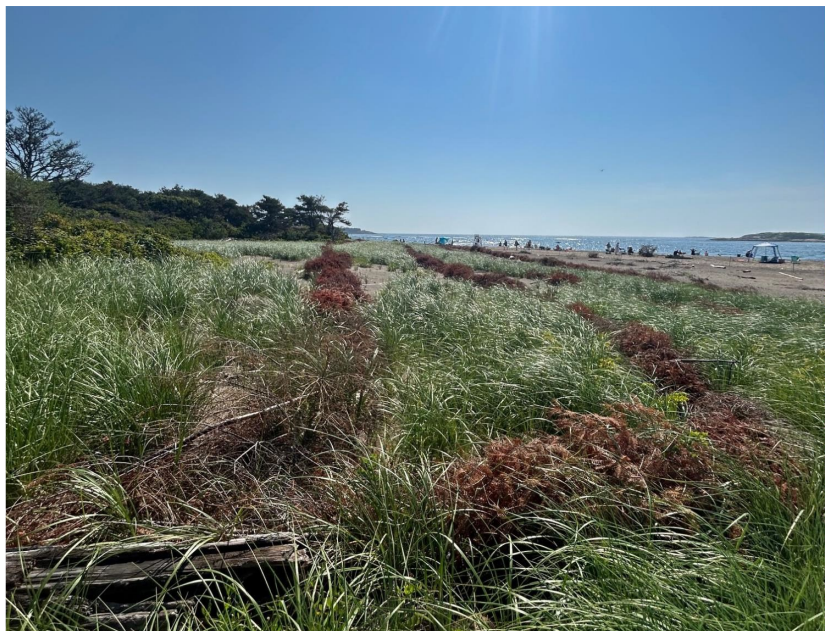
Photo 1 (July 17, 2024) Looking east at center beach at trees fourth months after placement. A fourth row was added and is almost completely covered. Note dune grass growth. N. Whiteman, MGS

As shown in Figure 3, 580 trees were placed in multiple rows along about 1,800 feet of the beach. Shore-parallel, narrow and shallow trenches were hand-excavated using shovels and trees placed “tip to tail” within the trenches. Even several months after the storms, the beach remained denuded of dune ridges and vegetation (Photo 2). Over the next several months, windblown and high-tide deposited sediment was trapped by the trees and dune vegetation established (Photos 1-5).

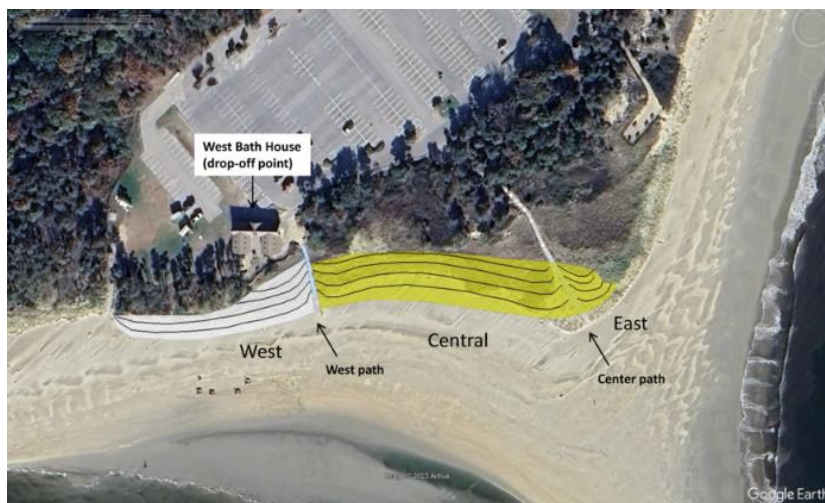
Figure 1. Sketch showing proposed locations of tree rows along West, Center, and East Beaches as part of the permit application. The actual locations and lengths of tree rows had to be altered in the field due to ground conditions. 2023 image from Google Earth.

Close to 1,000 trees were dropped off at Popham Beach by March 2024. The pilot project was designed by MGS and incorporated several rows of Christmas trees oriented parallel to the shoreline. The original project design (Figure 1) included the placement of over 500 trees in multiple rows along 2,800 linear feet of shoreline.

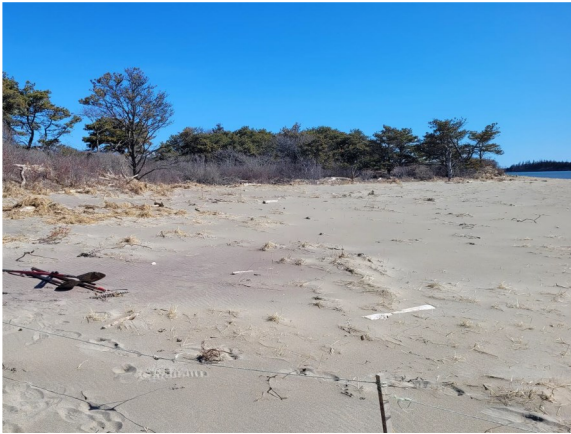
March 22, 2024

Photo 2:
Looking east along center beach at flattened and eroded dunes prior to tree placement. P. Slovinsky, MGS.

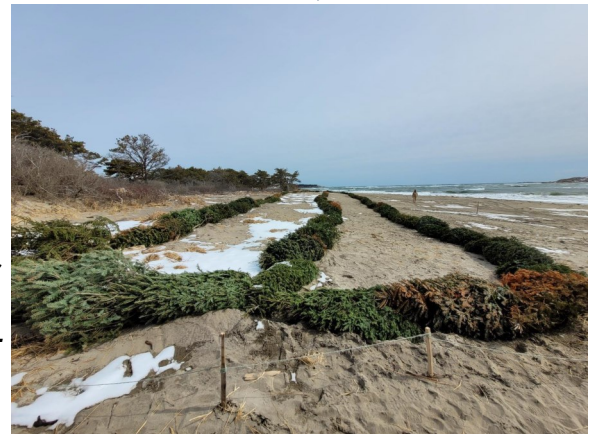
March 25, 2024

Photo 3:
Looking east at center beach at trees placed in 3 rows on the beach. A fourth row was not added yet due to proximity of the Morse River channel. P. Slovinsky, MGS.

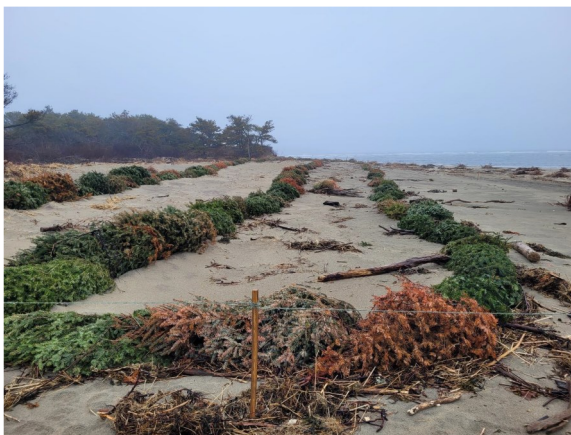
April 13, 2024

Photo 4:
Looking east at center beach at trees about a month after placement. Higher tides are washing sediment into the trees. P. Slovinsky, MGS.

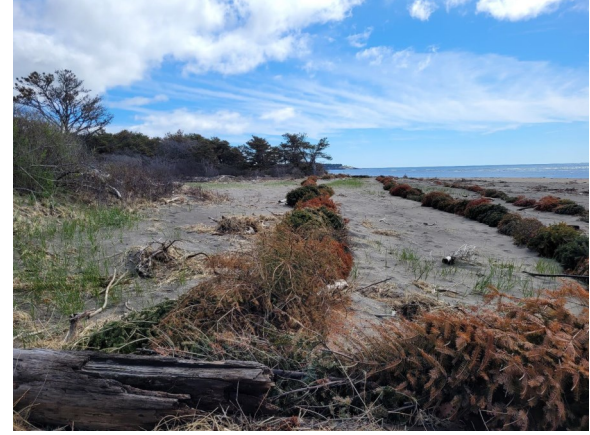
May 3, 2024

Photo 5:
Looking east at center beach. Note sand elevation is slightly increased and dune grass is beginning to establish. P. Slovinsky, MGS.
