# **Southern Maine Seagrass Mapping**

## **Aerial Photography Survey Coordination & GIS Mapping**

### **Eliot to Cape Elizabeth**

**January 21, 2022**

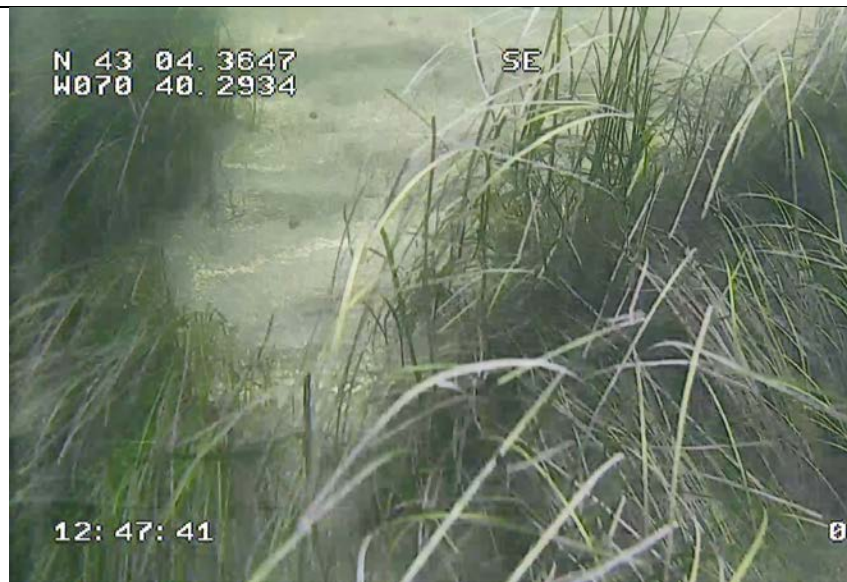
Eelgrass observed on sandy substrate (PR43)

**Figure 4. Seagrass Signatures**

Field verification took place over ten field days between late August and early October. Transects and camera drops were used to collect information on seagrass beds, and 252 strategically targeted locations were visited. These locations covered 79% (99/126) of all mapped polygons. Field verification was paramount in determining presence-absence for areas that had overlapping signatures with macroalgae, deep water and/or ledge (Figure 4).

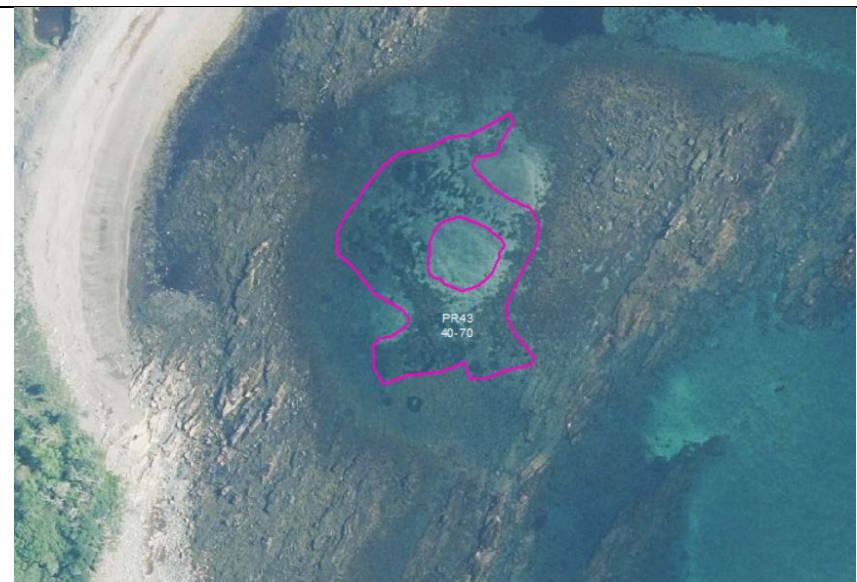
Digitized mapping of eelgrass on sandy substrate (PR43)

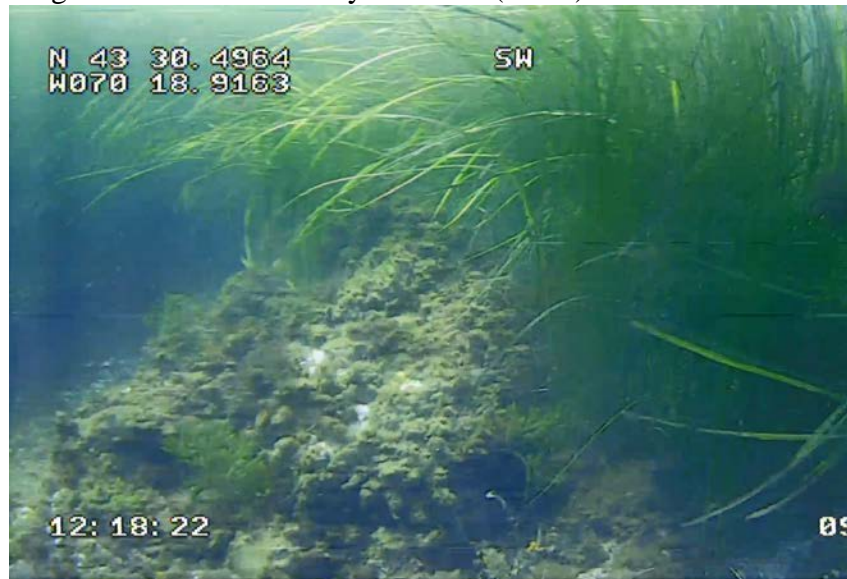
Eelgrass observed among rockier substrate (SB05)

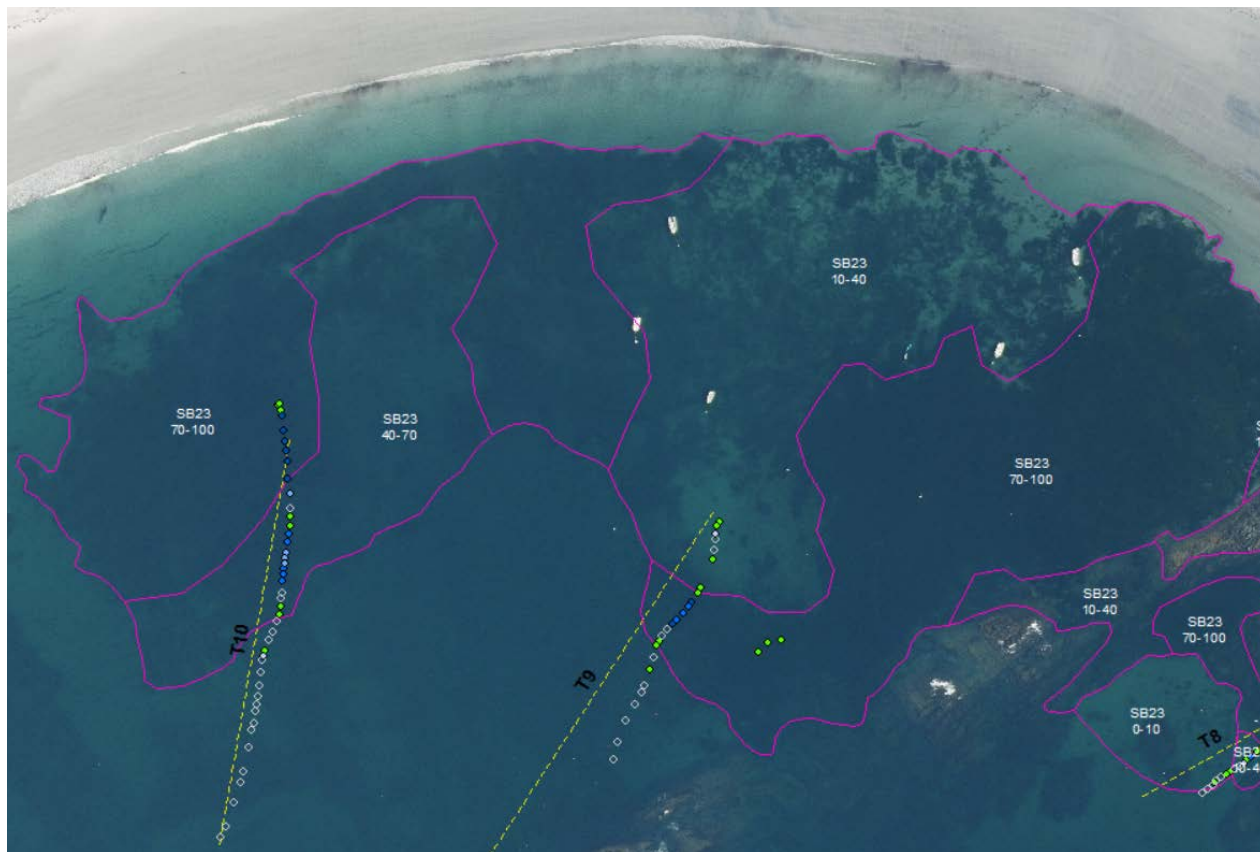
**Figure 6. Field Transects, GPS points, and underwater video were used to inform seagrass boundaries during digitizing. (Hollow circles=0% cover, green=eelgrass presence, white= 1-10% cover, light blue=10-40% cover, dark blue=40-70% cover, purple=70-100% cover)**

The final mapped seagrass dataset contains 126 mapped seagrass beds, and covers approximately 873 acres. 171.8 acres of seagrass were mapped as category 1, 0-10 percent cover, 115.8 acres of seagrass were mapped as category 2, 10-40 percent cover, 250.3 acres of seagrass were mapped as category 3, 40-70 percent cover, and 334.8 acres were mapped as category 4, 70-100 percent cover (Figure 5). Polygons that were visited in the field have an associated species identification, which is based solely on underwater video observation unless otherwise noted. Eelgrass was the dominant vascular species, covering approximately 859 acres. Sparse beds were often intermixed with a range of macroalgae species, comprised of red algae that appeared to include *Dasyisiphonia japonica*, as well as sea lettuce (*Ulva lactuca*) fucoids (likely *Ascophyllum* and *Fucus* species), and kelp (*Laminaria digitata*). Ectoprocts, chordates, and snails were occasionally observed on seagrass blades in the underwater video. Widgeon grass was noted in the Spinney Creek backwater, and covered approximately 13.7 acres. No other locations for this species were observed. Both video coordinates and field GPS points were used to refine the photointerpreted boundaries of mapped beds (Figure 6).

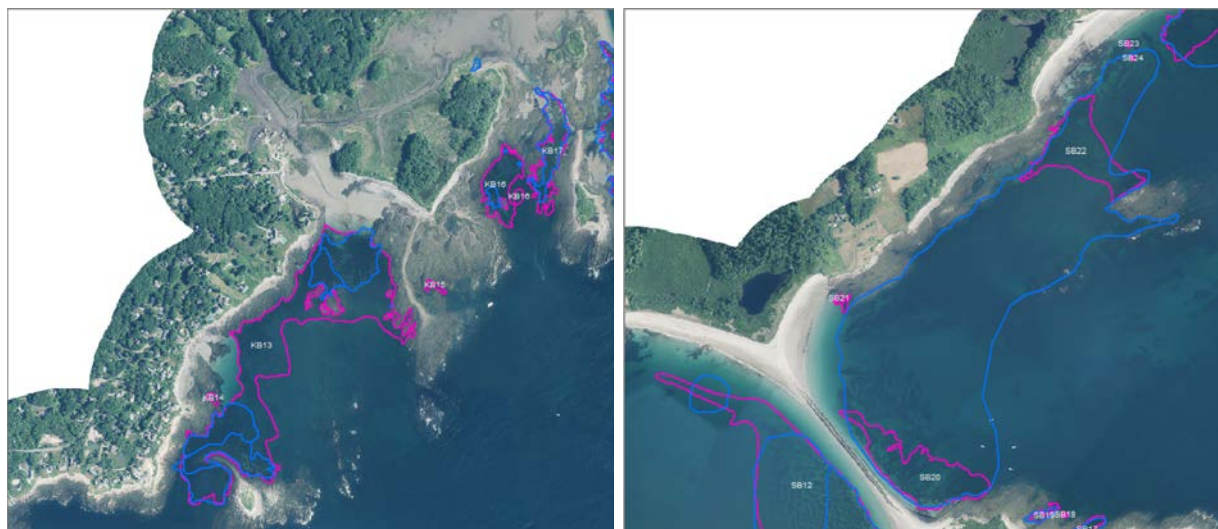
**Figure 7. Areas with the largest change in bed composition were observed south of Vaughn Island in Kennebunk (left, increase) and north of Richmond Island in Cape Elizabeth (right, decrease). Screen shots use the same scale. Pink beds correspond to 2021 mapping and blue beds are from the 2010 MEDMR mapping.**

Beach. In Kennebunk, seagrass increased south of Vaughn Island and was identified in new locations throughout this section of the project area. Seagrass was mapped in four new locations in the Saco River section, and near Biddeford Pool, seagrass beds were smaller than those previously mapped in 2010. Seagrass expansion was observed near the islands south of Prout's Neck, and adjacent to the west side of Prout's Neck east of the Scarborough River. The largest decrease in seagrass between the 2010 mapping occurred on the north side of Richmond Island in the Scarborough River section of the Project Area (Figure 7).
