TMDL Assessment Summary

Kimball Brook

Watershed Description

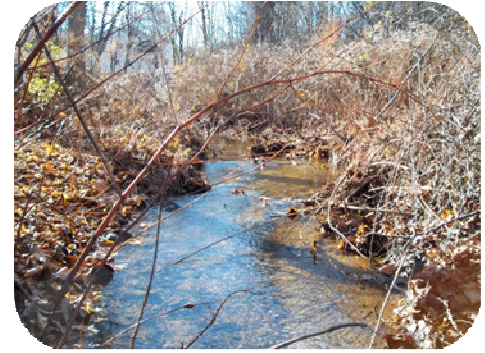
*Kimball Brook upstream of Station 795.
(Photo: FB Environmental)*

Kimball Brook impairment is based on data collected by DEP in 2005 at the sampling station upstream of Ocean Street (S-795) (DEP, 2010b). Data collected at this station indicated Class C Kimball Brook is “non attaining” (NA), meaning it does not meet Class A, B, or C conditions.
