## TMDL Assessment Summary

# Mere Brook *a.k.a. Mare Brook*

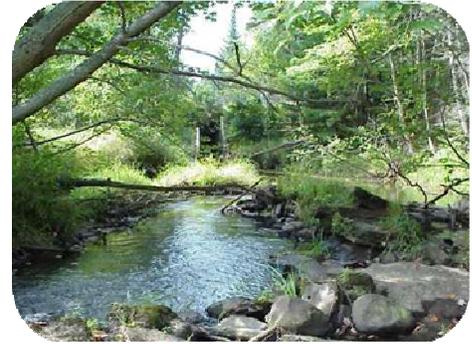
*Mere Brook downstream of S-144.  
(Photo: DEP Biomonitoring Program)*
