TMDL Assessment Summary

Shaw Brook

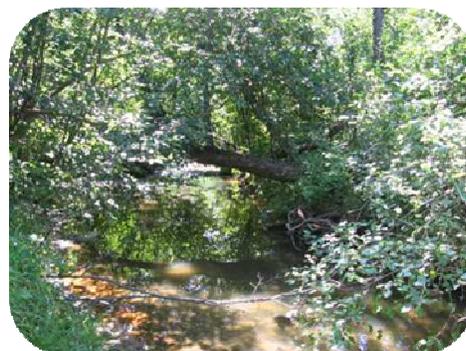
*Shaw Brook downstream of Station 480.
(Photo: DEP Biomonitoring Program)*

Shaw Brook impairment is based on data collected by DEP in 2006 at the sampling station downstream of Odlin Road (S-480) (DEP, 2010b). Data collected at this station indicates Class B Shaw Brook is “non attaining” (NA), meaning it does not meet Class A, B, or C conditions. Shaw was also sampled in 2011 and those results will be available in 2012.

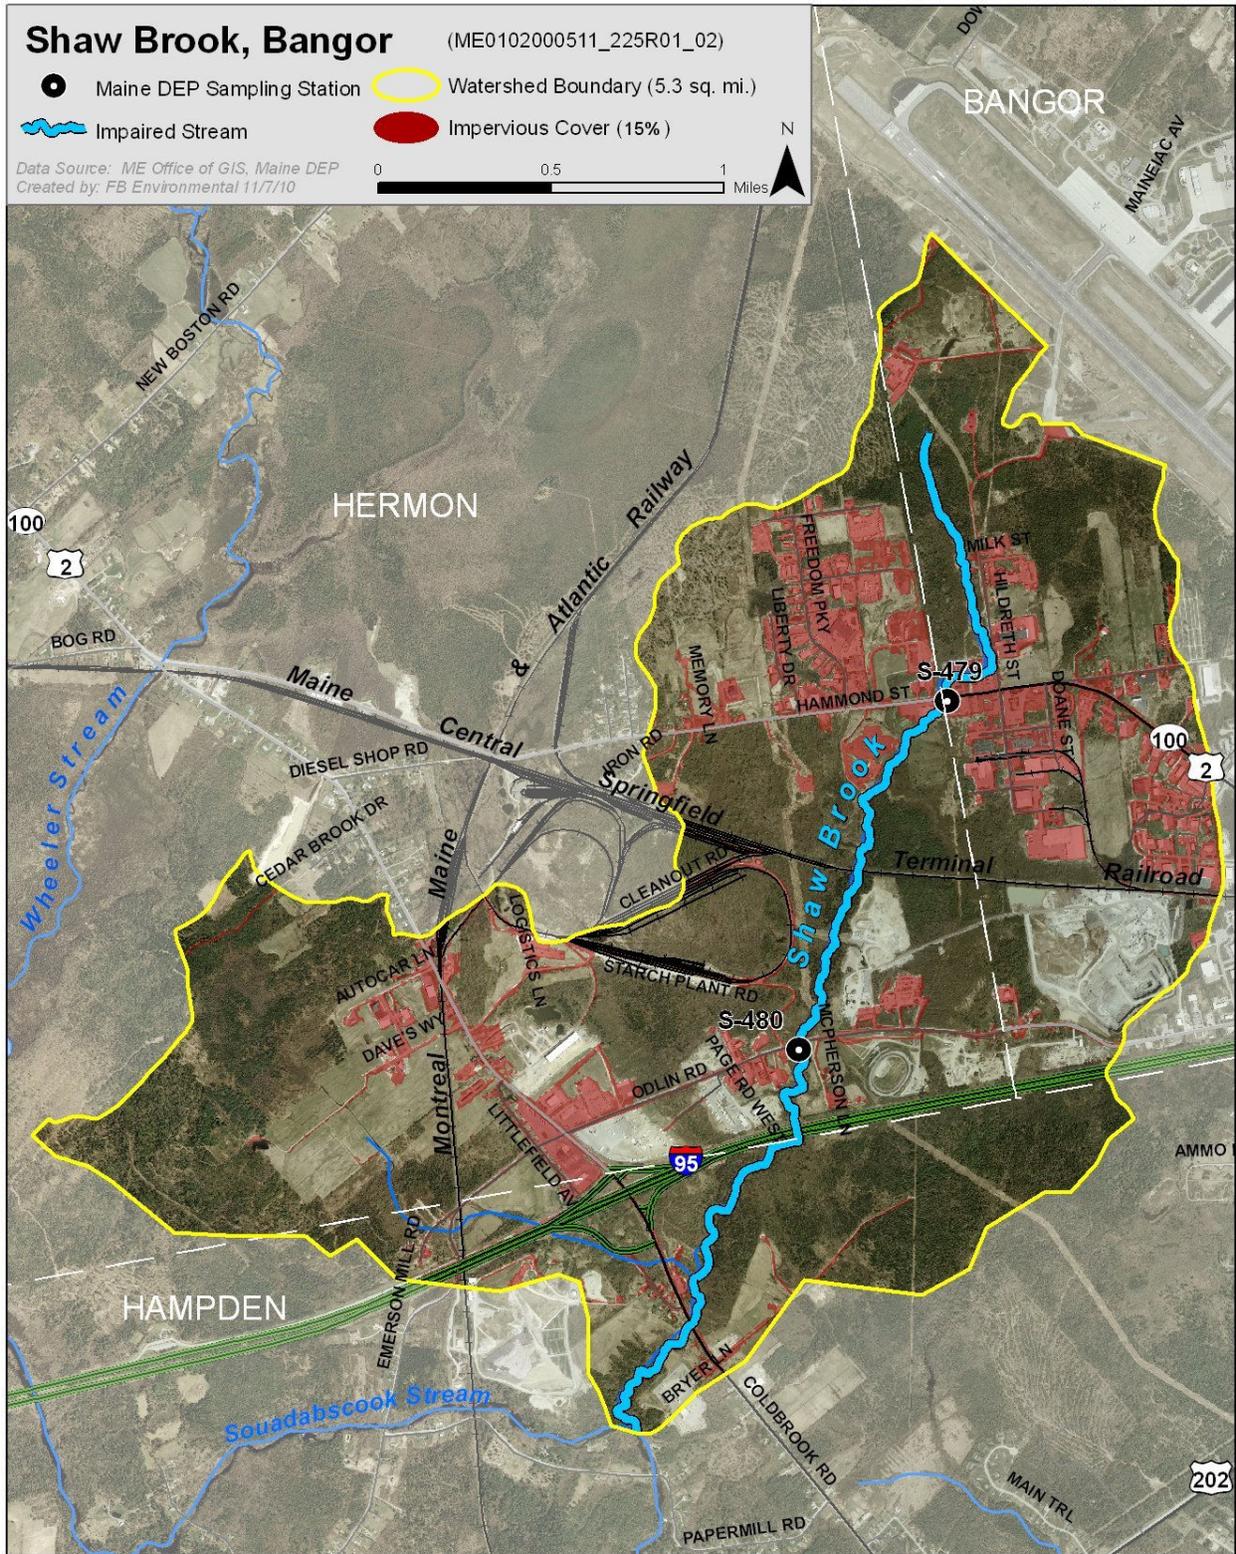
Figure 1: Map of Shaw Brook watershed impervious cover.

Impervious Cover GIS Calculations
The Impervious Cover Calculations are based on analysis of GIS coverage’s presented in Figure 1. The impervious area is derived from 2007 1 meter satellite imagery and the watershed boundary is an estimation based on contours and digital elevation models.

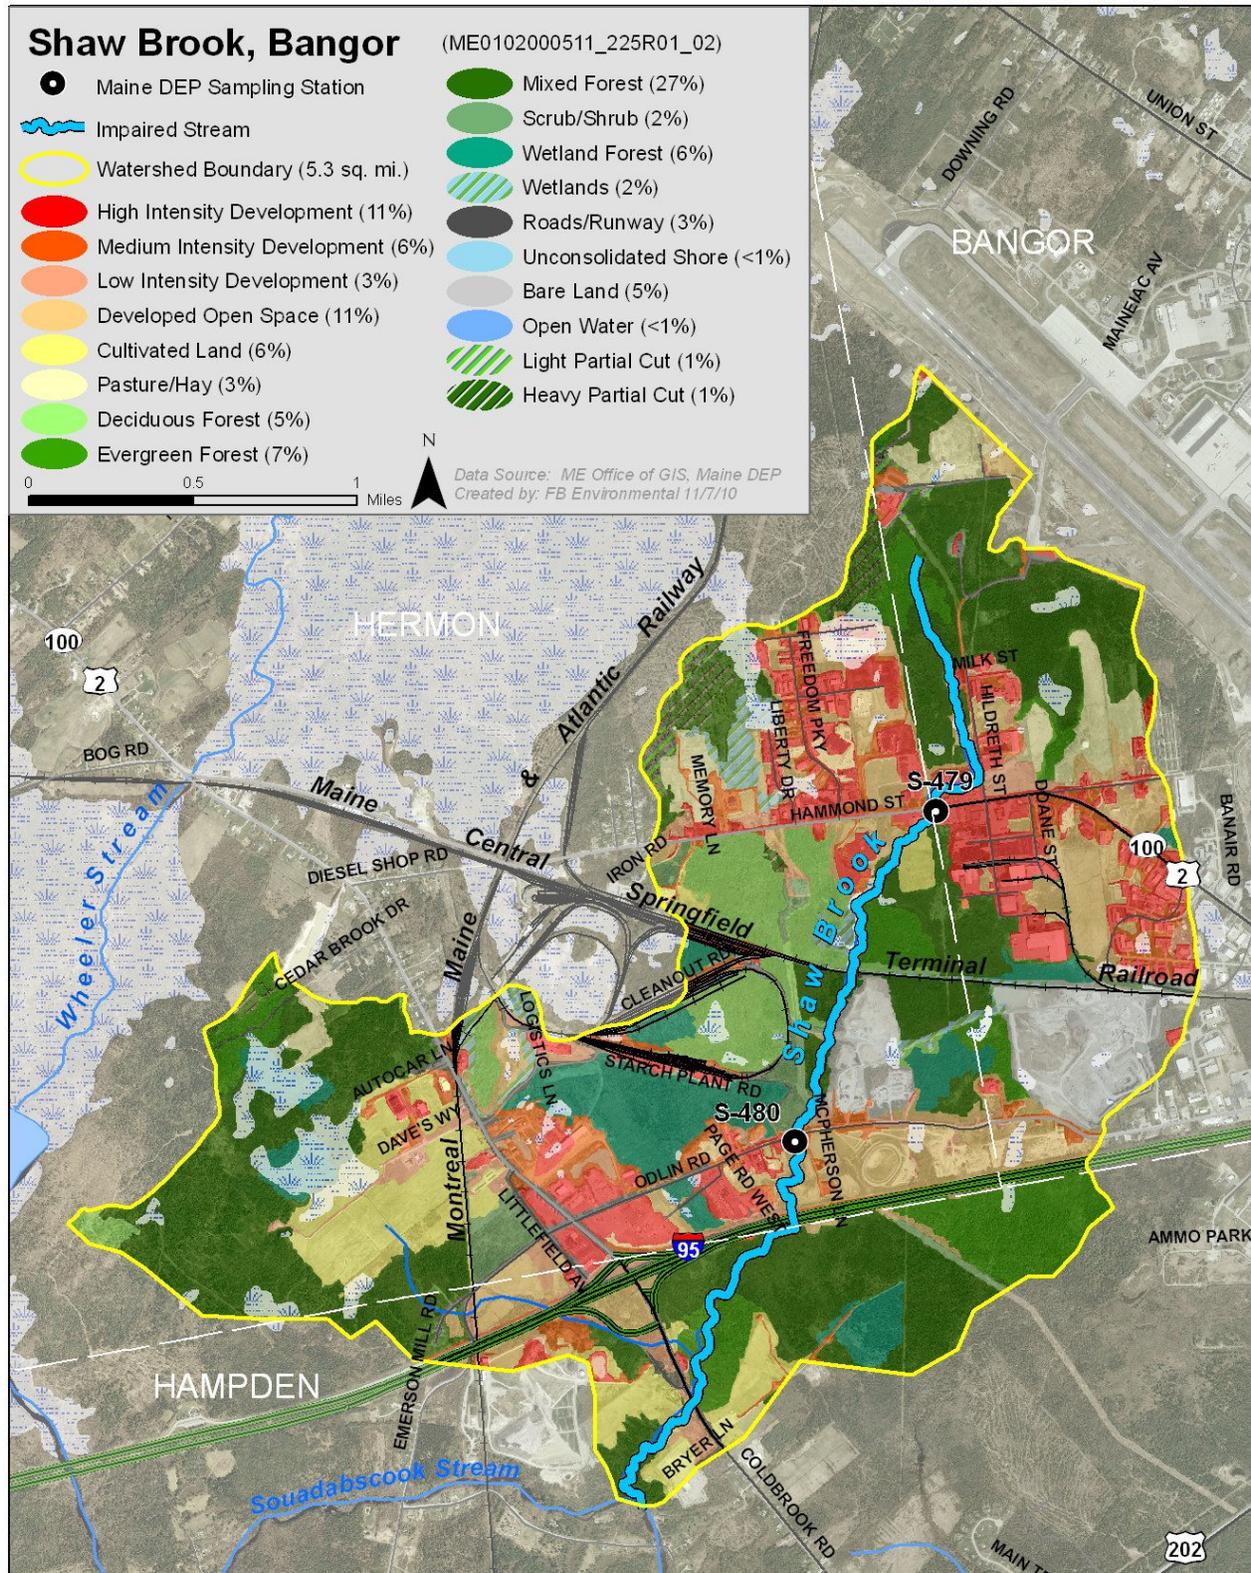
Figure 2: Map of Shaw Brook watershed land cover.
