## TMDL Assessment Summary

# Dole Brook

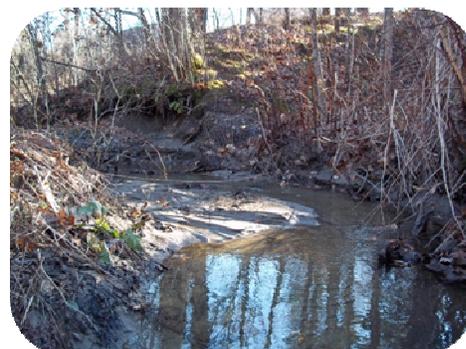
***Dole Brook upstream of Station 386.***  
*(Photo: FB Environmental)*
