TMDL SUMMARY

Coloney Brook

APPENDIX 6-1

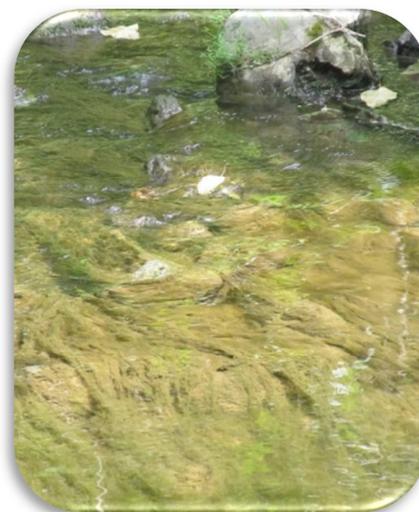
Algae in Coloney Brook in Fort Fairfield, ME.
