July 19, 2021

Re: Eelgrass Survey within the Proposed Bailey Coffin Department of Marine Resources (DMR) aquaculture lease site between Bustins Island and Sow and Pigs Island in Freeport, Maine.

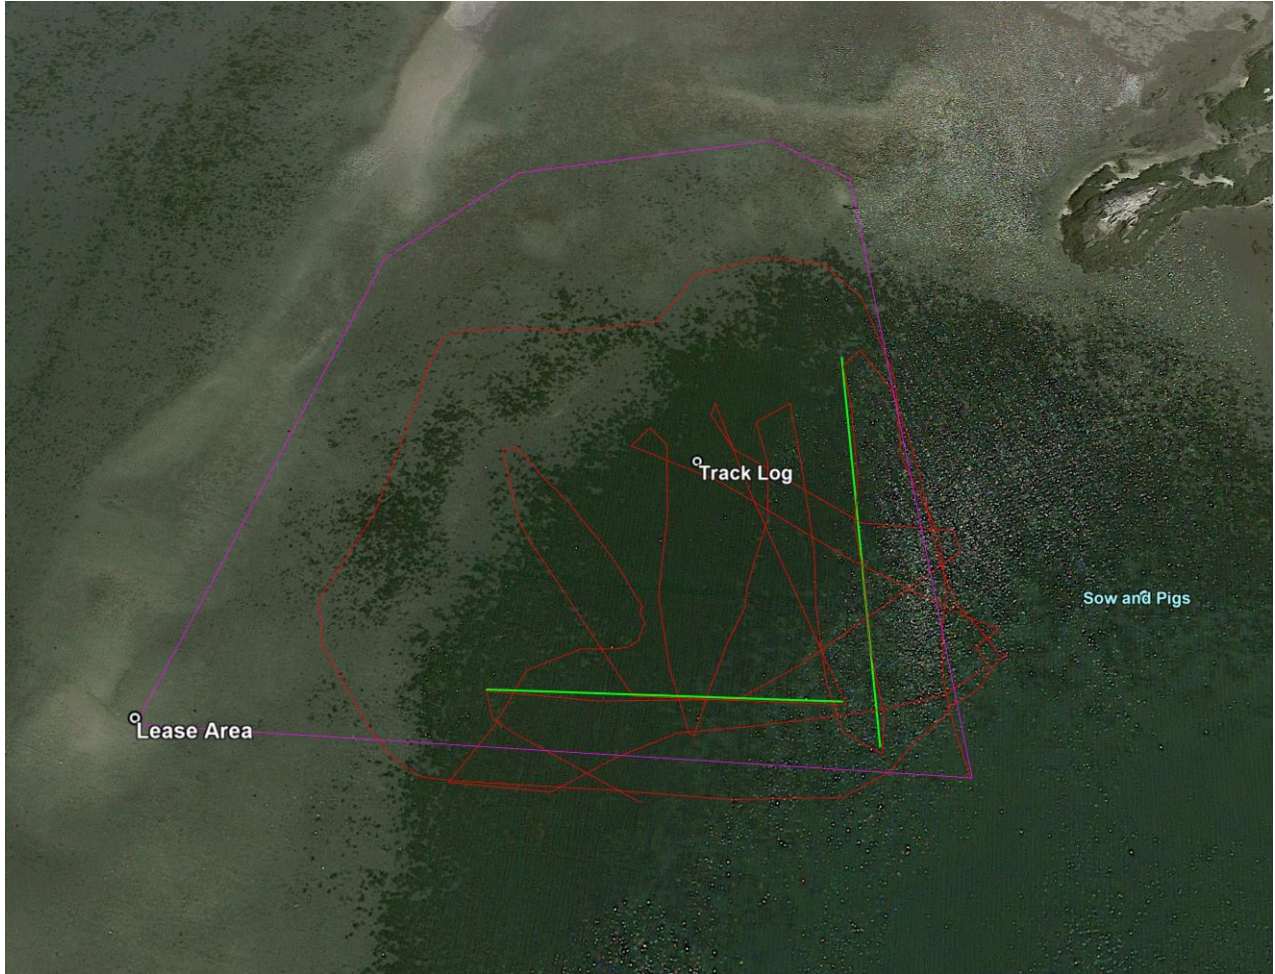
Image One: Google Earth Image (background 2016) indicating the proposed lease site, track log and video transects at the Bailey Coffin Proposed Lease site in Freeport Maine.

The site was accessed with a 16' aluminum boat outfitted with a Garmin GPS and sounder. The perimeter of the lease site was taken from the coordinates provided within the application and is shown in purple. The track log of the boat is shown in red. Video transect locations are

shown in green. Due to shallow depths within the site, the northwest portion of the lease site was not surveyed. However, based on visual observations from the boat eelgrass does not appear to be present within that area. Two (2) video transects were recorded with a GOPRO camera mounted on a pole beside the boat.

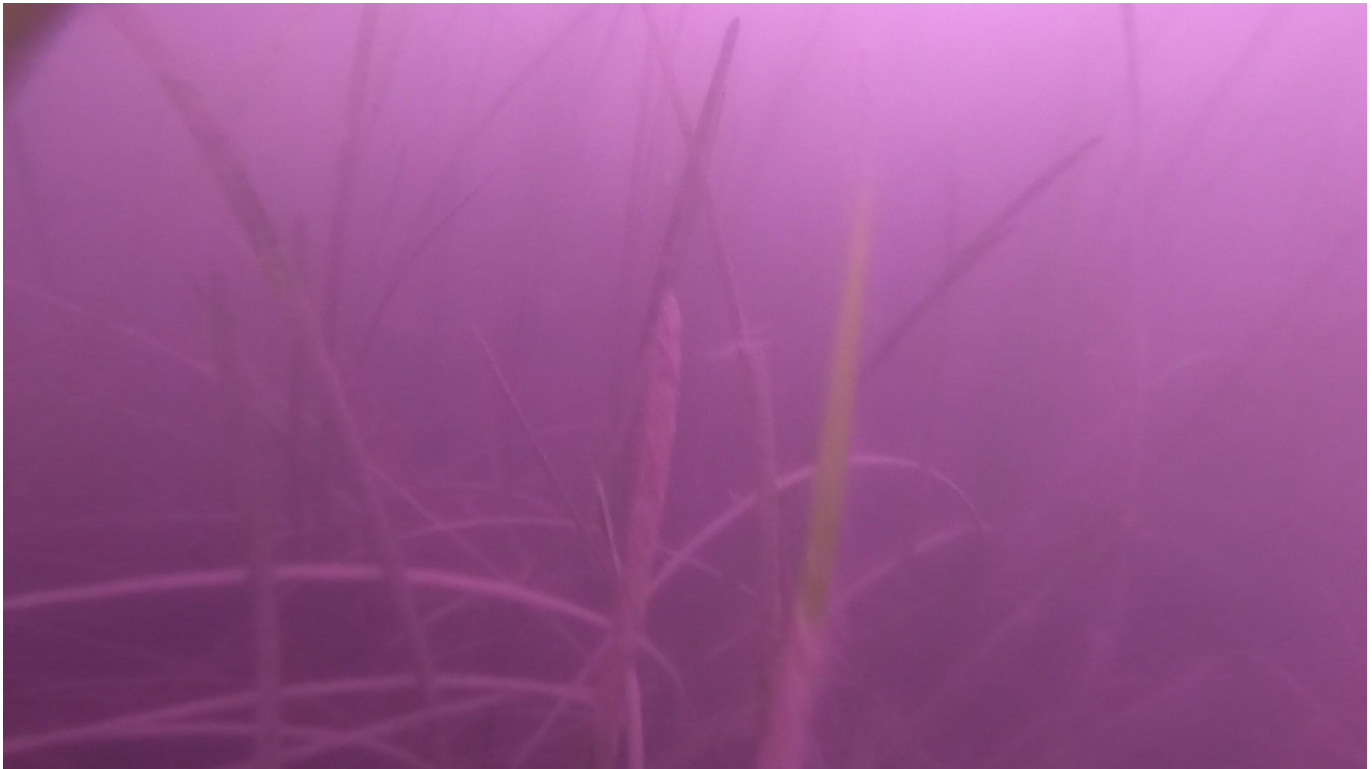
Photograph Two: Eelgrass within the Proposed Bailey Coffin Lease site in Freeport Maine. AE, July 12, 2021.

The purpose of the survey was to confirm, locate, and document the extent of eelgrass within the project area. Due to poor visibility the extent of eelgrass within the site could not be determined. However, it is AE's opinion that a significant area of eelgrass exists within the southeast corner of the lease site.
