### APPLICATION FOR LEASE RENEWAL

Lease Acronym	BHB-GC4
Name of Leaseholder	Acadia Aqua Farms, LLC
Name of Contact Person	Mary de Koning
Address	806 Bar Harbor Rd
City	Trenton
State, Zip	04605
Telephone	207-664-1644
Email	info@hollanderanddekoning.com
Term Requested	20 years

# Monitoring turbidity plumes from raising submerged oyster surface gear in Goose Cove, Maine

Report prepared for Acadia Aqua Farms LLC

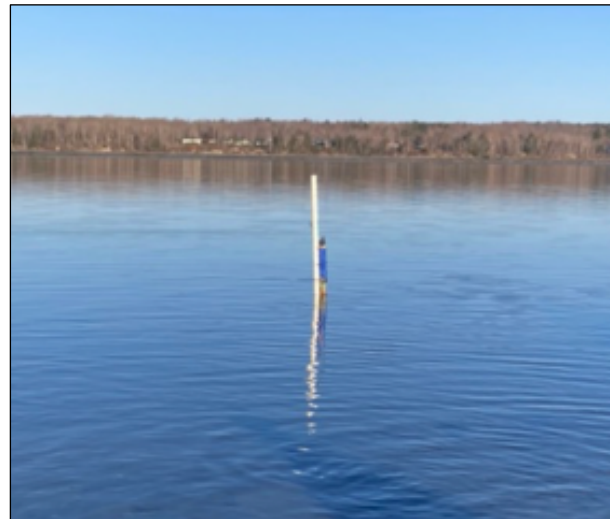
**Figure 3.** Deployment setup of eelgrass sonde attached to a PVC pole.

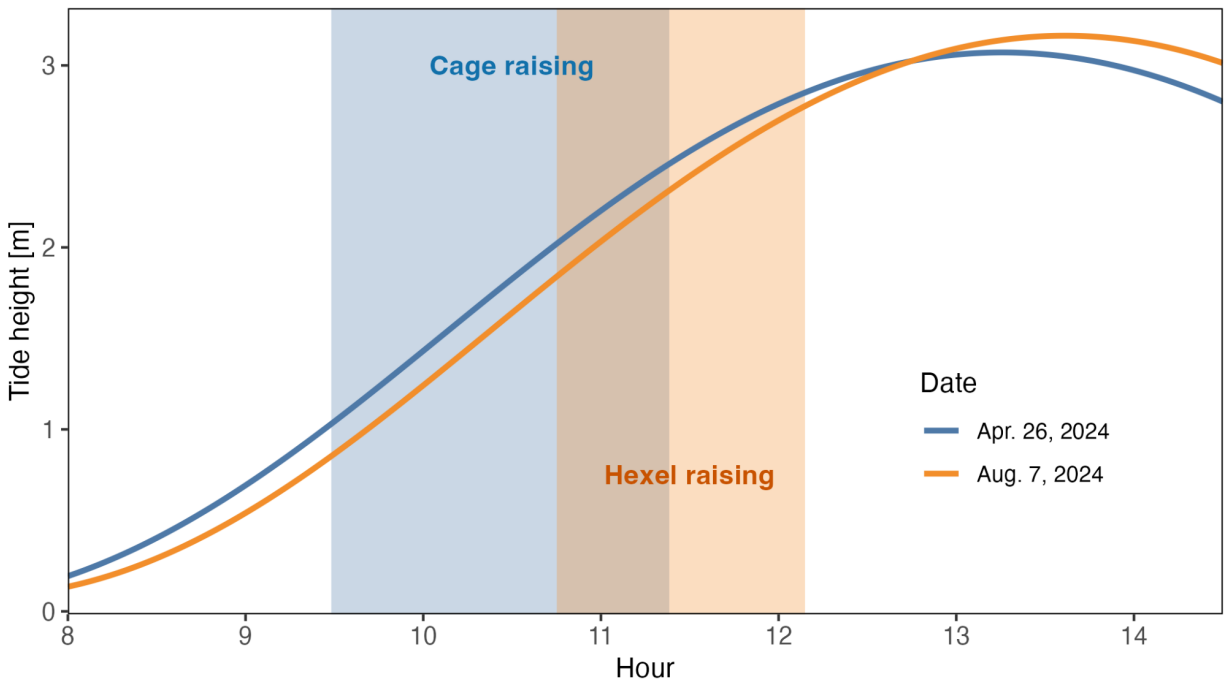
**Figure 4.** Tide height from the nearby NOAA Bar Harbor tide station. Shaded portions display the durations of gear raising on April 26th, 2024 (Cages, *blue*) and August 7th, 2024 (Hexel cages, *orange*).

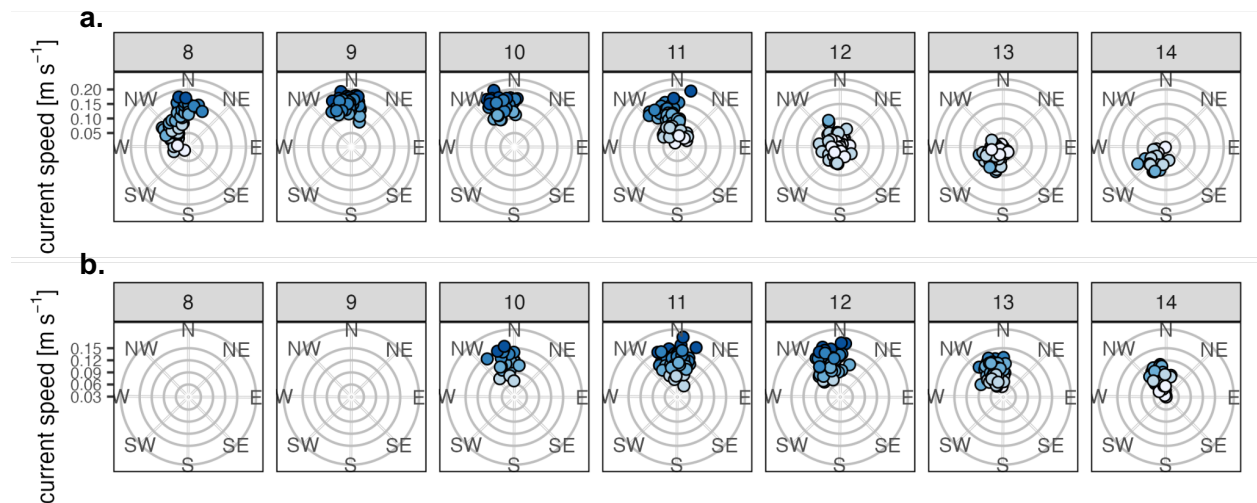
**Figure 10.** Current speed and cardinal direction from the cage raising experiment (a) and hexel bag raising experiment (b).

Both gear raising experiments occurred on a flood tide. The cage raising experiment took place directly at mid tide, while the hexel raising occurred slightly after mid-tide (Fig. 4). Current speeds during the deployments were similar ranging from  $0.0020$  to  $0.21 \text{ m s}^{-1}$  during cage raising and  $0.029$  to  $0.18 \text{ m s}^{-1}$  during the hexel raising (Fig. 10). For both experiments the current direction at the LPA sites was North to Northwest during the actual raising (Fig. 9). The midpoint sondes were located North-northwest of the farms, indicating that potential resuspension plumes would have traveled past the deployed sensors.

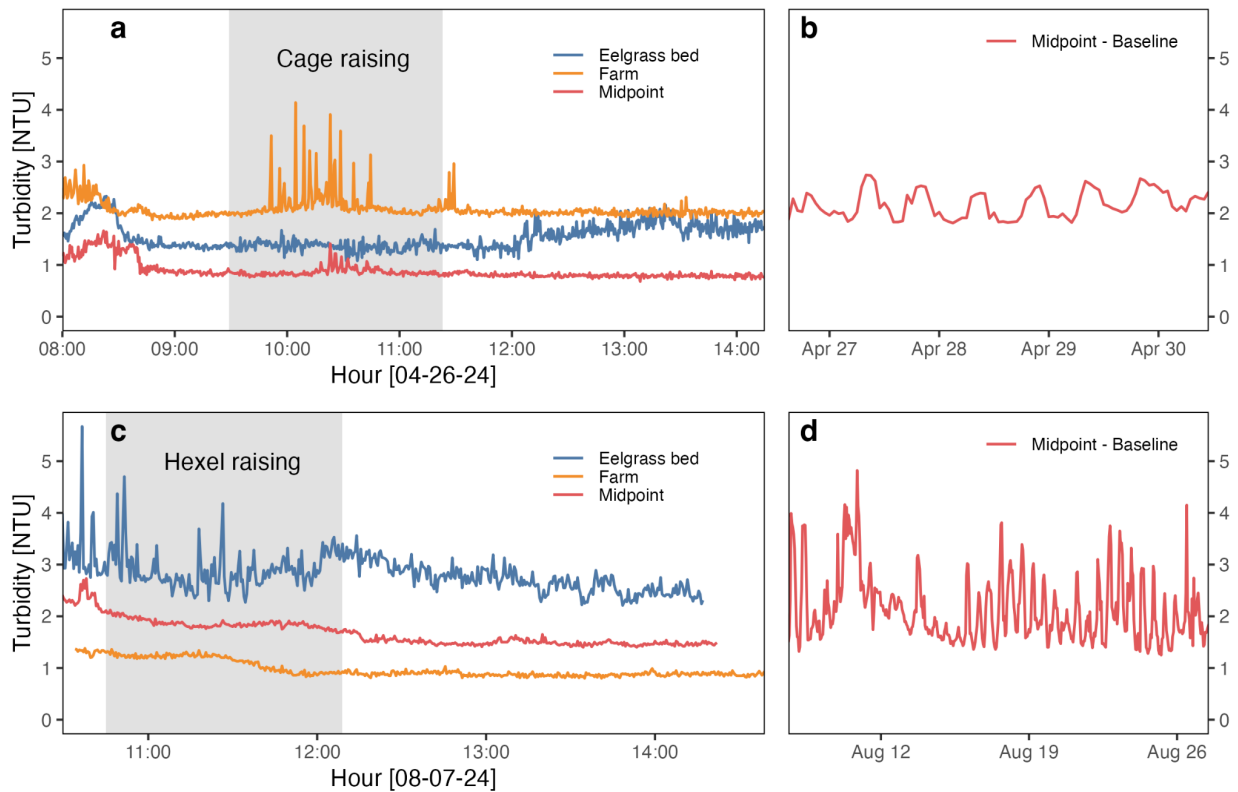
**Figure 11.** 30 second turbidity measurements from cage (a) and hexel (c) raising experiments on 4/26/24 and 8/7/24 respectively. Hourly measurements from sondes left at midpoint stations for 4 and 19 days after each experiment (b & d).

For the cage-raising experiment, mean turbidity across the high-frequency monitoring period was highest at the farm site ( $2.09 \pm 0.22 \text{ NTU}$ ), followed by the eelgrass bed ( $1.54 \pm 0.24 \text{ NTU}$ ), and lowest at the midpoint location ( $0.88 \pm 0.17 \text{ NTU}$ ; Fig. 13a). During the cage-raising period itself, small turbidity spikes were observed at the farm sonde, with a maximum value of  $4.14 \text{ NTU}$  (Fig. 11a). At the midpoint location, smaller increases were also detected, reaching up to  $1.41 \text{ NTU}$  during this same period (Fig. 11a). Although the elevated turbidity at the farm site is likely attributable to cage raising, the drivers of variability at the

midpoint and eelgrass sites are less clear. Importantly, the magnitude of these turbidity spikes (Fig. 11a) and associated increases in coefficient of variation (CV; Fig. 12a) were comparable to background variability observed during the hour prior to gear retrieval (Figs. 11 & 12) and to tidal-scale fluctuations recorded during post-experiment baseline monitoring at the midpoint (Figs. 12b, c).

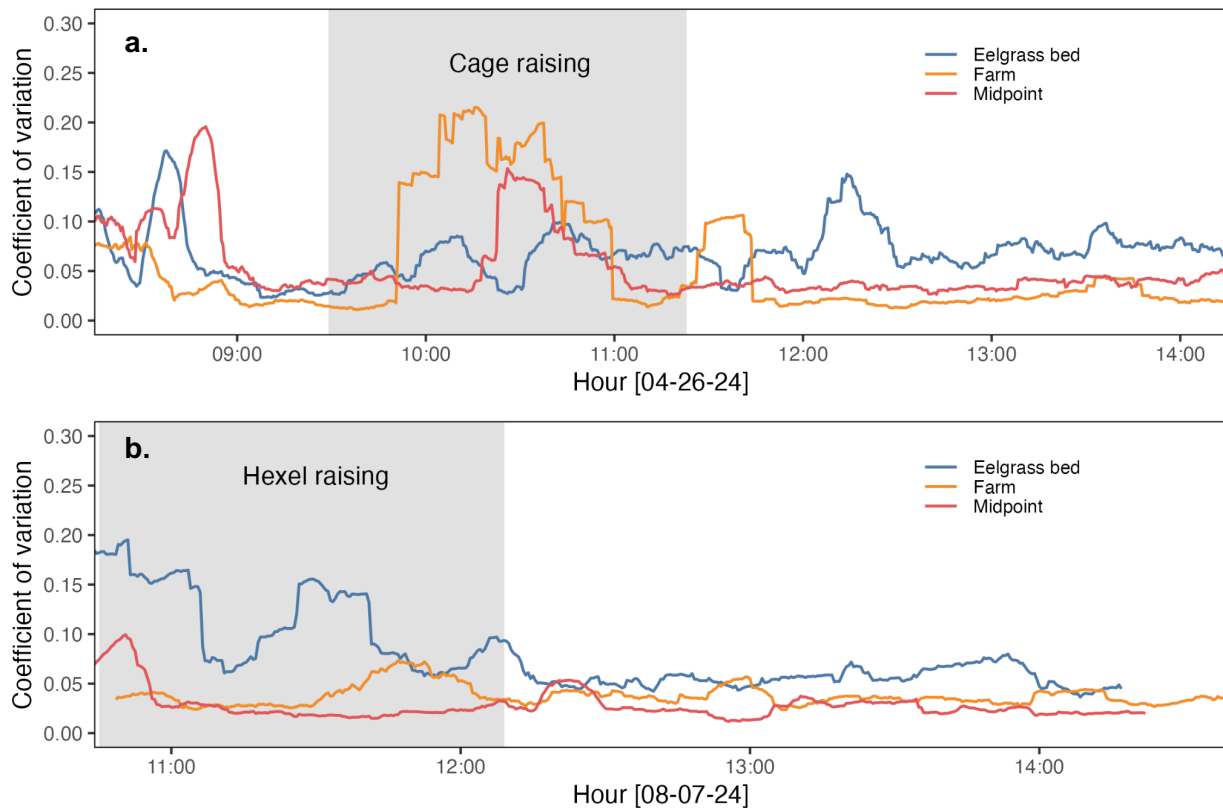
**Figure 12.** Rolling 30-minute coefficient of variation on turbidity data from cage raising (a) and hexel raising (b) experiments. Grey shading indicates duration of sunken gear raising.

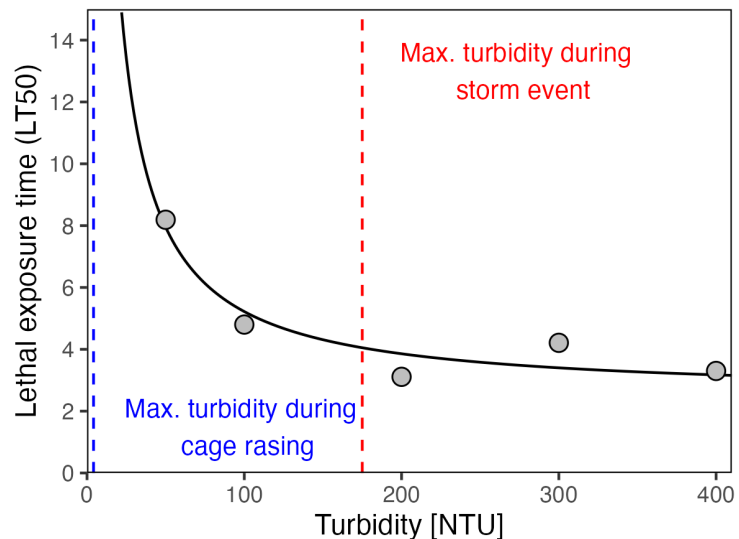
**Figure 14.** Lethal time to 50% mortality of experimental eelgrass (*Z. marina*) and maximum turbidity observed during cage raising (blue dashed line) and a storm event (red dashed line). Figure reproduced from Li et al. 2021.

The ecological significance of turbidity pulses depends on both magnitude and duration (Moore et al. 1997). A recent experimental study on *Z. marina* reported a lethal time to 50% mortality of approximately four days at sustained turbidity of 175 NTU (Fig. 14, Li et al. 2021). In Goose Cove, storm-driven turbidity peaks of comparable magnitude persisted for only several hours, and gear-raising effects peaked near 4–5 NTU, comparable to control conditions in Li et al. (2021).
