Figure 1: Proposed lease area¹

Location: Clark Cove, Damariscotta River, South Bristol, Lincoln County, Maine

Purpose: Standard lease for the suspended culture of seaweeds (*Saccharina latissima*, *Laminaria angustissima*, *Alaria esculenta*, *Laminaria digitata*, *Agarum cribrosum*, *Palmaria palmata*, *Porphyra umbilicalis*, *Chondrus crispus*, *Ulva lactuca*, *Gracilaria tikvahiae*, *Chorda tomentosa*, *Agardhiella tenera*, *Desmarestia viridis*, *Scytosiphon lomentaria*, and *Petalonia fascia*).

Report Completed: April 12, 2022

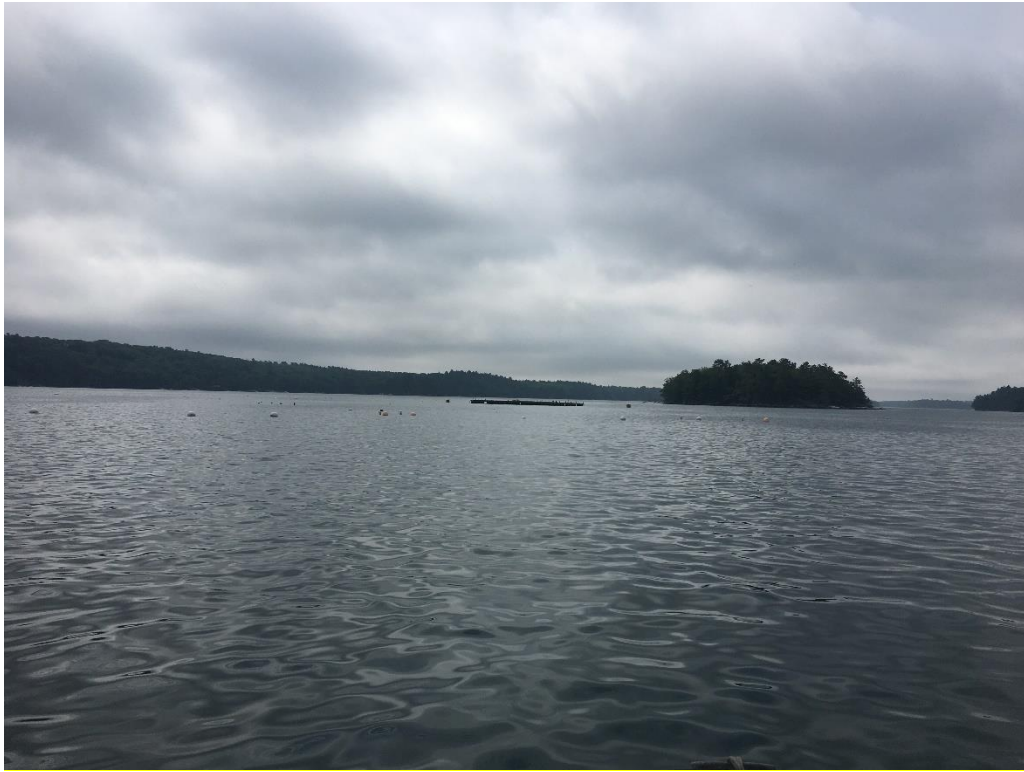
Image 3: Looking south toward the applicant’s existing aquaculture lease DAM CC3x, aquaculture lease DAM CC2, and Miller Island from west of proposed corner 5 (July 6, 2021).

On July 6, 2021, Maine Department of Marine Resources (MDMR) Scientists Marcy Nelson, Flora Drury, and Cheyenne Adams visited the proposed aquaculture lease site. MDMR staff arrived on site at approximately 11:00am; the tide was slack low at this time. The proposed lease occupies the same footprint as the existing experimental lease DAM CC3x, which is held by the applicant, and abuts the northwest boundaries of existing lease DAM CC2, held by Damariscove Seafood, LLC (Figure 2). Upland characteristics consist of a rocky shoreline leading to mixed forest and grassy fields (Image 1). Multiple houses are present along the shoreline of Clark Cove, within 1,000 feet of the proposed lease site, and others located at greater distances are visible from the proposed site (Image 1). Clark Cove is used for both commercial and recreational purposes. Aquaculture gear was present within the existing leases DAM CC2 and DAM CC3x at the time of MDMR's site assessment on July 6, 2021 (Image 3).

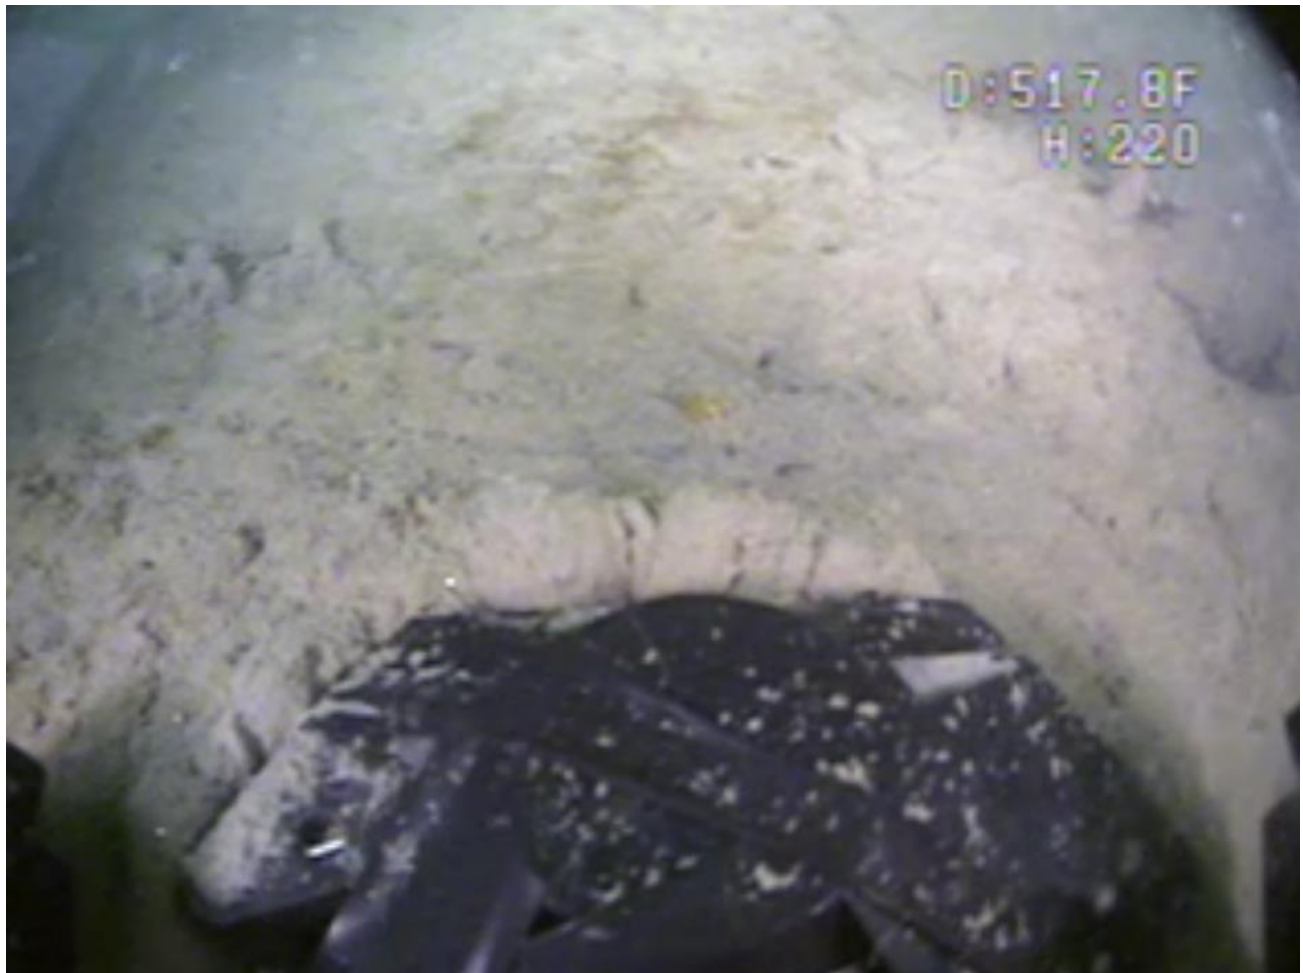
Image 5: Soft mud substrate on the bottom of the proposed lease area (July 6, 2021).

The bottom of the proposed lease site was assessed with a remotely operated vehicle (ROV) on July 6, 2021. The observed bottom substrate was entirely soft mud (Image 5). Bottom characteristics were categorized using the Coastal and Marine Ecological Classification Standard (CMECS), a national standard for describing features of the marine environment. Sediment information was determined based on visual analysis of the video; no sediment samples were taken, or grain size analysis performed. The substrate types observed during the ROV transects and drops are included in Table 2.

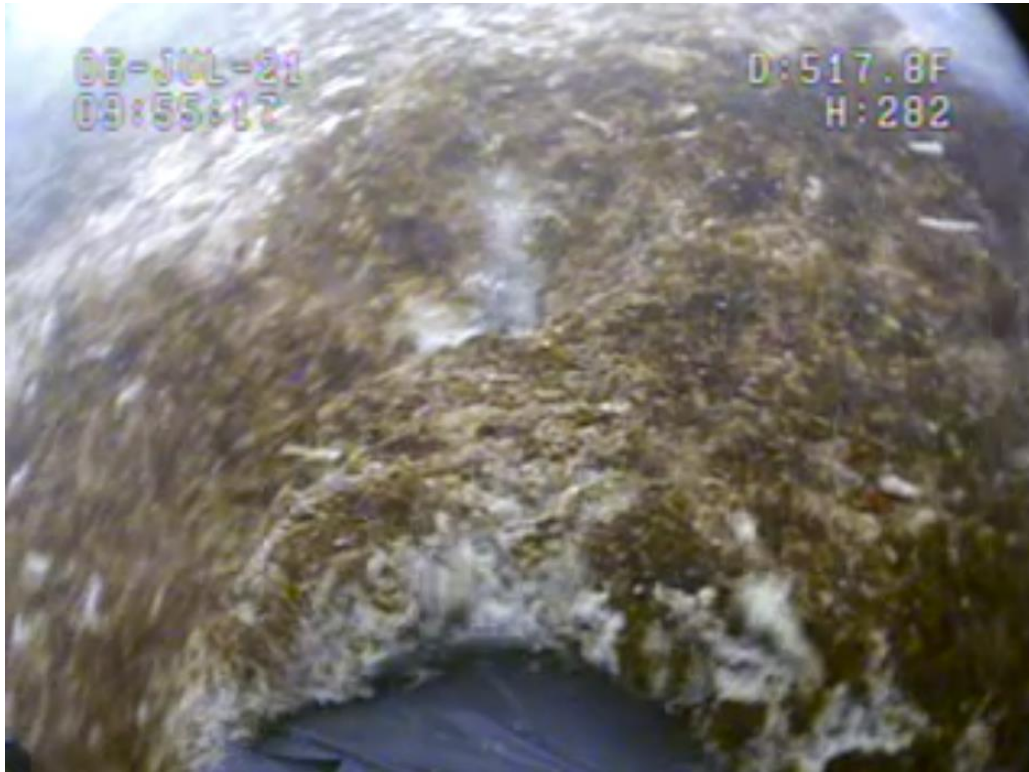
Image 11: Benthic diatoms on the proposed lease bottom (July 6, 2021).

On July 6, 2021, MDMR examined the epibenthic ecology of the proposed lease site with a Remotely Operated Vehicle (ROV). One stationary drop and two transects were conducted within the proposed lease boundaries, and one short transect was conducted immediately outside of the proposal (Figure 4). In the video footage obtained, the bottom substrate was observed to be entirely soft mud. The most abundant species observed was benthic diatoms. Other species and observations are listed in Table 4.

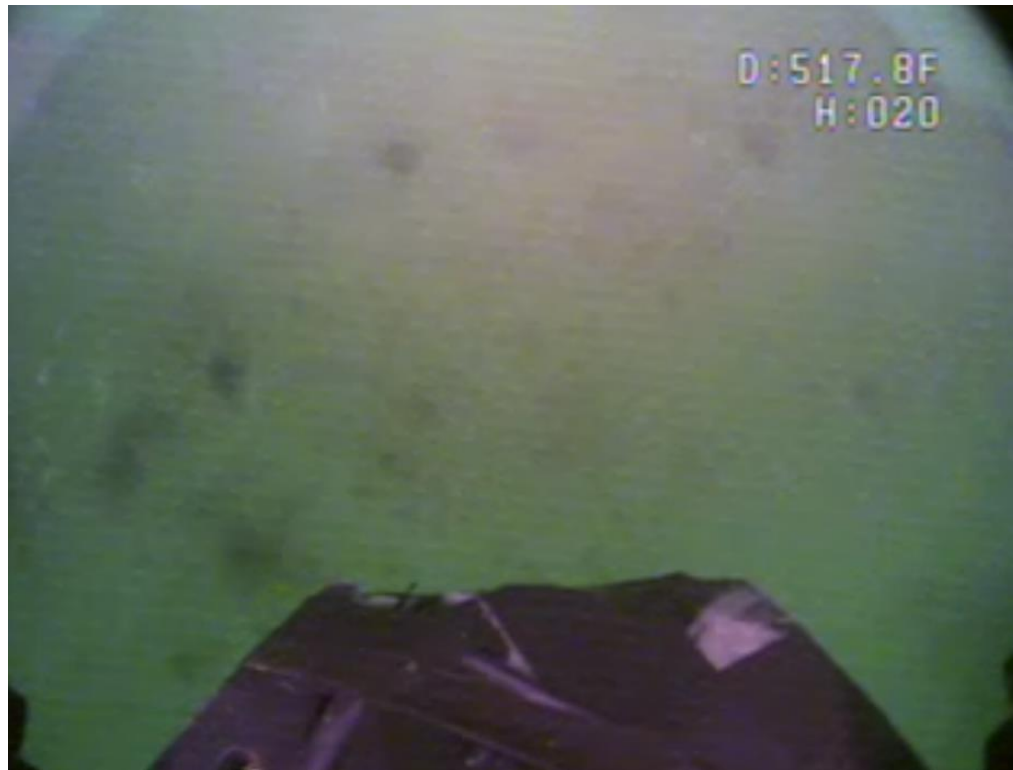
Image 11: Burrows on the proposed lease bottom (July 7, 2021).

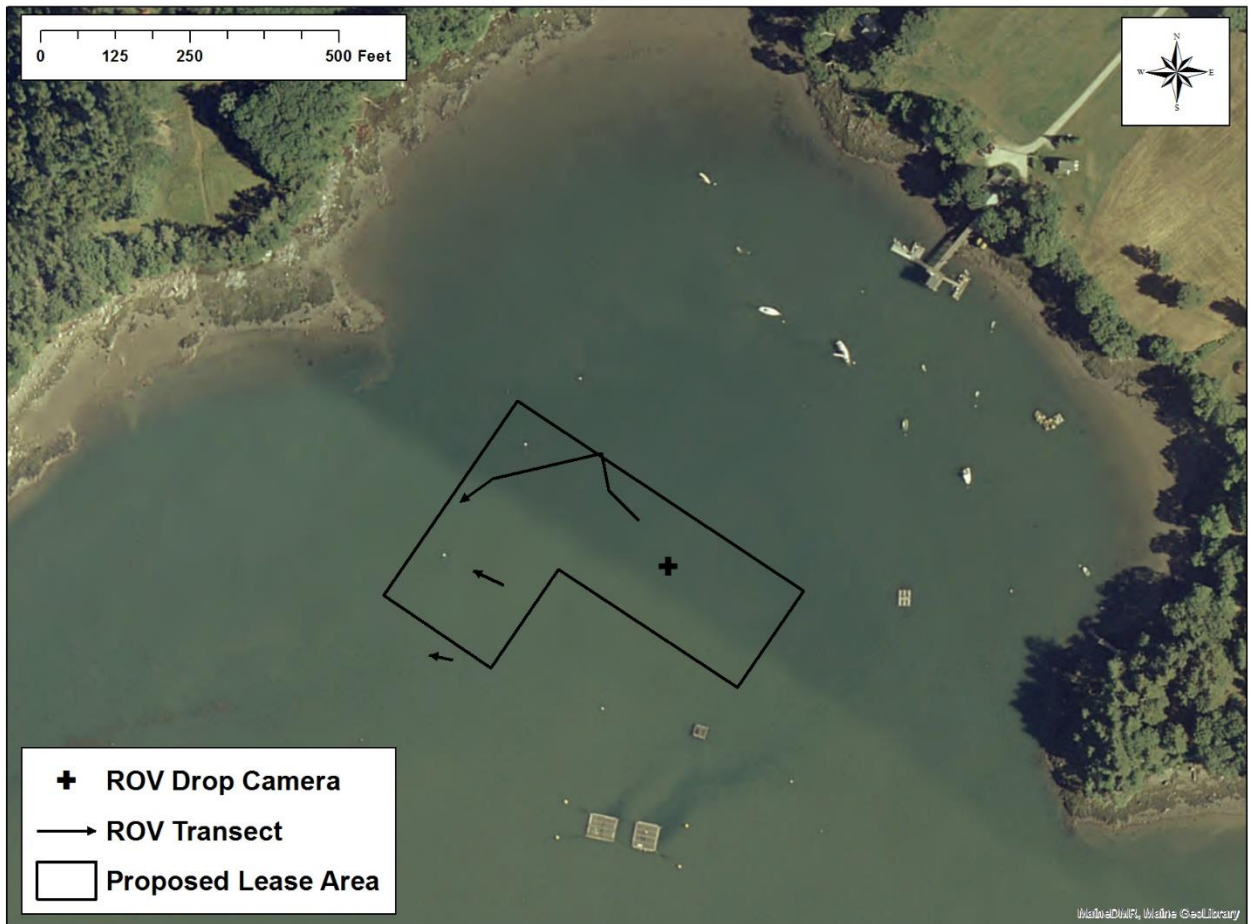
Figure 4. ROV stationary drop and transects conducted on July 6, 2021.

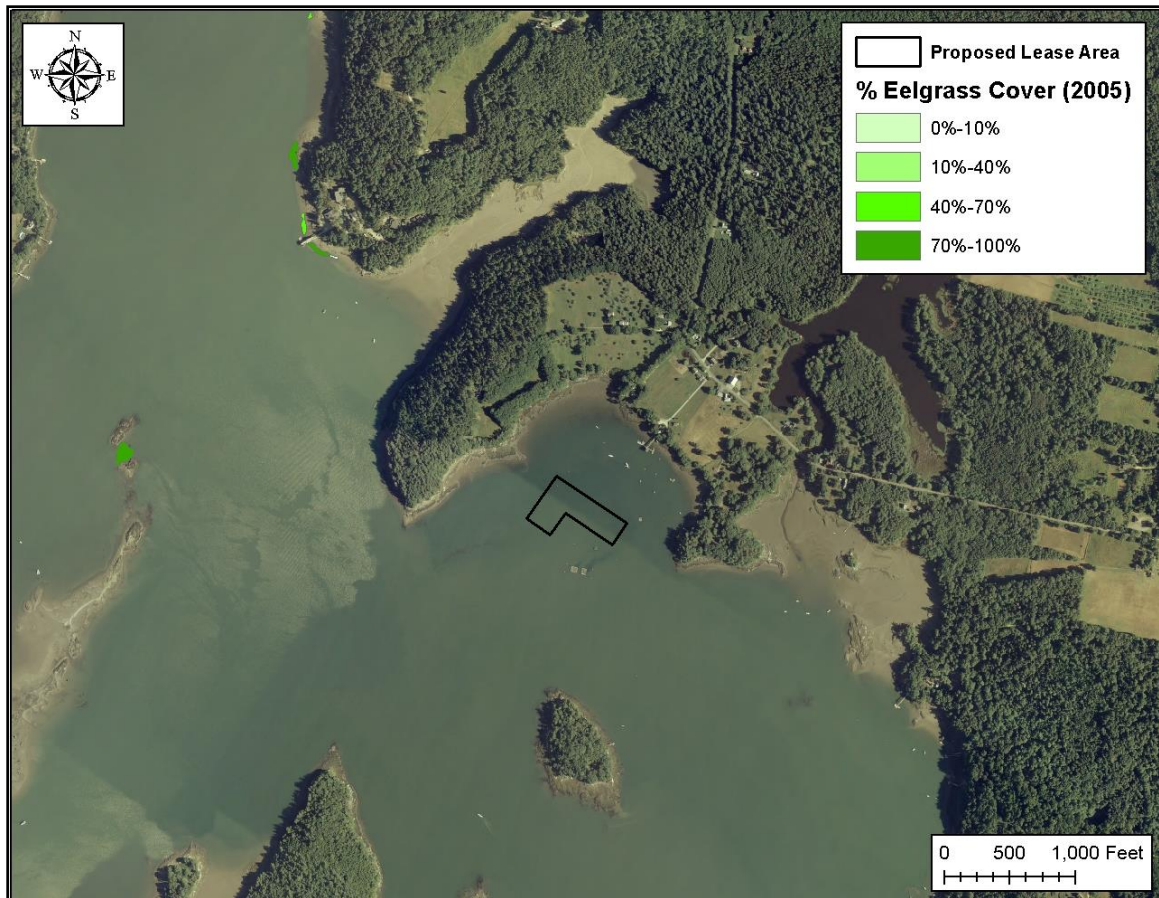
Figure 5: Historical eelgrass in vicinity of proposed lease site.⁵

No eelgrass was observed from the limited benthic observation via ROV. Additionally, records of eelgrass distribution collected by MDMR in 2005 do not indicate historical eelgrass presence in Clark Cove (Figure 5).
