## **Site Characterization Multibeam Survey around the Stillwater Bridge in Old Town, Maine**

At the request of VHB, Substructure recently completed a site characterization multibeam and sub-bottom profile survey around the Stillwater Avenue Bridge where it crosses the Stillwater River in Old Town, Maine (Figure 1). The following is a brief discussion of the methods employed during this survey. In addition, page-sized plots presenting the results of this survey are also provided.

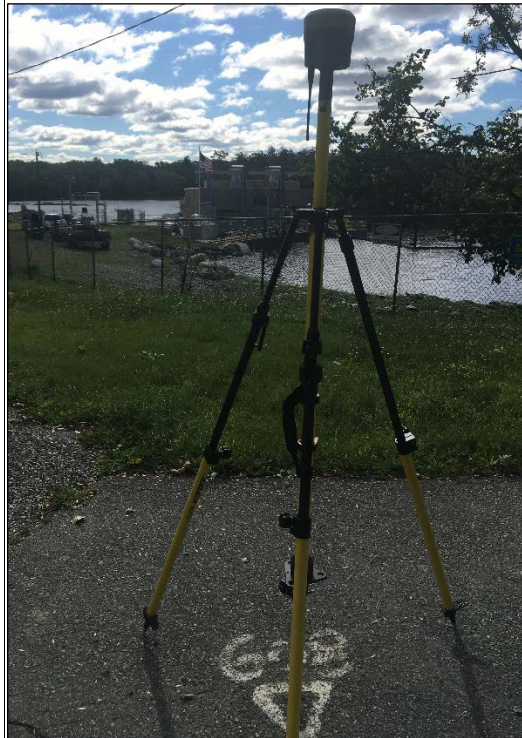
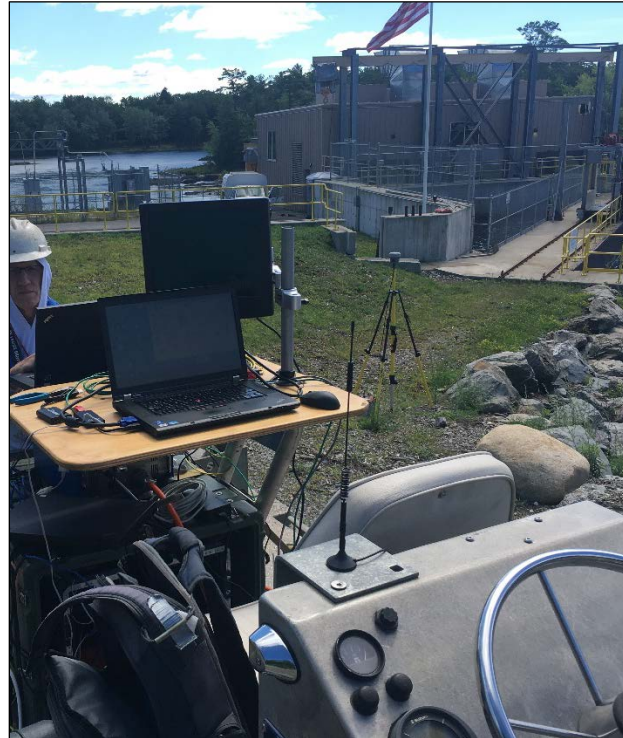
**Figure 2.** Overview of the DGNSS base station that was used to support the Stillwater Bridge site characterization survey. Left photo shows the R10 base GNSS receiver set-up over the MEDOT survey point 608 to obtain the initial RTK reference information for the temporary survey point on the Brookfield property. The right photo shows the base receiver in the background set-up over the temporary survey point that was used during the survey operations. The lower text box shows a portion of the OPUS computed results for the seven hours of 1-sec static GNSS data that were submitted for the temporary survey point.

1. Prior to the start of the survey, Substructure recovered the ME-DOT survey point 608 located along Stillwater Avenue north of the bridge and near the entrance drive into the Brookfield dam area. A Trimble R10 dual-frequency Global Navigation Satellite System (GNSS) receiver was set over this point to serve as a short-term base station and an R10 GNSS rover was used to set a temporary survey point on the Brookfield property between the boat ramp entrance and the dam area (Figure 2). The GNSS base receiver was moved to this new point and configured to log 1-second dual-frequency GNSS static data and to transmit real-time kinematic (RTK) differential GNSS (DGNSS) correctors to the survey vessel via a dedicated NTRIP caster network. This set-up provided cm-level horizontal and vertical accuracies on the survey vessel during most of the survey operations. During the survey, the NAD83 horizontal datum with a ME Central (ME-1812) state plane coordinate system (U.S. Survey Feet), and the NAVD88 vertical datum (U.S. Survey Feet) were used. The National Geodetic Survey (NGS) Geoid Model12B was used to transform the NAD83 GNSS ellipsoidal heights to NAVD88 orthometric heights. After completion of the survey operations, the static 1-second GNSS data logged at the base station were submitted to government-sponsored web-based processing services to compute a post-processed reference position for the base station.

recorded at the base station for around seven hours on the day of the survey and then submitted to both the NGS Online Positioning User Service (OPUS) and the Natural Resource Canada Precise Point Positioning (PPP) Service to check the original reference position and elevation derived from the initial RTK survey. The post-processed static GNSS reference results were used for POSPac post-processing, though the post-processed latitude, longitude, and ellipsoidal height agreed within 0.05 feet of the original RTK-derived reference values.

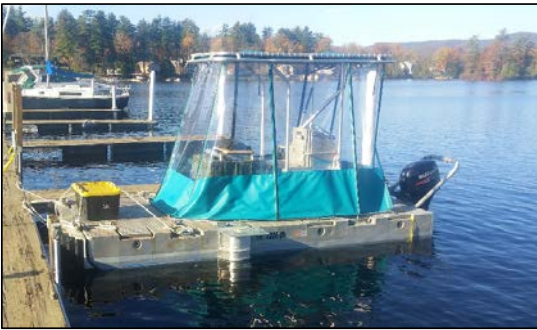
*Piper on a large inland lake configured for multibeam survey operations during a period of inclement weather*

**Figure 3.** Overview of Substructure's Survey Barge *Piper* that was used for the Stillwater Bridge survey. Due to the low bridge clearance, the canopy was removed and the POSMV antennas were mounted near the deck.

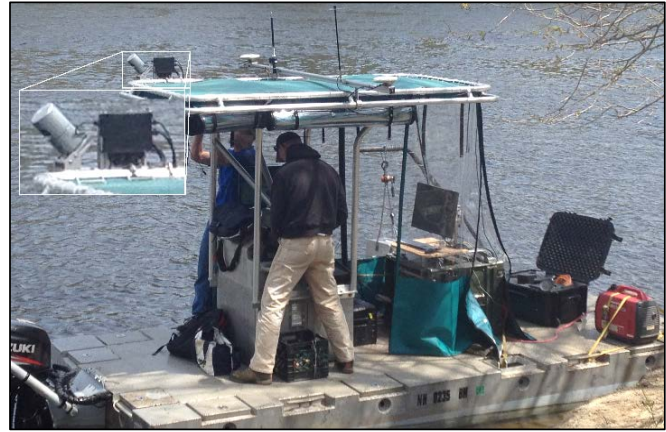
*Piper outfitted for combined multibeam and mobile laser scanning operations on a shallow inland river. Laser scanner is mounted on overhead canopy aft of POSMV antennas and multibeam sonar is mounted on port side.*

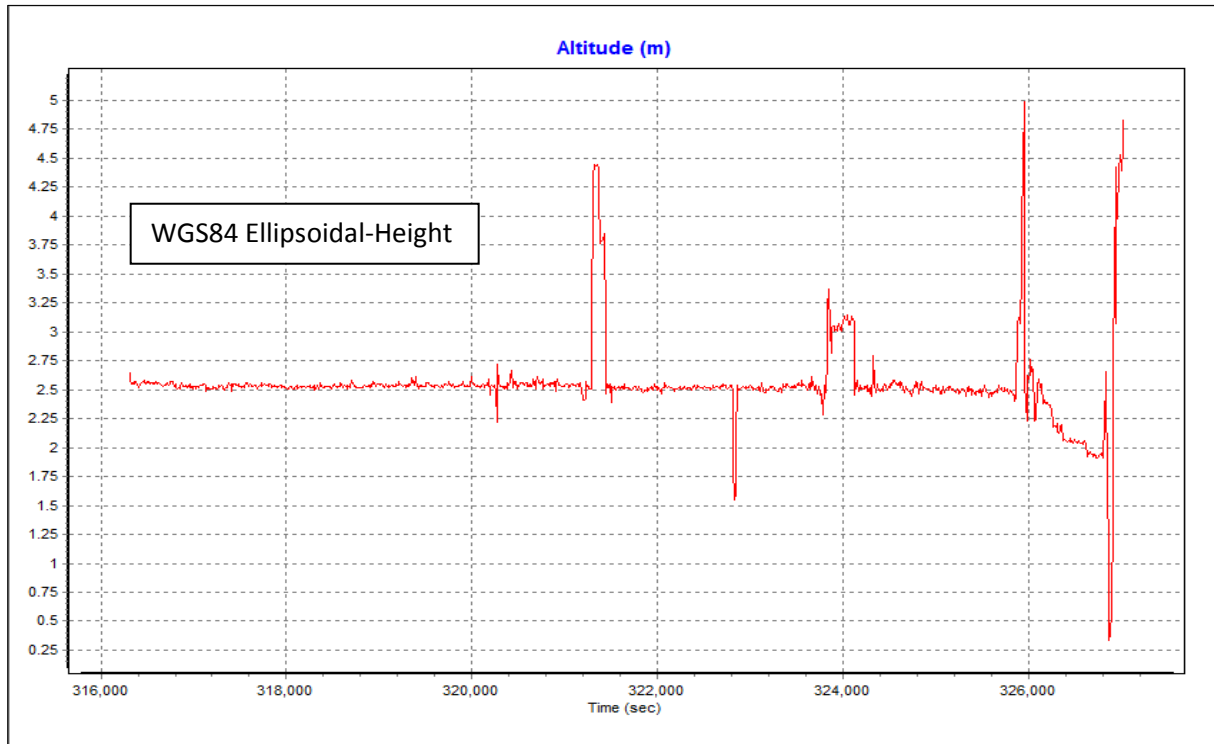
**Figure 4.** Overview of the POSPac MMS processing results for the survey period on 8/26/2020 (Day 239). The top panel shows that the post-processed horizontal Root Mean Square (RMS) values were consistently at or below 1 cm, while the vertical RMS values were consistently below 3 cm throughout the survey. The intermittent short term spikes in the RMS values were due to reduced satellite coverage while working around the bridge. The lower panel shows that the river water-level was consistent throughout the survey period, so that any short-term spikes in the elevation time-series due to the bridge obstruction could be smoothed over through interpolation using the valid data.

4. Initial processing of the multibeam data included confirming the base station reference information, reviewing the raw sensor and navigation data, reviewing and editing the RTK water-level data, reviewing and applying the speed of sound profile data, cleaning the raw acoustic data, and creation of preliminary gridded products to assess data coverage and conduct cross-check comparisons. All post-processing was conducted using QPS Qimera, Hypack, and SonarWiz software. In addition, the raw POSMV data were re-processed using the POSPac Mobile Mapping Suite (MMS) software to re-compute and reapply the complete navigation and elevation solution. Due to the overhead bridge obstruction and frequent disruption of satellite coverage, there were frequent short-term periods when the elevation solutions were degraded. After POSPac processing, horizontal Root Mean Square (RMS) values were consistently at or below 1 cm, while the vertical RMS values were consistently below 3 cm (Figure 4). The intermittent short term spikes in the elevation time-series due to the bridge obstruction were smoothed over through interpolation using the valid data. Static GNSS data were

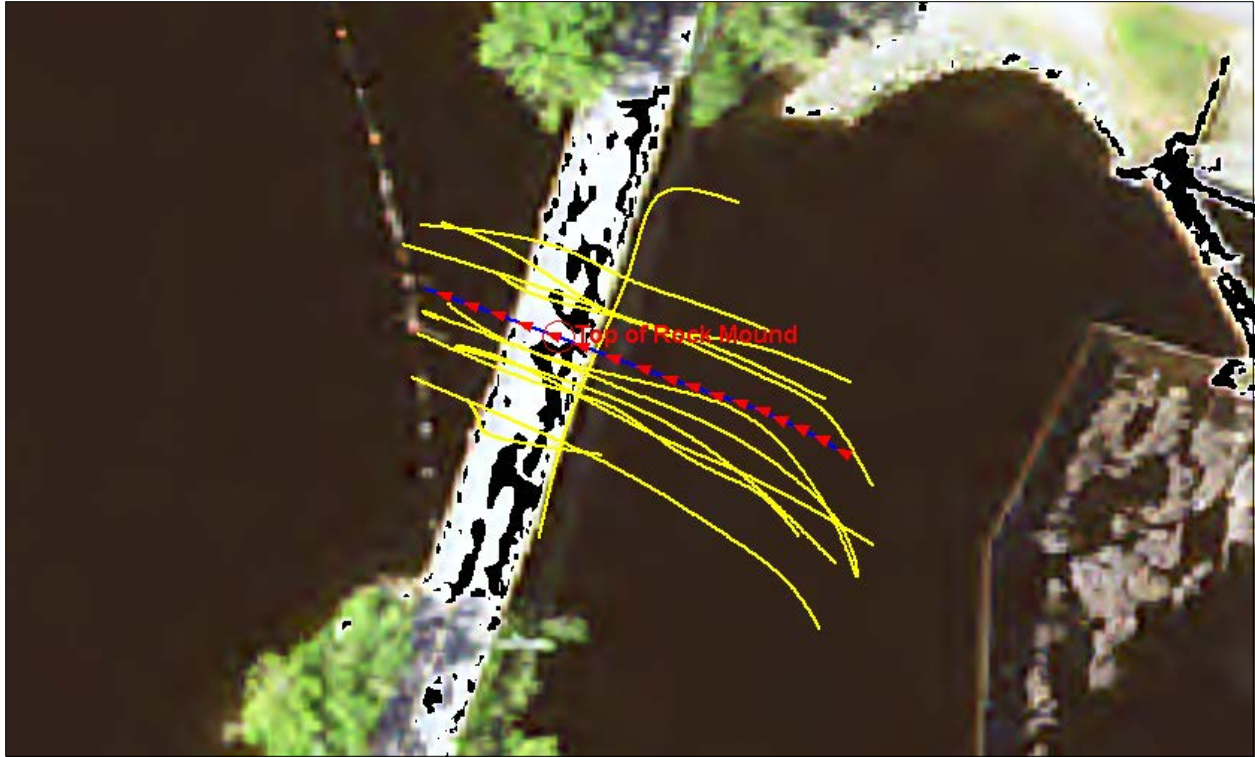
**Figure 5.** Sample SonarWiz view of one of the low frequency sub-bottom profile lines that were run between the piers of the northern bridge. These operations were conducted after the river barrier had been reinstalled, so navigation was restricted on the upstream side of the bridge. The top panel shows the trackplot for all of the sub-bottom profile lines that were run. The lower panel shows the low frequency (4 kHz) sonar trace for the highlighted line in the top panel. The high point of the rock mound located under the bridge has been identified on both the sonar trace and the trackplot. Because of the hardness of the river bottom, no acoustic horizons could be seen below the initial surface reflector.

2. Substructure conducted all survey operations aboard their small survey barge *Piper* on 8/26/2020 (Day 239) during a period of fair weather, strong northwesterly winds, and generally low flow conditions on the River. For the multibeam survey operations, standard equipment on *Piper* included an R2Sonic 2024 multibeam echosounder, an Applanix 320 POSMV vessel motion reference and navigation unit, a Valeport Mini sound velocity sensor (SVS) mounted near the multibeam array, a YSI Castaway conductivity-temperature-depth (CTD) speed of sound profiler, and QPS QINSy hydrographic data acquisition and processing software (Figure 3). For the sub-bottom profile operations, this same sensor and software suite was supplemented with an Innomar SES-2000 dual-frequency parametric sub-bottom profiler deployed on an over-the-bow fairing tightly integrated with the primary navigation system. Due to the hardness of the river bottom (primarily gravel and rock), the sub-bottom data did not provide any useful acoustic returns below the initial river bottom reflector.
