Survey Towns  
 Plotted L.I.B.  
 STATE HIGHWAY COMMISSION  
 Bridge Division  
**EMDEN-SOLON BRIDGE**  
 over the  
**KENNEBEC RIVER**  
 between the towns  
**EMDEN-SOLON**  
**SOMERSET CO.**  
**SURVEY PLAN**  
 Sheet of Augusta, Me. Sept. 1940

Survey Towne  
Plotted LJB  
STATE HIGHWAY COMMISSION  
BRIDGE DIVISION  
TOWN 13-16  
BRIDGE 2267  
**EMBDEN-SOLON BRIDGE**  
over the  
**KENNEBEC RIVER**  
between the towns of  
**EMBDEN-SOLON**  
**SOMERSET CO.**  
**SURVEY PLAN**  
Sheet of Augusta, Me Sept 1940

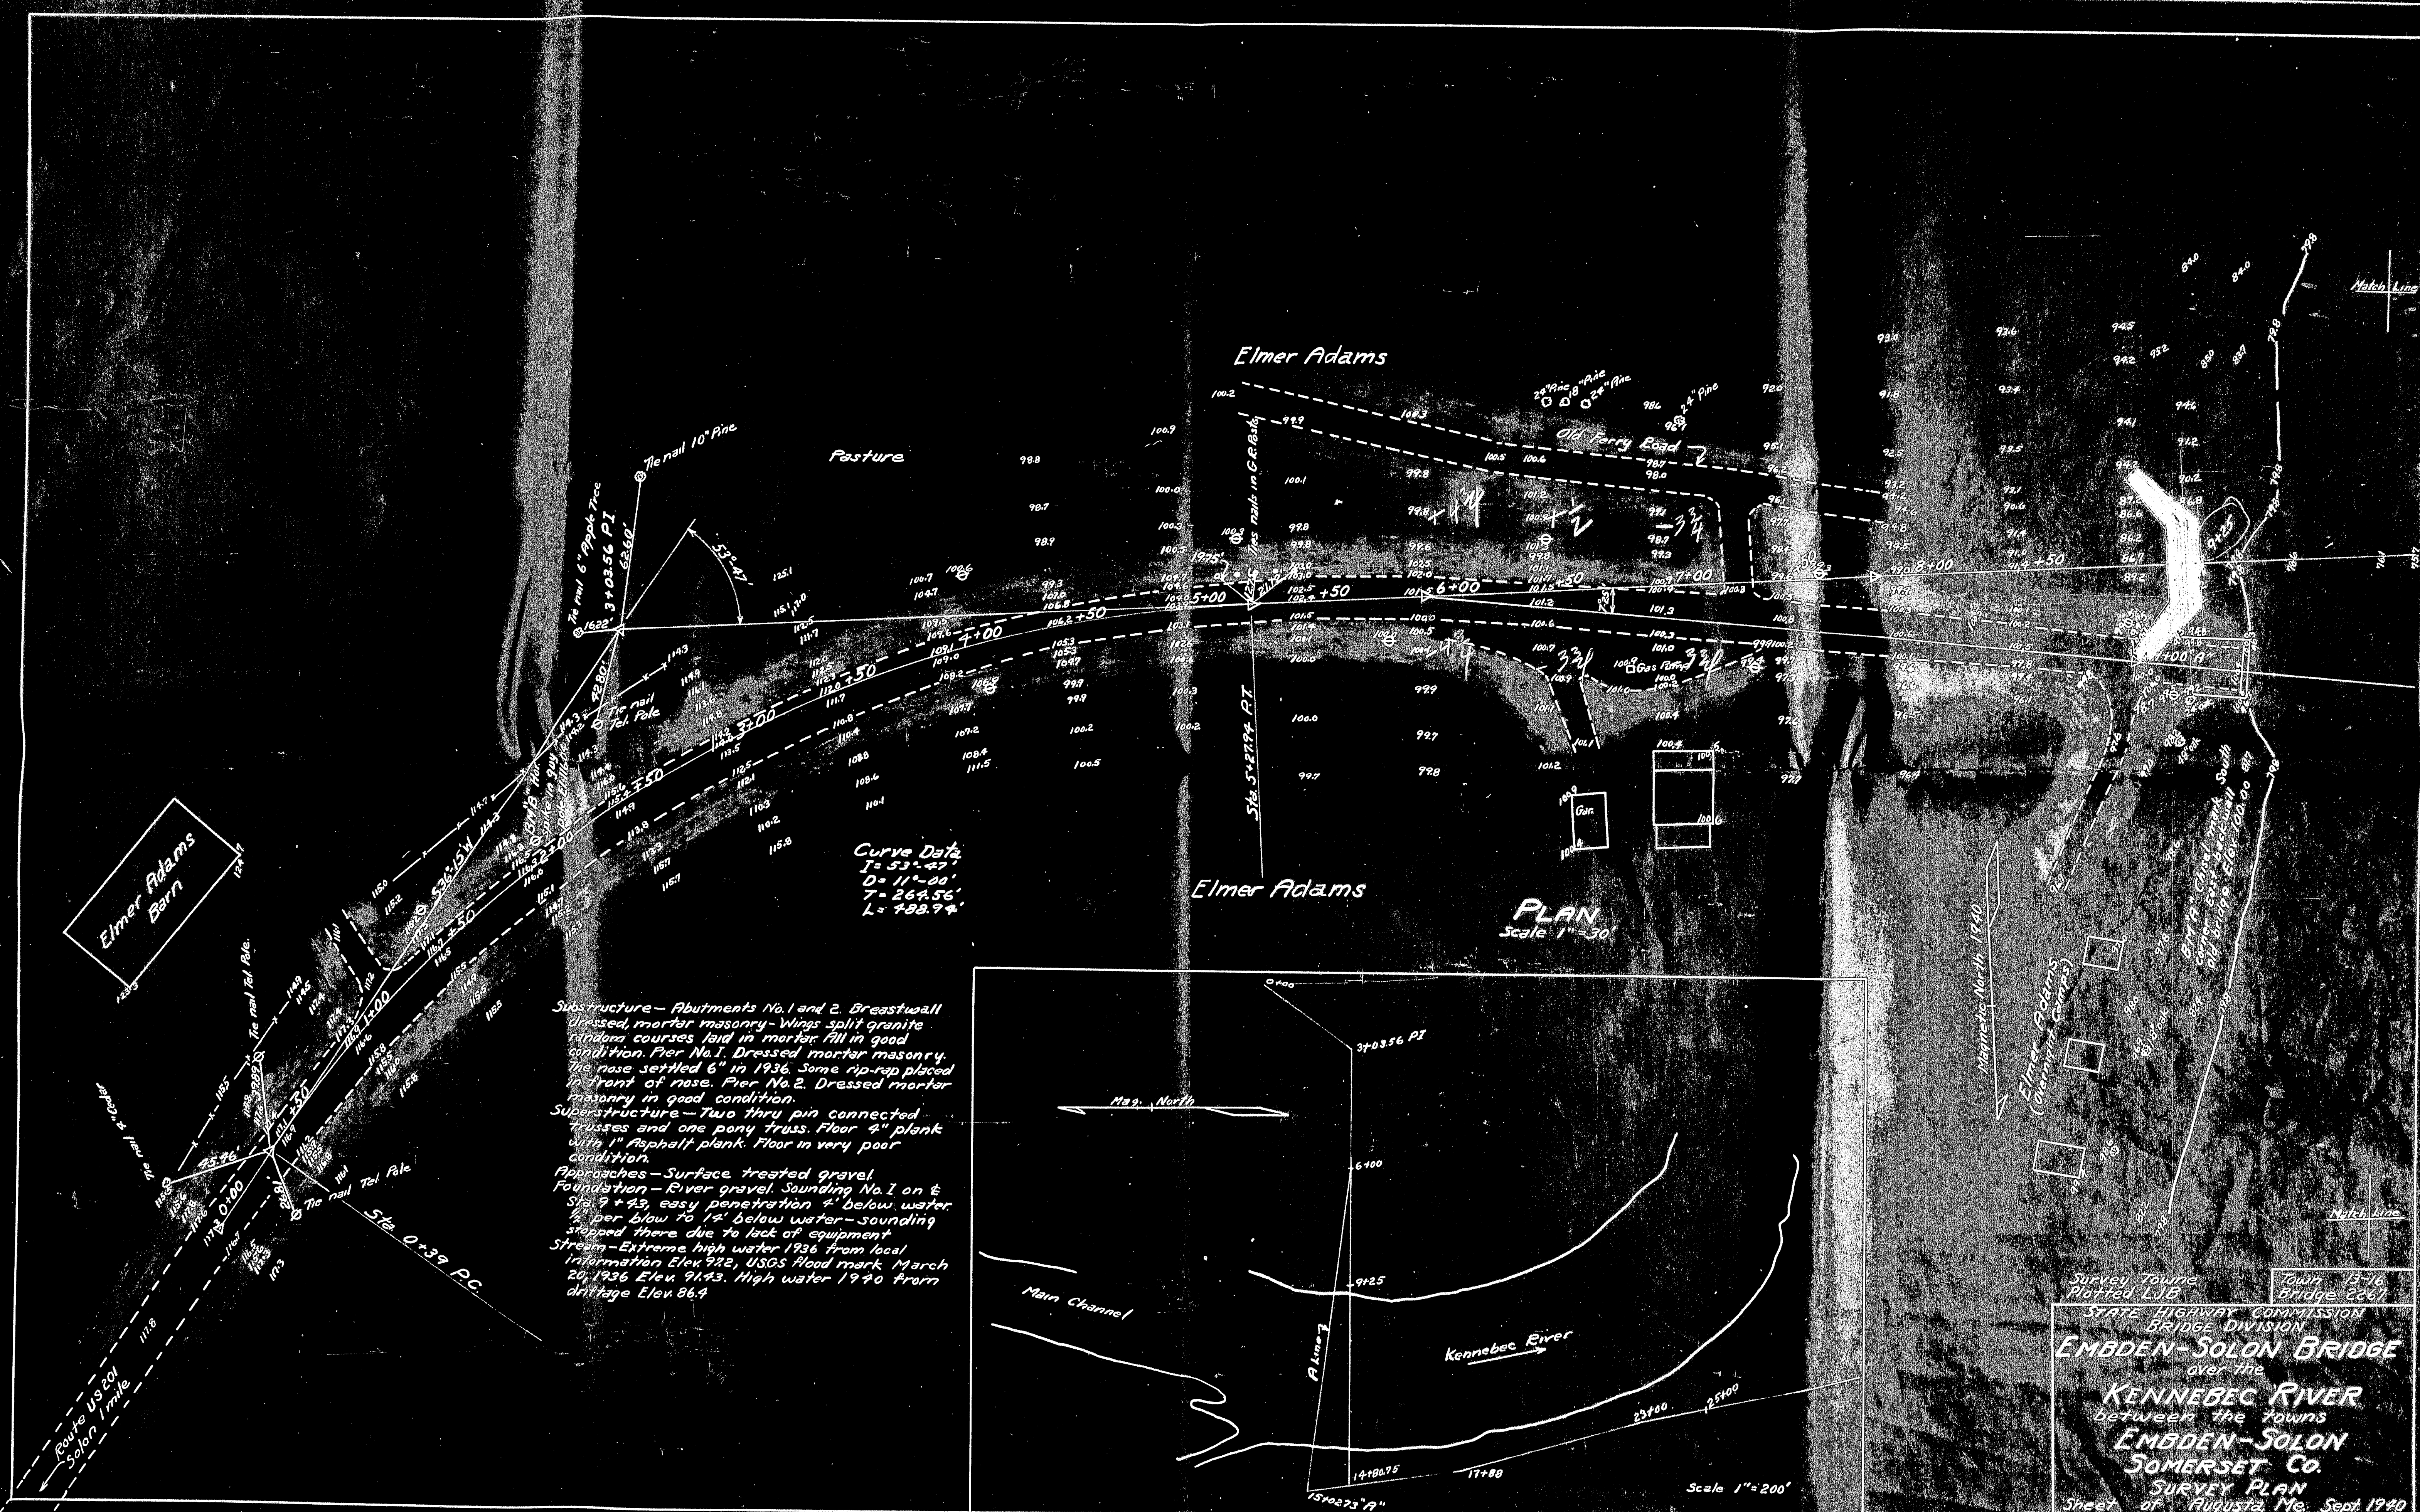
Substructure - Abutments No. 1 and 2. Breastwall dressed, mortar masonry - Wings split granite random courses laid in mortar. All in good condition. Pier No. 1. Dressed mortar masonry. The nose settled 6" in 1936. Some rip-rap placed in front of nose. Pier No. 2. Dressed mortar masonry in good condition.  
 Superstructure - Two thru pin connected trusses and one pony truss. Floor 4" plank with 1" asphalt plank. Floor in very poor condition.  
 Approaches - Surface treated gravel.  
 Foundation - River gravel. Sounding No. 1 on 6. Sta. 9+43, easy penetration 2' below water. 1/2 per blow to 14' below water - sounding stopped there due to lack of equipment.  
 Stream - Extreme high water 1936 from local information Elev. 92.2, USGS flood mark March 20, 1936 Elev. 91.43. High water 1970 from driftage Elev. 86.4.
