Maine Highway Commission
Bridge Division
HALL BRIDGE
over
NEZINSCOT RIVER
in
BUCKFIELD
OXFORD COUNTY
SURVEY
Sheet 2 of 6 Augusta, Me. Oct. 21, 1935

STATE HIGHWAY COMMISSION
BRIDGE DIVISION
HALL BRIDGE
OVER
NEZINSCOT RIVER
in the town of
BUCKFIELD
OXFORD COUNTY
GENERAL LAYOUT
Sheet 3 of 6 Augusta, Me. April 1936

STATE HIGHWAY COMMISSION
BRIDGE DIVISION
HALL BRIDGE
over
NEZINSCOT RIVER
in the town of
BUCKFIELD
OXFORD COUNTY
SUBSTRUCTURE DETAILS
Sheet 4 of 6 Augusta, Me. April 1936

STATE HIGHWAY COMMISSION
 BRIDGE DIVISION
HALL BRIDGE
 over
NEZINSCOT RIVER
 in the town of
BUCKFIELD
OXFORD COUNTY
 STRUCTURAL STEEL DETAILS
 Sheet 5 of 6 August 1936

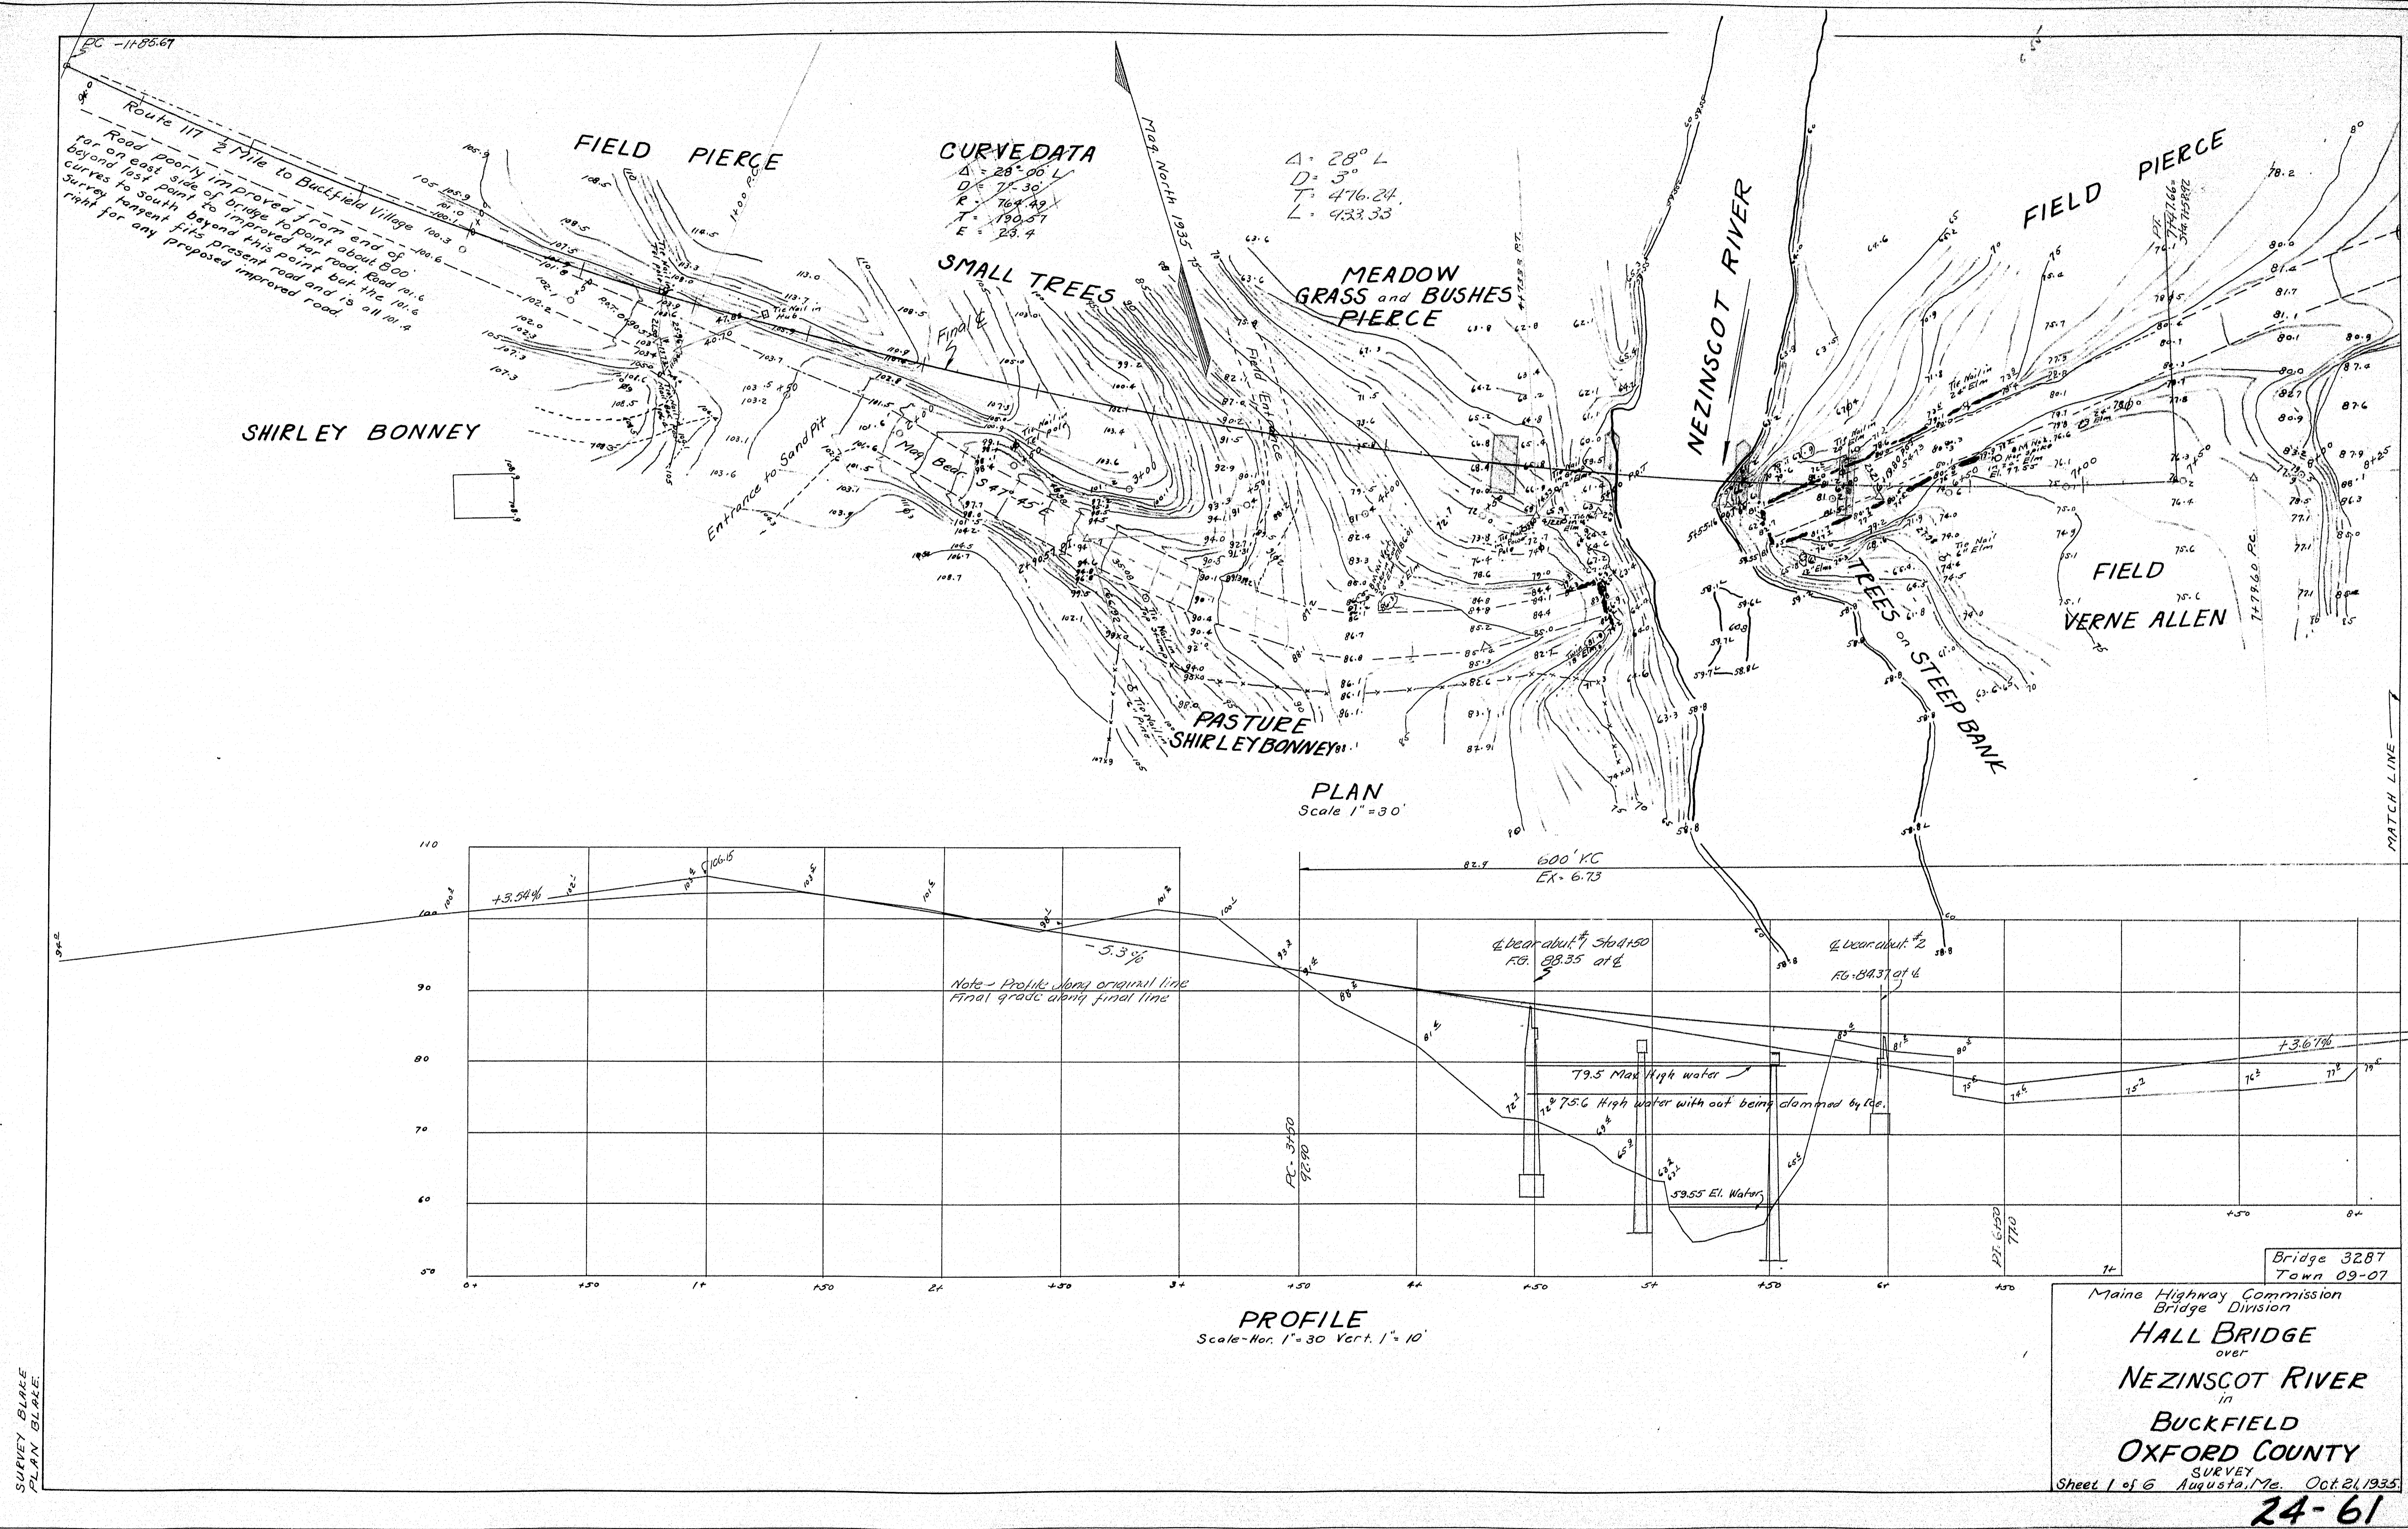
Superstructure — Lenticular steel truss in fair condition. Six panels of 12' each. (B) stringers of 6" x 8" and 3" x 8" spruce stringers. Transverse planking of 3" oak in good condition.
 Substructure — Abuts. of mostly split granite fairly well laid dry in fair condition.
 Stream — Extreme high water at El. 79.5. This high water due to ice jam below bridge. High water without being dammed by ice 75.6. Driftage on Abut. at El. 74.6. Stream appears to be constricted at bridge. Low water at present stage.
 Foundation — Ledge extends across entire stream bed just downstream from bridge.
 Sounding No. 1 @ Sta. 5+00. Rod pen. easily 4' to El. 59.2 then slower until hit Ledge at El. 56.5.
 Sounding No. 2 @ Sta. 5+00 Left 20' pent. thru soft mud to Ledge at El. 57.6.
 Streambed appears to be ledge at edge of water just upstream and downstream of line.
 Sounding No. 3 at Sta. 5+49 pent. easily 5' thru soft mud and clay to El. 51.6 to hit boulder or Ledge.

Sounding No. 4 20' Left Sta. 5+73 rod pen. easily 4' below ground to Ledge or boulder at El. 58.7.
 Sounding No. 5 20' Left Sta. 5+80 rod pen. easily 6' below ground to Ledge or boulder at El. 58.0.
 Edge of water upstream about 30' Ledge or boulders.
 Approaches — Road is improved and surface treated with tar on each side of bridge as shown on plan. Road between these points poorly improved gravel road.

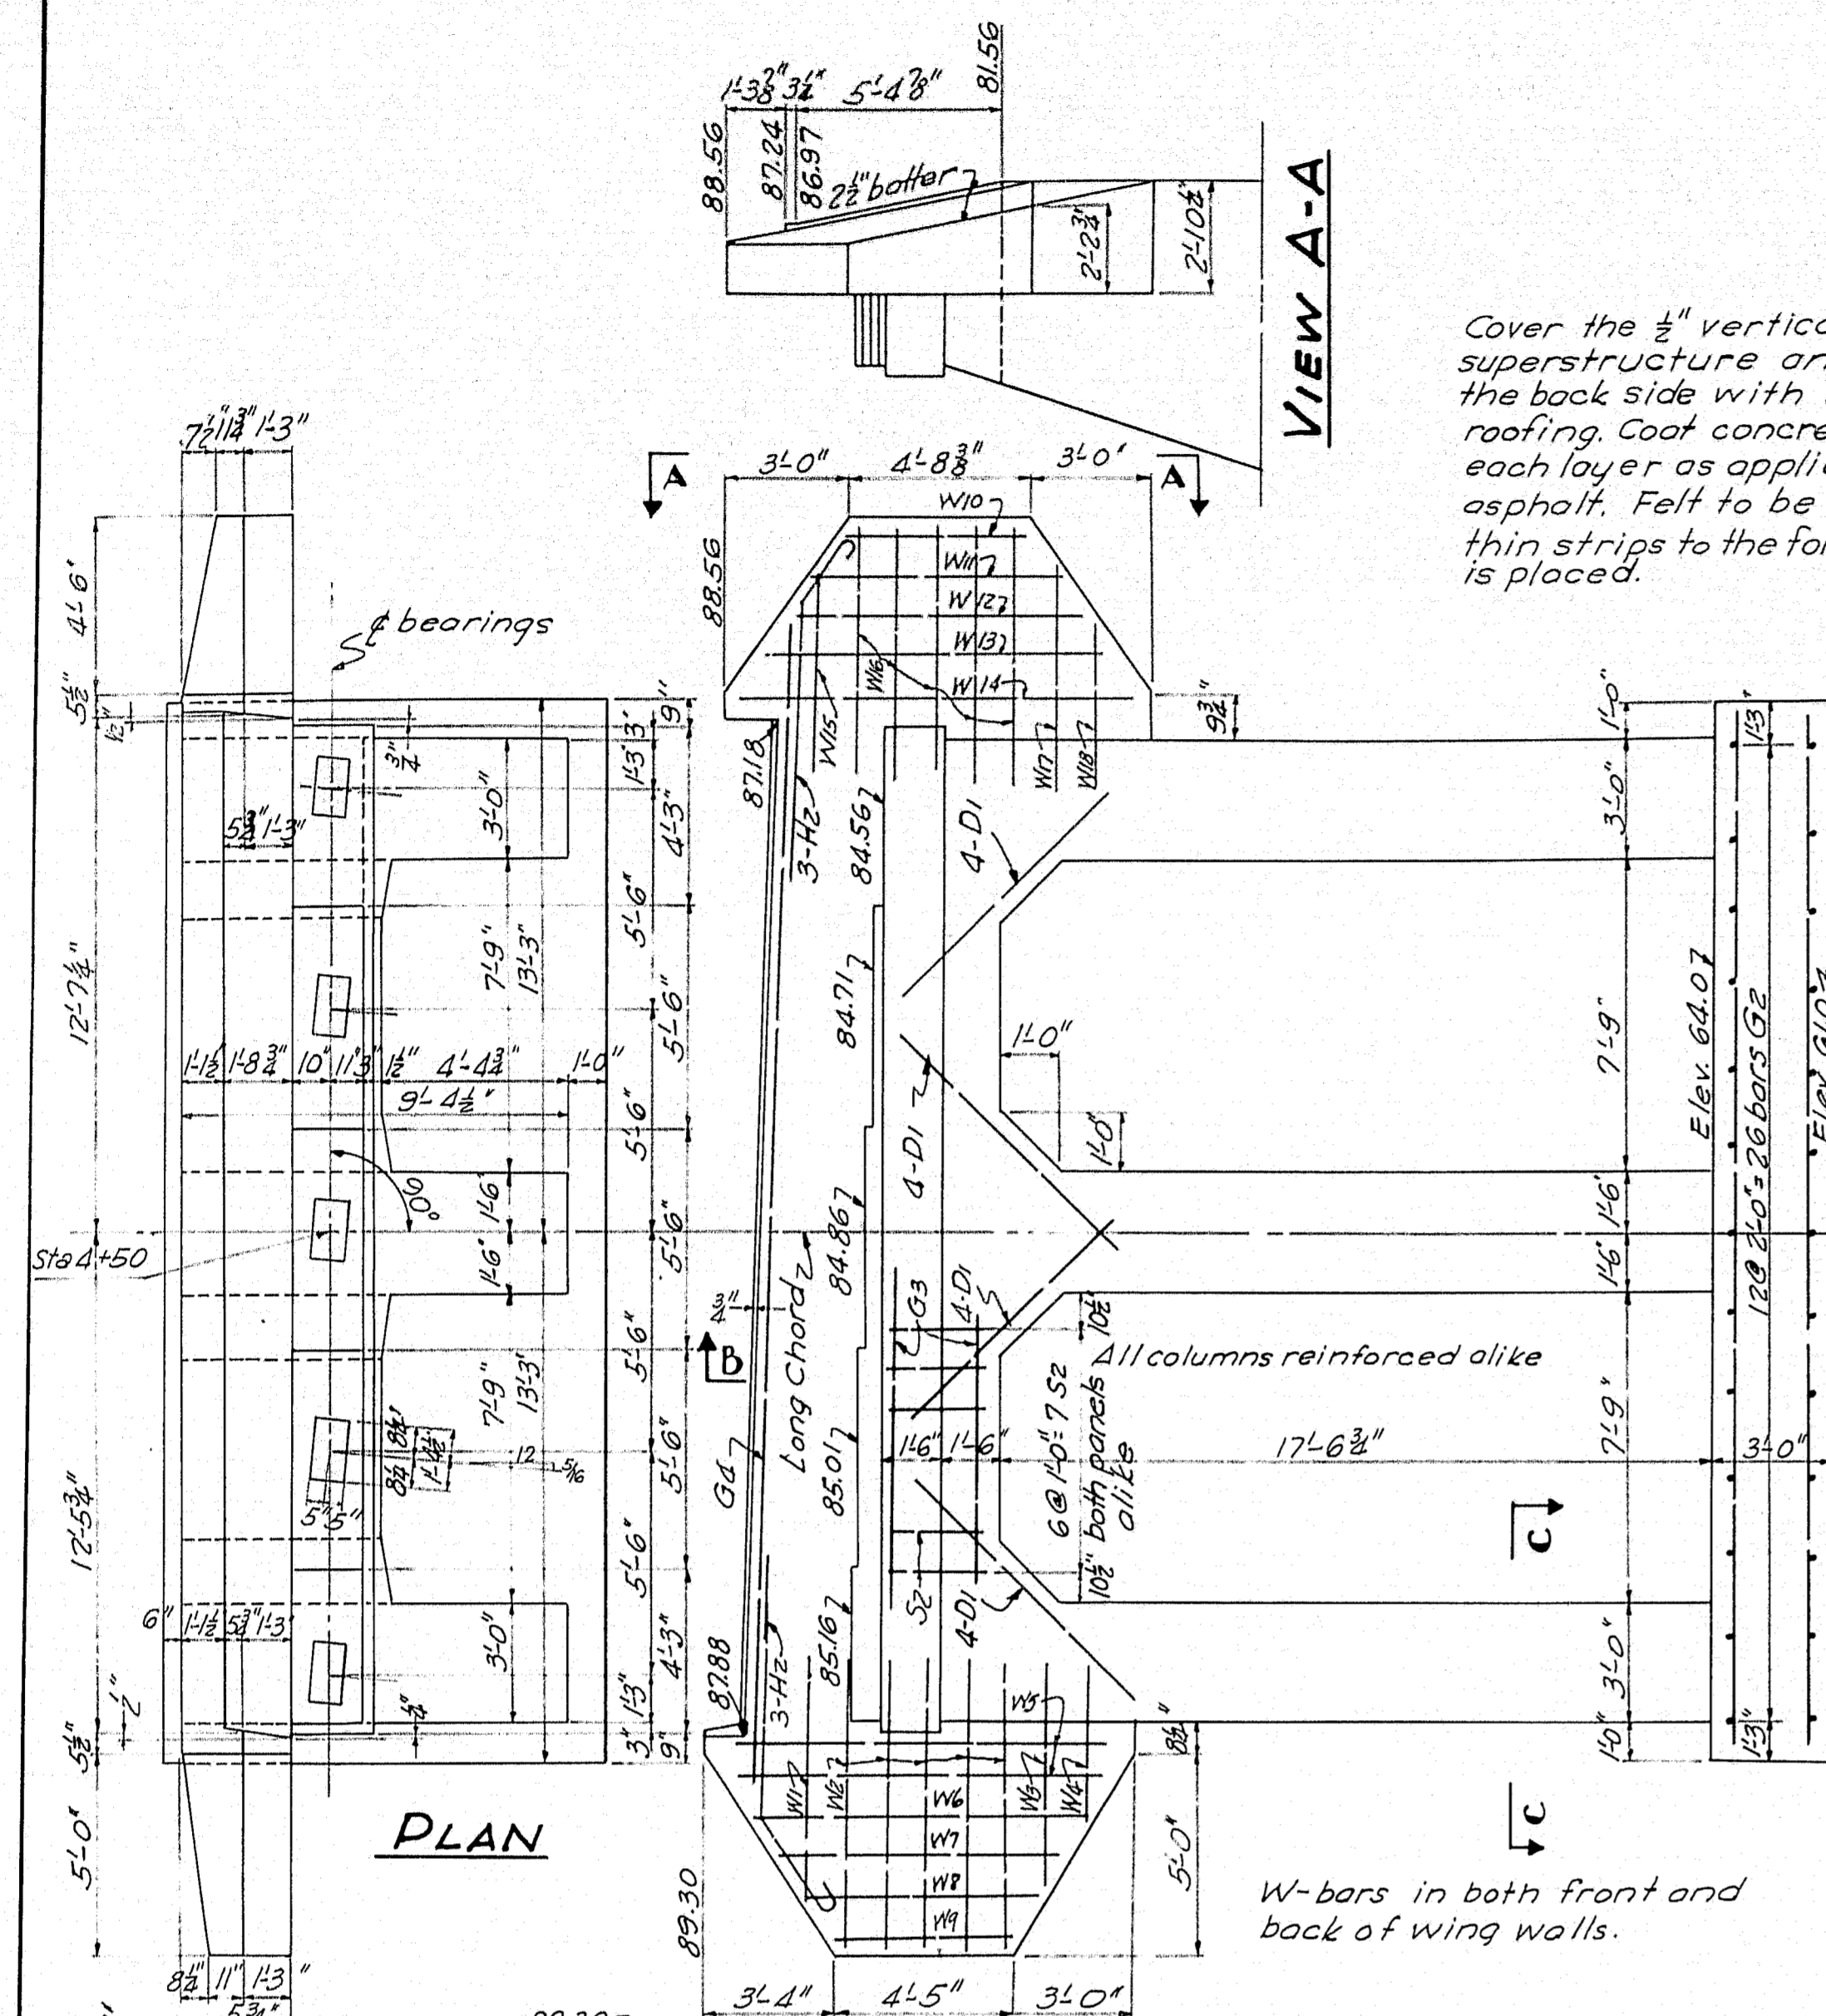
Cover the $\frac{1}{2}$ " vertical slots between superstructure and wing walls on the back side with two layers of heavy roofing. Coat concrete and back of each layer as applied with hot tar or asphalt. Felt to be recessed $\frac{1}{4}$ " by nailing thin strips to the forms before concrete is placed.
