TOWN 05-19  
 BRIDGE 3511  
 STATE HIGHWAY COMMISSION  
 BRIDGE DIVISION  
**TANNERY BRIDGE**  
 OVER  
**TANNERY BROOK**  
 IN THE TOWN OF  
 MARIAVILLE  
 HANCOCK COUNTY  
 SURVEY PLAN  
 SHEET 1 OF 3 AUGUSTA MAINE APRIL 1937

Design - C.H.G.  
Checked - V.  
TOWN 05-19  
BRIDGE 3511  
STATE HIGHWAY COMMISSION  
BRIDGE DIVISION  
**TANNERY BRIDGE**  
OVER  
**TANNERY BROOK**  
IN THE TOWN OF  
**MARIAVILLE**  
**HANCOCK COUNTY**  
SUBSTRUCTURE  
Sheet 2 of 3 Augusta, Me., August, 1937.

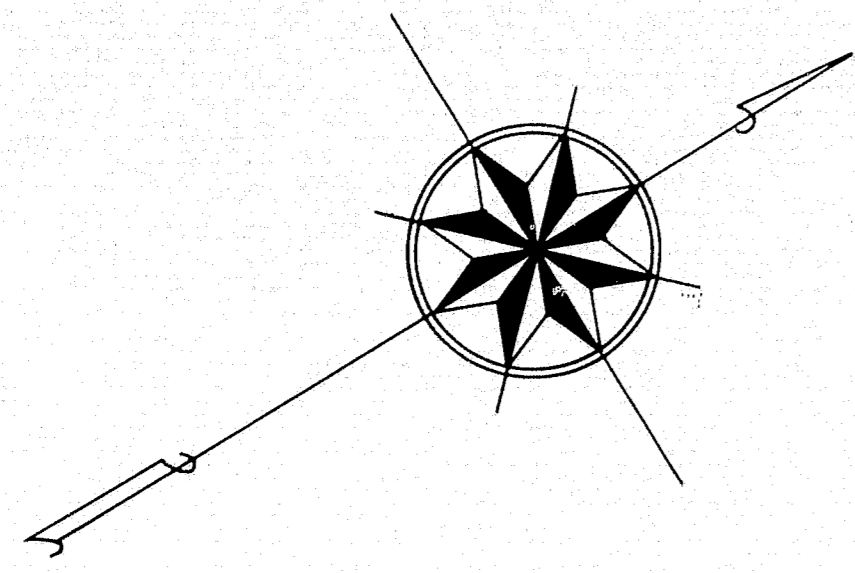
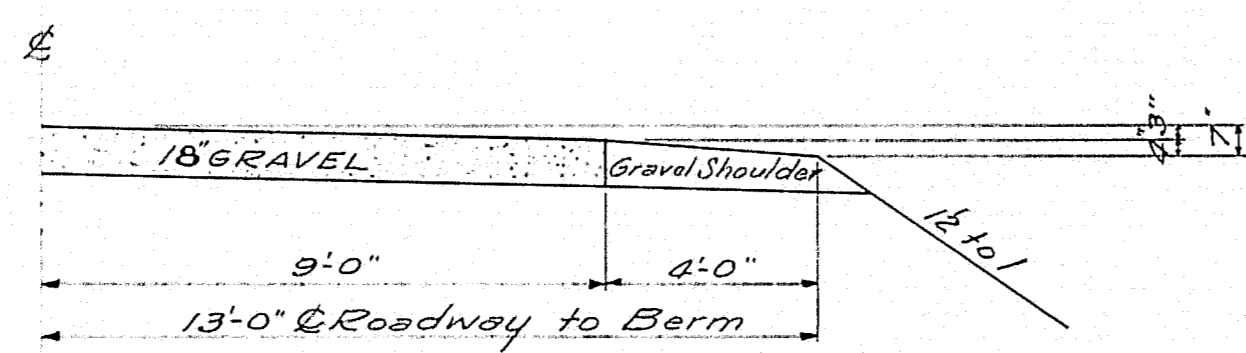
PLAN  
1" = 30'

- NOTES -  
 SUPERSTRUCTURE - Six 10" steel channels - transverse cedar poles - 2" longitudinal planking.  
 SUBSTRUCTURE - Abut #1 split granite faced with about 6" concrete. All in poor condition. Abut #2 split granite roughly laid dry - Poor Condition.  
 STREAM - High Water El. 63.2 Low Water 57.8. Swift Current.  
 FOUNDATION - Small boulders - no penetration.  
 APPROACHES - Improved gravel except from Sta. 1+25 to 7+00 inclusive.
