DESIGN REPORT

*Geotechnical and Hydrotechnical Slope Stabilization Evaluation
State Route 161 Unstable Slopes Adjacent to the St. John River
Allagash and St. Francis, Maine*

WIN 17236.00

Golder Associates Inc.

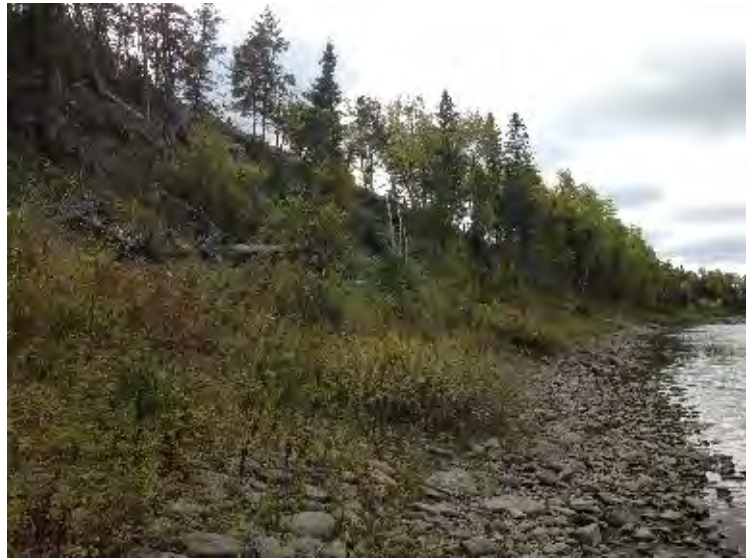
Slope conditions looking upstream
(2016)

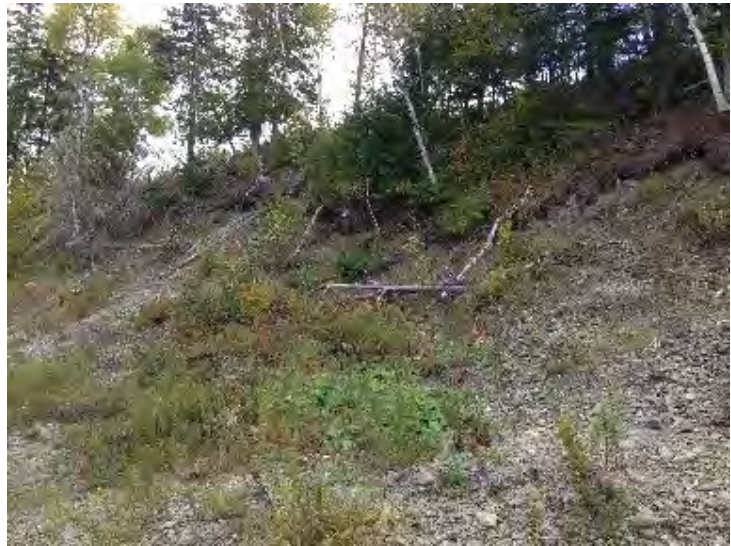
PHOTO 2

Slope conditions looking upslope
(2016)

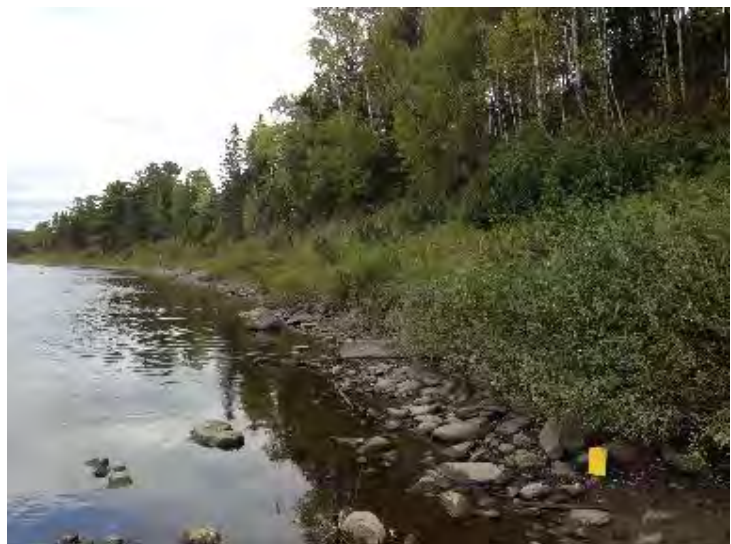
PHOTO 3

Slope conditions looking downstream
(2016)

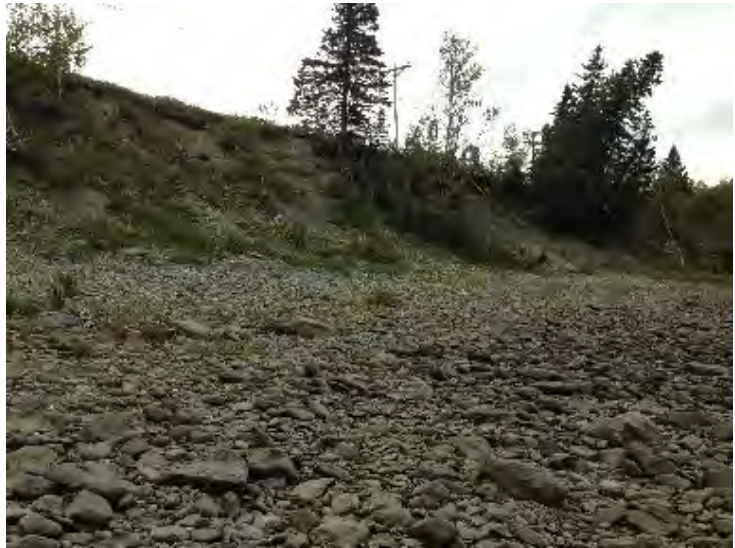
Slope conditions looking south
(2016)

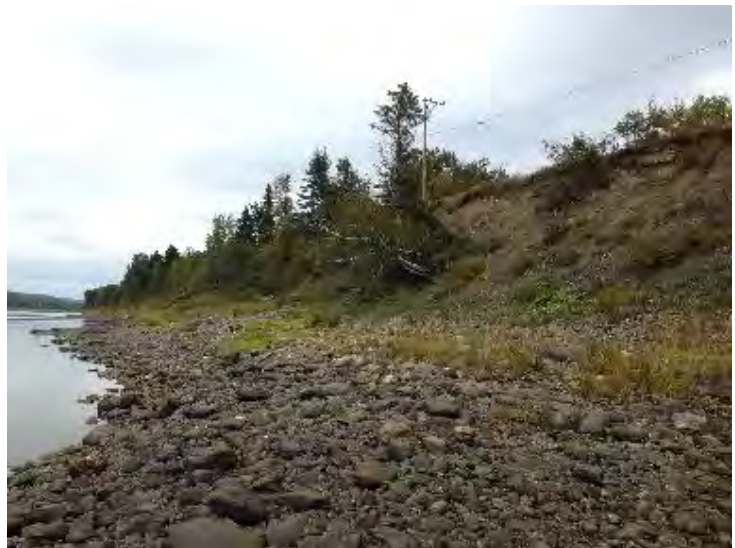
PHOTO 2

Slope conditions looking northeast
(2016)

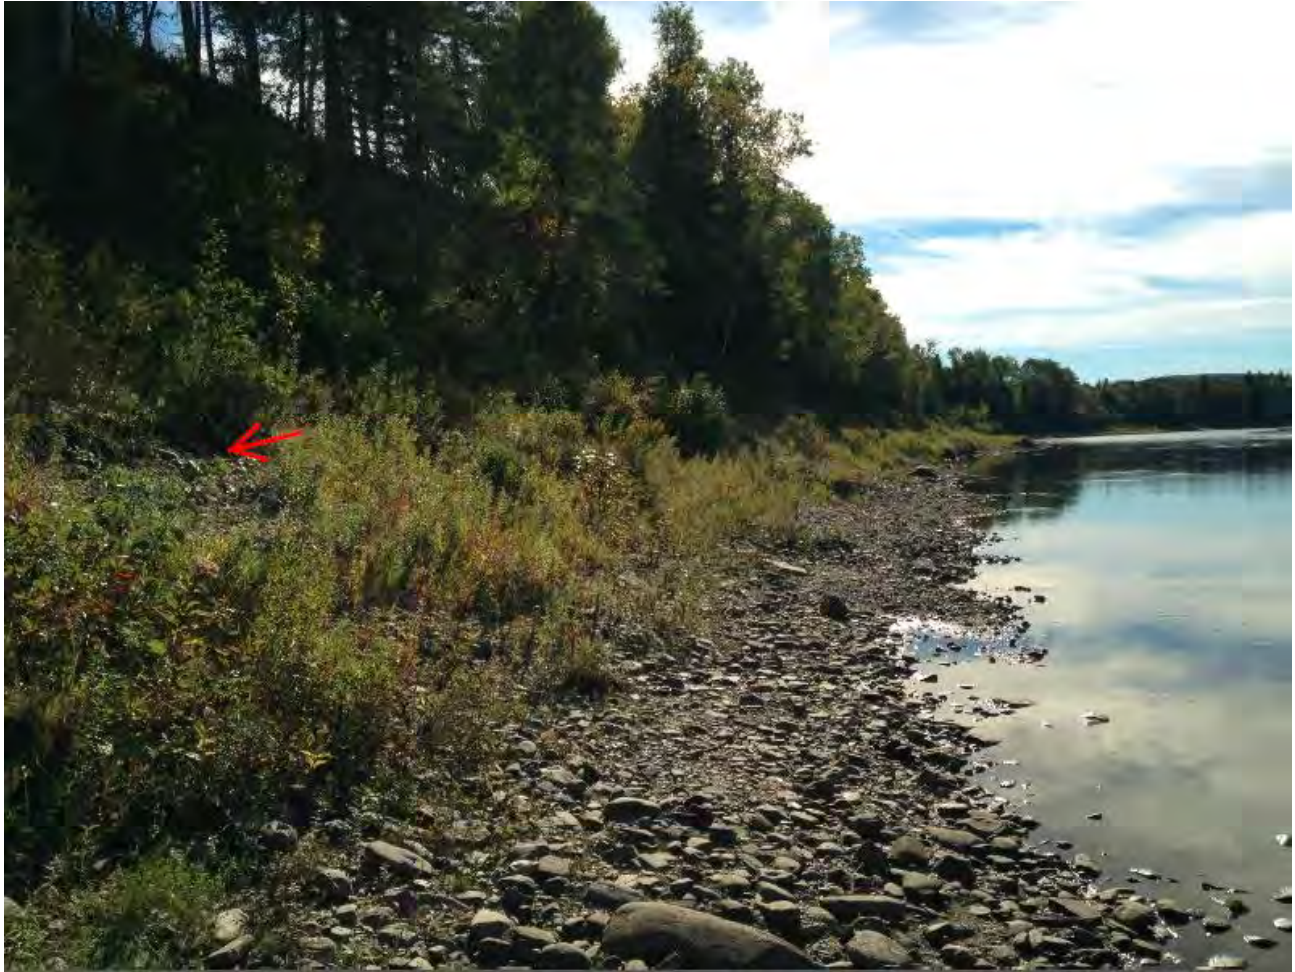
Figure 1. Eroding bank at Allagash site.

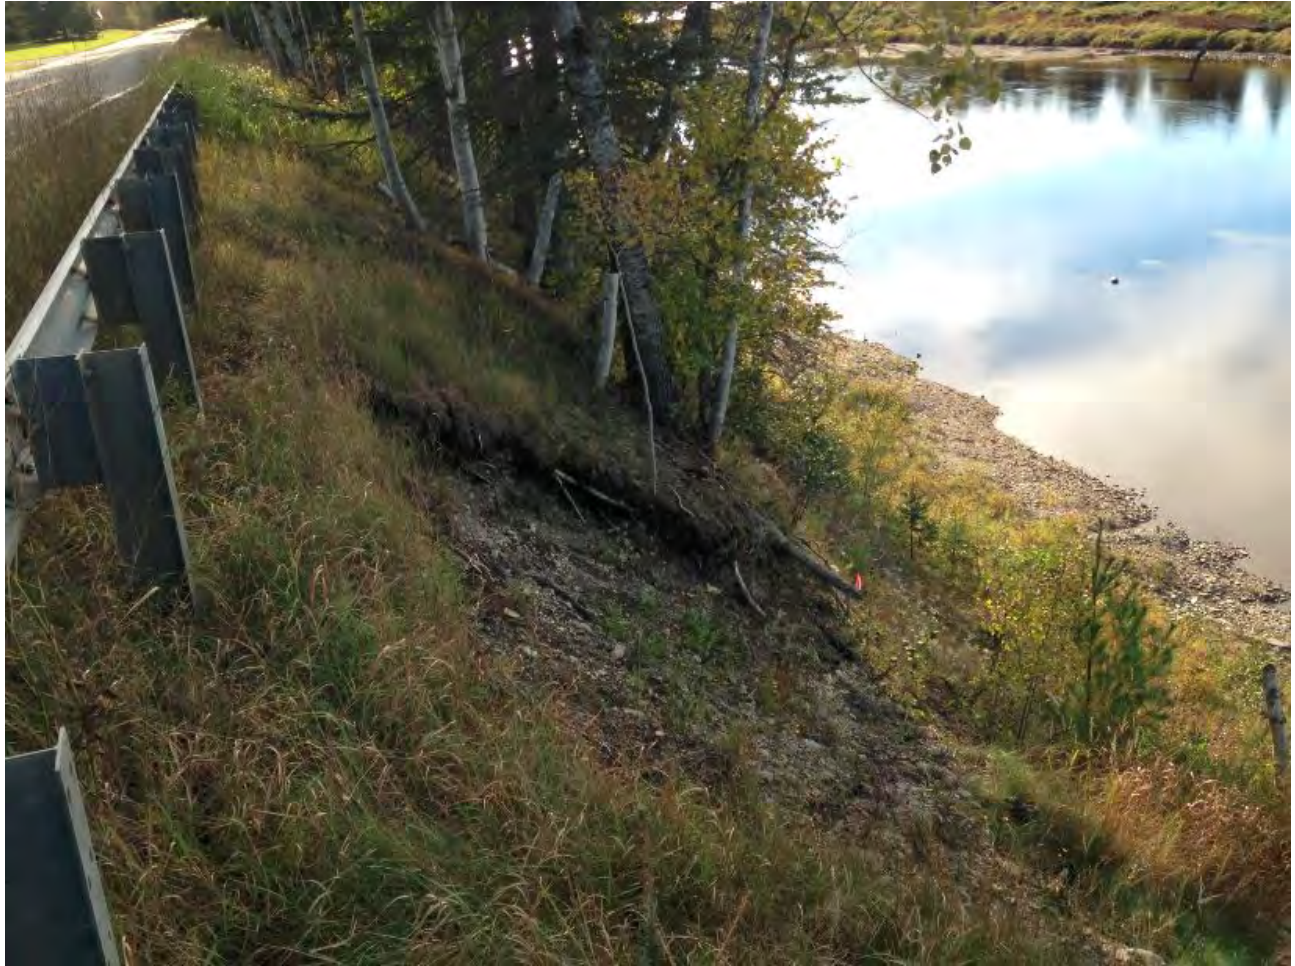
Figure 2. Planar slip bank failure at the top of the bank at the Allagash site.

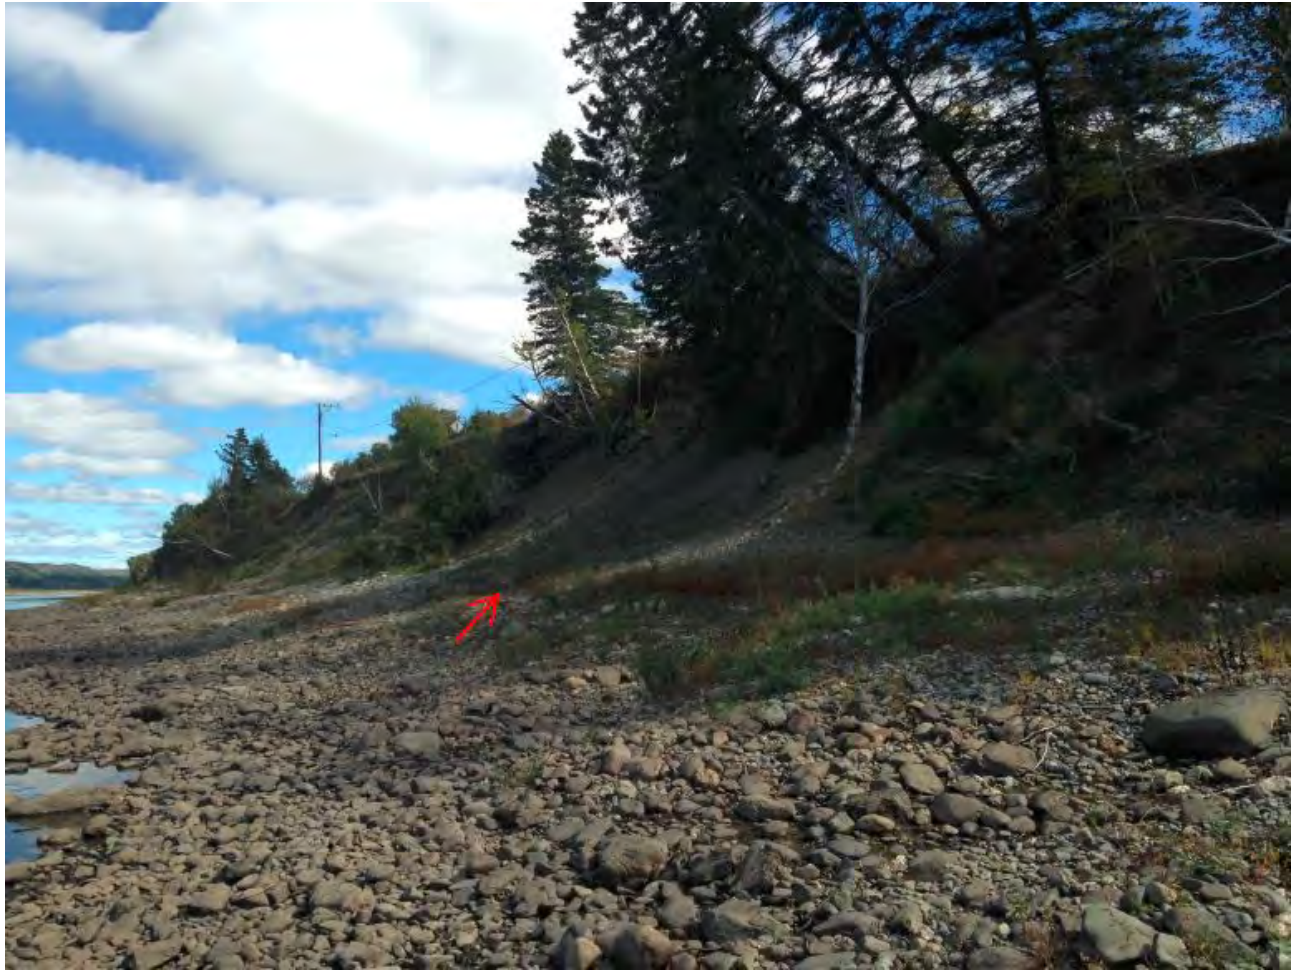
Figure 5. Eroding bank at St. Francis site.

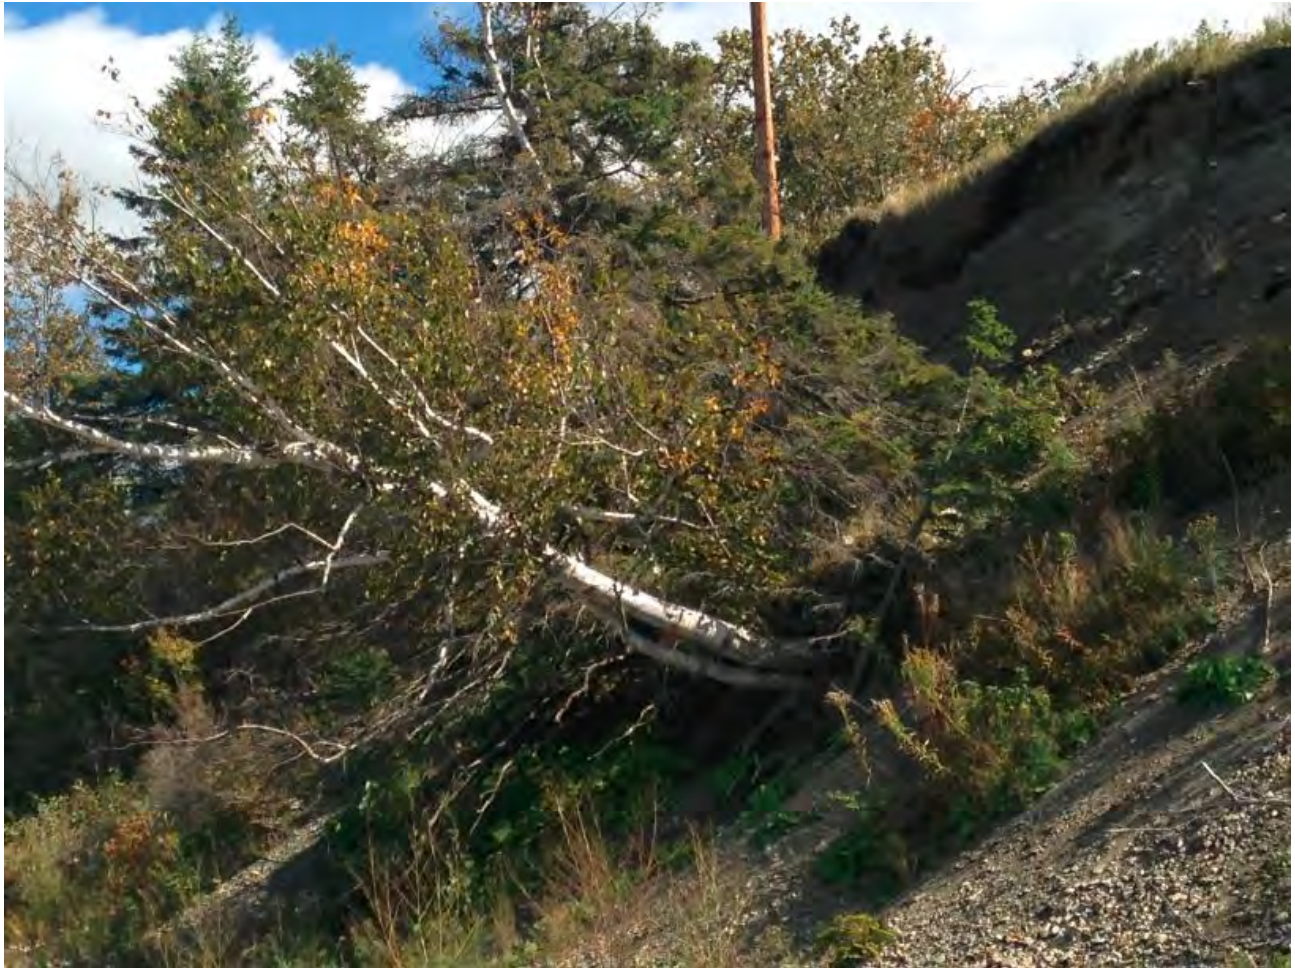
Figure 6. Leaning tree and vertical head scarp (at top of bank) are evidence of recent erosion at the St. Francis site.

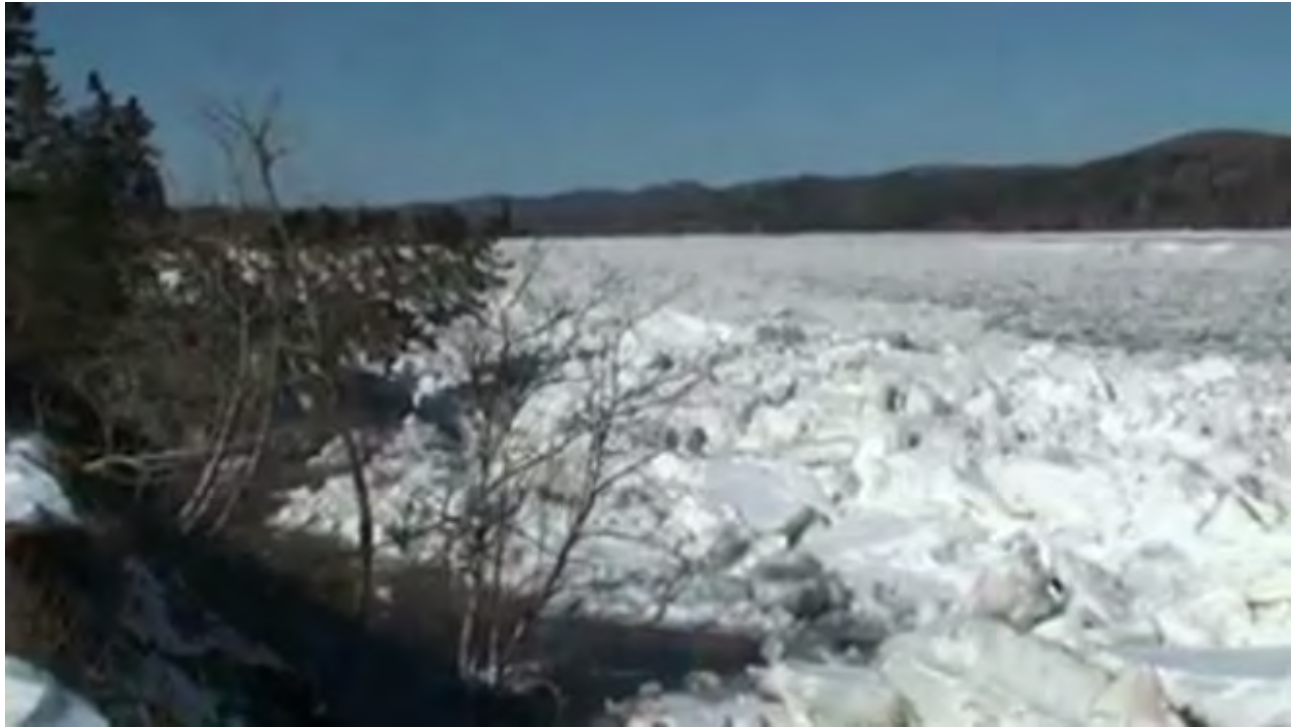
Figure 7. April 2014 ice jam alongside the St. Francis site.
