GEOTECHNICAL DESIGN REPORT
CLEWLEYVILLE ROAD OVER
INTERSTATE 395/ROUTE 9 CONNECTOR, BRIDGE NO. 6648
MAINEDOT WIN 018915.00
EDDINGTON, MAINE

by
Haley & Aldrich, Inc.
Portland, Maine

for
Maine Department of Transportation
Augusta, Maine

File No. 132076-007
August 2021

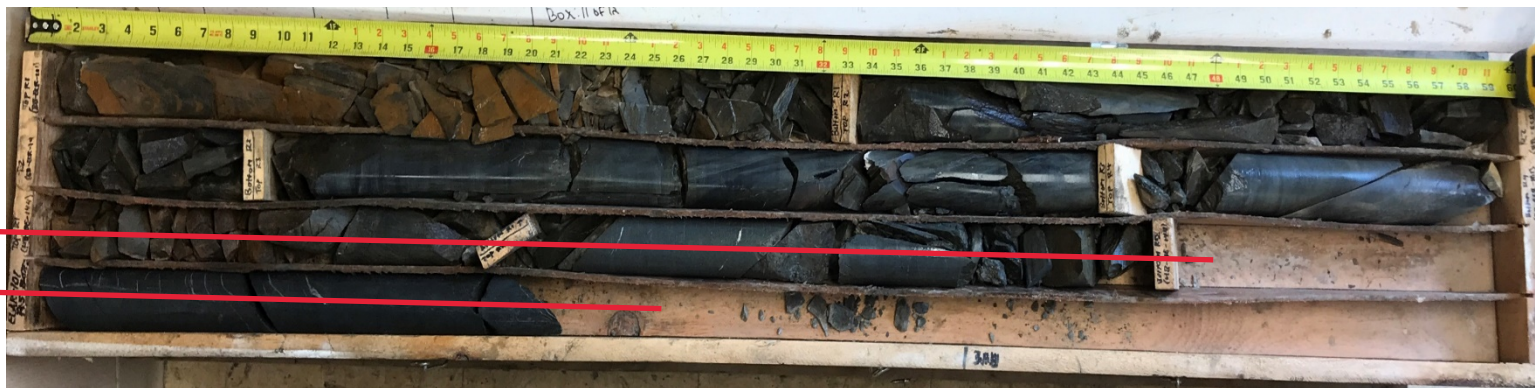
ROCK CORE PHOTOGRAPHS
I-395/ROUTE 9 CONNECTOR
MAINEDOT WIN 018915.00
BREWER/EDDINGTON, MAINE

- Top Row:** BB-ECR-101, Run No. R1 14.0 (left) to 16.5 (middle), Run No. R2 16.5 (middle) to 19.9 (right)
- Top Middle Row:** BB-ECR-101, Run No. R2 continued 16.5 (left) to 19.9 (middle-left), Run No. R3 19.9 (middle-left) to 22.5 (middle-right), Run No. R4 22.5 (middle-right) to 24.3 (right)
- Bottom Middle Row:** HB-BE-144, Run No. R1 9.1 (left) to 10.6 (middle), Run No. R2 10.6 (middle) to 14.1 (right)
- Bottom Row:** BB-ELAR-101, Run No. R5 11.6 (middle-right) to 15.5 (right)

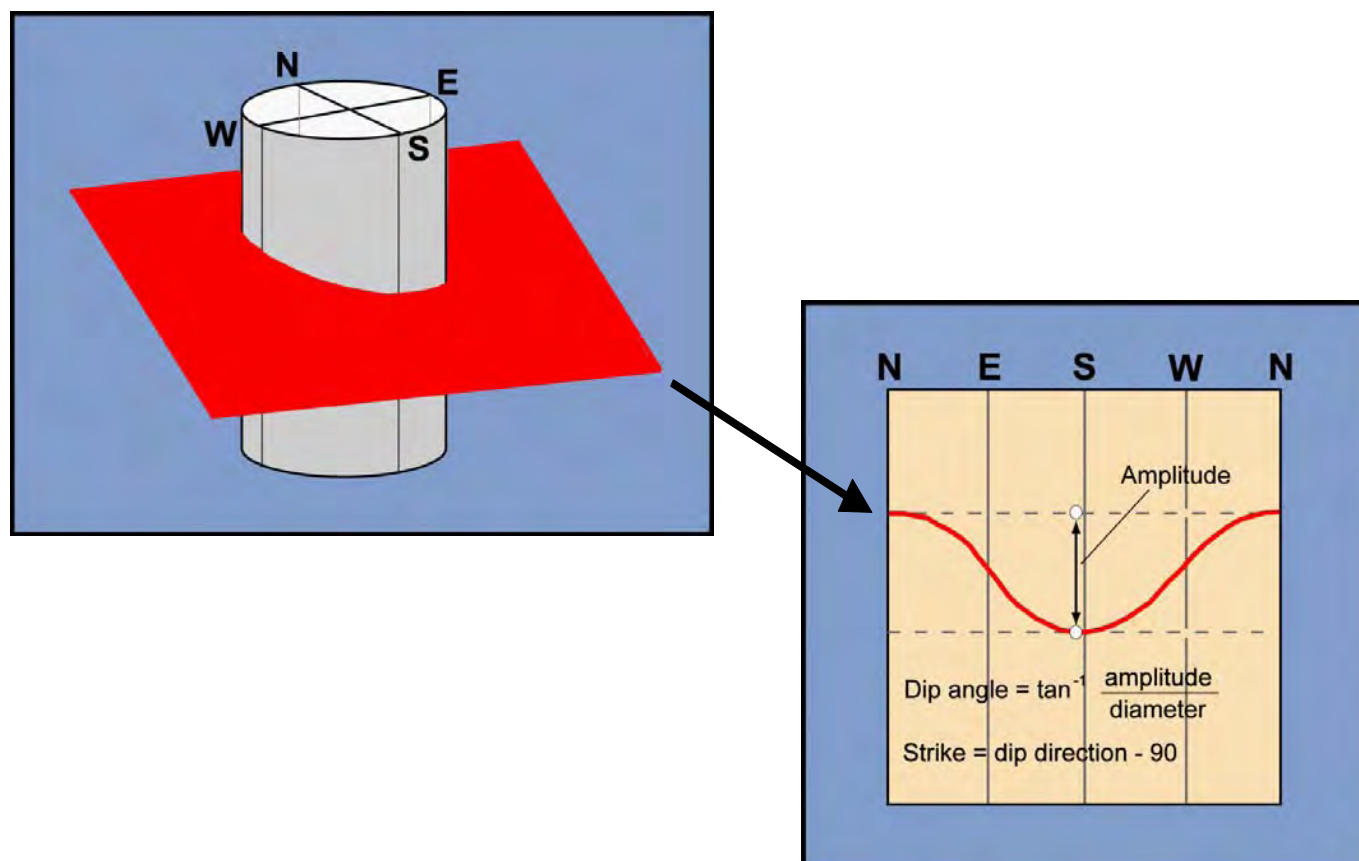
Figure 2. Tadpole plot explanation. The orientation of the bedrock structures is graphically displayed by a tadpole consisting of a circle, the head, and a line, the tail. The position of the head, left to right on the tadpole plot, gives the dip angle of the structure. The left side of the track indicates a dip angle of 0°, and the right side of the track indicates a dip angle of 90° from horizontal. The orientation of the tail gives the dip azimuth of the structure and can be read like a compass. The tail pointing directly up is 0°, north.

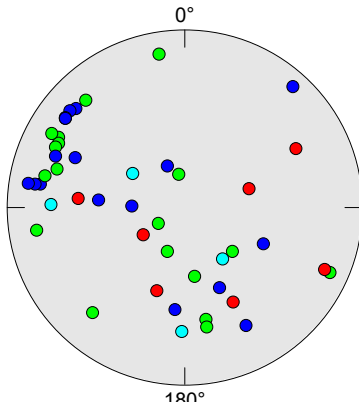
Stereogram - Lower Hemisphere of Bedrock Fractures	Dip Azimuth Rose Diagram of Bedrock Fractures	Dip Angle Histogram of Bedrock Fractures	Stereogram - Lower Hemisphere of Foliation & Veins	Dip Azimuth Rose Diagram of Foliation & Veins	Dip Angle Histogram of Foliation & Veins																																																																																
<div>Schmidt Plot - LH - Bedrock Structures</div>

<table><tr><th></th><th>Counts</th><th>Dip[deg]</th><th>Azi[deg]</th></tr><tr><td>Mean</td><td>47</td><td>55.60</td><td>84.61</td></tr><tr><td>●</td><td>18</td><td>59.98</td><td>108.66</td></tr><tr><td>●</td><td>18</td><td>56.72</td><td>79.66</td></tr><tr><td>●</td><td>7</td><td>47.34</td><td>331.48</td></tr><tr><td>●</td><td>4</td><td>45.66</td><td>45.90</td></tr></table>		Counts	Dip[deg]	Azi[deg]	Mean	47	55.60	84.61	●	18	59.98	108.66	●	18	56.72	79.66	●	7	47.34	331.48	●	4	45.66	45.90	<div>Azimuth - Absolute (Count)</div>

The measured foliation and joint pole vectors and great circle representing the orientation of the proposed Connector cut slopes were plotted on stereonet to assess the potential for planar and wedge sliding and toppling failures to occur. A stereonet is a geological engineering tool that presents three-dimensional data in a two-dimensional format. On a stereonet, a discontinuity (i.e., joint) plane can be plotted as a 'great circle' or as a line (plots as a single point) called a pole, which is measured 90 degrees from the plane and represents each plane. Therefore, if a joint plane dips to the northeast, the pole to that plane will appear as a point in the southwest quadrant of the stereonet. Poles that are close to the outer edges of the stereonet represent steeply dipping planes and poles at the center of the stereonet represent planes that are horizontal. The geophysical data collected was plotted in polar format to simplify the data output. The results of the kinematic analyses are summarized below.

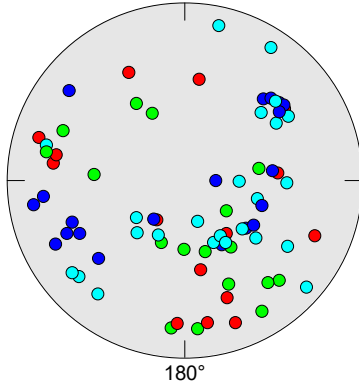
Stereogram - Lower Hemisphere of Bedrock Fractures	Dip Azimuth Rose Diagram of Bedrock Fractures	Dip Angle Histogram of Bedrock Fractures	Stereogram - Lower Hemisphere of Foliation & Veins	Dip Azimuth Rose Diagram of Foliation & Veins	Dip Angle Histogram of Foliation & Veins																																																																																
<div>Schmidt Plot - LH - Bedrock Structures</div>

<table><tr><th></th><th>Counts</th><th>Dip[deg]</th><th>Azi[deg]</th></tr><tr><td>Mean</td><td>76</td><td>51.51</td><td>334.04</td></tr><tr><td>●</td><td>17</td><td>49.90</td><td>354.96</td></tr><tr><td>●</td><td>15</td><td>56.81</td><td>352.58</td></tr><tr><td>●</td><td>24</td><td>49.24</td><td>312.02</td></tr><tr><td>●</td><td>20</td><td>51.55</td><td>327.71</td></tr></table>		Counts	Dip[deg]	Azi[deg]	Mean	76	51.51	334.04	●	17	49.90	354.96	●	15	56.81	352.58	●	24	49.24	312.02	●	20	51.55	327.71	<div>Azimuth - Absolute (Count)</div>

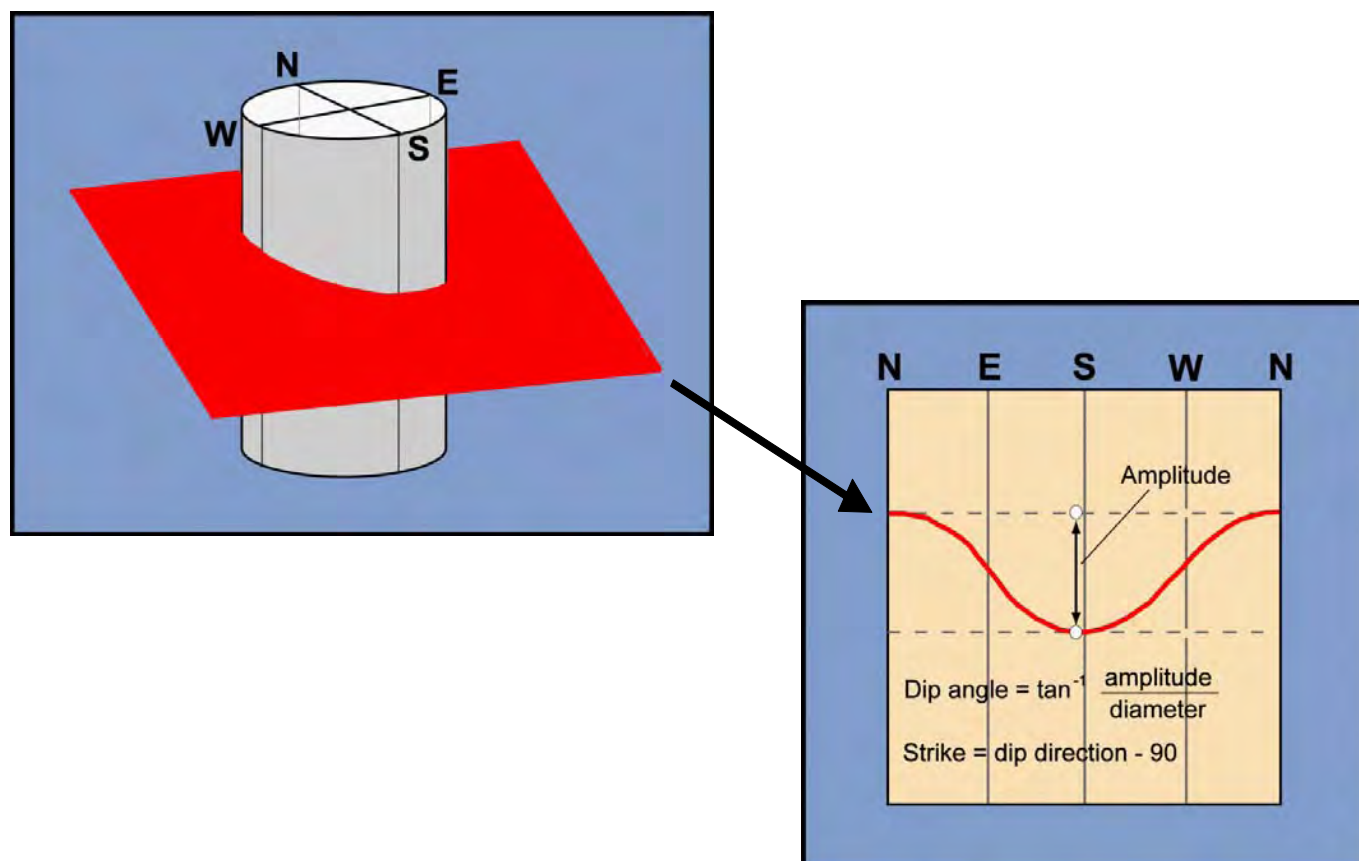
Figure 2. Tadpole plot explanation. The orientation of the bedrock structures is graphically displayed by a tadpole consisting of a circle, the head, and a line, the tail. The position of the head, left to right on the tadpole plot, gives the dip angle of the structure. The left side of the track indicates a dip angle of 0°, and the right side of the track indicates a dip angle of 90° from horizontal. The orientation of the tail gives the dip azimuth of the structure and can be read like a compass. The tail pointing directly up is 0°, north.

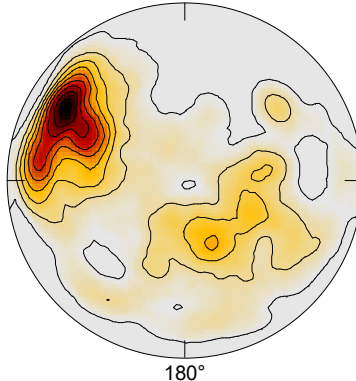
Stereogram - Lower Hemisphere of Bedrock Fractures	Dip Azimuth Rose Diagram of Bedrock Fractures	Dip Angle Histogram of Bedrock Fractures	Stereogram - Lower Hemisphere of Foliation & Veins	Dip Azimuth Rose Diagram of Foliation & Veins	Dip Angle Histogram of Foliation & Veins																																																																																
<div>Schmidt Plot - LH - Bedrock Structures</div>

<table><tr><th></th><th>Counts</th><th>Dip[deg]</th><th>Azi[deg]</th></tr><tr><td>Mean</td><td>682</td><td>53.27</td><td>83.43</td></tr><tr><td>●</td><td>134</td><td>51.71</td><td>72.78</td></tr><tr><td>●</td><td>165</td><td>52.25</td><td>86.53</td></tr><tr><td>●</td><td>319</td><td>55.92</td><td>87.55</td></tr><tr><td>●</td><td>64</td><td>45.74</td><td>333.67</td></tr></table>		Counts	Dip[deg]	Azi[deg]	Mean	682	53.27	83.43	●	134	51.71	72.78	●	165	52.25	86.53	●	319	55.92	87.55	●	64	45.74	333.67	<div>Azimuth - Absolute (Count)</div>

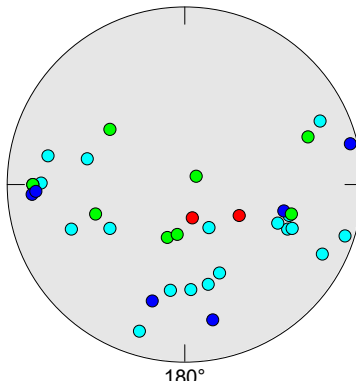
Stereogram - Lower Hemisphere of Bedrock Fractures	Dip Azimuth Rose Diagram of Bedrock Fractures	Dip Angle Histogram of Bedrock Fractures	Stereogram - Lower Hemisphere of Foliation & Veins	Dip Azimuth Rose Diagram of Foliation & Veins	Dip Angle Histogram of Foliation & Veins																																																																																
<div>Schmidt Plot - LH - Bedrock Structures</div>

<table><tr><th></th><th>Counts</th><th>Dip[deg]</th><th>Azi[deg]</th></tr><tr><td>Mean</td><td>35</td><td>53.86</td><td>351.34</td></tr><tr><td>●</td><td>18</td><td>56.54</td><td>342.77</td></tr><tr><td>●</td><td>8</td><td>41.85</td><td>28.92</td></tr><tr><td>●</td><td>6</td><td>67.87</td><td>3.59</td></tr><tr><td>●</td><td>3</td><td>39.41</td><td>355.95</td></tr></table>		Counts	Dip[deg]	Azi[deg]	Mean	35	53.86	351.34	●	18	56.54	342.77	●	8	41.85	28.92	●	6	67.87	3.59	●	3	39.41	355.95	<div>Azimuth - Absolute (Count)</div>

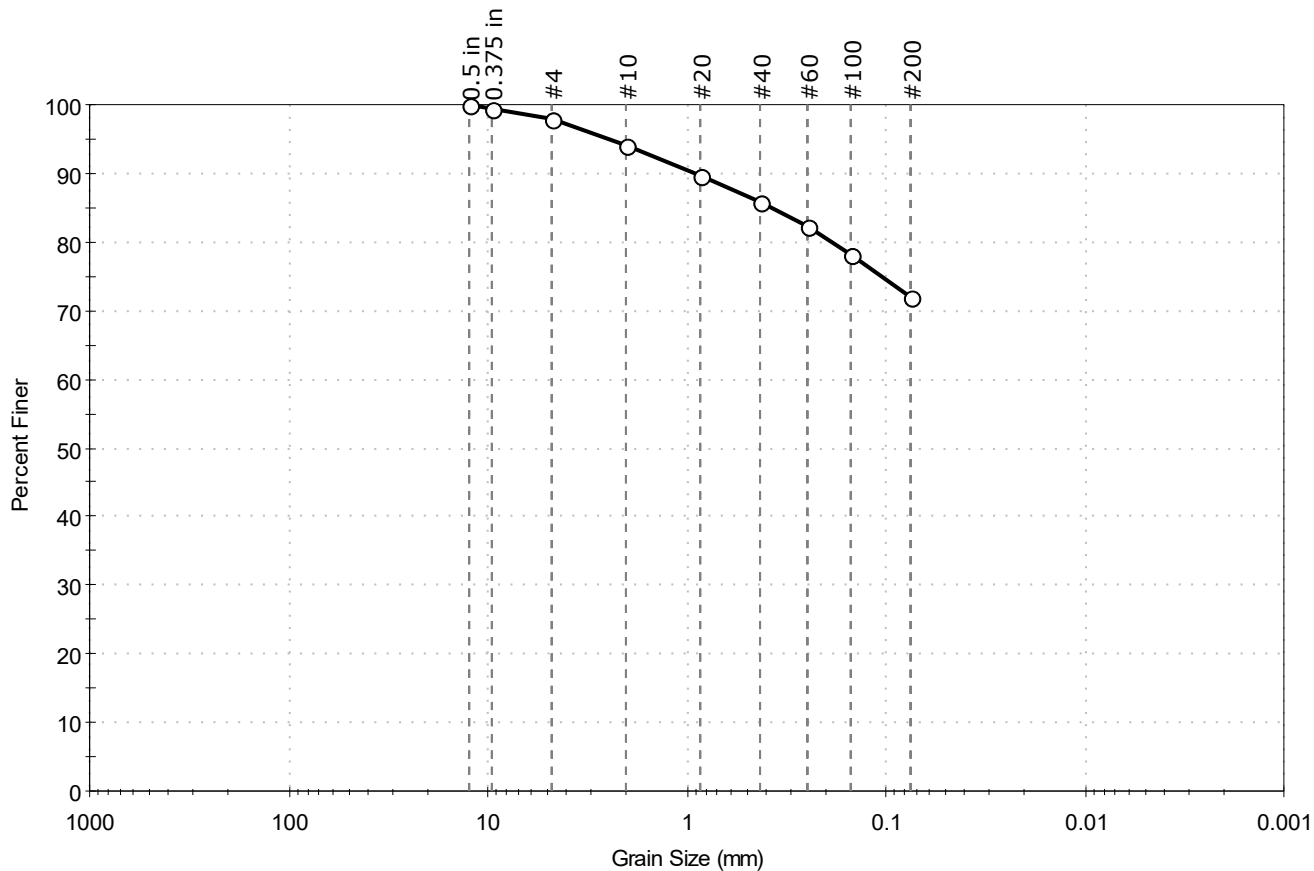
Particle Size Analysis - ASTM D422

% Cobble	% Gravel	% Sand	% Silt & Clay Size
—	2.2	25.8	72.0

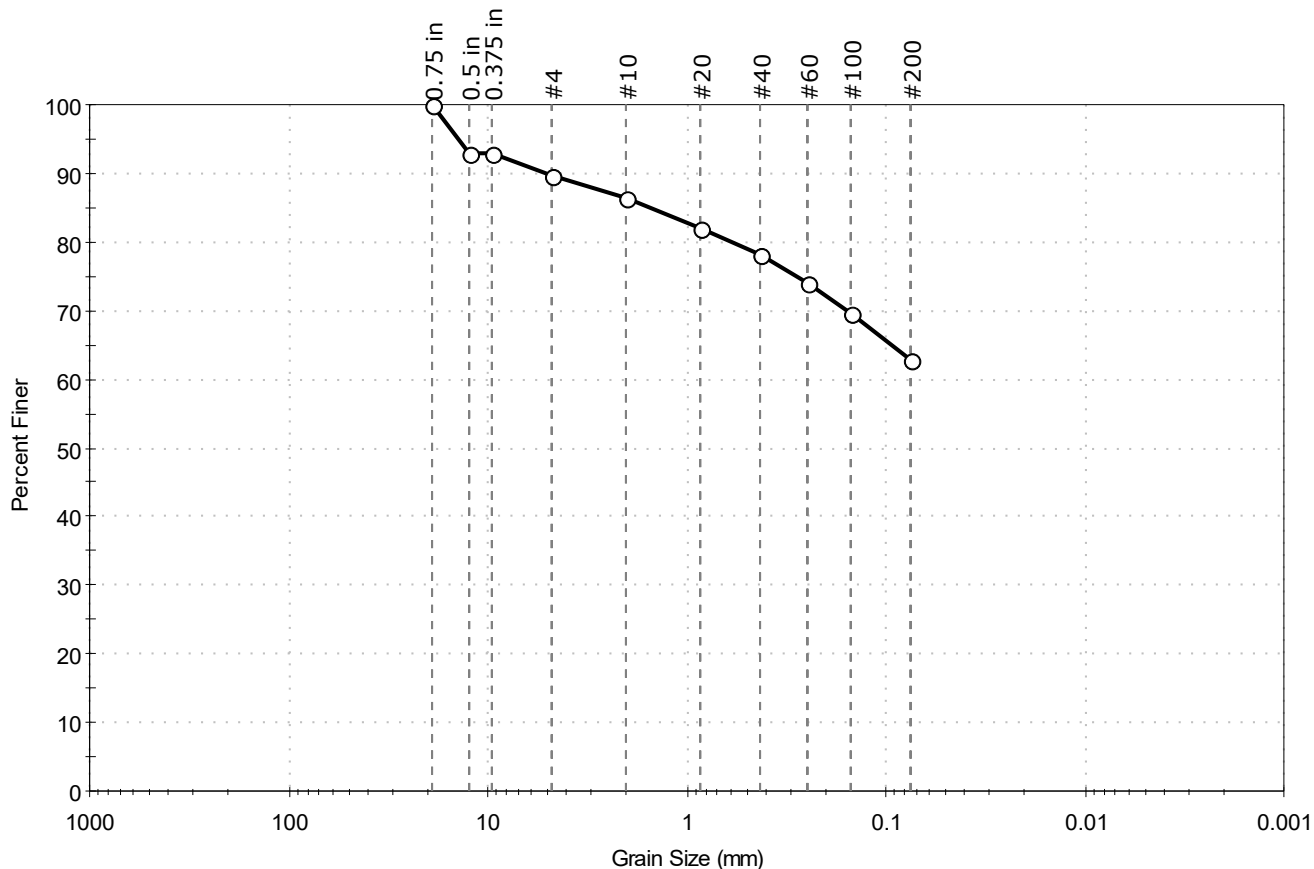
Particle Size Analysis - ASTM D422

% Cobble	% Gravel	% Sand	% Silt & Clay Size
—	10.3	26.9	62.8

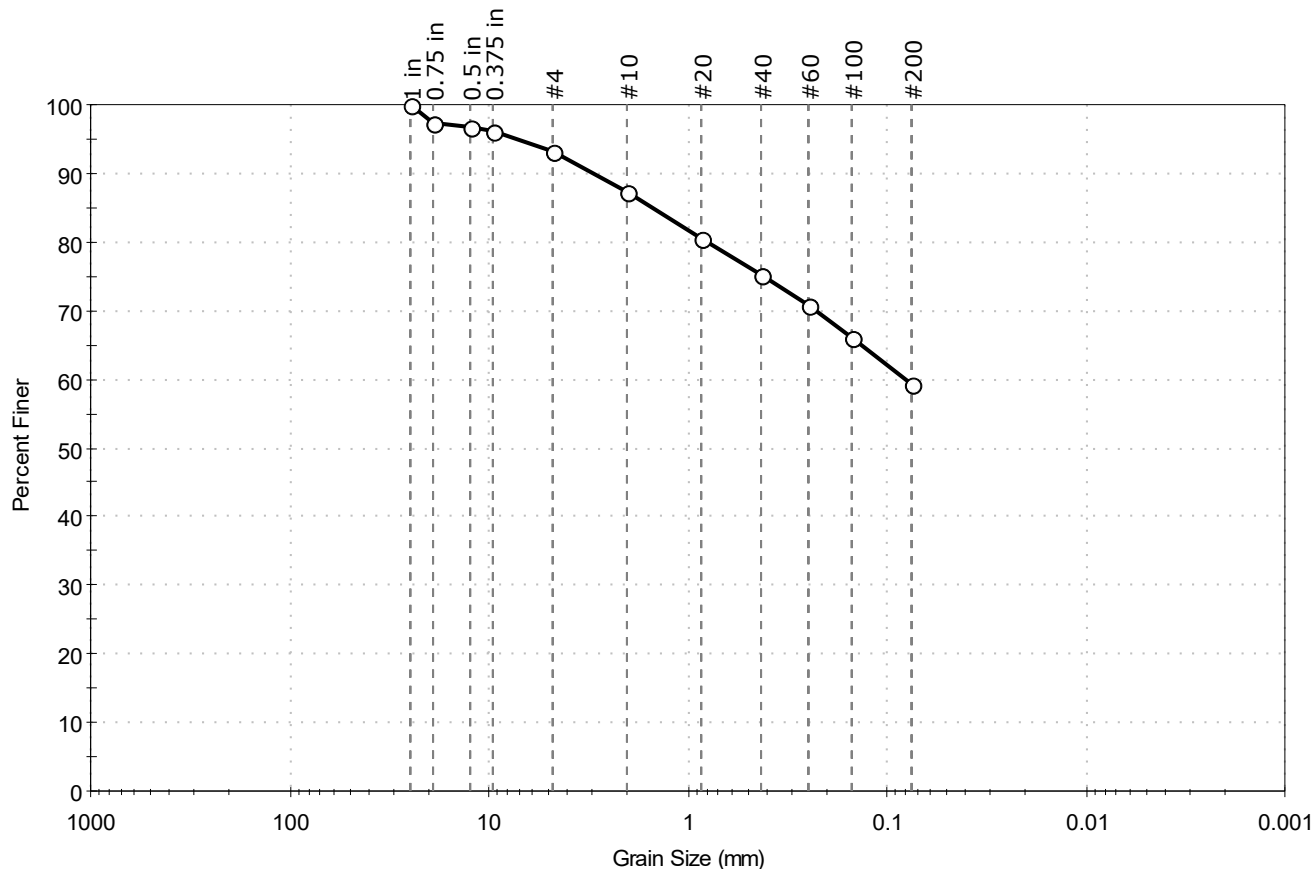
Particle Size Analysis - ASTM D422

% Cobble	% Gravel	% Sand	% Silt & Clay Size
—	6.8	34.0	59.2

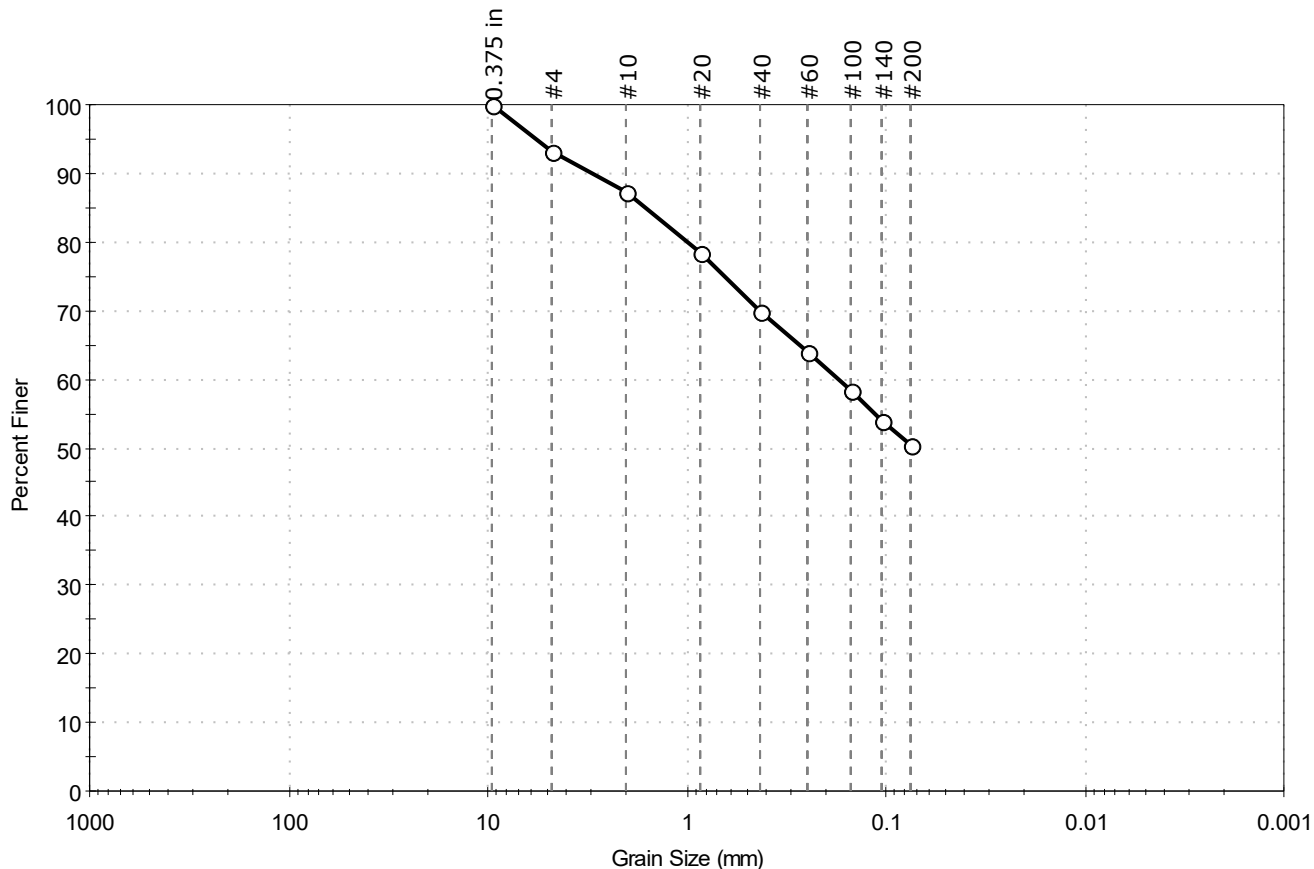
Particle Size Analysis - ASTM D6913

% Cobble	% Gravel	% Sand	% Silt & Clay Size
—	6.9	42.7	50.4

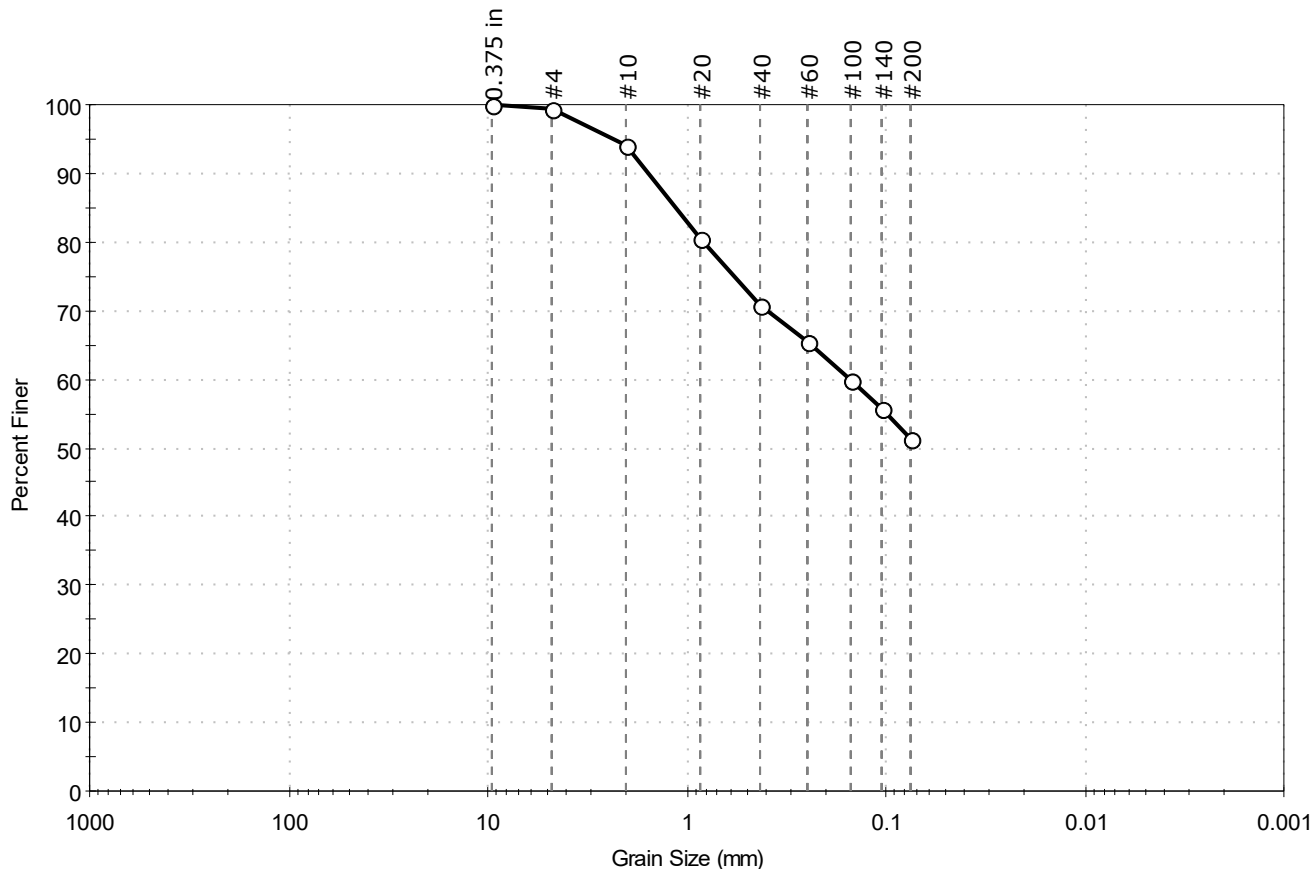
Particle Size Analysis - ASTM D6913

% Cobble	% Gravel	% Sand	% Silt & Clay Size
—	0.7	47.9	51.4

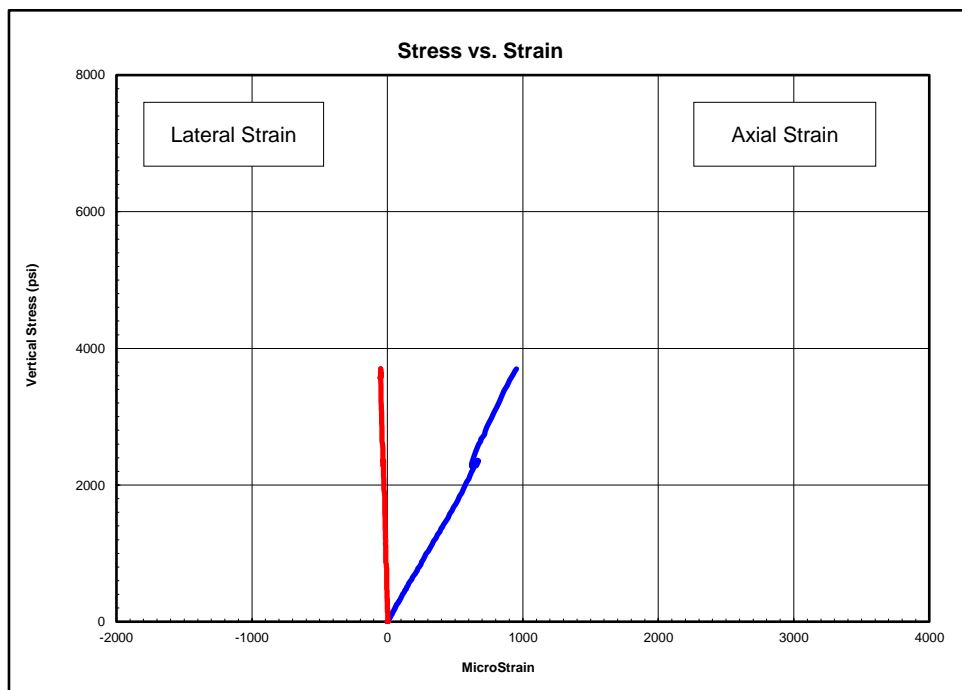
Compressive Strength and Elastic Moduli of Rock by ASTM D7012 - Method D

Peak Compressive Stress: 6,527 psi

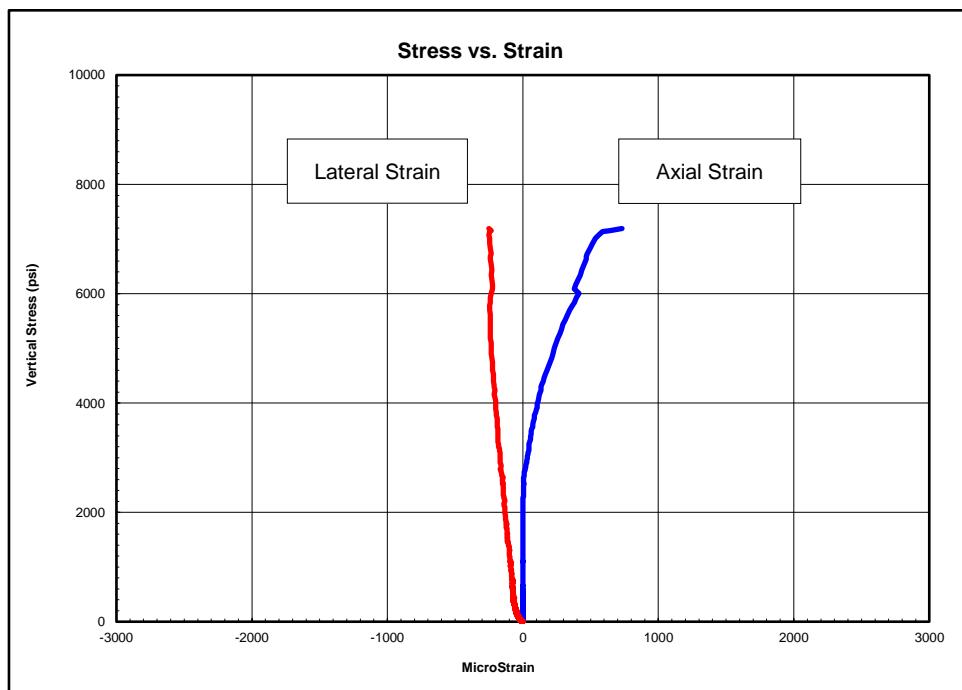
Compressive Strength and Elastic Moduli of Rock by ASTM D7012 - Method D

Peak Compressive Stress: 7,193 psi

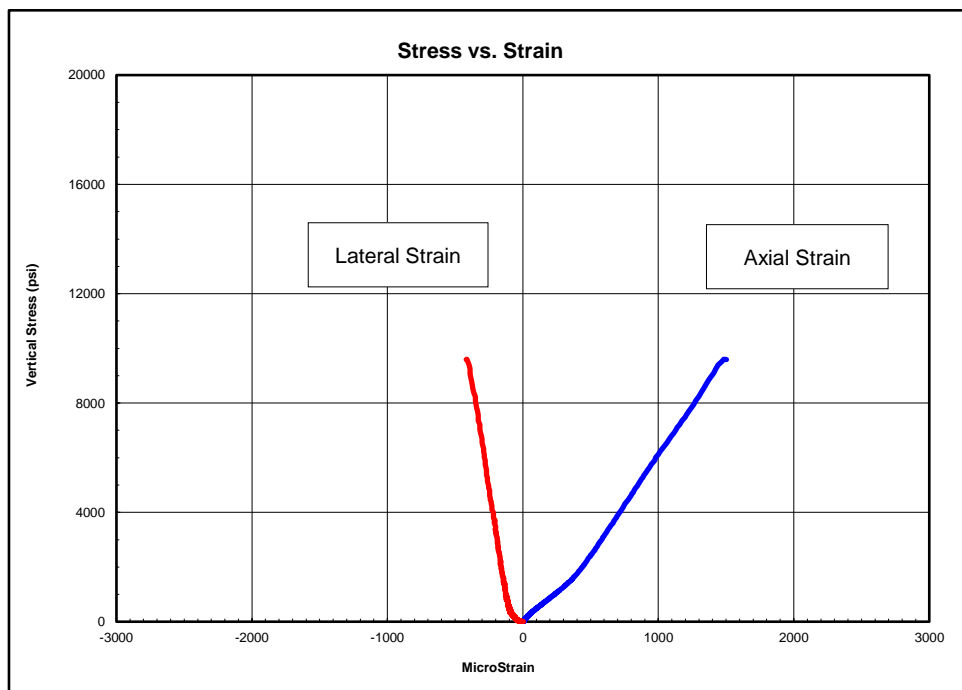
Compressive Strength and Elastic Moduli of Rock by ASTM D7012 - Method D

Peak Compressive Stress: 9,759 psi

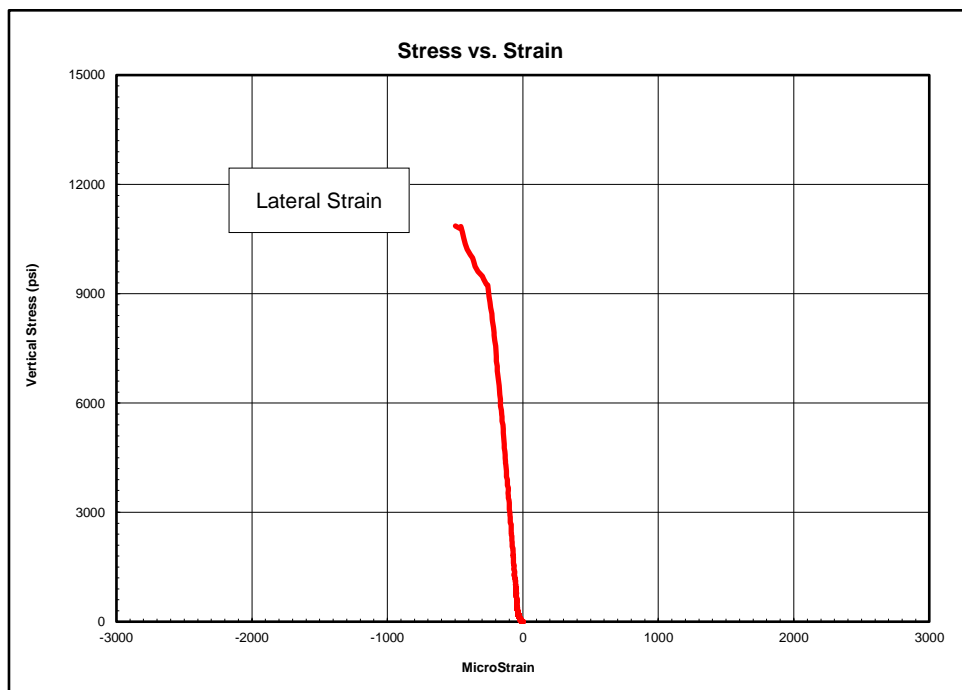
Compressive Strength and Elastic Moduli of Rock by ASTM D7012 - Method D

Peak Compressive Stress: 10,859 psi

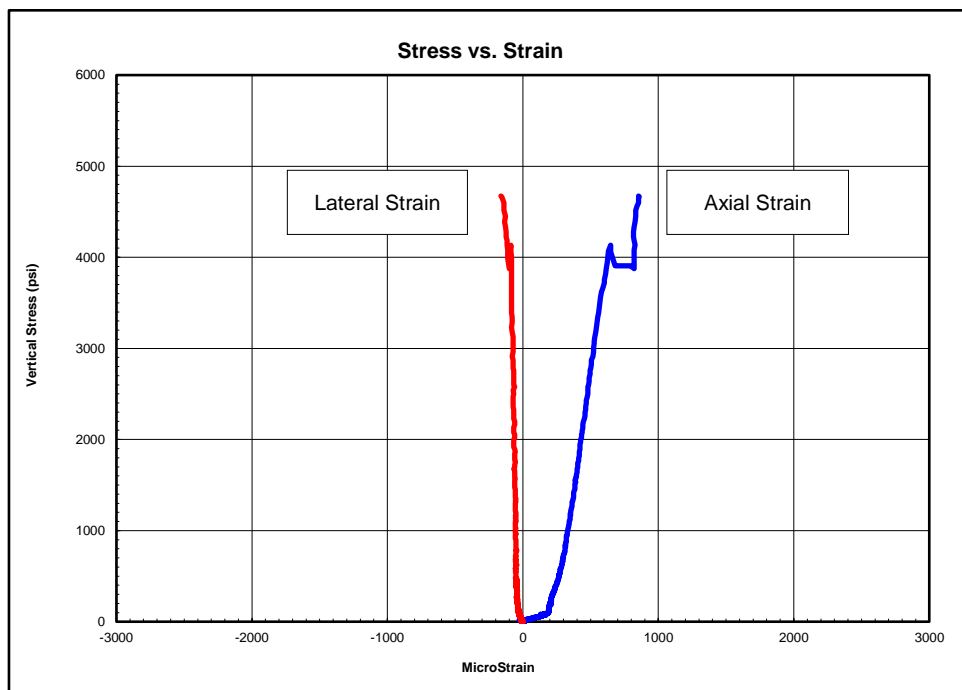
Compressive Strength and Elastic Moduli of Rock by ASTM D7012 - Method D

Peak Compressive Stress: 4,672 psi

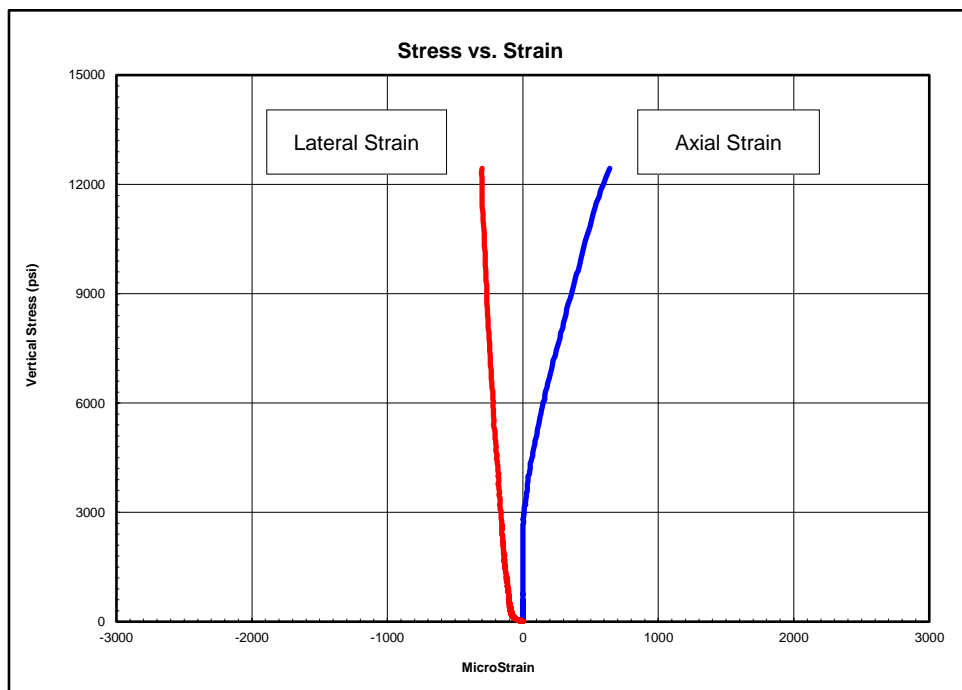
Compressive Strength and Elastic Moduli of Rock by ASTM D7012 - Method D

Peak Compressive Stress: 12,440 psi

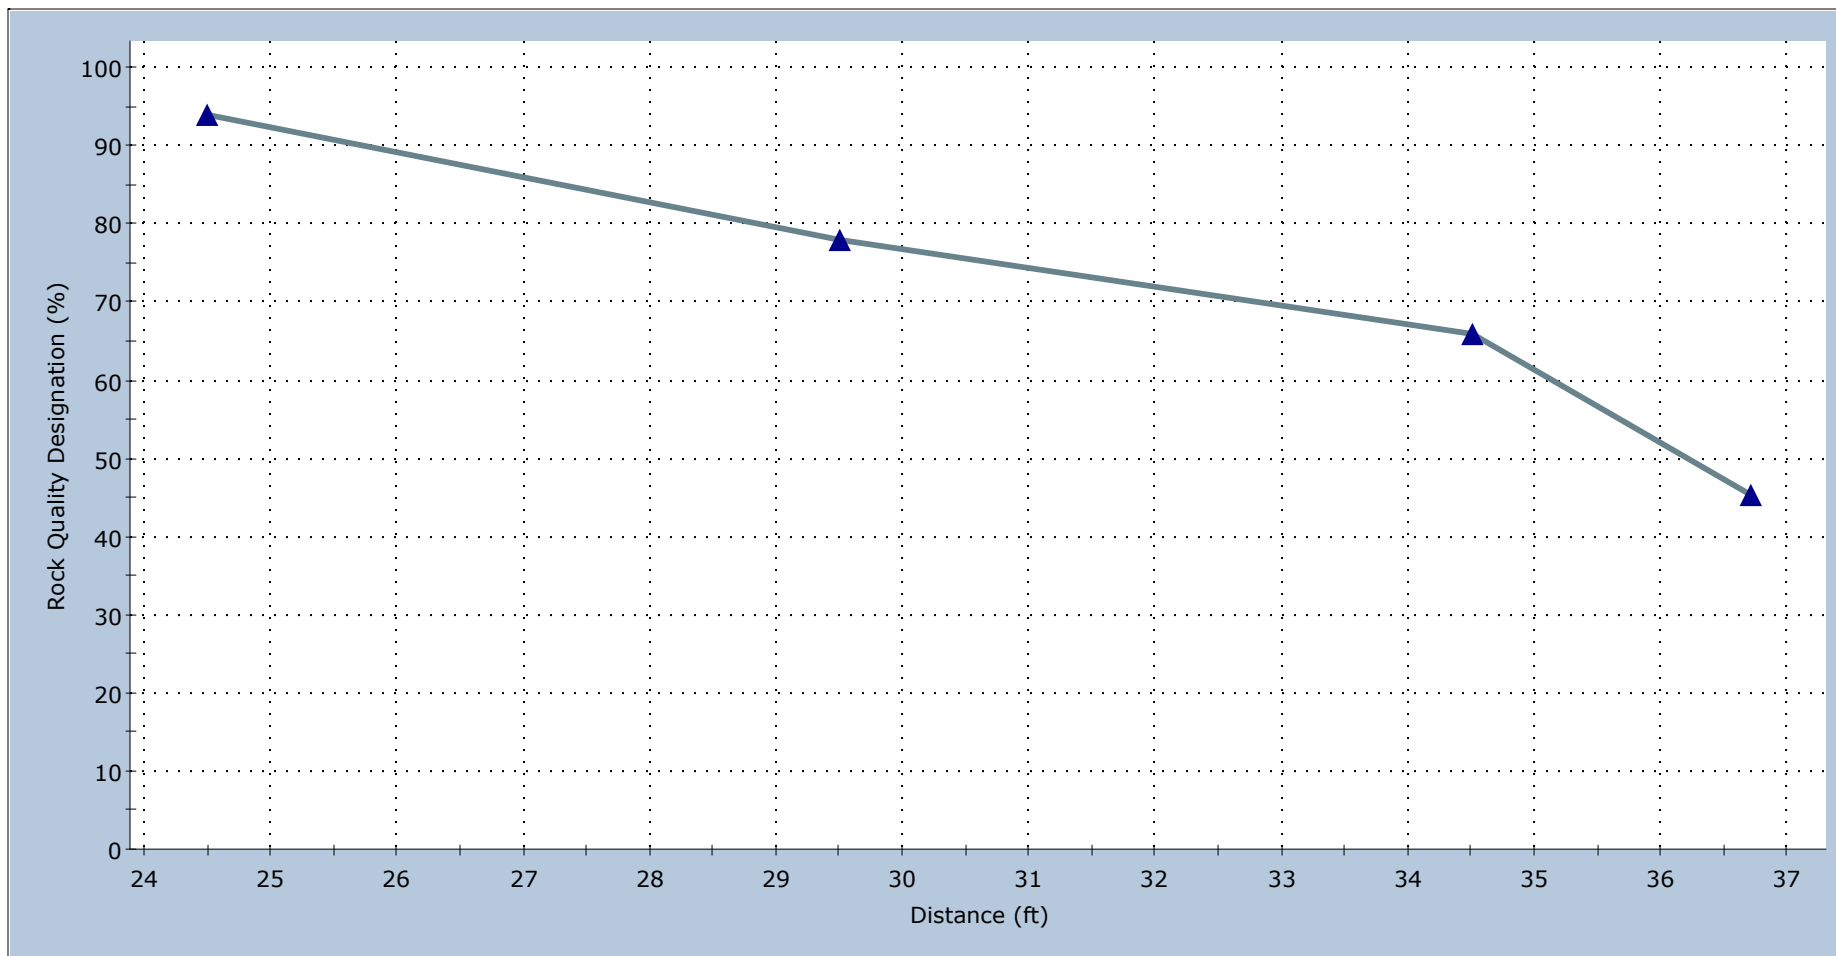
RQD Analysis Traverse L1

mean=70.864 s.d.=17.716 min=45.455 max=94.000

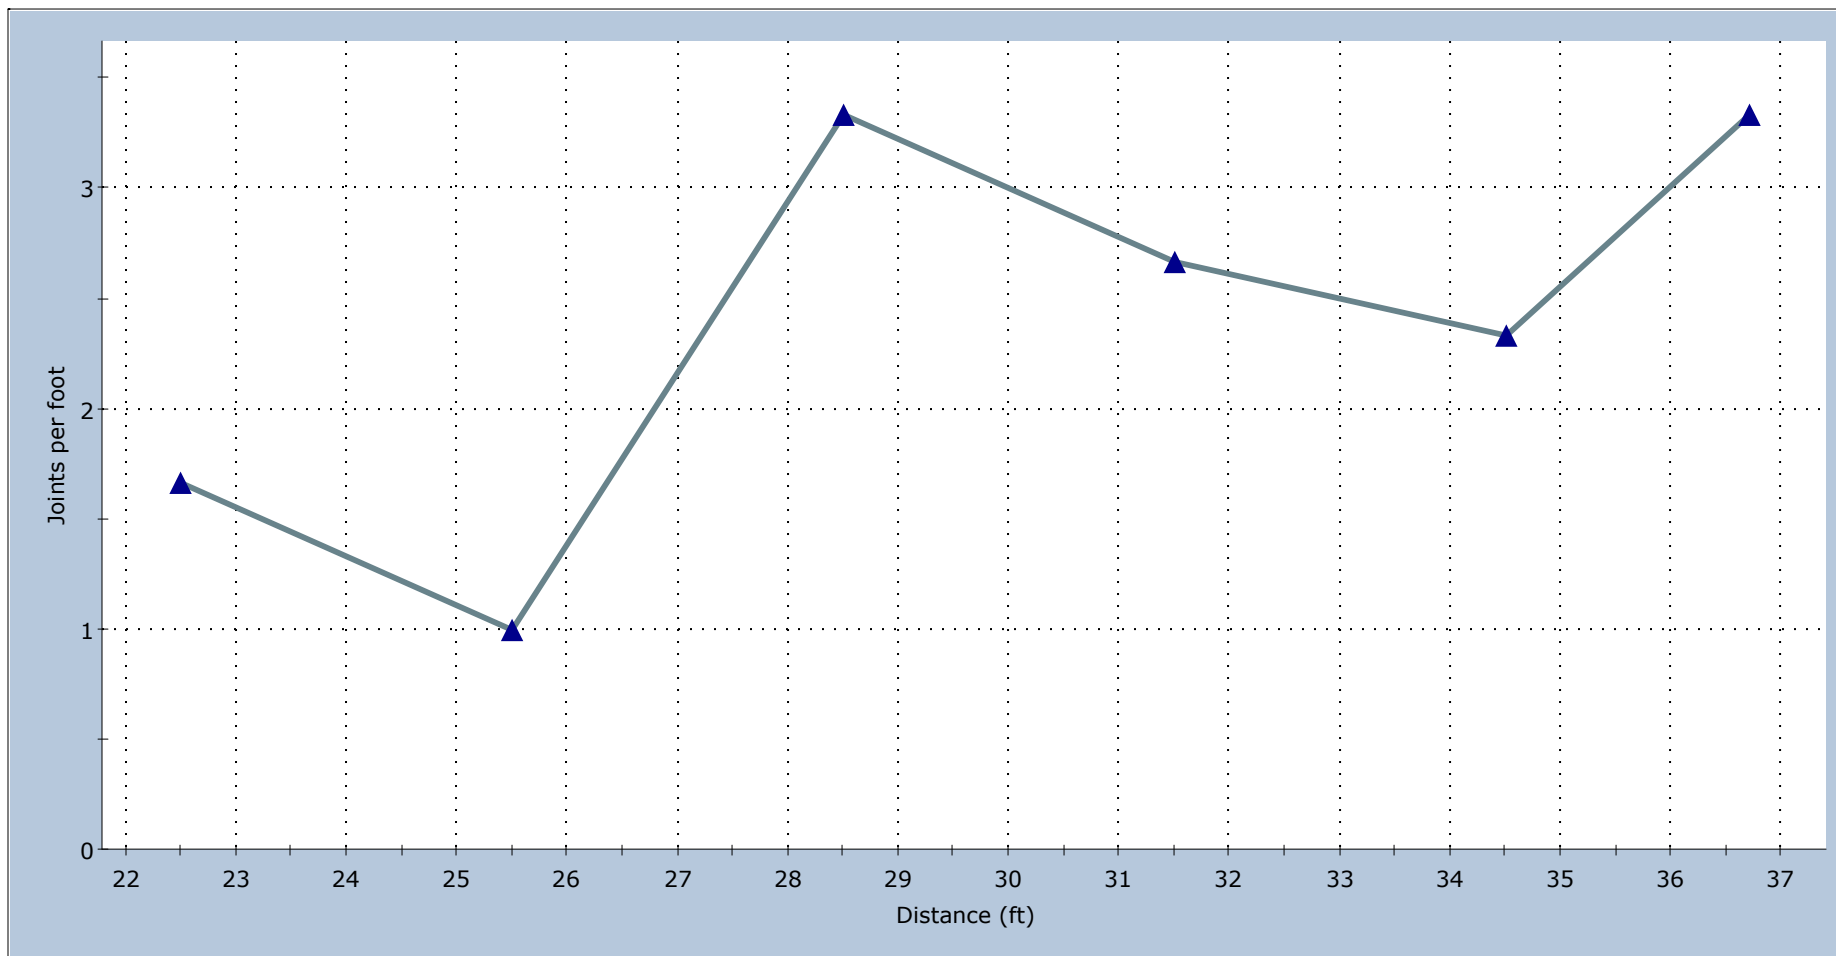
Joint Frequency Analysis Traverse L1

mean=2.389 s.d.=0.848 min=1.000 max=3.333

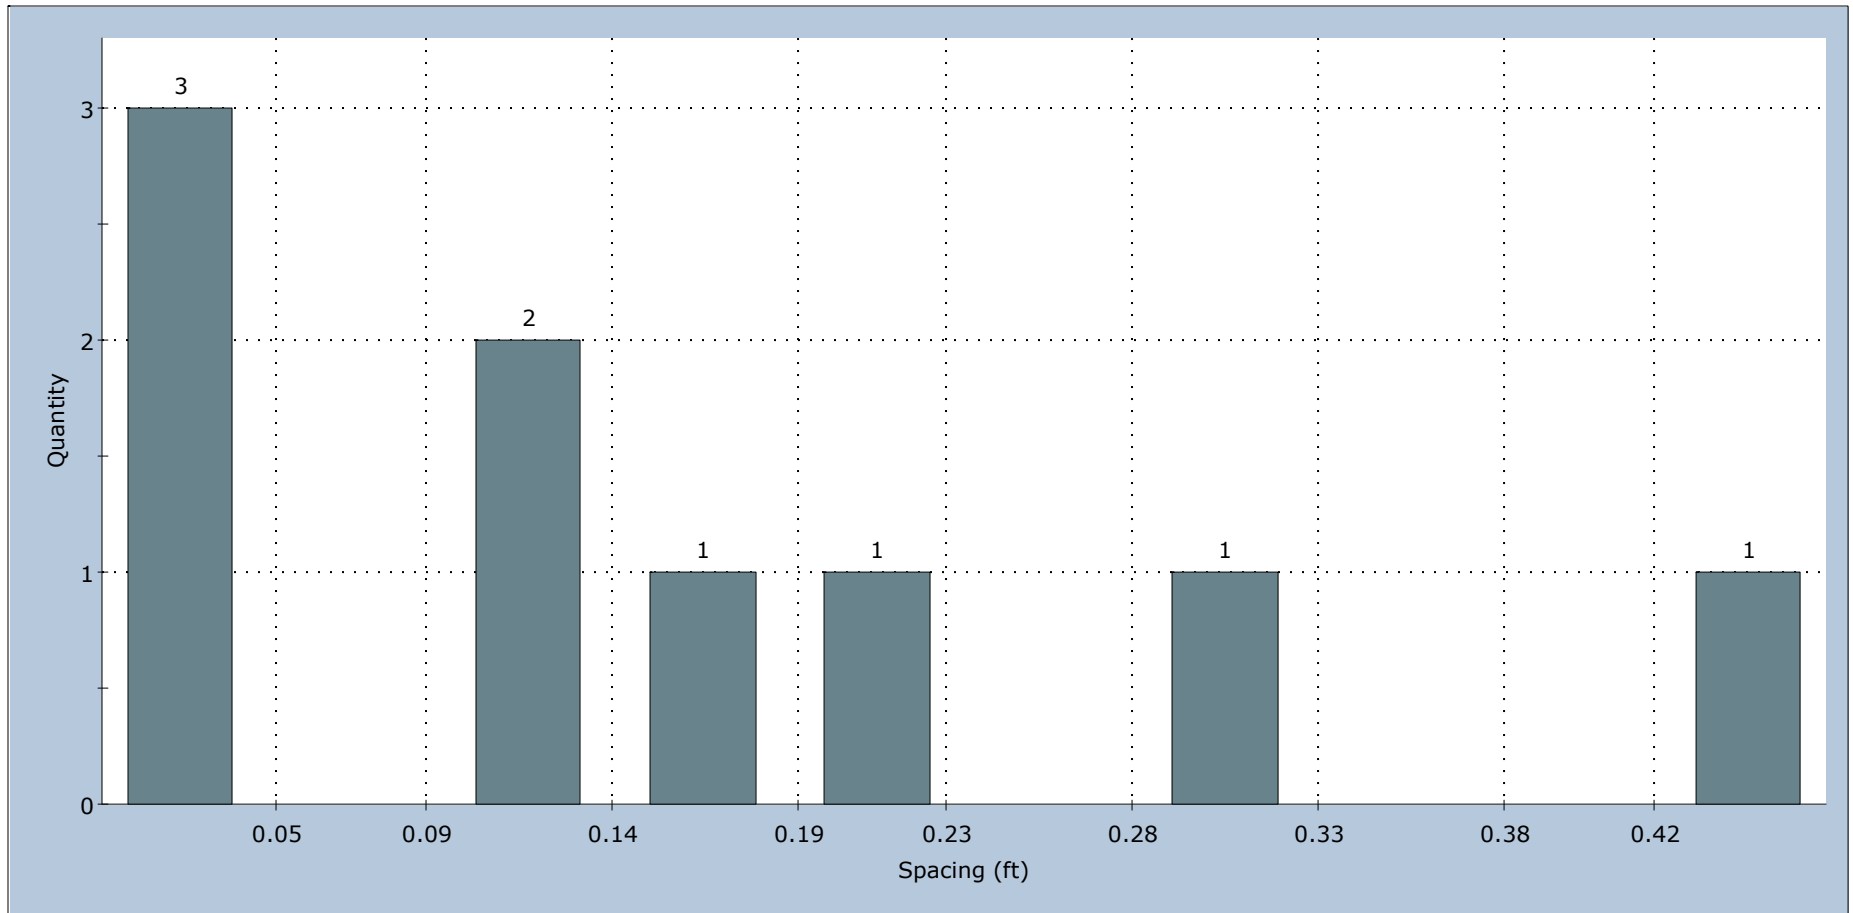
True Joint Spacing Set 1: J1 All Traverses

mean=0.156 s.d.=0.142 min=0.001 max=0.469

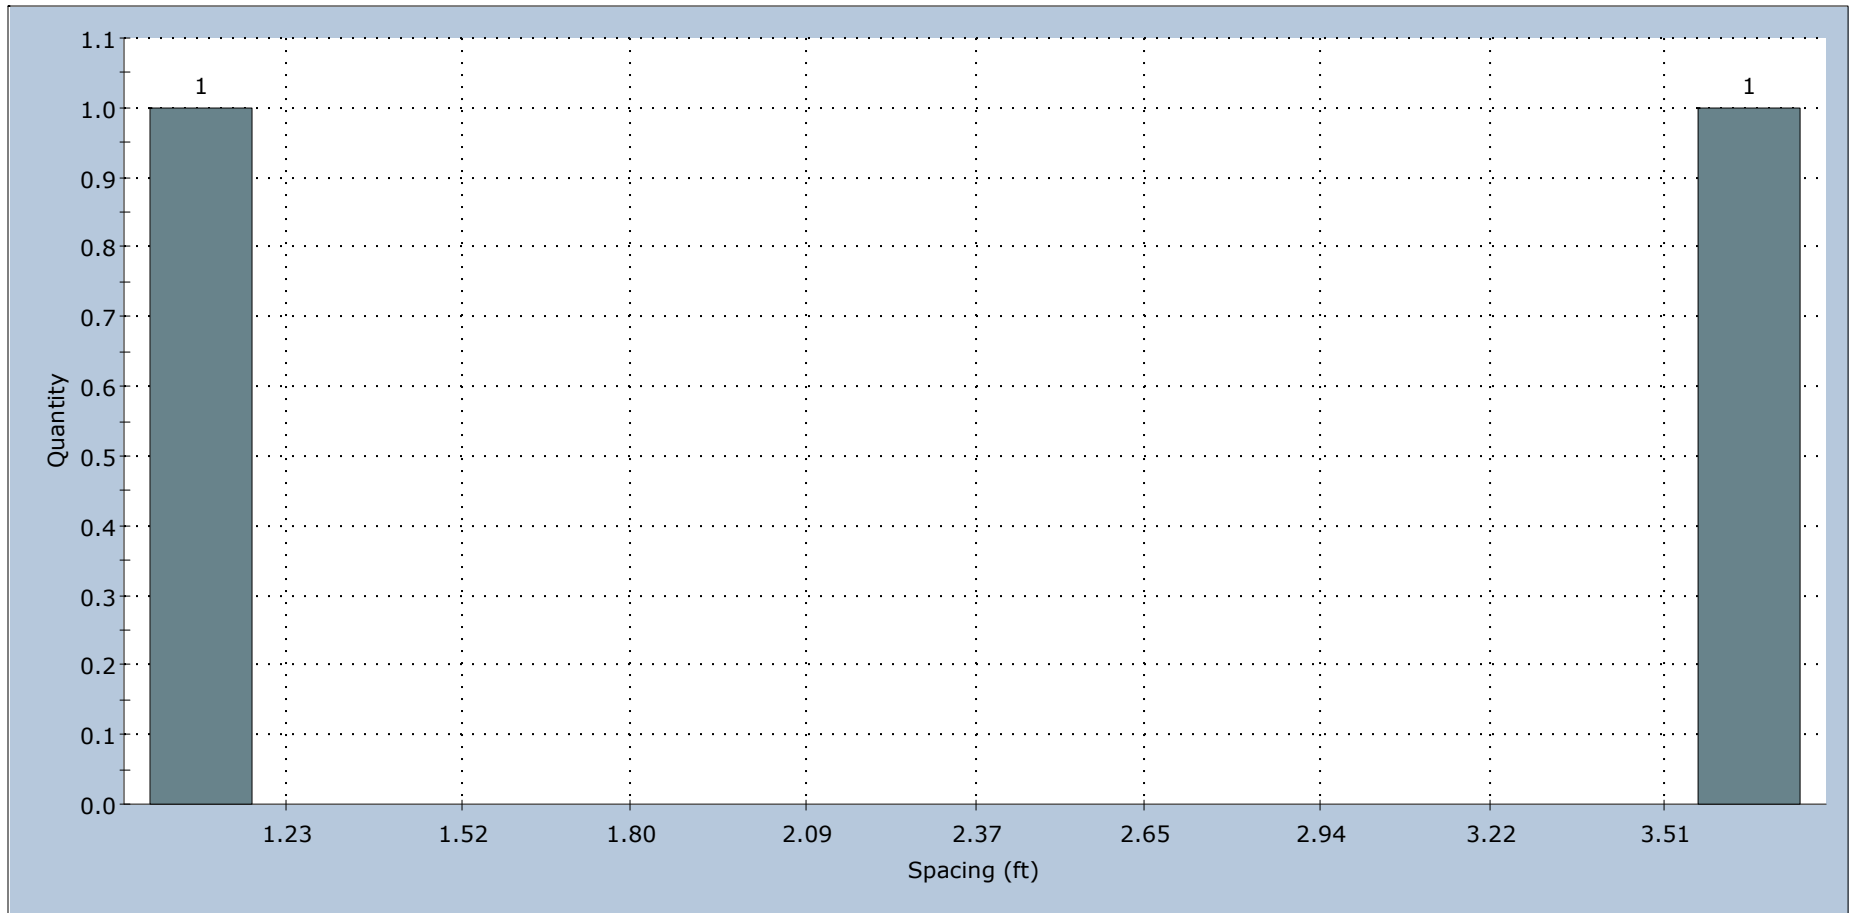
True Joint Spacing Set 2: J2 All Traverses

mean=2.370 s.d.=1.422 min=0.948 max=3.791
