GEOTECHNICAL SERIES 100 REPORT

Route 25
Gorham, Maine

WIN 020277.00
Fed Project #: NHP-2027(700)
June 30, 2014

SUBJECT: Gorham, Route 25, WIN 020277.00
Geotechnical Pavement Assessment Report No. 2014-132

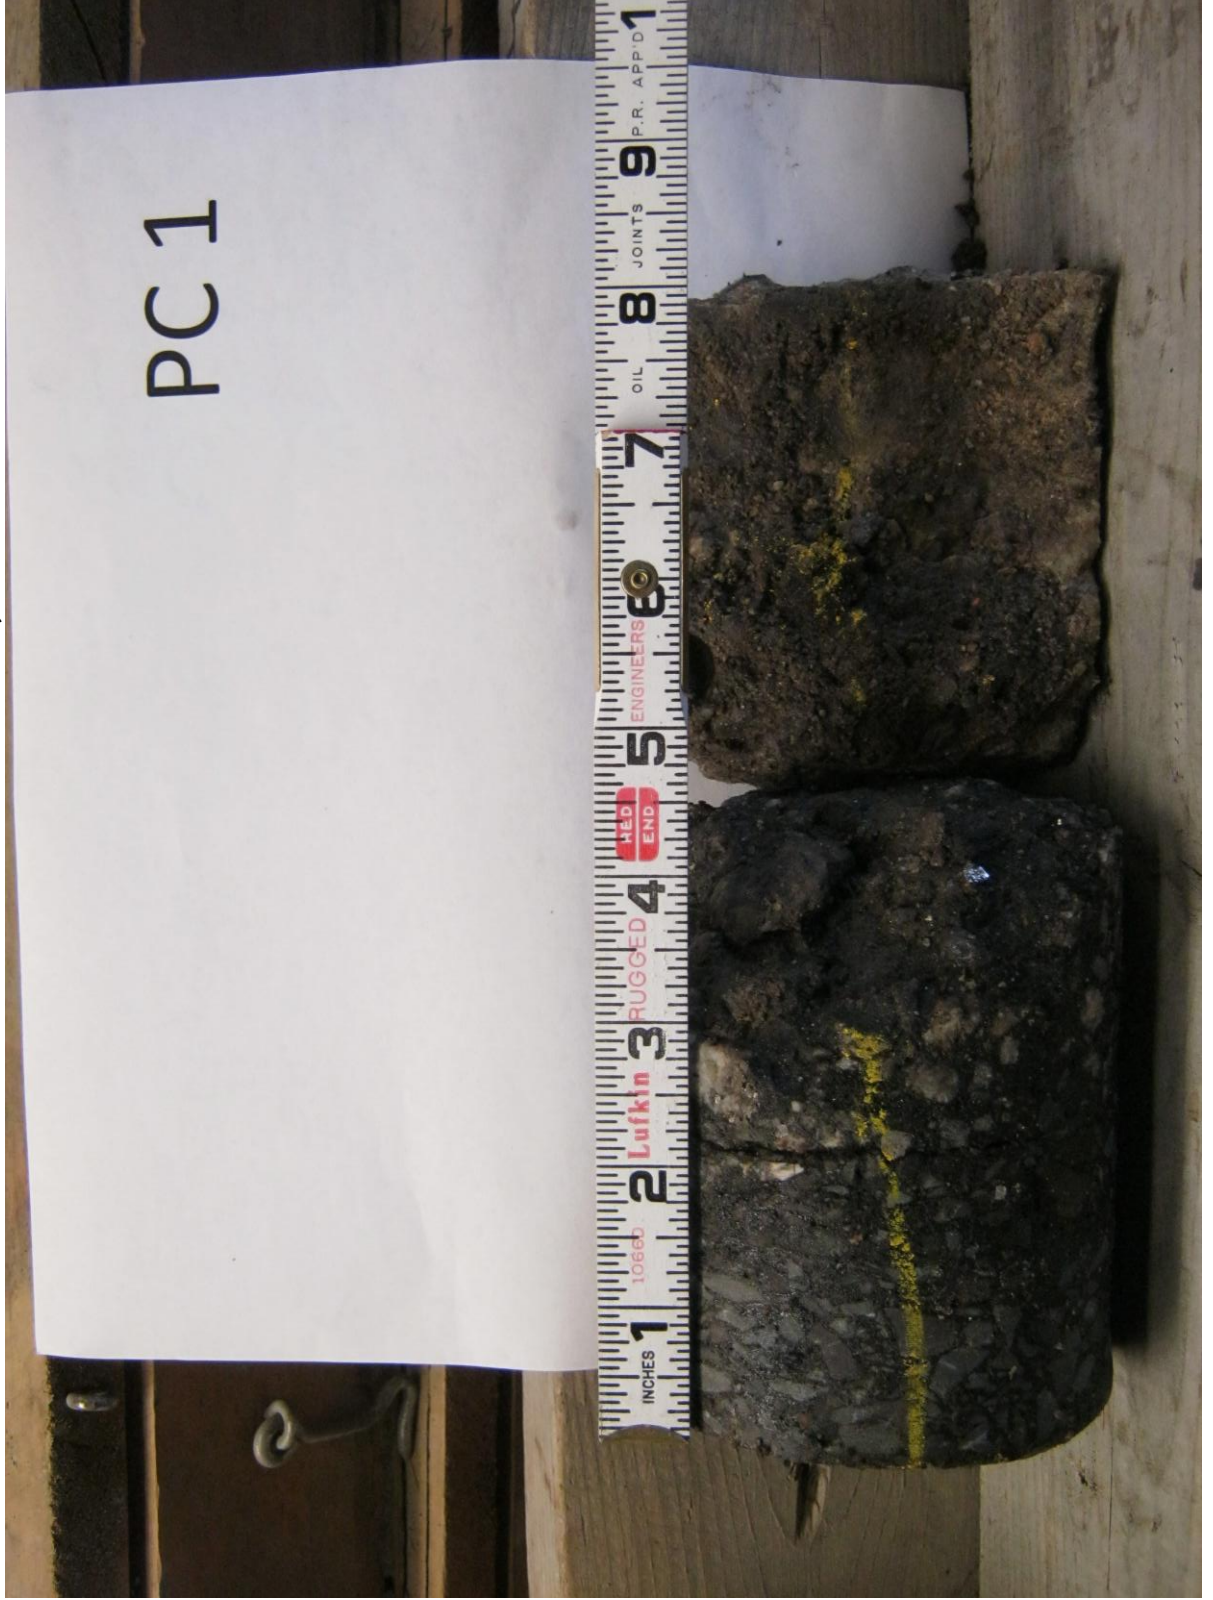
Pavement Cores
020277.00 - Gorham
STATION 15+00, 9' LT

Station (Feet)	Offset (Feet)	Pavement Depth (Inches)	Unbound Pavement	PC-Number	Saved Core	Comments / Date 6/18/2014
15+00	9.0 Lt.	5.0		1	yes	to top of concrete
25+00	9.0 Lt.	5.3		2	yes	to top of concrete
25+00	9.0 Rt.	6.3		3	yes	to top of concrete
37+00	9.0 Rt.	10.3		4	yes	to top of gravel (no concrete)
40+00	9.0 Rt.	6.0		5	yes	to top of concrete
40+00	9.0 Lt.	7.0		6	yes	to top of concrete
62+00	9.0 Lt.	7.0		7	yes	to top of concrete
72+00	9.0 Rt.	7.5		8	yes	to top of concrete
