SUBJECT: Geotechnical Design Basis Memorandum for Bedrock Dowels at Pier 2
Rehabilitation of Barter's Island Bridge No. 2039 over the Back River
Maine Department of Transportation WIN 22607.00
Boothbay, Maine

**GEOTECHNICAL DESIGN REPORT
BARTER'S ISLAND BRIDGE NO. 2039 OVER
THE BACK RIVER
MAINE DOT WIN 22607.00
BOOTHBAY, MAINE**

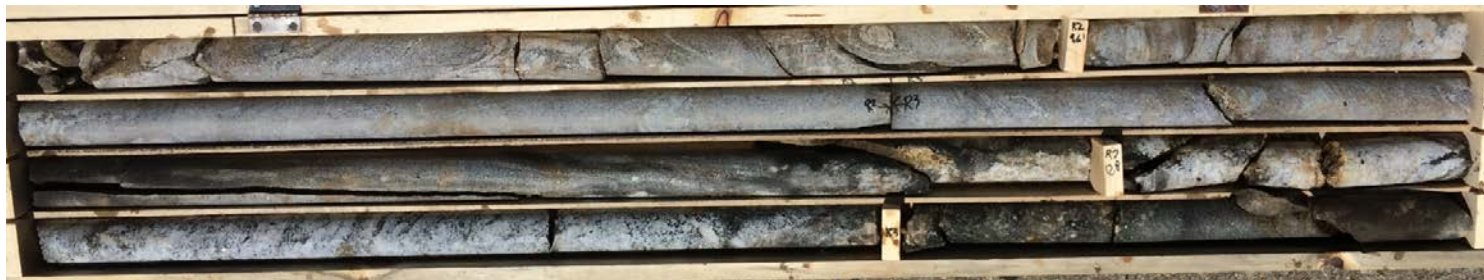
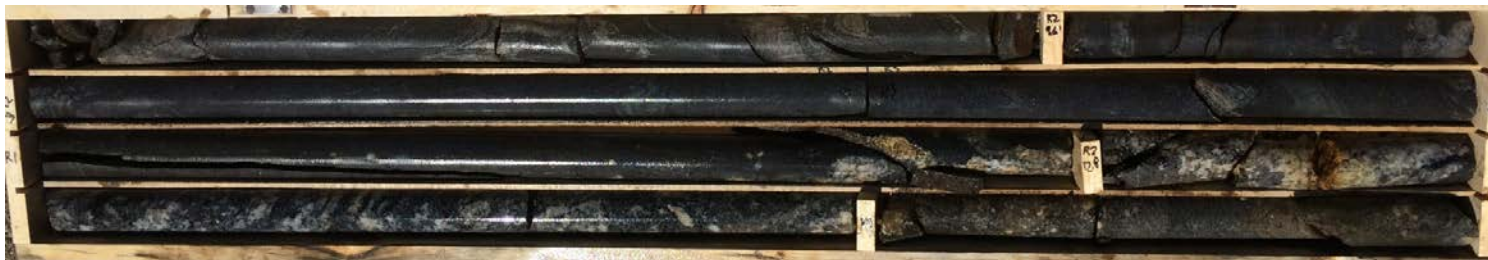
**MaineDOT Barters Island
 Bridge #2039 over the Back River
 Boothbay, ME
 Rock Core Photographs**

Boring No.	Run	Depth (ft)	Recovery (in)	Recovery (%)	RQD (in)	RQD (%)	Rock Type	Box Row
BB-BTBR-101	R1	5.6 - 9.6	45	94%	26	54%	GNEISS	1
BB-BTBR-101	R2	9.6 - 13.6	51	106%	48	100%	GNEISS	1,2
BB-BTBR-101	R3	13.6 - 15.6	24	100%	24	100%	GNEISS	2
BB-BTBR-103	R1	9.0 - 12.8	45	98%	31	67%	GNEISS	3
BB-BTBR-103	R2	12.8 - 17.0	50	100%	41	82%	GNEISS	3,4
BB-BTBR-103	R3	17.0 - 19.0	24	100%	19	79%	GNEISS	4

- Notes:**
1. Box row corresponds to the core box section in which the rock core sample is contained; Row 1=Top, Row 4=Bottom.
 2. Top photo is dry, bottom photo is wet.
 3. Transition between core runs within a row are marked by wood separators.

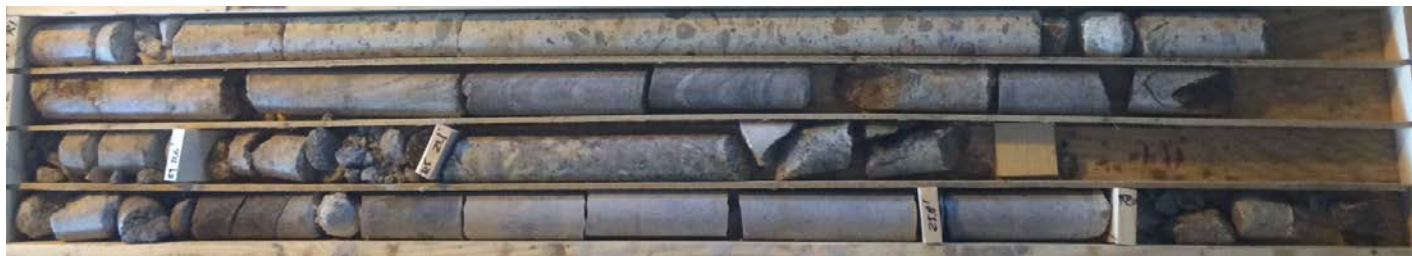
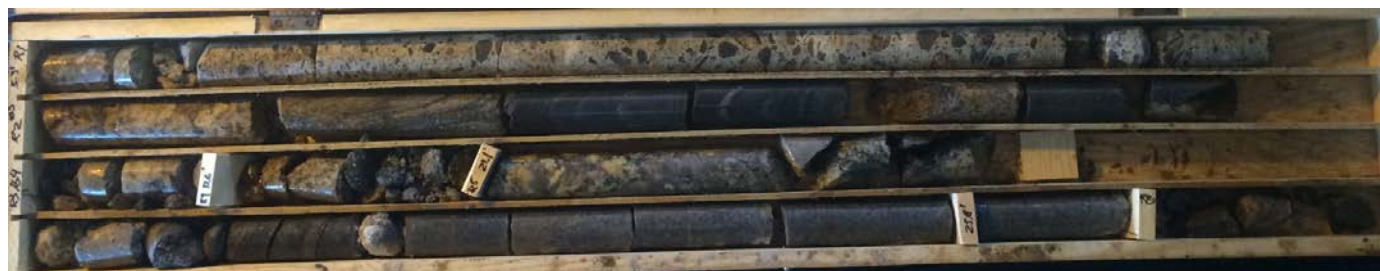
**MaineDOT Barthers Island
Bridge #2039 over the Back River
Boothbay, ME
Rock Core Photographs**

Boring No.	Run	Depth (ft)	Recovery (in)	Recovery (%)	RQD (in)	RQD (%)	Rock Type	Box Row
BB-BTBR-102	R1	5.3 - 10.3	55	92%	--	--	Masonry/Concrete	1
BB-BTBR-102	R2	10.3 - 16.4	65	89%	--	--	Masonry/Concrete	2
BB-BTBR-102	R3	16.4 - 17.6	8	57%	--	--	Masonry/Concrete	3
BB-BTBR-102	R4	17.6 - 21.1	11	26%	--	--	Masonry/Concrete	3
BB-BTBR-102	R5	21.1 - 23.1	22	92%	--	--	Masonry/Concrete	3
BB-BTBR-102	R6	23.1 - 25.8	38	119%	--	--	Masonry/Concrete	4
BB-BTBR-102	R7	25.8 - 27.0	6	43%	--	--	Masonry/Concrete	4
BB-BTBR-102	R8	27.0 - 28.8	7	35%	--	--	Masonry/Concrete	4

- Notes:**
1. Box row corresponds to the core box section in which the rock core sample is contained; Row 1=Top, Row 4=Bottom.
 2. Top photo is dry, bottom photo is wet.
 3. Transition between core runs within a row are marked by wood separators.

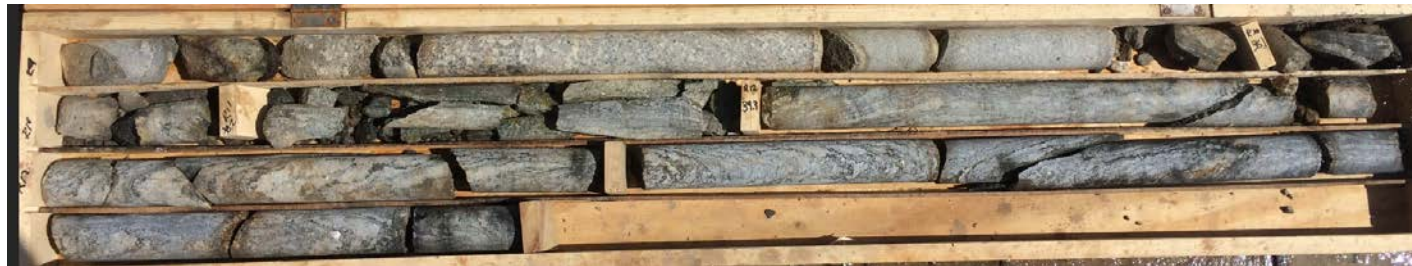
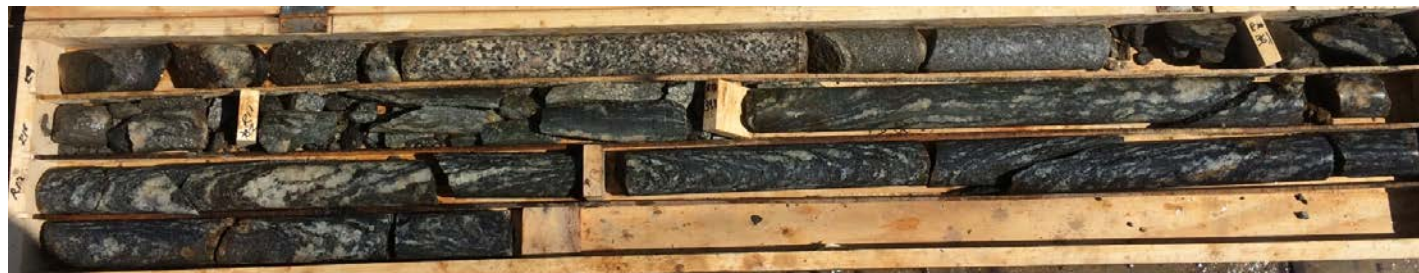
**MaineDOT Barters Island
 Bridge #2039 over the Back River
 Boothbay, ME
 Rock Core Photographs**

Boring No.	Run	Depth (ft)	Recovery (in)	Recovery (%)	RQD (in)	RQD (%)	Rock Type	Box Row
BB-BTBR-102	R9	28.8 - 36.1	46	52%	--	--	Masonry/Concrete	1
BB-BTBR-102	R10	36.1 - 38.2	14	56%	0	0%	GNEISS	1,2
BB-BTBR-102	R11	38.2 - 39.3	18	138%	0	0%	GNEISS	2
BB-BTBR-102	R12	39.3 - 43.5	48	96%	30	60%	GNEISS	2,3
BB-BTBR-102	R13	43.5 - 47.8	53	104%	50	98%	GNEISS	3,4

- Notes:**
1. Box row corresponds to the core box section in which the rock core sample is contained; Row 1=Top, Row 4=Bottom.
 2. Top photo is dry, bottom photo is wet.
 3. Transition between core runs within a row are marked by wood separators.

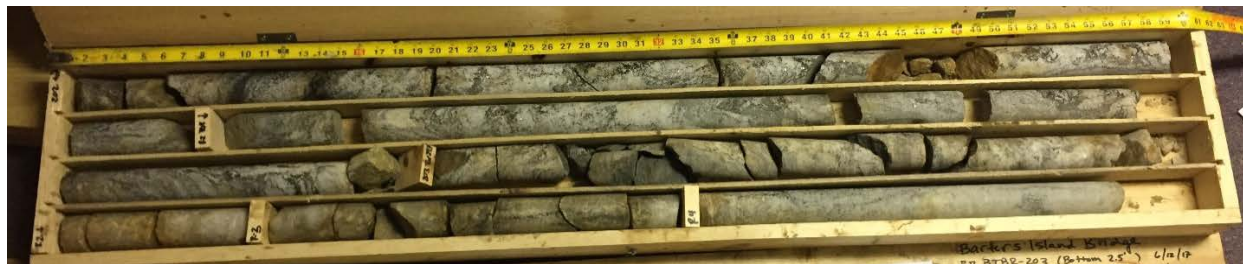
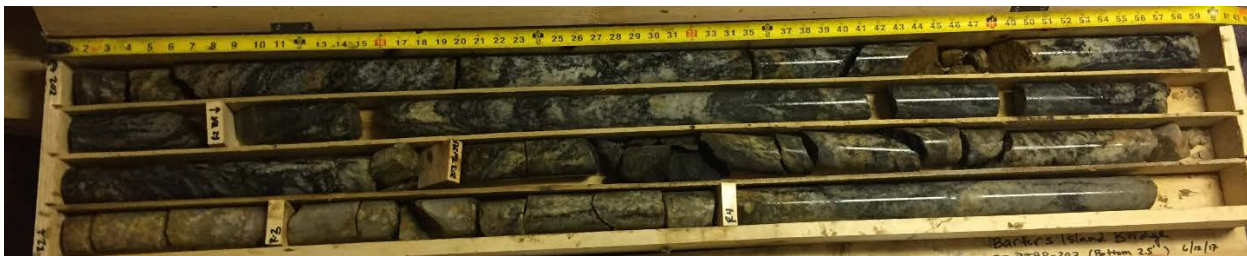
**MaineDOT Barbers Island
 Bridge #2039 over the Back River
 Boothbay, ME
 Rock Core Photographs**

Boring No.	Run	Depth (ft)	Recovery (in)	Recovery (%)	RQD (in)	RQD (%)	Rock Type	Box Row
BB-BTBR-202	R1	30.0 - 35.0	60	100%	49	82%	GNEISS	1,2
BB-BTBR-202	R2	35.0 - 40.0	60	100%	58	97%	GNEISS	2,3
BB-BTBR-203	R1	29.7 - 32.8	37	100%	12	32%	GNEISS, PEGMATITE	3
BB-BTBR-203	R2	32.8 - 33.7	10	91%	5	45%	PEGMATITE	4
BB-BTBR-203	R3	33.7 - 35.4	21	100%	4	19%	PEGMATITE	4
BB-BTBR-203 (Top 22")	R4	35.4 - 39.9	51	96%	37	70%	PEGMATITE	4

- Notes:**
1. Box row corresponds to the core box section in which the rock core sample is contained; Row 1=Top, Row 4=Bottom.
 2. Top photo is dry, bottom photo is wet.
 3. Transition between core runs within a row are marked by wood separators.

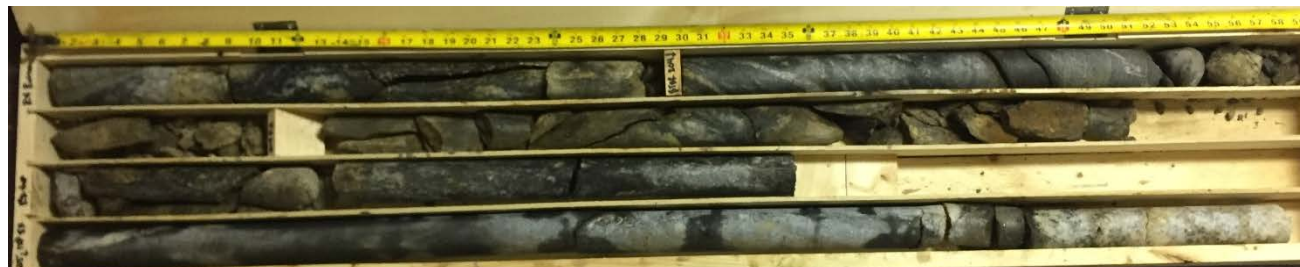
**MaineDOT Barthers Island
 Bridge #2039 over the Back River
 Boothbay, ME
 Rock Core Photographs**

Boring No.	Run	Depth (ft)	Recovery (in)	Recovery (%)	RQD (in)	RQD (%)	Rock Type	Box Row
BB-BTAR-203 (Bottom 30")	R4	35.4 - 39.9	51	96%	37	70%	PEGMATITE, GNEISS	1
BB-BTBR-204	R1	38.3 - 42.8	41	76%	20	37%	GNEISS, PEGMATITE	1,2
BB-BTBR-204	R2	42.8 - 45.5	32	100%	4	12%	GNEISS	2
BB-BTBR-204	R3	45.5 - 48.3	34	100%	22	65%	PEGMATITE/GNEISS	3
BB-BTBR-205	R1	4.7 - 9.7	58	96%	47	78%	GNEISS, PEGMATITE	4

- Notes:**
1. Box row corresponds to the core box section in which the rock core sample is contained; Row 1=Top, Row 3=Bottom.
 2. Top photo is dry, bottom photo is wet.
 3. Transition between core runs within a row are marked by red lines.

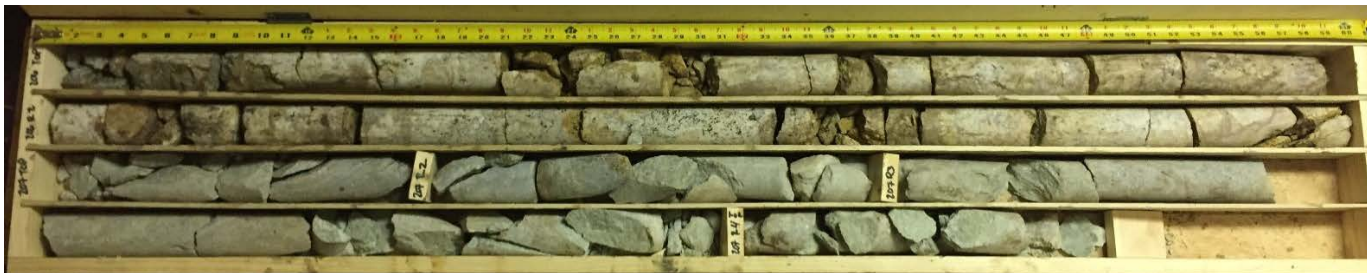
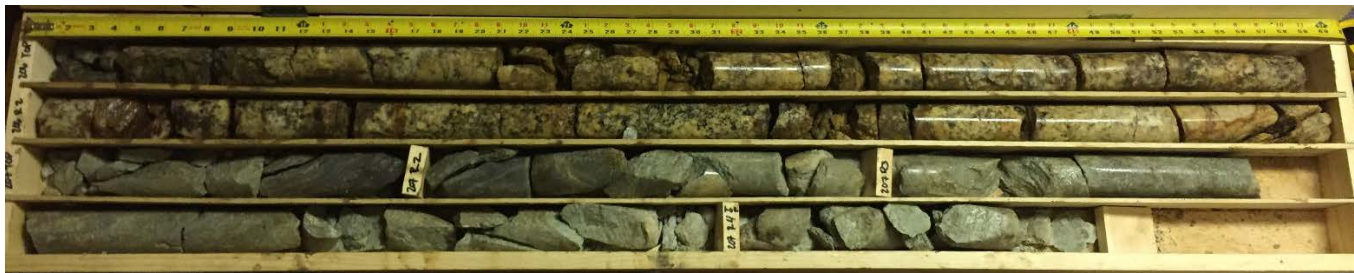
**MaineDOT Barbers Island
 Bridge #2039 over the Back River
 Boothbay, ME
 Rock Core Photographs**

Boring No.	Run	Depth (ft)	Recovery (in)	Recovery (%)	RQD (in)	RQD (%)	Rock Type	Box Row
BB-BTBR-206	R1	2.0 - 7.0	60	100%	26	43%	PEGMATITE	1
BB-BTBR-206	R2	7.0 - 12.0	60	100%	30	50%	PEGMATITE	2
BB-BTBR-207	R1	5.0 - 6.5	18	100%	0	0%	GNEISS	3
BB-BTBR-207	R2	6.5 - 8.0	18	86%	0	0%	GNEISS	3
BB-BTBR-207	R3	8.3 - 11.9	43	100%	14	33%	GNEISS	3,4
BB-BTBR-207	R4	11.9 - 13.3	14	82%	0	0%	GNEISS	4

- Notes:**
1. Box row corresponds to the core box section in which the rock core sample is contained; Row 1=Top, Row 4=Bottom.
 2. Top photo is dry, bottom photo is wet.
 3. Transition between core runs within a row are marked by wood separators.

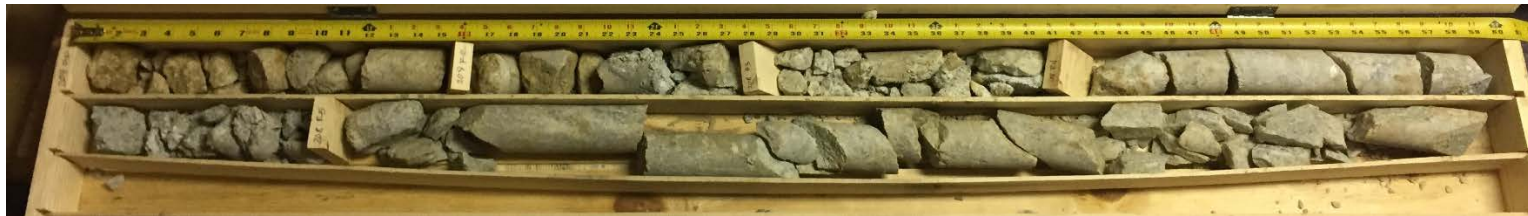
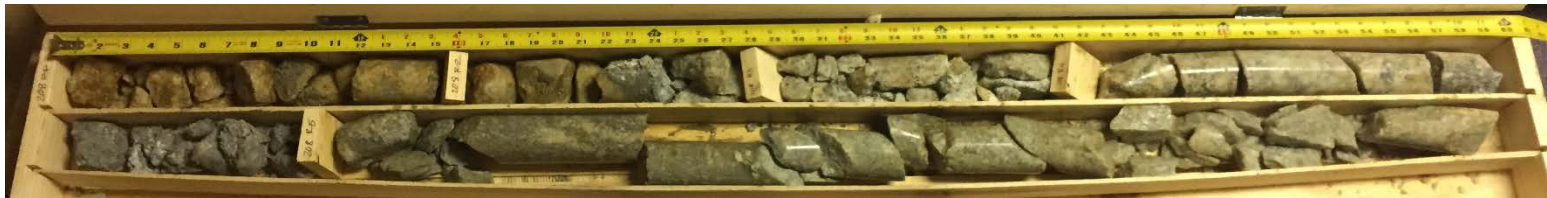
**MaineDOT Barbers Island
 Bridge #2039 over the Back River
 Boothbay, ME
 Rock Core Photographs**

Boring No.	Run	Depth (ft)	Recovery (in)	Recovery (%)	RQD (in)	RQD (%)	Rock Type	Box Row
BB-BTBR-208	R1	14.0 - 15.3	13	100%	0	0%	GNEISS	1
BB-BTBR-208	R2	15.3 - 19	15	100%	0	0%	GNEISS	1
BB-BTBR-208	R3	19.0 - 20.3	12	100%	0	0%	GNEISS, PEGMATITE	1
BB-BTBR-208	R4	20.3 - 23.1	25	91%	5	12%	PEGMATITE	1,2
BB-BTBR-208	R5	23.1 - 26.6	42	100%	4	36%	PEGMATITE	2

- Notes:**
1. Box row corresponds to the core box section in which the rock core sample is contained; Row 1=Top, Row 4=Bottom.
 2. Top photo is dry, bottom photo is wet.
 3. Transition between core runs within a row are marked by wood separators.
