HALEY ALDRICH PROSPECT SOUTH ROCK SLOPE STABILIZATION
 MAINEDOT WIN 022966.00
 PROSPECT, MAINE

**ROCK SLOPE REMEDIATION
 AREA LOCATION PLAN**

FIGURE 4

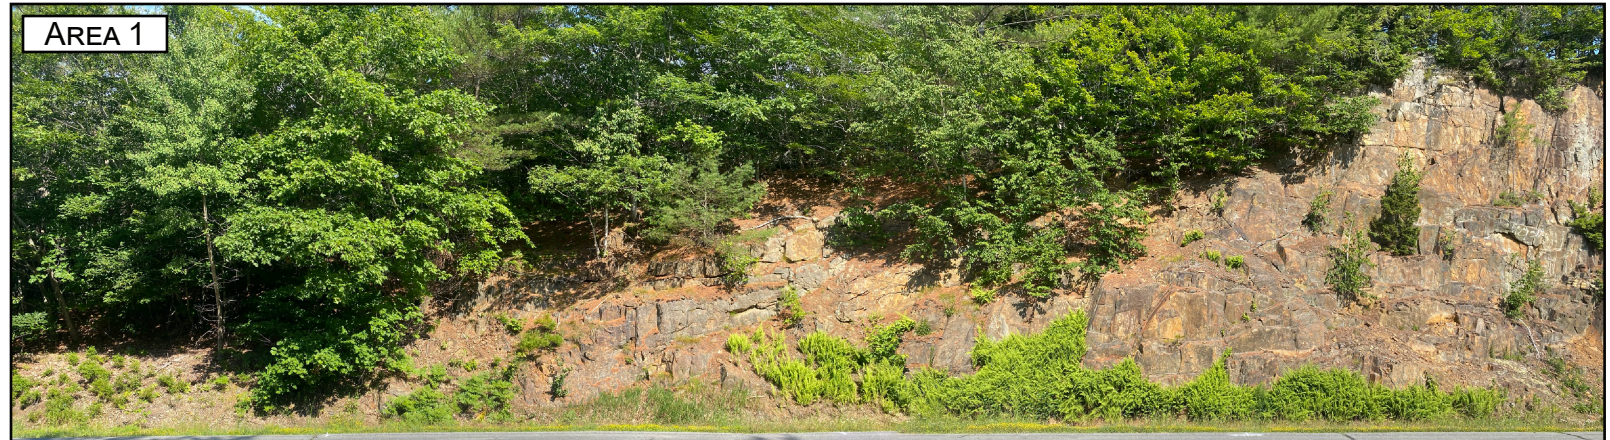
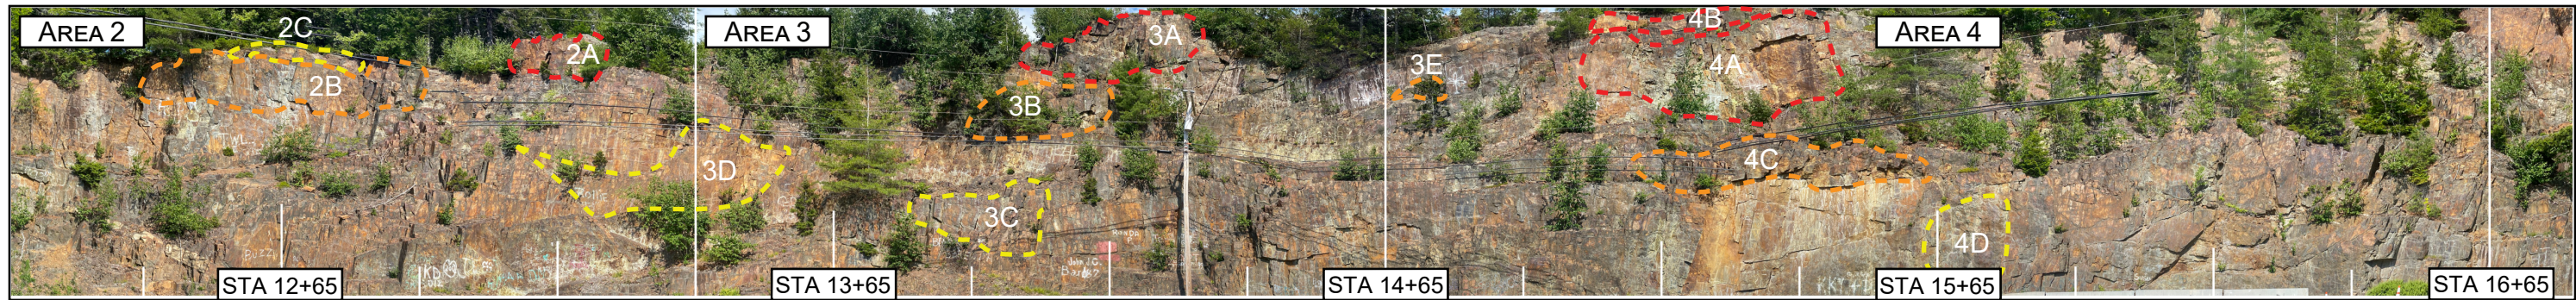
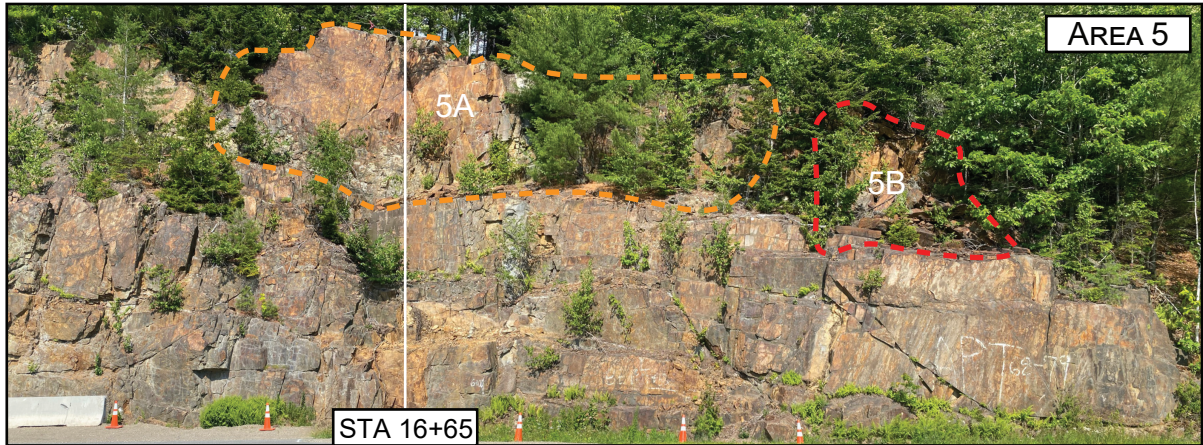
COMPOSITE IMAGE OF STITCHED PHOTOS FROM THE 2022 SITE INSPECTION, SCALED WITH FIELD STATIONING SUPERIMPOSED OVER THE IMAGES. THE AREAS ARE BROKEN OUT INTO THEIR CRITICAL AREAS WITH OVERALL MITIGATION ELEMENTS HIGHLIGHTED FOR EACH AREA. AS NOTED IN THE REPORT, AREA 1 DOES NOT REQUIRE ANY MITIGATION EXCEPT FOR VEGETATION REMOVAL.
