TRACY BROOK BRIDGE  
OVER MEADOW BROOK

WIN 23657.00

Town of Durham  
Androscoggin County  
Maine

GEOTECHNICAL  
DESIGN REPORT

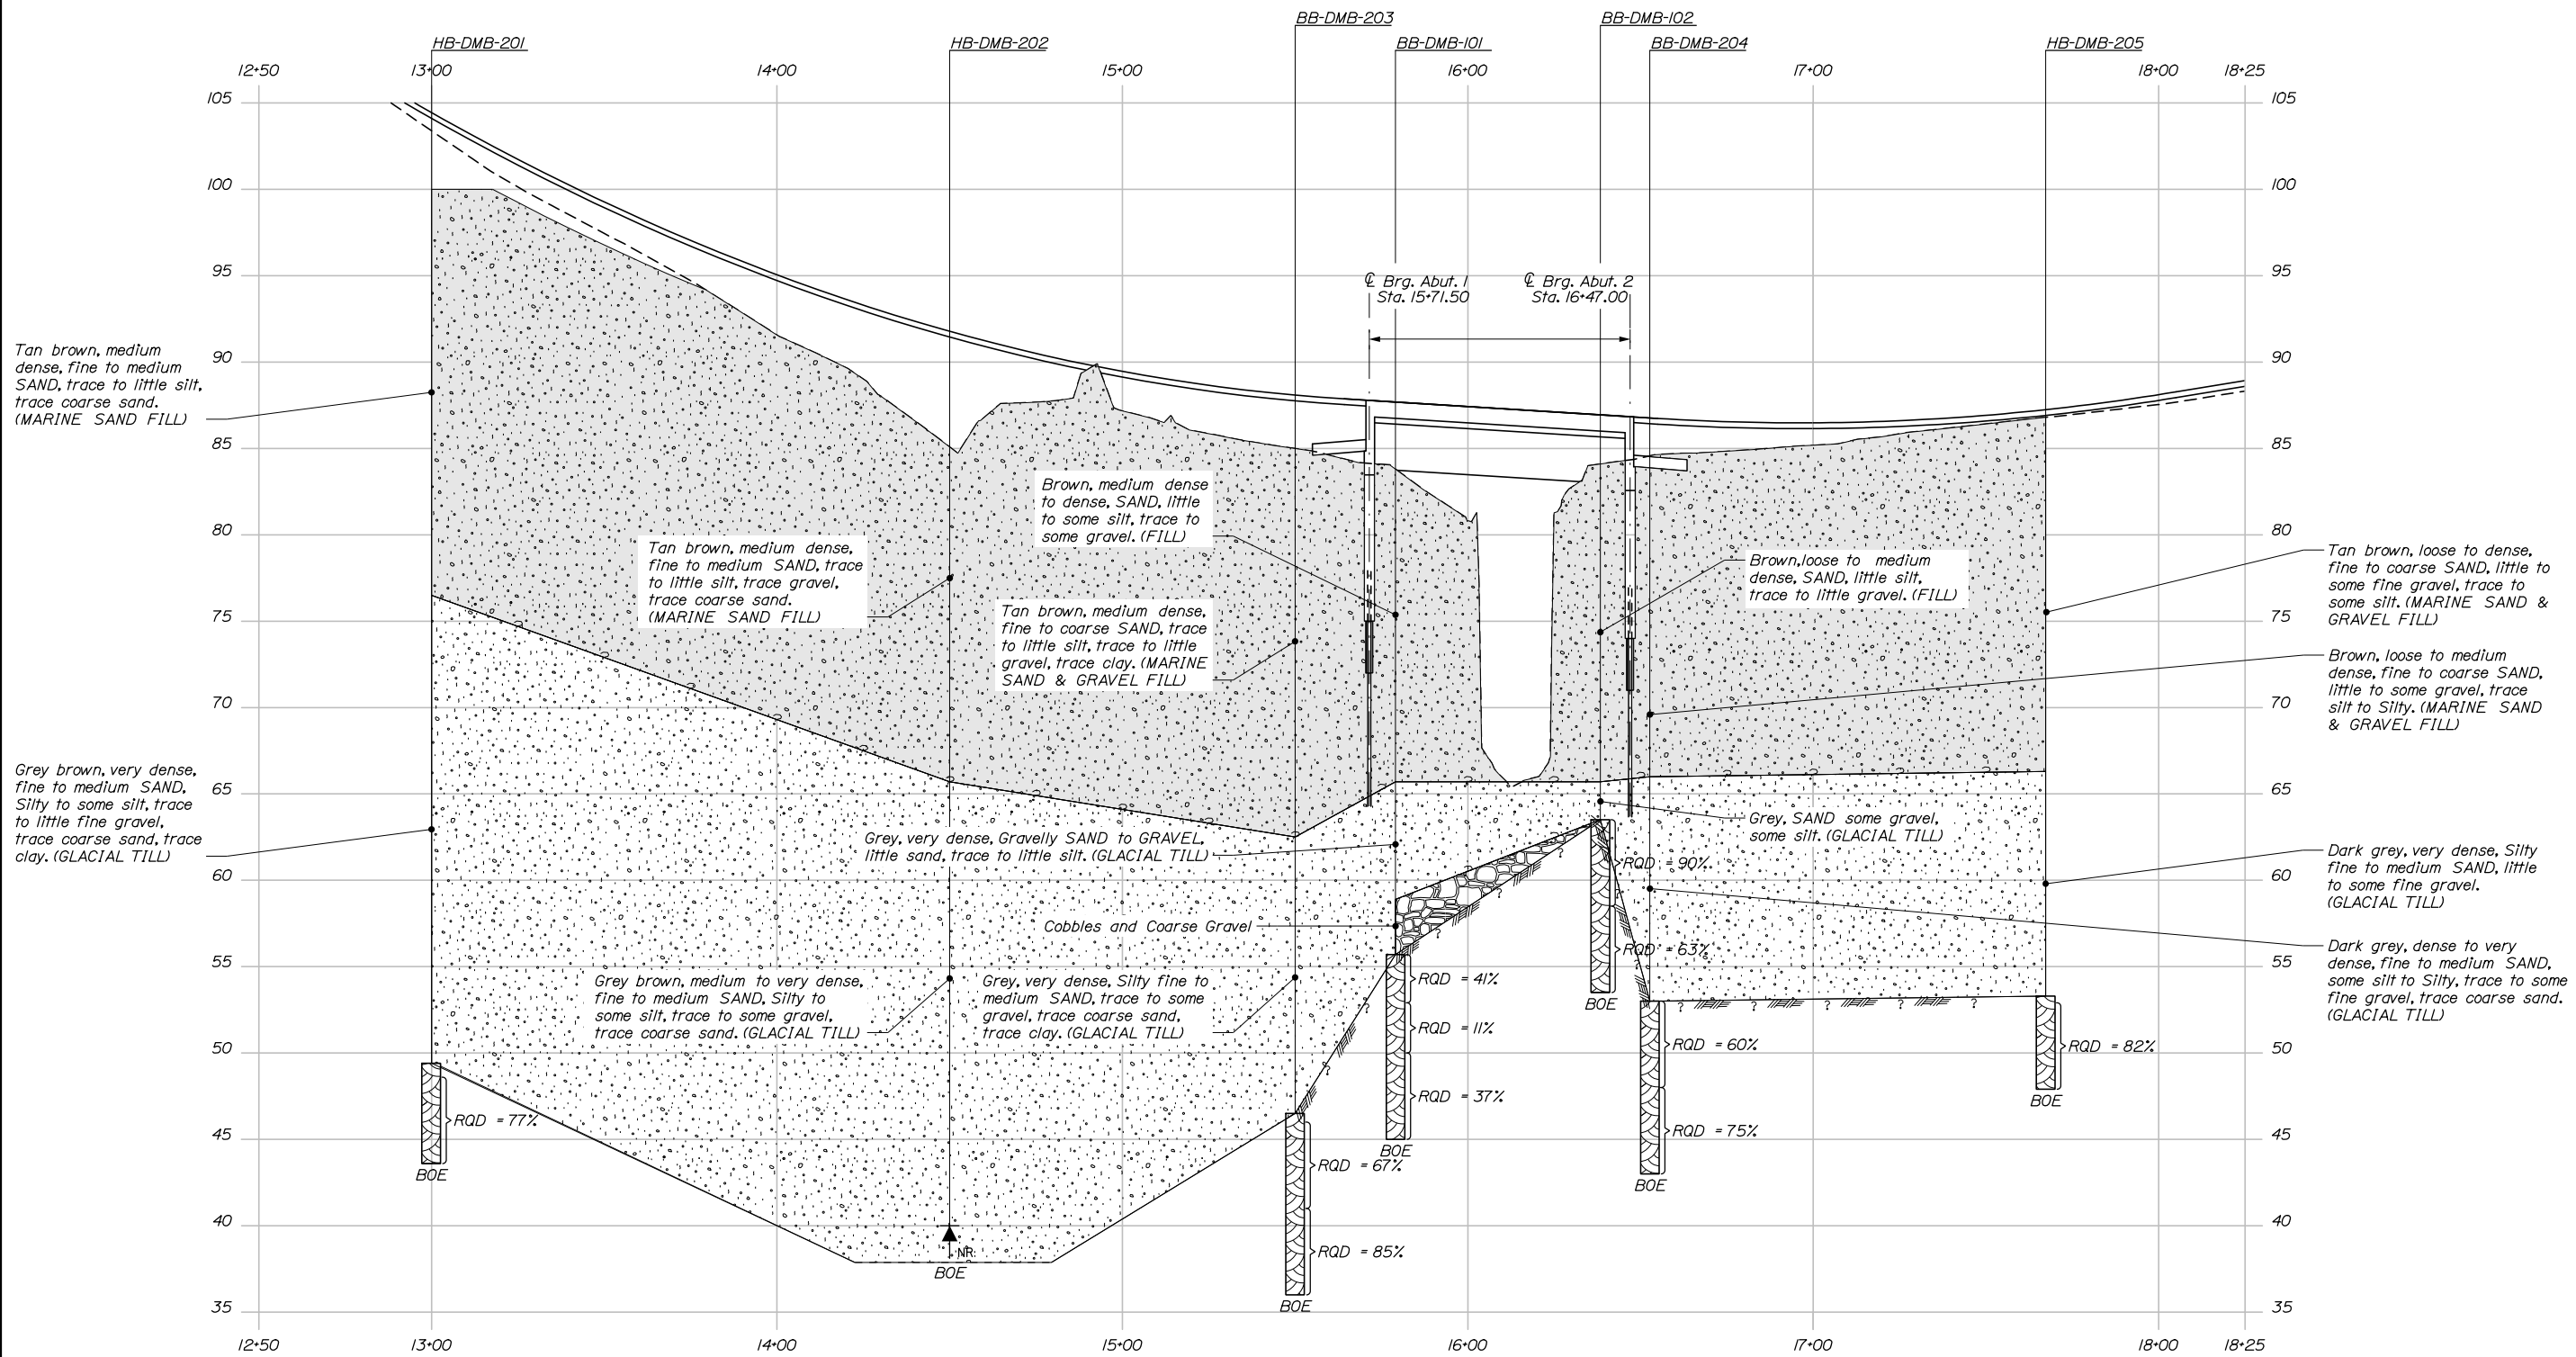
# FIGURE 5

**Note:**  
 This generalized interpretive soil profile is intended to convey trends in subsurface conditions. The boundaries between strata are approximate and idealized, and have been developed by interpretations of widely spaced explorations and samples. Actual soil and bedrock transitions may vary and are probably more erratic. For more specific information refer to the exploration logs.

A thorough review of the boring logs and laboratory test results was conducted to establish the general stratigraphy of the site. The purpose of “stratifying” a site is to group similar soil materials that have the same geologic origin. Stratification not only aids in visualizing the subsurface conditions, but also facilitates computations since the soil material throughout a particular stratum usually exhibits similar engineering characteristics, e.g., strength and compressibility. It should be noted that the strata boundaries shown on the logs have been inferred using available subsurface data.

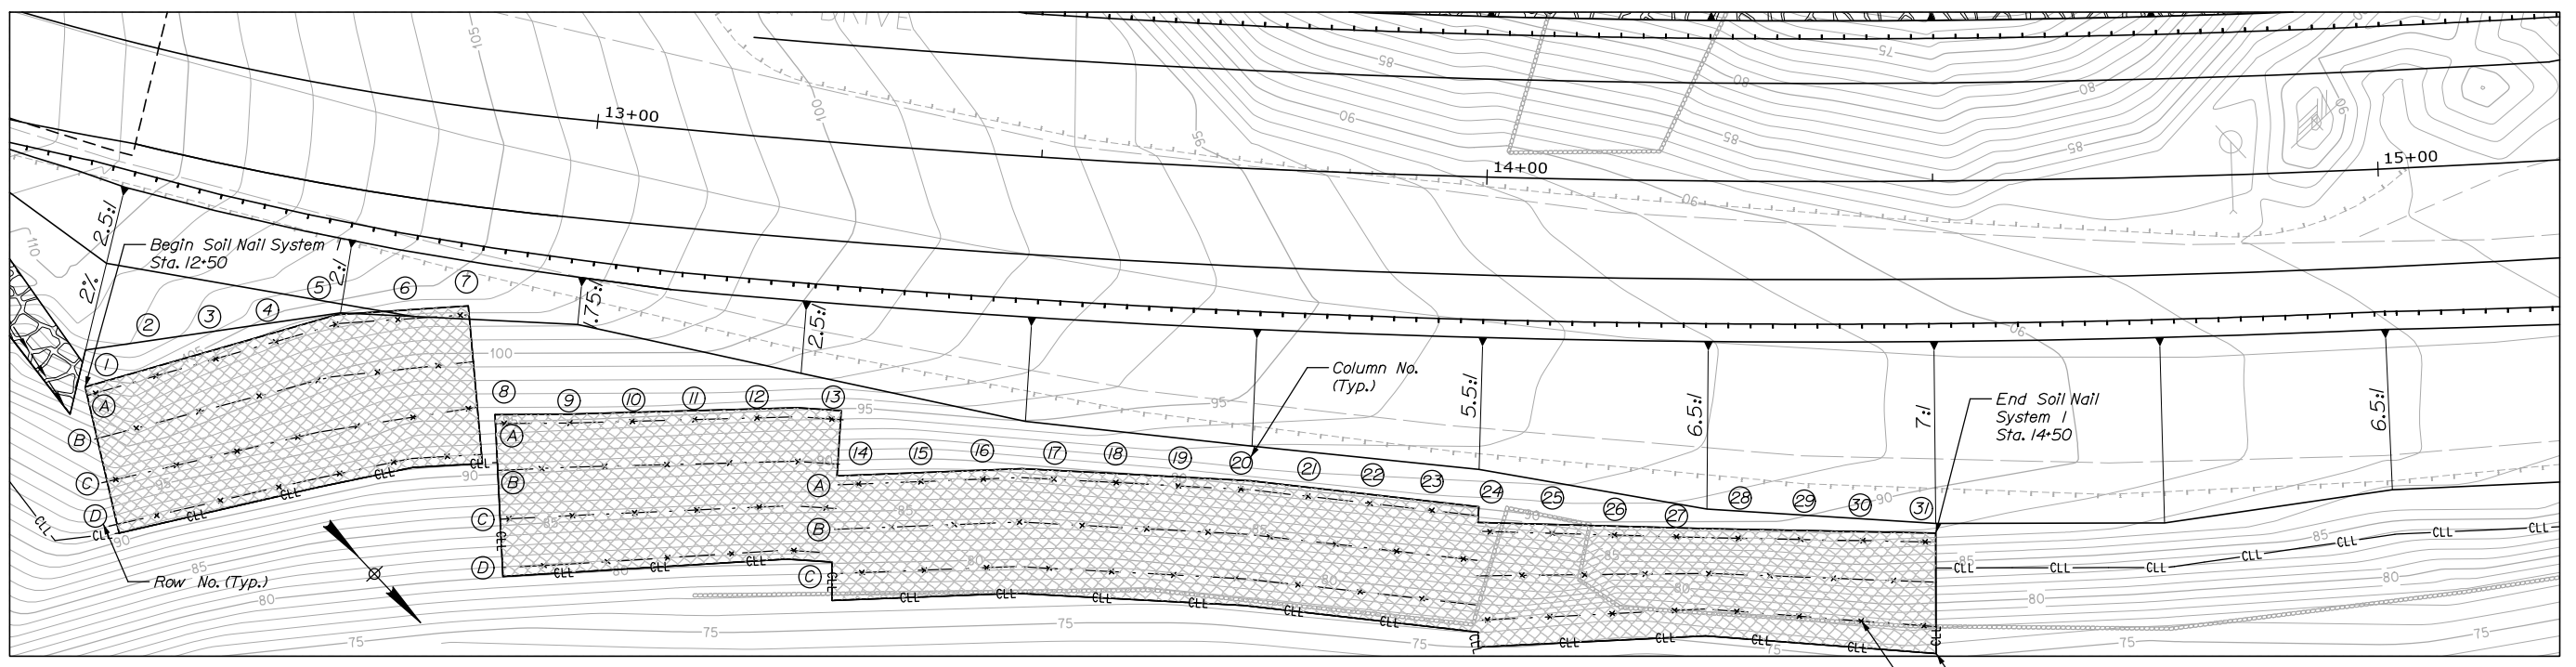
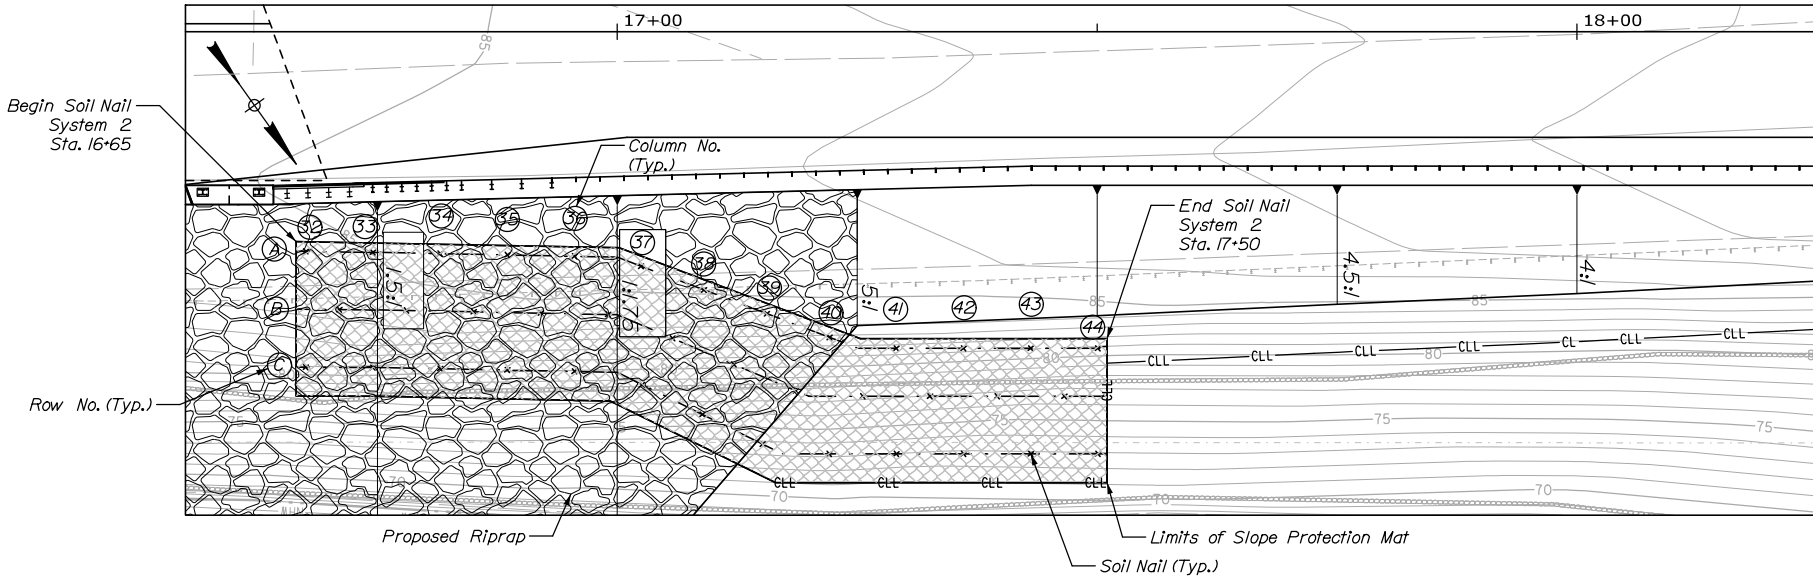
**Note:**  
1. Soil nail plan layout as shown is schematic only. Final layout shall be determined per Contractor's shop drawing as reviewed and approved by the Department. Soil nails shall be located in accordance with the Typical Soil Nail Spacing detail on this sheet and per the Soil Nail Details.

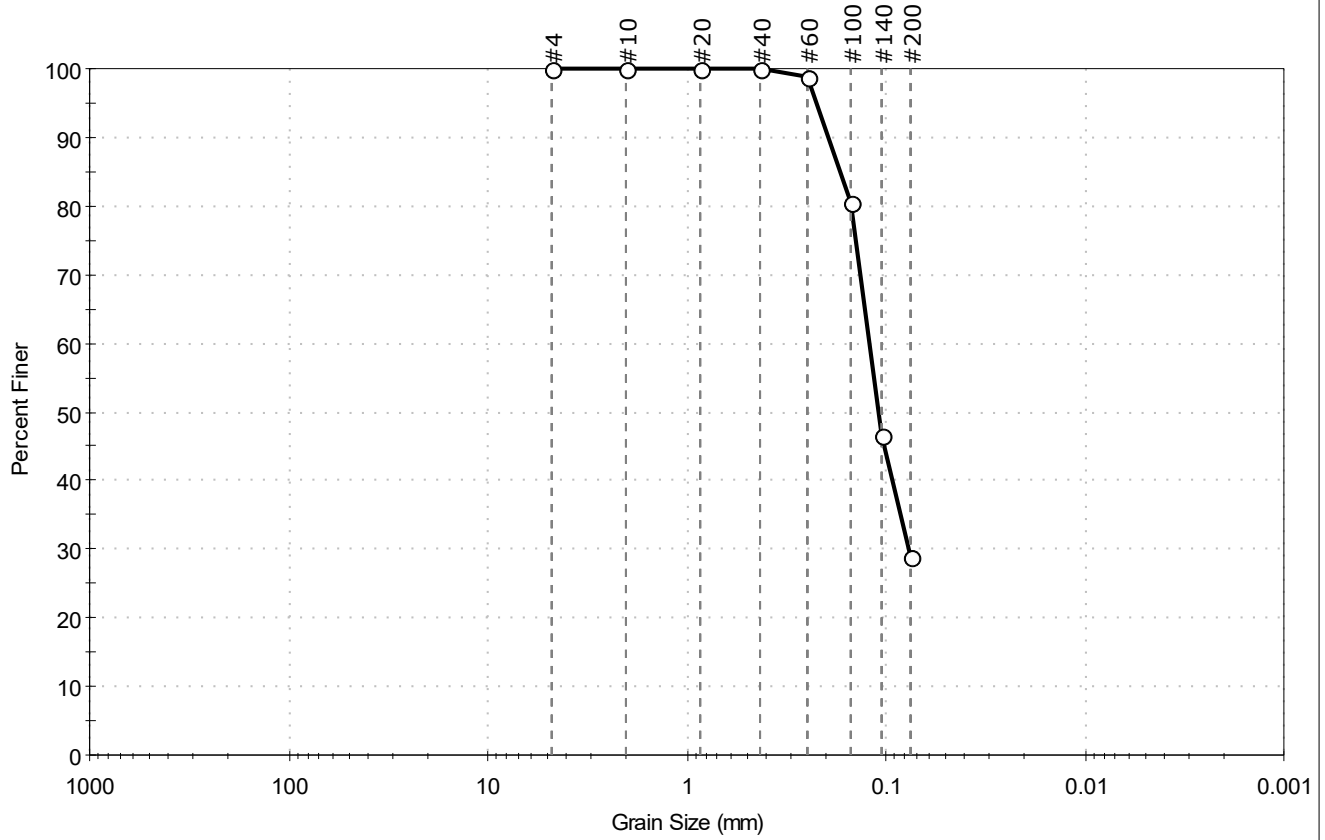
## Particle Size Analysis - ASTM D6913

Client: HNTB Corporation	Project: MEDOT Tracy Brook Bridge	Location: Durham, ME	Project No: GTX-316027
Boring ID: HB-DMB-201	Sample Type: jar	Tested By: ckg	Checked By: ank
Sample ID: 2D	Test Date: 09/07/22	Test Id: 684754	
Depth: 4-6			
Test Comment: ---			
Visual Description: Moist, yellowish brown silty sand			
Sample Comment: ---

% Cobble	% Gravel	% Sand	% Silt & Clay Size
—	0.0	71.2	28.8

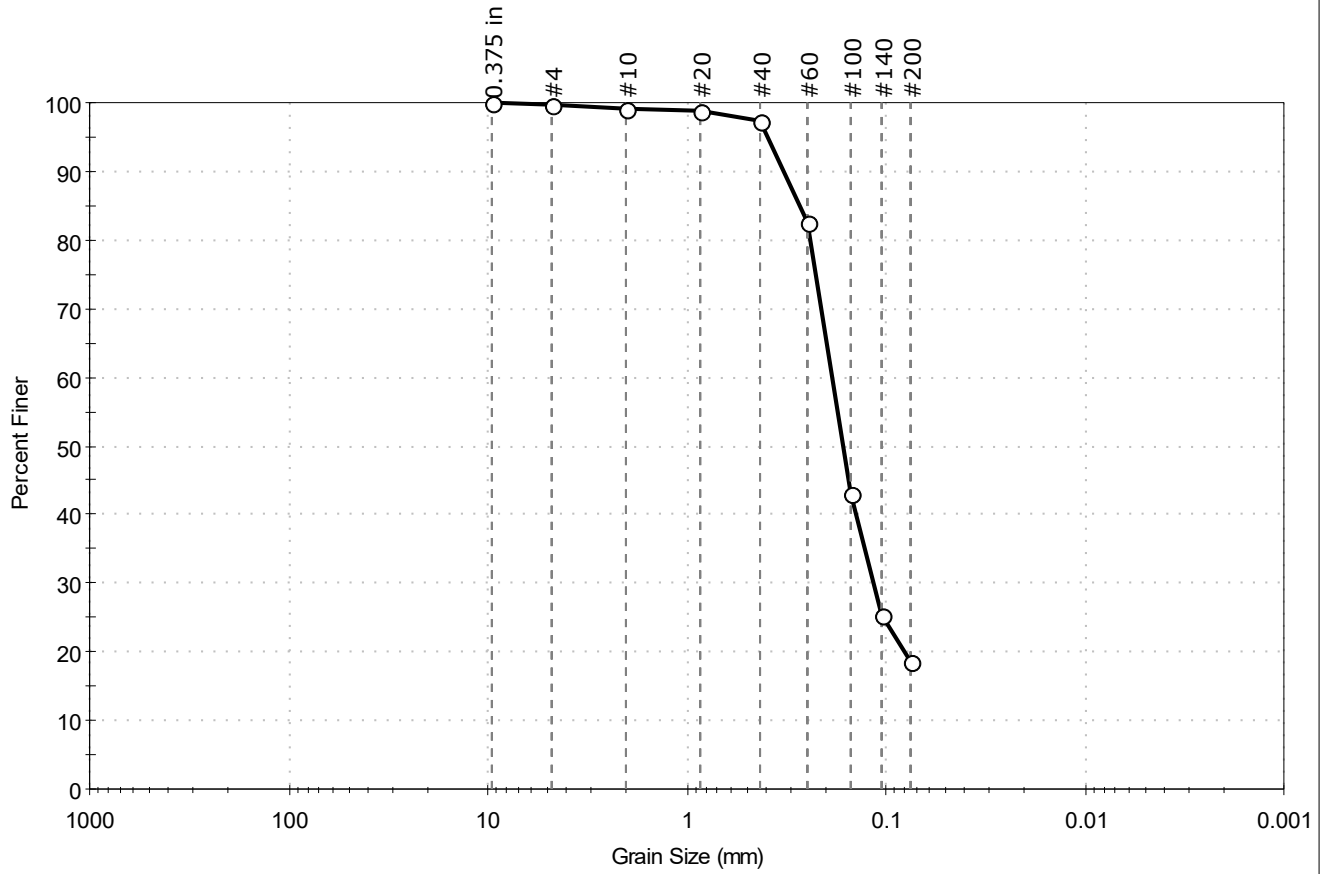
## Particle Size Analysis - ASTM D6913

Client: HNTB Corporation	Project: MEDOT Tracy Brook Bridge	Location: Durham, ME	Project No: GTX-316027
Boring ID: HB-DMB-201	Sample Type: jar	Tested By: ckg	Checked By: ank
Sample ID: 4D	Test Date: 09/07/22	Test Id: 684755	
Depth: 14-16			
Test Comment: ---	Visual Description: Moist, yellowish brown silty sand		
Sample Comment: ---

% Cobble	% Gravel	% Sand	% Silt & Clay Size
—	0.2	81.1	18.7

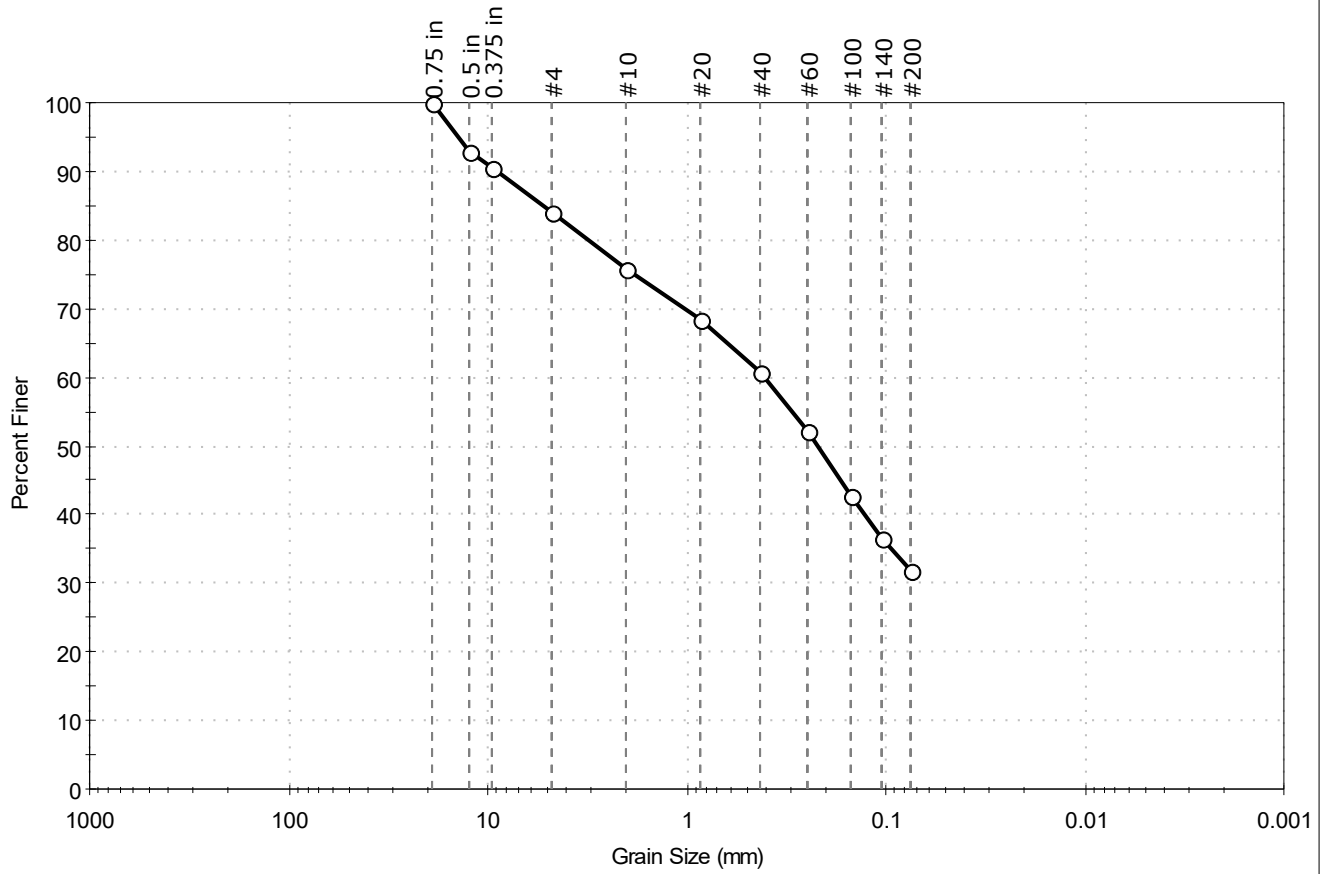
## Particle Size Analysis - ASTM D6913

Client: HNTB Corporation	Project: MEDOT Tracy Brook Bridge	Location: Durham, ME	Project No: GTX-316027
Boring ID: HB-DMB-201	Sample Type: jar	Tested By: ckg	Checked By: ank
Sample ID: 7D	Test Date: 09/07/22	Test Id: 684756	
Depth: 29-31			
Test Comment: ---			
Visual Description: Moist, gray silty sand with gravel			
Sample Comment: ---

% Cobble	% Gravel	% Sand	% Silt & Clay Size
—	15.9	52.3	31.8

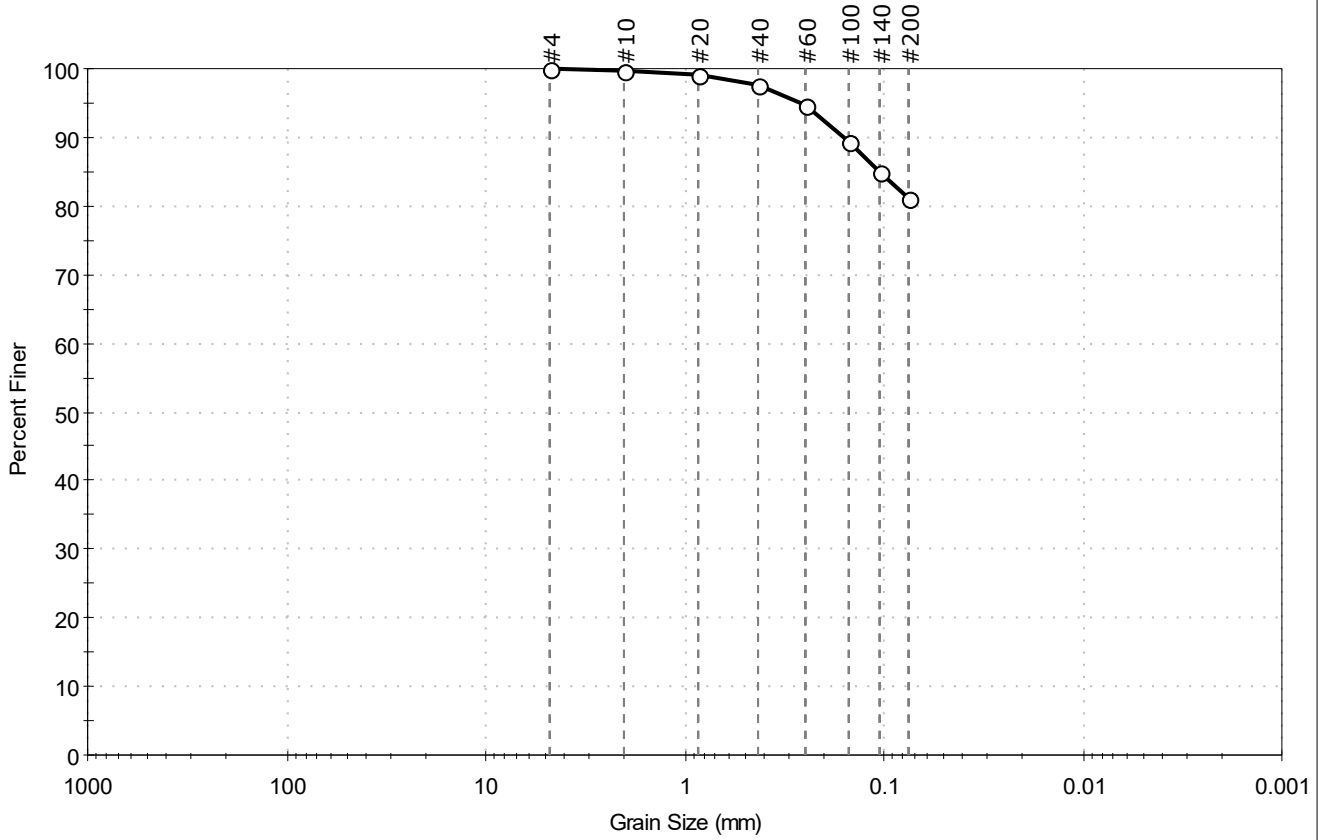
## Particle Size Analysis - ASTM D6913

Client: HNTB Corporation	Project: MEDOT Tracy Brook Bridge	Location: Durham, ME	Project No: GTX-316027
Boring ID: HB-DMB-201	Sample Type: jar	Tested By: ckg	Checked By: ank
Sample ID: 9D	Test Date: 09/07/22	Test Id: 684757	
Depth: 39-40.8			
Test Comment: ---	Visual Description: Moist, gray silt with sand	Sample Comment: ---

% Cobble	% Gravel	% Sand	% Silt & Clay Size
—	0.0	18.8	81.2

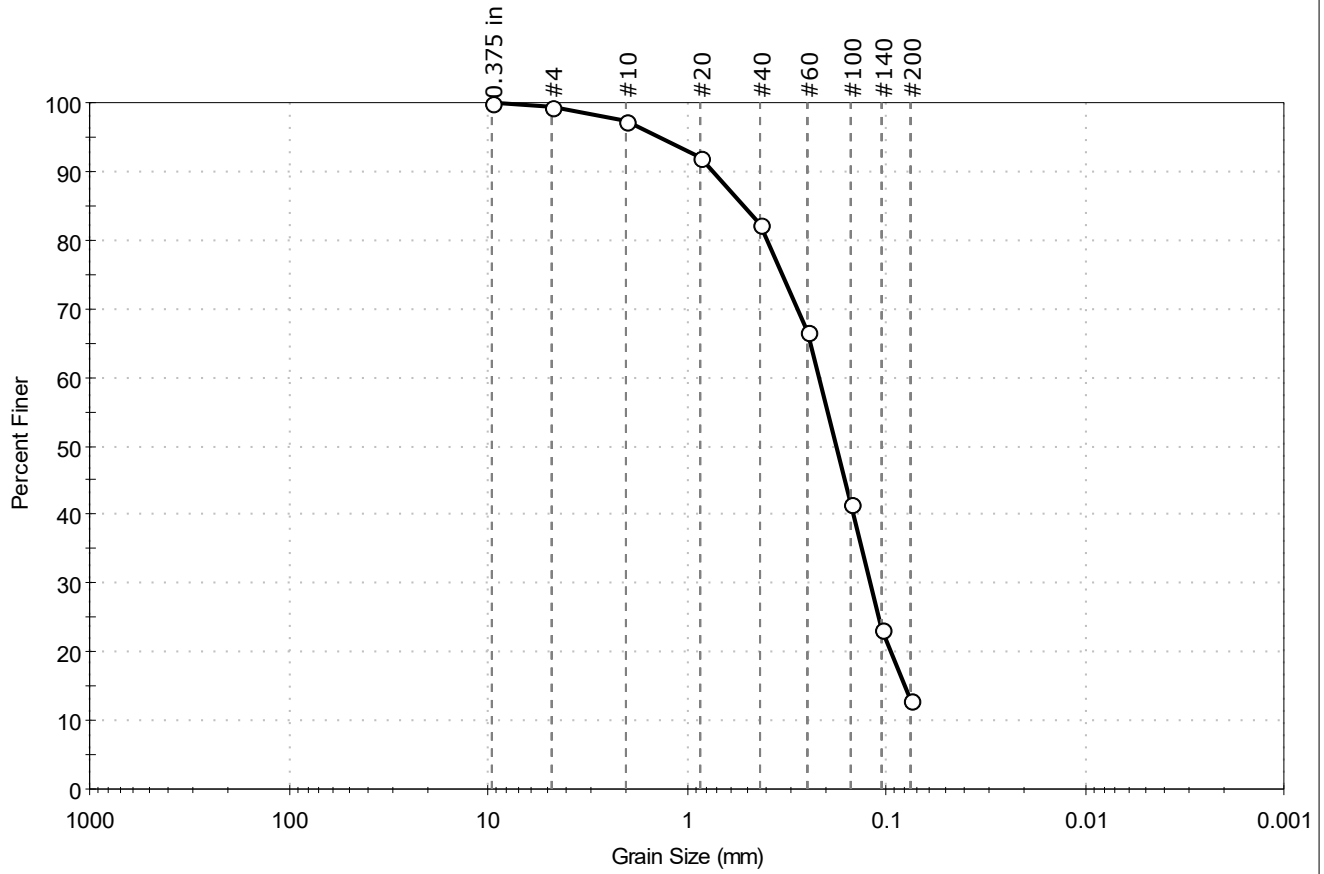
## Particle Size Analysis - ASTM D6913

Client: HNTB Corporation	Project: MEDOT Tracy Brook Bridge	Location: Durham, ME	Project No: GTX-316027
Boring ID: HB-DMB-202	Sample Type: jar	Tested By: ckg	Checked By: ank
Sample ID: 2D	Test Date: 09/07/22	Test Id: 684758	
Depth: 5-7			
Test Comment: ---			
Visual Description: Moist, brown silty sand			
Sample Comment: ----

% Cobble	% Gravel	% Sand	% Silt & Clay Size
—	0.4	86.5	13.1

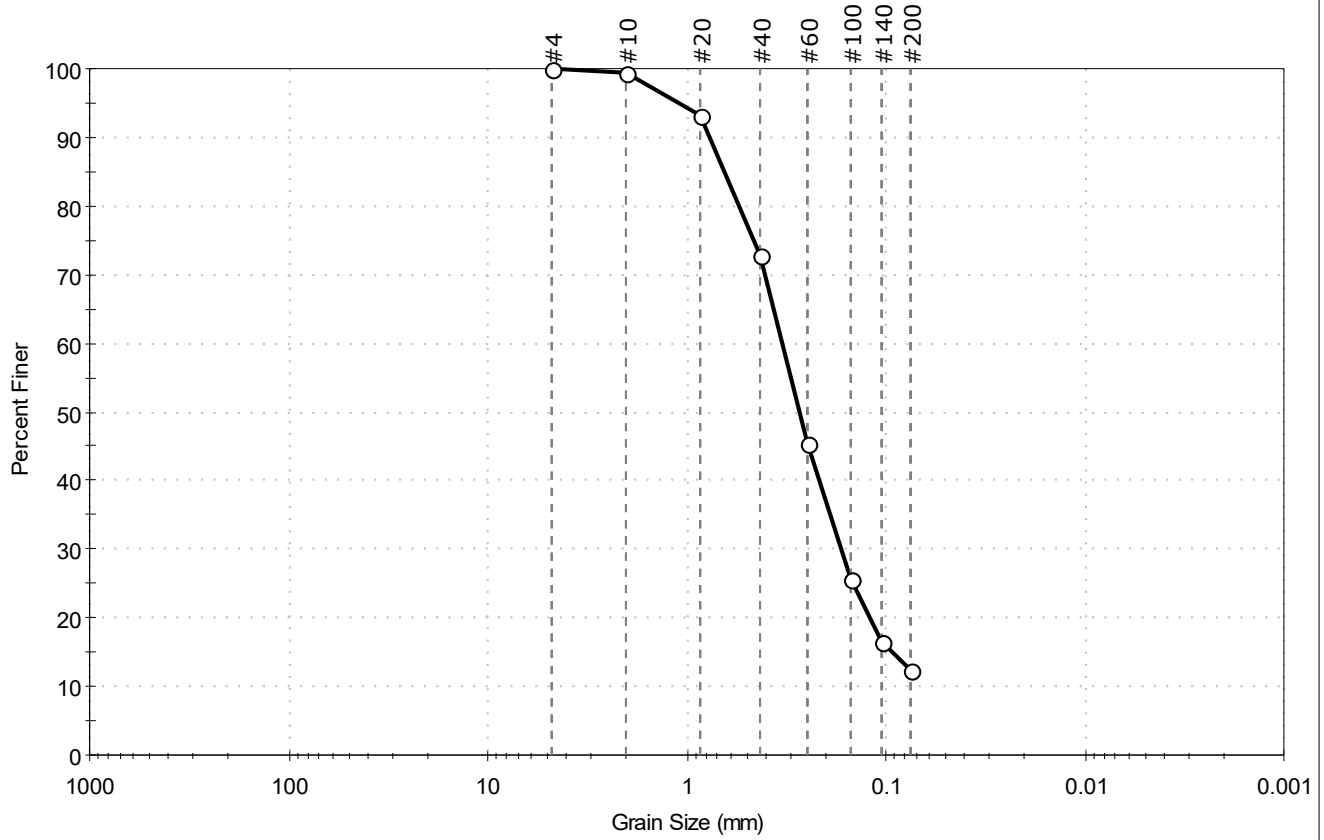
## Particle Size Analysis - ASTM D6913

Client: HNTB Corporation	Project: MEDOT Tracy Brook Bridge	Location: Durham, ME	Project No: GTX-316027
Boring ID: HB-DMB-202	Sample Type: jar	Tested By: ckg	Checked By: ank
Sample ID: 5D	Test Date: 09/07/22	Test Id: 684759	
Depth: 19-21			
Test Comment: ---			
Visual Description: Moist, brown silty sand			
Sample Comment: ---

% Cobble	% Gravel	% Sand	% Silt & Clay Size
—	0.0	87.7	12.3

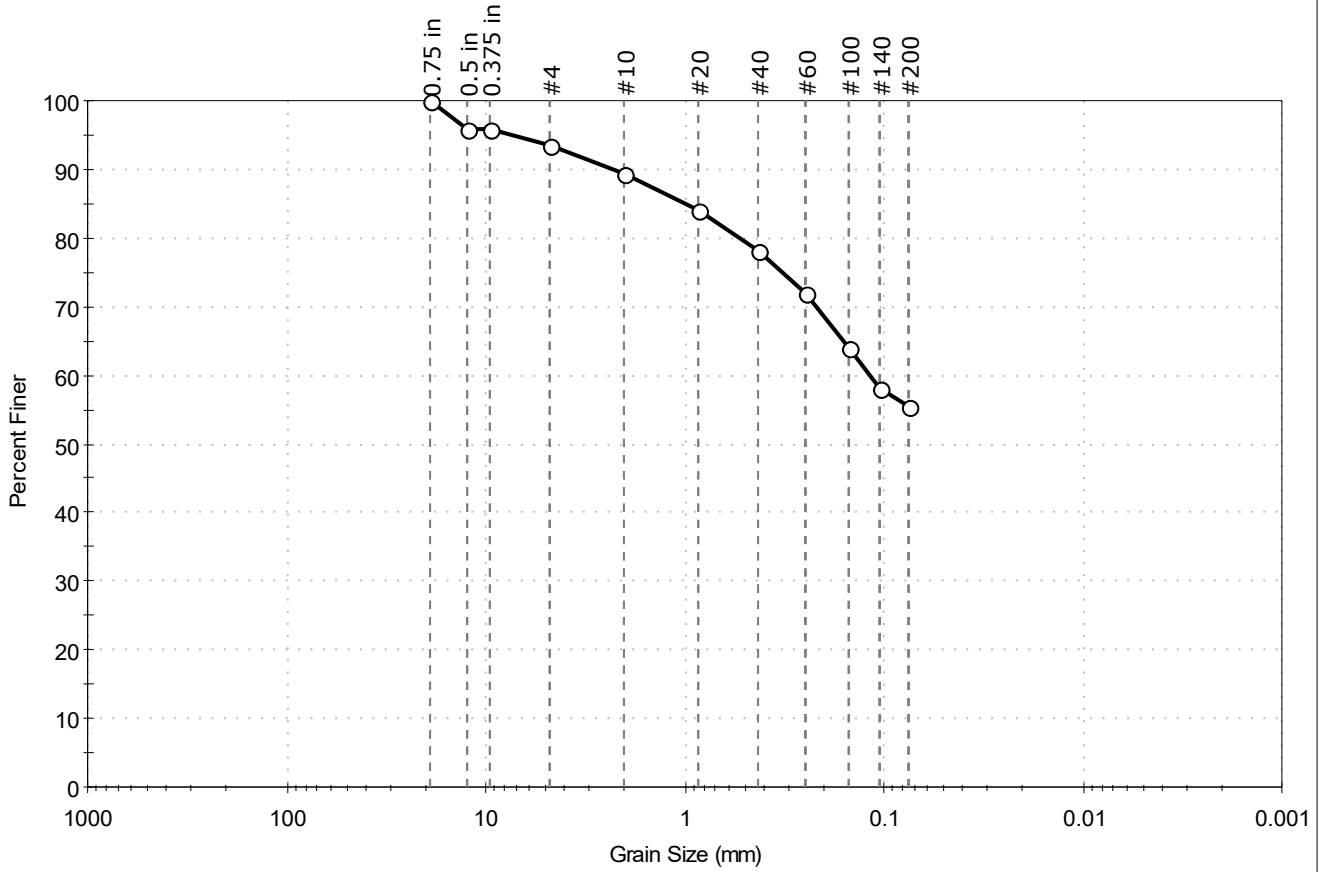
## Particle Size Analysis - ASTM D6913

Client: HNTB Corporation	Project: MEDOT Tracy Brook Bridge	Location: Durham, ME	Project No: GTX-316027
Boring ID: HB-DMB-203	Sample Type: jar	Tested By: ckg	Checked By: ank
Sample ID: 7D	Test Date: 09/07/22	Test Id: 684760	
Depth: 29-31			
Test Comment: ---	Visual Description: Moist, gray sandy silt	Sample Comment: ---

% Cobble	% Gravel	% Sand	% Silt & Clay Size
—	6.6	38.0	55.4

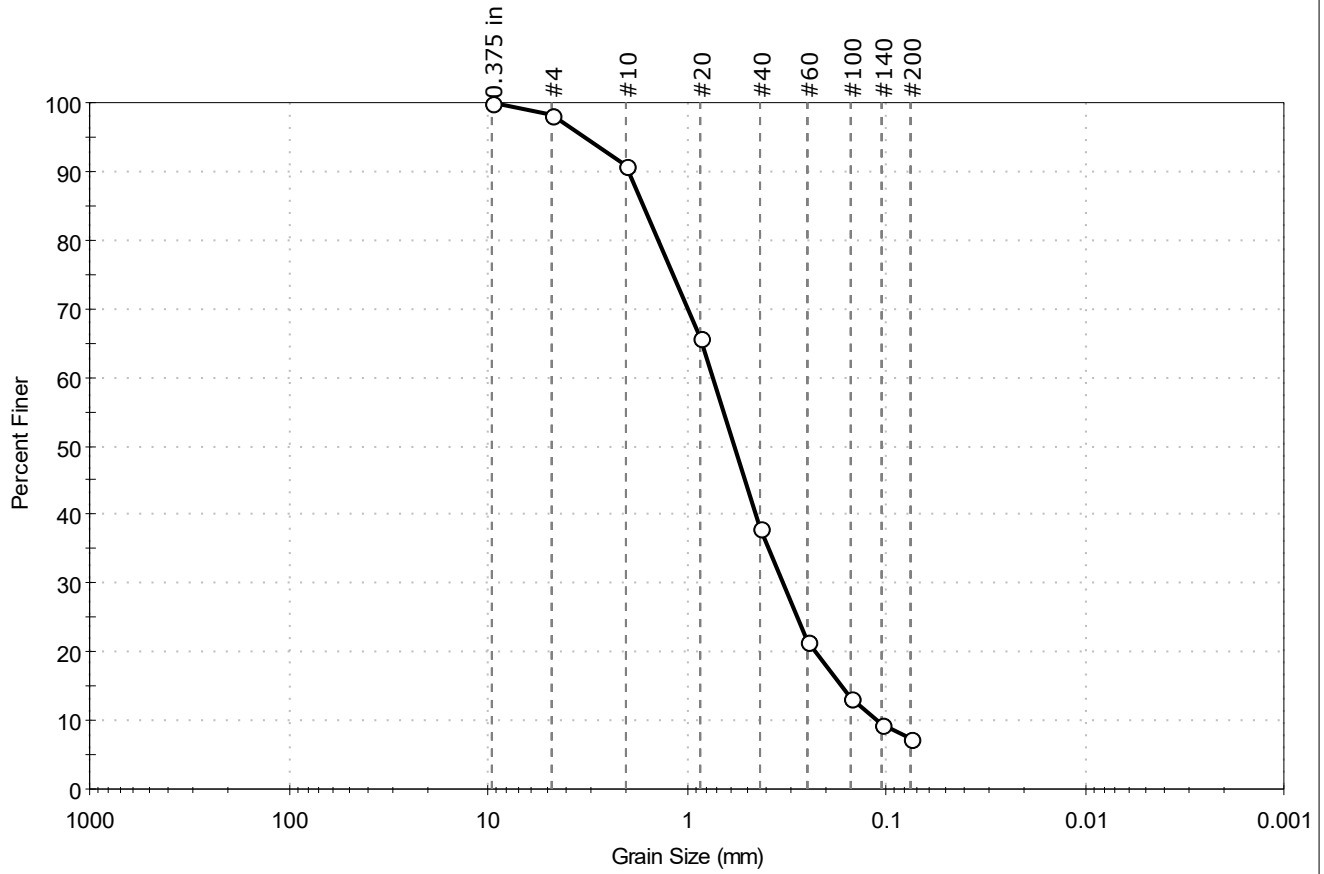
## Particle Size Analysis - ASTM D6913

Client: HNTB Corporation	Project: MEDOT Tracy Brook Bridge	Location: Durham, ME	Project No: GTX-316027
Boring ID: HB-DMB-203	Sample Type: jar	Tested By: ckg	Checked By: ank
Sample ID: 4D	Test Date: 09/07/22	Test Id: 684783	
Depth: 14-16			
Test Comment: ---	Visual Description: Moist, brown sand with silt		
Sample Comment: ---

% Cobble	% Gravel	% Sand	% Silt & Clay Size
—	1.7	90.9	7.4

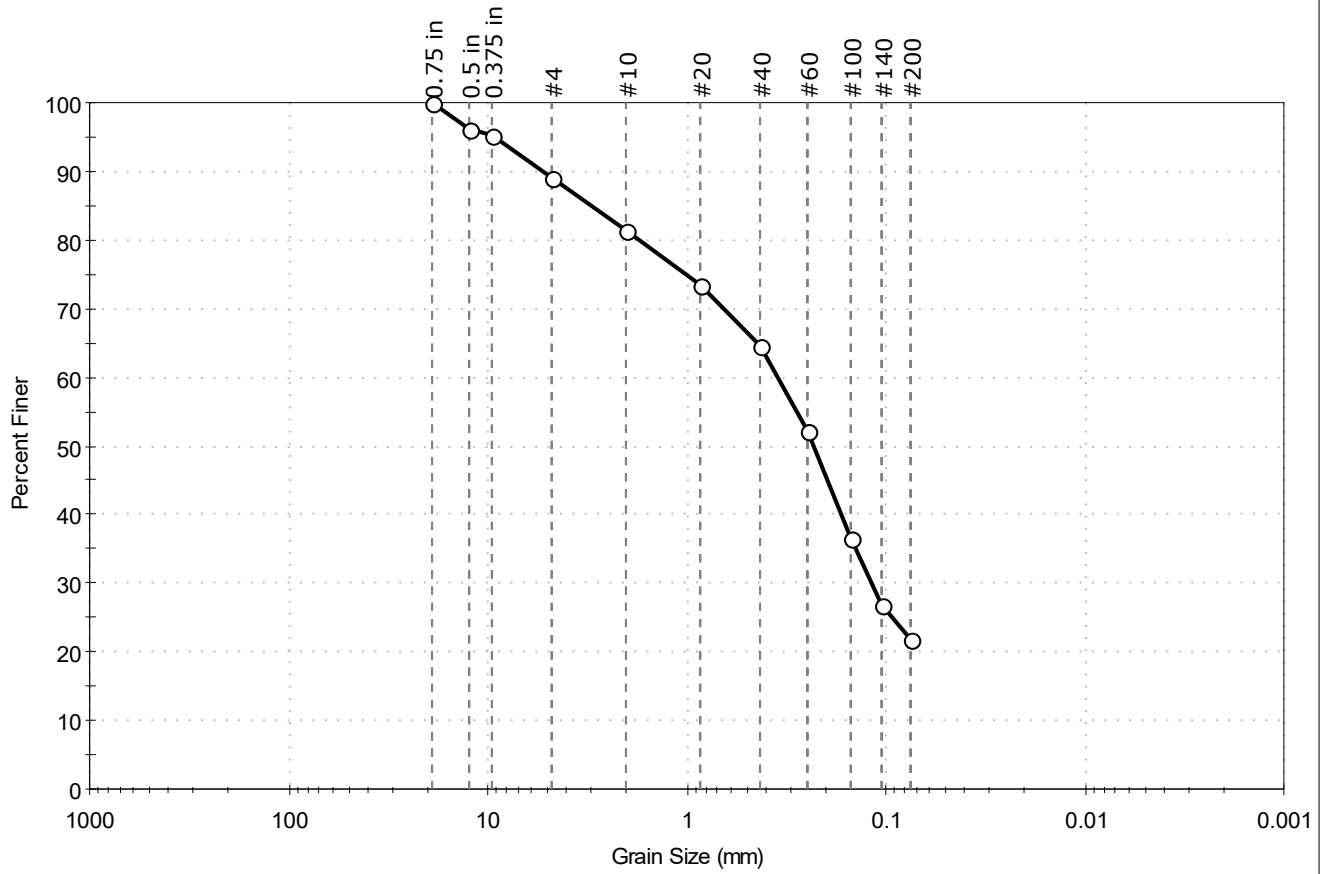
## Particle Size Analysis - ASTM D6913

Client: HNTB Corporation	Project: MEDOT Tracy Brook Bridge	Location: Durham, ME	Project No: GTX-316027
Boring ID: HB-DMB-204	Sample Type: jar	Tested By: ckg	Checked By: ank
Sample ID: 2D	Test Date: 09/07/22	Test Id: 684761	
Depth: 4-6			
Test Comment: ---			
Visual Description: Moist, brown silty sand			
Sample Comment: ----

% Cobble	% Gravel	% Sand	% Silt & Clay Size
—	10.8	67.3	21.9

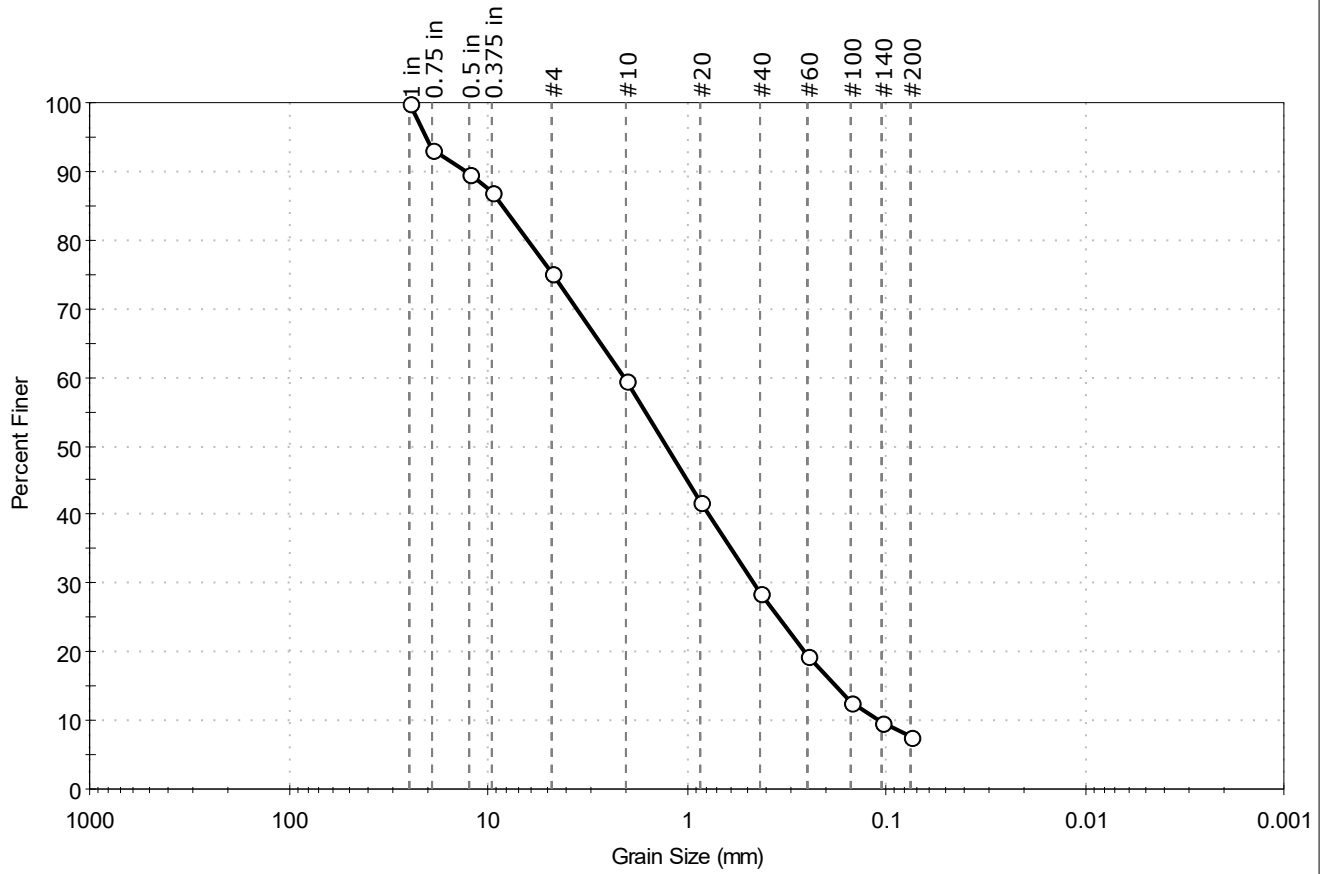
## Particle Size Analysis - ASTM D6913

Client:	HNTB Corporation		
Project:	MEDOT Tracy Brook Bridge		
Location:	Durham, ME	Project No:	GTX-316027
Boring ID:	HB-DMB-205	Sample Type:	jar
Sample ID:	2D	Test Date:	09/07/22
Depth :	4-6	Test Id:	684762
Test Comment:	---		
Visual Description:	Moist, brown sand with silt and gravel		
Sample Comment:	---

% Cobble	% Gravel	% Sand	% Silt & Clay Size
—	24.9	67.3	7.8

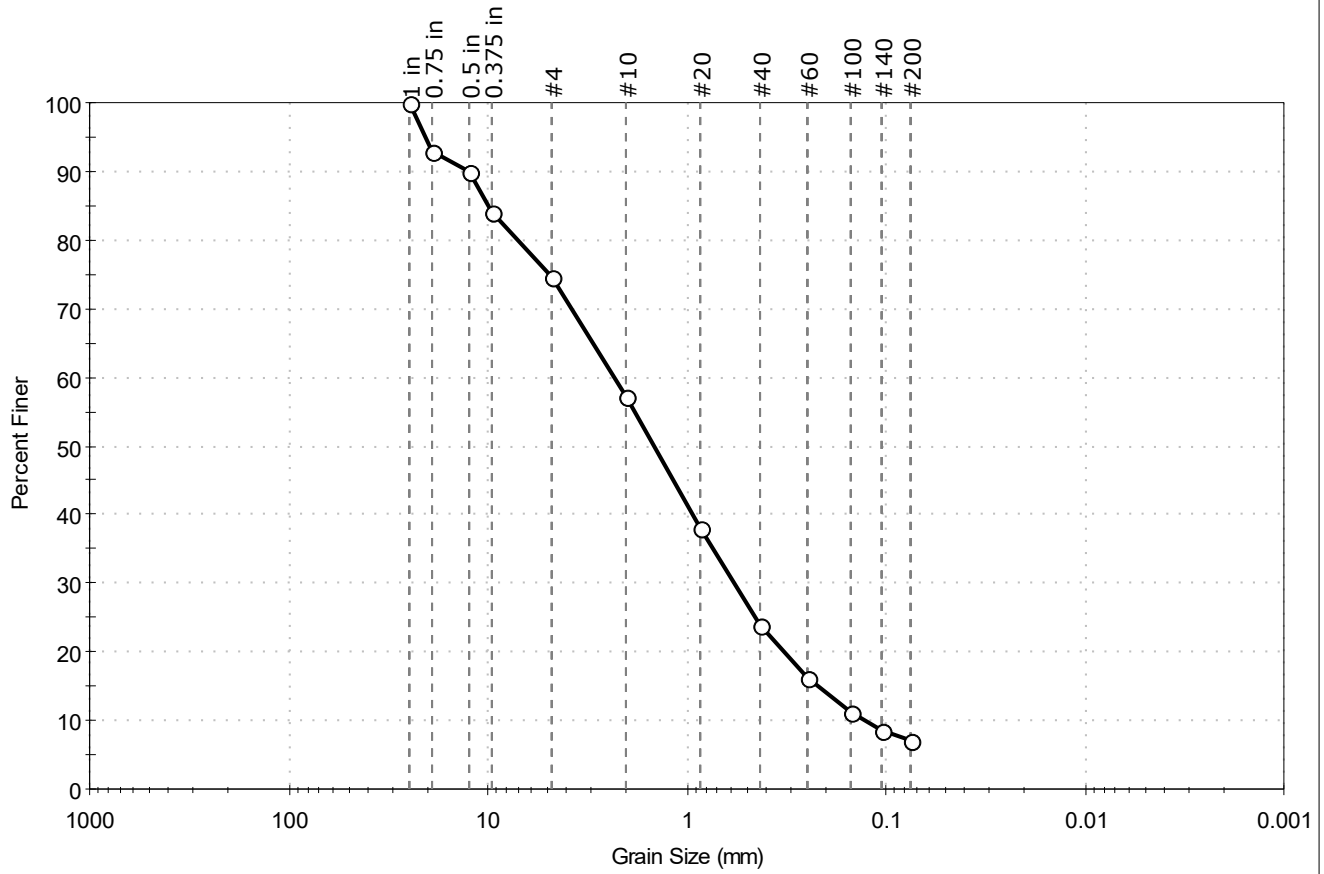
## Particle Size Analysis - ASTM D6913

Client:	HNTB Corporation		
Project:	MEDOT Tracy Brook Bridge		
Location:	Durham, ME	Project No:	GTX-316027
Boring ID:	HB-DMB-205	Sample Type:	jar
Sample ID:	4D	Test Date:	09/07/22
Depth :	14-16	Checked By:	ank
		Test Id:	684784
Test Comment:	---		
Visual Description:	Moist, brown sand with silt and gravel		
Sample Comment:	---

% Cobble	% Gravel	% Sand	% Silt & Clay Size
—	25.5	67.4	7.1

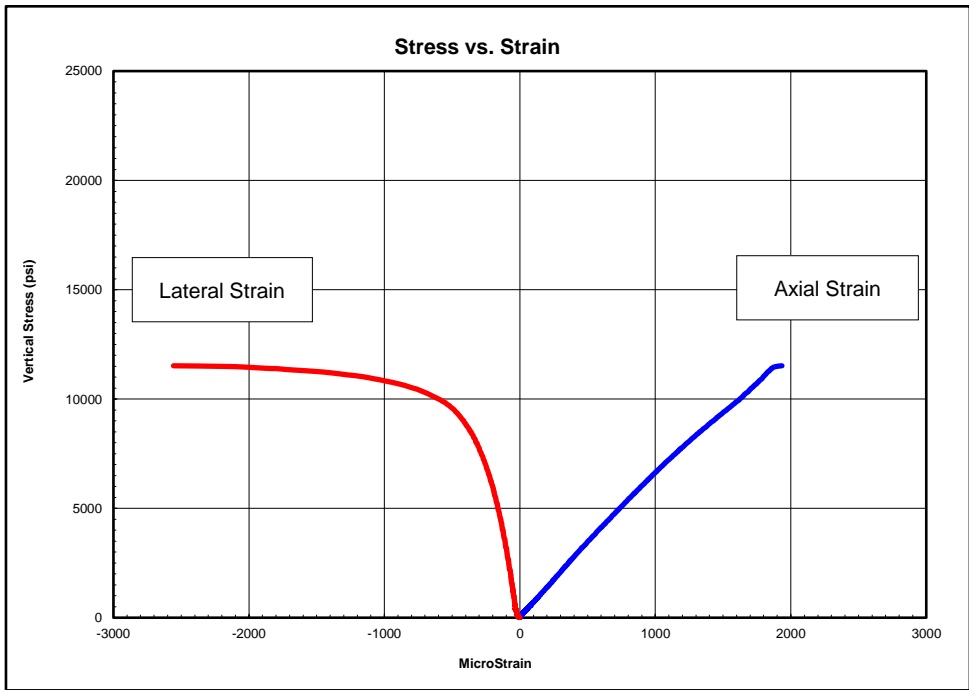
## Compressive Strength and Elastic Moduli of Rock by ASTM D7012 - Method D

Peak Compressive Stress: 11,521 psi

The strain values recorded within the third stress range for this test produce values of Poisson's Ratio that exceed maximum values found in rocks.

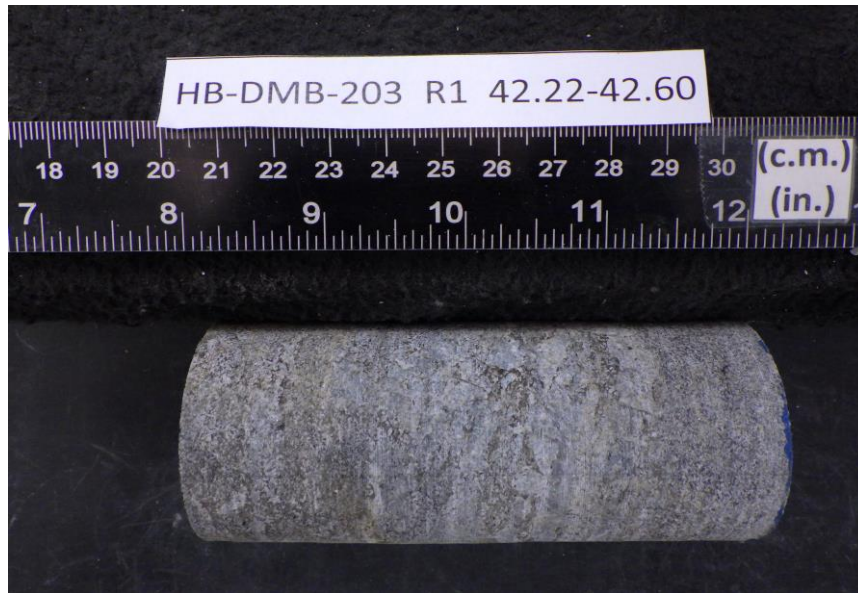
After cutting and grinding

Client:	HNTB Corporation
Project Name:	MEDOT Tracy Brook Bridge
Project Location:	Durham, ME
GTX #:	316027
Test Date:	9/27/2022
Tested By:	bp
Checked By:	smd
Boring ID:	HB-DMB-203
Sample ID:	R1
Depth, ft:	42.22-42.60

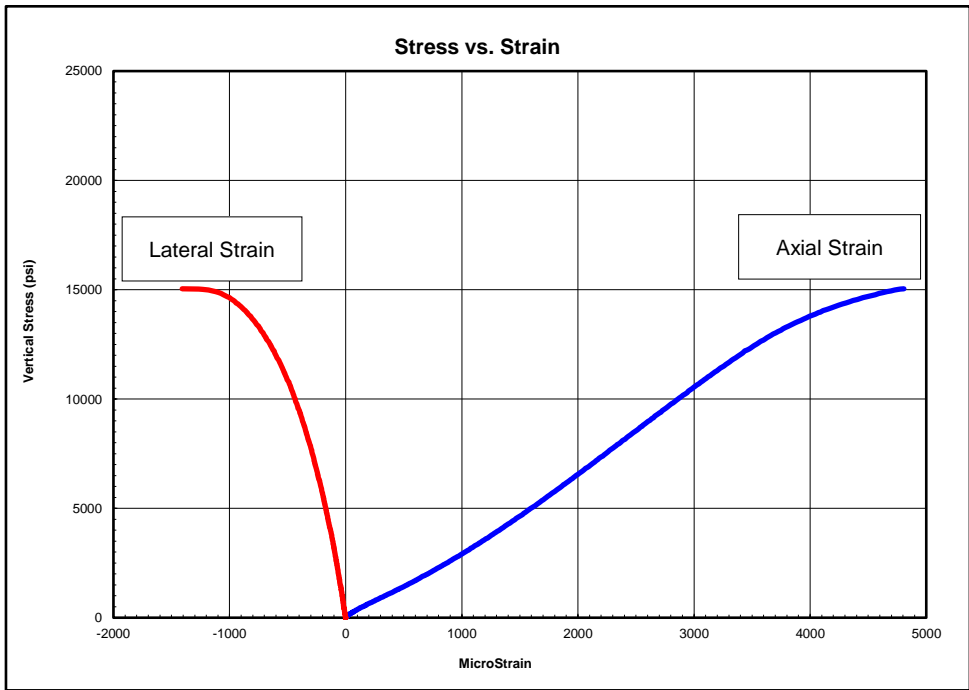
## Compressive Strength and Elastic Moduli of Rock by ASTM D7012 - Method D

Peak Compressive Stress: 15,042 psi

Stress Range, psi	Young's Modulus, psi	Poisson's Ratio
1500-5500	3,330,000	0.12
5500-9500	3,980,000	0.21
9500-13500	3,580,000	0.33

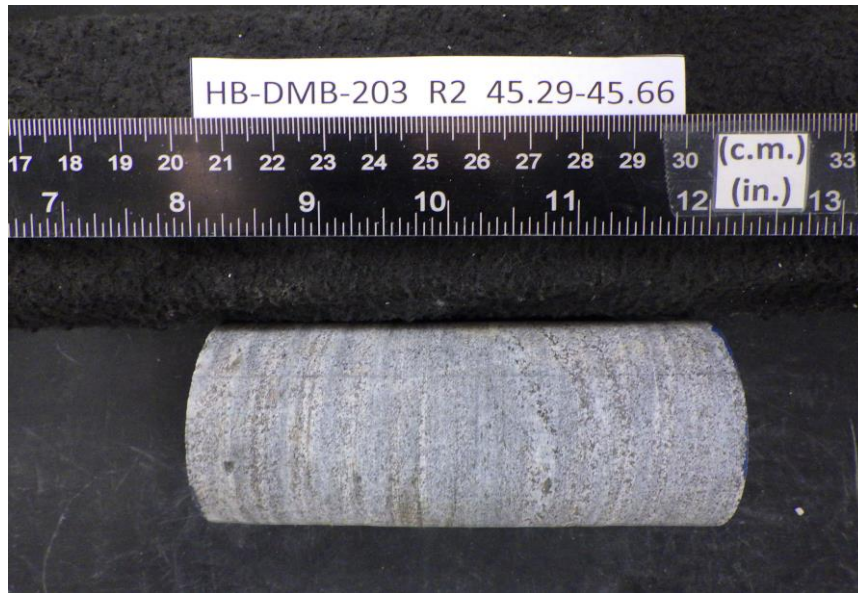
After cutting and grinding

Client:	HNTB Corporation
Project Name:	MEDOT Tracy Brook Bridge
Project Location:	Durham, ME
GTX #:	316027
Test Date:	9/27/2022
Tested By:	bp
Checked By:	smd
Boring ID:	HB-DMB-203
Sample ID:	R2
Depth, ft:	45.29-45.66
