TRACY BROOK BRIDGE  
OVER MEADOW BROOK

WIN 23657.00

Town of Durham  
Androscoggin County  
Maine

GEOTECHNICAL  
DESIGN REPORT

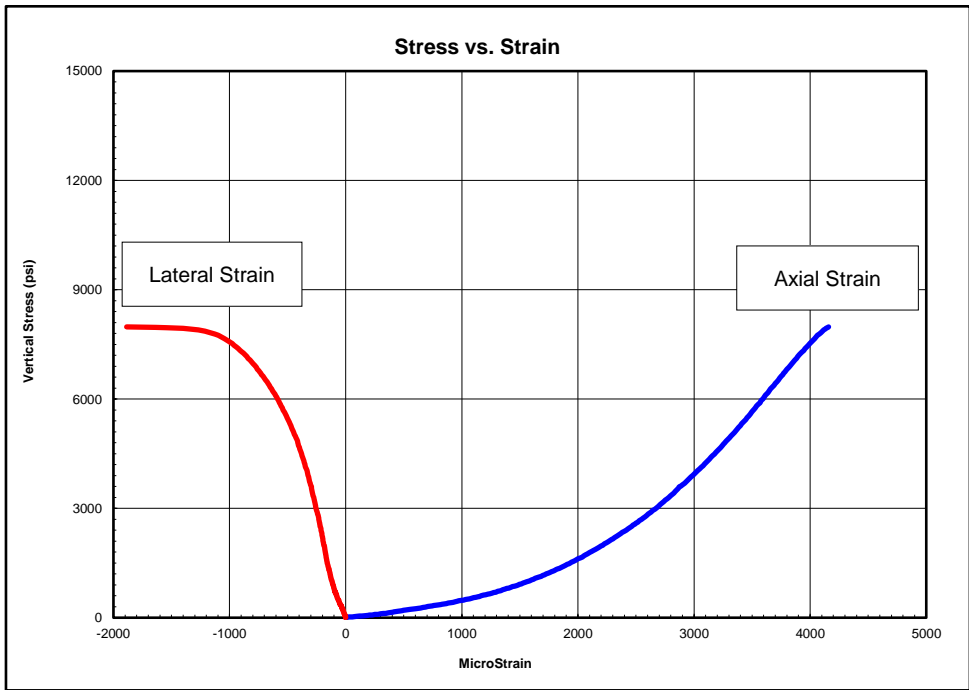
## Compressive Strength and Elastic Moduli of Rock by ASTM D7012 - Method D

Peak Compressive Stress: 7,979 psi

The strain values recorded within the third stress range for this test produce values of Poisson's Ratio that exceed maximum values found in rocks.

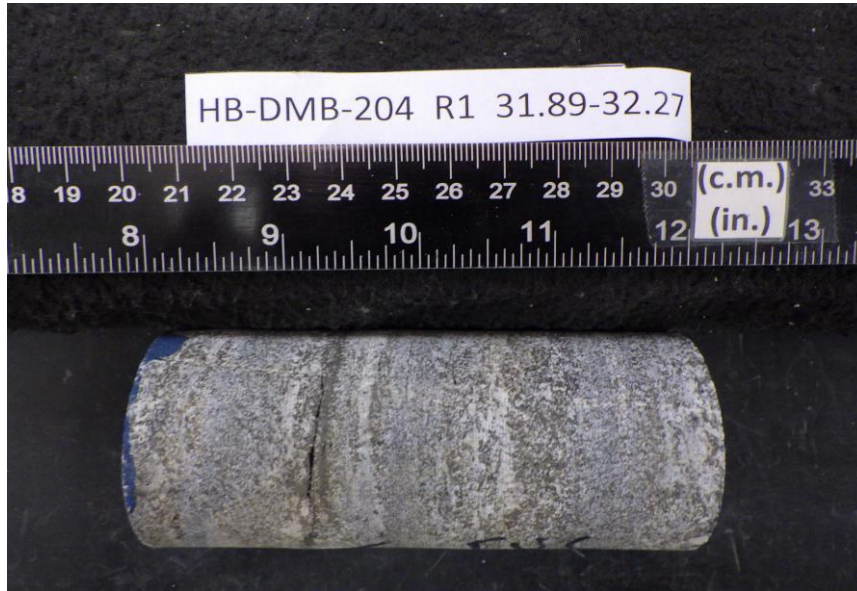
After cutting and grinding

Client:	HNTB Corporation
Project Name:	MEDOT Tracy Brook Bridge
Project Location:	Durham, ME
GTX #:	316027
Test Date:	9/27/2022
Tested By:	bp
Checked By:	smd
Boring ID:	HB-DMB-204
Sample ID:	R1
Depth, ft:	31.89-32.27

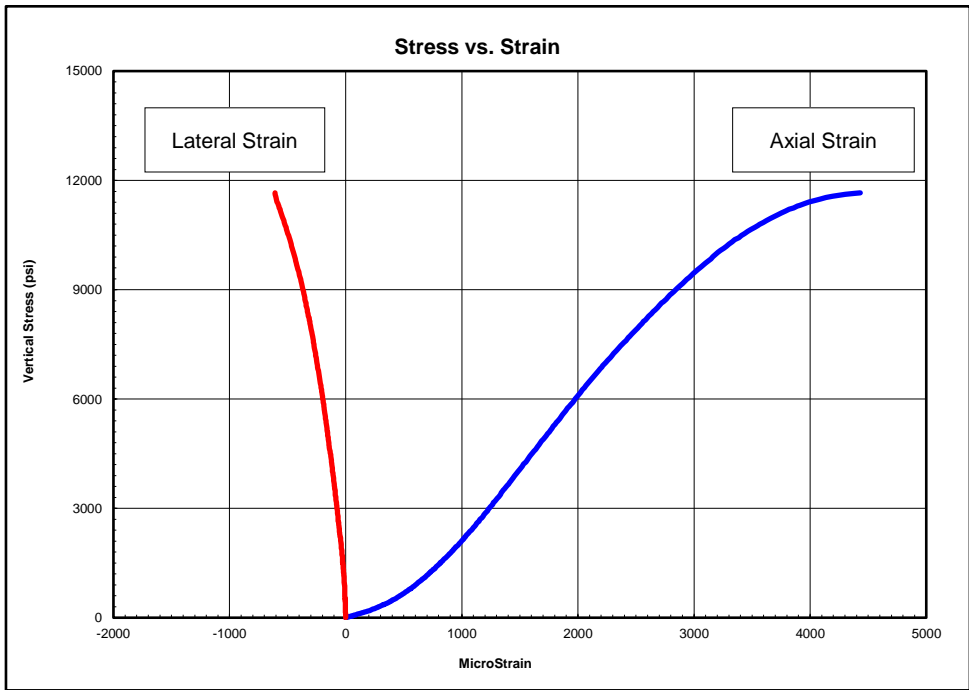
## Compressive Strength and Elastic Moduli of Rock by ASTM D7012 - Method D

Peak Compressive Stress: 11,659 psi

Stress Range, psi	Young's Modulus, psi	Poisson's Ratio
1200-4300	3,710,000	0.13
4300-7400	3,940,000	0.18
7400-10500	2,970,000	0.21

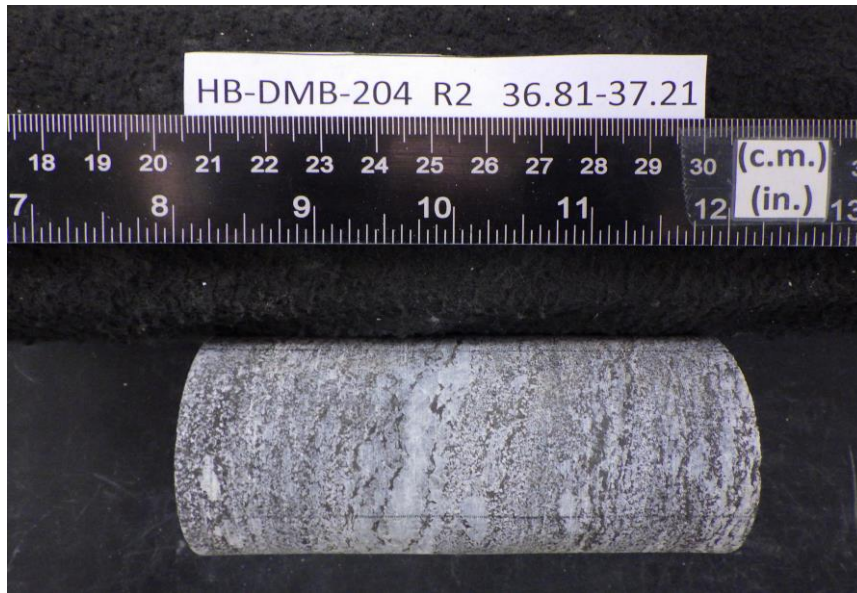
After cutting and grinding

Client:	HNTB Corporation
Project Name:	MEDOT Tracy Brook Bridge
Project Location:	Durham, ME
GTX #:	316027
Test Date:	9/27/2022
Tested By:	bp
Checked By:	smd
Boring ID:	HB-DMB-204
Sample ID:	R2
Depth, ft:	36.81-37.21
