MAINE DEPARTMENT OF TRANSPORTATION
HIGHWAY PROGRAM
GEOTECHNICAL GROUP
AUGUSTA, MAINE

**SUBSURFACE INVESTIGATION FOR
RETAINING WALL REPAIR
WOODSTOCK, MAINE**

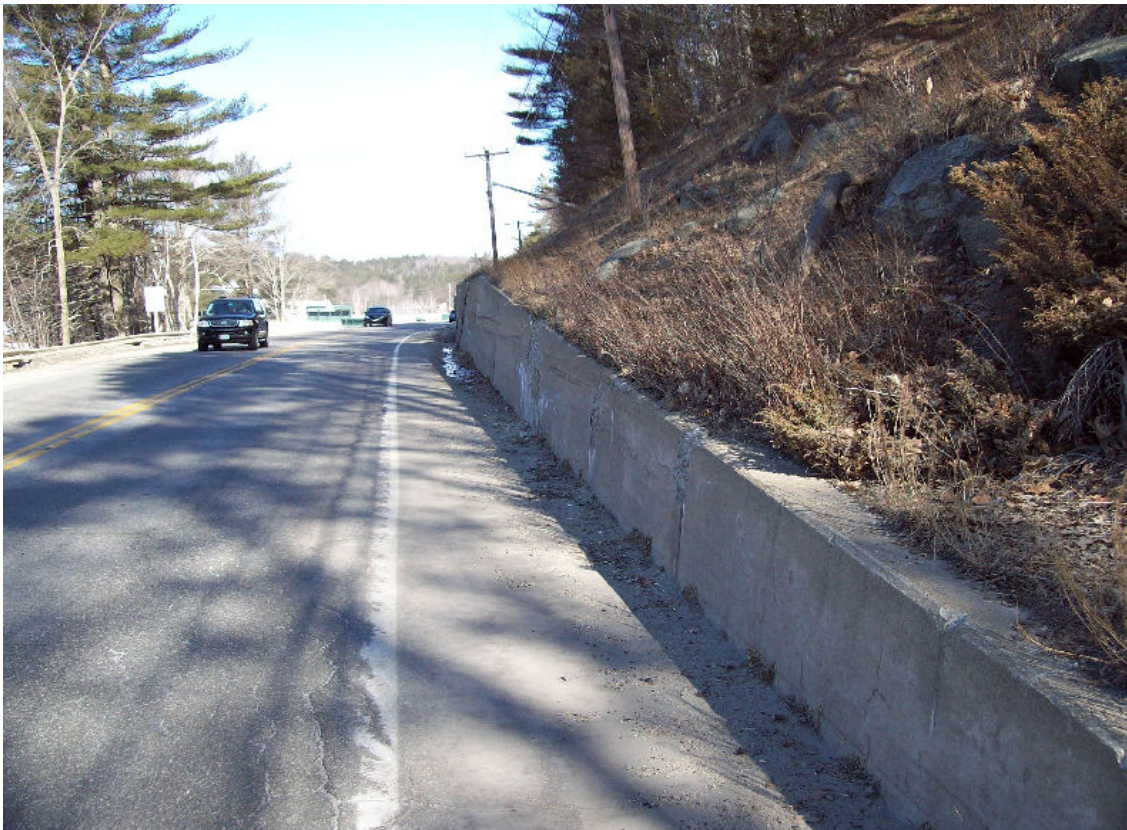
MaineDOT proposes to repair a retaining wall on Route 26 in Bryant Pond, approximately 0.1 miles west of Pine Point Road. The existing wall is cast-in-place concrete built in 1941, and is in poor condition. The plans for the 1941 project show cuts of as much as five feet in the area of the wall, with a change of horizontal alignment towards the railroad tracks.

Traffic along this highway is on the order of 5000 vehicles per day. The roadway consists of two 12 foot lanes with narrow shoulders. The narrowest point from the existing face of wall to the face of the guardrail is approximately 31 feet at the south end of the wall, although for most of the length of the wall more width is available. The guardrail protects traffic from a steep slope down to railroad tracks of the St. Lawrence & Atlantic Railroad, and it cannot be moved for this project.

The existing pavement is in fair to poor condition. No paving will be done as part of this project, but the Contractor should exercise reasonable caution to prevent additional pavement damage.

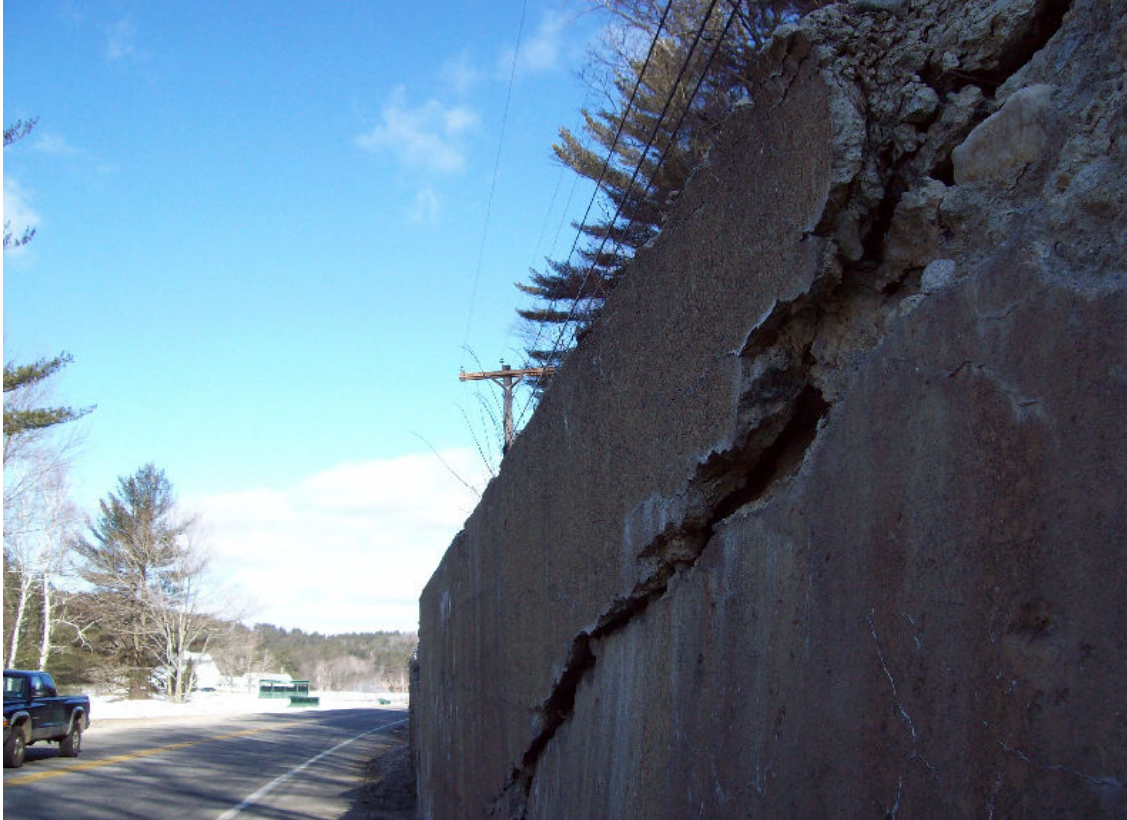
Existing Wall

The existing wall was built in 1941. It is a cast-in-place concrete gravity wall with a face batter of 1" per foot, a minimum width at the top of 12", and a batter at the back of the concrete of 1h:4v. No reinforcing steel is visible in the wall face

although 1333 lbs of reinforcing steel are listed on the plans. Expansion joints are every 25 feet. A 6" perforated ACCMP drain is shown behind the heel, with 4" weep holes spaced 25 feet on center. Subgrade embedment is shown as 3.5 feet. Pay limits for the construction slope are shown as 1h:4v starting 16" behind the wall, with a slope of 1.1v:1h behind the excavation. The material used for backfill is described as "clean gravel". This wall cannot feasibly be replaced with a gravity wall, and construction would be problematic for any type of wall replacement. The existing wall will be repaired using soil nails or dowels and a shotcrete facing. The original plan and sections are attached to this report.

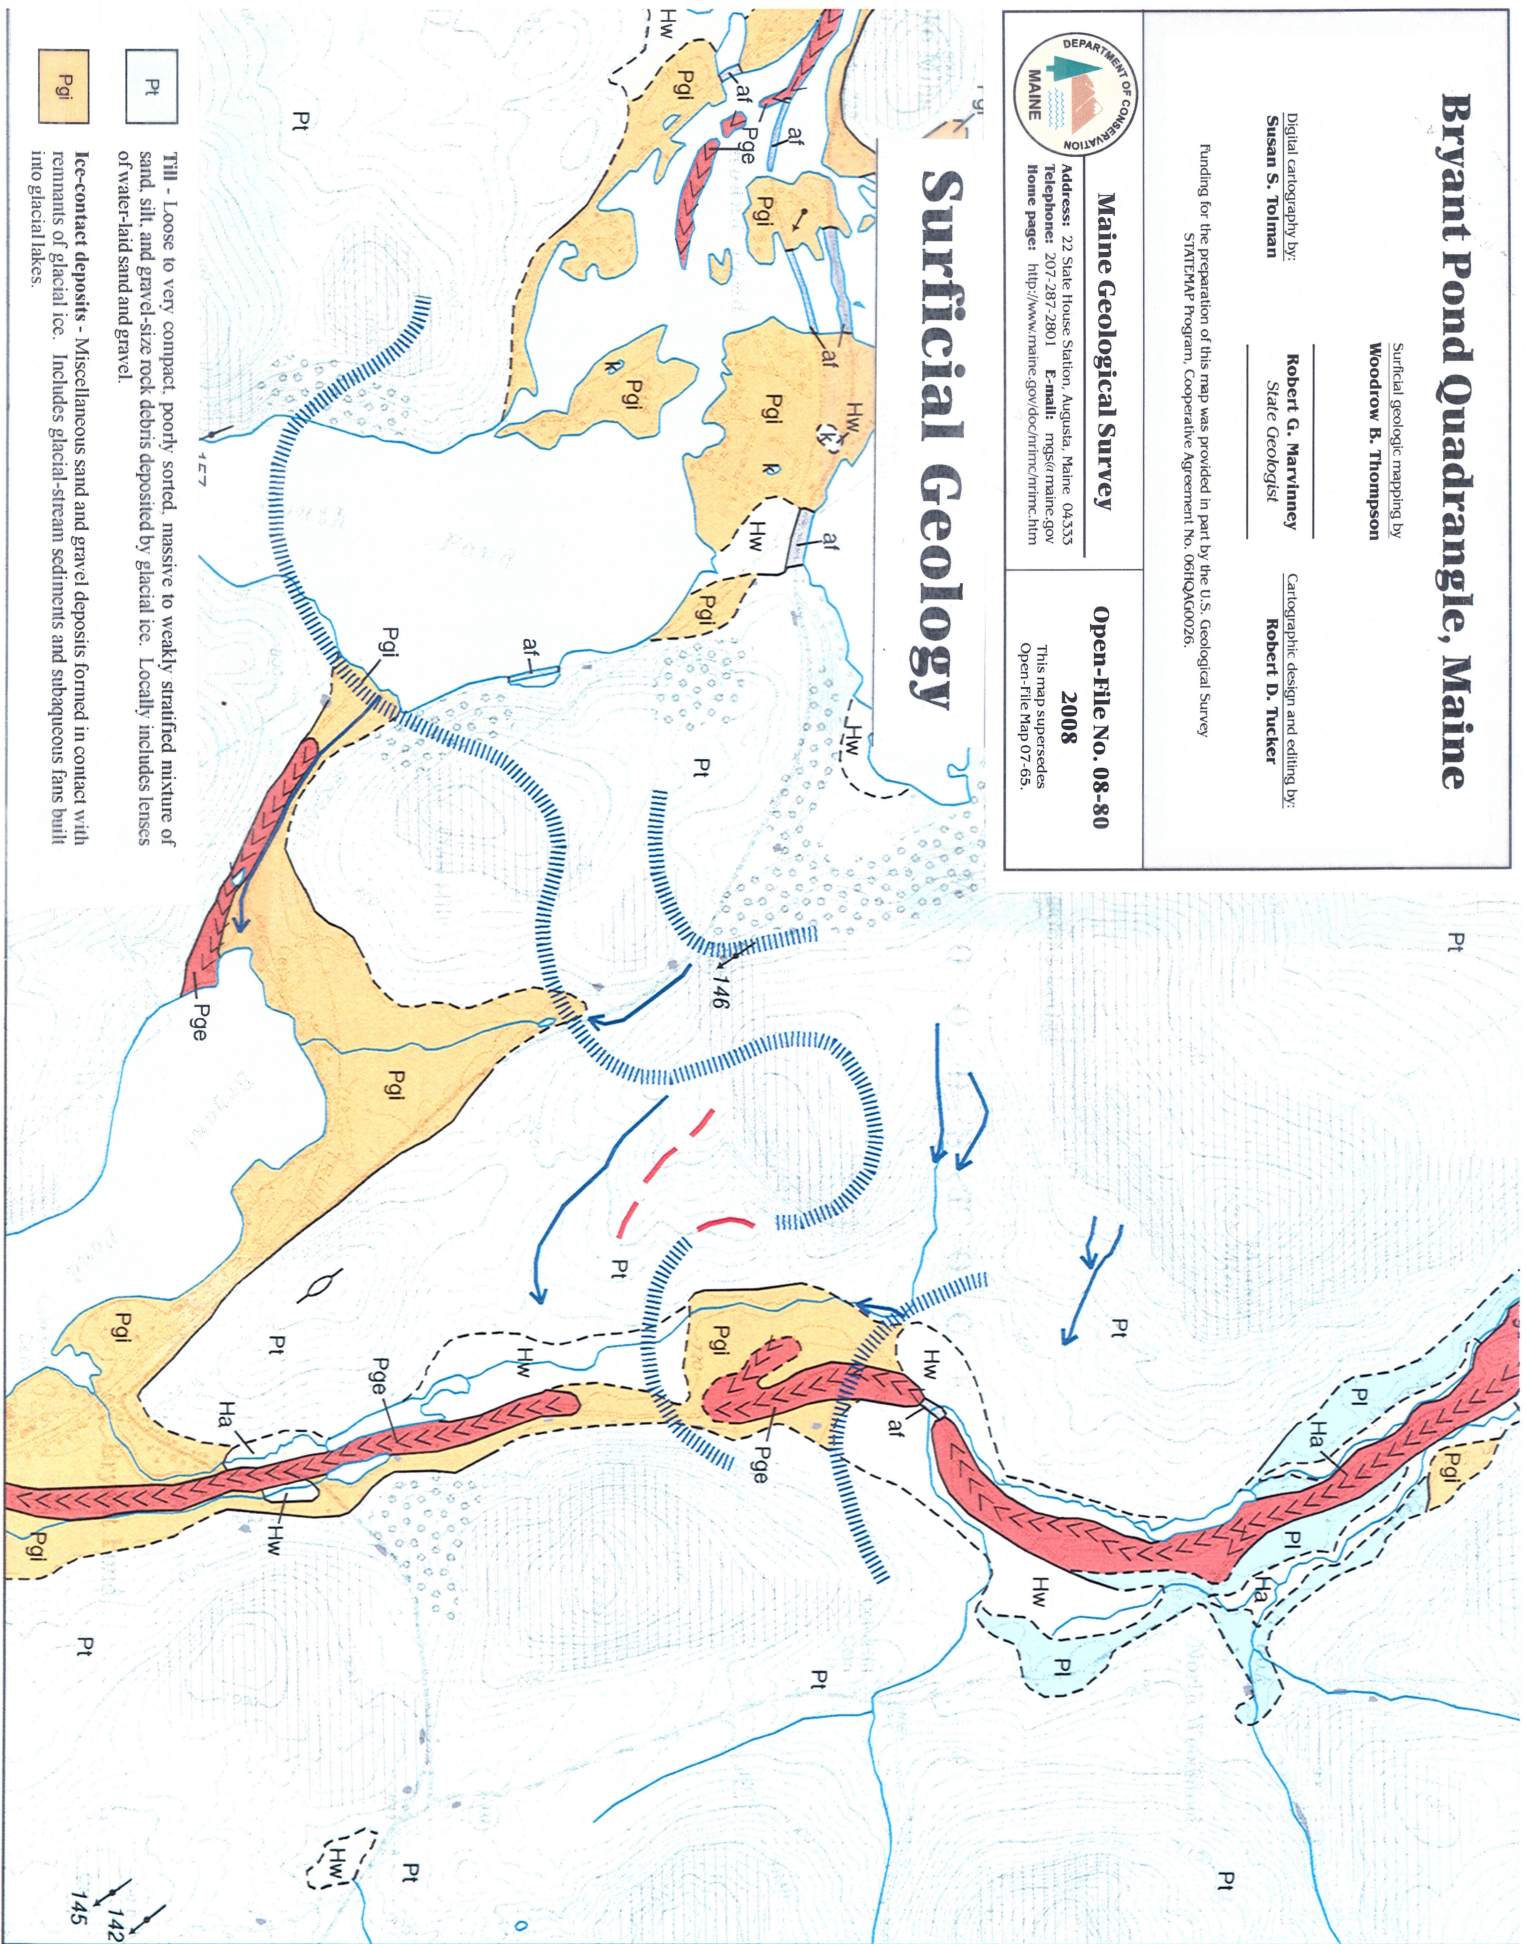
Pt - Till - Loose to very compact, poorly sorted, massive to weakly stratified mixture of sand, silt, and gravel-size rock debris deposited by glacial ice. Locally includes lenses of water-laid sand and gravel.

Pgi - Ice-contact deposits - Miscellaneous sand and gravel deposits formed in contact with remnants of glacial ice. Includes glacial-stream sediments and subaqueous fans built into glacial lakes.

The Maine Geologic Survey Surficial Geology map for this area shows the hill behind this retaining wall to be a Till drumlin. The map shows a clear change of soil types at Route 26, with ice-contact deposits between the road and Bryant Pond. These soil types should be granular materials. Mapping by NRCS shows soils surrounding this wall to be "Colton gravelly loamy sand" with very low fines content. Shallow bedrock is indicated further up the hill. Neither the MGS nor NRCS maps indicate shallow bedrock in the lower portion of this drumlin. Portions of both MGS and NRCS maps are attached to this report.
