# PRELIMINARY DESIGN REPORT

**Tibbetts Bridge  
Bridge #3344**

**Loggin Road  
Over  
Marsh Stream**

**PIN 016763.00**

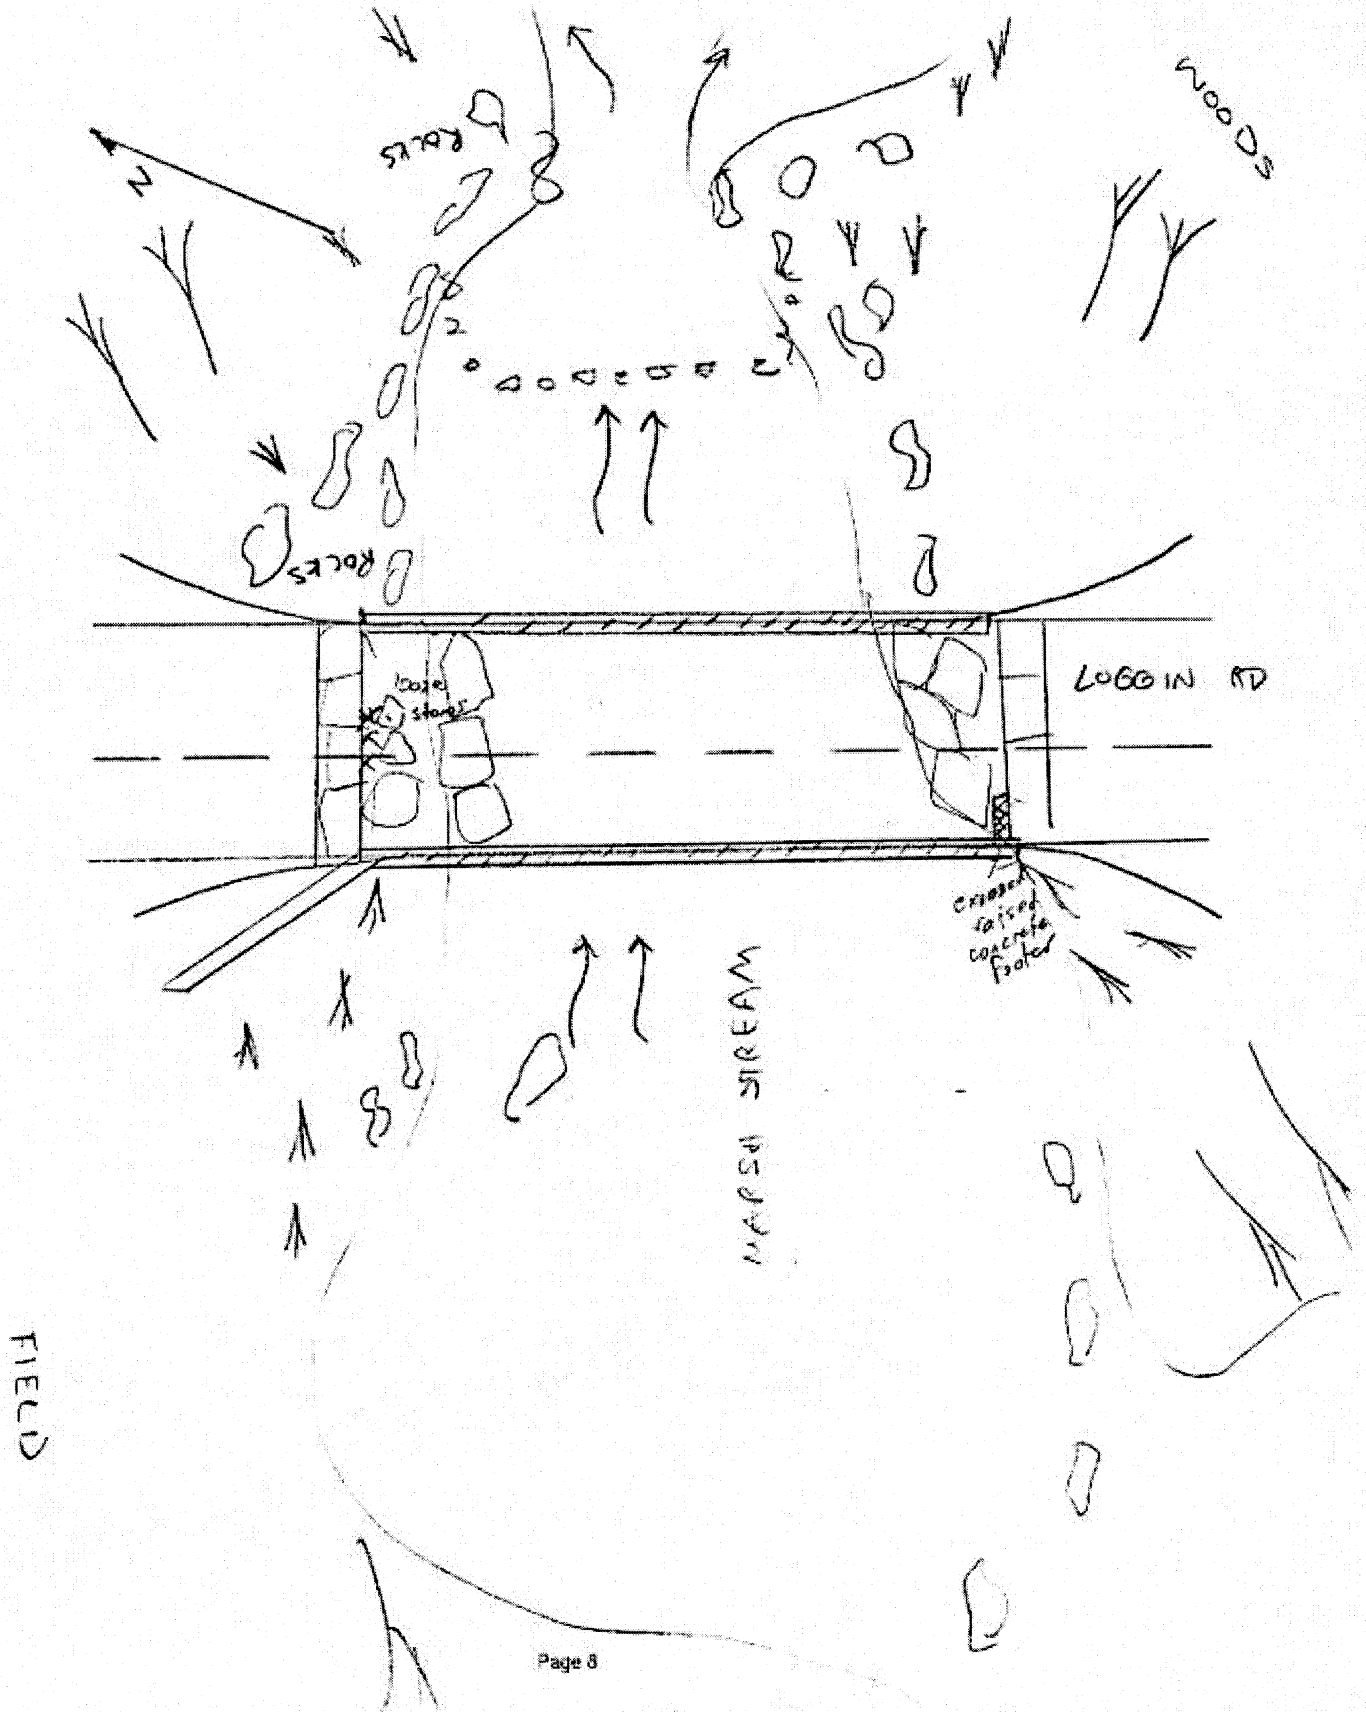
## Sketch (Plan view)

Bridge plans supplemented by field sketch.

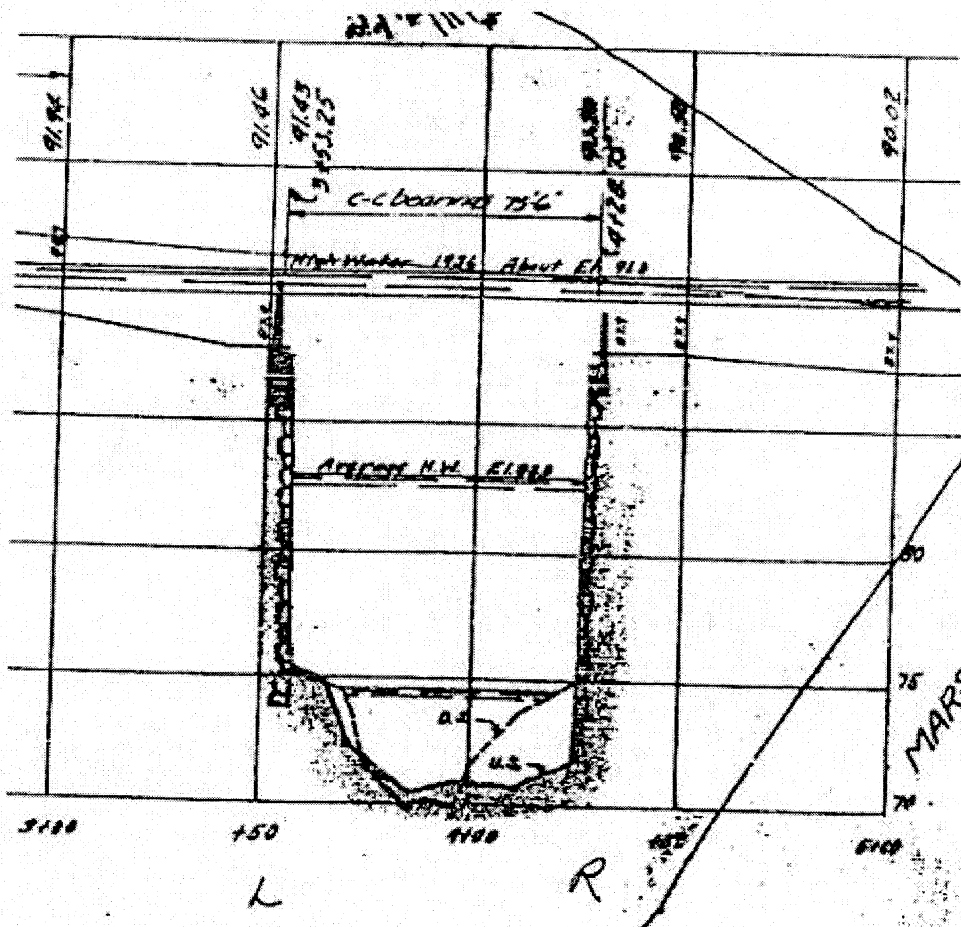
Sketch (Profile)

Bridge plans supplemented by field sketch.

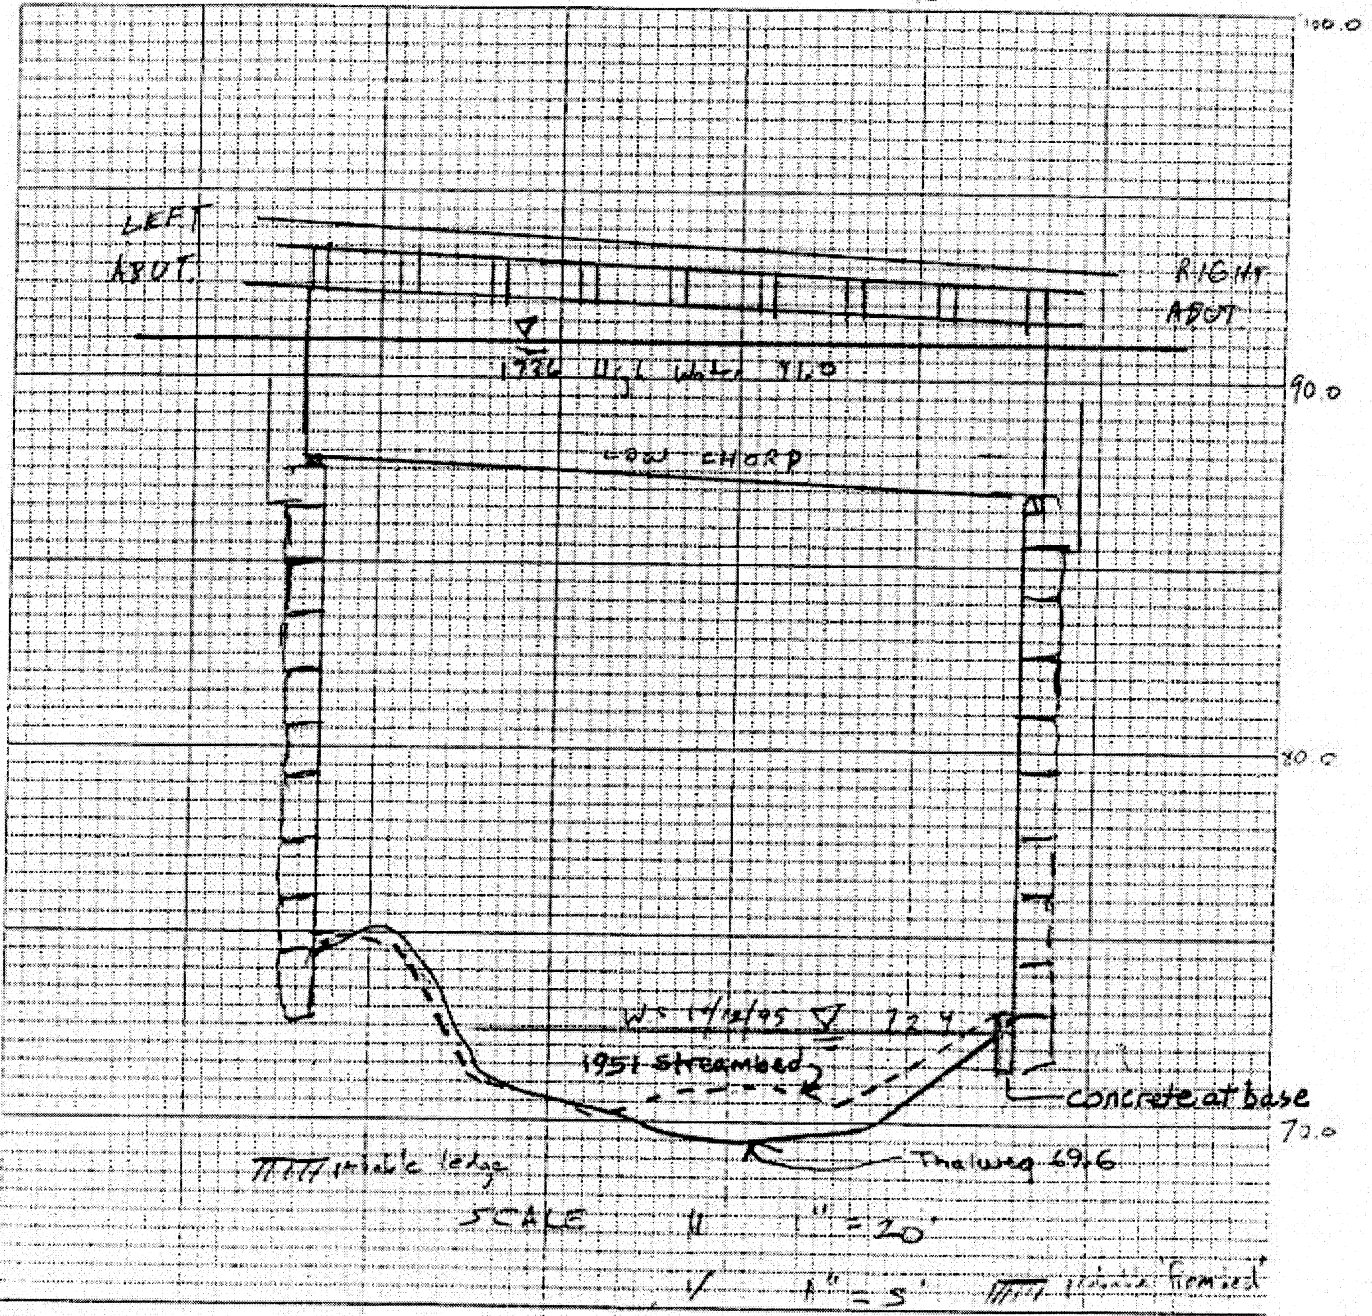
## Stream Cross Section at Bridge (Facing Downstream)

Upstream Side: X      Downstream Side: \_\_\_\_\_

5. STREAM CROSS SECTION (See sheet 11)  Upstream Face  Downstream Face

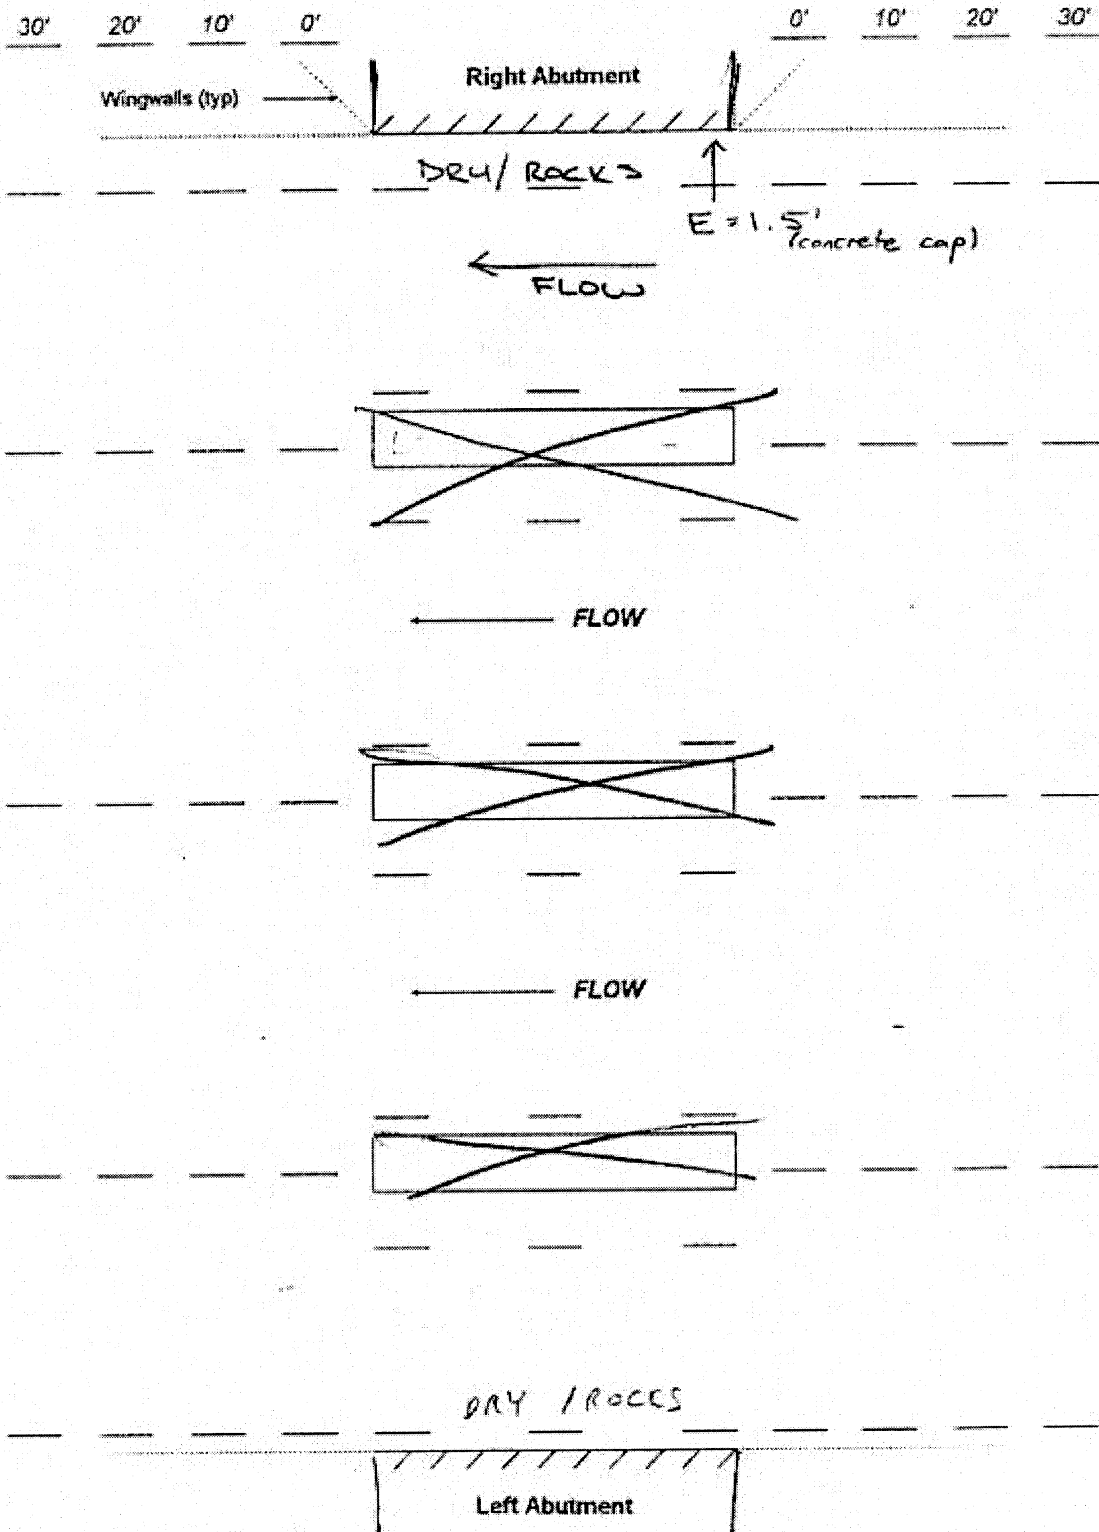
## Soundings/Probings

E - Footing Exposure      U - Depth of Undermining  
 P - Depth of Rod Probe      W - Water Depth

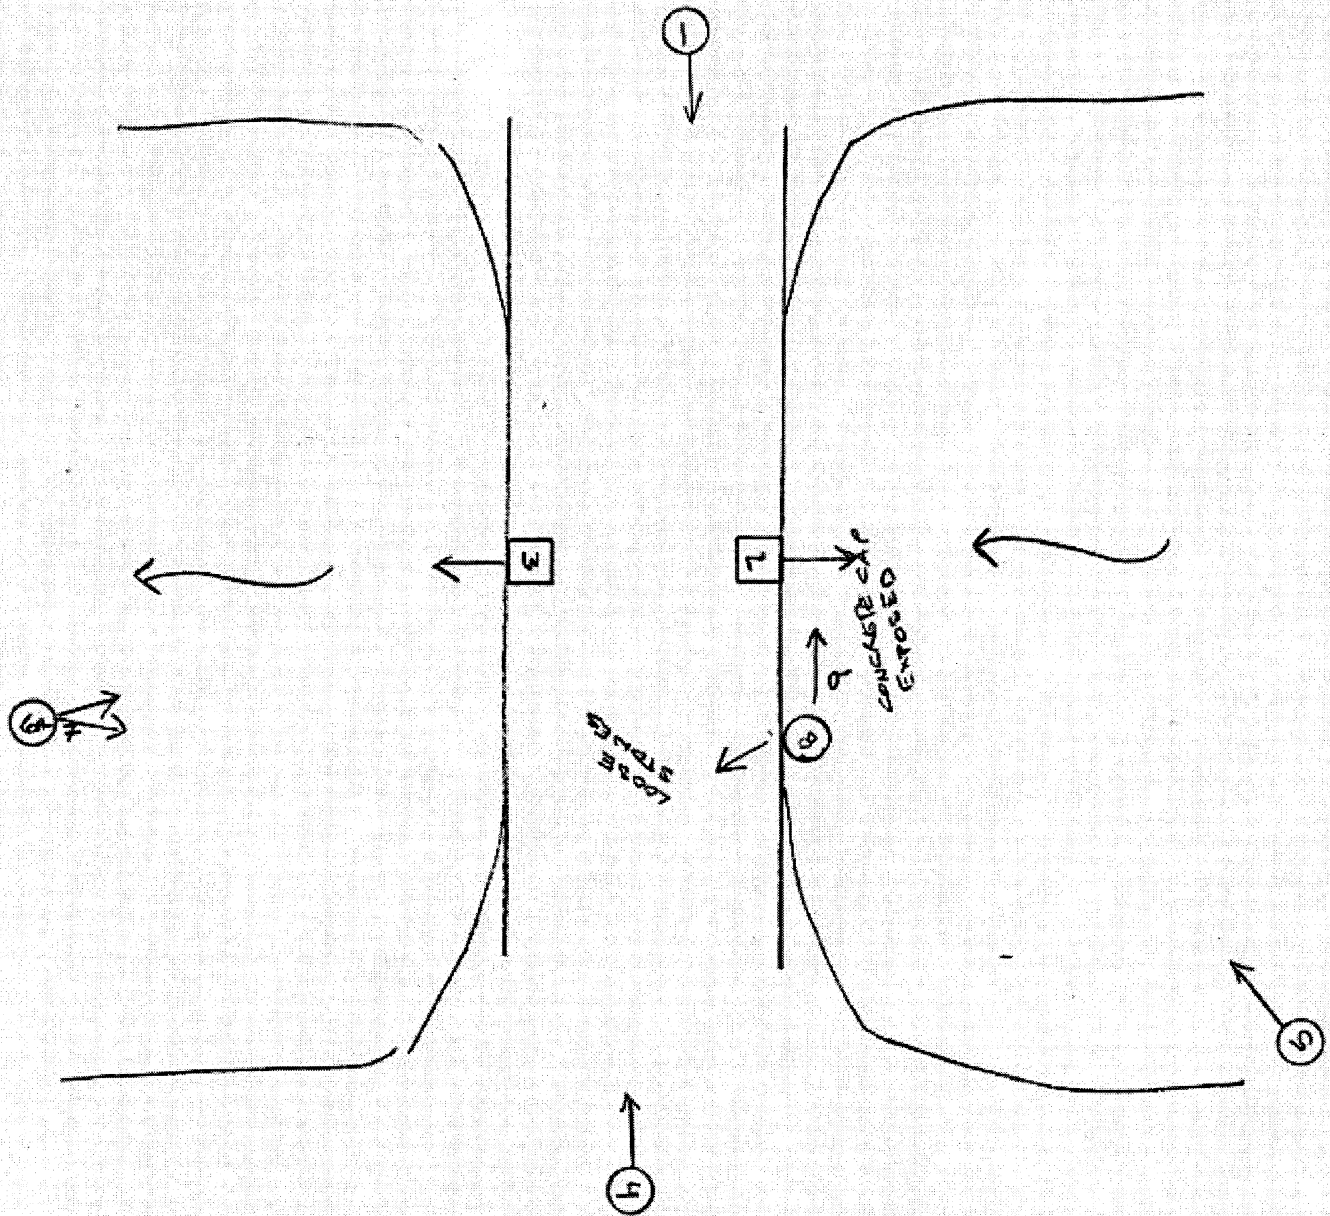
## Picture Locations

○ → From Ground

□ → From Bridge Deck

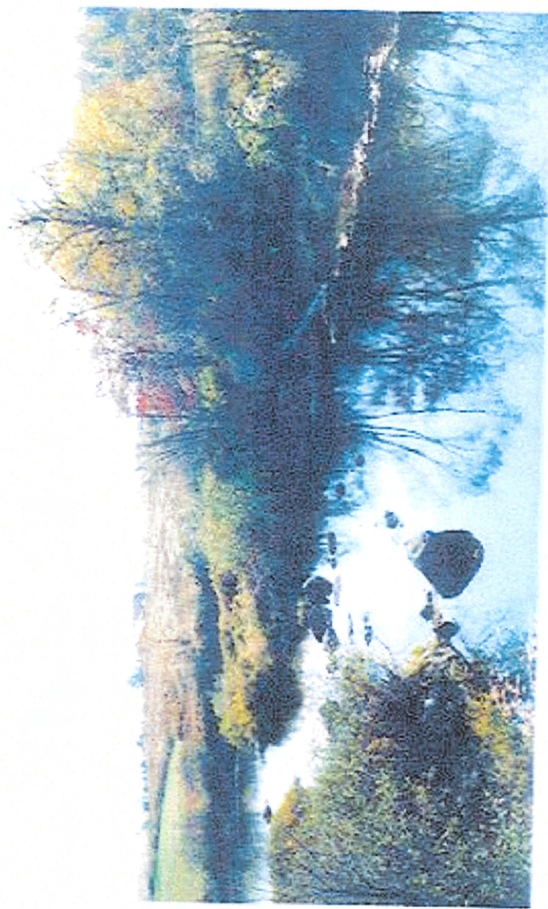
② Facing Upstream

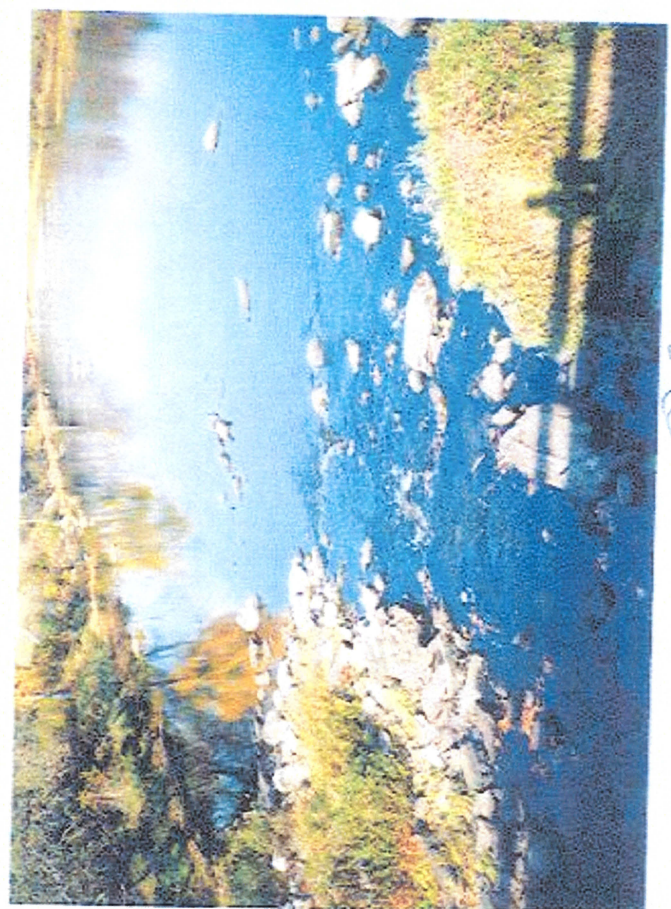
③ Facing Downstream

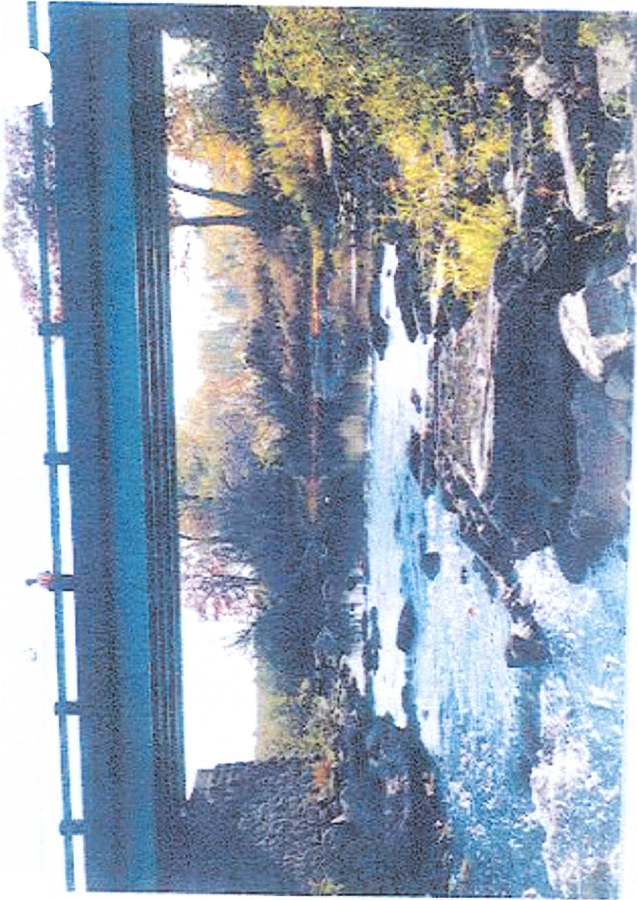
⑦ downstream face, right abutment

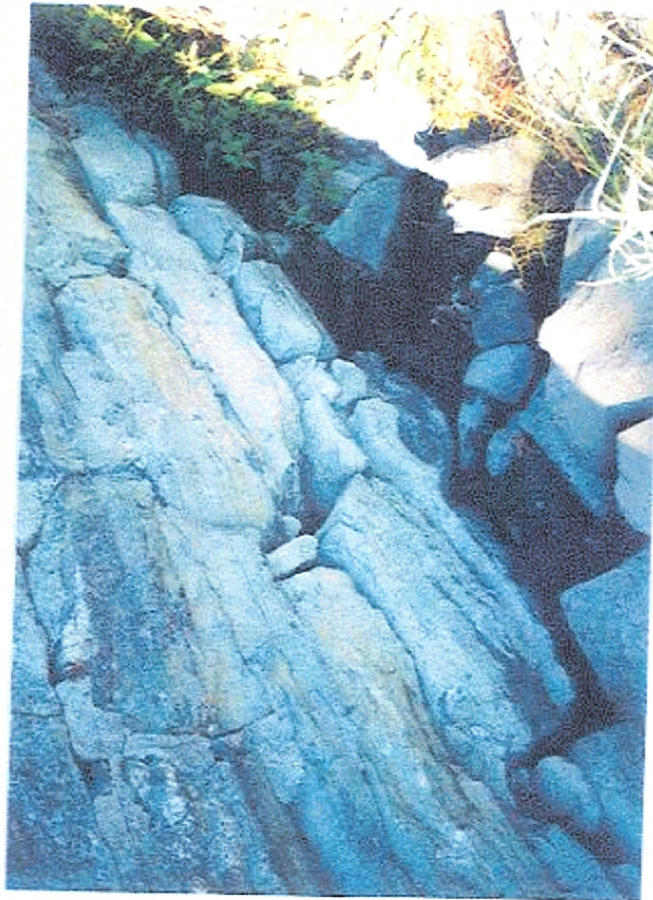
⑧ left abutment, showing loose stones

The streambed measured by soundings shows approximately 1.5 foot degradation of the thalweg from the streambed on the 1951 design plans. Flow attacks the left abutment at a 20 degree angle. Stones from the middle of the left abutment at bed level are loose. The 1951 plans indicate "probable ledge" under the left abutment at elevation 68.8 feet (5.5 feet below streambed at the abutment face); and "very firm material through boulders and gravel" under the right abutment at elevation 65.8 feet (7.1 feet below streambed at face of abutment). MDOT inspections report settlement and tilting of both abutments: (7/18/90) "NW (left) abut: lower crses of field stone have tumbled out of abut"; "signs of settlement at NW abut"; recommended "repair base of NW abut"; "SE abutment: portion of downstream backwall cracked and moved 2 1/2" D.S.; superstructure jammed against SE abutment"; (4/29/92) "NW'ly abut (left) has stones missing @ base w. vert crack < 1/2" running up to conc cap"; and (5/4/94) "point mortar missing, scour under No. (left) abut"; SE'ly (right) abut has rotated forward est. 3" @ top"; "long, cracking @ SE'ly abut indicates settlement". Both abutments are well-protected with large riprap (2 foot diameter). Protection was also noted in MDOT inspection: "Bottom well protected with large stone with upstream concrete jacket at southerly abutment" (4/29/92).

7) Comments: *left abutment losing chinking stones and gout at base*

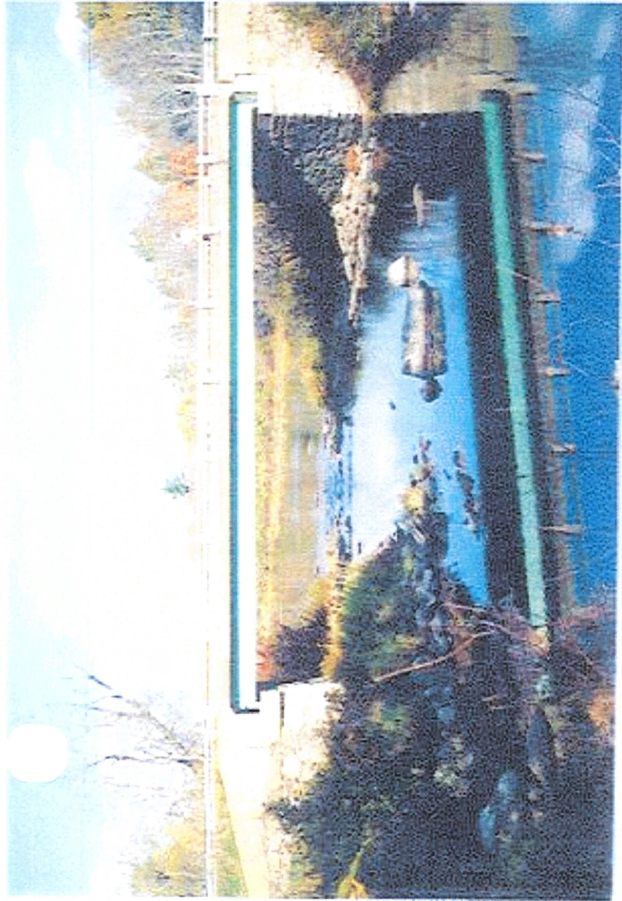
⑤ upshear face, looking at right abutment

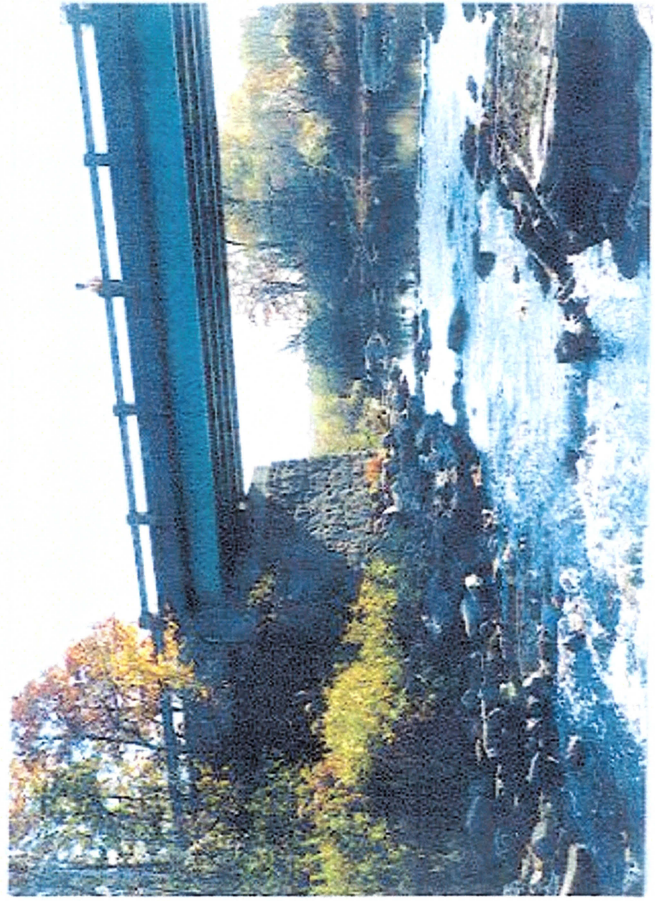
⑥ downstream face, right abutment

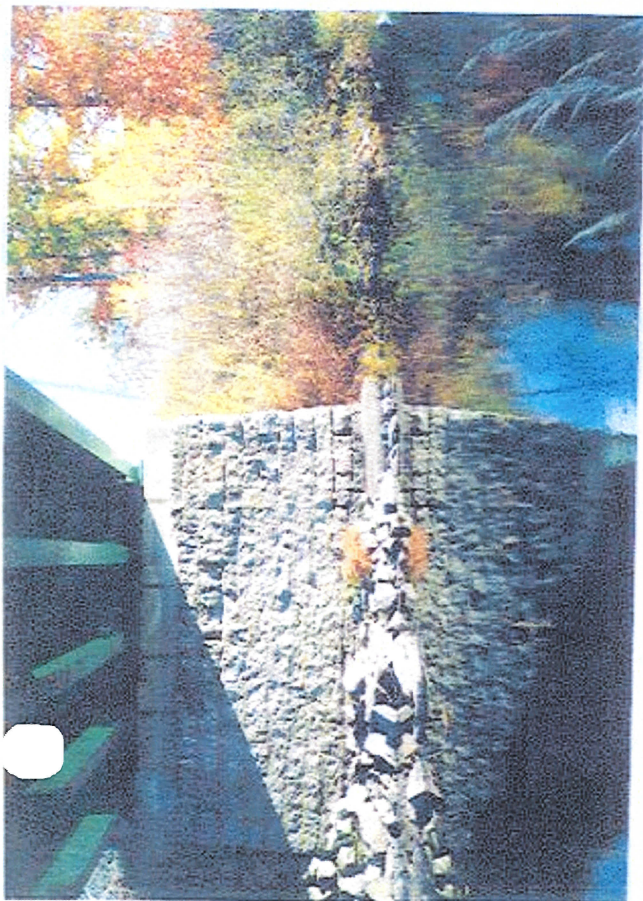
① looking at right  
abutment, note  
concrete cap, U.S.

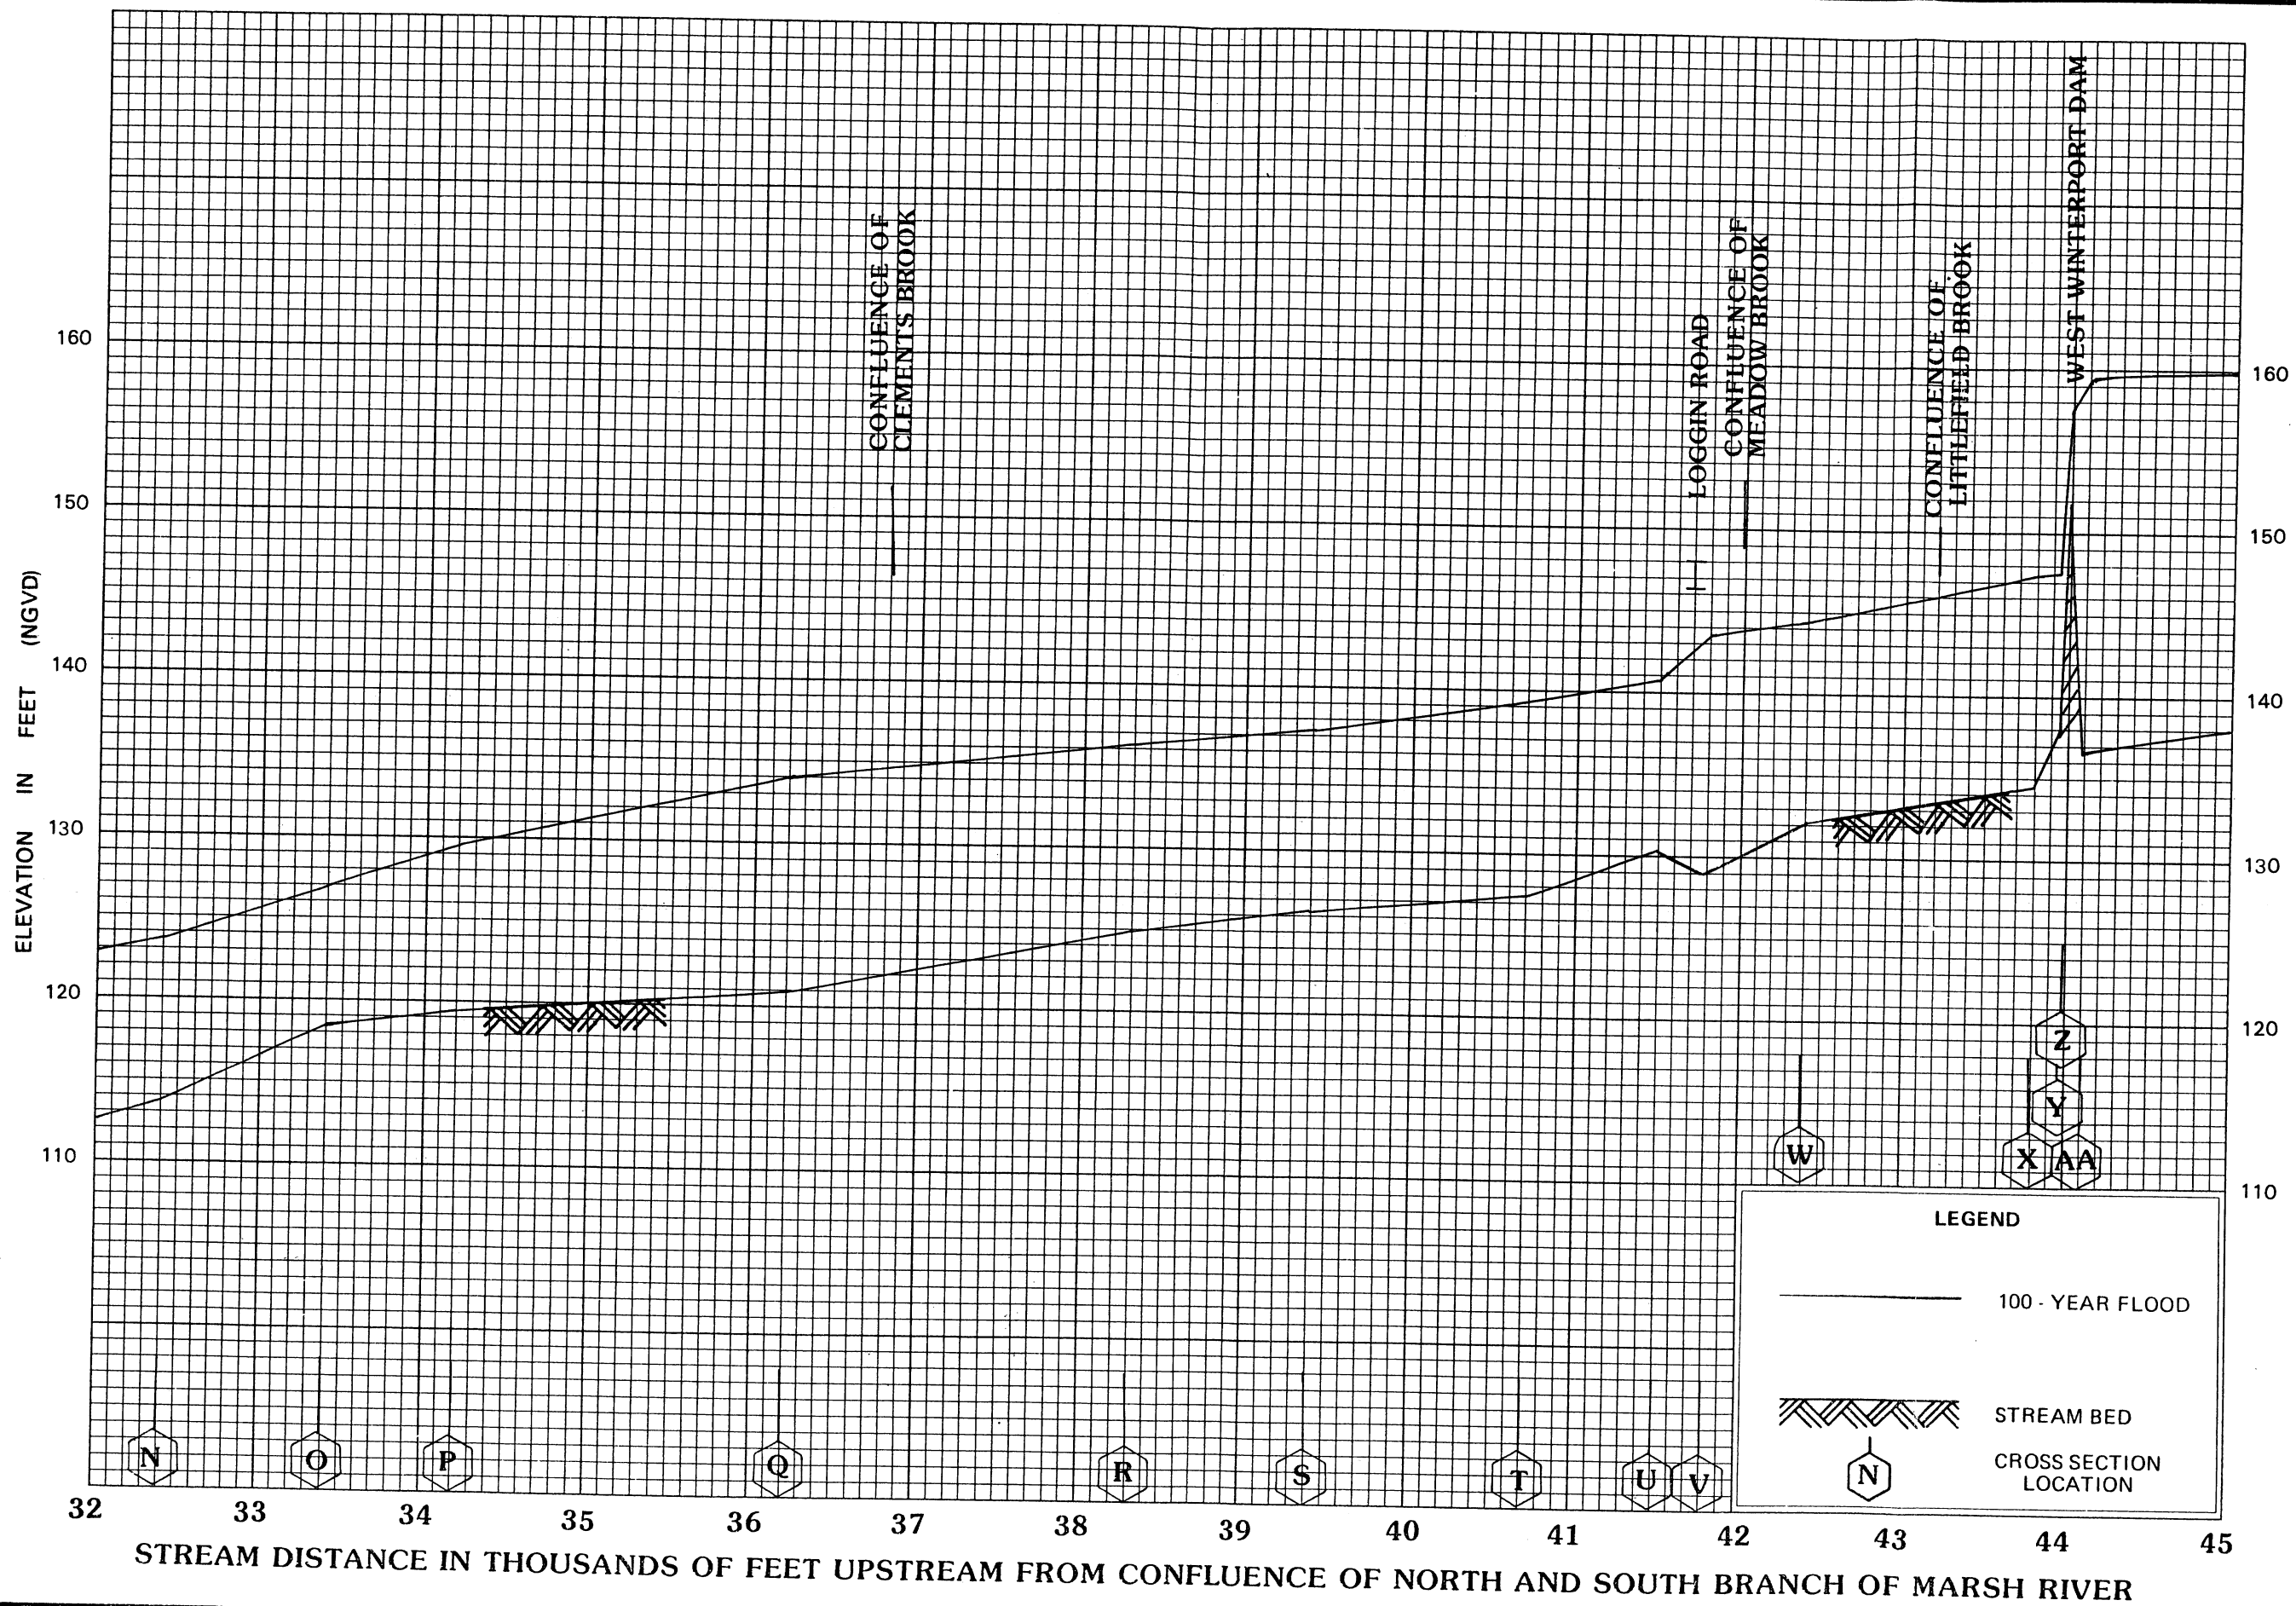
TABLE 2

**FLOOD PROFILES**  
MARSH STREAM

The upstream stream slope was calculated based on the profile in the Flood Insurance Study. It is difficult to get an accurate average stream slope from just the survey data because of the short length of survey and the variability of the streambed elevations in that length. The downstream stream slope in the Flood Insurance Study is 0.0034 ft/ft; however, in order to calibrate the model and match the head difference at the bridge between upstream and downstream, the stream slope was changed to 0.0005 ft/ft after several iterations.

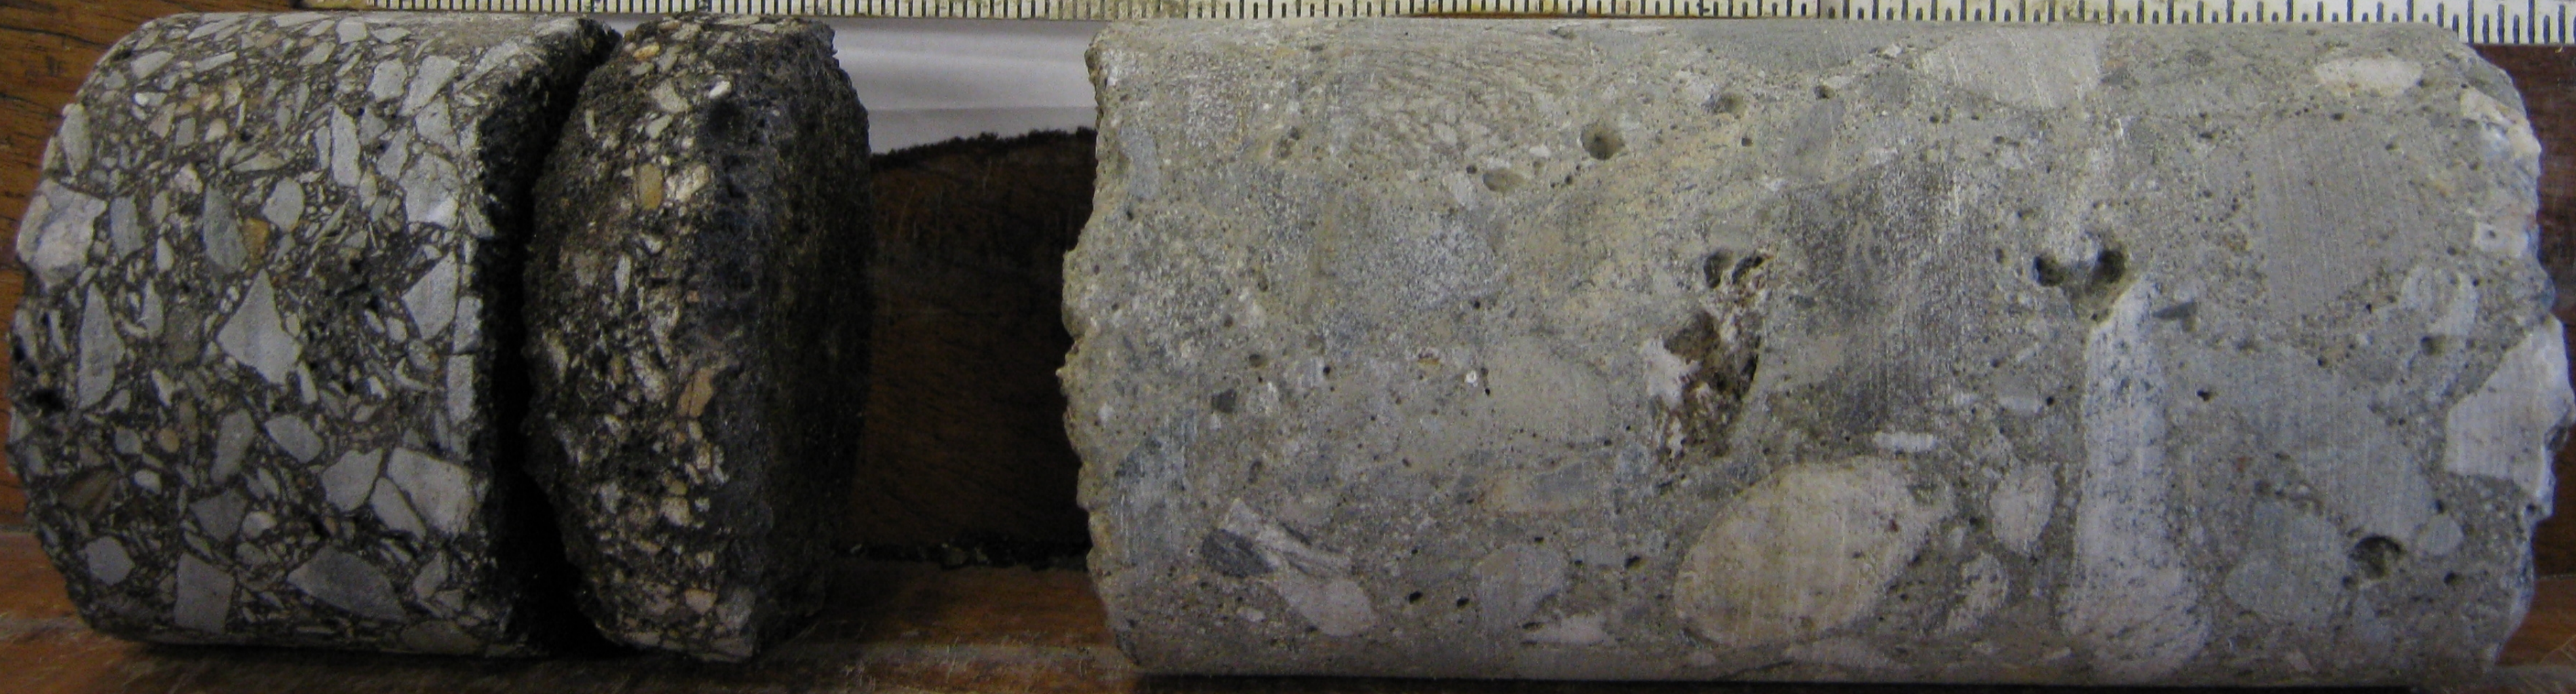
Frankfort Bridge # 3344  
Loggin Rd. Core # 1

# BRIDGE CORE TEST REPORT

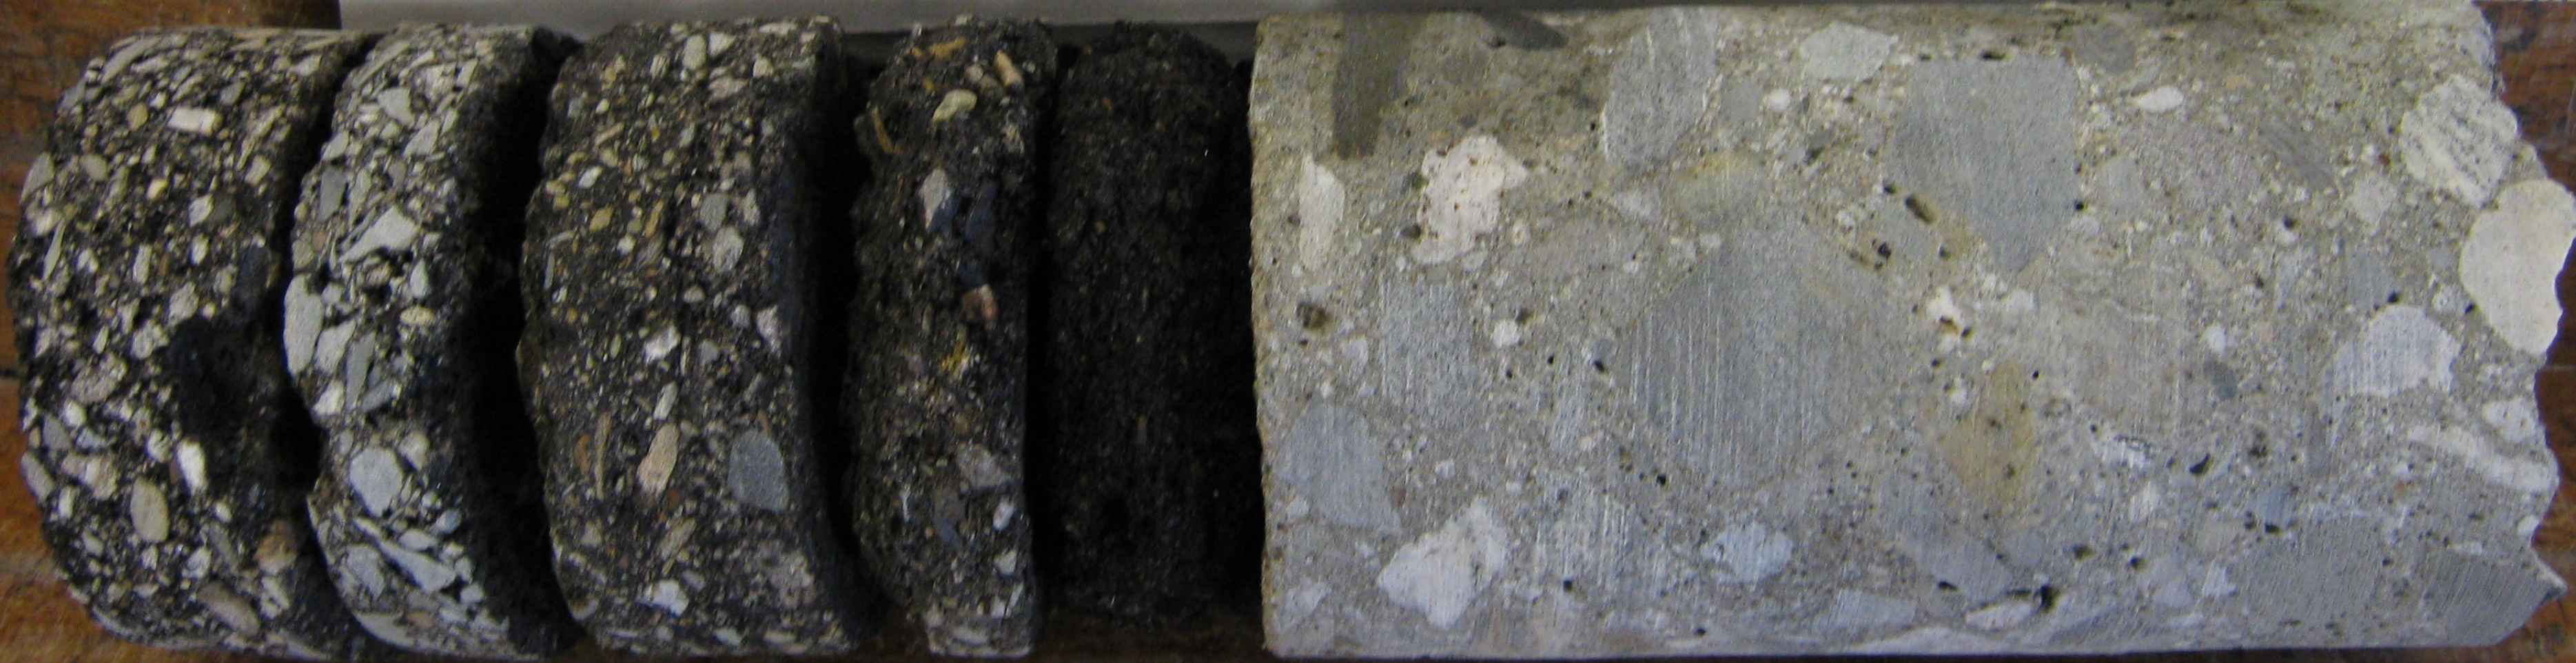
Loggin Rd. Core # 2

# BRIDGE CORE TEST REPORT

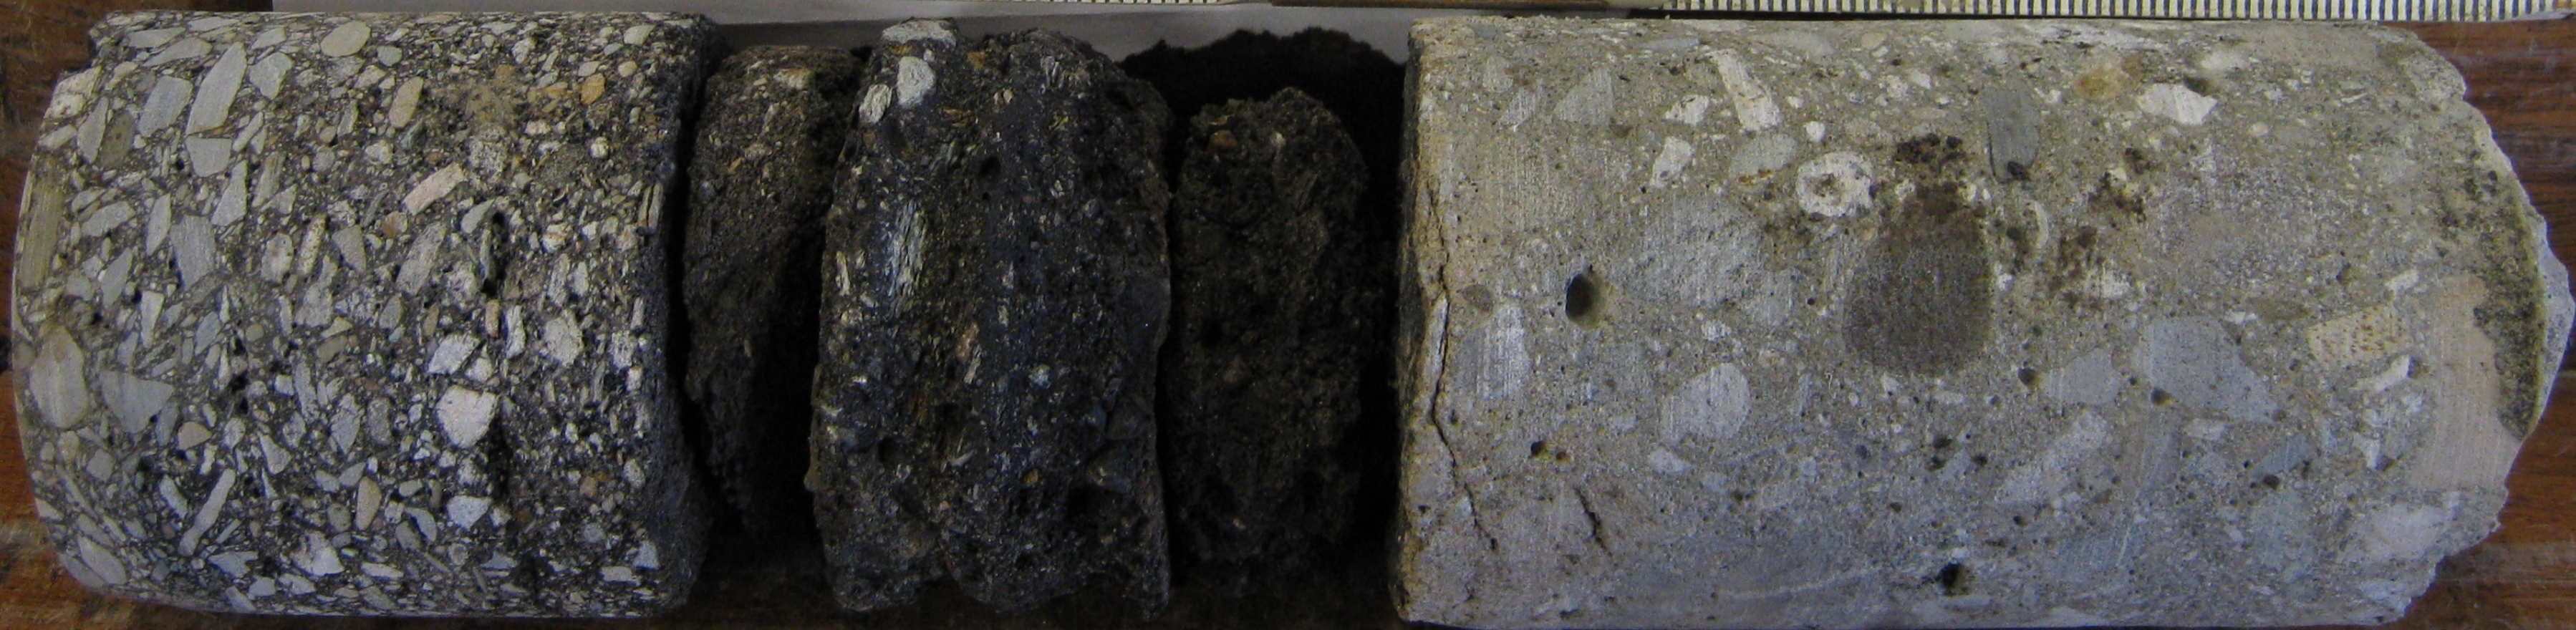
Frankfort Bridge # 3344  
Loggin Rd. Core # 3

# BRIDGE CORE TEST REPORT
