# PRELIMINARY DESIGN REPORT

**Tibbetts Bridge  
Bridge #3344**

**Loggin Road  
Over  
Marsh Stream**

**PIN 016763.00**

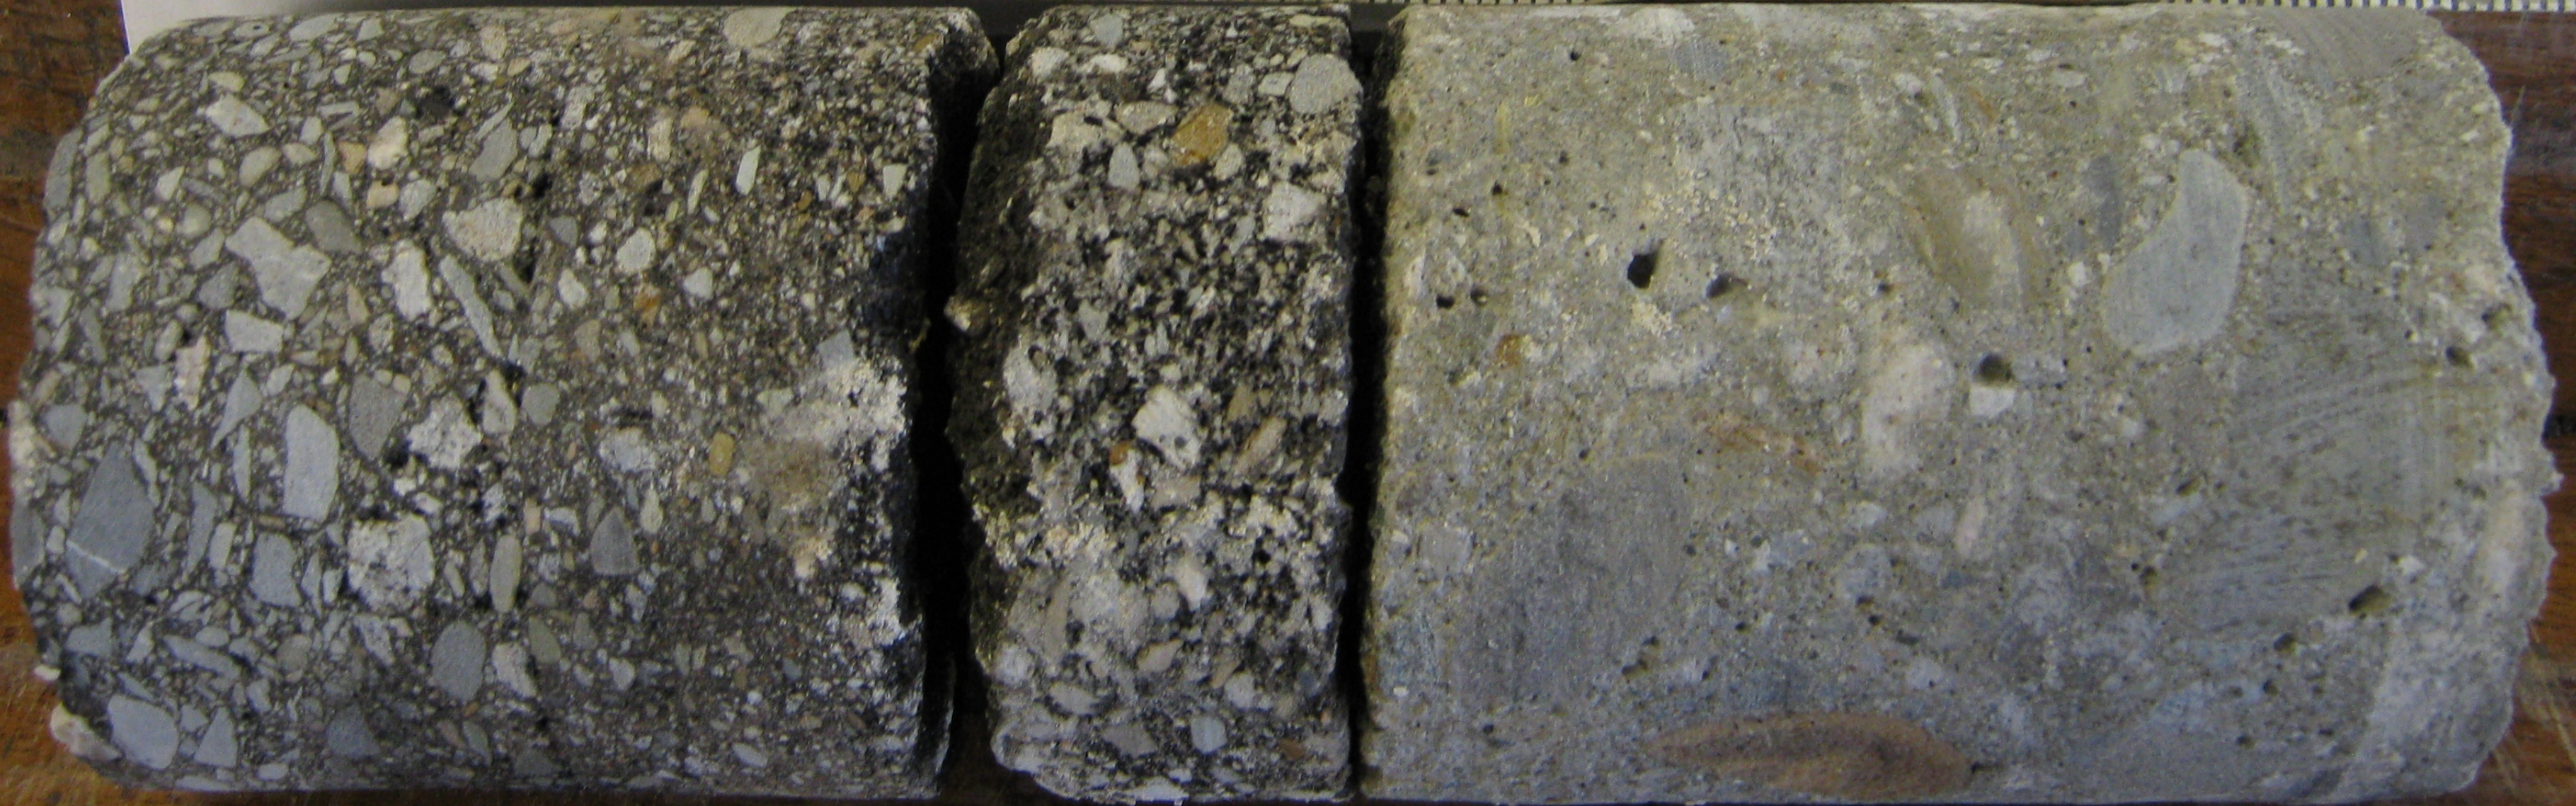
Frankfort Bridge # 3344  
Loggin Rd. Core # 4

# BRIDGE CORE TEST REPORT

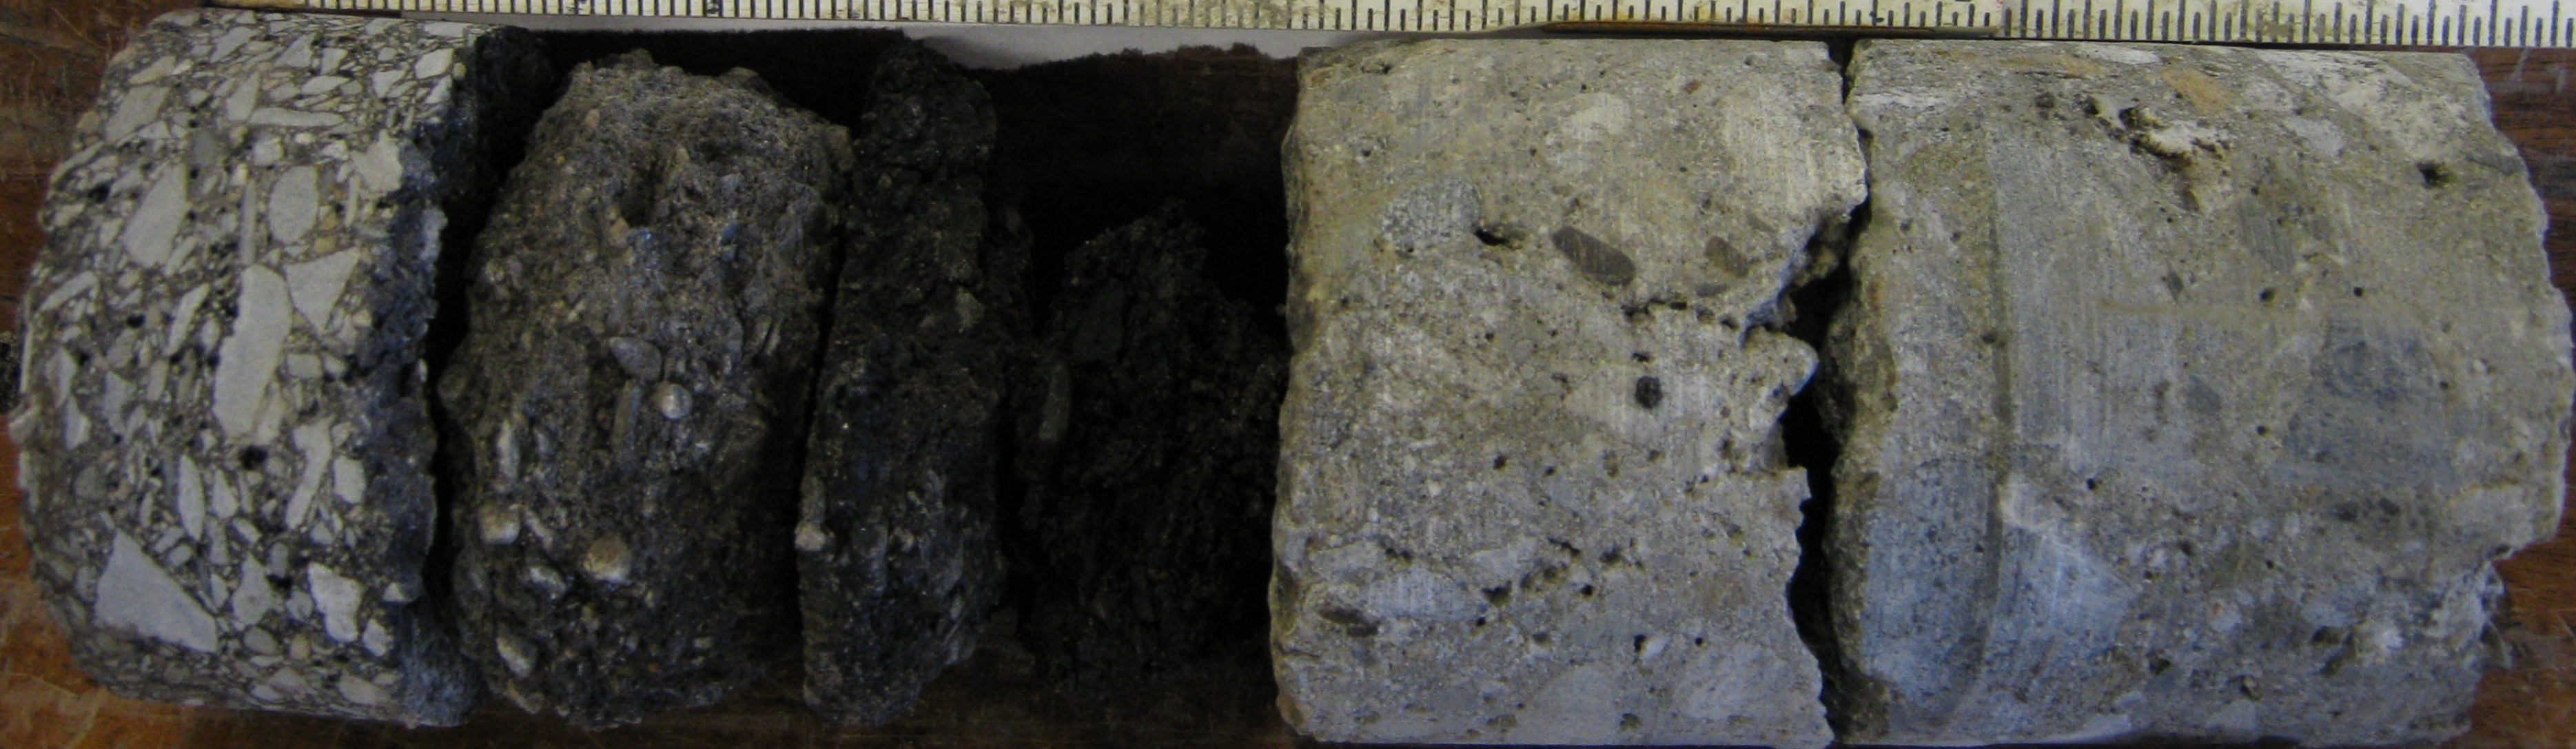
Frankfort Bridge # 3344  
loggin Rd. Core # 5

# BRIDGE CORE TEST REPORT

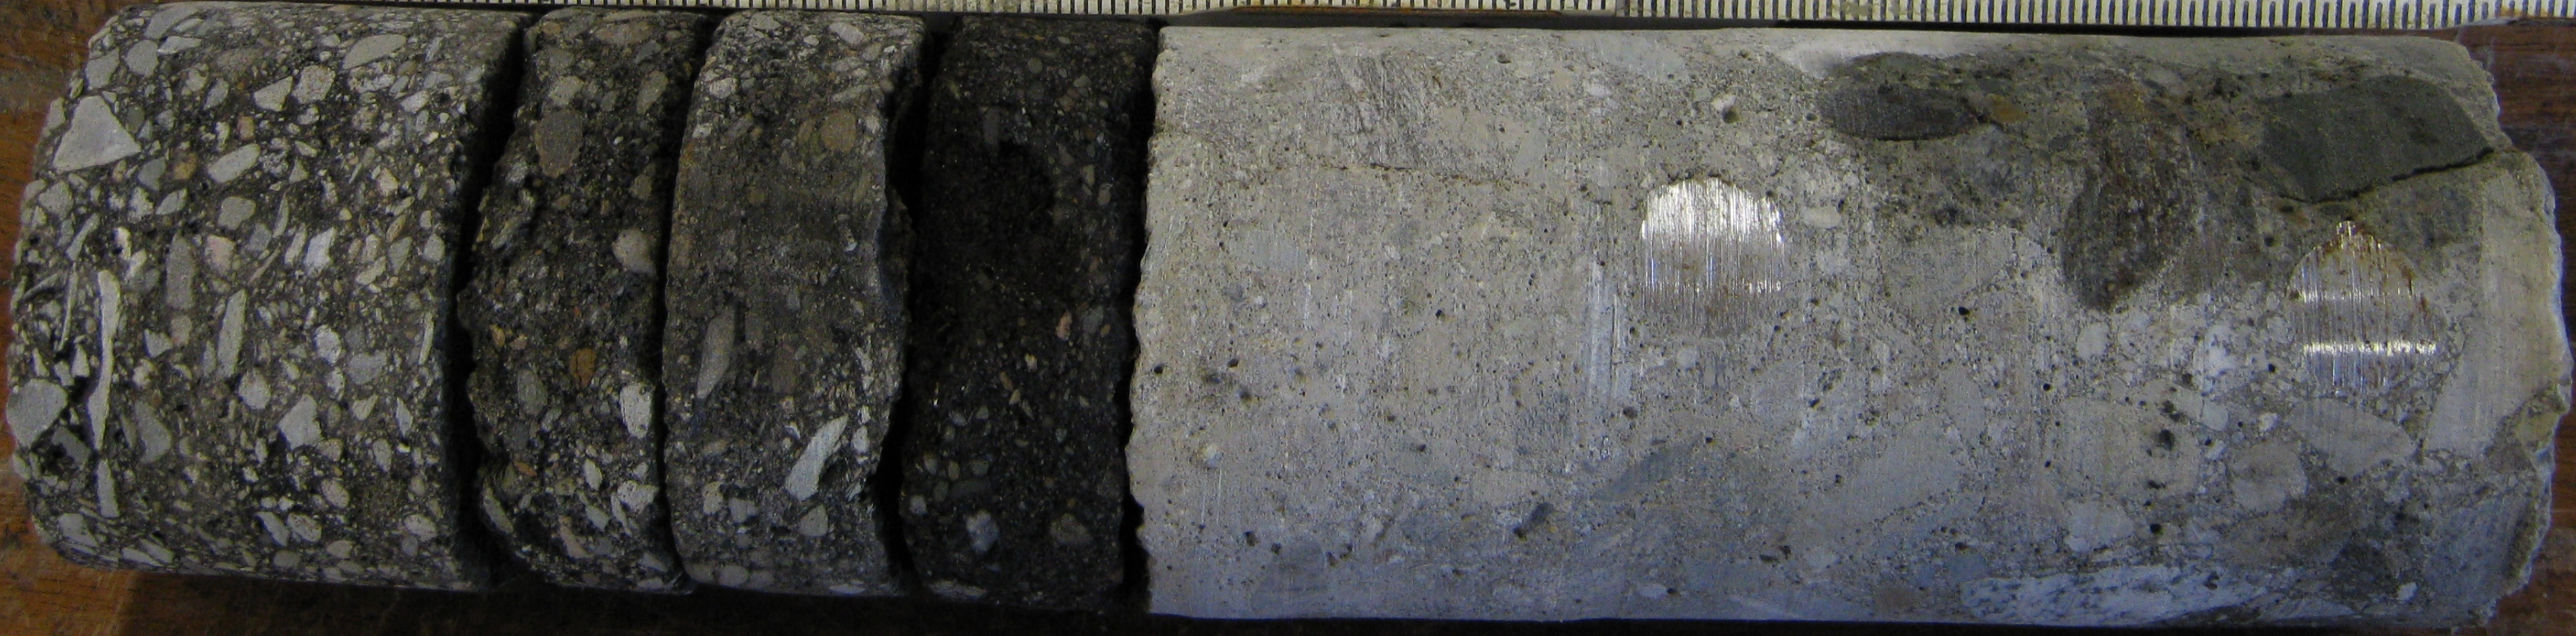
Frankfort Bridge # 3344  
Loggin Rd. Core # 6

# BRIDGE CORE TEST REPORT
