Hydraulic Report

**Brewer-Eddington Route 9 Connector
over
Felts Brook, Eaton Brook, and Tributaries**

**Federal Project No. 1891500
WIN 018915.00**

***Maine Department of Transportation
Bridge Program***

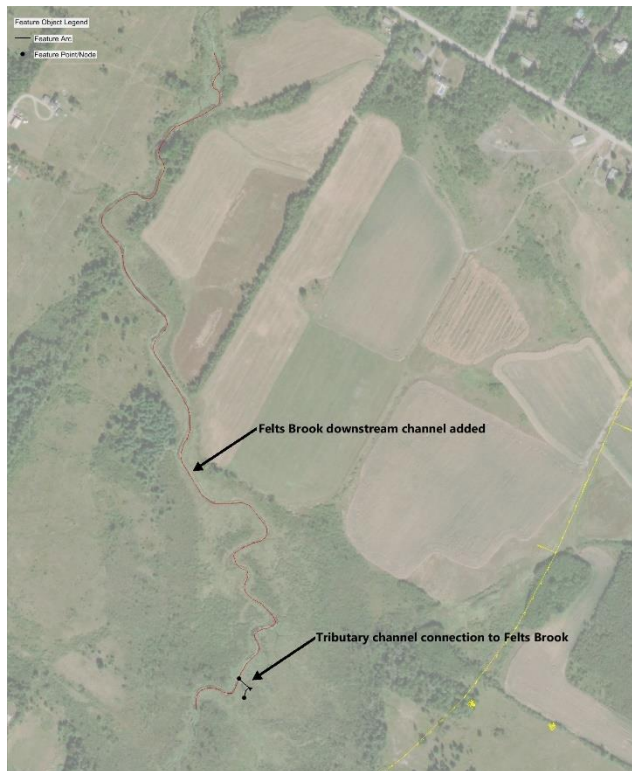
Figure 7: Layout of channels added to LiDAR data

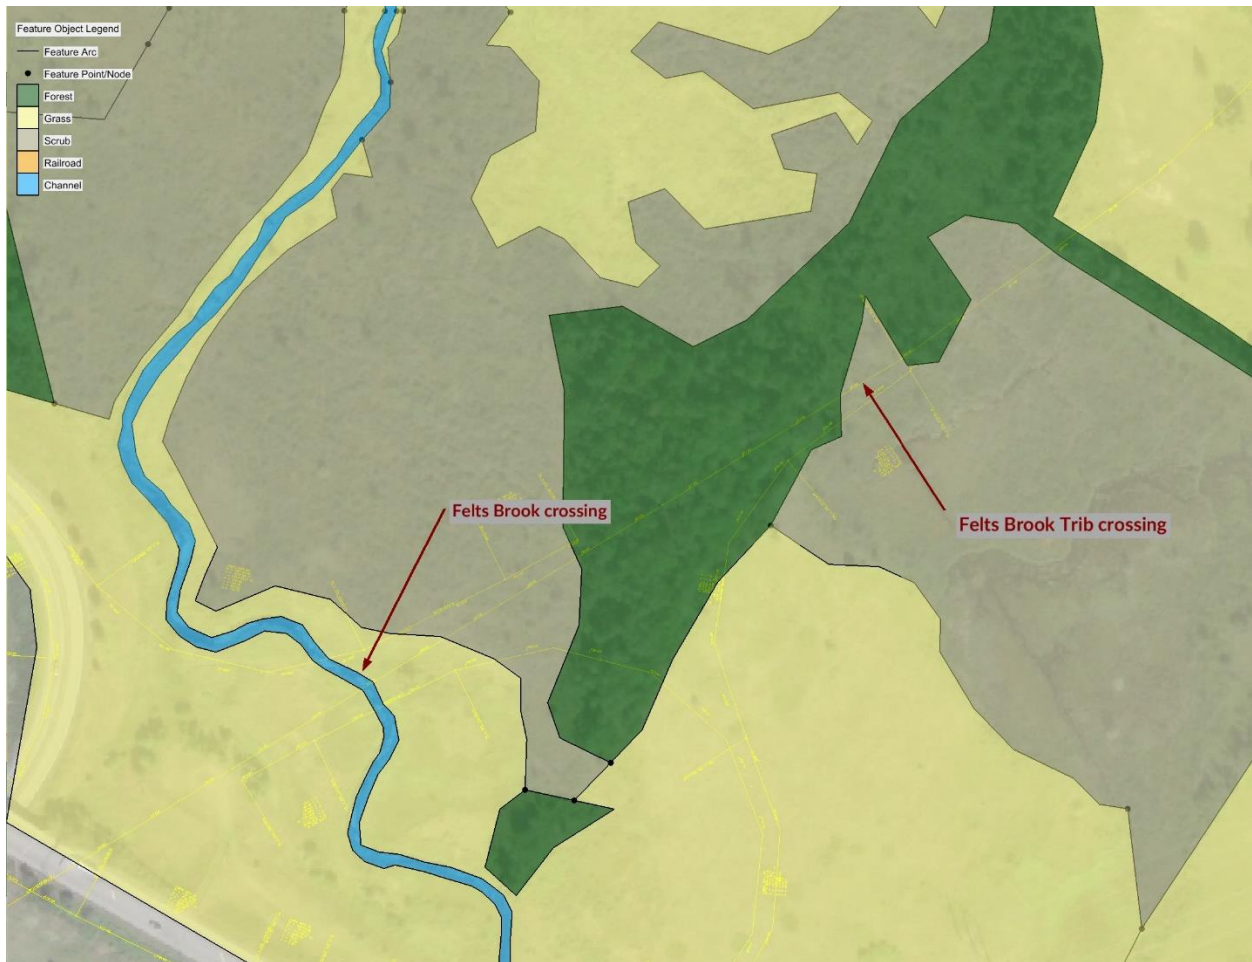
Figure 12: Roughness assignments at the structures for the existing condition

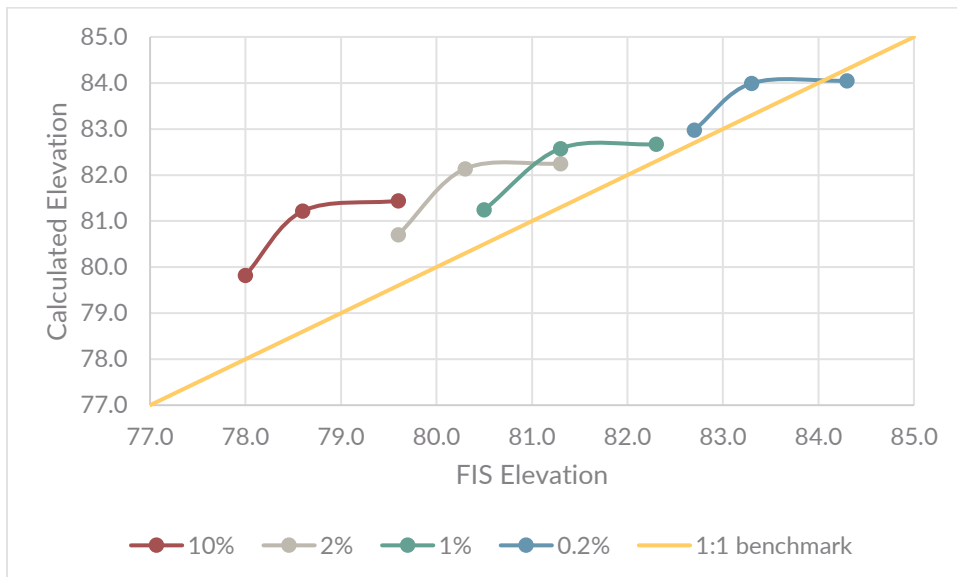
Figure 14: Graph of computed vs. FIS elevations

The discrepancy at lower flows is harder to explain. Since the model sensitivity testing showed the model was stable relative to roughness and downstream boundary conditions, it seems likely that the discrepancy is due to differences in the topographic data used, but without detailed information from the FIS model it is impossible to say for sure. Since the results have a reasonable discrepancy at the design flood flows, the comparison to the FIS is enough to validate the general accuracy of the model and that it is suitable for design.

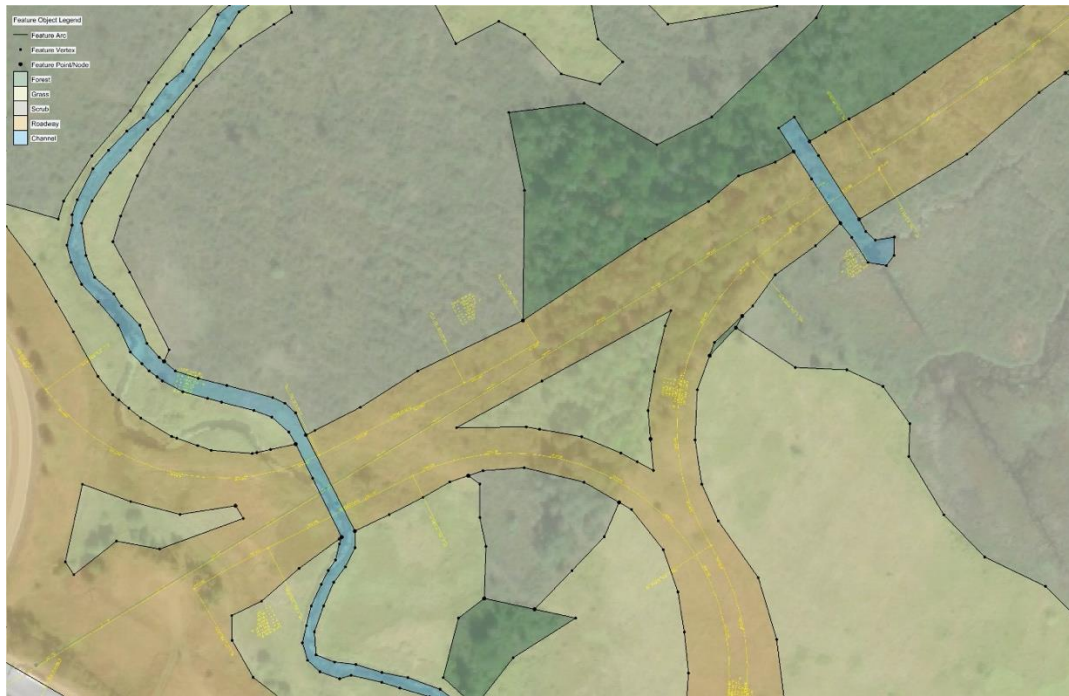
Figure 17: Detailed view of revised material roughness layout at culverts for the proposed condition

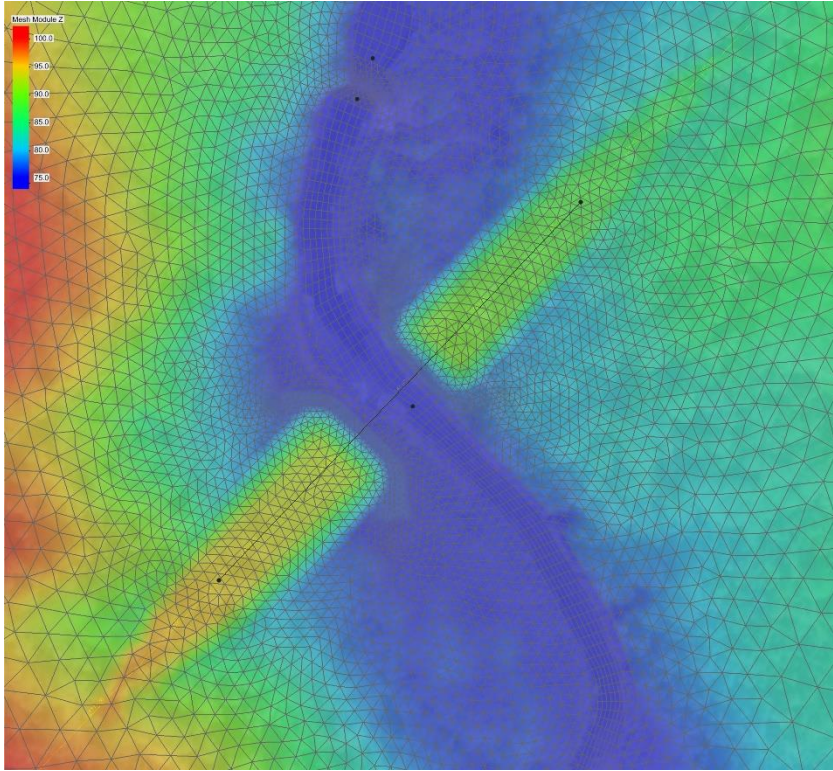
Figure 7: Detailed view of mesh at the bridge for the proposed condition with color assigned by elevation

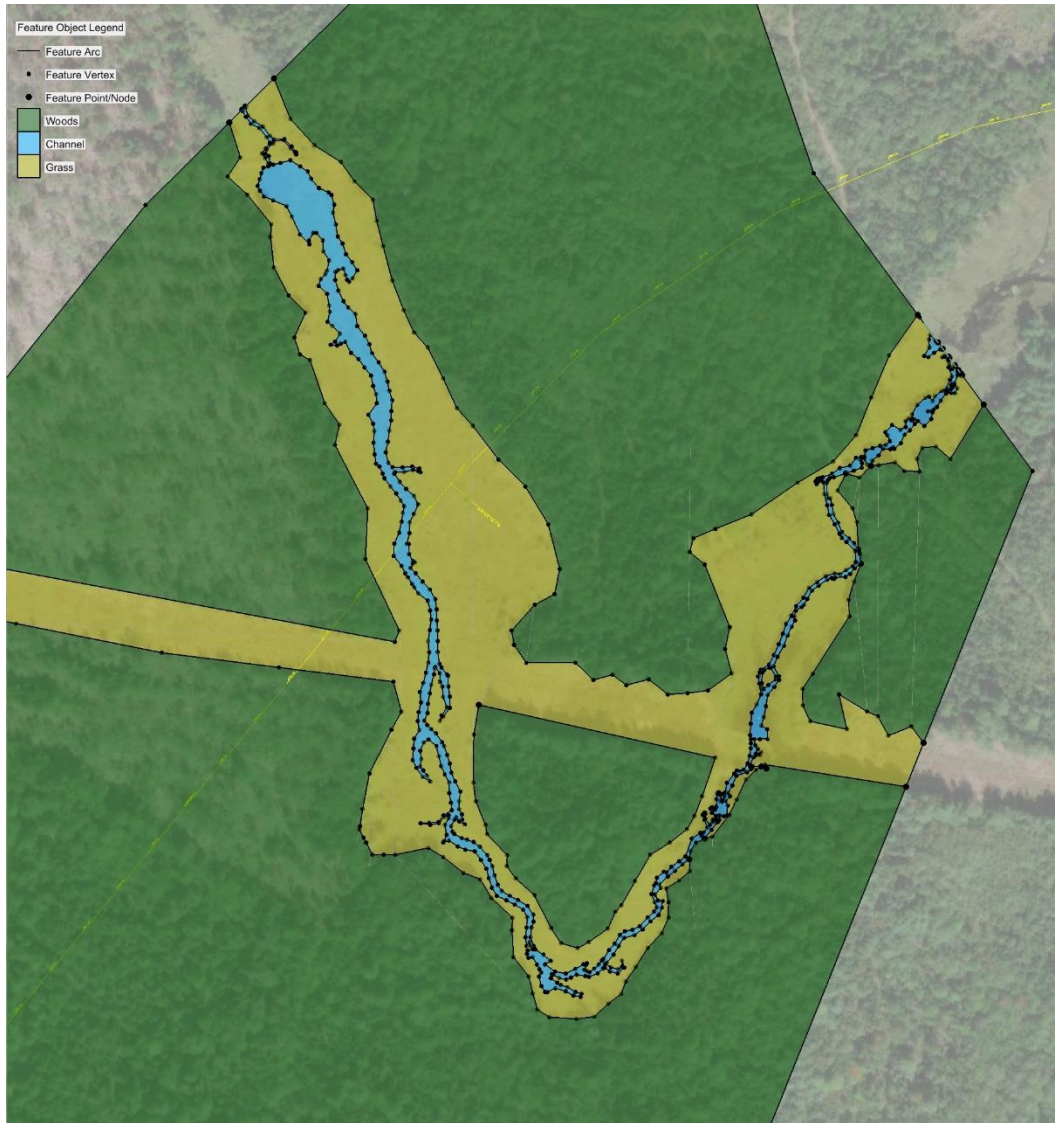
Figure 6: Roughness assignments for the existing model

The model uses a Manning's n in the channel of 0.05, 0.14 for forested areas, and 0.06 for tall grass in the floodplain. The model's sensitivity to changes in the roughness was tested by running the Q100 flow and boundary condition multiple times with a single roughness value adjusted up or down by 0.005 each time. All changes to water elevations were less than 1 inch in magnitude at the proposed structure location, so the model is not sensitive to changes in roughness.
