## HYDROLOGY REPORT

# Preliminary Design Hydrology and Hydraulics Report

## Boombridge Road - Bridge # 3587, Greenbush, Maine

### 1.0 Introduction.

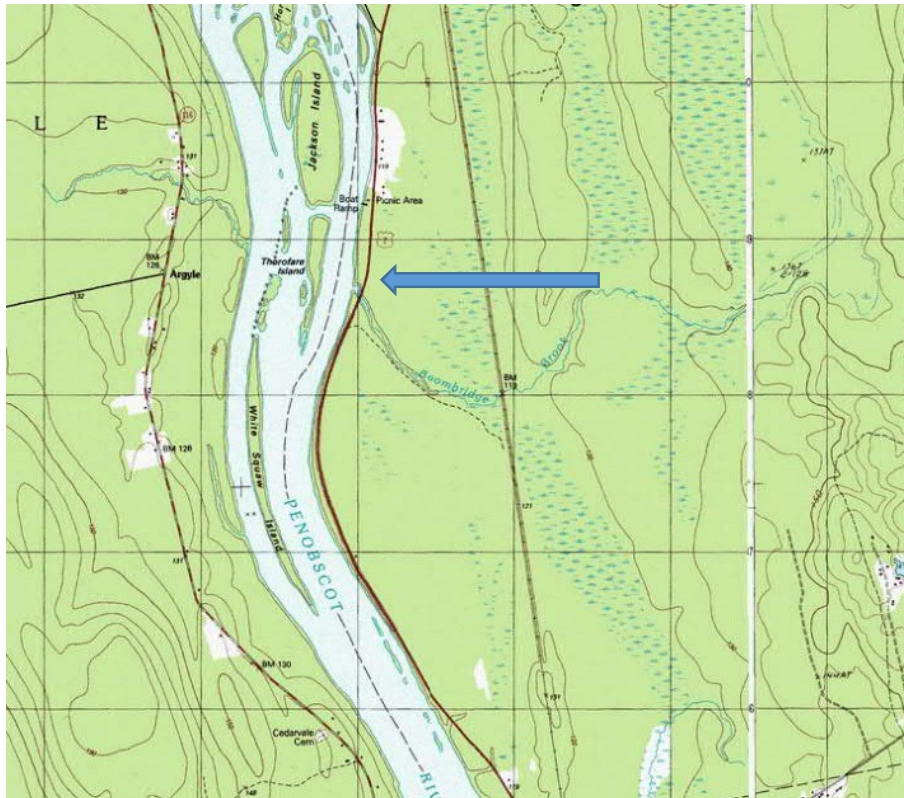
Figure 1. Boombridge Brook Bridge, Greenbush

This report details work on hydrologic and hydraulic evaluation of Bridge #3587 for the replacement of Route 2 over Boombridge Brook in Greenbush, Maine. The work was prepared for CLD as part of their preliminary design work for the Maine DOT on a replacement bridge. Figure 1 is the topographic map of the project site.

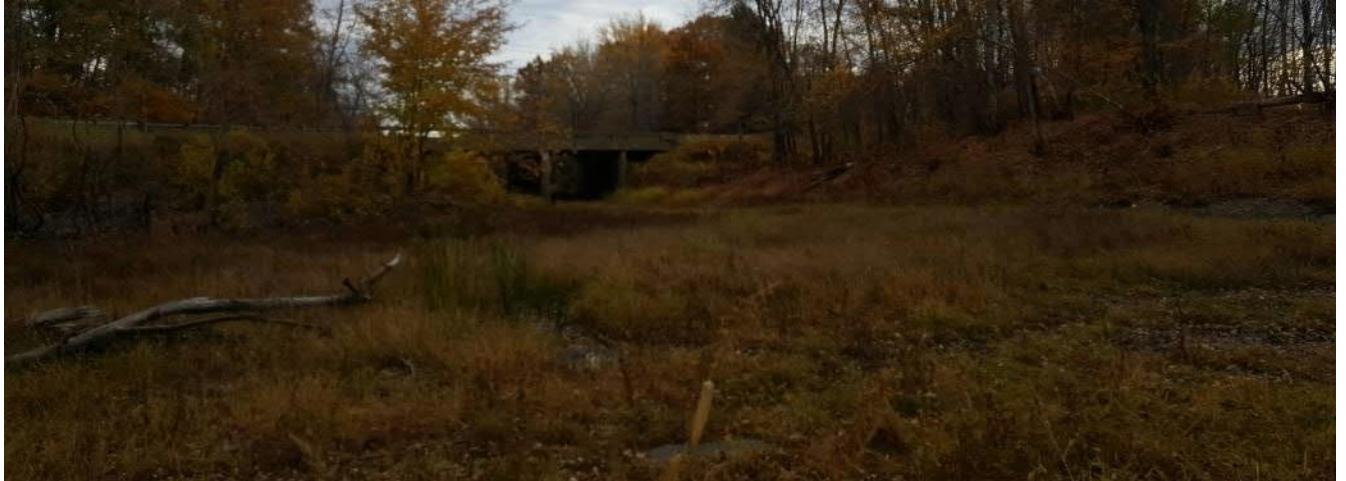
*Figure 2. Boombridge from downstream at Penobscot River*

The bridge is located just upstream of the confluence of Boombridge Brook with the Penobscot River. The bridge and surrounding area is shown in figures 2-5. The bridge is subject to backwater flooding from the Penobscot River during high water events on the river. A large low swamp or wetland area upstream of the bridge serves as floodplain storage for floodwaters from the river. Flow at the bridge is influenced by runoff from the upstream watershed and backflow/return flow from the Penobscot River during high water.

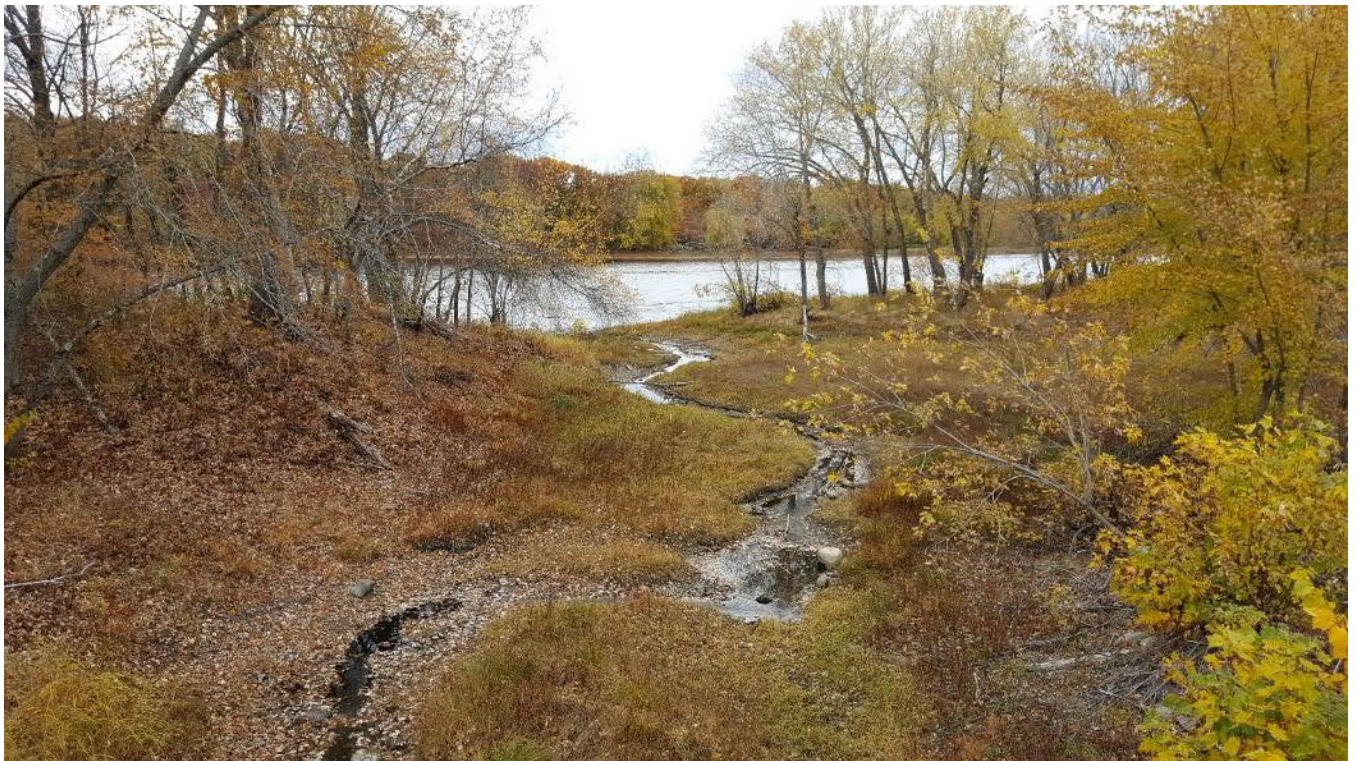
*Figure 3. Looking downstream at Penobscot River from bridge. Photo taken during fall 2016 drought.*

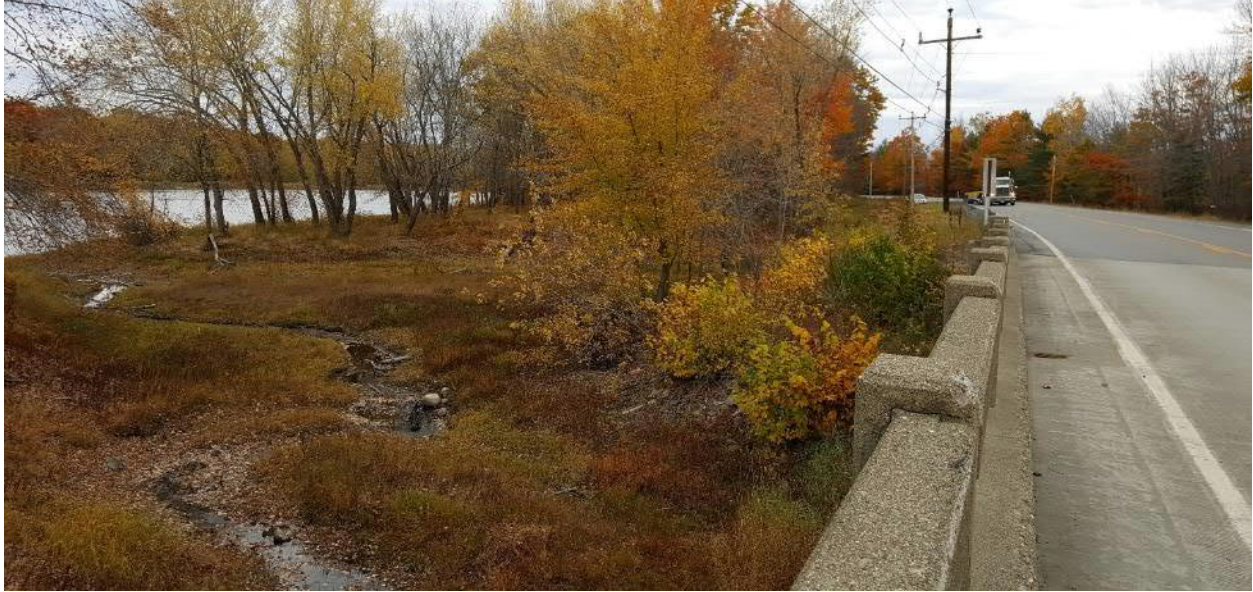
*Figure 4. Penobscot River from Bridge, facing north.*

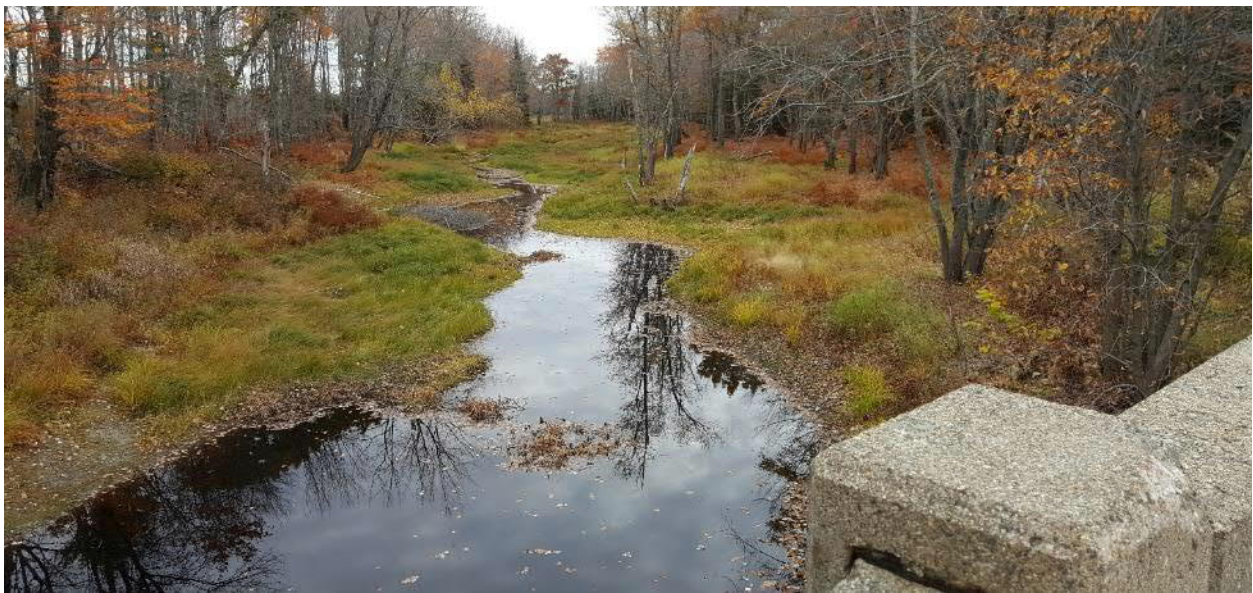
*Figure 5. Looking upstream from Bridge.*

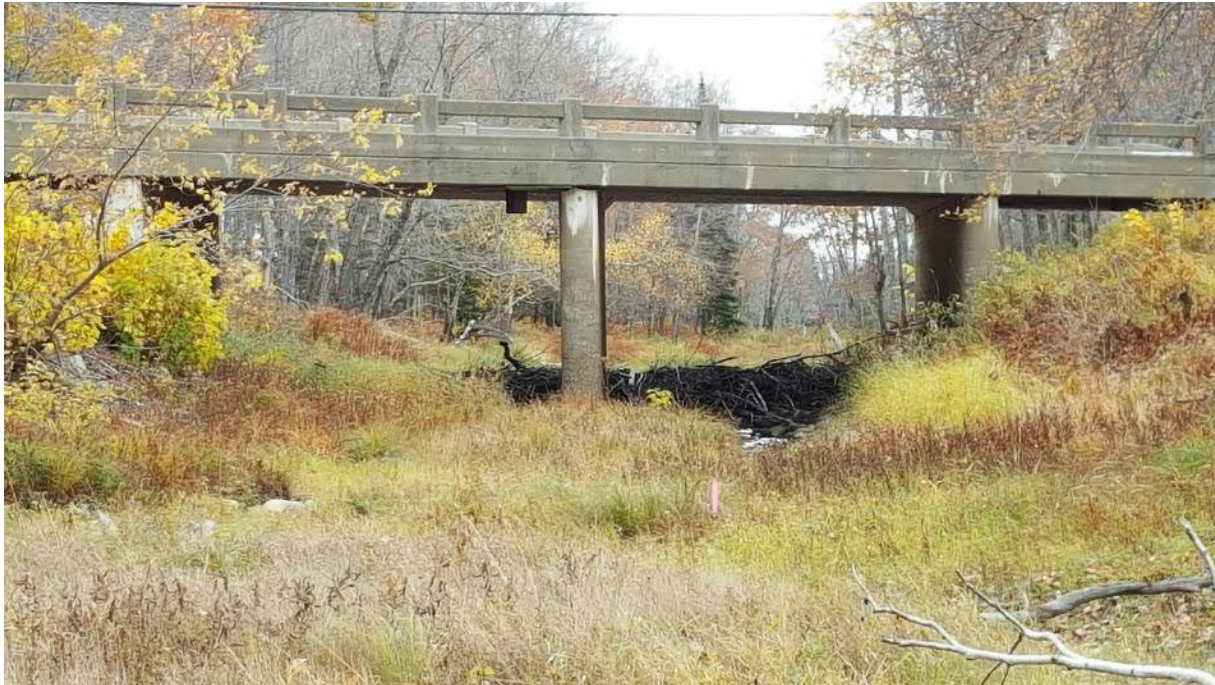
Figure 9. Boom Bridge from downstream

The existing bridge piers are aligned with the stream flow, but are not perpendicular to the road. The abutments and piers are skewed to the road but not to flow. The bridge has two piers with the center channel being deepest and the two side areas being less deep. Figure 9 is a photo of the bridge from downstream during very low water in October of 2016. The upstream side of the bridge has some blockage due to a beaver dam and is shown in figure 10.

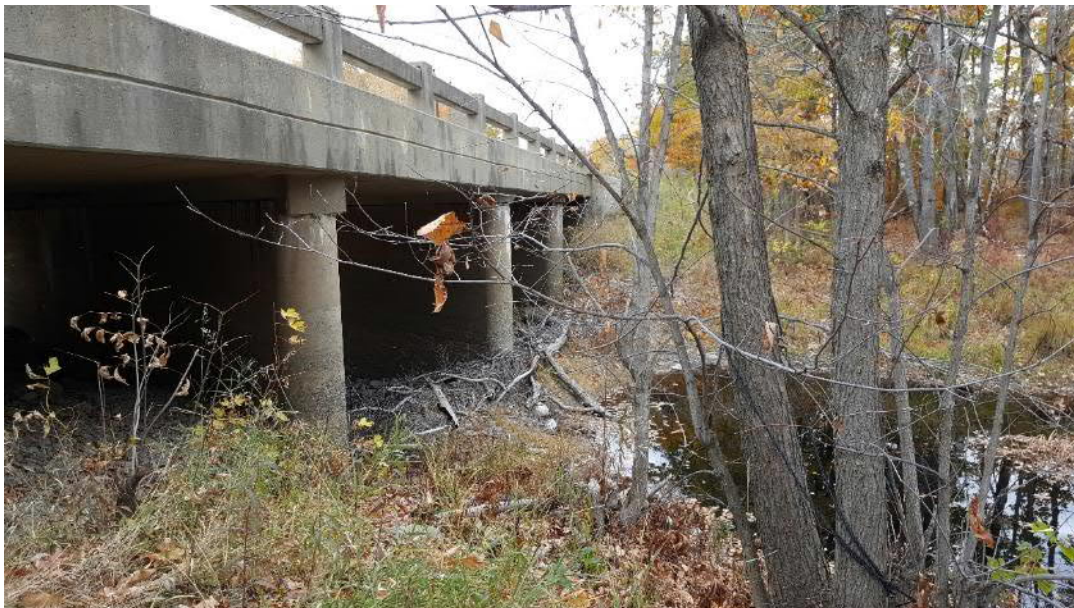
Figure 10. Upstream face of bridge from south side.

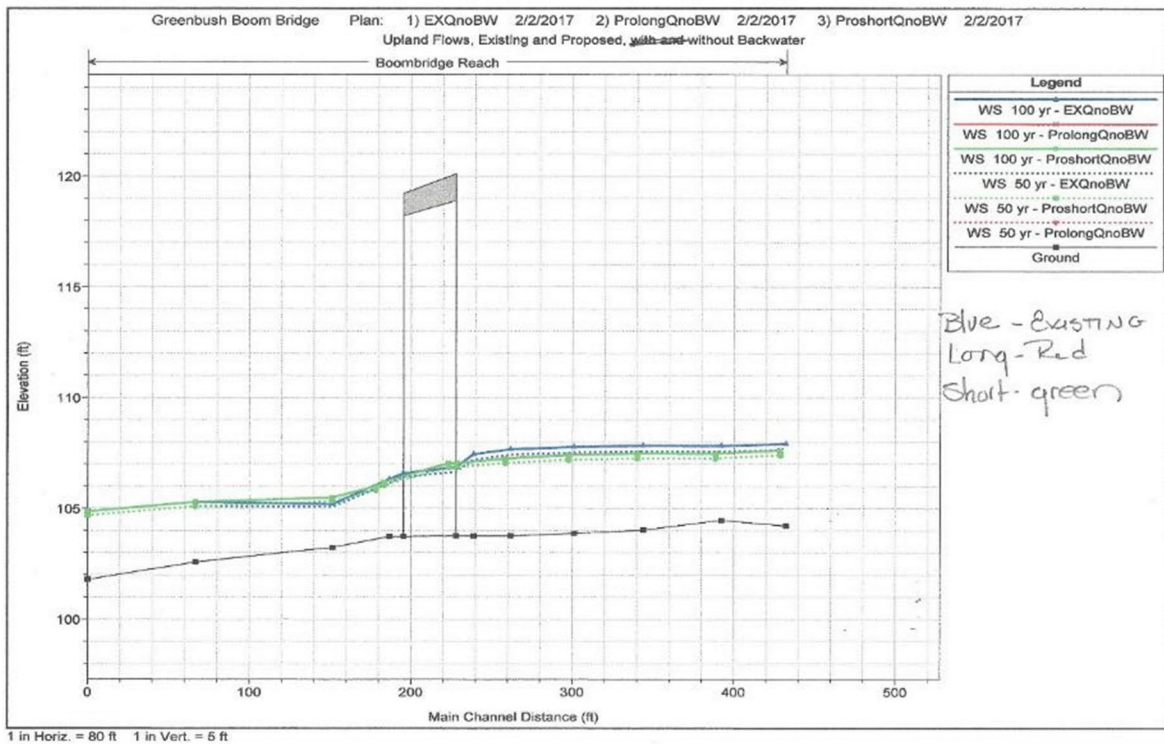
Figure 14. Flood profiles for existing and long and short options without backwater, 50- and 100-year profiles.

Rating curves for each bridge option for upland flows were developed using model HECRAS. Figure 13 shows flow vs elevation for selected flow rates at each bridge option under conditions of no backwater on river and backwater on river. Figure 14 and 15 show water surface elevation profiles through the bridge for each bridge option under no backwater and backwater conditions for predicted upland runoff rates.

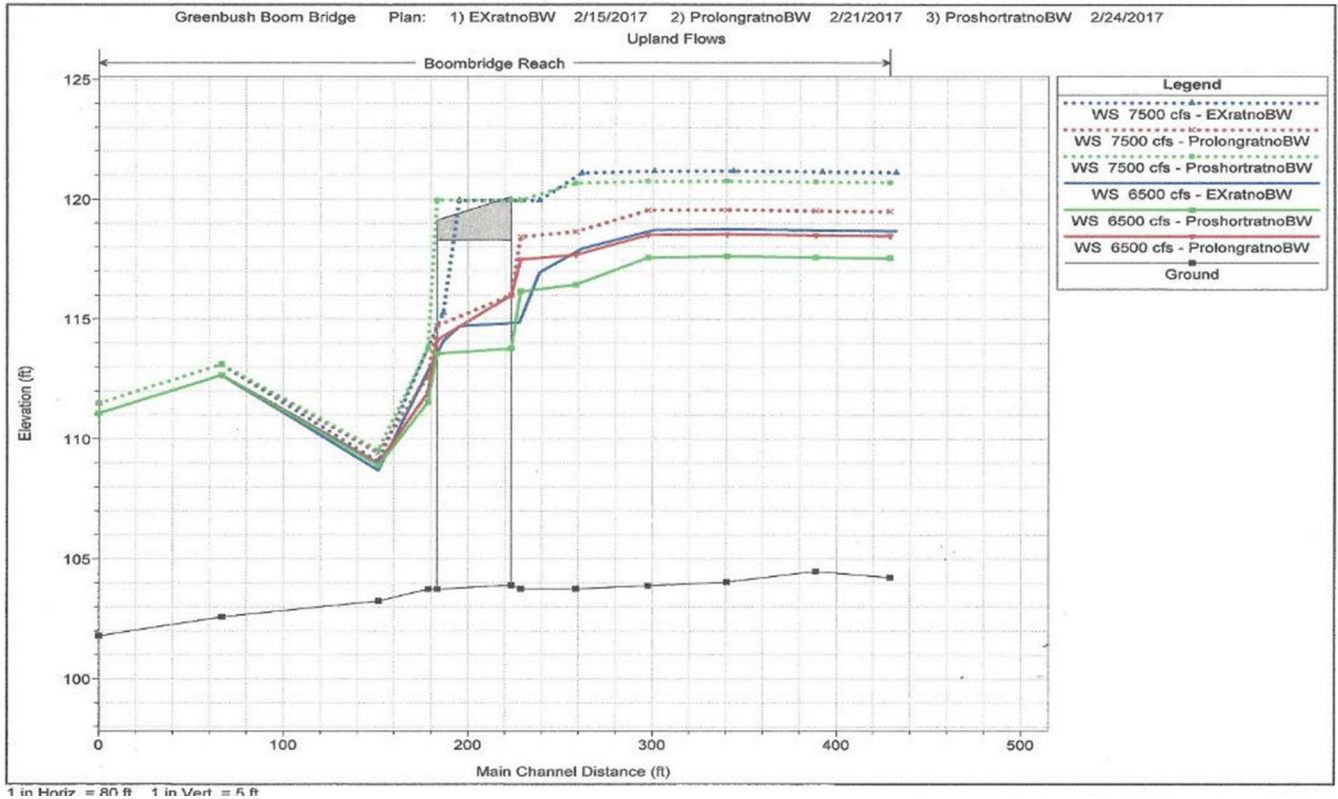
Figure 17. High return flow for existing, short and long span options. 6500 and 7500 cfs without backwater.

Figure 16 shows bridge rating curves for a wide range of flows assuming backflow from the Penobscot River. The plot shows rating curves for existing and long and short options, assuming that return flow happens under backwater conditions, and no backwater conditions. Flow profiles for selected high flows representing worst case backflow rates are shown in figures 17 and 18.

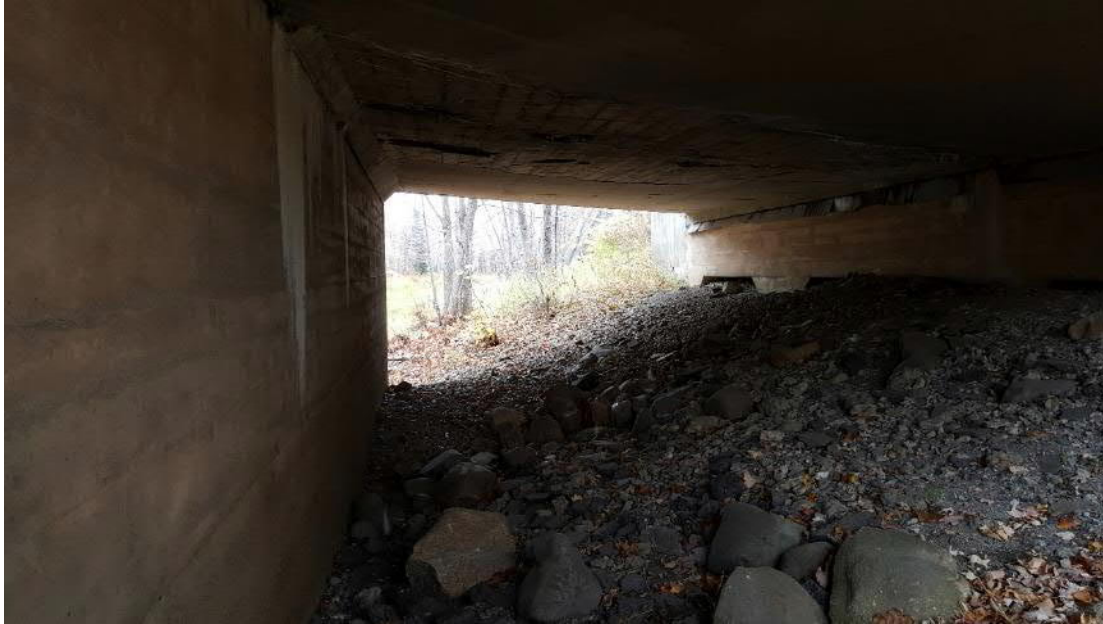
*Figure 19. South channel of bridge (looking upstream). Note large rocks and erosion near pier.*

Site evidence indicates rapid flow through the bridge. The three channels under the bridge appear to have ongoing scour holes near piers and show sorting of bed material with largest material remaining in the channel and finer material being washed away.

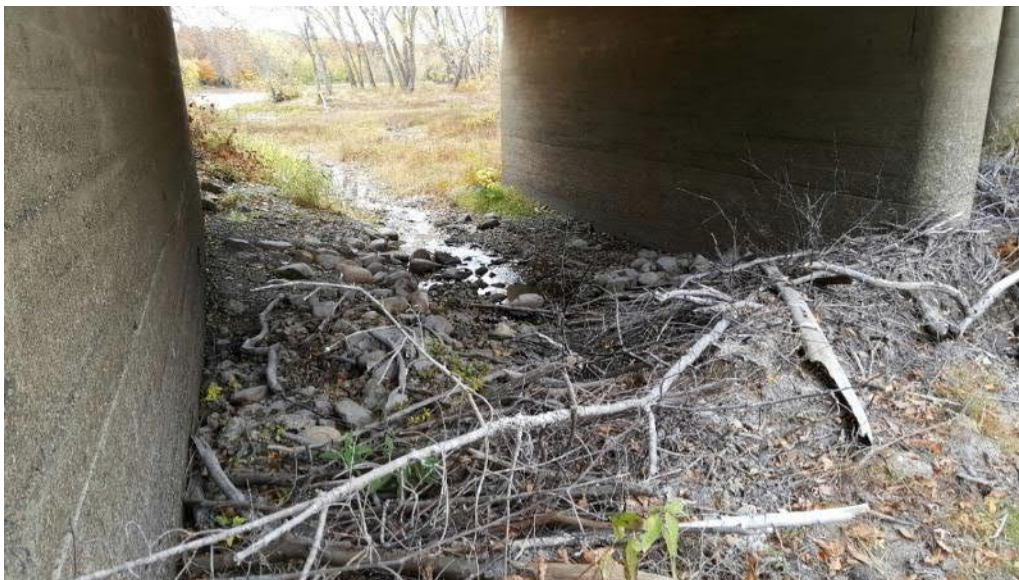
*Figure 20. Center channel of existing bridge looking downstream from beaver dam. Note large stones in channel and erosion near piers.*

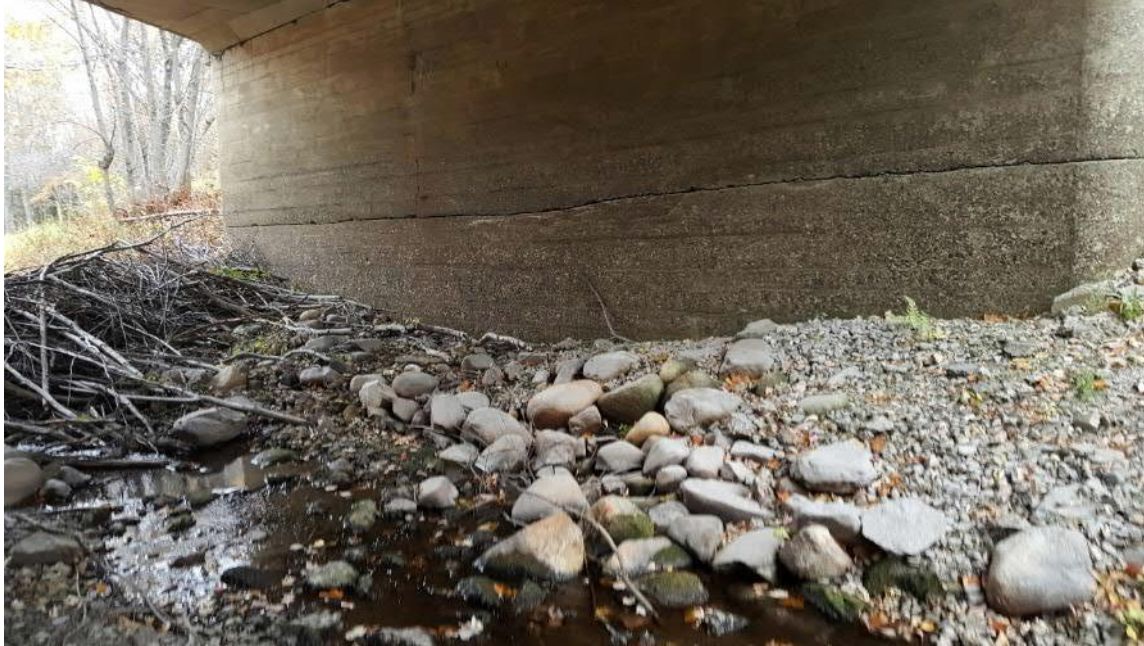
Figure 21. Center channel. Note scour hole along center of pier.

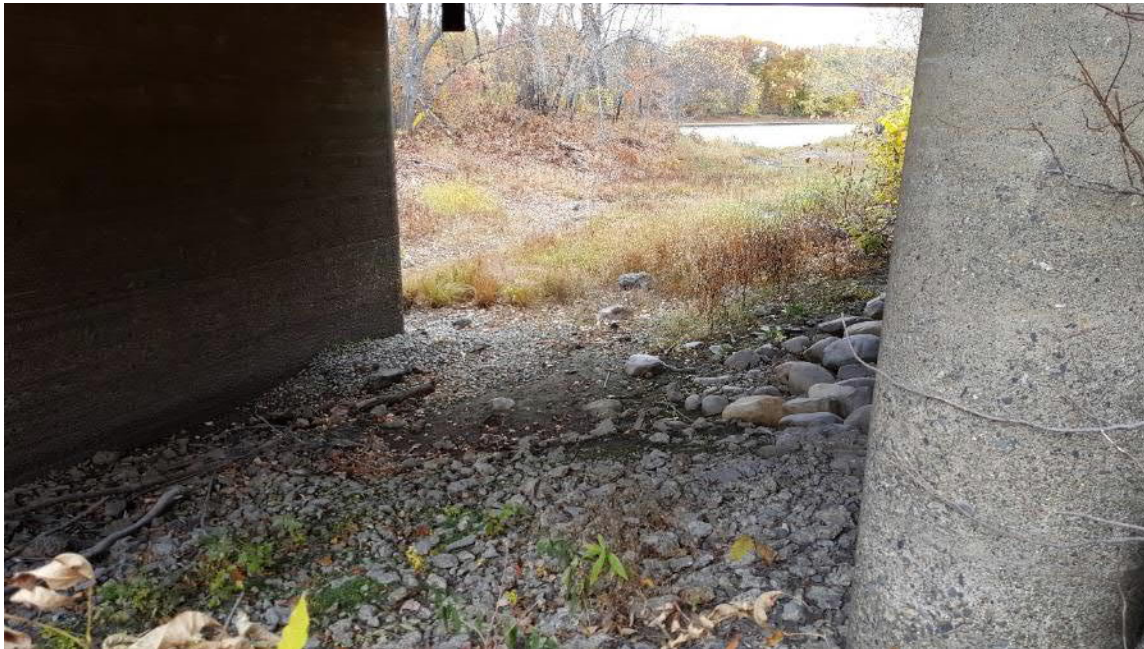
Figure 22. Center channel. Note large stones and scour along pier.
