HYDROLOGY REPORT

HYDRAULIC REPORT

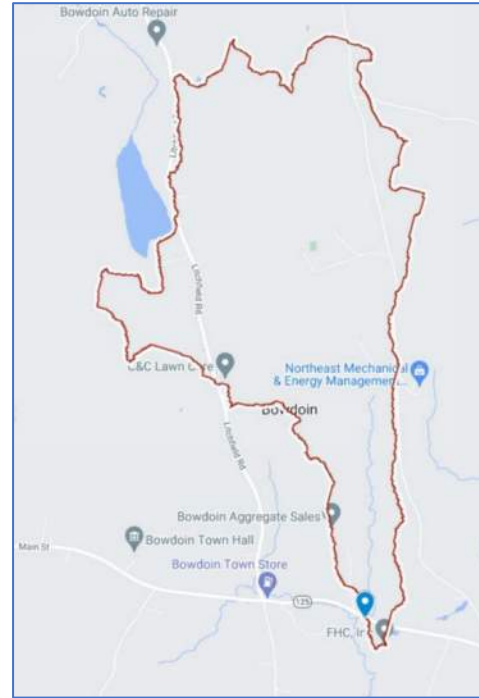
Figure 3 - West Cathance Stream Watershed

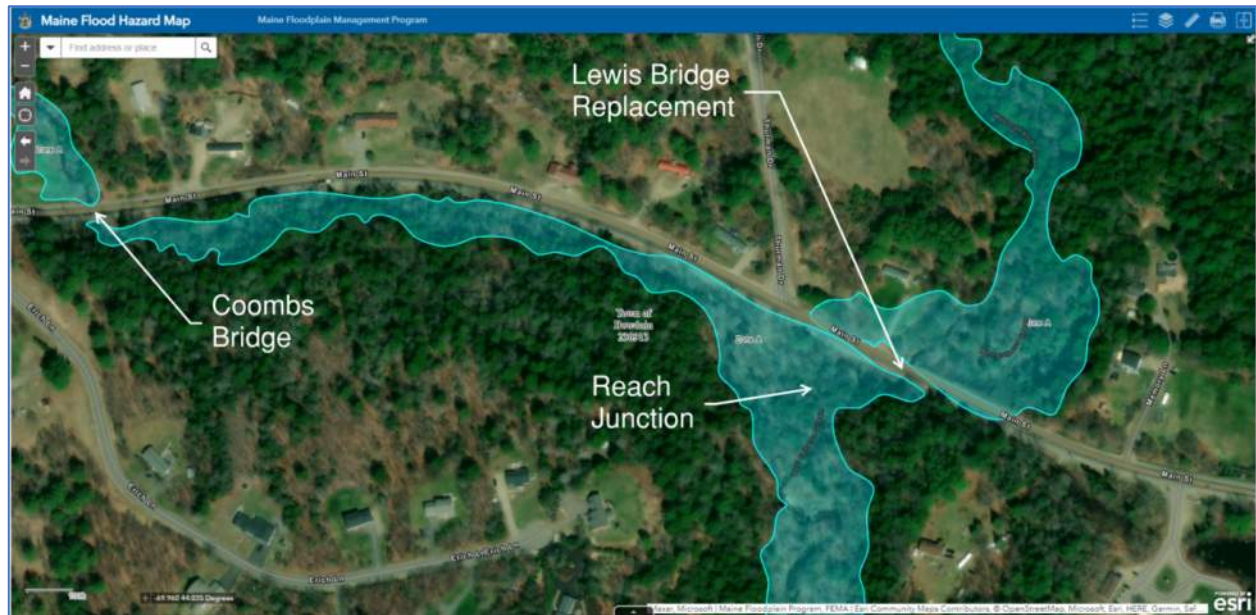
The FEMA Flood Insurance Study (FIS) that covers the Town of Bowdoin, Maine was published July 16, 2015, and is a comprehensive report covering many communities in Sagadahoc County. FEMA and the Maine Flood Hazard Map indicate that both Lewis Bridge and Coombs Bridge are in a Zone A floodplain, which is a “Special Flood Hazard Area” without Base Flood Elevation (BFE). The FIS states that the Zone A limits were developed for a 1-percent-annual-chance

Figure 4 - Maine Flood Hazard Map

floodplain using approximate methods. See Figure 4.

2. As discussed previously, the bridge inspection report rating and description of waterway adequacy is “6 – Occasional Overtopping of Approaches – Insignificant Delays”. This appears generally consistent with the Flood Hazard map shown in Figure 4. The existing conditions model results appear generally consistent with both of these since it indicates that flows of Q50 and greater overtop the low point on the west roadway approach with the following approximate depths (see Figure 12):

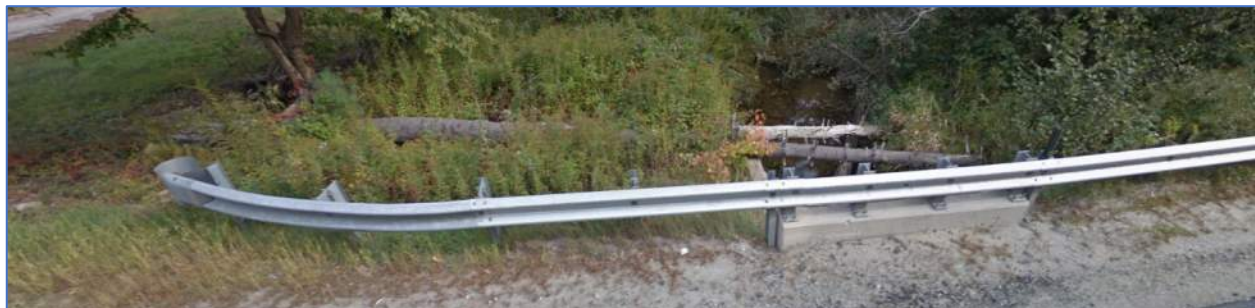
There is no information from abutters or town officials regarding flooding at the project site. However, Google Street View imagery shows fallen trees carried by floodwaters on top of the inlet’s west wingwall. See Figures 5 & 6.

Figure 5 - Fallen Trees on Top of Inlet Wingwall (Google Streetview image captured Sept 2016)

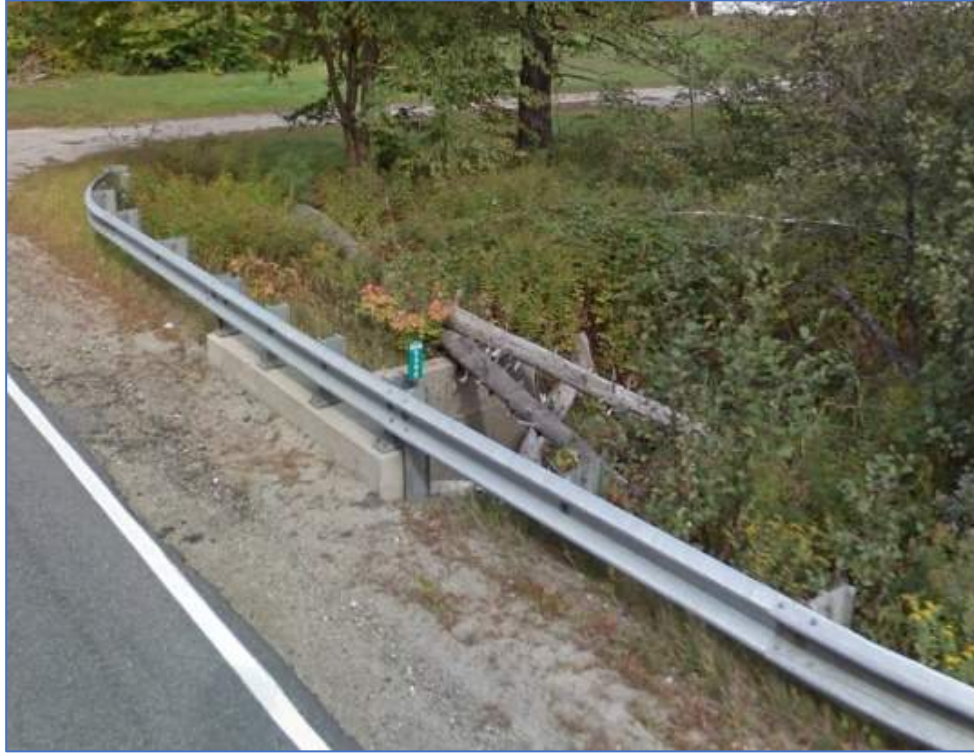
Figure 6 - Fallen Trees on Top of Inlet Wingwall (Google Streetview image captured Sept 2016)

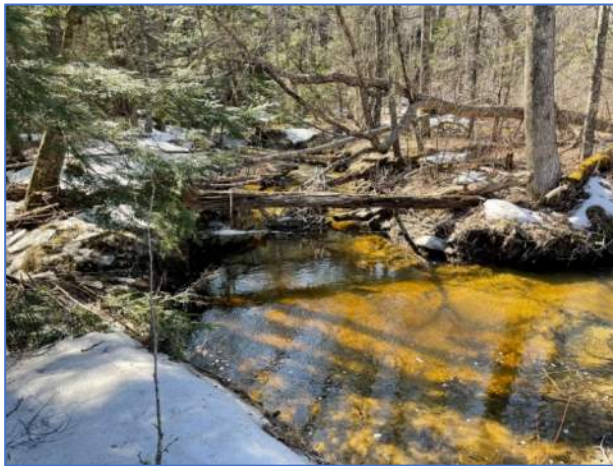
Site observations and Google Street View imagery indicates numerous fallen trees being transported in West Cathance Stream during high flows. Fallen trees with diameters of up to 12” to 14” were observed within the stream channel, spanning the channel, and along the streambanks. (See Figures 7 to 9).

Figure 7 – Fallen Trees Across West Cathance Stream Channel (looking downstream toward stream junction)

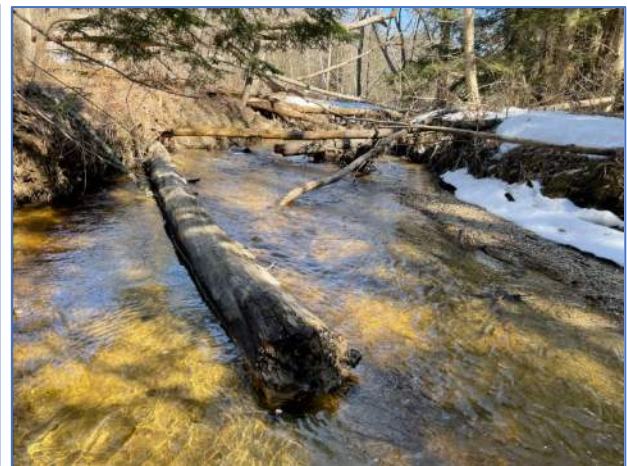
Figure 8 - Fallen Trees Across and Within West Cathance Stream Channel (looking upstream from stream junction)

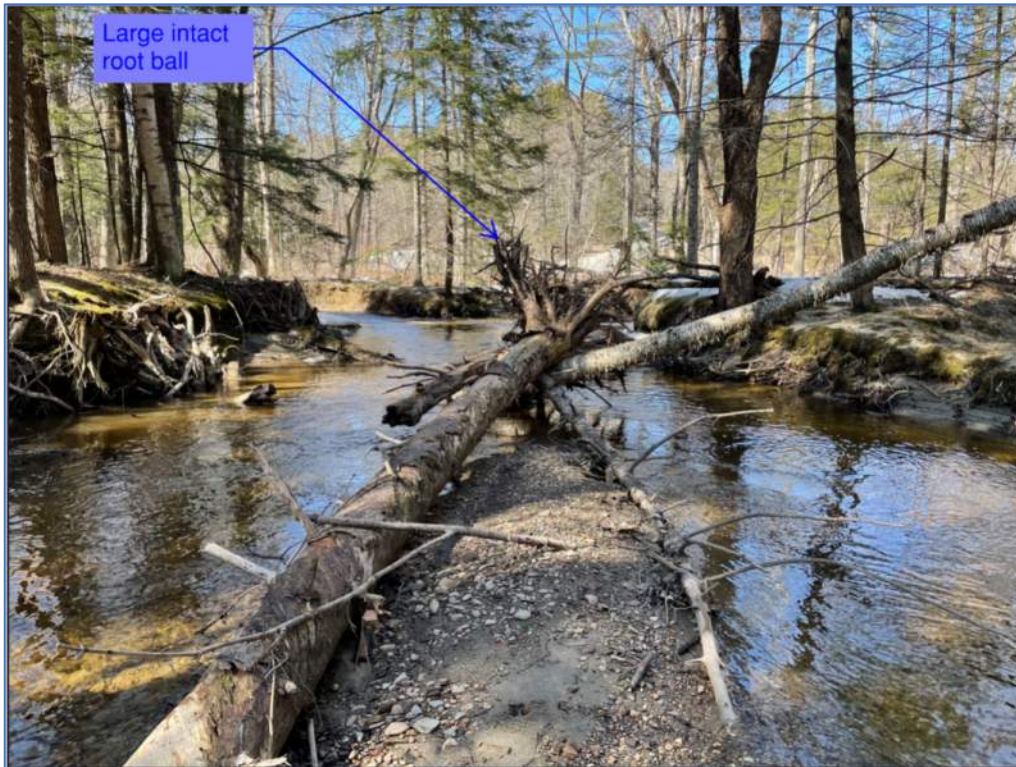
Figure 9 - Fallen Trees in West Cathance Stream Channel (looking upstream at stream junction)

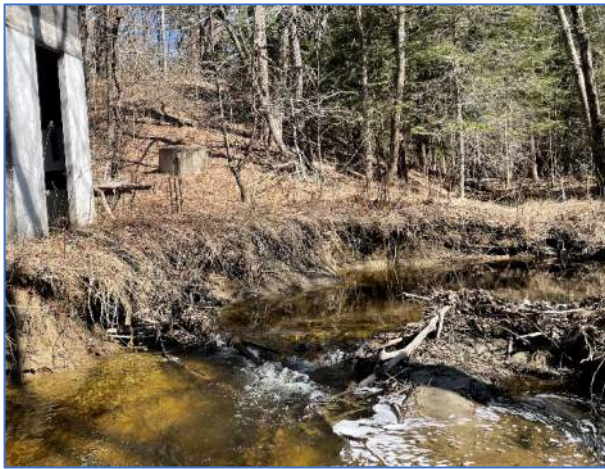
Figure 10 - Looking Upstream at Beaver Dam 2

As can be seen in Figure 10, there is an 8.5-ft wide square outbuilding on the bank of the stream adjacent to Beaver Dam 2. Due to its relatively small size in comparison to the FEMA Zone A floodplain area, the effects from this outbuilding were not considered in the hydraulic model. A private residence located approximately 180-ft north of Lewis Bridge was also excluded from the model since it is outside the FEMA Zone A floodplain area, and its lowest surveyed elevation is El. 136.63, which is nearly 9-ft higher than the existing Lewis Bridge top of curb/headwall.

Ground survey contained data for two small beaver dams spanning the channel upstream of Lewis Bridge near reach station (RS) 303+83 (Beaver Dam 1) and RS 304+87 (Beaver Dam 2). Beaver Dam 1 is closest to Lewis Bridge and was partially washed out with dam remnants occupying slightly more than 1/2 the channel width on the left side of the river (instead of the full channel width shown in the survey file and Inspection Report photos). Beaver Dam 2 was in relatively poor condition. Large key logs were not visible and the dam looked old. There was no evidence of recent beaver activity (newly harvested branches, felled trees, or stumps), so both dams are expected to continue deteriorating unless beaver activity resumes to rebuild them. Based on likely continued deterioration, and since the beaver dams are upstream of Lewis Bridge, they were not included in the hydraulic model.

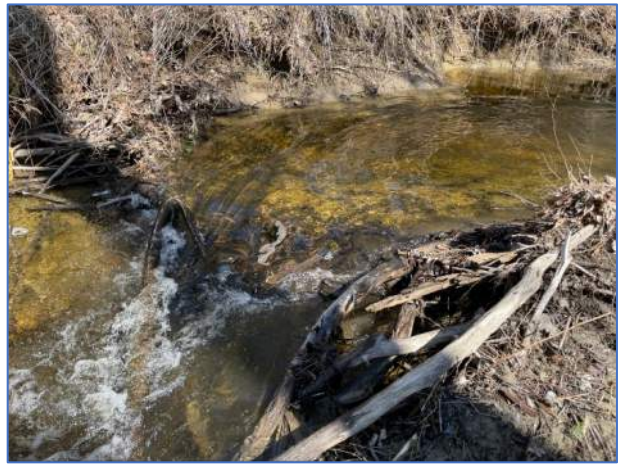
Figure 11 - Beaver Dam 2 in Poor Condition w Low Stability

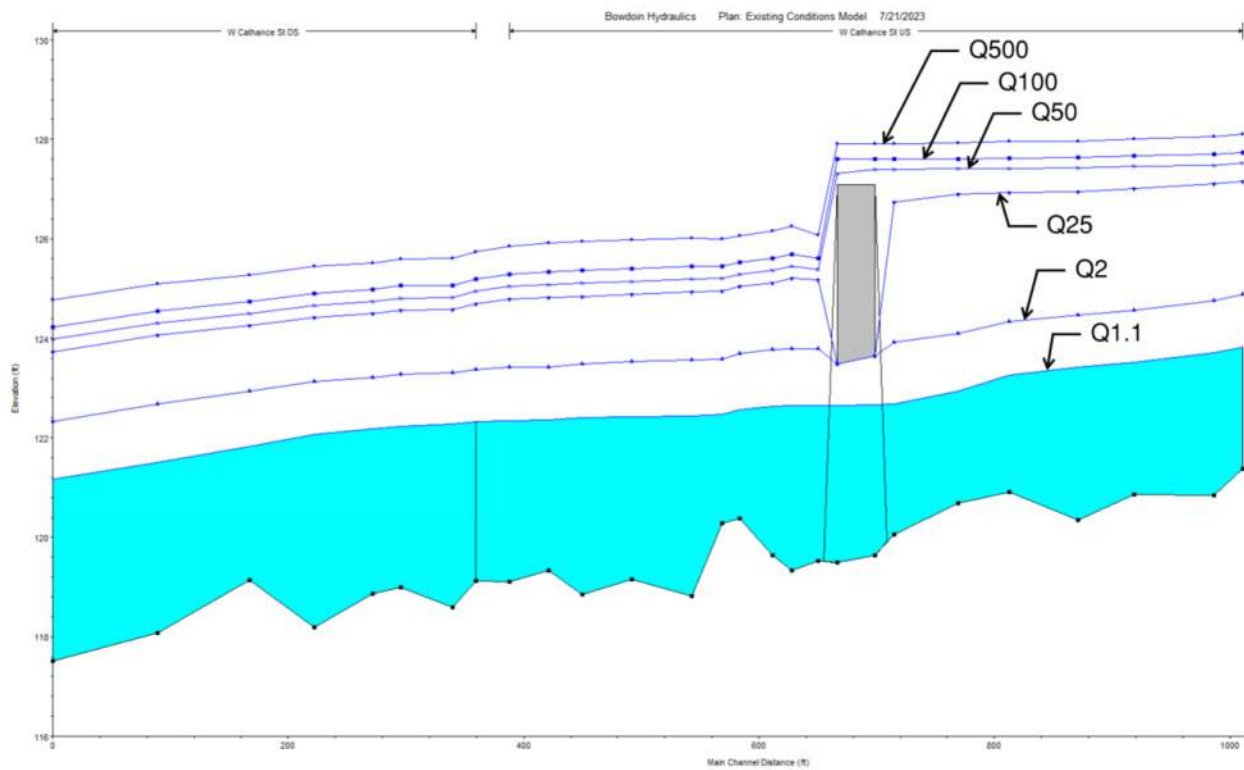
Results from the existing conditions model indicate that the box culvert is submerged for Q2 and larger flows with roadway overtopping likely occurring for Q50 and larger flows. See Figure 12.

Figure 12 – Existing Conditions Model Water Surface Profiles for West Cathance Stream

- a. 0.3 ft for Q50
 - b. 0.5 ft for Q100
 - c. 0.8 ft for Q500

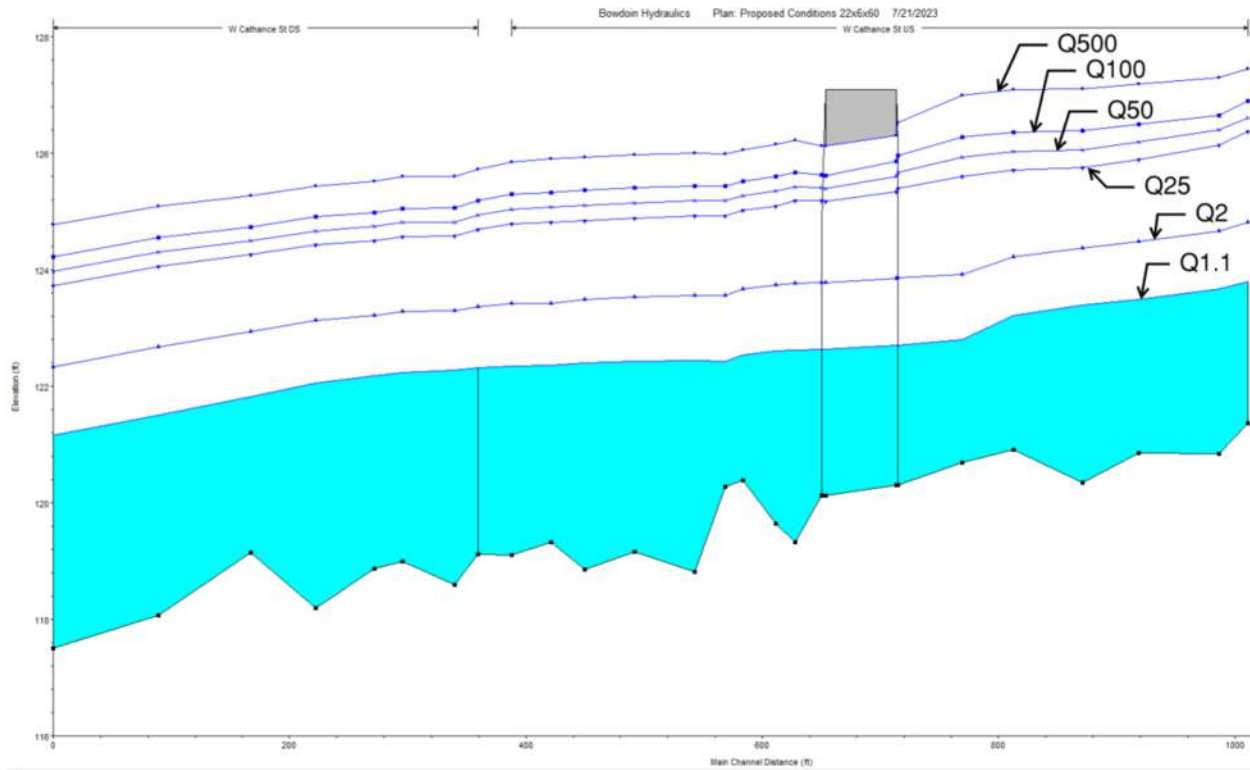
With a span of 22'-0", the proposed box culvert has a hydraulic opening of over 117 square feet, which is almost three times larger than the existing hydraulic opening of 40 square feet. It is expected to pass all flows up to and including the 500-year return period flow, thus reducing the expected frequency of roadway approach inundation. See Figure 13.

Figure 13 – Proposed Conditions Model Water Surface Profiles for West Cathance Stream

1. For Q1.1 and Q2, the proposed conditions water surface elevations upstream of Lewis Bridge are very similar to the existing conditions.
2. For Q5 to Q500, the water surface elevations for the proposed conditions upstream of Lewis Bridge are improved compared to existing. See Table 2 for details.
3. No changes are expected in the water surface elevations downstream of the proposed culvert.
