Preliminary Design Report

Spring Brook Bridge #2794

Camden, Maine

WIN 022608.00

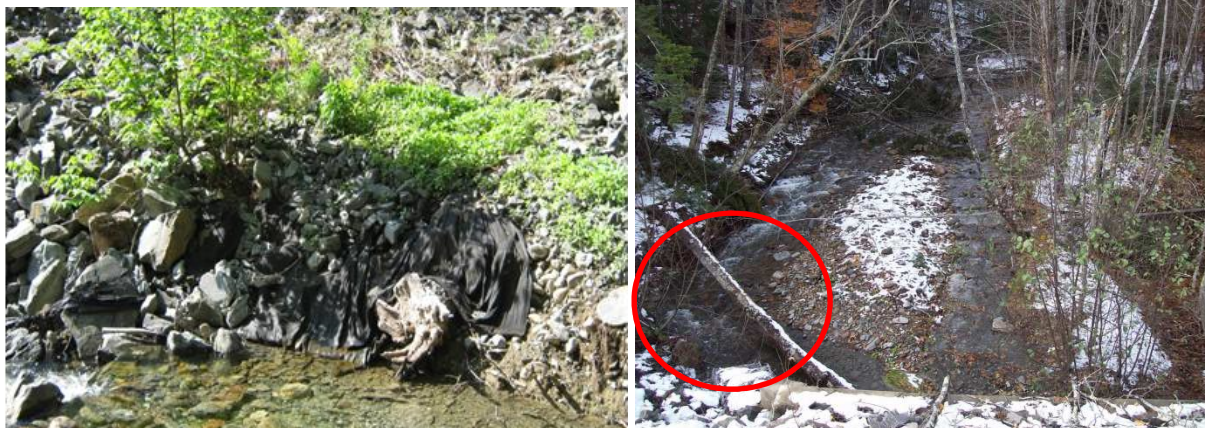
Figure 1 Upstream Bank Erosion due to Aggradation and Stream Diversion

Figure 2 Bird's eye view of upstream showing the sand bar that was built by the sediment dump. The red circle in the lower left hand corner highlights where the upstream river right bank has eroded.

There are also scour issues upstream of the culvert due to the slope change from stream to the culvert. The right river channel banks are eroding and the erosion is beginning to move behind the wingwalls, which can be seen in Figure 1. The erosion is also apparent by the gabions that are slowly moving away from the banks. Figure 2 shows the sand bar in the middle of the channel. Figures 3 and 4 show the surveys from December 1932 and September 2012 respectively. The culvert that was built in 1918 and extended upstream in 1933 to reconstruct the road upstream. From the surveys, it is clear the upstream channel has widened since the culvert was extended.

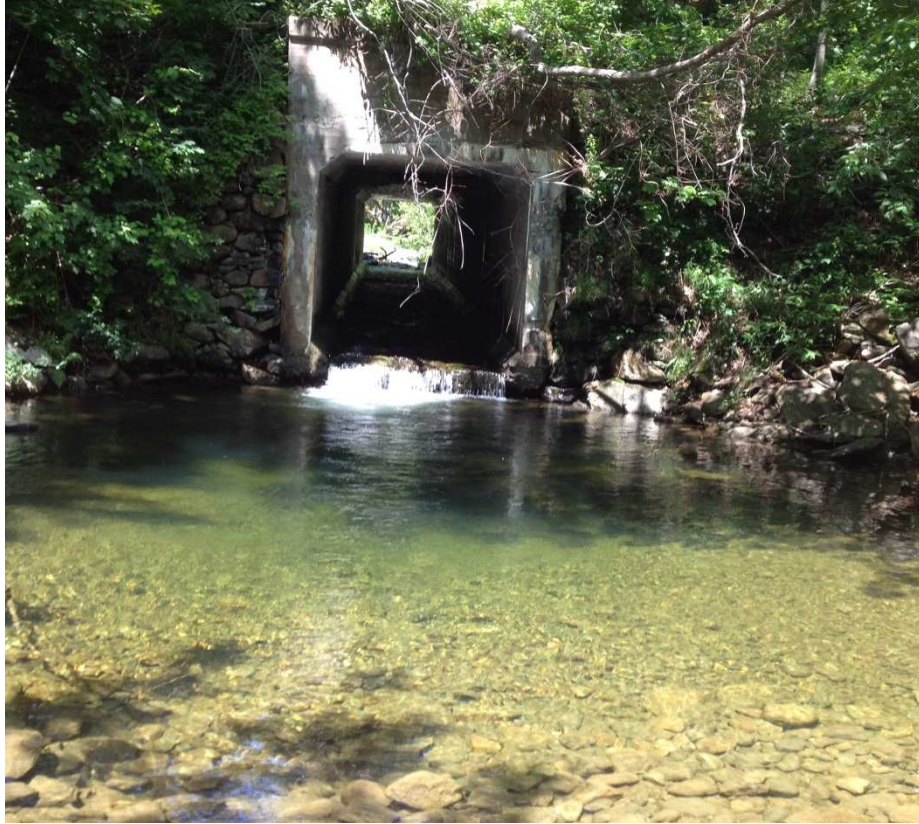
Scour hole looking from downstream (June 30, 2015)

GENERAL CONDITION: The structure is in poor condition. The downstream end of the box culvert is hanging and is severely undermined and flows into a deep scour hole. There are significant amounts of exposed rebar at the box culvert floor. There are also two large spalls at the downstream end.

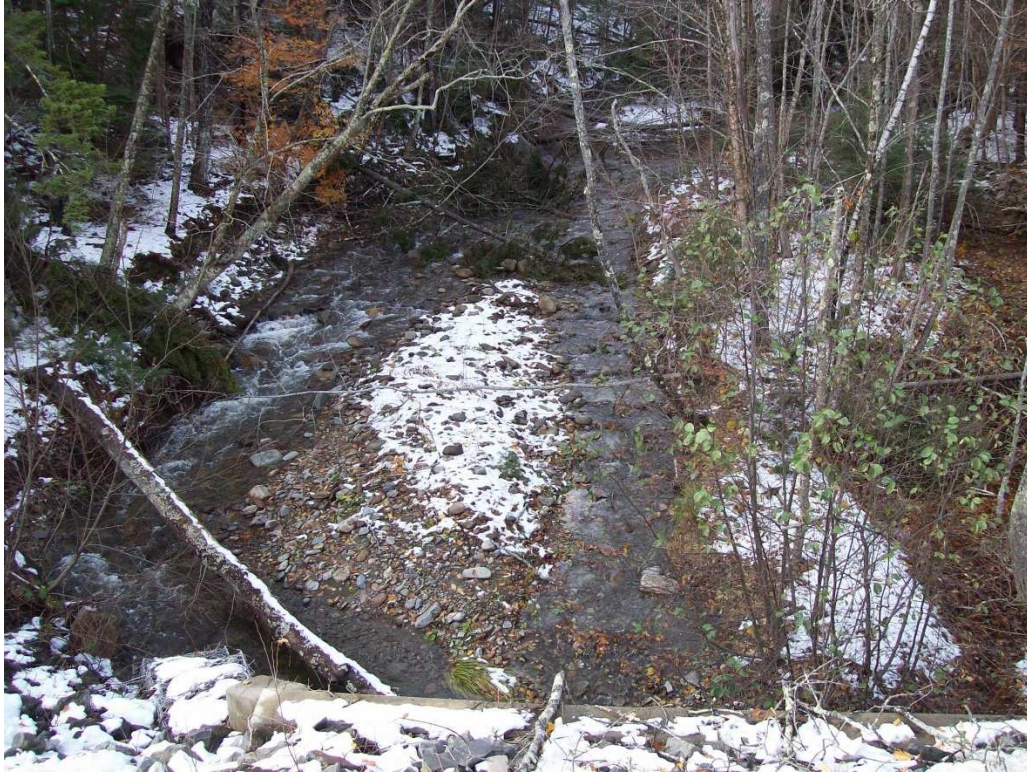
Bird's eye view of upstream showing sandbar (November 5, 2014)

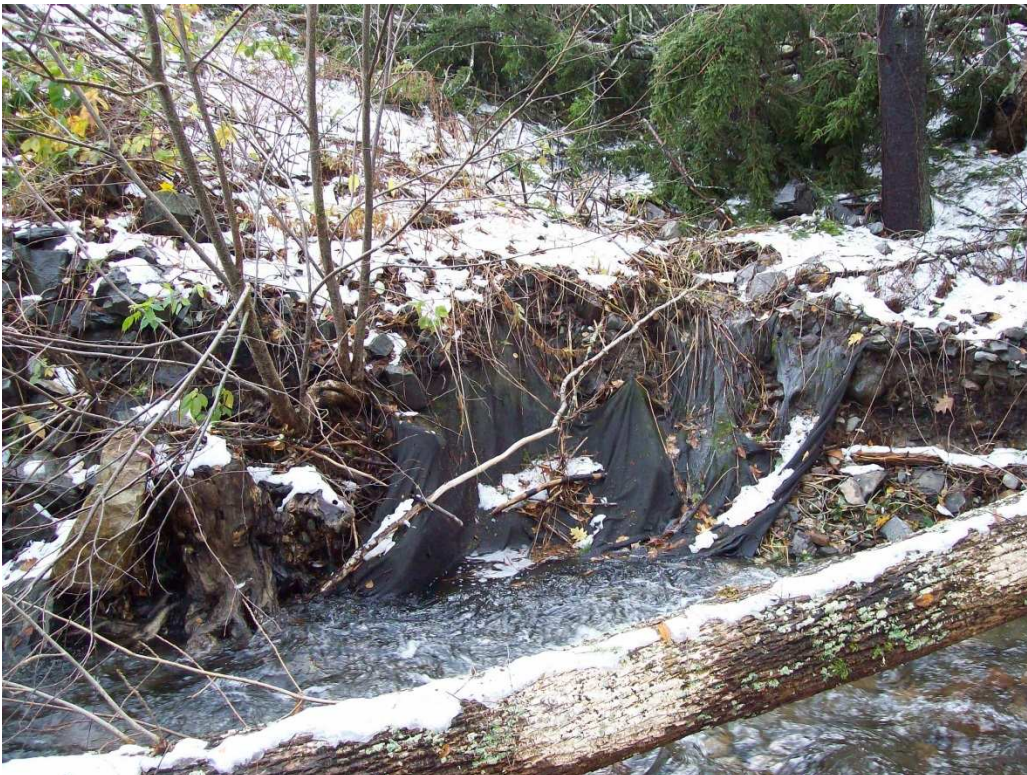
Upstream view erosion of river right channel bank (November 5, 2014)

OTHER COMMENTS: There is a large amount of bank erosion upstream along the right bank leading up to the gabion wall with a 5-6 foot cut at the corner. The upstream half of the culvert that was built in 1933 is in fair condition and has very little deterioration

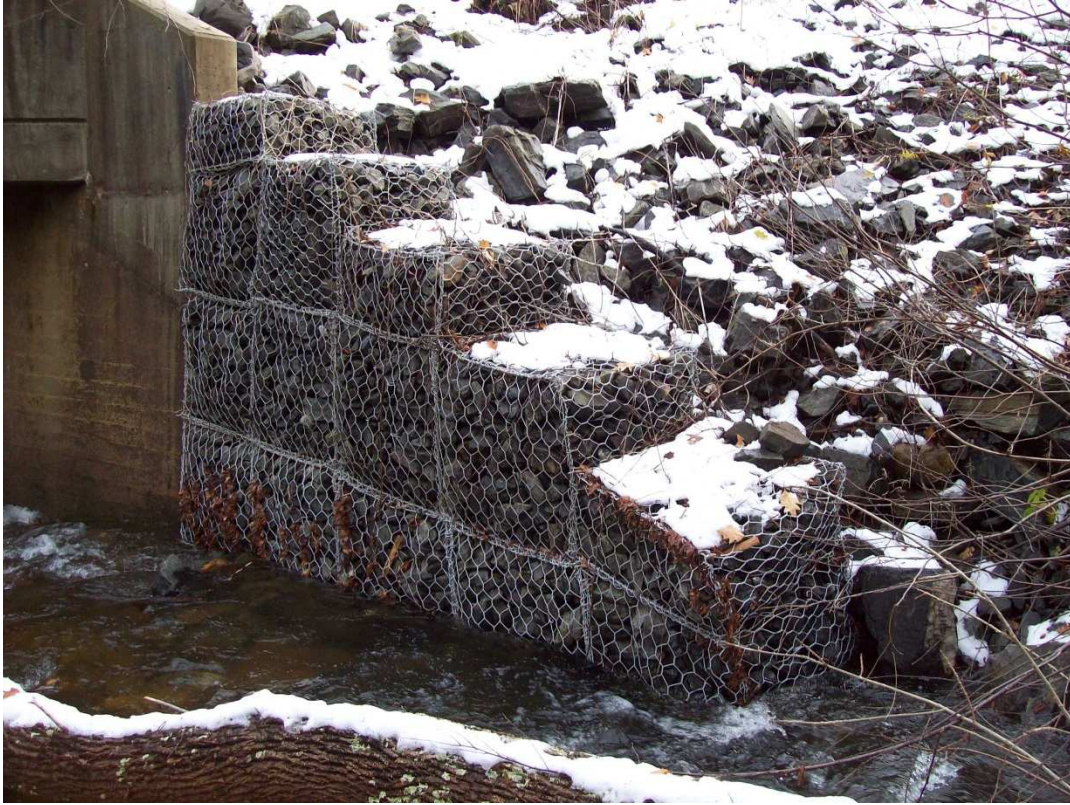
Upstream gabions that are leaning in towards the stream (November 5, 2014)

MAINTENANCE PROBLEMS: Erosion on culvert and streambed due to high stream velocity, concrete spalling, exposed rebar, slanted gabion wall.

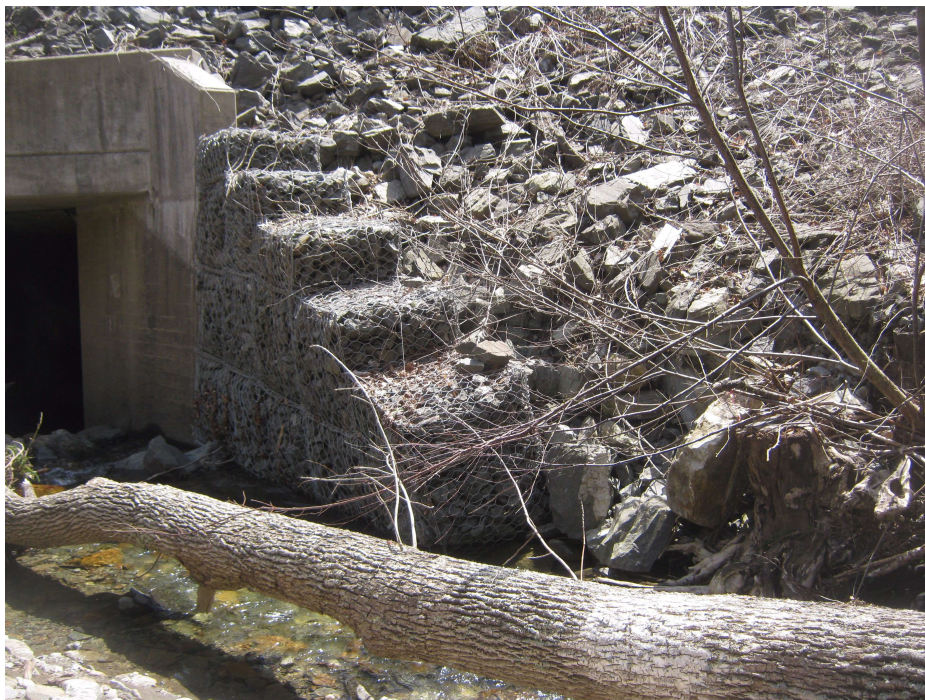
PHOTO 3

Description View showing log against US gabion baskets and erosion behind end of wall

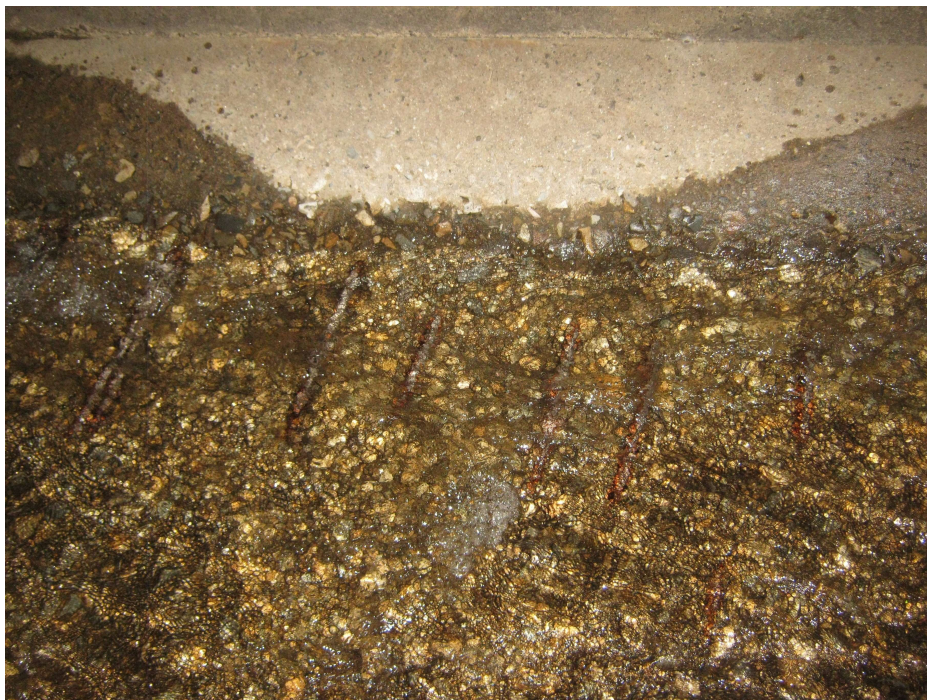
PHOTO 5

Description View showing heavy scaling of floor with exposed rebar

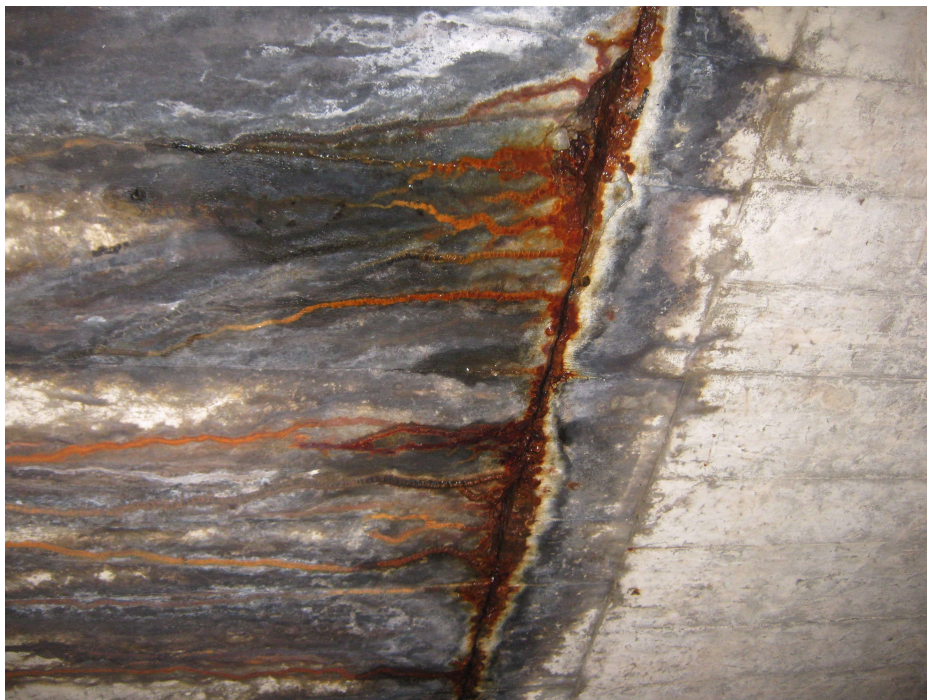
PHOTO 6

Description View showing rust leakage and efflo at center joint

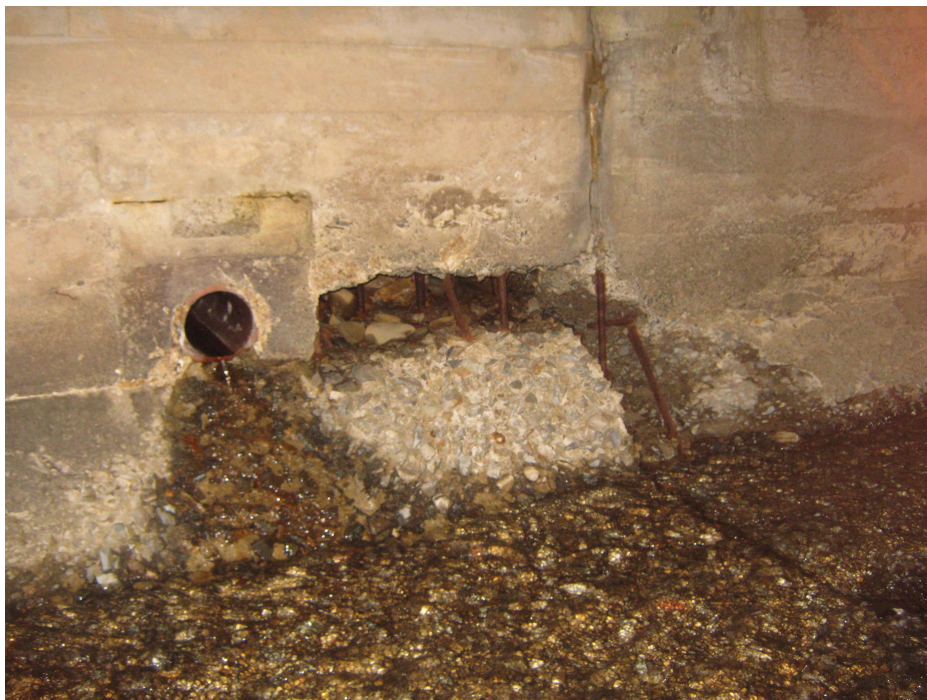
PHOTO 7

Description View showing hole with exposed rebar in wall

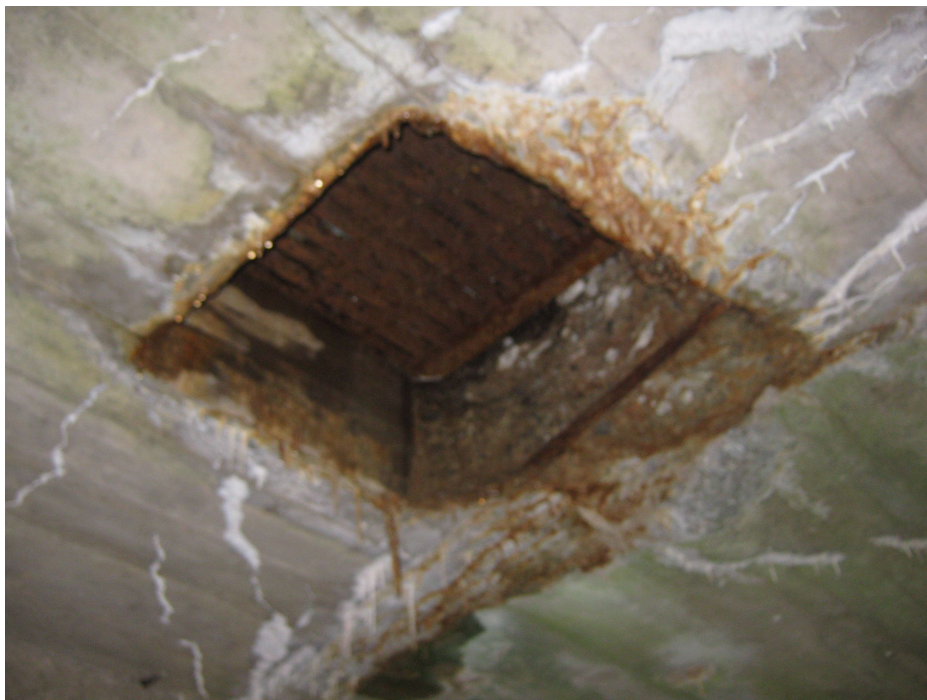
PHOTO 8

Description View showing spalling cracking and efflo at drain

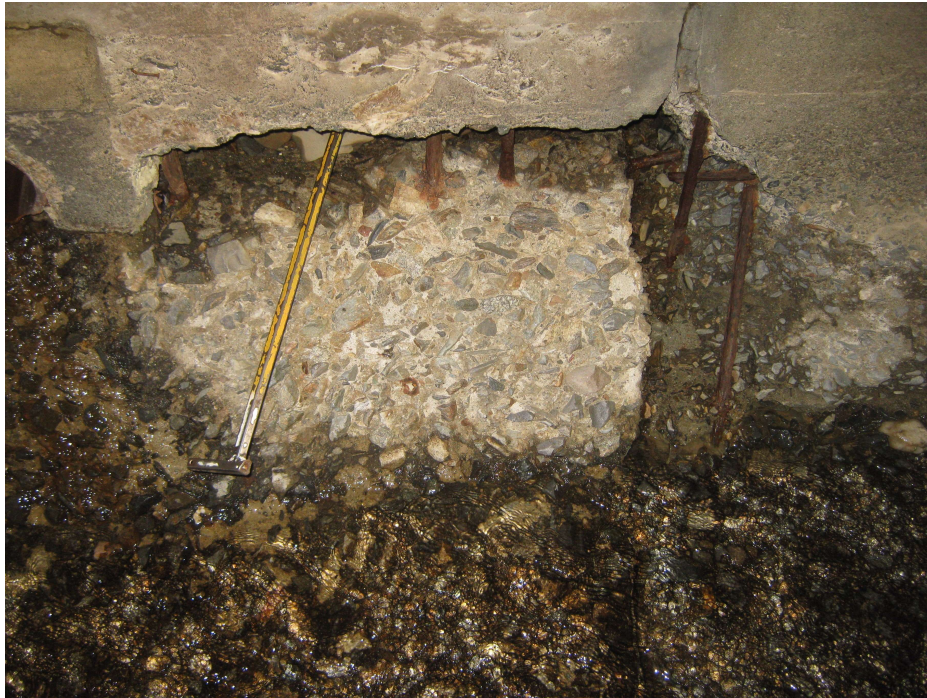
PHOTO 9

Description View showing hole with exposed rebar in wall

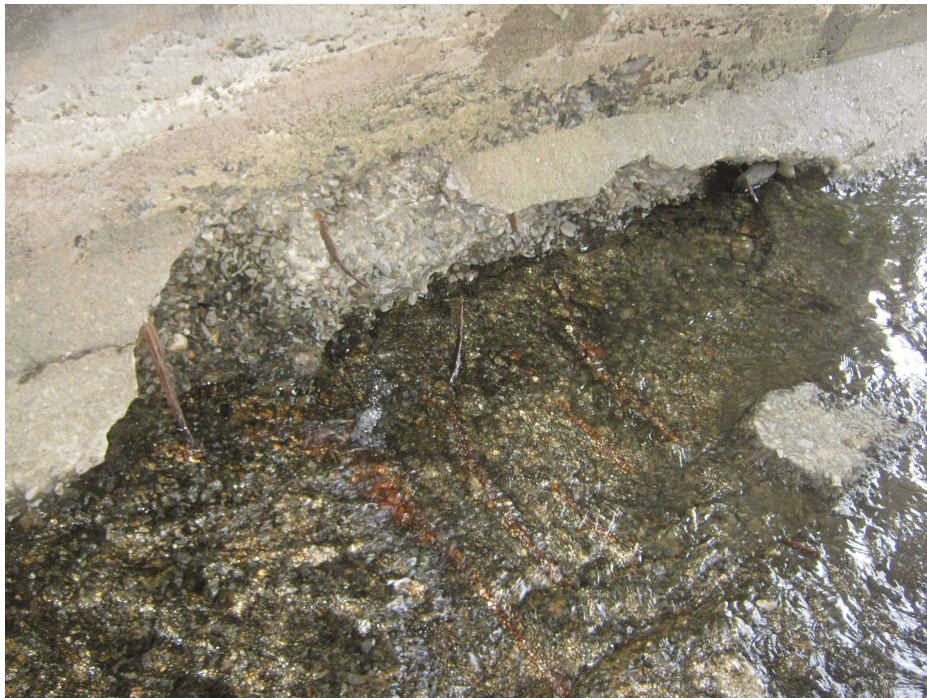
PHOTO 10

Description View showing large spall at DS end of floor/wall

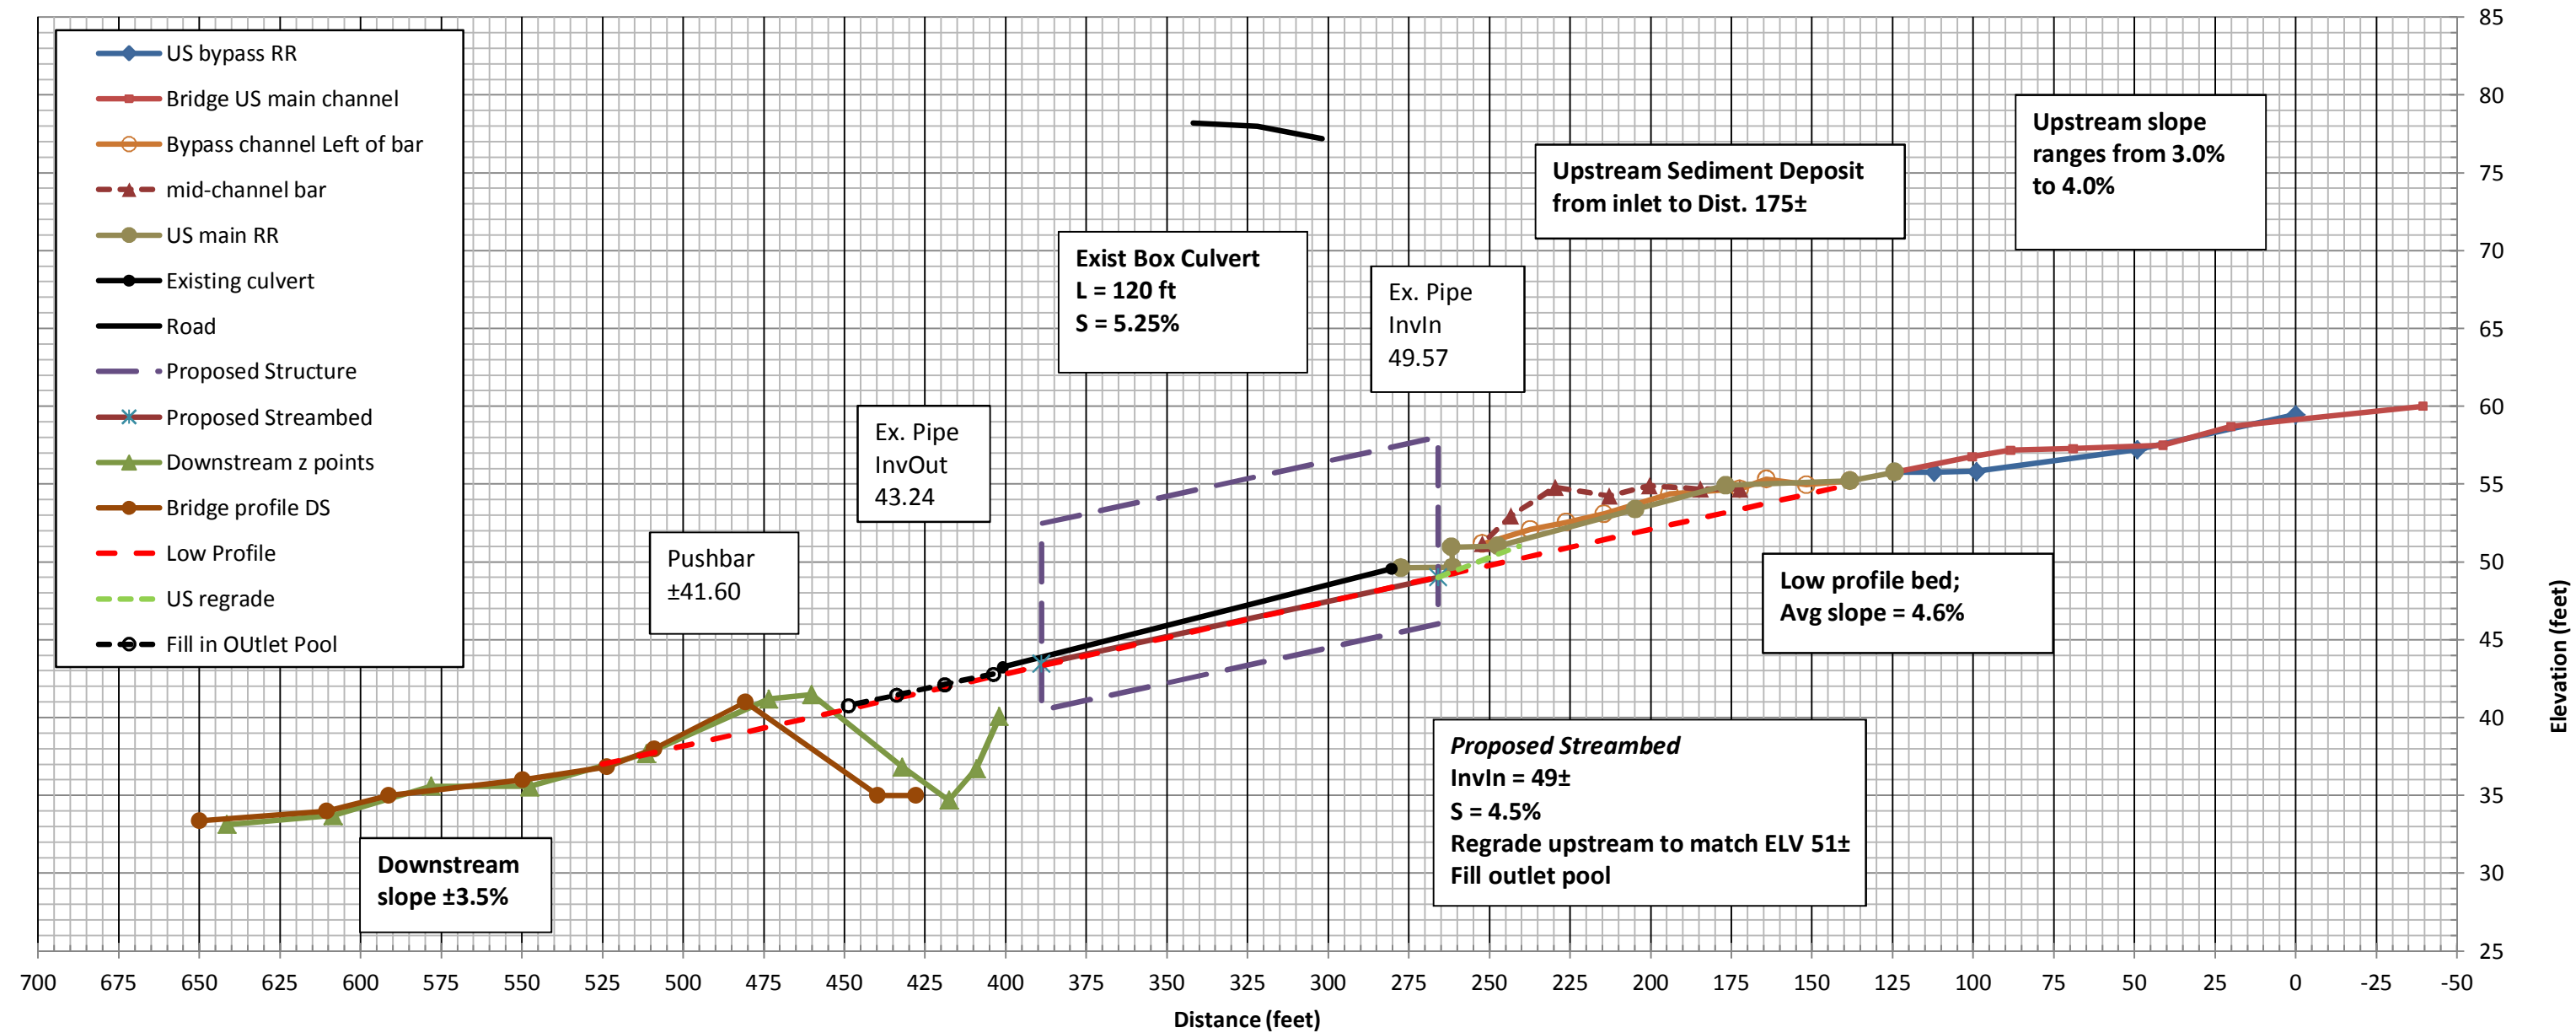
Camden Spring Brook (WIN 22608.00) -- Existing and proposed streambed profile
