Preliminary Design Report

Great Brook Bridge #2326

Great Brook

Camden, Maine

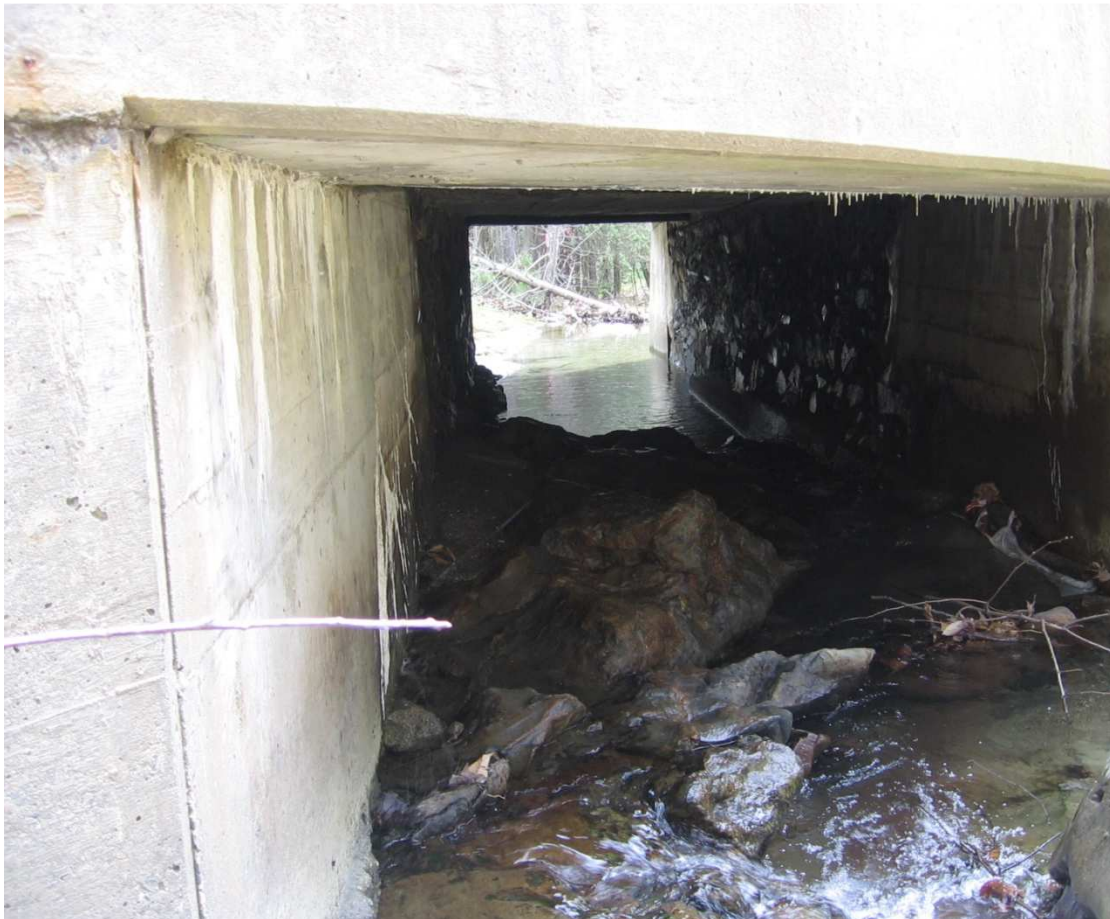
Figure 1 Ledge under Bridge

On June 30th, 2015, the stream was moving at a fairly high velocity. At the upstream, there is a large rock that spans the stream. The water flows over this rock from a slightly higher elevation and then flows through a ledge and rocky bottom. The upstream floodplains consist mainly of vegetation. There is ledge in the culvert that is above the culvert bottom elevation on the left side right after the inlet, which is depicted in Figure 1. Downstream of the culvert, there is ledge, boulders and a few fallen trees and brush. The downstream floodplains are made up of vegetation and trees.

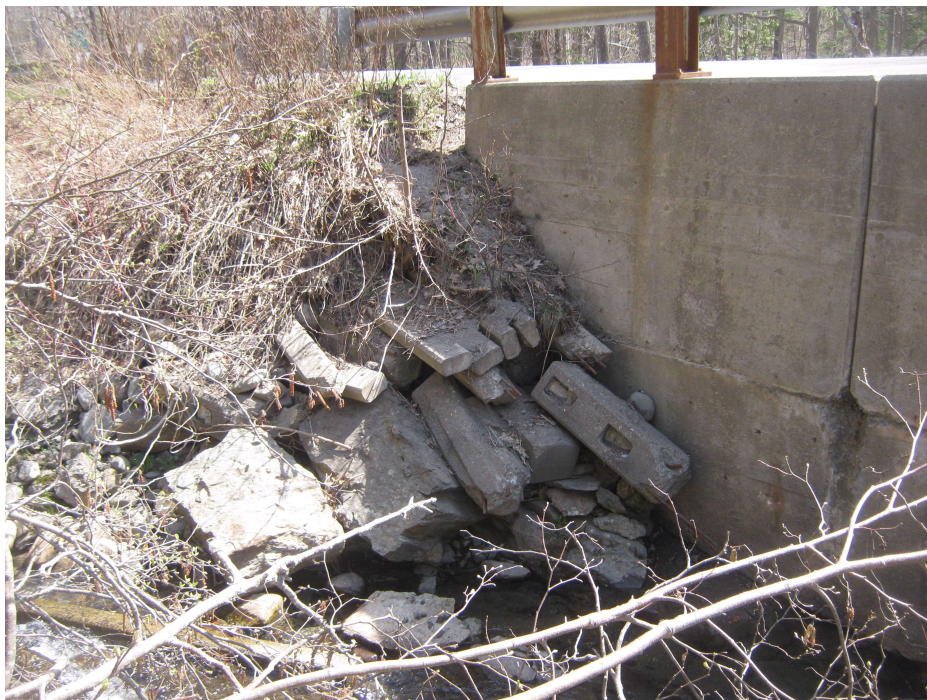
PHOTO 3

Description View showing loose rip rap at US end

| Type | Work Item | Priority | Notes |
|---|---|---|---|
| Maintenance | Repair Slope Protection | 2 | Repair sliding rip rap |

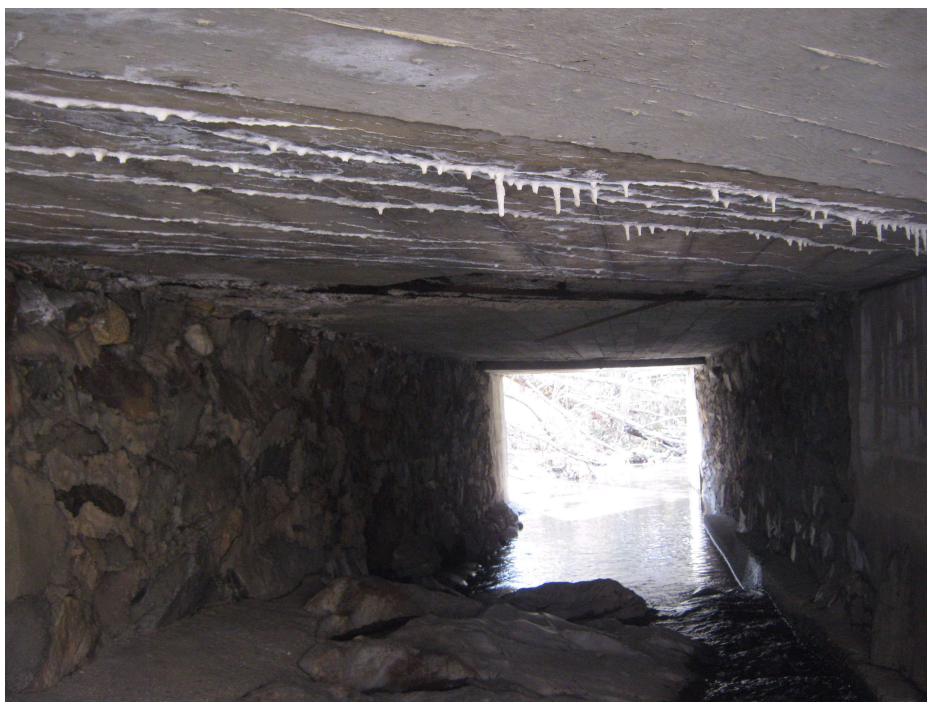
PHOTO 4

Deck has pervasive cracking and efflo, and one large spall with exposed rebar. See photo.

Description View showing cracking and efflo at US end of soffit

| Type | Work Item | Priority | Notes |
|---|---|---|---|
| Maintenance | Repair Deck | 3 | Rehab or replace deck |

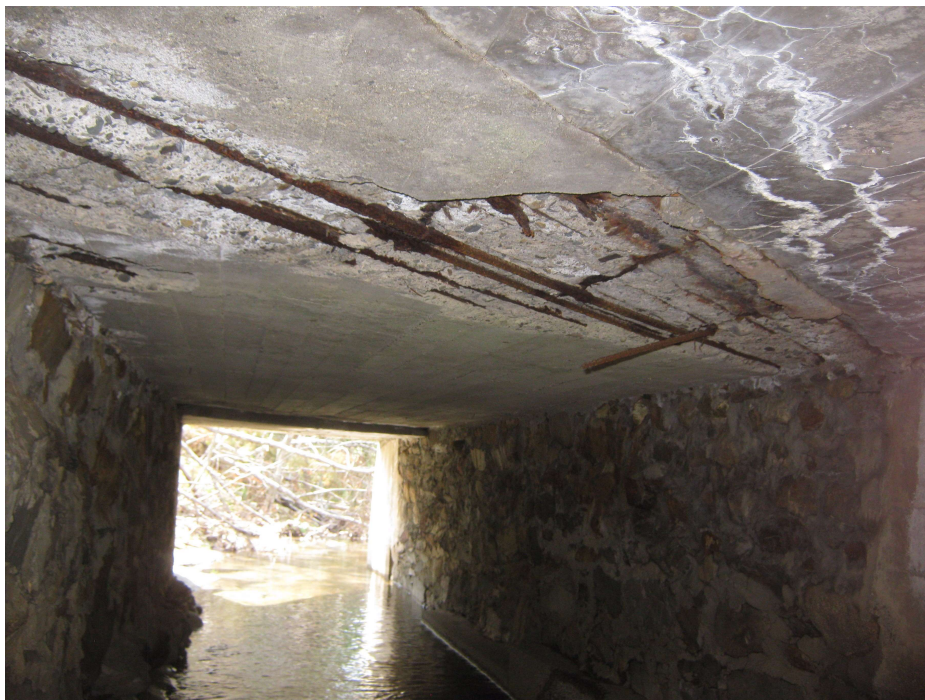
PHOTO 5

Description View showing large spall with exposed rebar in soffit

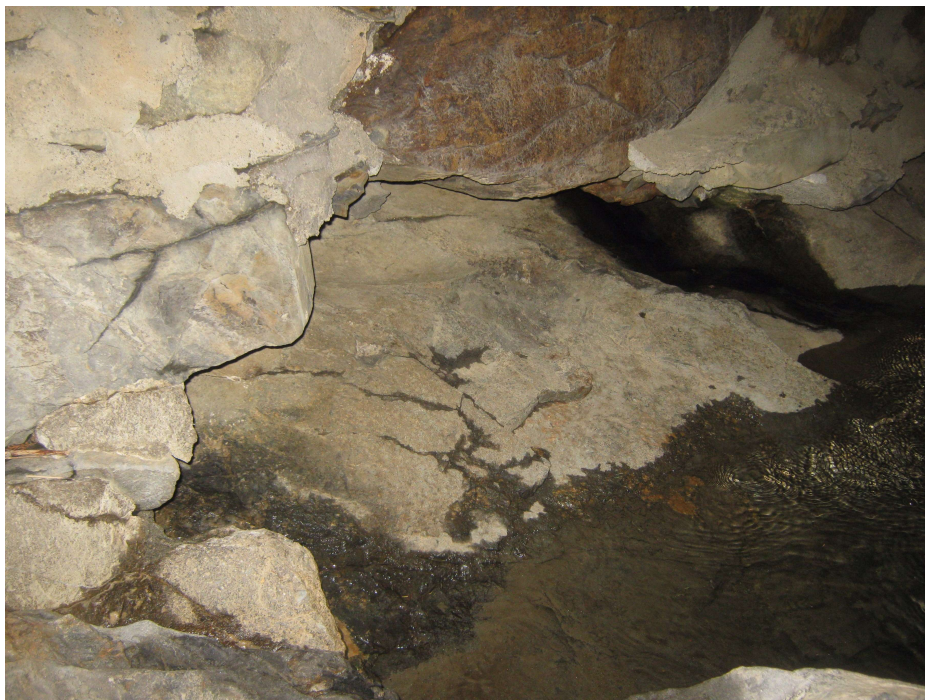
PHOTO 6

Stone Abt has an area of voids around a large stone. See photo Otherwise Abts in fair condition. Rip rap at both ends needs to be added to. See photos.

Description View of voids around stone in SW Abt.

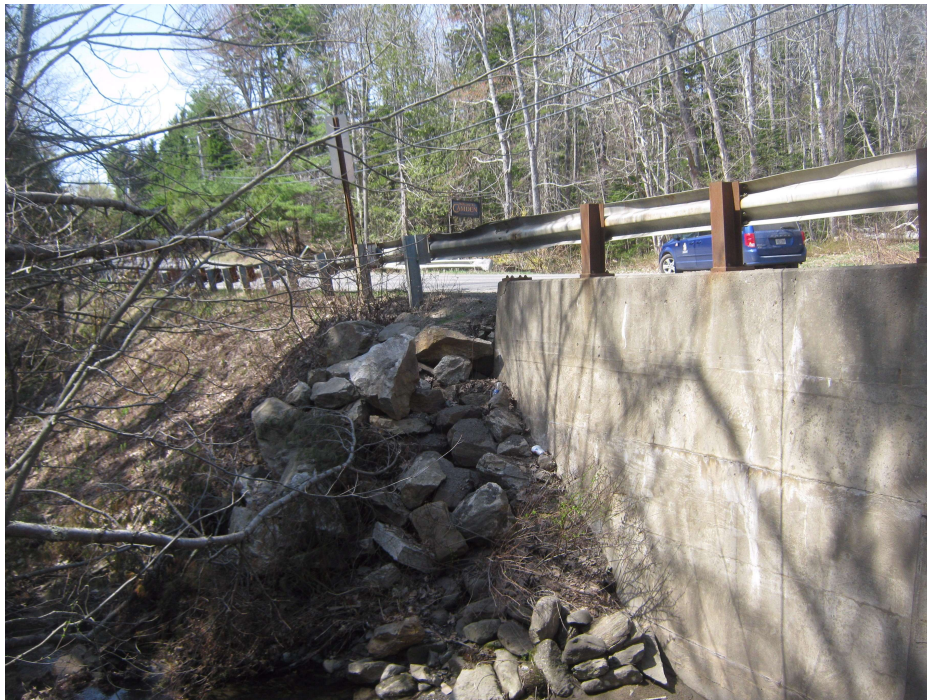
PHOTO 8

Description View of loose rip rap pile at DS end
