GEOTECHNICAL DATA REPORT
DRUMMOND ROAD BRIDGE NO. 5784 OVER
INTERSTATE 95
MAINE DOT WIN 29486.00 (LEGACY WIN 25469.00)
SIDNEY, MAINE

June 2025
09.0026242.00

Prepared for:
Maine Department of Transportation
Augusta, Maine

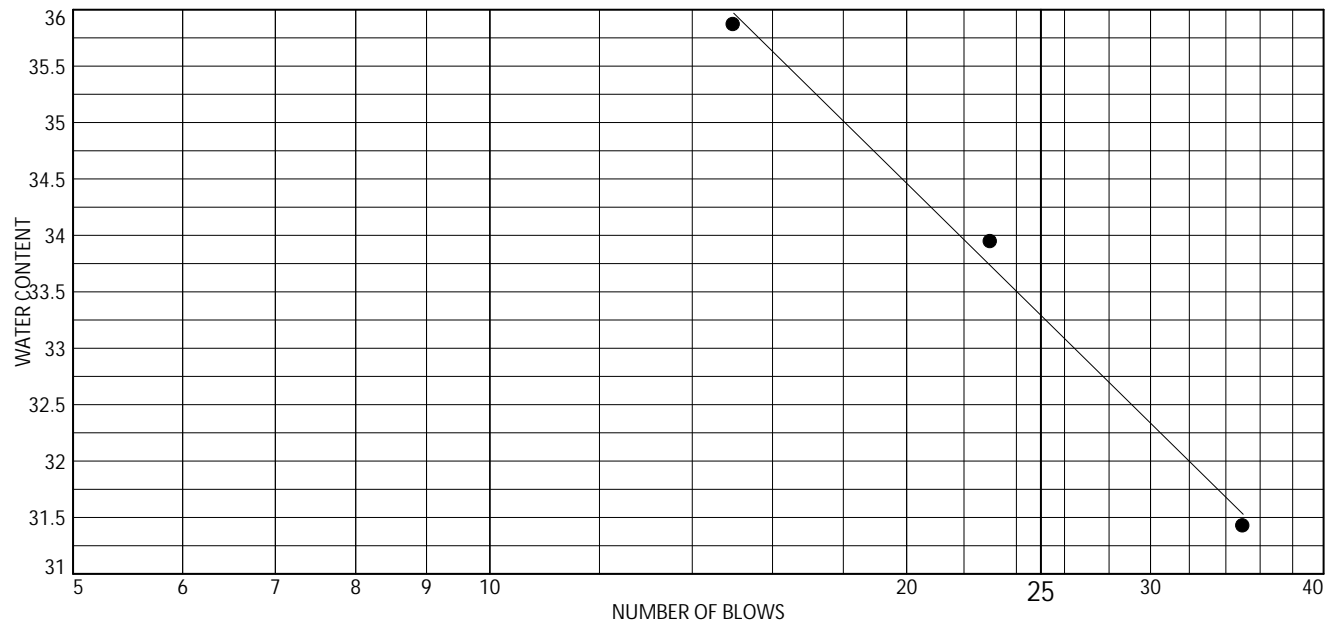
LIQUID AND PLASTIC LIMITS TEST REPORT

MATERIAL DESCRIPTION	LL	PL	PI	%<#40	%<#200	USCS
Brown CLAY & SILT	33	18	15

Project No. 09.0026242.00 Task 3 Client: GZA GeoEnvironmental
Project: Drummond Road Bridge #5784
Sidney, Maine
Source of Sample: BB-SDRR-102 Depth: 5-7'
Sample Number: 2D

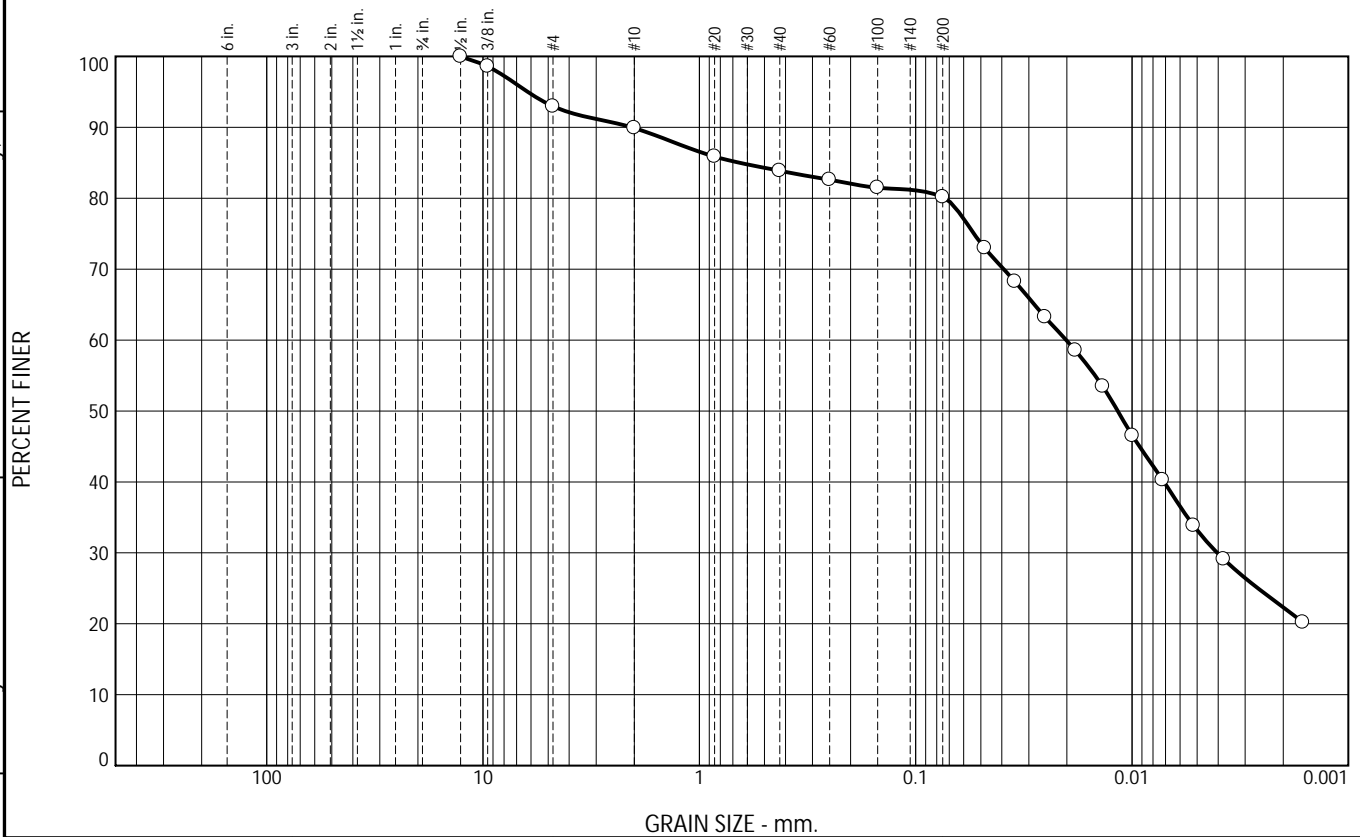
Particle Size Distribution Report

% +3"	% Gravel		% Sand			% Fines	
	Coarse	Fine	Coarse	Medium	Fine	Silt	Clay
0.0	0.0	7.0	3.1	6.0	3.7	57.9	22.3

SIEVE SIZE OR DIAMETER	PERCENT FINER	SPEC.* PERCENT	PASS? (X=NO)
1/2"	100.0		
3/8"	98.6		
#4	93.0		
#10	89.9		
#20	85.9		
#40	83.9		
#60	82.6		
#100	81.5		
#200	80.2		
0.0480 mm.	73.0		
0.0348 mm.	68.3		
0.0253 mm.	63.3		
0.0183 mm.	58.6		
0.0137 mm.	53.5		
0.0100 mm.	46.5		
0.0072 mm.	40.3		
0.0052 mm.	33.8		
0.0038 mm.	29.1		
0.0016 mm.	20.2

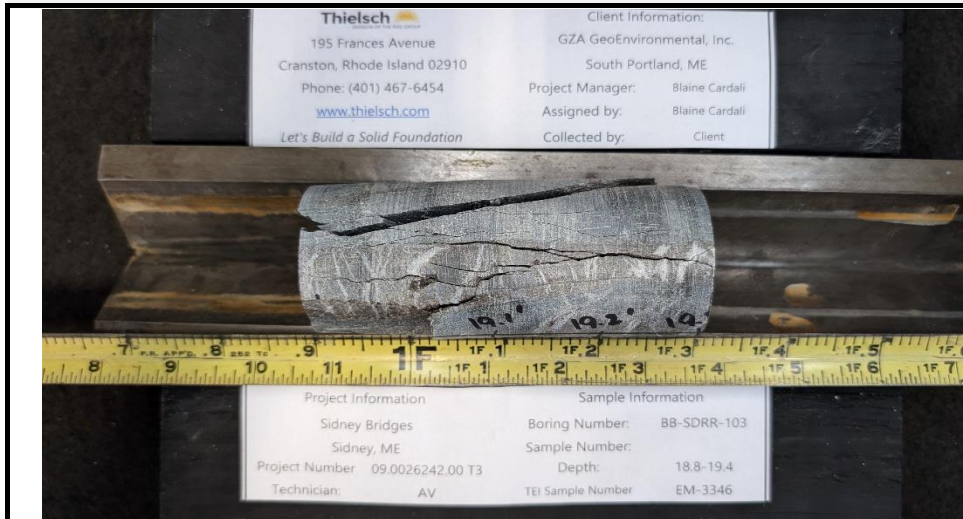
ASTM D7012 Compressive Strength and Elastic Moduli of Intact Rock Core Specimens

Sample Information		Compressive Test Information	
Boring ID:	BB-SDRR-102	Unit Weight (pcf):	174.0
Sample #:		Failure Stress (psi):	5,548
Depth (ft):	18.8-19.4	Failure Mode:	Fresh
Tested Depth (ft):	18.9-19.1	Time to Failure (min)	6.27
Rock Type:	Grey Slate		
Features:	Broke along foliation		
Test Specimen Information		Elastic Moduli Test Information	
Diameter, D (in):	1.988	Poisson's Ratio @ 50%:	0.14
Length, L (in):	4.600	Strain %:	0.314
L:D Ratio:	2.31	E sec PSI @ 50%:	2.03E+06

SUMMARY OF BEDROCK STRENGTH TEST RESULTS						
Boring	Depth below Existing Ground (ft)	Depth below Top of Rock (ft)	Unconfined Compressive Strength (psi)	Secant Modulus @ 50% of Failure Stress (ksi)	Unit Weight (pcf)	Rock Type
BB-SDRR-102	18.8	3.0	5,548	2,030	174.0	Pelite
BB-SDRR-103	56.4	4.3	5,442	5,130	175.9	Pelite

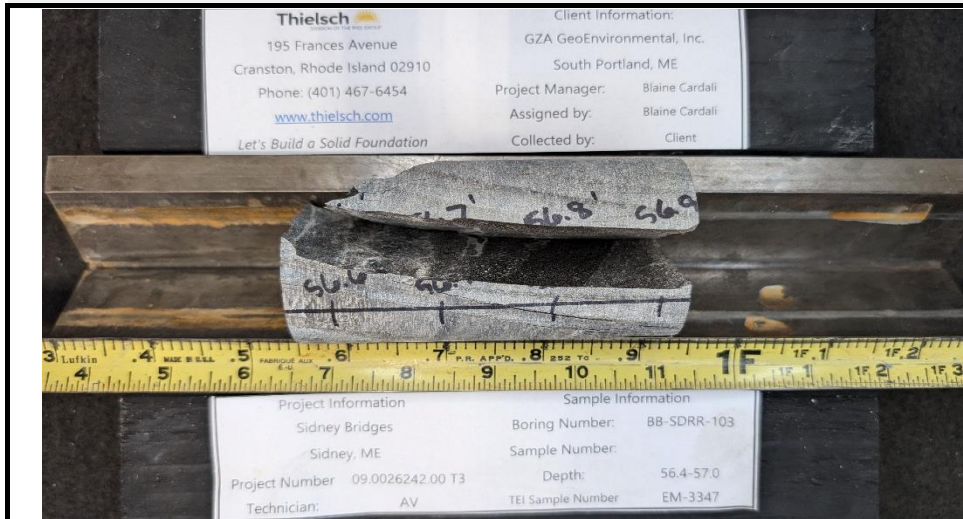
ASTM D7012 Compressive Strength and Elastic Moduli of Intact Rock Core Specimens

Sample Information		Compressive Test Information	
Boring ID:	BB-SDRR-103	Unit Weight (pcf):	175.9
Sample #:		Failure Stress (psi):	5,442
Depth (ft):	56.4-57.0	Failure Mode:	Fresh
Tested Depth (ft):	56.58-56.93	Time to Failure (min)	6.27
Rock Type:	Grey Slate		
Features:	Broke along foliation		
Test Specimen Information		Elastic Moduli Test Information	
Diameter, D (in):	1.964	Poisson's Ratio @ 50%:	0.31
Length, L (in):	4.431	Strain %:	0.426
L:D Ratio:	2.26	E sec PSI @ 50%:	5.13E+06

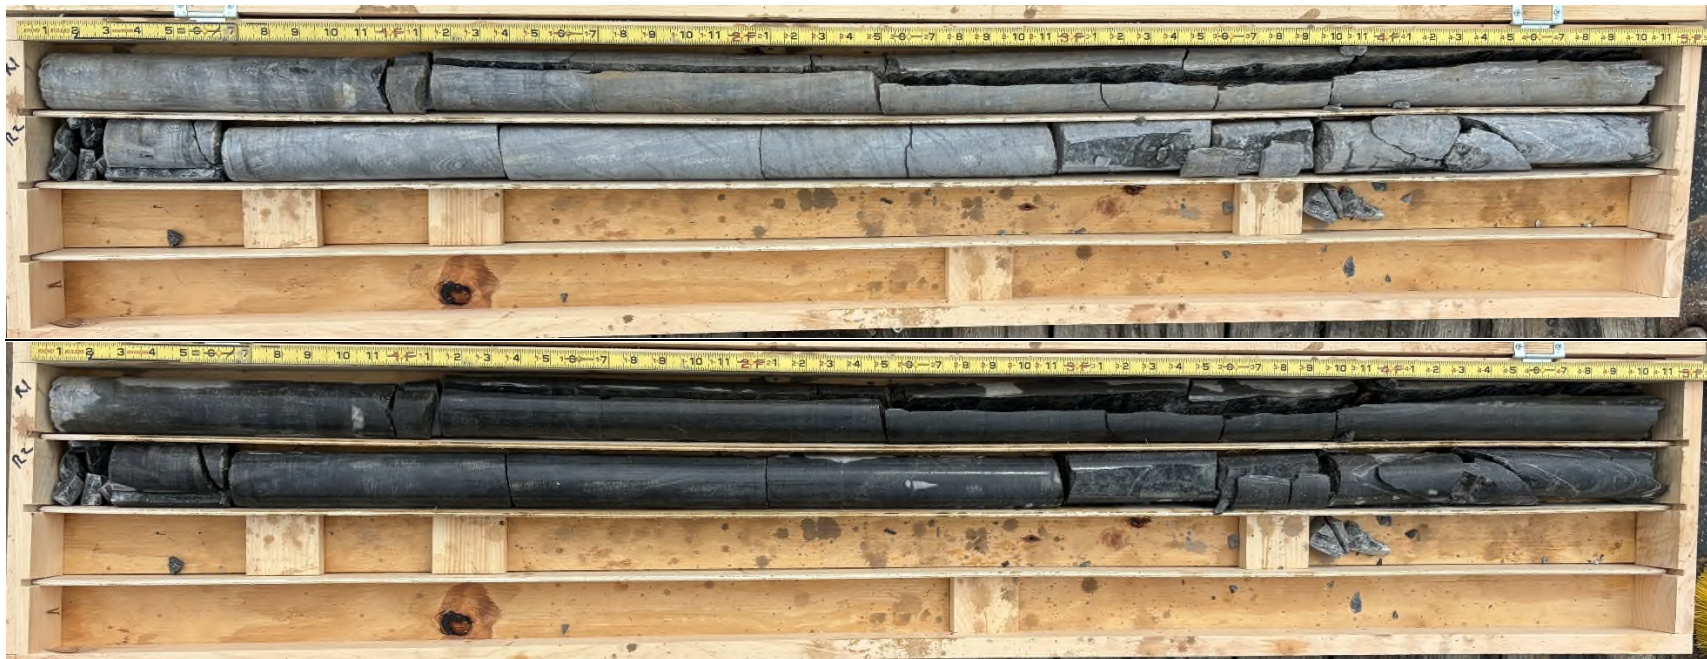
MaineDOT Bridge No. 5784
Drummond Rd over I-95
Sidney, ME
WIN 25469.00
Rock Core Photographs

Boring No.	Run	Depth (ft)	Recovery (in)	Recovery (%)	RQD (in)	RQD (%)	Rock Type	Box Row
BB-SDRR-101	R1	32.8 - 37.8	60	100%	58	97%	PELITE	1
BB-SDRR-101	R2	37.8 - 42.8	60	100%	54	90%	PELITE	2

- Notes:
1. Box row corresponds to the core box section in which the rock core sample is contained; Row 1=Top, Row 4=Bottom.
 2. Top photo is dry, bottom photo is wet.
