**GEOTECHNICAL DATA REPORT
DINSMORE ROAD BRIDGE NO. 5782 OVER
INTERSTATE 95
MAINE DOT WIN 29486.00 (LEGACY WIN 25473.00)
SIDNEY, MAINE**

June 2025
09.0026242.00

Prepared for:
Maine Department of Transportation
Augusta, Maine

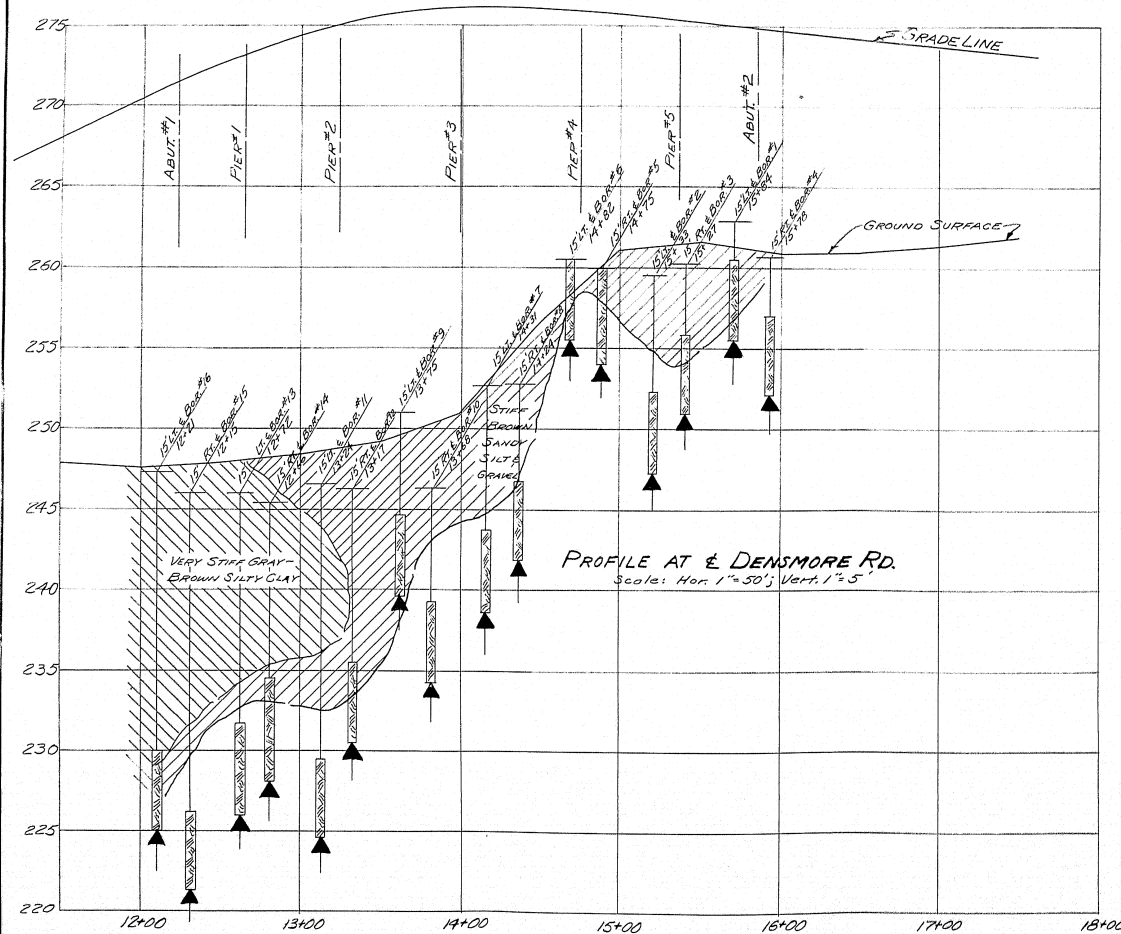
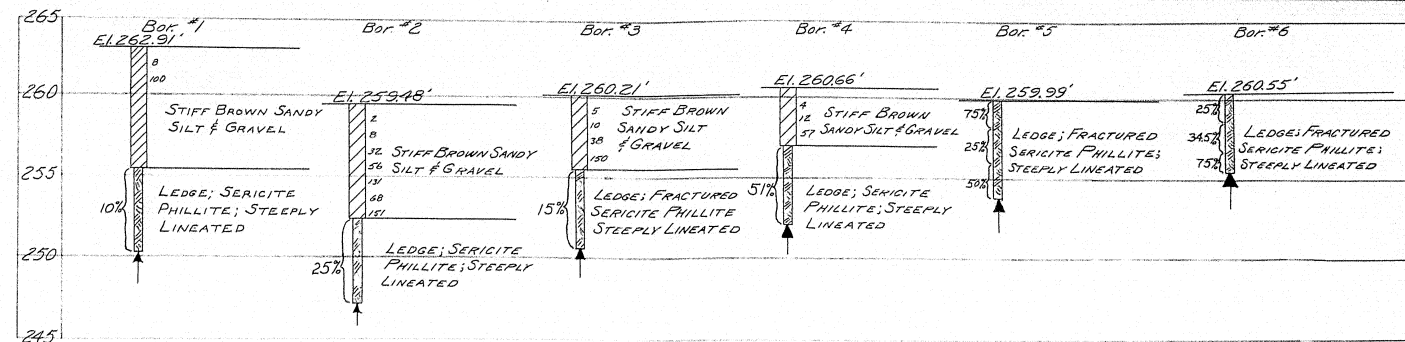
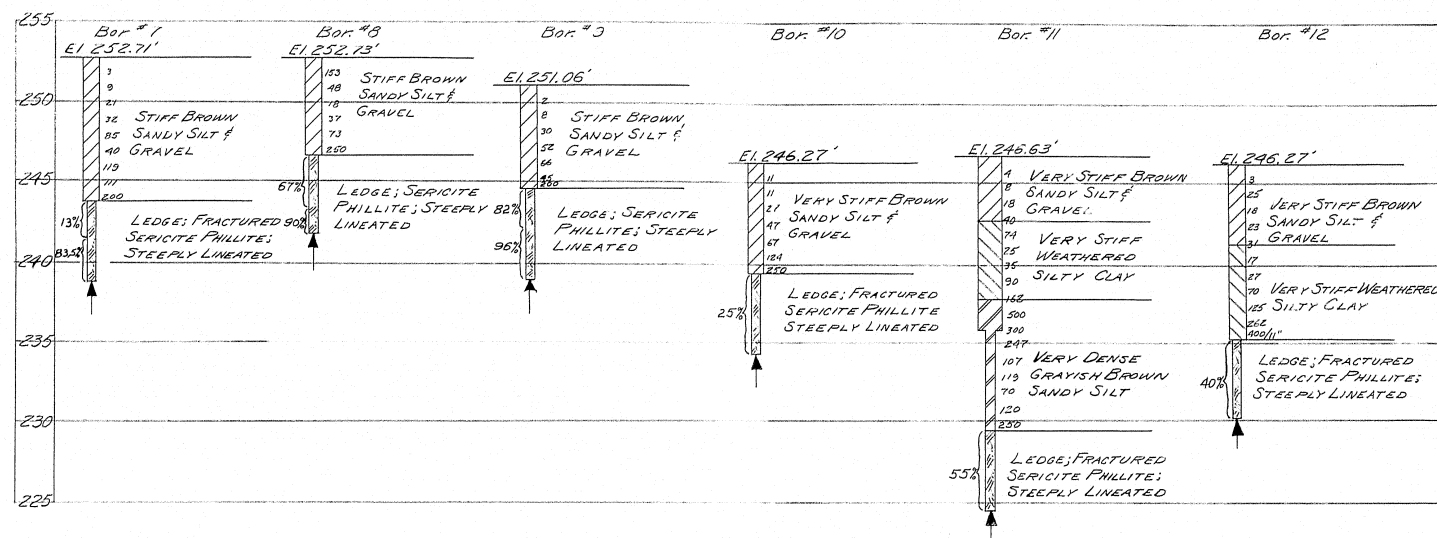
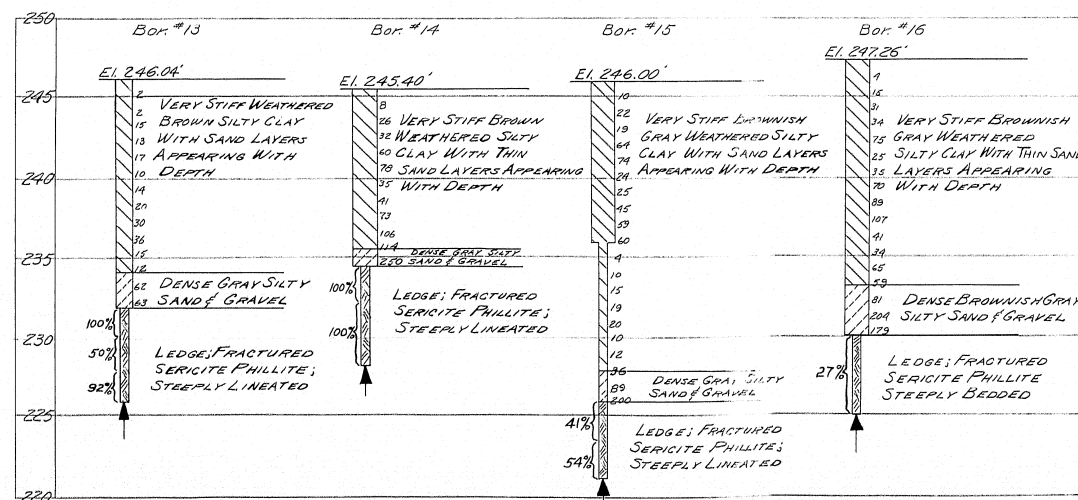
BORING LOGS
Scale: Vert. 1"=5'

Ground Surface
4' casing
28' casing
No. of blows of 275 "Hammer"
falling 18" required to drive
extra heavy casing one foot.
71% Percent recovery of rock
core by diamond bit.
Bottom of boring

In 1958, MaineDOT conducted sixteen test borings, designated Boring #1 through #16, to explore subsurface conditions for bridge construction. These borings were drilled prior to construction of I-95. At the time, the grades were 14 to 25 feet lower than Dinsmore Road is today. Each boring was drilled through the overburden and to bedrock, and approximately 5 feet of core was collected from each boring.

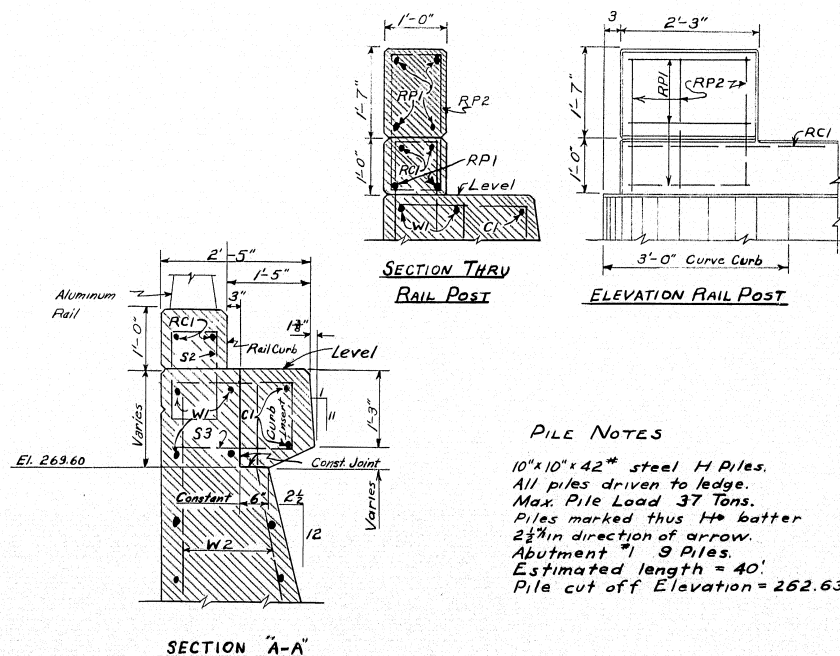
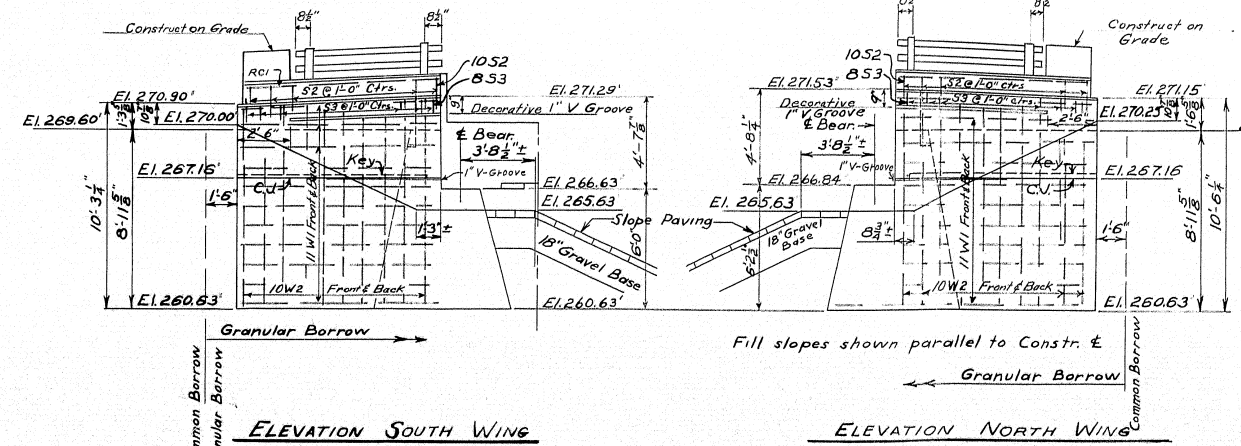
SHEET 11 OF 22 AUGUSTA, MAINE APRIL 1958

DESIGN-B DETAIL-McDOUGAL
TRACE-MESERVE
CHECK-*[Signature]*
BRIDGE NO. 1052
SURVEY - PLOT -
STATE HIGHWAY COMMISSION
BRIDGE DIVISION
DENSMORE ROAD BRIDGE
OVER
INTERSTATE HIGHWAY
IN THE TOWN OF
SIDNEY
KENNEBEC COUNTY
ABUTMENT #1

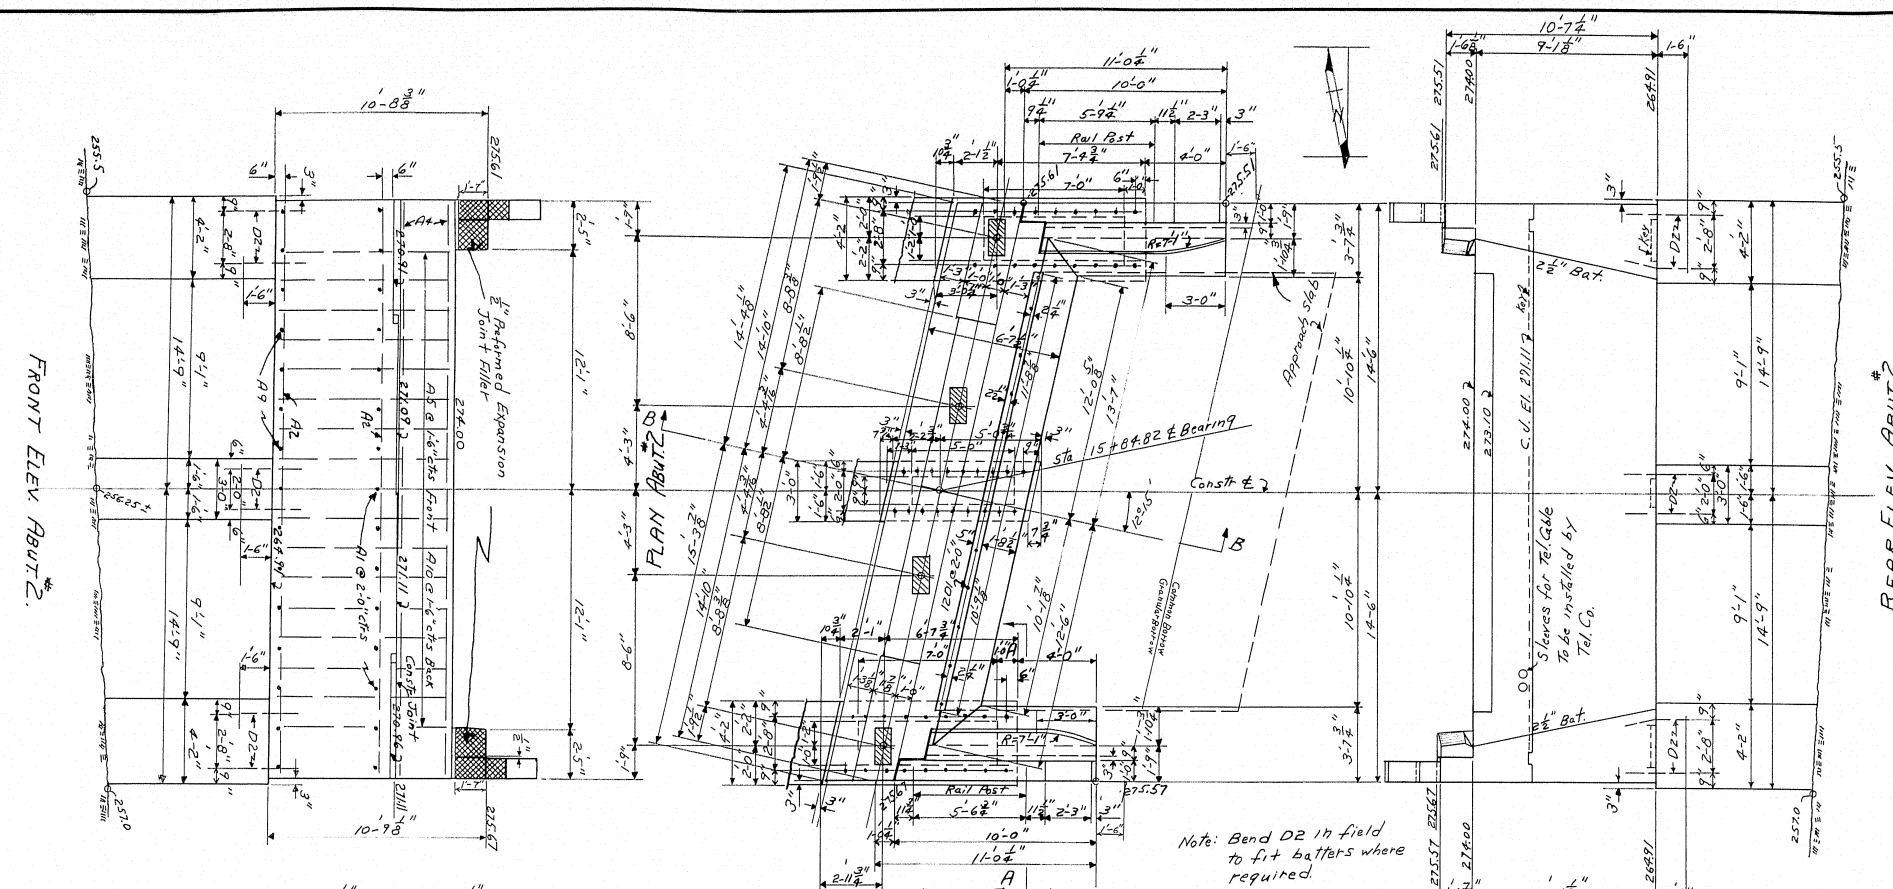
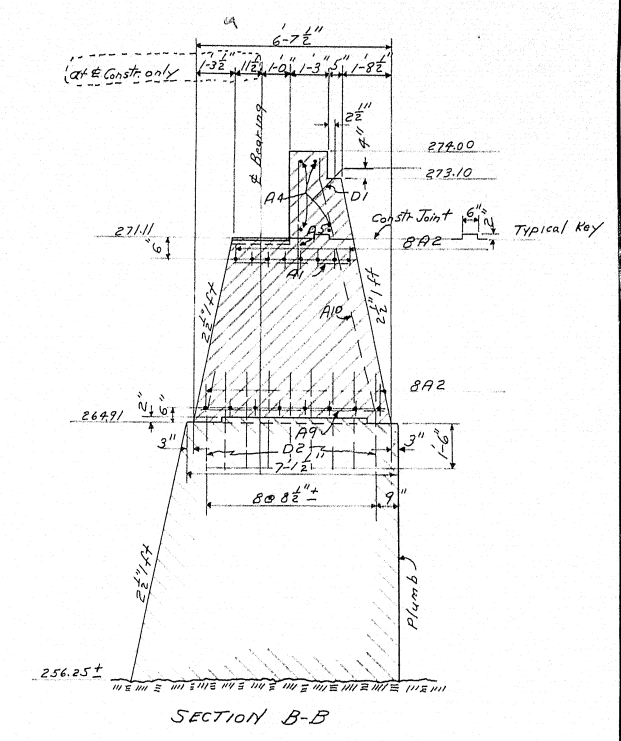
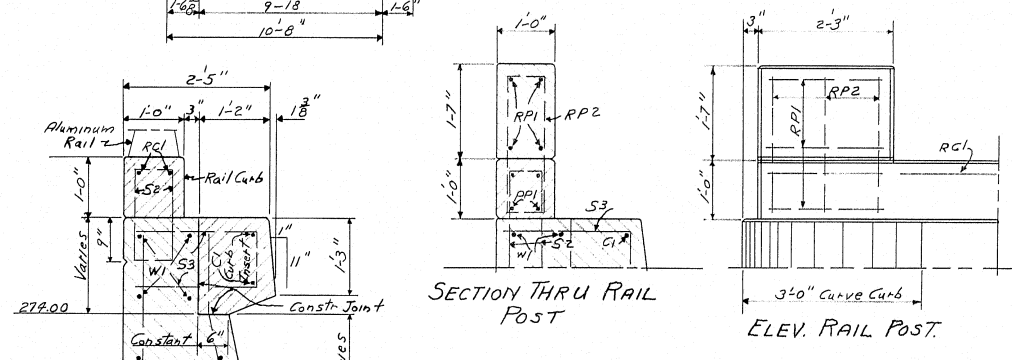
Notes:
 Dress shaded areas 1" larger all around than size of masonry plate to exact bridge seat elevations shown.
 All chamfers to be 1/2" and V grooves 1".
 Place reinforcing steel in bridge seats to clear anchor bolts.
 Wing steel to be at 1'-0" centers vertically and horizontally and to have 3" cover. All bars "W" front and back unless noted.
 Concrete rail posts, rail curbs and curb inserts to be Class A concrete and to be paid for as Item 701-33 P.C.C. abutments and retaining walls.
 Back wall to be built after structural steel is erected.
 1/2" preformed expansion joint filler to be used on all vertical joints between abutment curbs and superstructure curbs.

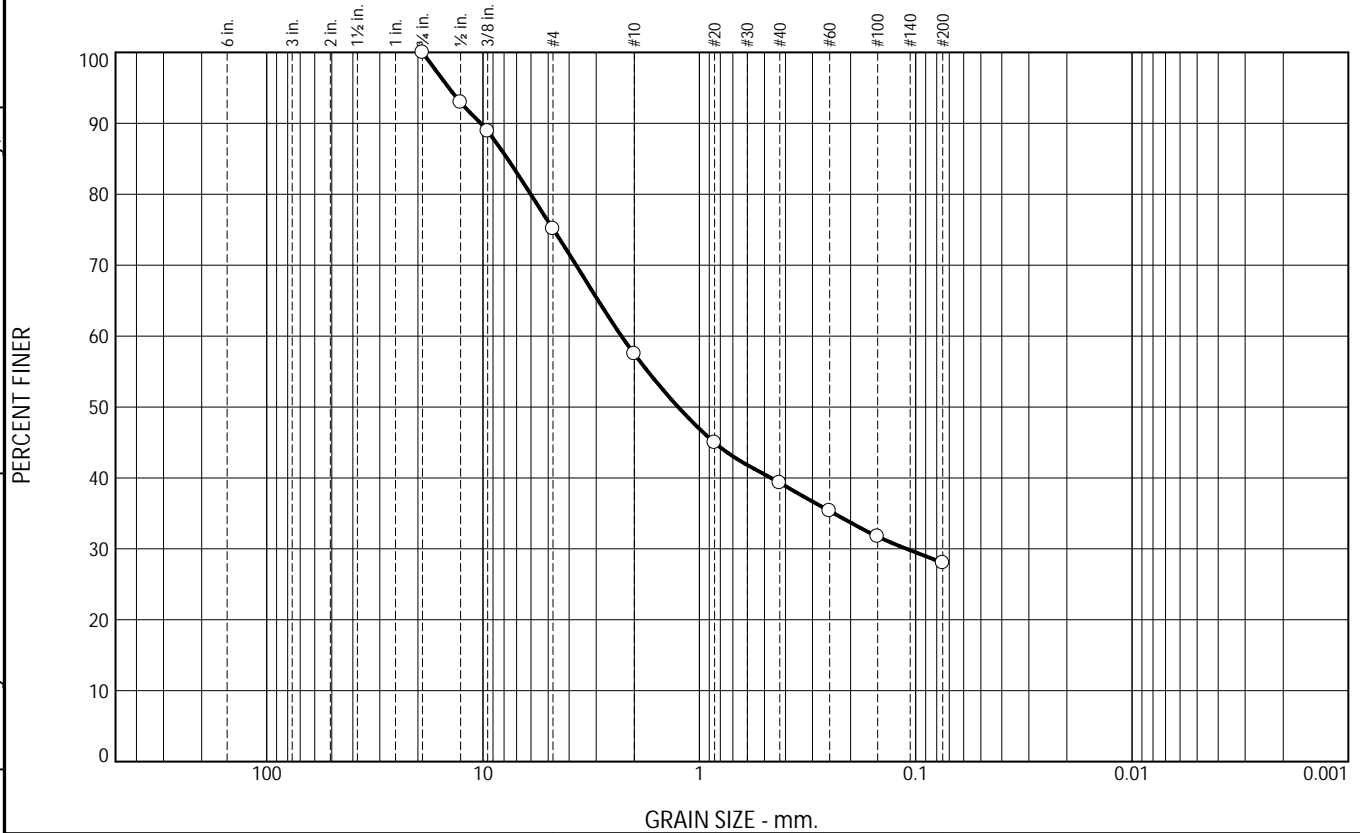
Particle Size Distribution Report

% +3"	% Gravel		% Sand			% Fines	
	Coarse	Fine	Coarse	Medium	Fine	Silt	Clay
0.0	0.0	24.9	17.6	18.2	11.3	28.0

SIEVE SIZE OR DIAMETER	PERCENT FINER	SPEC.* PERCENT	PASS? (X=NO)
3/4"	100.0		
1/2"	92.9		
3/8"	88.9		
#4	75.1		
#10	57.5		
#20	45.0		
#40	39.3		
#60	35.3		
#100	31.7		
#200	28.0

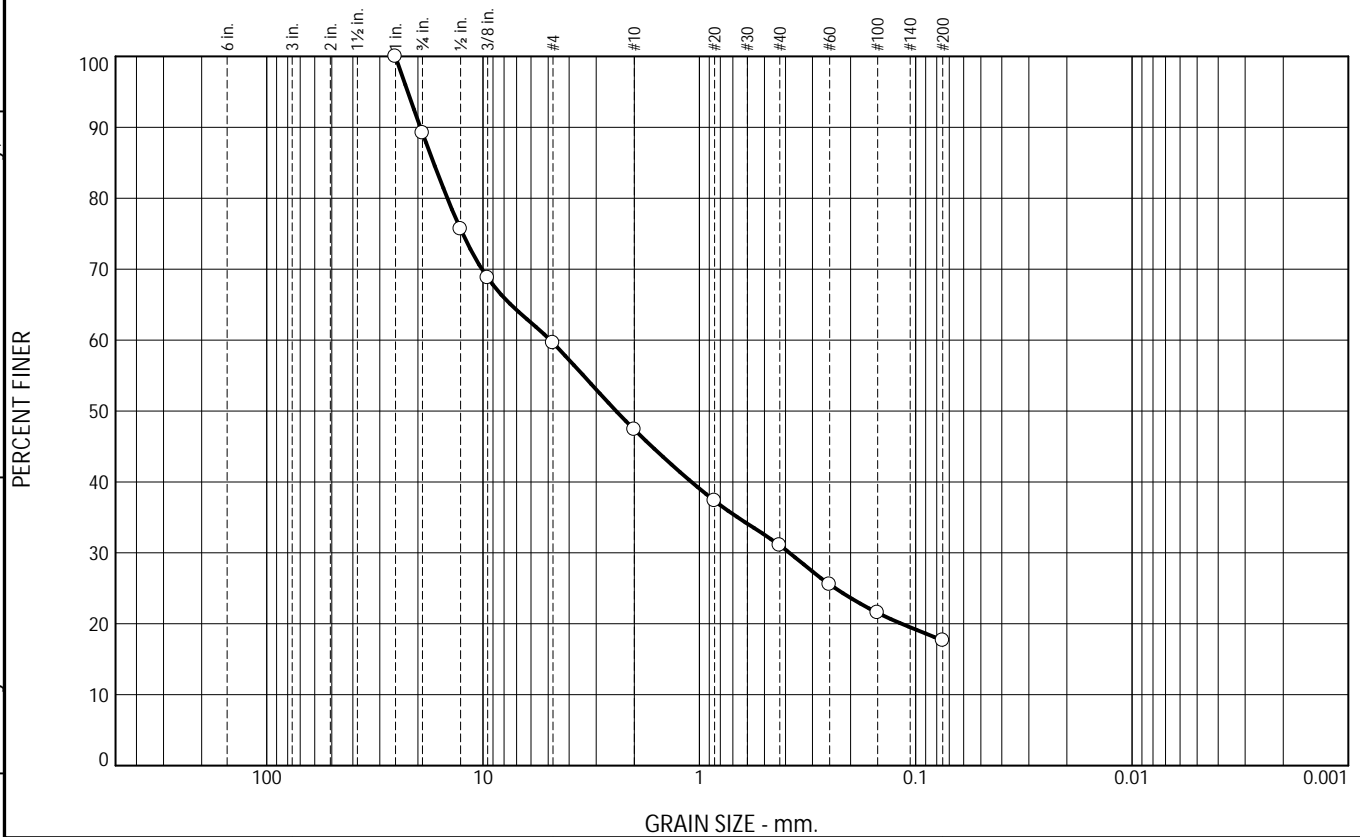
Particle Size Distribution Report

% +3"	% Gravel		% Sand			% Fines	
	Coarse	Fine	Coarse	Medium	Fine	Silt	Clay
0.0	10.8	29.6	12.2	16.3	13.5	17.6

SIEVE SIZE OR DIAMETER	PERCENT FINER	SPEC.* PERCENT	PASS? (X=NO)
1"	100.0		
3/4"	89.2		
1/2"	75.7		
3/8"	68.8		
#4	59.6		
#10	47.4		
#20	37.3		
#40	31.1		
#60	25.5		
#100	21.5		
#200	17.6

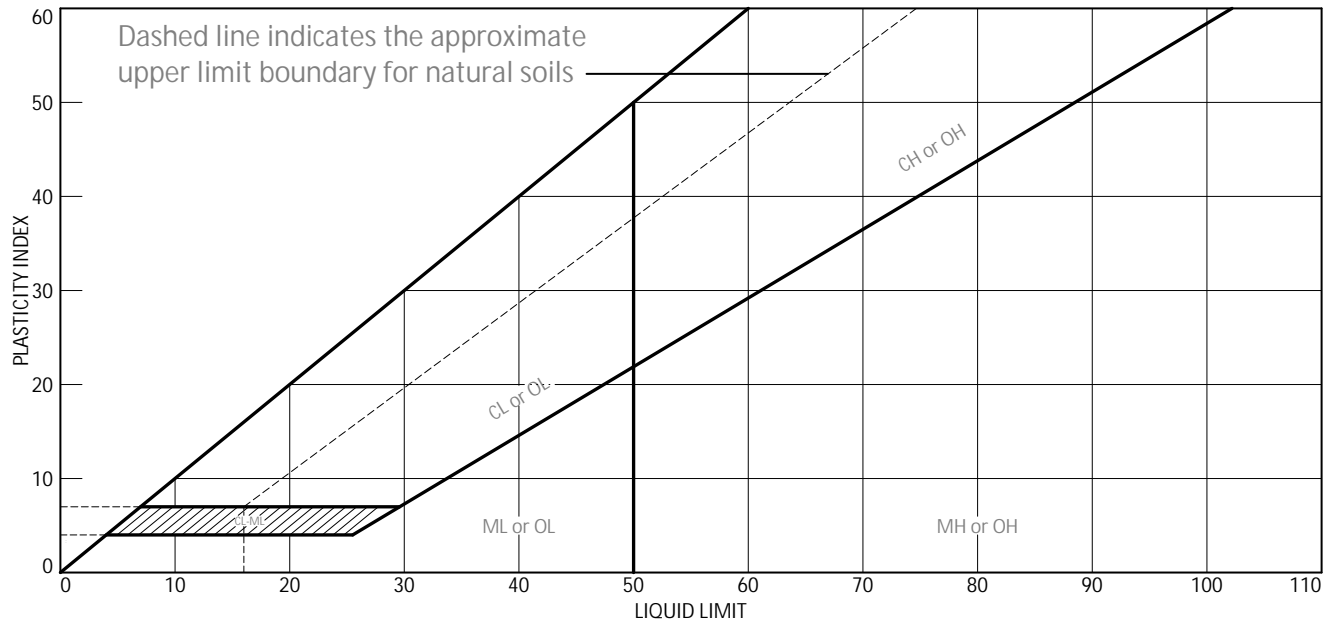
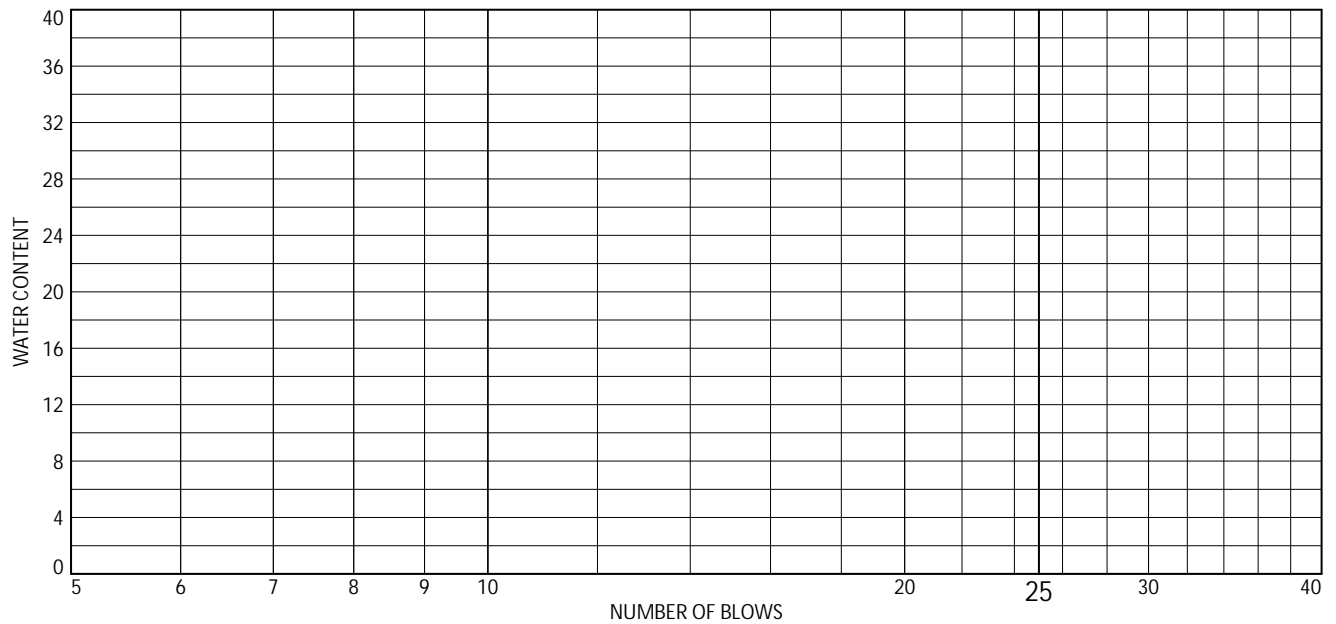
LIQUID AND PLASTIC LIMITS TEST REPORT

MATERIAL DESCRIPTION	LL	PL	PI	%<#40	%<#200	USCS
Brown f-c GRAVEL, some f-c Sand, little Silt	NV	NP	NP	18.2	13.2	GM

Project No. 09.0026242.00 Task 4 Client: GZA GeoEnvironmental
Project: Densmore Road Bridge #5782
Sidney, ME
Source of Sample: BB-SDER-101 Depth: 20-22'
Sample Number: 6D

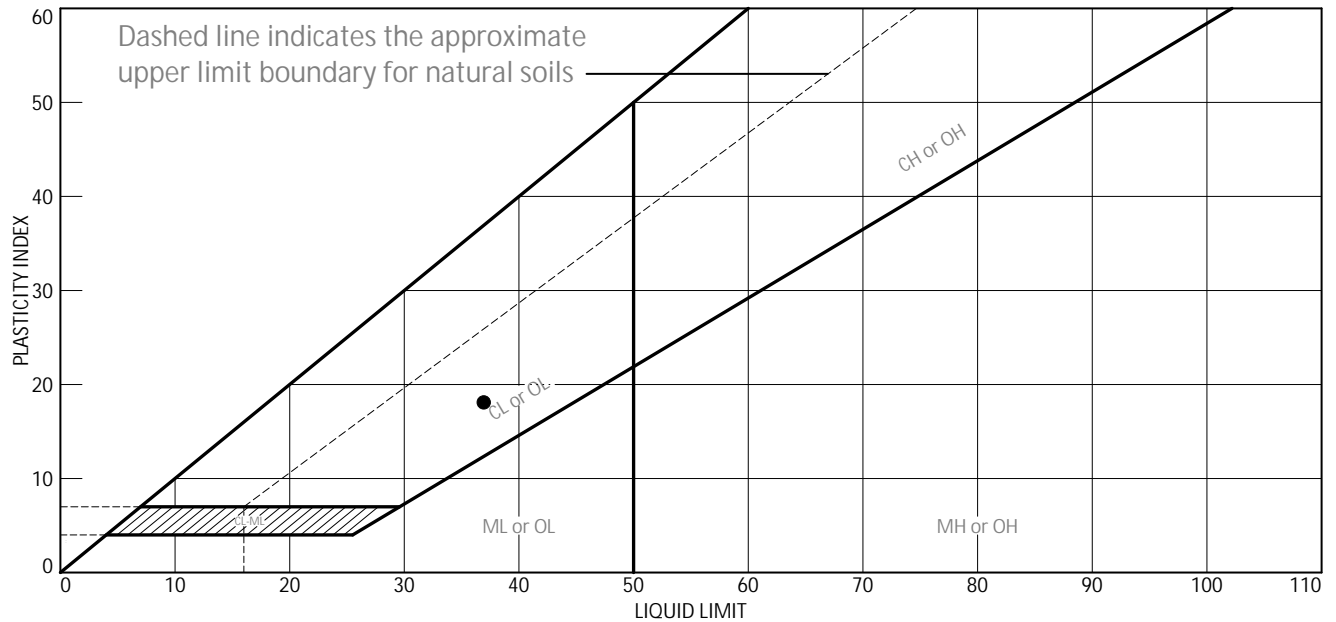
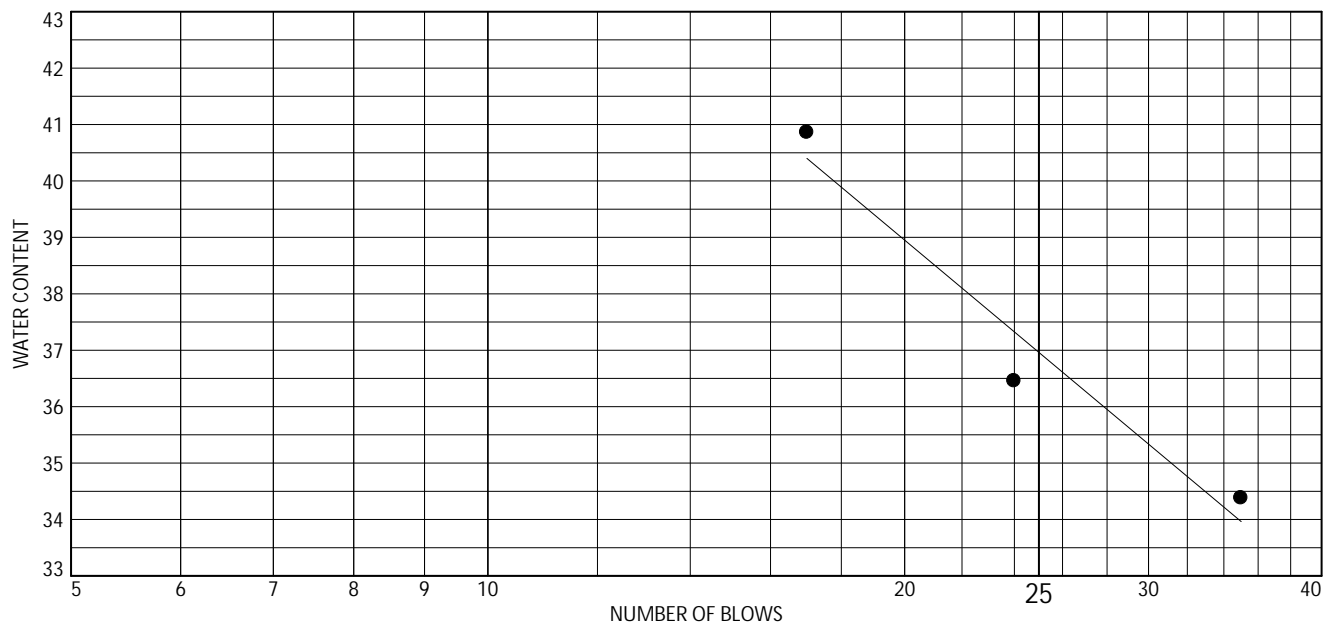
LIQUID AND PLASTIC LIMITS TEST REPORT

MATERIAL DESCRIPTION	LL	PL	PI	%<#40	%<#200	USCS
Olive CLAY & SILT	37	19	18

Project No. 09.0026242.00 Task 4 Client: GZA GeoEnvironmental
Project: Densmore Road Bridge #5782
Sidney, ME
Source of Sample: BB-SDER-101 Depth: 30-32'
Sample Number: 8D

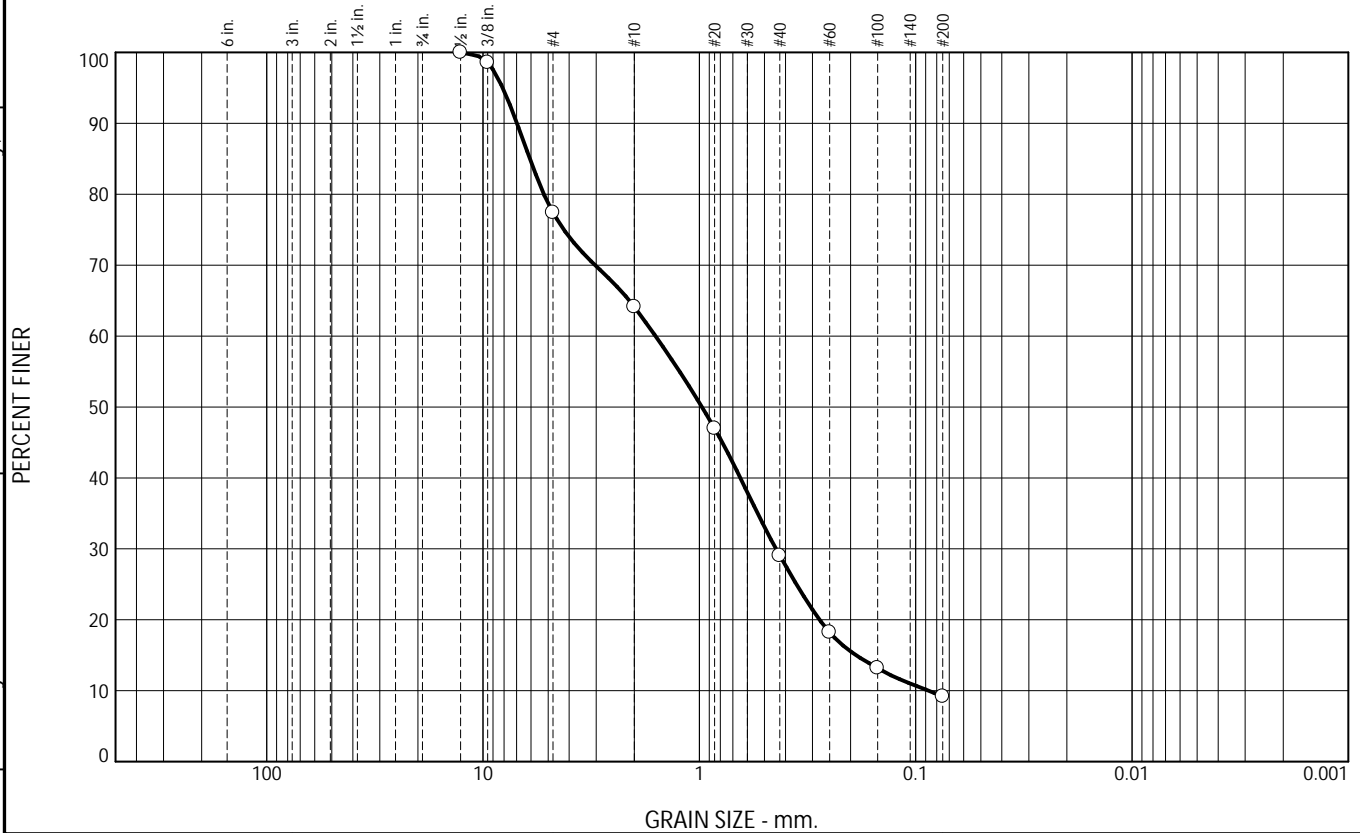
Particle Size Distribution Report

% +3"	% Gravel		% Sand			% Fines	
	Coarse	Fine	Coarse	Medium	Fine	Silt	Clay
0.0	0.0	22.6	13.3	35.1	19.8	9.2

SIEVE SIZE OR DIAMETER	PERCENT FINER	SPEC.* PERCENT	PASS? (X=NO)
1/2"	100.0		
3/8"	98.6		
#4	77.4		
#10	64.1		
#20	47.0		
#40	29.0		
#60	18.2		
#100	13.2		
#200	9.2

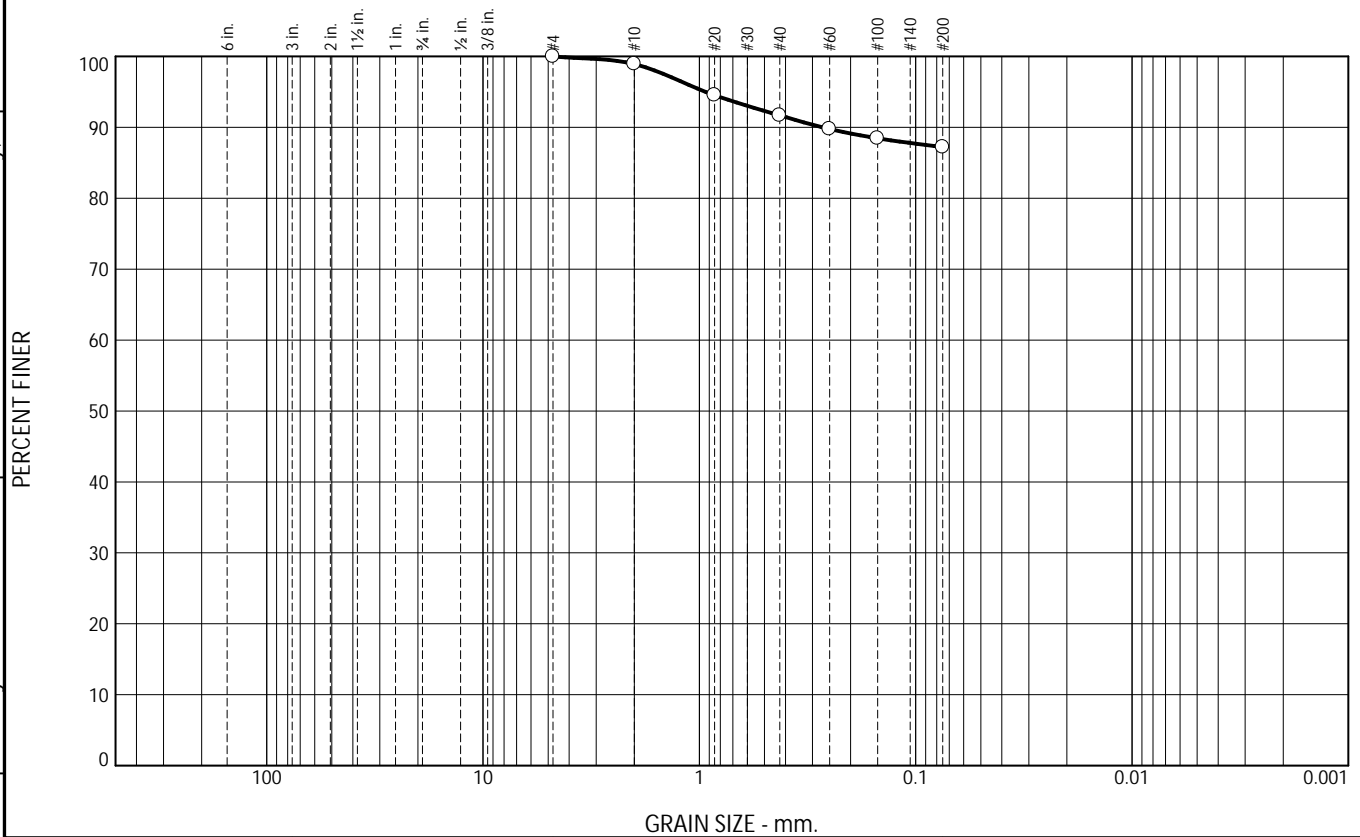
Particle Size Distribution Report

% +3"	% Gravel		% Sand			% Fines	
	Coarse	Fine	Coarse	Medium	Fine	Silt	Clay
0.0	0.0	0.0	1.1	7.2	4.5	87.2

SIEVE SIZE OR DIAMETER	PERCENT FINER	SPEC.* PERCENT	PASS? (X=NO)
#4	100.0		
#10	98.9		
#20	94.5		
#40	91.7		
#60	89.8		
#100	88.5		
#200	87.2

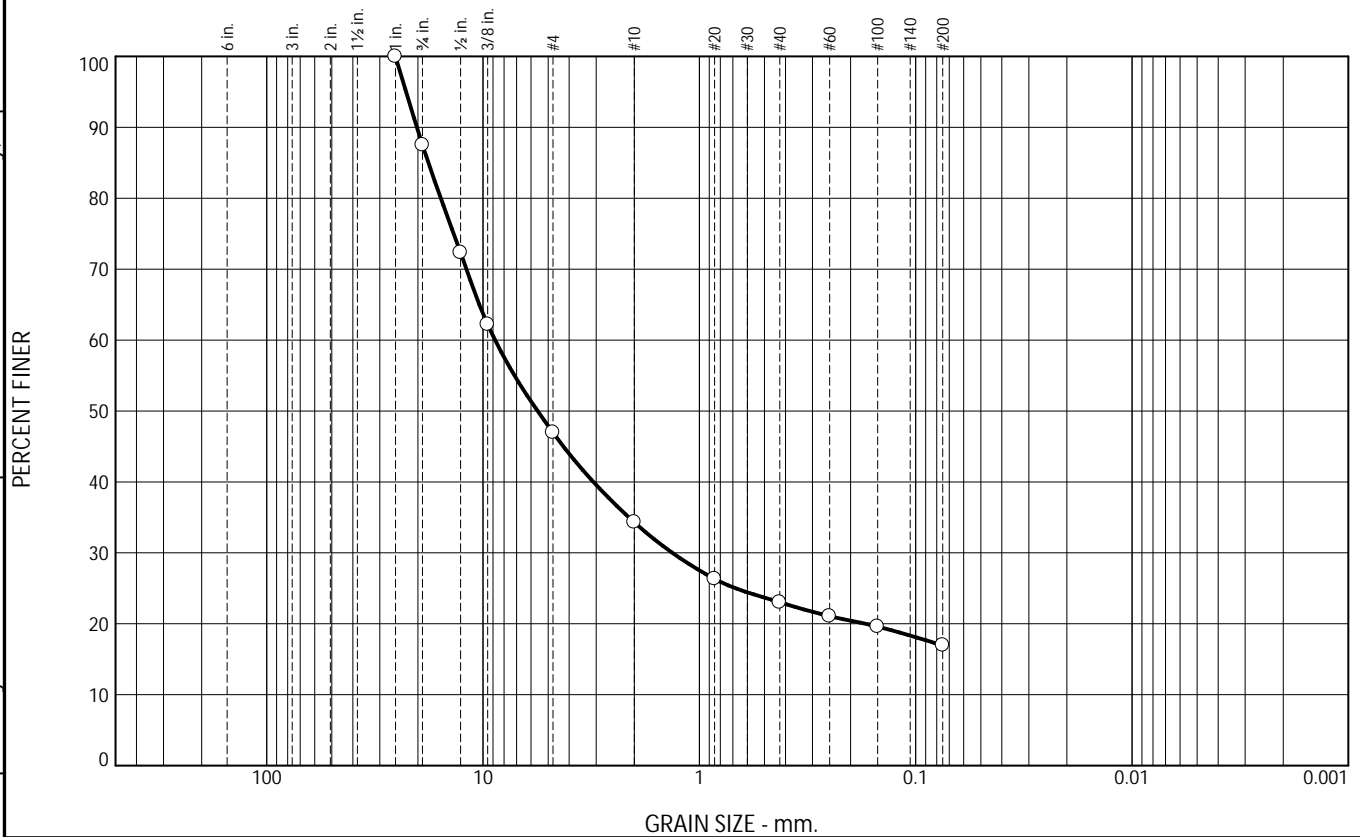
Particle Size Distribution Report

% +3"	% Gravel		% Sand			% Fines	
	Coarse	Fine	Coarse	Medium	Fine	Silt	Clay
0.0	12.5	40.5	12.7	11.3	6.0	17.0

SIEVE SIZE OR DIAMETER	PERCENT FINER	SPEC.* PERCENT	PASS? (X=NO)
1"	100.0		
3/4"	87.5		
1/2"	72.3		
3/8"	62.2		
#4	47.0		
#10	34.3		
#20	26.3		
#40	23.0		
#60	21.1		
#100	19.6		
#200	17.0

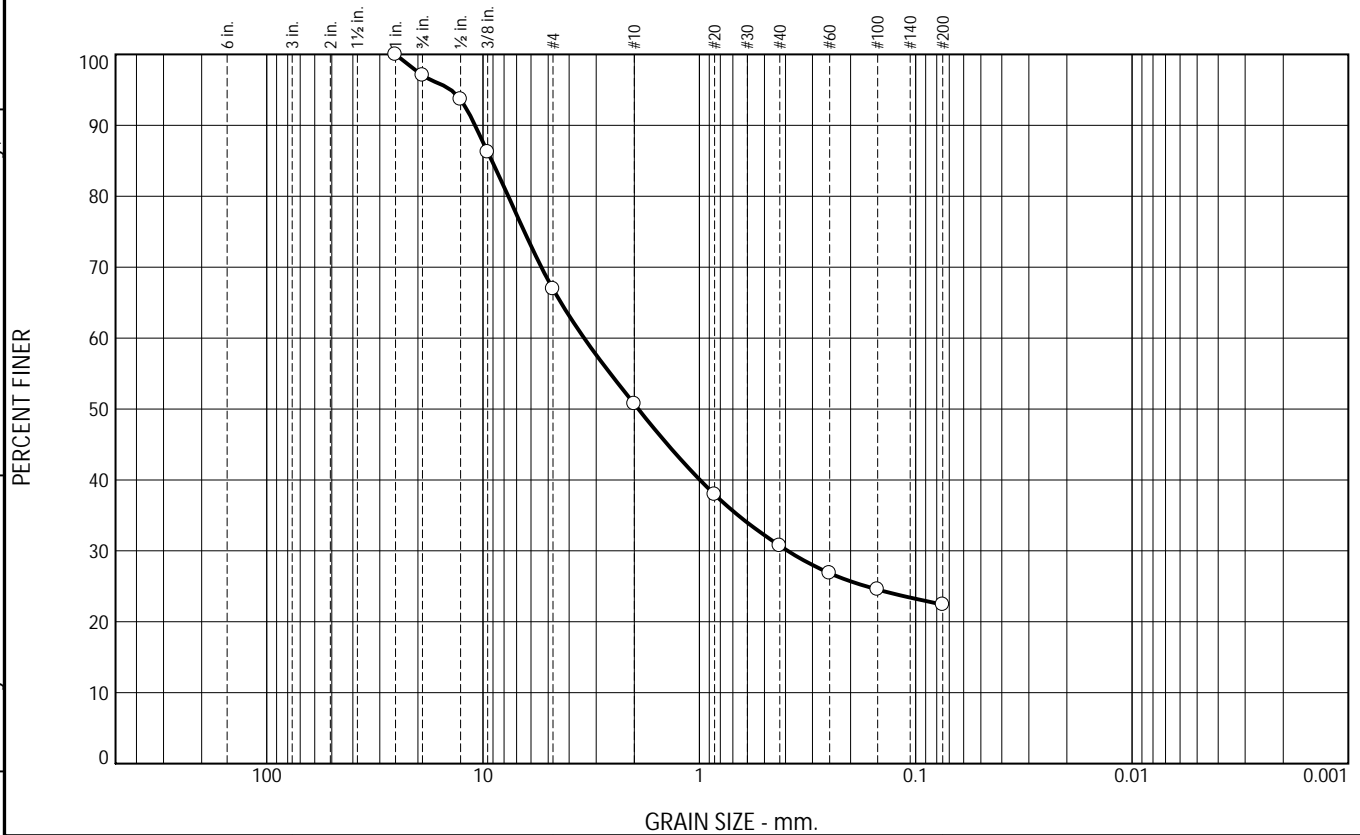
Particle Size Distribution Report

% +3"	% Gravel		% Sand			% Fines	
	Coarse	Fine	Coarse	Medium	Fine	Silt	Clay
0.0	2.9	30.2	16.2	20.0	8.3	22.4

SIEVE SIZE OR DIAMETER	PERCENT FINER	SPEC.* PERCENT	PASS? (X=NO)
1"	100.0		
3/4"	97.1		
1/2"	93.7		
3/8"	86.2		
#4	66.9		
#10	50.7		
#20	37.9		
#40	30.7		
#60	26.8		
#100	24.5		
#200	22.4

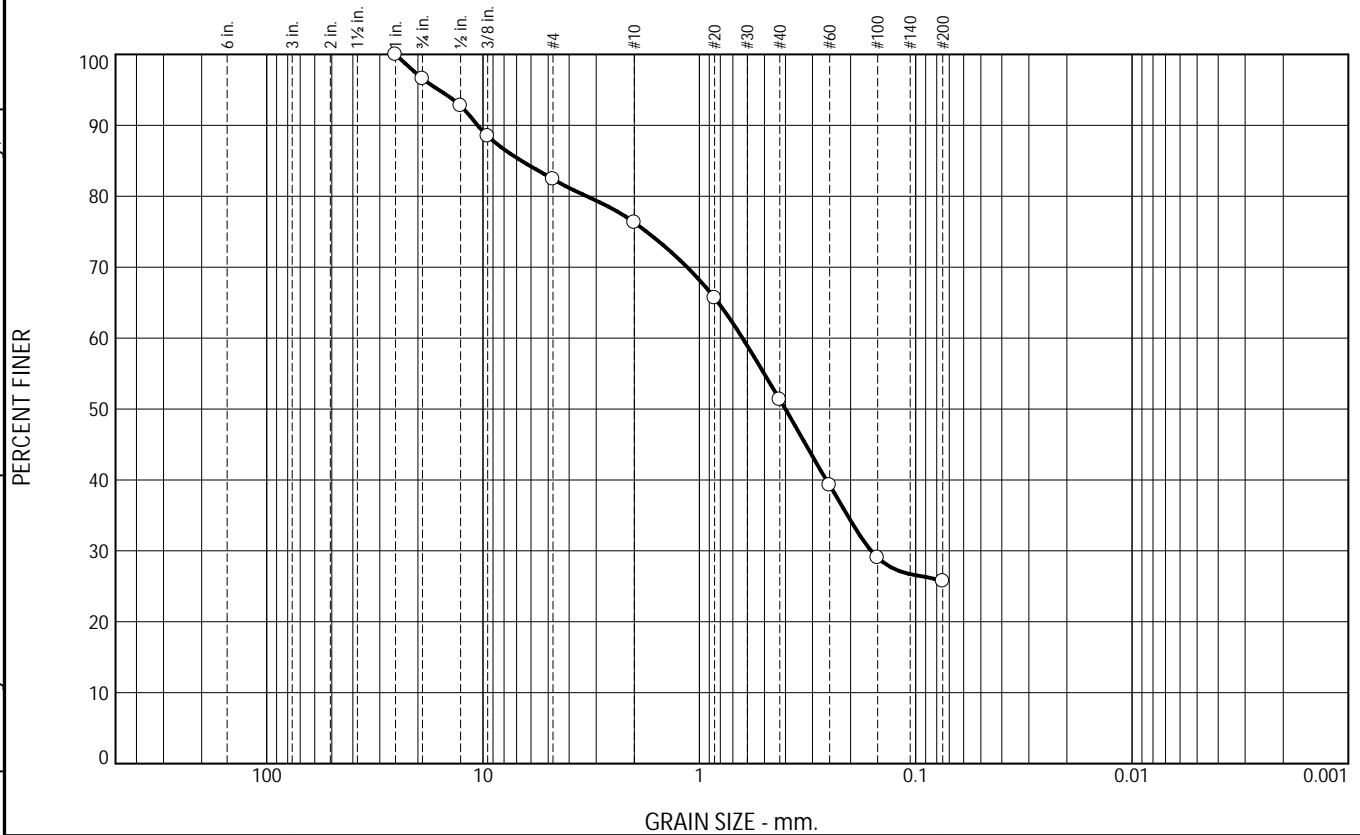
Particle Size Distribution Report

% +3"	% Gravel		% Sand			% Fines	
	Coarse	Fine	Coarse	Medium	Fine	Silt	Clay
0.0	3.4	14.2	6.1	25.0	25.6	25.7

SIEVE SIZE OR DIAMETER	PERCENT FINER	SPEC.* PERCENT	PASS? (X=NO)
1"	100.0		
3/4"	96.6		
1/2"	92.8		
3/8"	88.5		
#4	82.4		
#10	76.3		
#20	65.7		
#40	51.3		
#60	39.2		
#100	29.0		
#200	25.7

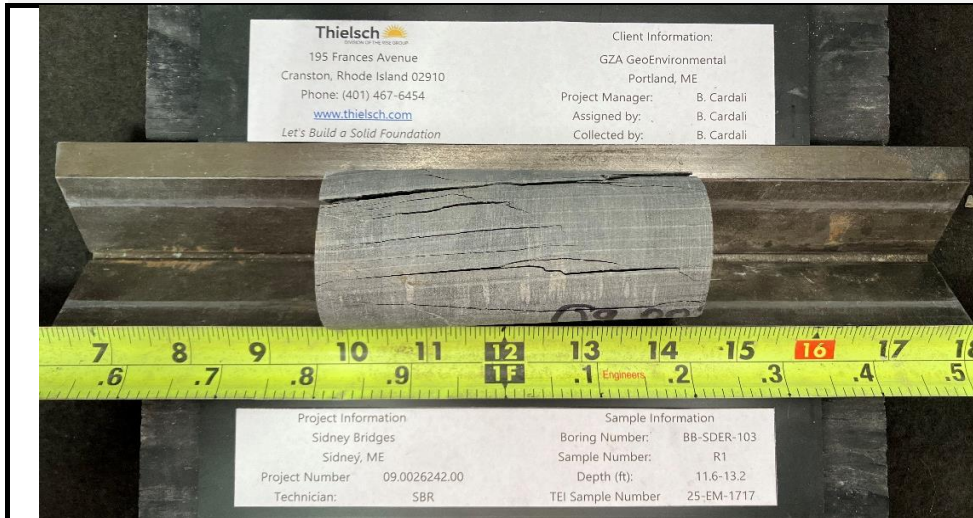
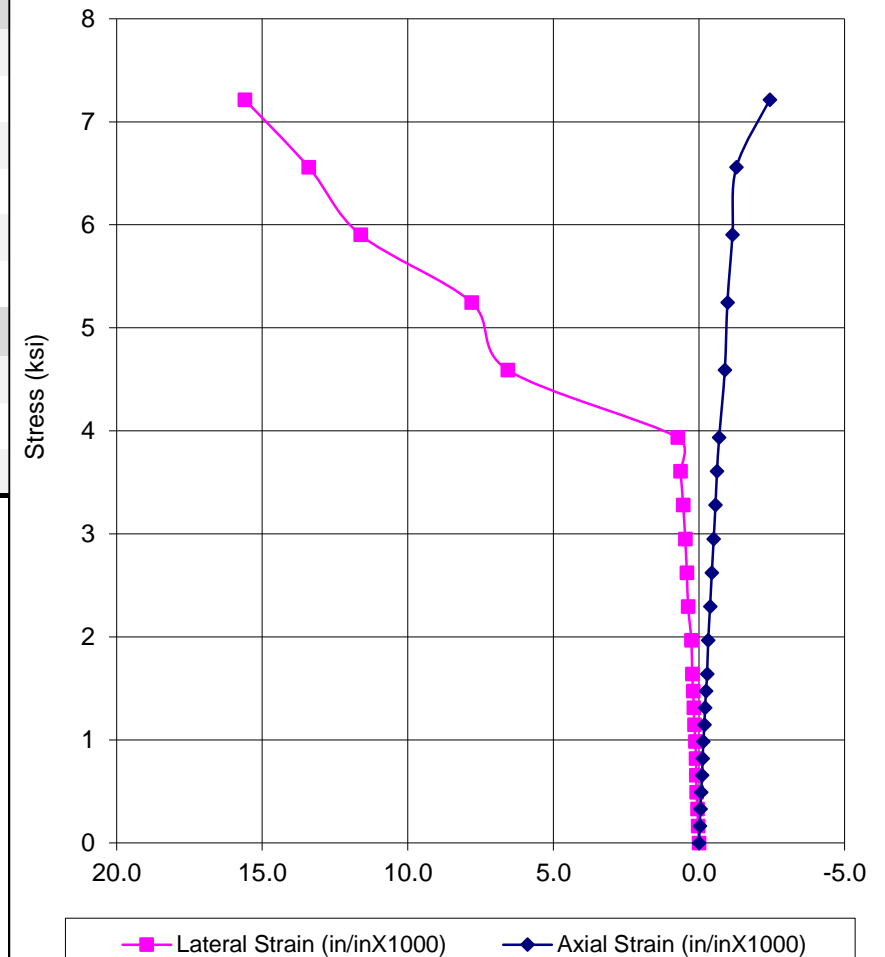
ASTM D7012 Compressive Strength and Elastic Moduli of Intact Rock Core Specimens

Sample Information		Compressive Test Information	
Boring ID:	BB-SDER-103	Unit Weight (pcf):	176.7
Sample #:	R1	Failure Stress (psi):	7,428
Depth (ft):	11.6-13.2	Failure Mode:	Fresh
Tested Depth (ft):	11.8-12.2	Time to Failure (min)	4.78
Rock Type:	Grey Slate		
Features:	Fresh Break along foliation		
Test Specimen Information		Elastic Moduli Test Information	
Diameter, D (in):	1.971	Poisson's Ratio @ 50%:	1.03
Length, L (in):	4.478	Strain %:	0.243
L:D Ratio:	2.27	E sec PSI @ 50%:	5.83E+06

Testing Notes: Partial break around 12000 pounds, 4000 psi.

SUMMARY OF BEDROCK STRENGTH TEST RESULTS						
Boring	Depth below Existing Ground (ft)	Depth below Top of Rock (ft)	Unconfined Compressive Strength (psi)	Secant Modulus @ 50% of Failure Stress (ksi)	Unit Weight (pcf)	Rock Type
BB-SDER-102	17.2	2.1	6,148	4,510	175.7	Pelite
BB-SDER-103	11.6	4.9	7,428	5,830	176.7	Pelite
BB-SDER-104A	18.9	3.6	6,252	330	178.3	Pelite

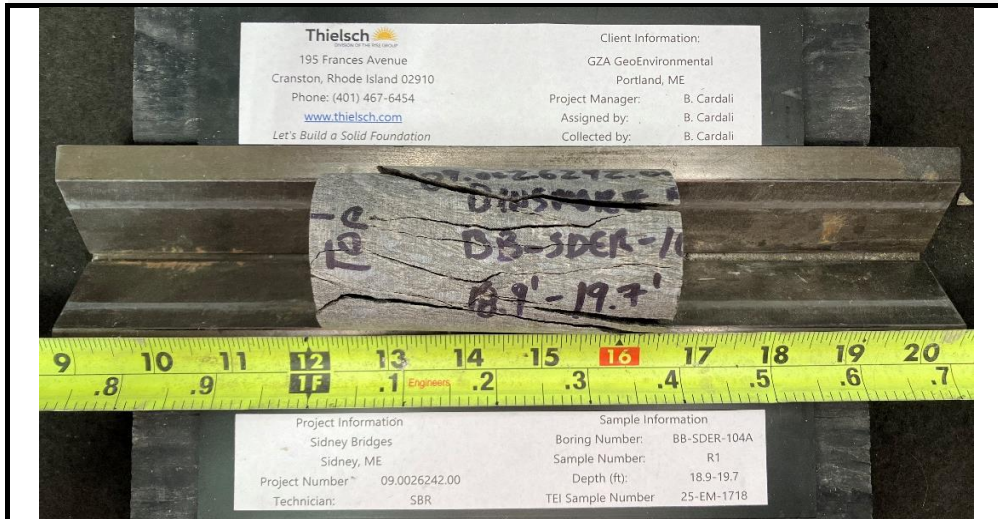
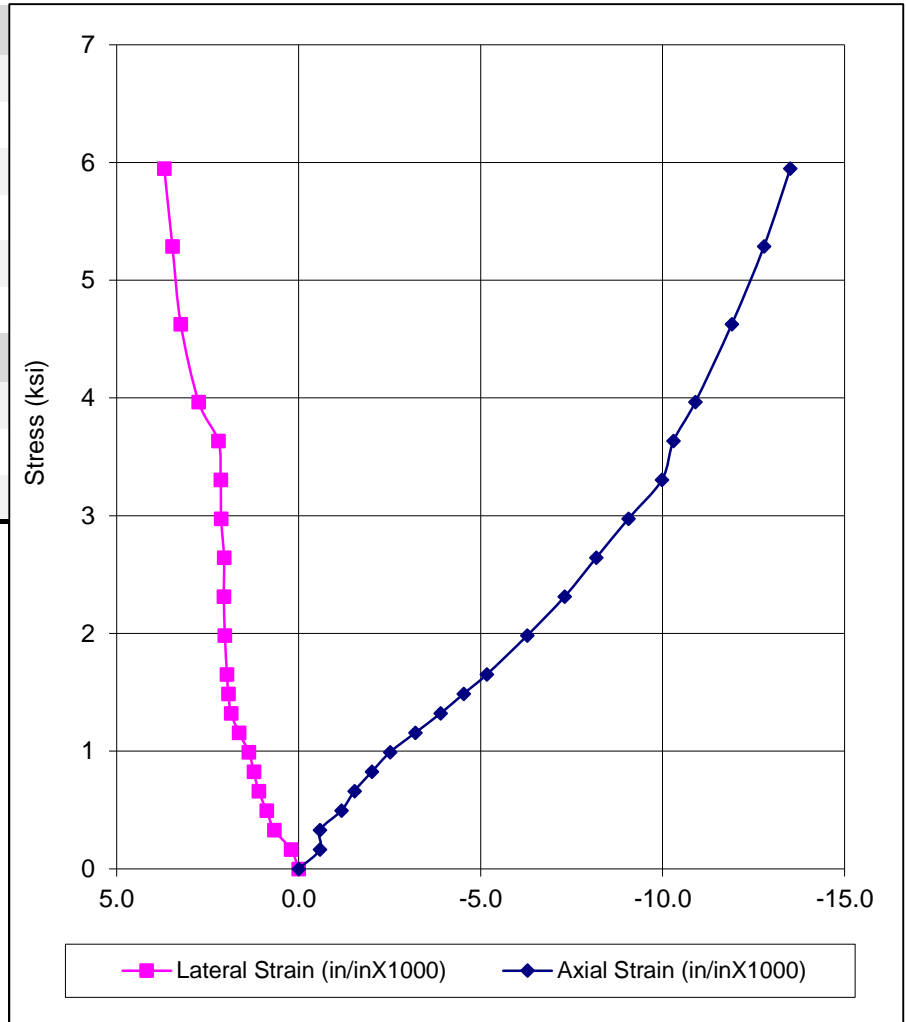
Sample Information		Compressive Test Information	
Boring ID:	BB-SDER-104A	Unit Weight (pcf):	178.3
Sample #:	R1	Failure Stress (psi):	6,252
Depth (ft):	18.9-19.7	Failure Mode:	Fresh
Tested Depth (ft):	19.0-19.4	Time to Failure (min)	4.02
Rock Type:	Grey Slate		
Features:	Fresh Break along foliation, evidence of weathering		
Test Specimen Information		Elastic Moduli Test Information	
Diameter, D (in):	1.963	Poisson's Ratio @ 50%:	0.22
Length, L (in):	4.250	Strain %:	1.351
L:D Ratio:	2.17	E sec PSI @ 50%:	3.30E+05

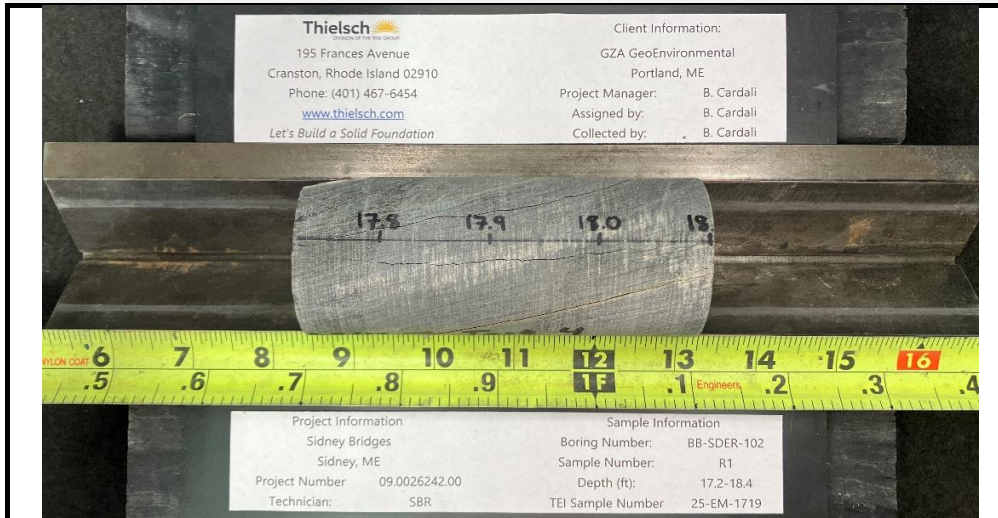
ASTM D7012 Compressive Strength and Elastic Moduli of Intact Rock Core Specimens

Sample Information		Compressive Test Information	
Boring ID:	BB-SDER-102	Unit Weight (pcf):	175.7
Sample #:	R1	Failure Stress (psi):	6,148
Depth (ft):	17.2-18.4	Failure Mode:	Fresh
Tested Depth (ft):	17.7-18.1	Time to Failure (min)	3.93
Rock Type:	Grey Slate		
Features:	Breaks along weathered plane and foliation		
Test Specimen Information		Elastic Moduli Test Information	
Diameter, D (in):	1.983	Poisson's Ratio @ 50%:	0.20
Length, L (in):	4.610	Strain %:	0.147
L:D Ratio:	2.33	E sec PSI @ 50%:	4.51E+06

Testing Notes: Minor break at 14000 pounds (4500 psi)
