**GEOTECHNICAL DATA REPORT
DINSMORE ROAD BRIDGE NO. 5782 OVER
INTERSTATE 95
MAINE DOT WIN 29486.00 (LEGACY WIN 25473.00)
SIDNEY, MAINE**

June 2025
09.0026242.00

Prepared for:
Maine Department of Transportation
Augusta, Maine

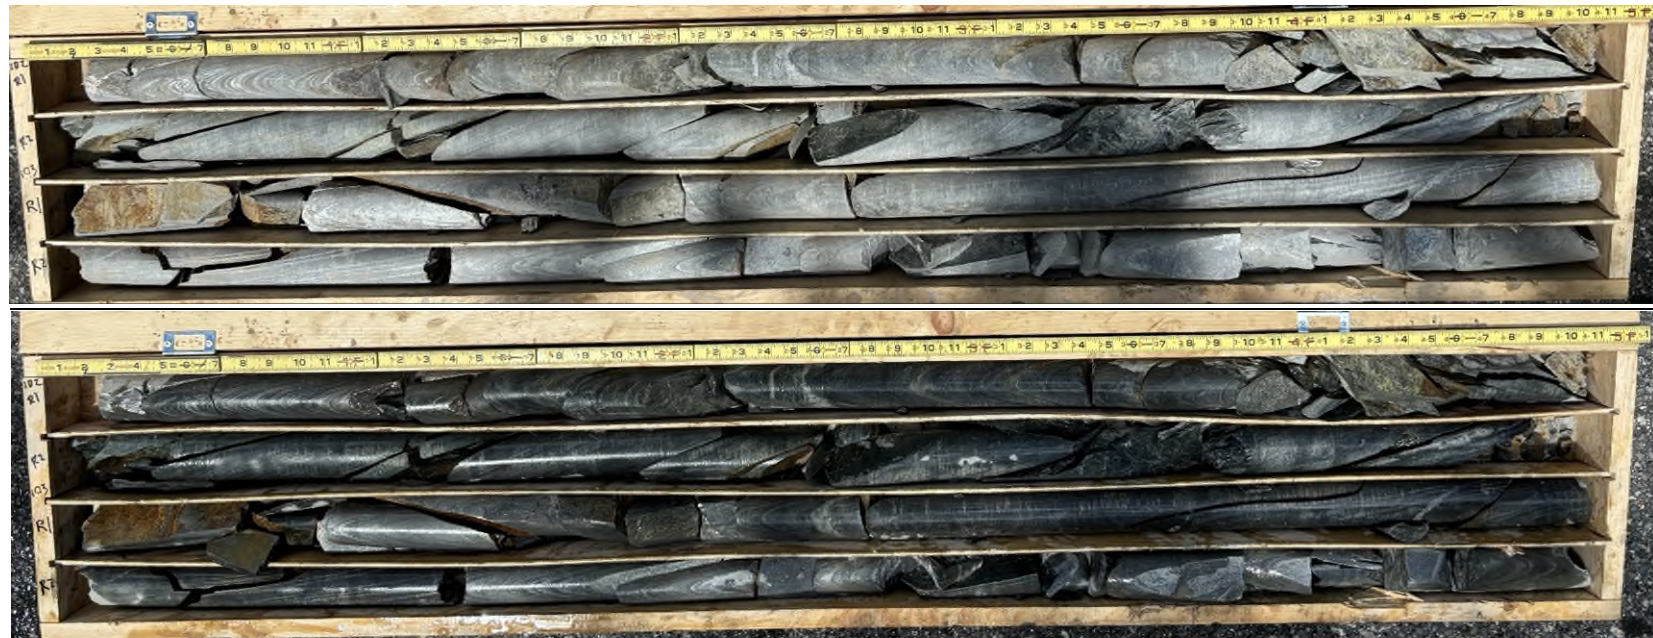
Boring No.	Run	Depth (ft)	Recovery (in)	Recovery (%)	RQD (in)	RQD (%)	Rock Type	Box Row
BB-SDER-102	R1	15.1 - 20.1	60	100%	17	28%	PELITE	1
BB-SDER-102	R2	20.1 - 25.1	57	95%	12	20%	PELITE	2
BB-SDER-103	R1	8.4 - 13.4	60	100%	36	60%	PELITE	3
BB-SDER-103	R2	13.4 - 18.4	59	98%	29	48%	PELITE	4

- Notes:**
1. Box row corresponds to the core box section in which the rock core sample is contained; Row 1=Top, Row 4=Bottom.
 2. Top photo is dry, bottom photo is wet.

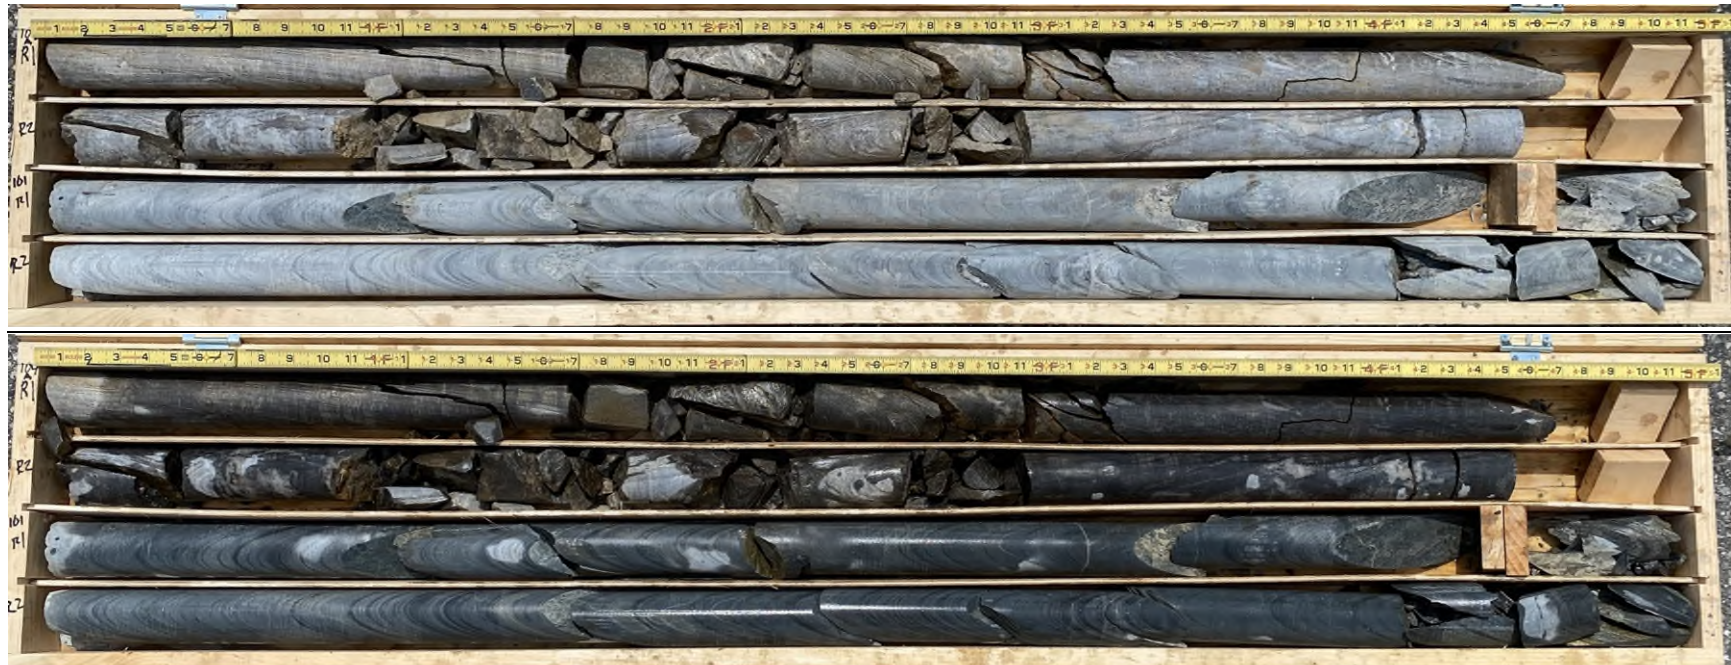
Boring No.	Run	Depth (ft)		Recovery (in)	Recovery (%)	RQD (in)	RQD (%)	Rock Type	Box Row
BB-SDER-104A	R1	15.5	- 20.5	55	92%	32	53%	PELITE	1
BB-SDER-104A	R2	20.5	- 25.5	54	90%	26	43%	PELITE	2
BB-SDER-101	R1	39.0	- 44.0	53	88%	42	70%	PELITE	3
BB-SDER-101	R2	44.0	- 49.0	60	100%	49	82%	PELITE	4

- Notes:**
1. Box row corresponds to the core box section in which the rock core sample is contained; Row 1=Top, Row 4=Bottom.
 2. Top photo is dry, bottom photo is wet
