**GEOTECHNICAL DATA REPORT  
TOWN FARM ROAD BRIDGE NO. 5785 OVER  
INTERSTATE 95  
MAINE DOT WIN 29486.00 (LEGACY WIN 27266.00)  
SIDNEY, MAINE**

June 2025  
09.0026242.00

**Prepared for:**  
Maine Department of Transportation  
Augusta, Maine

**Prepared by:**  
**GZA GeoEnvironmental, Inc.**  
707 Sable Oaks Drive | Suite 150 | South Portland, Maine 04106  
207.879.9190

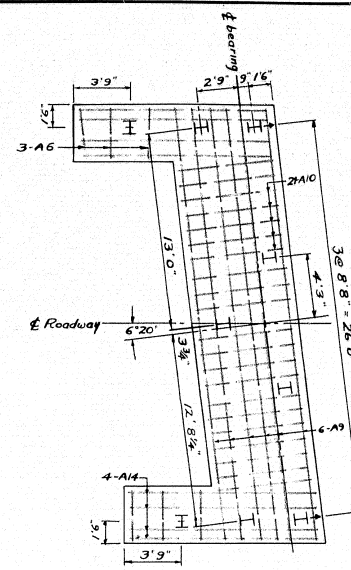
PILE & REINFORCING STEEL  
PLAN - ABUTMENT NO. 1

Required: 9-10" 10" 42" steel H-piles (Driven to ledge)  
Est. length 30'0". Max. pile load 37 tons.  
Pile cutoff elevation 189.08.

The 1958 as-built plans indicate that the two stub abutments are supported by HP 10x42 piles that are either plumb or battered at 2.5:12. Abutments 1 and 2 are supported by 9 and 12 piles, respectively. The piles were designed using an allowable design capacity of 37 and 30 tons for Abutments 1 and 2, respectively. The piles supporting the abutments were estimated to be between 30 to 40 feet long. The four pier stems are shown to be supported by spread footings bearing on marine sand or glacial till. The pier spread footings were designed an allowable bearing pressure of 2.5 tons per square foot (tsf). The existing approach embankments are approximately 13 to 19 feet above original grades. The available historic foundation drawings are attached in **Appendix B**.

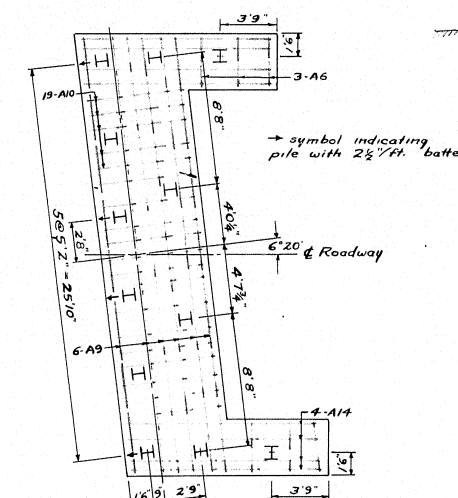
PILE & REINFORCING STEEL  
PLAN - ABUTMENT NO. 2

Required: 12-10" 10" 42" steel H-piles.  
Est. length 40'0". Max. pile load 30 tons.  
Pile cutoff elevation 182.13.

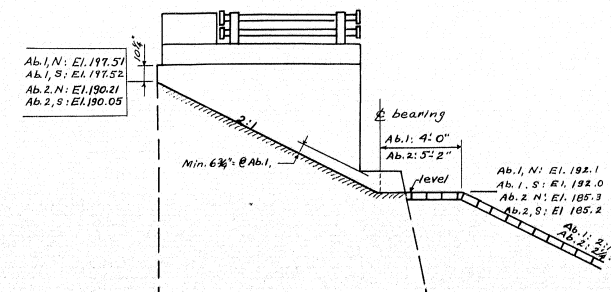
SLOPES AT ABUTMENTS

Abutment No. 1, South Wing, & Abutment No. 2, North Wing: As shown. Other Wings: Opp. hand.

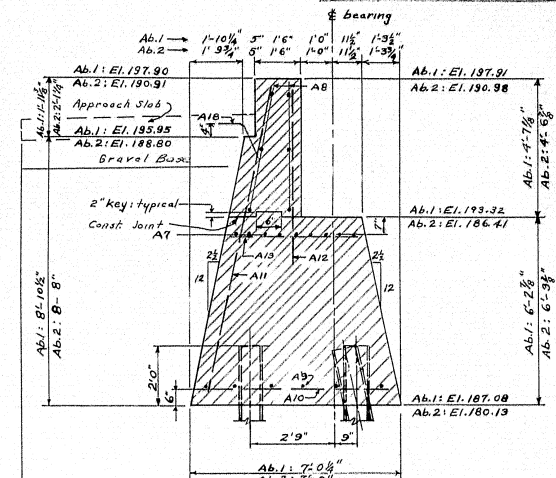
SECTION B-B

Grade areas under abutments to elevations shown before driving piles.

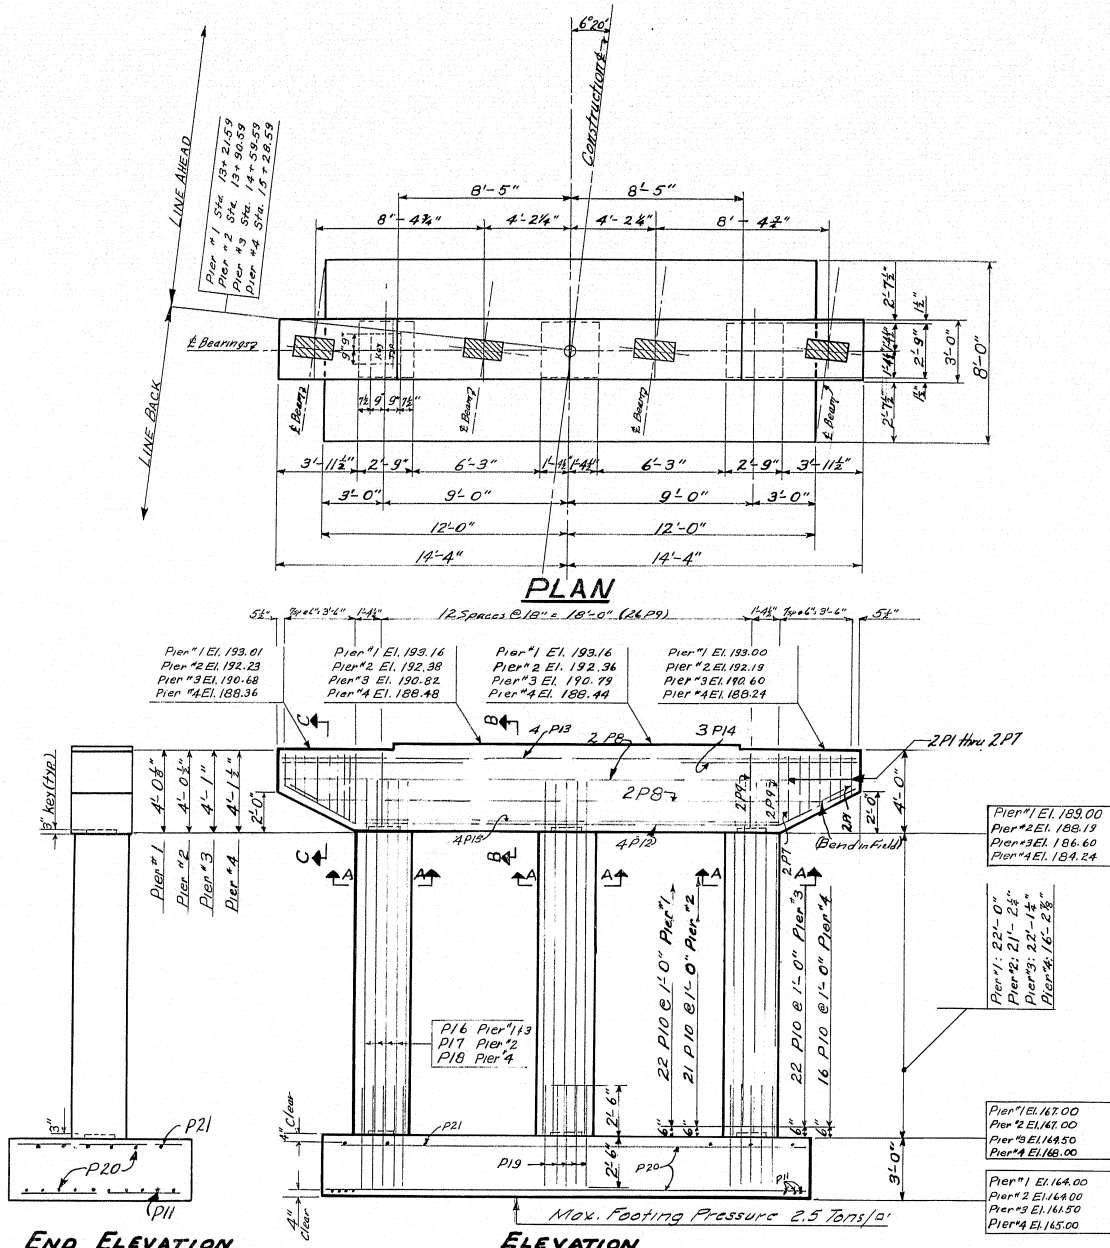
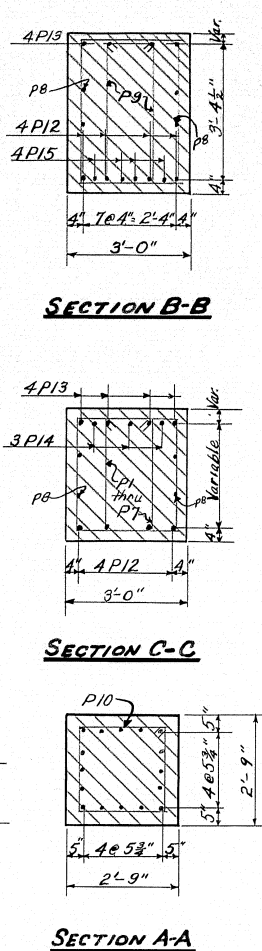
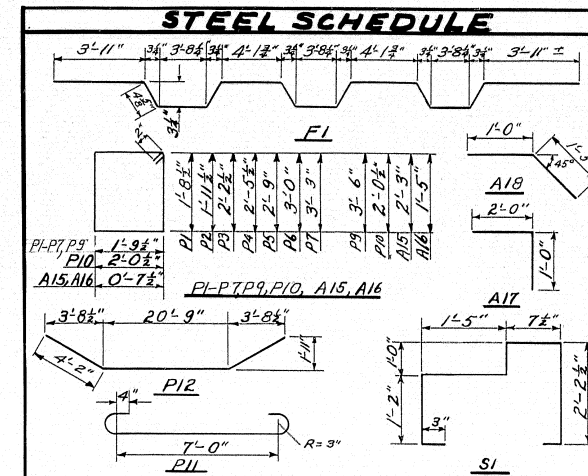
DESIGN-DRESELY TRACE-MWM & R.D. CHECK-N. J. Smith	BRIDGE NO. SURVEY - PLOT
STATE HIGHWAY COMMISSION BRIDGE DIVISION	
TOWN FARM ROAD BRIDGE OVER INTERSTATE HIGHWAY IN THE TOWN OF SIDNEY KENNEBEC COUNTY	
ABUTMENTS	
SHEET 11 OF 18 AUGUSTA, MAINE MARCH, 1958

Dress shaded areas to exact bridge seat elevations shown.  
All chamfers to be 1/2" and V-grooves 1".  
Place reinforcing steel in bridge seats to clear anchor bolts.  
Concrete end posts, rail curbs and curb inserts to be Class A concrete, and to be paid for under Item 701-33, PCC abutments and retaining walls.  
Backwall to be built after structural steel is erected. See sheet 15 for setting expansion dams in backwalls.

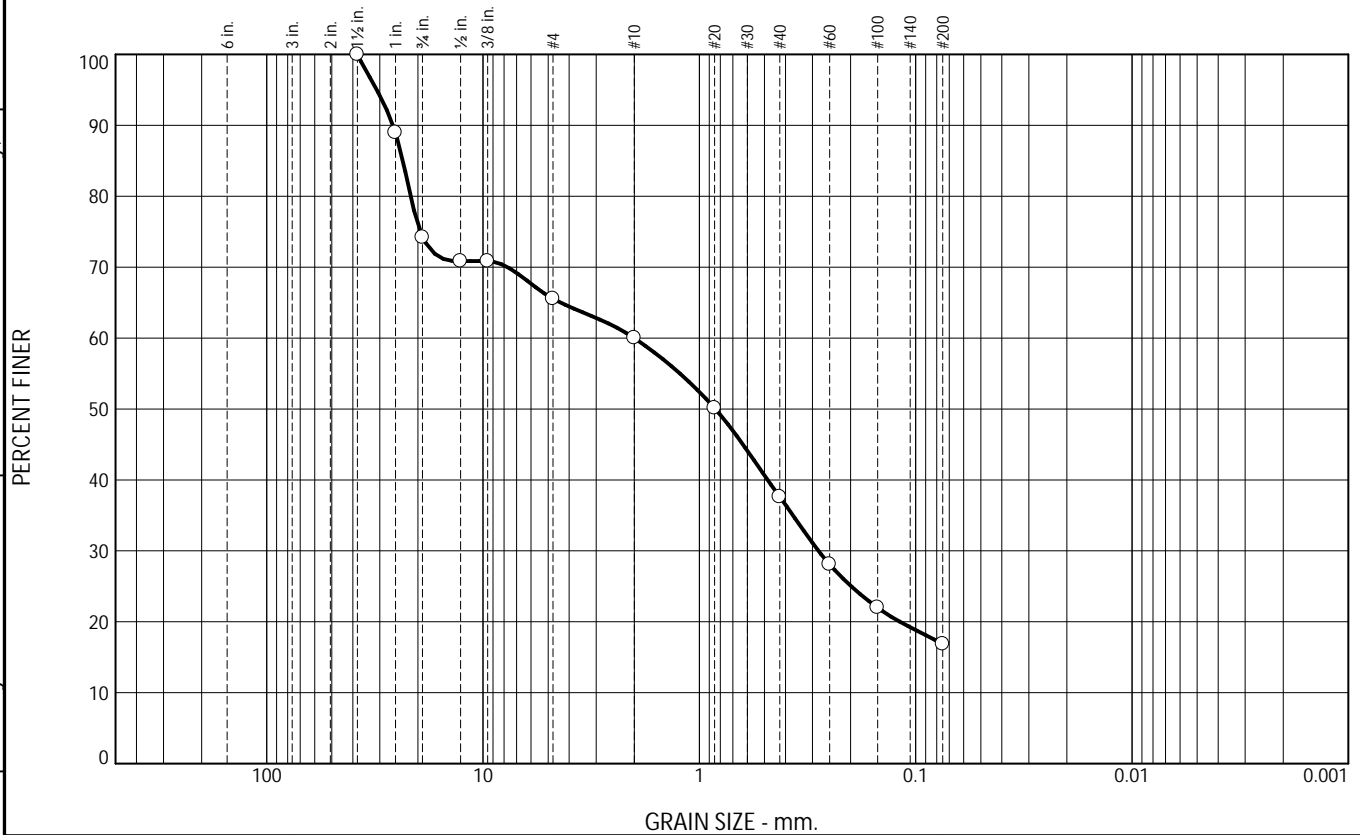
## Particle Size Distribution Report

% +3"	% Gravel		% Sand			% Fines	
	Coarse	Fine	Coarse	Medium	Fine	Silt	Clay
0.0	25.8	8.6	5.6	22.4	20.8	16.8

SIEVE SIZE OR DIAMETER	PERCENT FINER	SPEC.* PERCENT	PASS? (X=NO)
1 1/2"	100.0		
1"	89.0		
3/4"	74.2		
1/2"	70.9		
3/8"	70.9		
#4	65.6		
#10	60.0		
#20	50.1		
#40	37.6		
#60	28.1		
#100	22.0		
#200	16.8

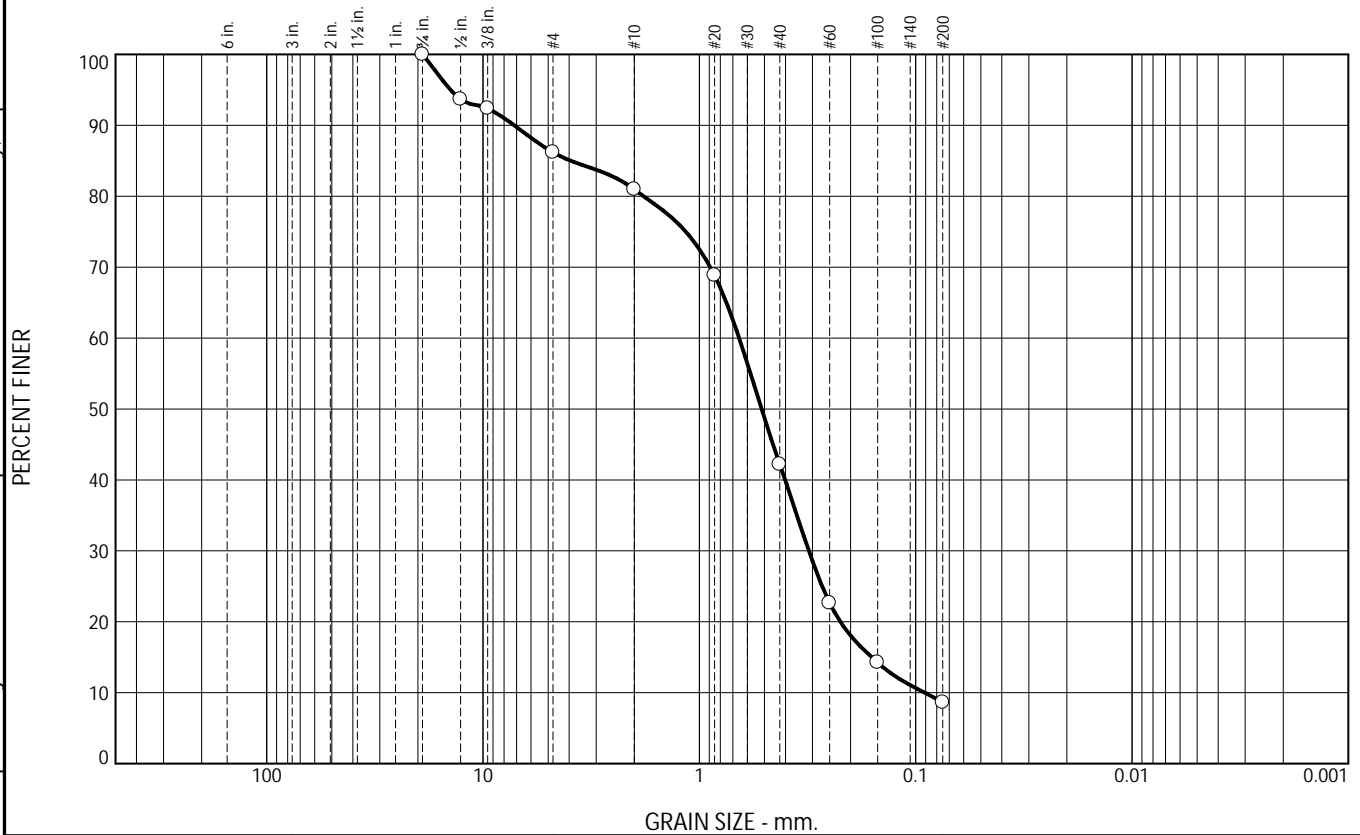
## Particle Size Distribution Report

% +3"	% Gravel		% Sand			% Fines	
	Coarse	Fine	Coarse	Medium	Fine	Silt	Clay
0.0	0.0	13.8	5.2	38.8	33.6	8.6

SIEVE SIZE OR DIAMETER	PERCENT FINER	SPEC.* PERCENT	PASS? (X=NO)
3/4"	100.0		
1/2"	93.7		
3/8"	92.4		
#4	86.2		
#10	81.0		
#20	68.8		
#40	42.2		
#60	22.7		
#100	14.3		
#200	8.6

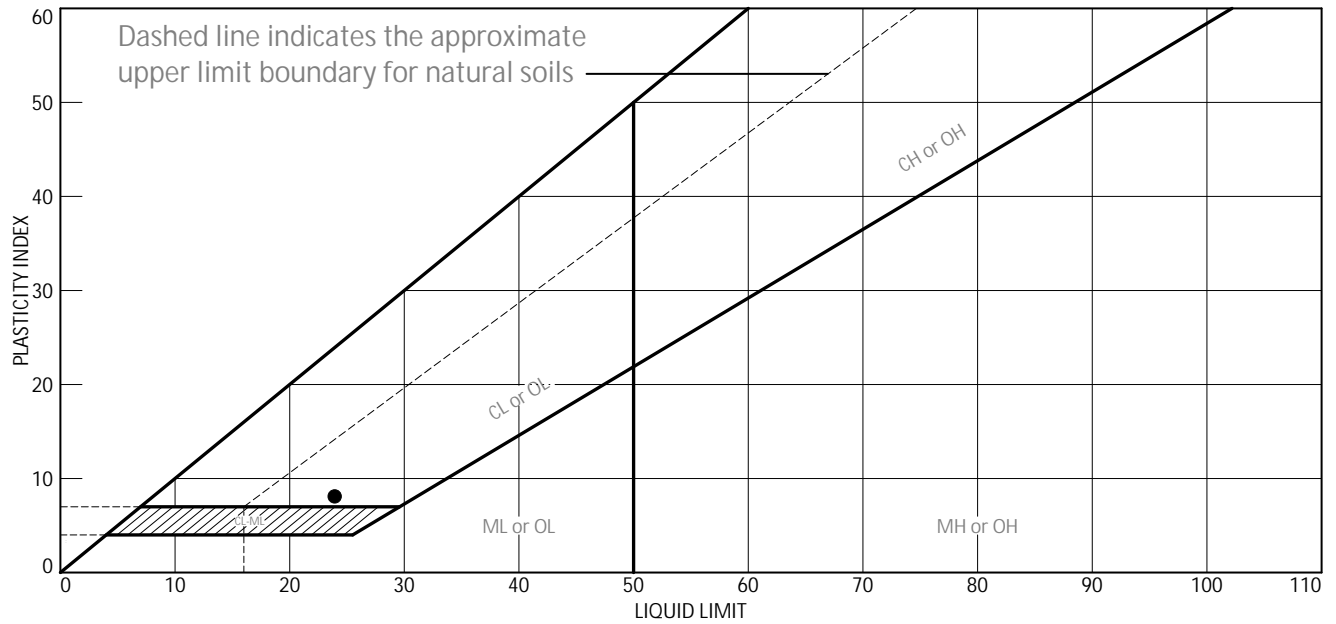
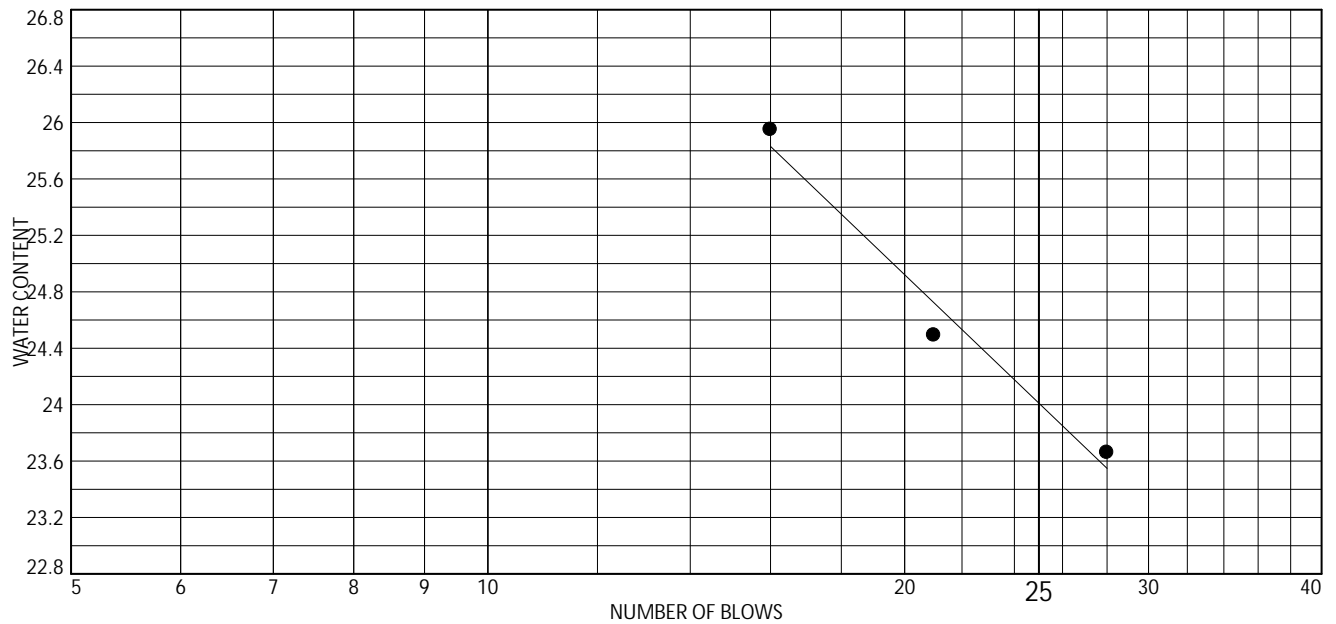
## LIQUID AND PLASTIC LIMITS TEST REPORT

MATERIAL DESCRIPTION	LL	PL	PI	%<#40	%<#200	USCS
Brown SILT & CLAY, trace fine Sand	24	16	8	100.0	95.8	CL

Project No. 09.0026242.00 Task 1 Client: GZA GeoEnvironmental  
Project: Town Farm Road Bridge #5785  
Sidney, ME  
Source of Sample: BB-STFR-102 Depth: 8-10'  
Sample Number: 2D

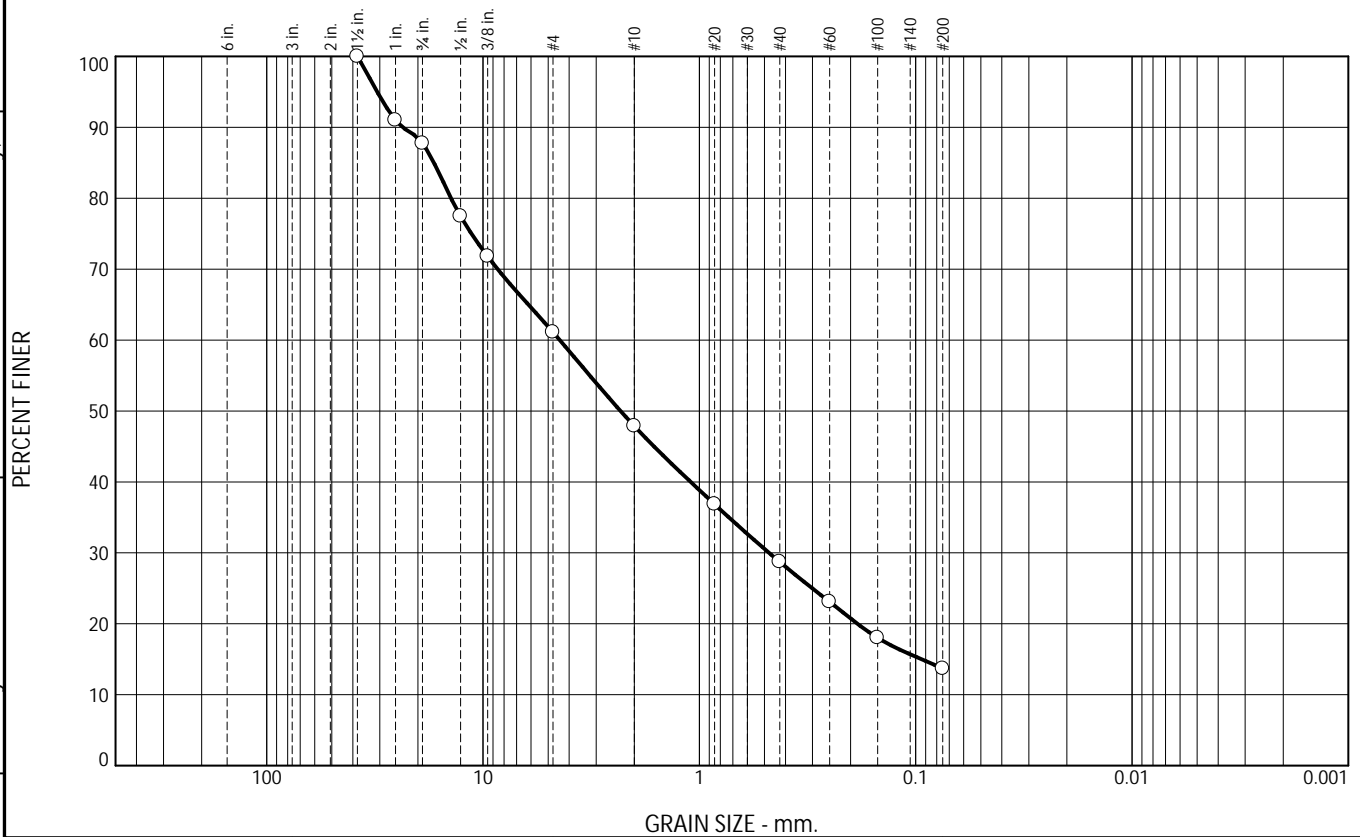
## Particle Size Distribution Report

% +3"	% Gravel		% Sand			% Fines	
	Coarse	Fine	Coarse	Medium	Fine	Silt	Clay
0.0	12.3	26.6	13.2	19.2	15.0	13.7

SIEVE SIZE OR DIAMETER	PERCENT FINER	SPEC.* PERCENT	PASS? (X=NO)
1 1/2"	100.0		
1"	91.0		
3/4"	87.7		
1/2"	77.5		
3/8"	71.8		
#4	61.1		
#10	47.9		
#20	36.8		
#40	28.7		
#60	23.1		
#100	18.0		
#200	13.7

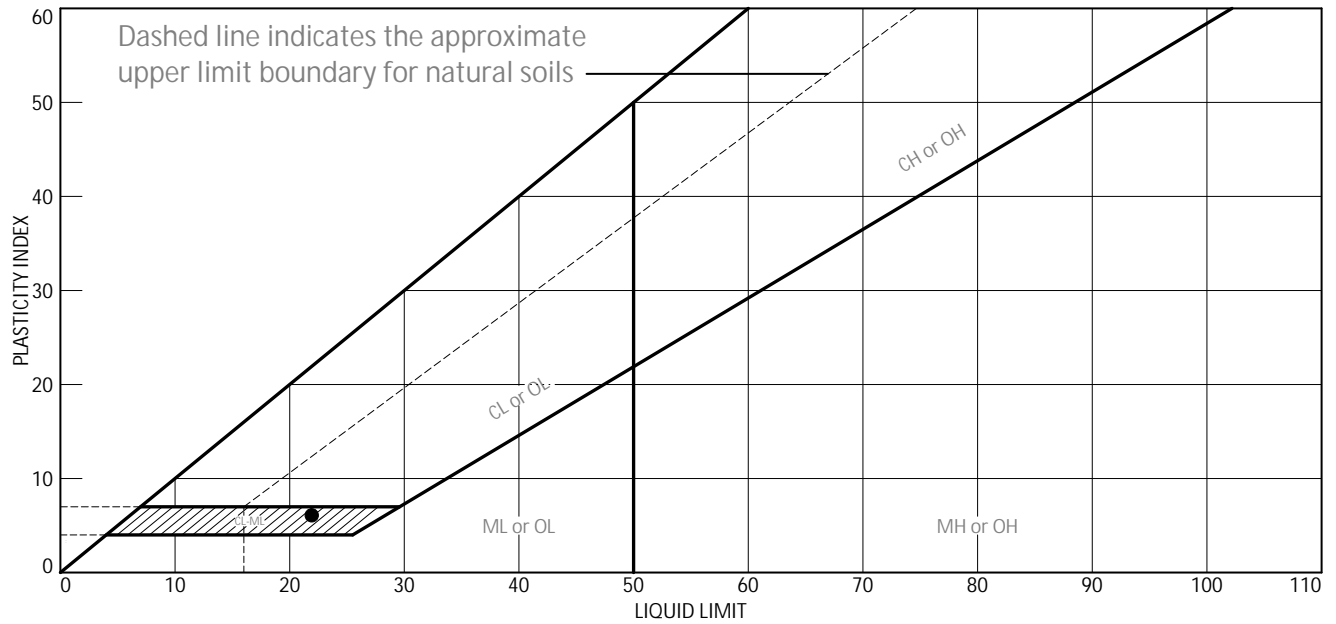
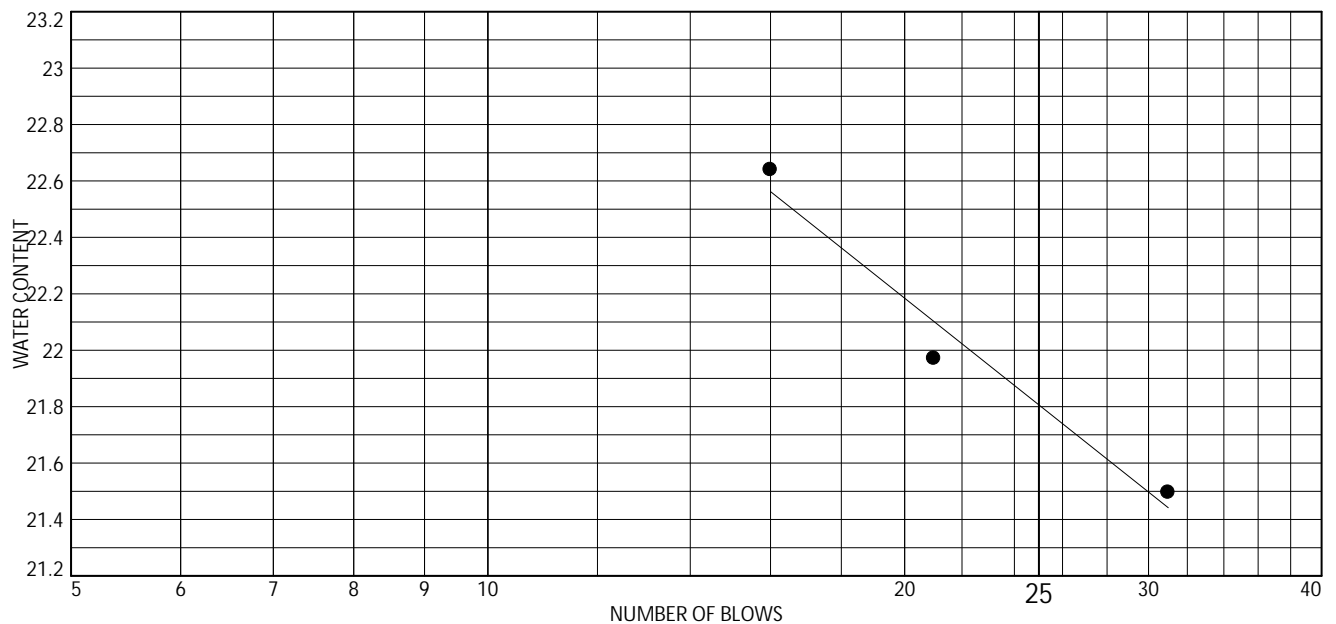
## LIQUID AND PLASTIC LIMITS TEST REPORT

MATERIAL DESCRIPTION	LL	PL	PI	%<#40	%<#200	USCS
Brown SILT & CLAY	22	16	6

Project No. 09.0026242.00 Task 1 Client: GZA GeoEnvironmental  
Project: Town Farm Road Bridge #5785  
Sidney, ME  
Source of Sample: BB-STFR-103 Depth: 5-7'  
Sample Number: 2D

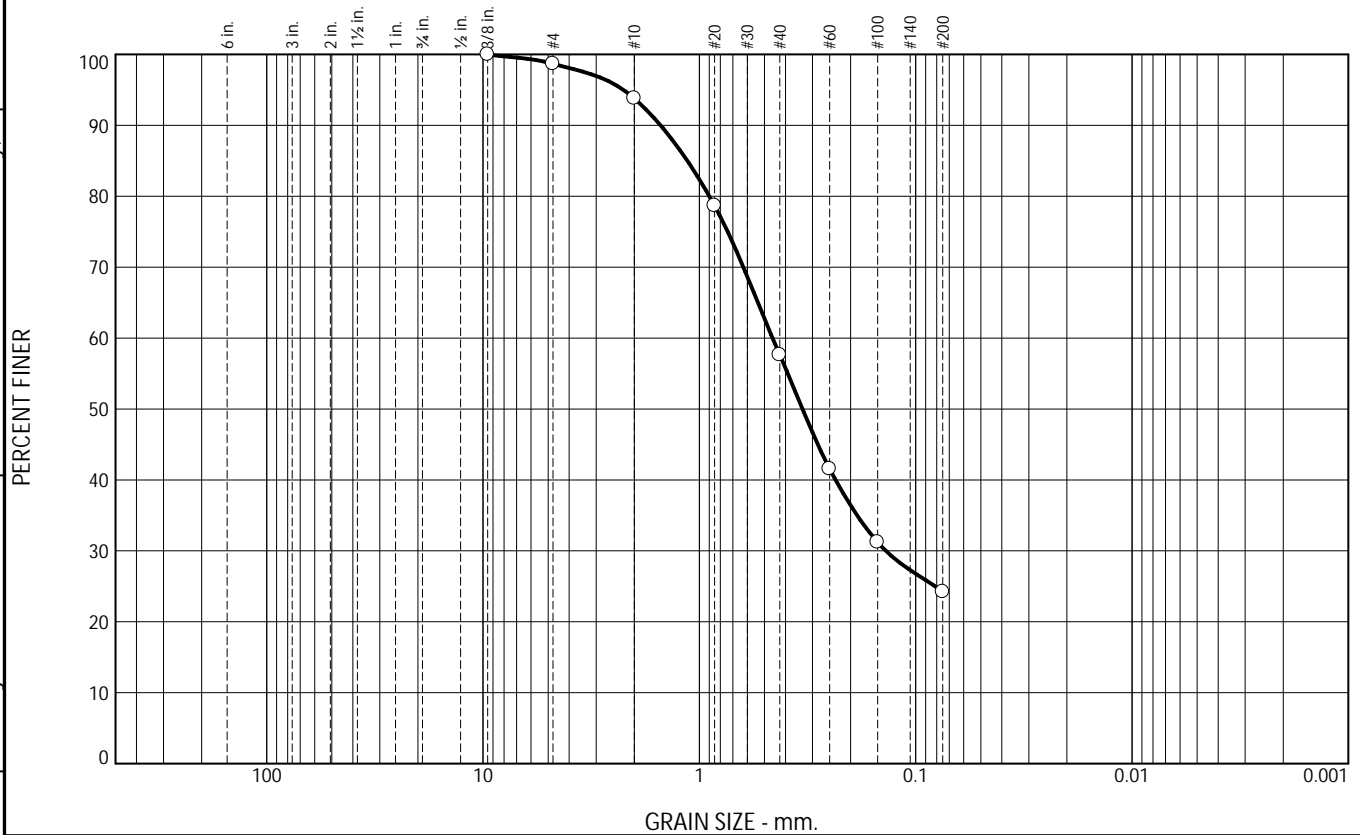
## Particle Size Distribution Report

% +3"	% Gravel		% Sand			% Fines	
	Coarse	Fine	Coarse	Medium	Fine	Silt	Clay
0.0	0.0	1.3	4.9	36.2	33.4	24.2

SIEVE SIZE OR DIAMETER	PERCENT FINER	SPEC.* PERCENT	PASS? (X=NO)
3/8"	100.0		
#4	98.7		
#10	93.8		
#20	78.7		
#40	57.6		
#60	41.6		
#100	31.2		
#200	24.2

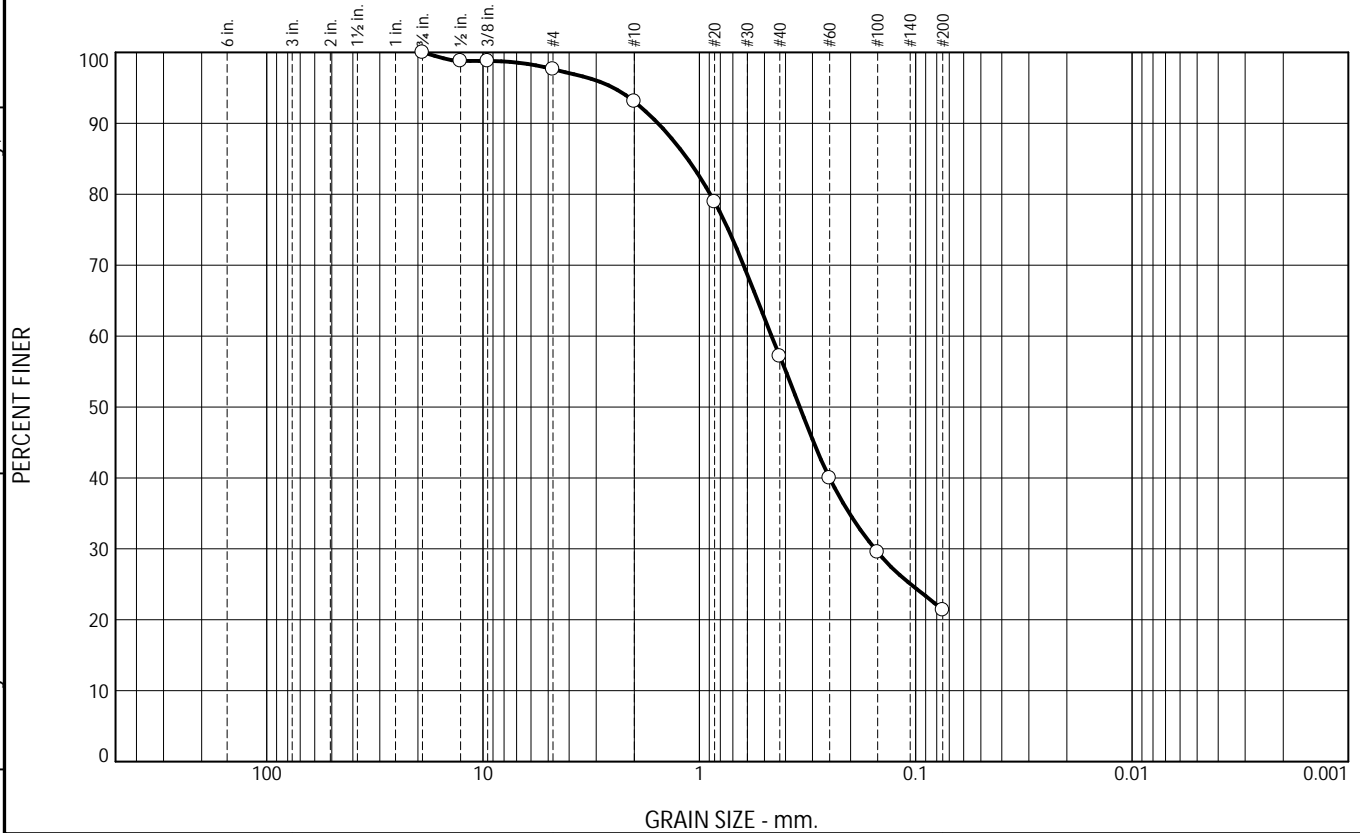
## Particle Size Distribution Report

% +3"	% Gravel		% Sand			% Fines	
	Coarse	Fine	Coarse	Medium	Fine	Silt	Clay
0.0	0.0	2.4	4.5	35.9	35.9	21.3

SIEVE SIZE OR DIAMETER	PERCENT FINER	SPEC.* PERCENT	PASS? (X=NO)
3/4"	100.0		
1/2"	98.8		
3/8"	98.8		
#4	97.6		
#10	93.1		
#20	78.9		
#40	57.2		
#60	40.0		
#100	29.5		
#200	21.3

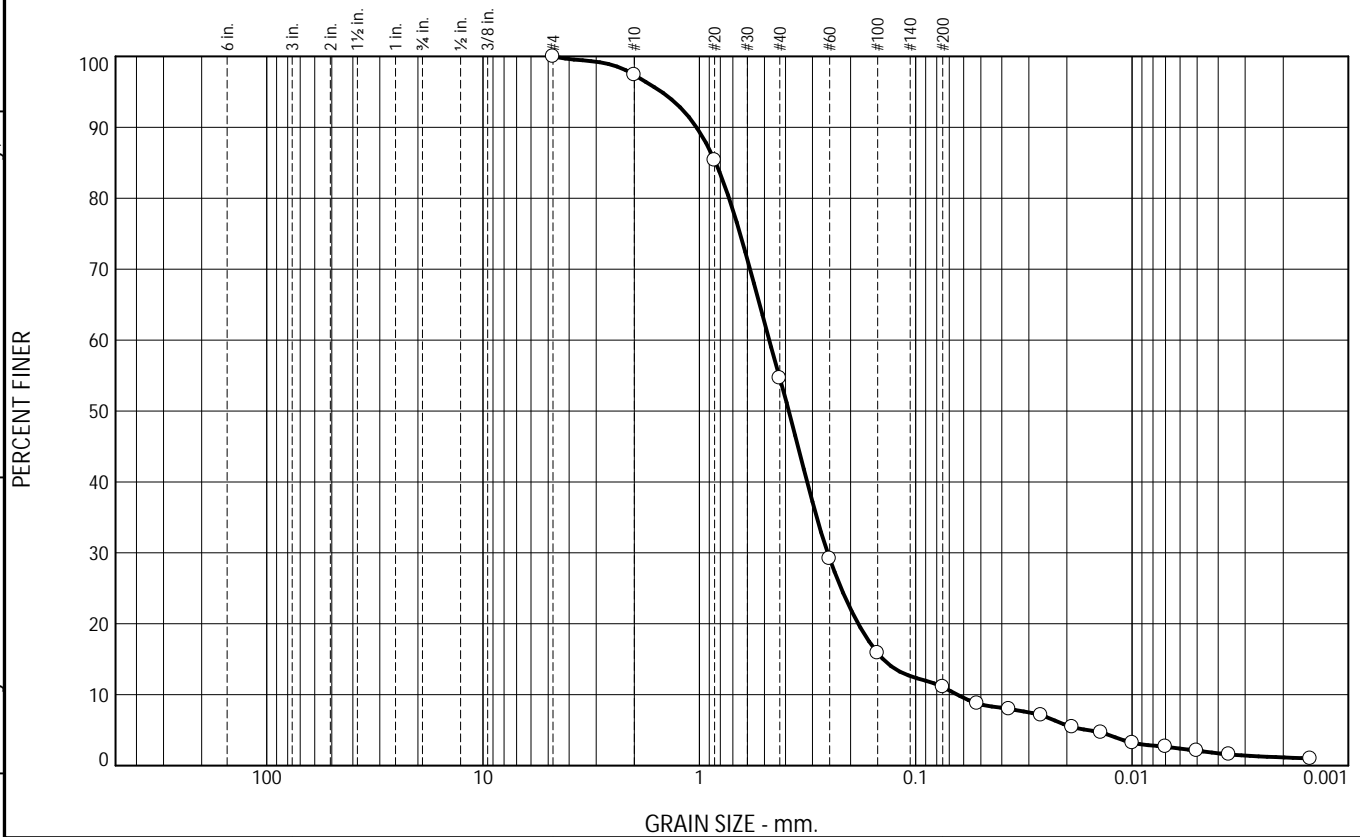
## Particle Size Distribution Report

% +3"	% Gravel		% Sand			% Fines	
	Coarse	Fine	Coarse	Medium	Fine	Silt	Clay
0.0	0.0	0.0	2.6	42.8	43.5	9.9	1.2

SIEVE SIZE OR DIAMETER	PERCENT FINER	SPEC.* PERCENT	PASS? (X=NO)
#4	100.0		
#10	97.4		
#20	85.4		
#40	54.6		
#60	29.2		
#100	15.9		
#200	11.1		
0.0520 mm.	8.8		
0.0370 mm.	8.0		
0.0264 mm.	7.1		
0.0189 mm.	5.4		
0.0139 mm.	4.7		
0.0099 mm.	3.2		
0.0070 mm.	2.7		
0.0050 mm.	2.1		
0.0036 mm.	1.6		
0.0015 mm.	1.0

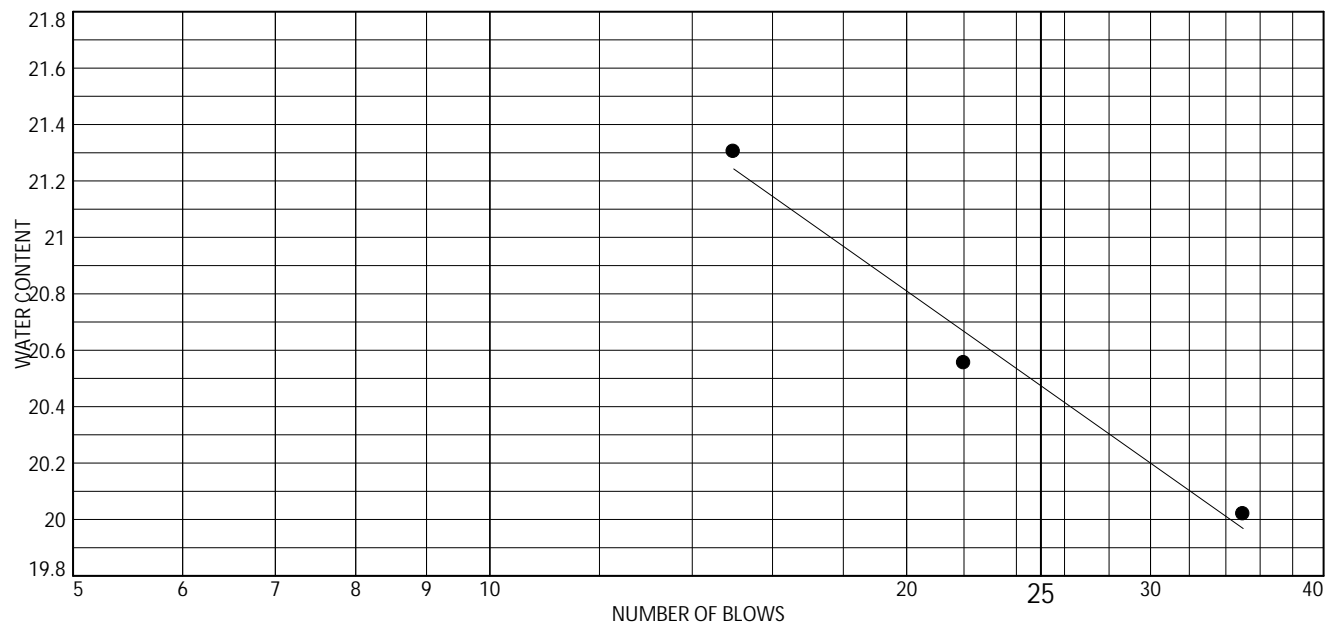
## LIQUID AND PLASTIC LIMITS TEST REPORT

MATERIAL DESCRIPTION	LL	PL	PI	%<#40	%<#200	USCS
● Grey SILT & CLAY	20	13	7

Project No. 09.0026242.00 Task 1 Client: GZA GeoEnvironmental  
Project: Town Farm Road Bridge #5785  
Sidney, ME  
Source of Sample: BB-STFR-104 Depth: 50-52'  
Sample Number: 12D

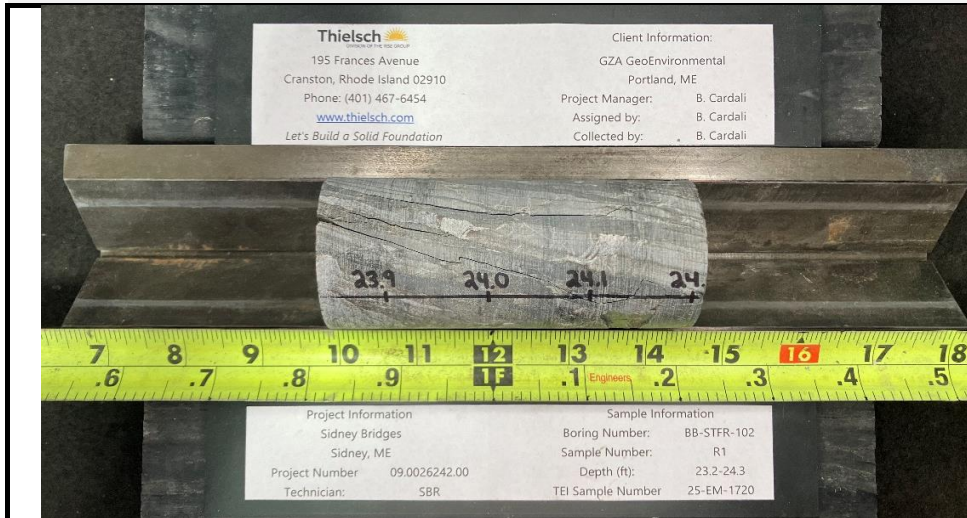
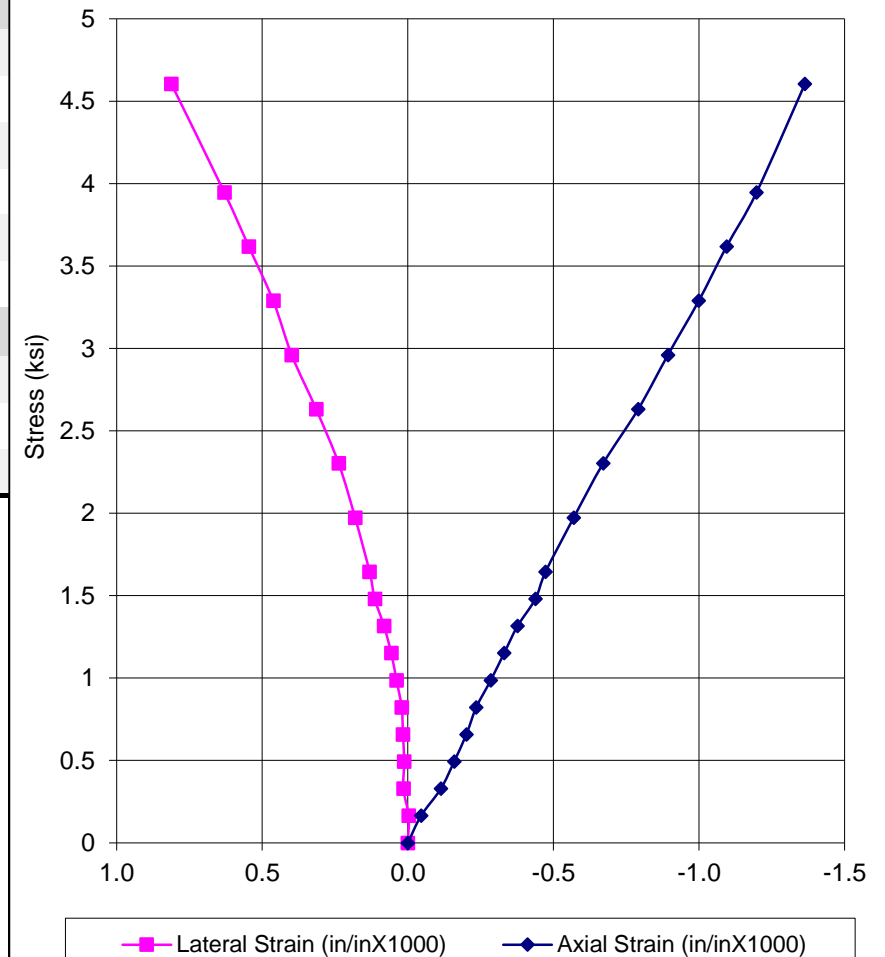
## ASTM D7012 Compressive Strength and Elastic Moduli of Intact Rock Core Specimens

Sample Information		Compressive Test Information	
Boring ID:	BB-STFR-102	Unit Weight (pcf):	172.4
Sample #:	R1	Failure Stress (psi):	5,063
Depth (ft):	23.2-24.3	Failure Mode:	Fresh
Tested Depth (ft):	23.8-24.2	Time to Failure (min)	3.27
Rock Type:	Grey Gneiss		
Features:	Fresh Break along foliation		
Test Specimen Information		Elastic Moduli Test Information	
Diameter, D (in):	1.968	Poisson's Ratio @ 50%:	0.38
Length, L (in):	4.504	Strain %:	0.136
L:D Ratio:	2.29	E sec PSI @ 50%:	3.37E+06

SUMMARY OF BEDROCK STRENGTH TEST RESULTS						
Boring	Depth below Existing Ground (ft)	Depth below Top of Rock (ft)	Unconfined Compressive Strength (psi)	Secant Modulus @ 50% of Failure Stress (ksi)	Unit Weight (pcf)	Rock Type
BB-STFR-101	42.0	7.6	11,932	5,480	175.5	Pelite
BB-STFR-102	23.2	3.6	5,063	3,370	172.4	Pelite

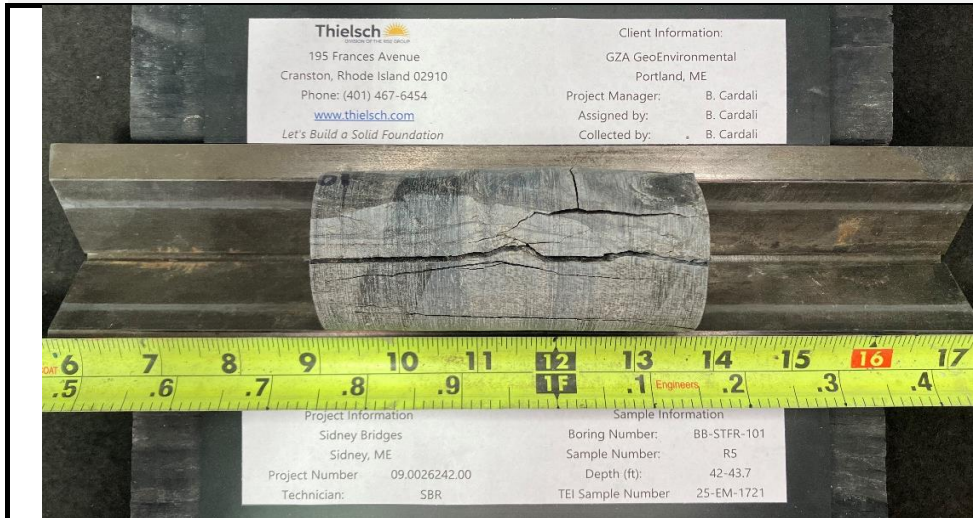
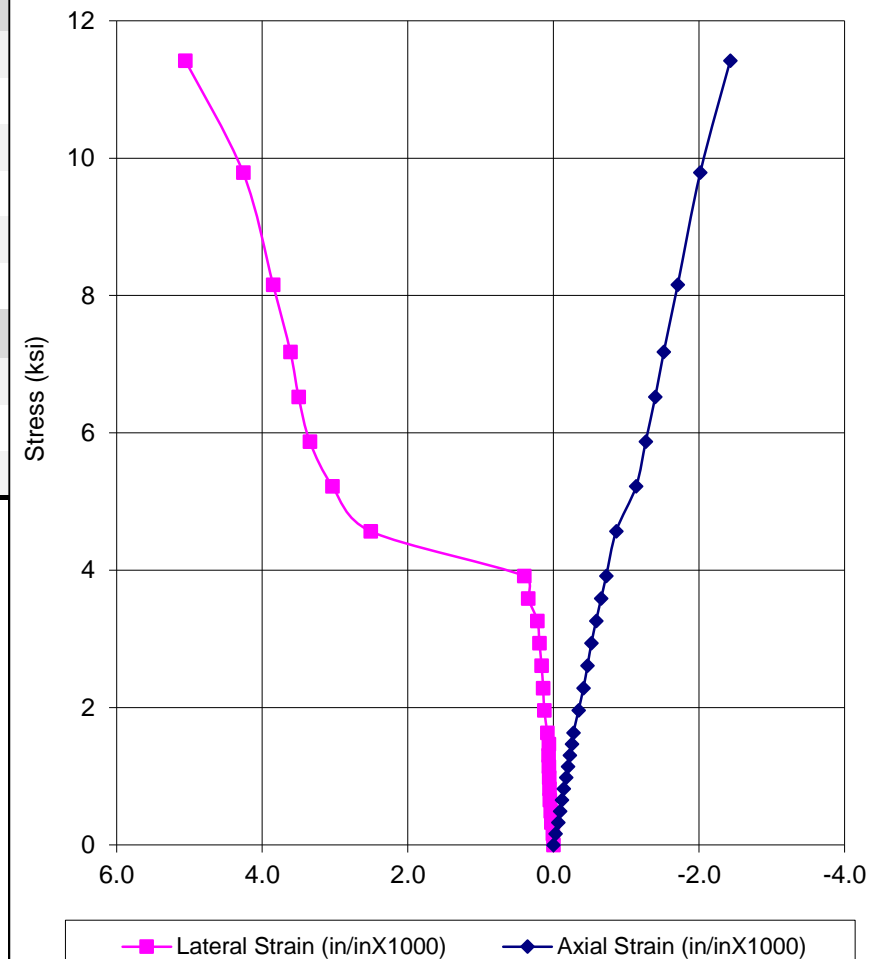
Sample Information		Compressive Test Information	
Boring ID:	BB-STFR-101	Unit Weight (pcf):	175.5
Sample #:	R5	Failure Stress (psi):	11,932
Depth (ft):	42-43.7	Failure Mode:	Fresh
Tested Depth (ft):	42.8-43.1	Time to Failure (min)	7.75
Rock Type:	Grey Gneiss		
Features:	Fresh Break along foliation		
Test Specimen Information		Elastic Moduli Test Information	
Diameter, D (in):	1.976	Poisson's Ratio @ 50%:	0.53
Length, L (in):	4.465	Strain %:	0.243
L:D Ratio:	2.26	E sec PSI @ 50%:	5.48E+06

**Testing Notes:** Early break around 12000 lbs (4000 psi)

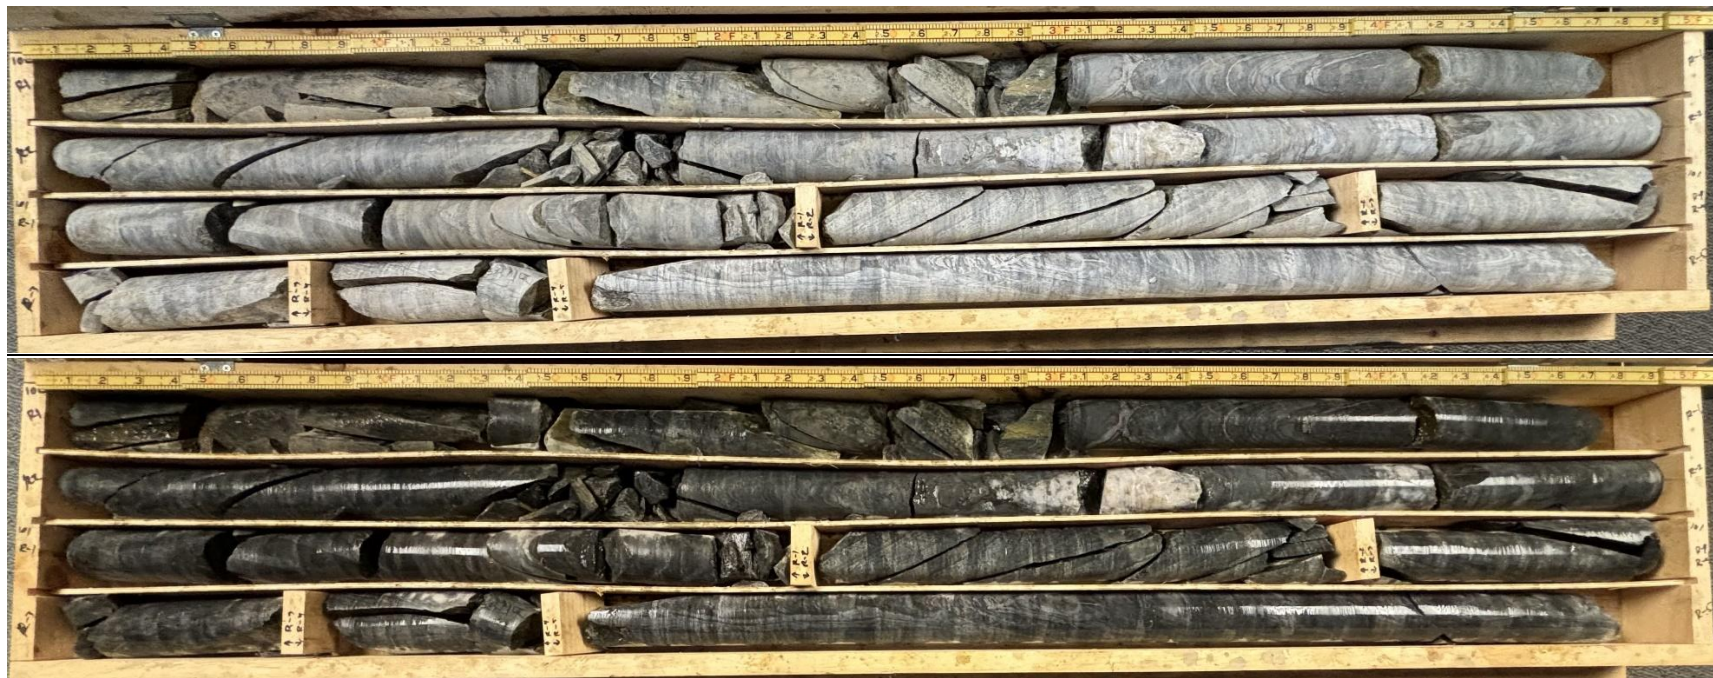
Boring No.	Run	Depth (ft)	Recovery (in)	Recovery (%)	RQD (in)	RQD (%)	Rock Type	Box Row
BB-STFR-102	R1	20.0 - 25.0	59	98%	27	45%	PELITE	1
BB-STFR-102	R2	25.0 - 30.0	60	100%	40	67%	PELITE	2
BB-STFR-101	R1	35.0 - 37.3	26	96%	13	51%	PELITE	3
BB-STFR-101	R2	37.3 - 39.0	20	100%	0	0%	PELITE	3
BB-STFR-101	R3	39.0 - 41.0	19	79%	12	50%	PELITE	3
BB-STFR-101	R4	41.0 - 42.0	10	83%	5	42%	PELITE	4
BB-STFR-101	R5	42.0 - 45.0	36	100%	36	100%	PELITE	4

1. Box row corresponds to the core box section in which the rock core sample is contained; Row 1=Top, Row 4=Bottom.
2. Top photo is dry, bottom photo is wet.

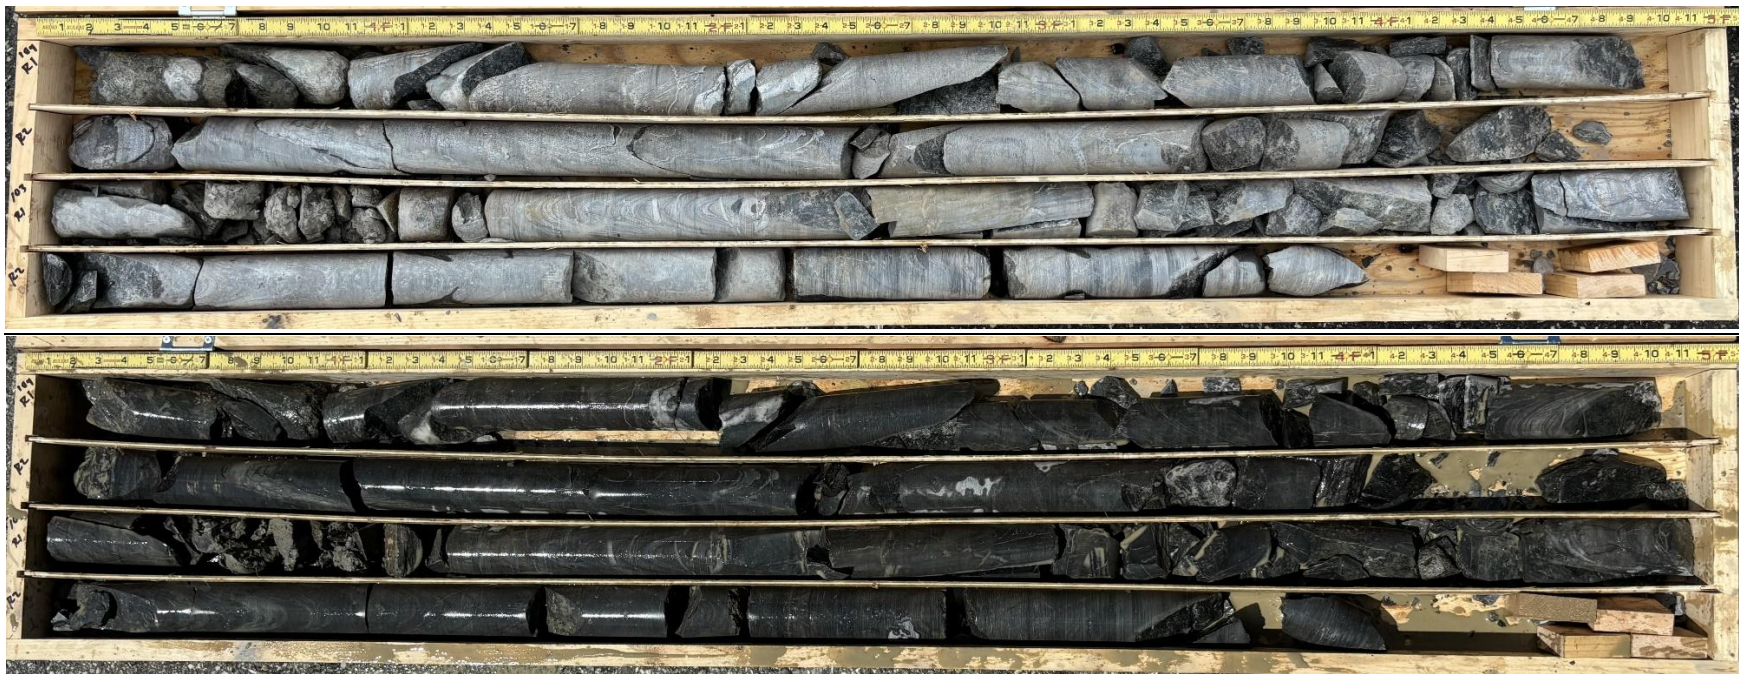
Boring No.	Run	Depth (ft)	Recovery (in)	Recovery (%)	RQD (in)	RQD (%)	Rock Type	Box Row
BB - STFR - 104	R1	69.0 - 74.0	58	97%	6	10%	PELITE	1
BB - STFR - 104	R2	74.5 - 79.5	53	88%	19	36%	PELITE	2
BB - STFR - 103	R1	24.0 - 29.0	60	100%	10	17%	PELITE	3
BB - STFR - 103	R2	28.6 - 33.6	48	80%	23	48%	PELITE	4

- Notes:**
1. Box row corresponds to the core box section in which the rock core sample is contained; Row 1=Top, Row 4=Bottom.
  2. Top photo is dry, bottom photo is wet.
