# **Dinsmore Road Bridge (BR 5782) over Interstate 95 Wetland and Watercourse Delineation and Monarch Butterfly Habitat Assessment Report**

Sidney, Maine  
WIN 25473.00

Prepared for:  
Maine Department of Transportation

Prepared by:  
Stantec Consulting Services Inc.

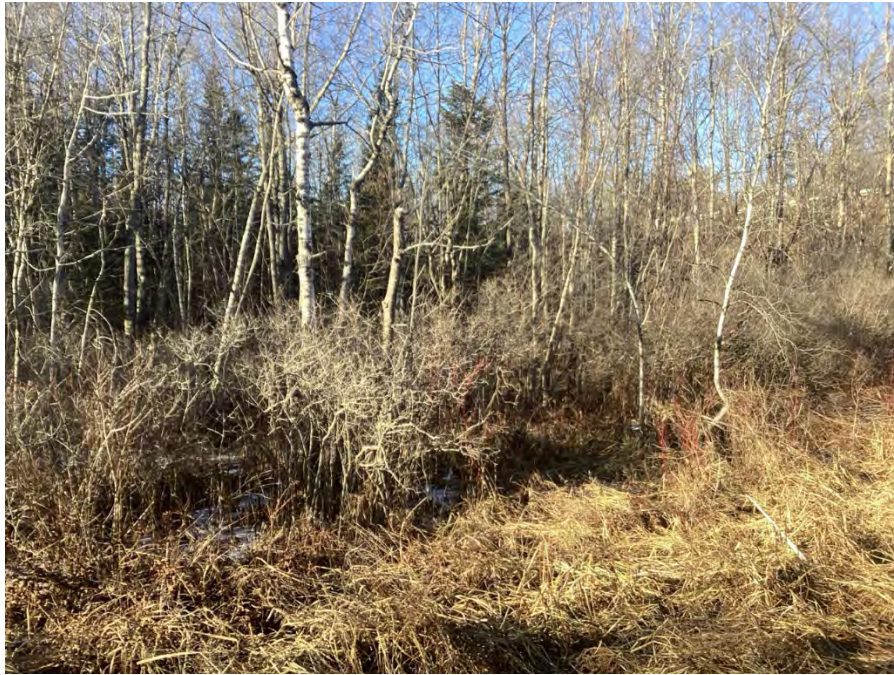
Photo 1. Wetland VK-01M. Stantec. January 10, 2025.

| Wetland Identifier | Wetland Classification <sup>1</sup> | Dominant and Characteristic Vegetation Type | Hydric Soil Criteria | WoSS Notes | Evidence of Hydrology | Comments |
|---|---|--|---|---|---|--|
| VK-01M | PFO | <b>Trees:</b> red maple ( <i>Acer rubrum</i> ), gray birch ( <i>Betula populifolia</i> ), balsam fir ( <i>Abies balsamea</i> )<br><b>Shrubs:</b> common winterberry ( <i>Ilex verticillata</i> ), broad-lead meadowsweet ( <i>Spiraea latifolia</i> ), speckled alder ( <i>Alnus incana</i> )<br><b>Herbs:</b> sensitive fern ( <i>Onoclea sensibilis</i> ), northwest territory sedge ( <i>Carex utriculata</i> ) | Frozen – not assessed | No | Surface Water, Water Marks, Water Stained Leaves | Forested wetland continuing southwest of Project site |

| <b>9. Wetland description including a soil description:</b><br>Forested wetland along I-95 and Dinsmore Rd, surface water present, continues SW off site<br>Soil: Frozen– not assessed at time of delineation. USDA NRCS soil mapped as Ridgebury very stony fine sandy loam | | | | | | | | | | | | | |

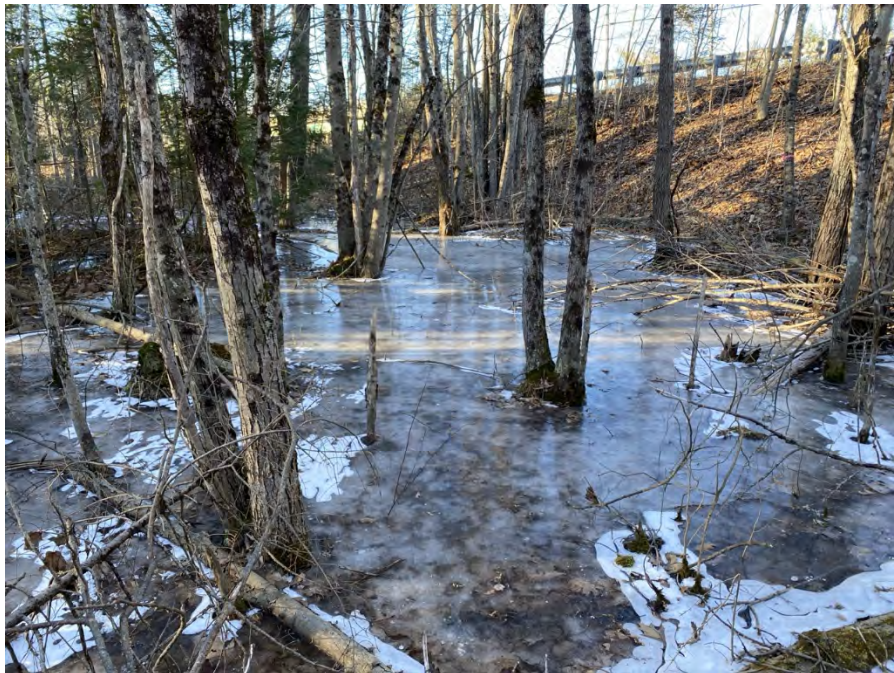
Photo 2. Wetland VK-01N and PSVP VP-01P. Stantec. January 10, 2025.

| Wetland Identifier | Wetland Classification <sup>1</sup> | Dominant and Characteristic Vegetation Type | Hydric Soil Criteria | WoSS Notes | Evidence of Hydrology | Comments |
|---|---|--|---|---|---|--|
| VK-01N | PFO | <b>Trees:</b> red maple, balsam fir, eastern hemlock ( <i>Tsuga canadensis</i> )<br><b>Shrubs:</b> common winterberry | Frozen – not assessed | Potential (contains PSVP) | Surface Water, Water Marks, Water Stained Leaves, Microtopographic Relief | Forested depression; contains PSVP (VP-01P); a natural modified ephemeral basin with approximately 4 inches of surface water at the time of the delineation; PVP basin modified from past land use including road fill and vegetation clearing |

| <b>9. Wetland description including a soil description:</b><br>Forested wetland along Dinsmore Rd, surface water present. Potential Significant Vernal Pool present; ephemeral hydrology, natural-modified basin from past land use<br>Soil: Frozen– not assessed at time of delineation. USDA NRCS soil mapped as Lyman-Tunbridge complex | | | | | | | | | | | | | |

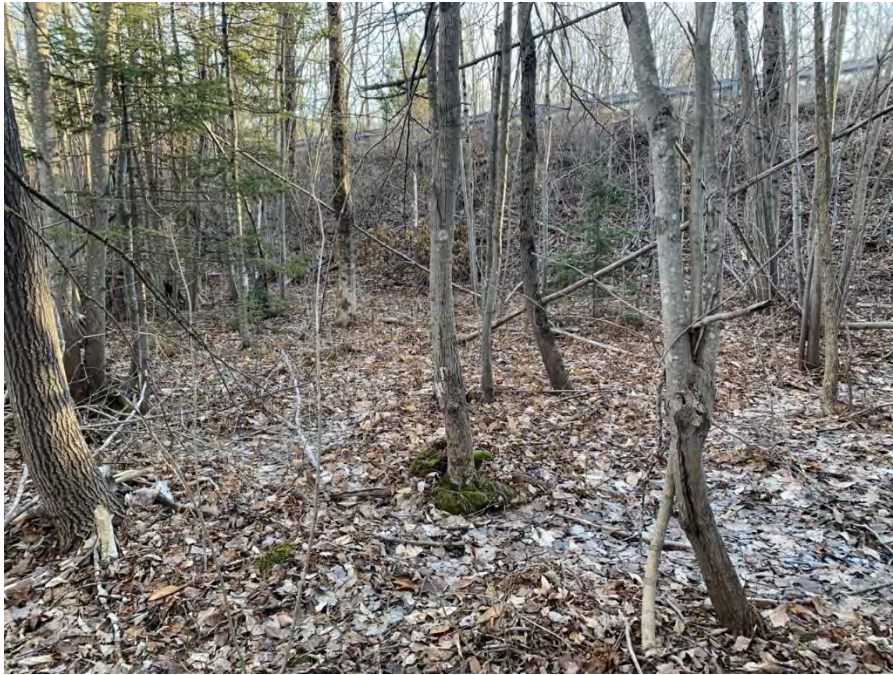
Photo 3. Wetland VK-010. Stantec. January 10, 2025.

| Wetland Identifier | Wetland Classification <sup>1</sup> | Dominant and Characteristic Vegetation Type | Hydric Soil Criteria | WoSS Notes | Evidence of Hydrology | Comments |
|---|---|--|---|---|---|--|
| VK-01O | PFO | <b>Trees:</b> red maple, American elm ( <i>Ulmus americana</i> )<br><b>Shrubs:</b> red maple, balsam fir<br><b>Herbs:</b> sensitive fern | Frozen – not assessed | No | Water Marks, Surface Water | Depressional wetland at base of road embankments |

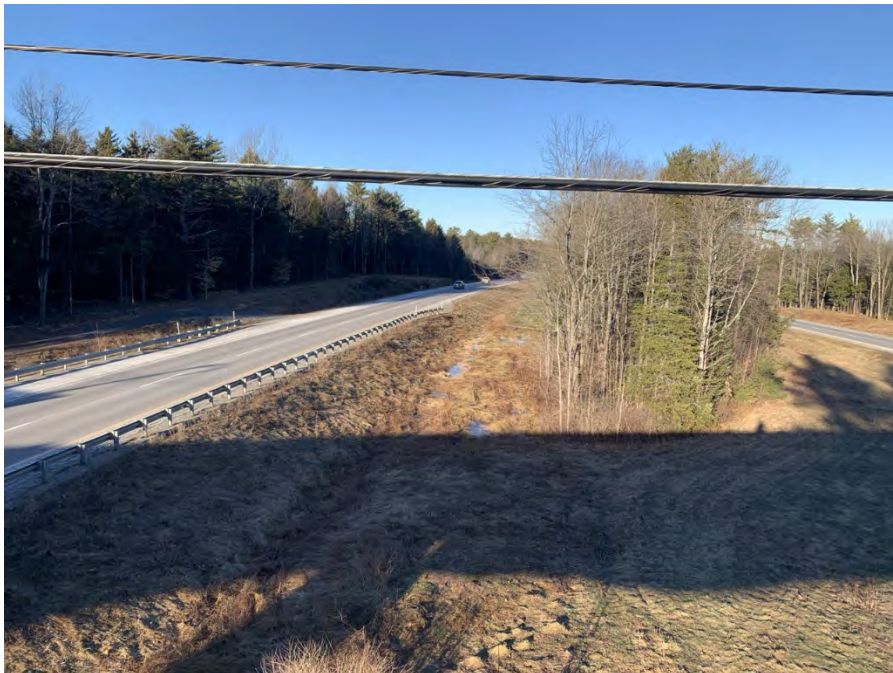
Photo 4. Inaccessible potential wetland in median north of bridge. Stantec. January 10, 2025.

A total of 3 wetlands were delineated within the Project area (Figure 1); a fourth potential wetland was observed in the median approximately 50 feet north of the bridge location but was not accessible due to high traffic volume and safety concerns at the time of the delineation. A single PSVP (VP-01P) was also observed within the Project area in wetland VK-01N; VP-01P is a natural modified basin with likely ephemeral hydrology. No streams or other potential Waters of the United States were observed. Representative photographs are provided in Appendix A and Standard MaineDOT Information / F&V Forms are provided in Appendix B. Table 1 summarizes the delineated wetlands, including the observed PSVP.

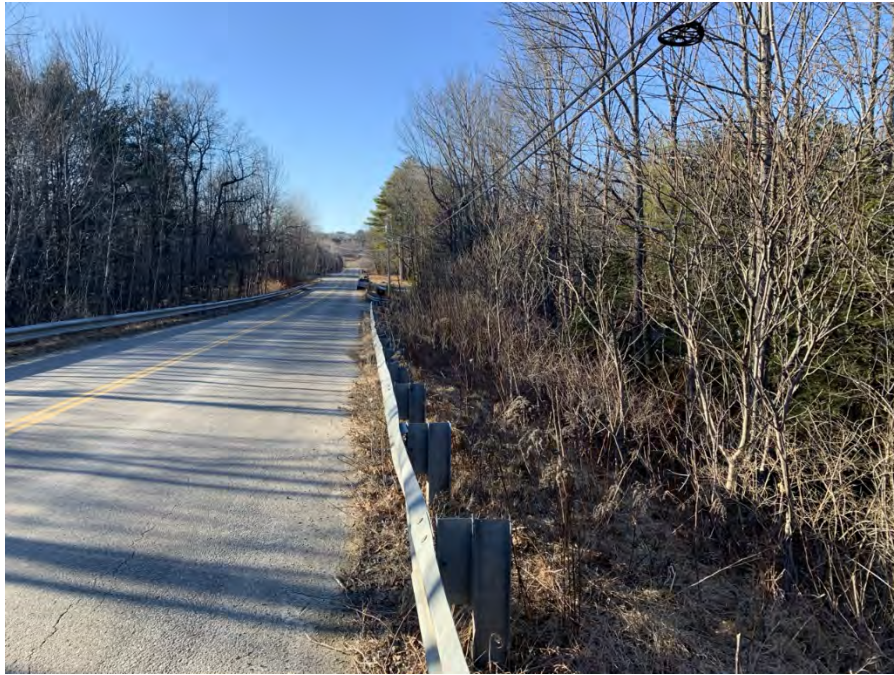
Photo 5. Dinsmore Road shoulder and location of single common milkweed plant along western bridge approach. Stantec. January 10, 2025.

The Project area includes very limited potentially suitable monarch habitat. A single plant of common milkweed (*Asclepias syriaca*) was observed along the edge of Dinsmore Road to the west of the bridge. The associated habitat consists of a shrub-dominated road shoulder containing Morrow's honeysuckle (*Lonicera morrowii*) and Canadian goldenrod (*Solidago canadensis*). No other milkweed observations were made.

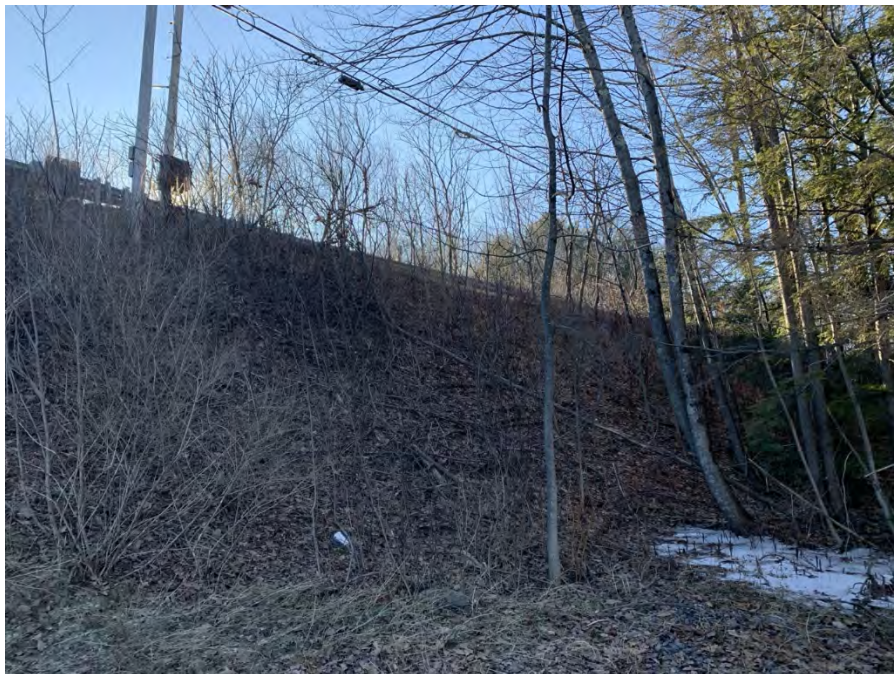
Photo 6. Dinsmore Road shrub-dominated embankment west of bridge. Stantec. January 10, 2025.

The road embankments of Dinsmore Road are dominated by trees and shrubs such as Morrow's honeysuckle, quaking aspen (*Populus tremuloides*), eastern hemlock (*Tsuga canadensis*), and staghorn sumac (*Rhus hirta*). Aggressive herbaceous plants including Canadian goldenrod (*Solidago canadensis*), wrinkle-leaf goldenrod (*Solidago rugosa*), false rye grass (*Schedonorus* spp.), and Japanese-knotweed (*Reynoutria japonica*) are common associates. The road embankments provide limited opportunity for milkweed species due to the current shrub density although small gaps and openings amongst the shrub growth could provide opportunity for milkweed plants. However, only a single remnant specimen was observed at the time of the survey.

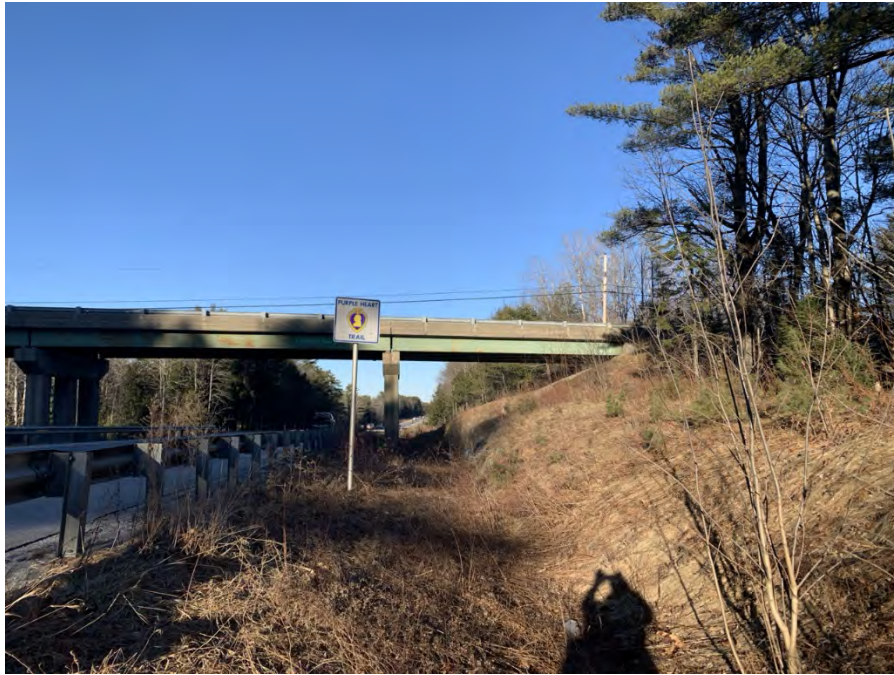
Photo 7. Dinsmore Road bridge road shoulder habitat along I-95, view to the north. Stantec.  
January 10, 2025.

Open field and meadow habitat areas beyond the edge of the I-95 pavement are maintained periodically through mowing by MaineDOT. Frequent mowing largely limits the potential for common milkweed establishment and for monarch larvae to complete their life cycle.

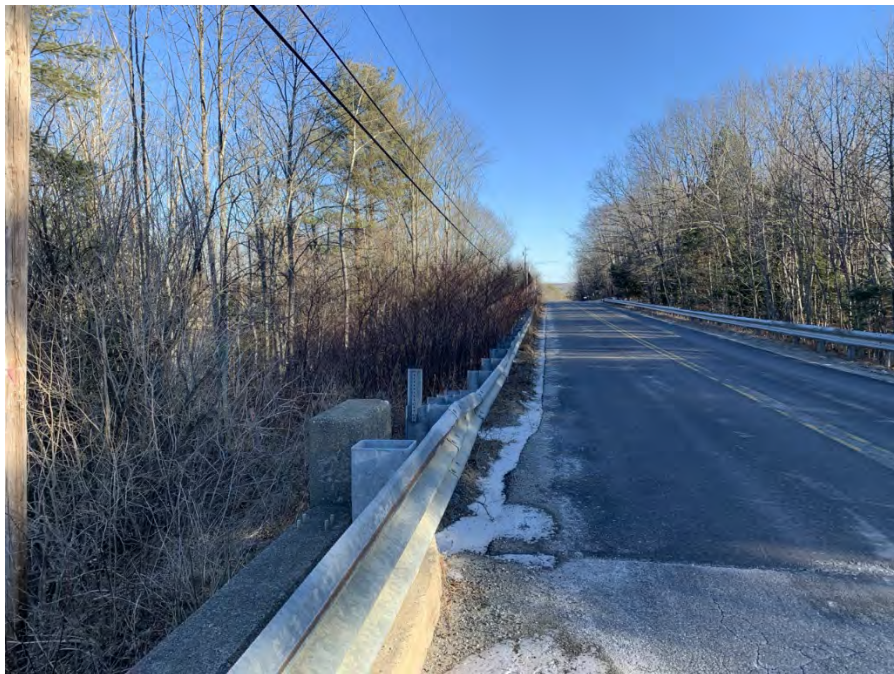
Photo 8. Dinsmore Road shrub-dominated road embankment to east of bridge. Stantec.  
January 10, 2025.
