# **Drummond Road Bridge (BR 5784) over Interstate 95 Wetland and Watercourse Delineation and Monarch Butterfly Habitat Assessment Report**

Sidney, Maine  
WIN 25469.00

Prepared for:  
Maine Department of Transportation

January 15, 2025

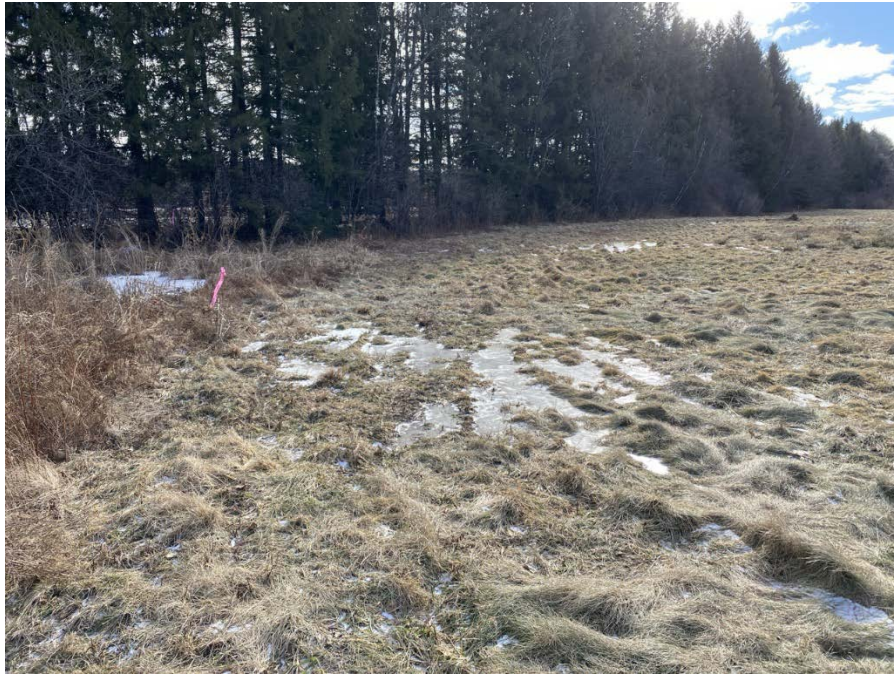
Photo 1. Wetland VE-01F. Stantec. January 10, 2025.

Wetland Identifier	Wetland Classification <sup>1</sup>	Dominant and Characteristic Vegetation Type	Hydric Soil Criteria	WoSS Notes	Evidence of Hydrology	Comments
VE-01F	PEM	<b>Herbs:</b> sensitive fern ( <i>Onoclea sensibilis</i> ), purple loosestrife ( <i>Lythrum salicaria</i> ), lamp rush ( <i>Juncus effusus</i> ), wrinkle-leaf goldenrod ( <i>Solidago rugosa</i> ), broad-leaf cat-tail ( <i>Typha latifolia</i> )	Frozen – not assessed	No	Surface Water, Geomorphic Position	Depressional wetland on edge of mowed field
VE-01G	PEM	<b>Herbs:</b> reed canary grass ( <i>Phalaris arundinacea</i> )	Frozen – not assessed	No	Geomorphic Position, FAC-Neutral Test	Herbaceous depression along edge of I-95
VK-01H	PFO	<b>Trees:</b> red maple ( <i>Acer rubrum</i> ) <b>Herbs:</b> purple loosestrife, sensitive fern, wrinkle-leaf goldenrod	Frozen – not assessed	No	Water Stained Leaves, Drainage Patterns, Surface Water	Depressional wetland at base of road embankments; abuts mowed field

MaineDOT Functional Assessment:													
<b>1. Town:</b> Sidney			<b>2. Drummond Road</b> BR 5784			<b>3. WIN:</b> 25469.00							
<b>4. Wetland ID/ Line ID:</b> VE-01F			<b>5. Cowardin Class:</b> PEM			<b>6. Stationing/Location</b>							
<b>7. Dominant Vegetation:</b> <i>Onoclea sensibilis, Lythrum salicaria, Juncus effusus, Solidago rugosa, Typha latifolia</i>						<b>8. Wetland Morphology HGM Type:</b> Depressional wetland, no stream association							
<b>9. Wetland description including a soil description:</b> Mowed wetland field at toe of road embankment and edge of mowed field. Surface water present Soil: Frozen along edges – not assessed at time of delineation. USDA NRCS soil mapped as Scio very fine sandy loam													
<b>10. FVA Table:</b>													
Whole Wetland:													
F/V	GRD	FFA	FSH	STR	NRRT	PE	SSS	WH	REC	ESV	U/H	VQA	ES
Occurs				X									
Principal					X								
Impacted area: TBD

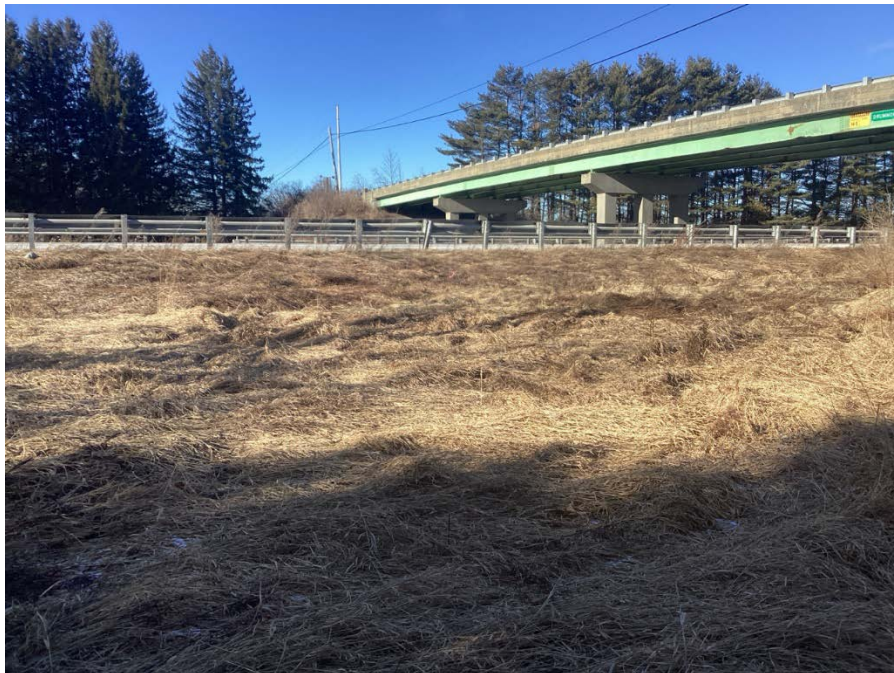
Photo 2. Wetland VE-01G. Stantec. January 10, 2025.

MaineDOT Functional Assessment:													
<b>1. Town:</b> Sidney			<b>2. Drummond Road</b> BR 5784			<b>3. WIN:</b> 25469.00							
<b>4. Wetland ID/ Line ID:</b> VE-01G			<b>5. Cowardin Class:</b> PEM			<b>6. Stationing/Location</b>							
<b>7. Dominant Vegetation:</b> <i>Phalaris arundinacea</i>						<b>8. Wetland Morphology HGM Type:</b> Depressional wetland, no stream association							
<b>9. Wetland description including a soil description:</b> Depressional wetland at base of road embankment. Soil: Frozen along edges – not assessed at time of delineation. USDA NRCS soil mapped as Scio very fine sandy loam and Lamoine silt loam													
<b>10. FVA Table:</b>													
Whole Wetland:													
F/V	GRD	FFA	FSH	STR	NRRT	PE	SSS	WH	REC	ESV	U/H	VQA	ES
Occurs				X									
Principal					X								
Impacted area: TBD													
<b>11. Is this wetland part of larger complex?</b> No.

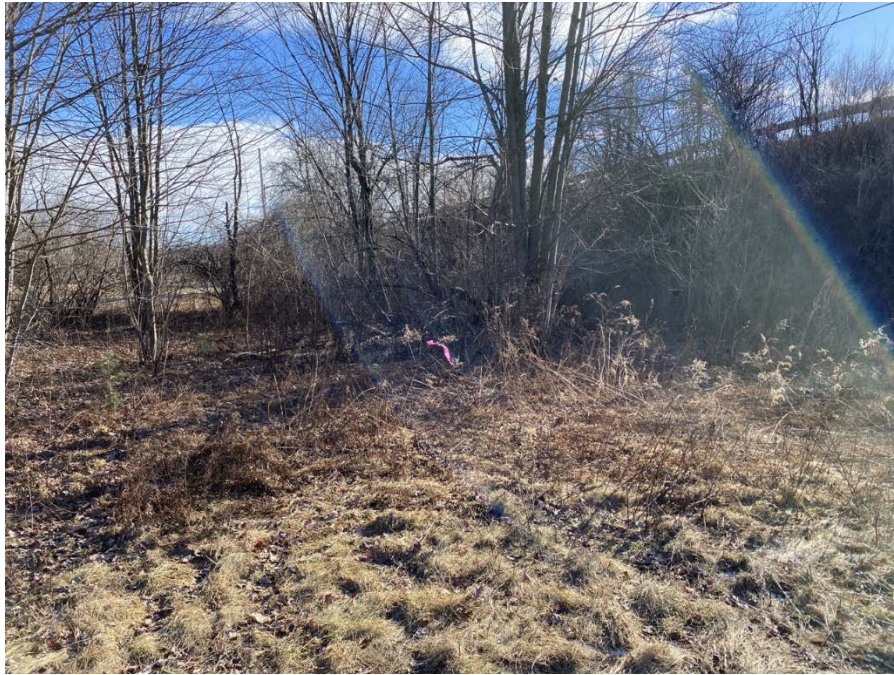
Photo 3. Wetland VK-01H. Stantec. January 10, 2025.

MaineDOT Functional Assessment:													
<b>1. Town:</b> Sidney			<b>2. Drummond Road</b> BR 5784			<b>3. WIN:</b> 25469.00							
<b>4. Wetland ID/ Line ID:</b> VK-01H			<b>5. Cowardin Class:</b> PFO			<b>6. Stationing/Location</b>							
<b>7. Dominant Vegetation:</b> <i>Acer rubrum, Lythrum salicaria, Onoclea sensibilis, Solidago rugosa</i>						<b>8. Wetland Morphology HGM Type:</b> Depressional wetland, no stream association							
<b>9. Wetland description including a soil description:</b> Depressional wetland at base of road embankment and edge of mowed field; edges of PFO mowed wet meadow Soil: Frozen along edges – not assessed at time of delineation. USDA NRCS soil mapped as Lamoine silt loam													
<b>10. FVA Table:</b>													
Whole Wetland:													
F/V	GRD	FFA	FSH	STR	NRRT	PE	SSS	WH	REC	ESV	U/H	VQA	ES
Occurs					X								
Principal				X									
Impacted area: TBD

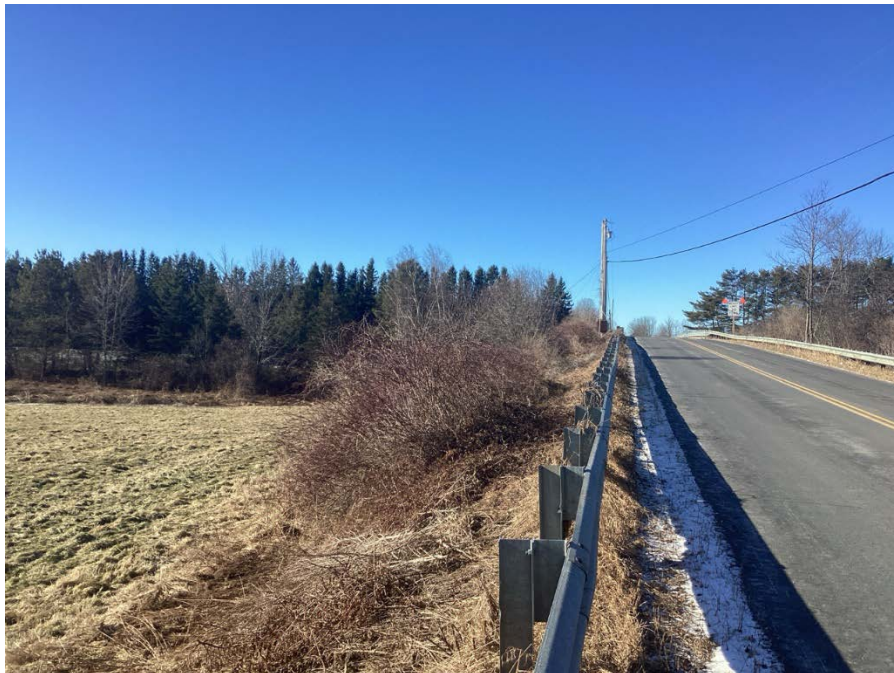
Open field and meadow habitat areas beyond the edge of the I-95 and Drummond Road pavement are maintained periodically through mowing by MaineDOT and adjacent landowners. Frequent mowing largely limits the potential for common milkweed establishment and for monarch larvae to complete their life cycle.

Photo 4. Drummond Road shoulder and adjacent mowed field habitat along eastern approach. Stantec.  
January 10, 2025.

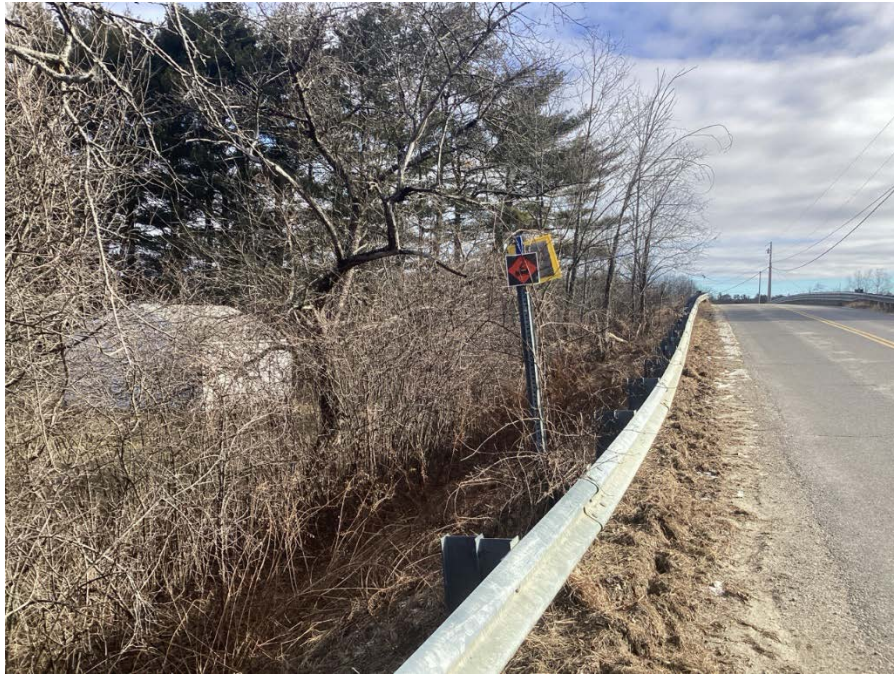
The road embankments of Drummond Road are dominated by non-native invasive shrubs such as Morrow's honeysuckle (*Lonicera morrowii*), European buckthorn (*Rhamnus cathartica*), rambler rose (*Rosa multiflora*), and autumn-olive (*Elaeagnus umbellata*). Aggressive herbaceous plants including common wormwood (*Artemisia vulgaris*), Canadian goldenrod (*Solidago canadensis*), and wrinkle-leaf goldenrod (*Solidago rugosa*) are common associates. The road embankments provide limited opportunity for milkweed species due to the current shrub density although small gaps and openings amongst the shrub growth could provide opportunity for milkweed plants. However, no remnant specimens were observed in these areas at the time of the survey.

Photo 5. Drummond Road shoulder along western bridge approach. Stantec. January 10, 2025.

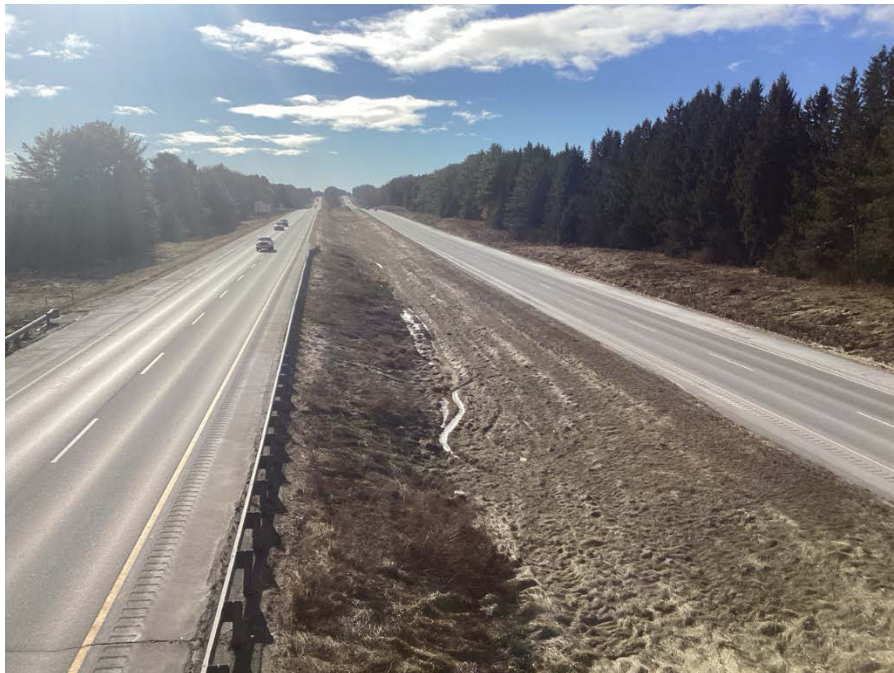
The Project area includes potentially suitable monarch habitat along the open roadway embankments and I-95 median. A single plant of common milkweed (*Asclepias syriaca*) was observed within the open upland habitats of the I-95 median to the north of the bridge. The associated habitat consists of a narrow concave graminoid-dominated area with a stormwater drainage swale paralleling the roadway. The area is periodically mowed. No other milkweed observations were made.

Photo 6. Common milkweed habitat in I-95 median north of bridge. Stantec. January 10, 2025.

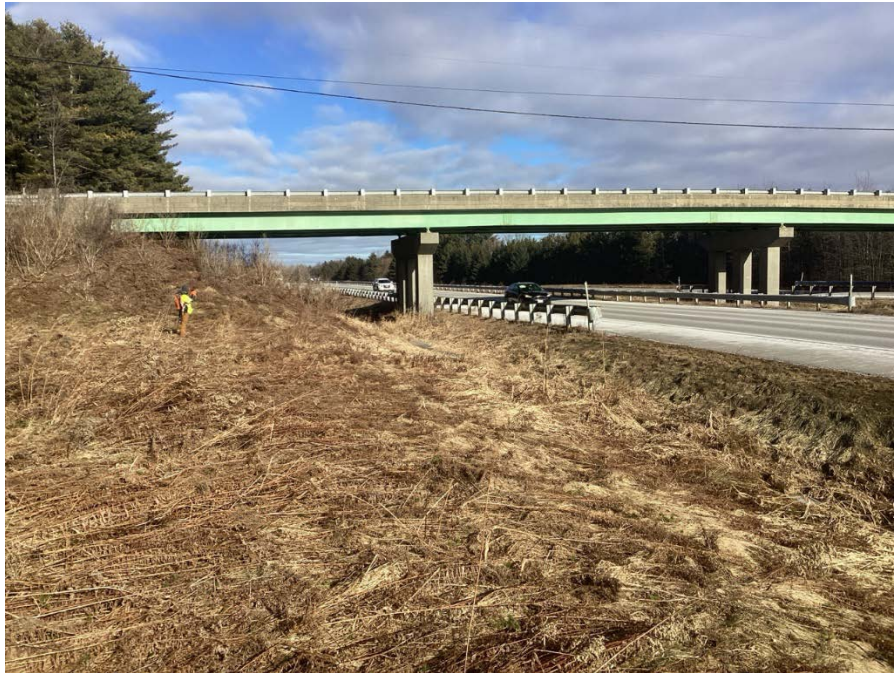
Photo 7. Drummond Road bridge meadow habitat along I-95, view to the north. Stantec.  
January 10, 2025.

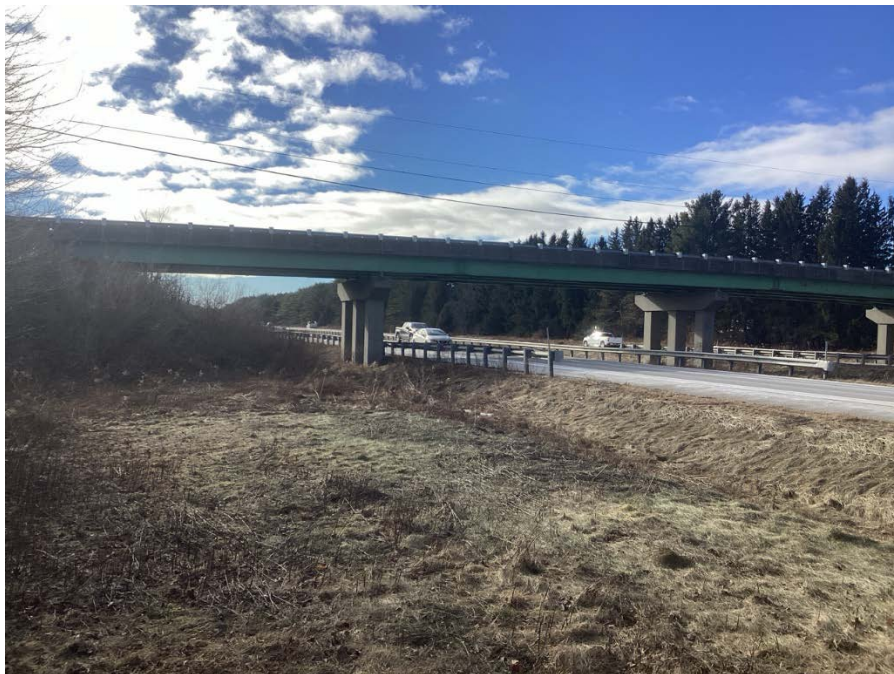
Photo 8. Drummond Road bridge meadow habitat along I-95, view to the south. Stantec.  
January 10, 2025.

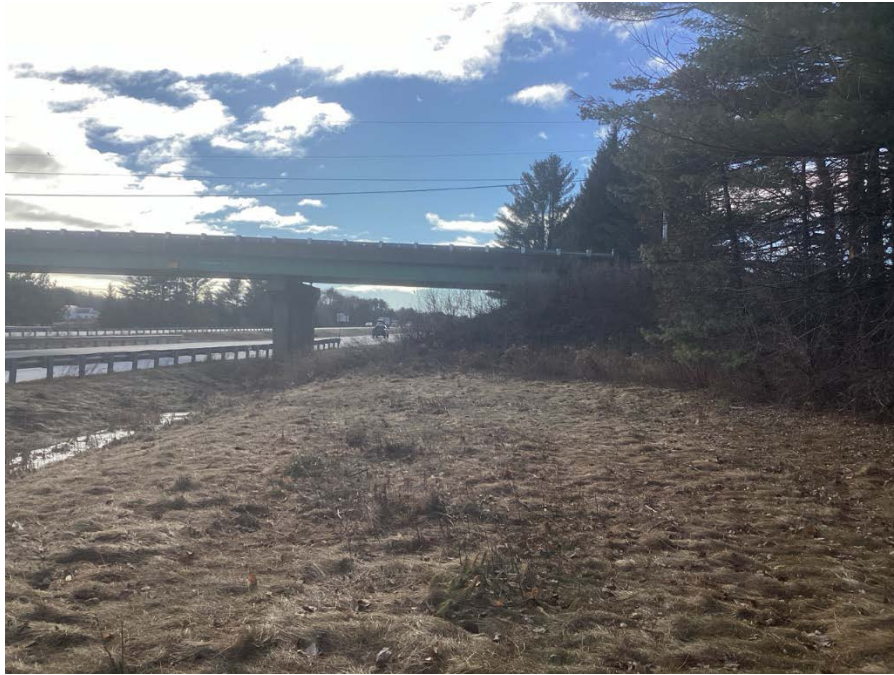
Photo 9. Drummond Road bridge meadow habitat along I-95, view to the south. Stantec.  
January 10, 2025.

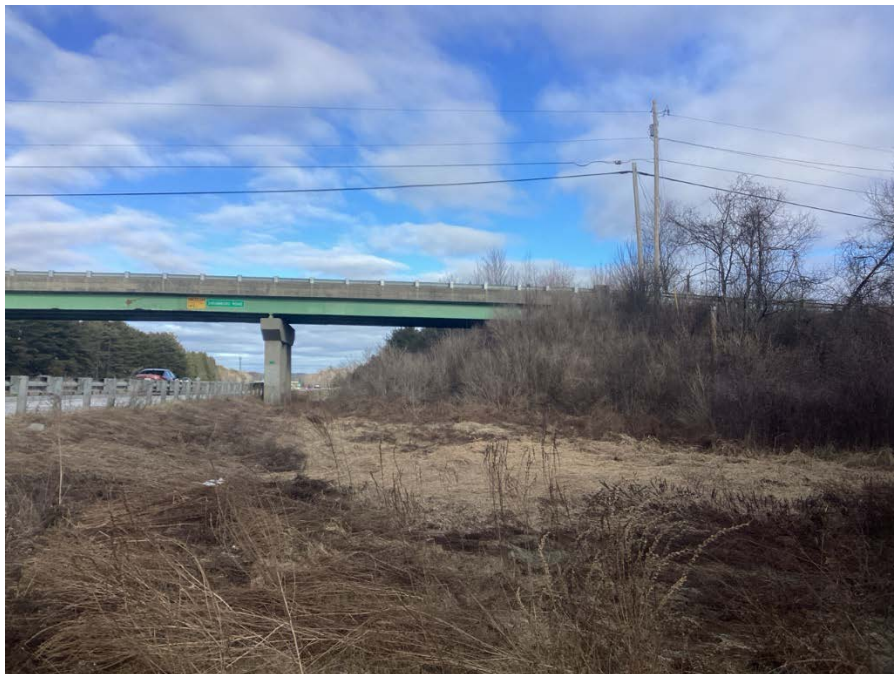
Photo 10. Drummond Road bridge, view to the north (wetland VE-01G is in foreground). Stantec.  
January 10, 2025.
