Town Farm Road Bridge (BR 5785) over Interstate 95 Wetland and Watercourse Delineation and Monarch Butterfly Habitat Assessment Report

Sidney, Maine
WIN 27266.00

Prepared for:
Maine Department of Transportation

February 28, 2025

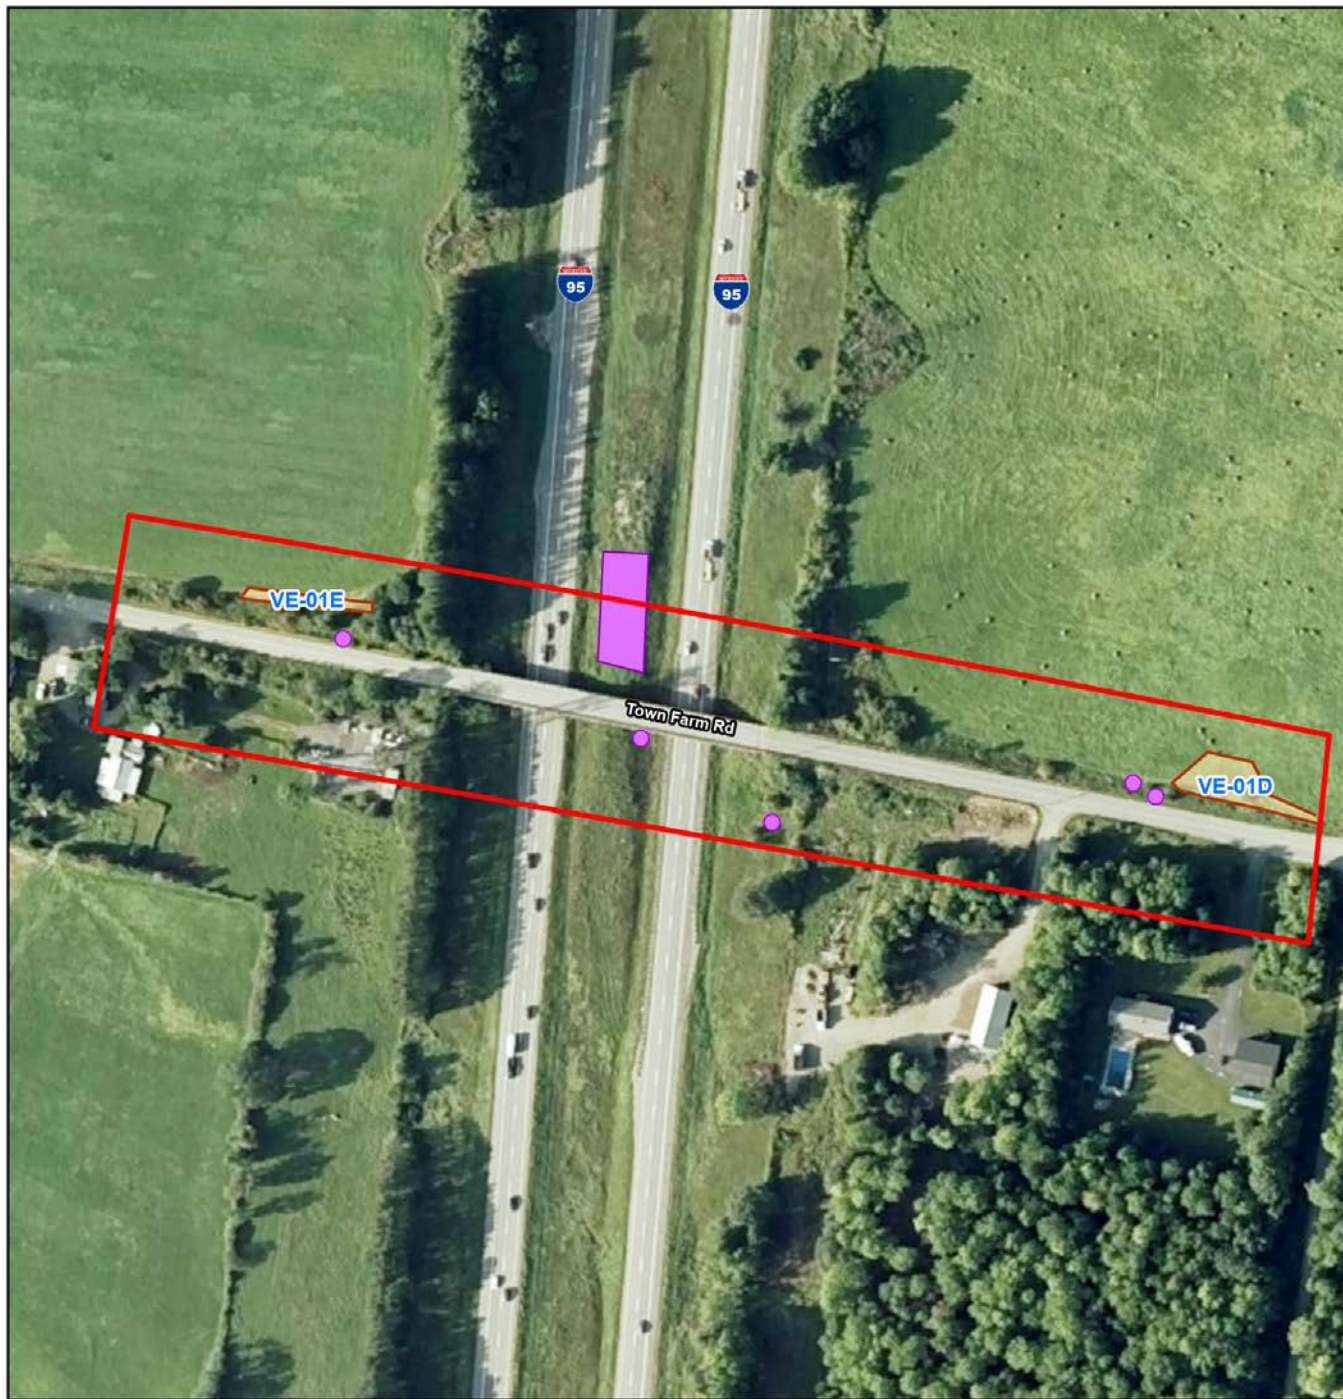
Figure No.
1

A total of 2 wetlands were delineated within the Project area (Figure 1). No streams, other potential Waters of the United States, or PVPs were observed. Representative photographs are provided in Appendix A and Standard MaineDOT Information / F&V Forms are provided in Appendix B. Table 1 summarizes the delineated wetlands.

Representative habitat photographs are provided in Appendix A and the locations of observed milkweed are indicated on Figure 1.

Wetland and Watercourse Delineation and Milkweed Survey Map

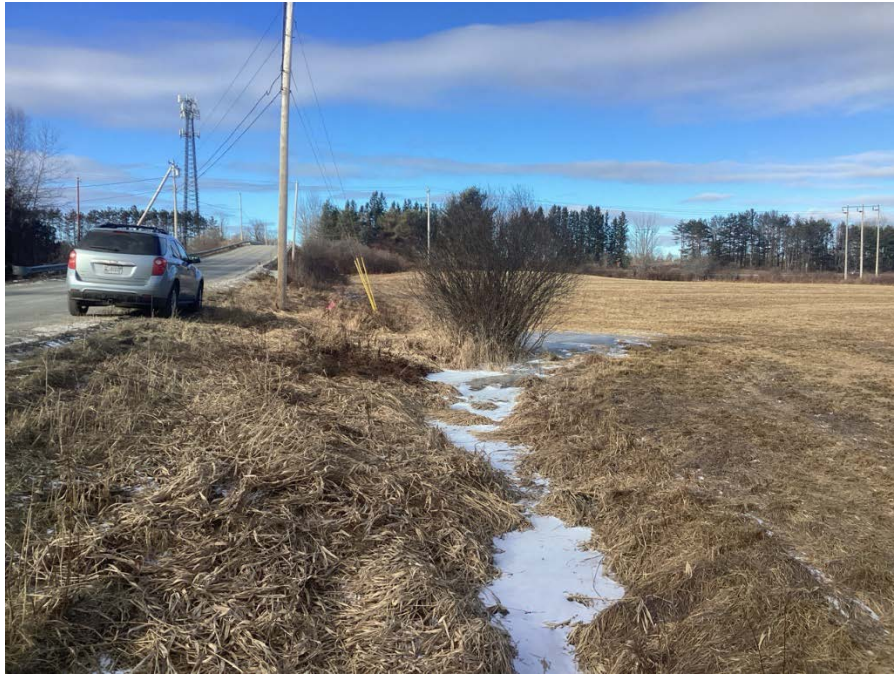
Photo 1. Wetland VE-01D. Stantec. January 10, 2025.

9. Wetland description including a soil description: Mowed wetland field at toe of road embankment and continuing easterly off-site via drainage ditch. Surface water present Soil: Frozen along edges – not assessed at time of delineation. USDA NRCS soil mapped as Lamoine silt loam

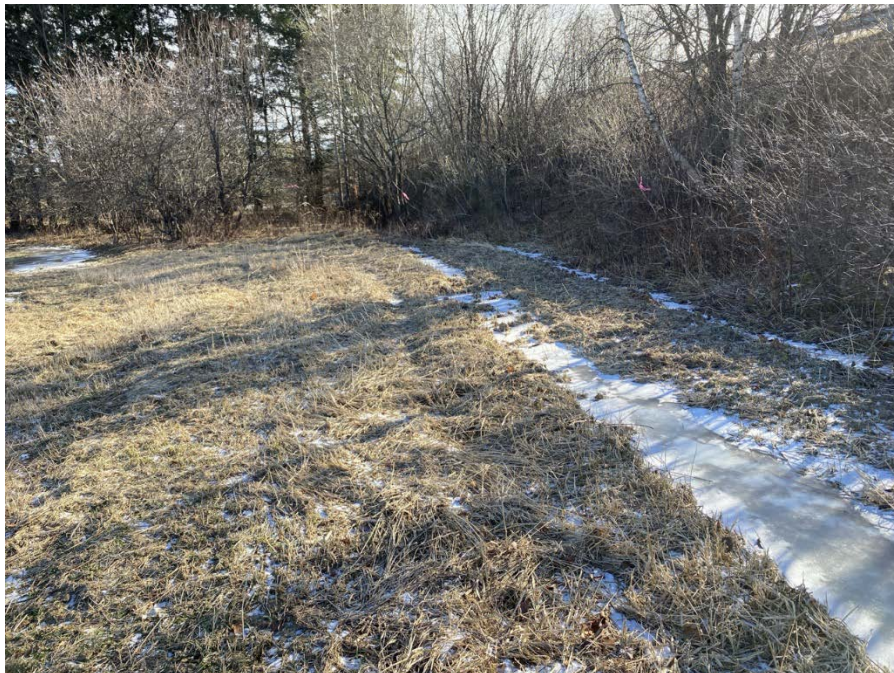
Photo 2. Wetland VE-01E. Stantec. January 10, 2025.

9. Wetland description including a soil description: Mowed linear swale at base of road embankment and edge of field; drainage patterns and surface water present Soil: Frozen– not assessed at time of delineation. USDA NRCS soil mapped as Lamoine silt loam

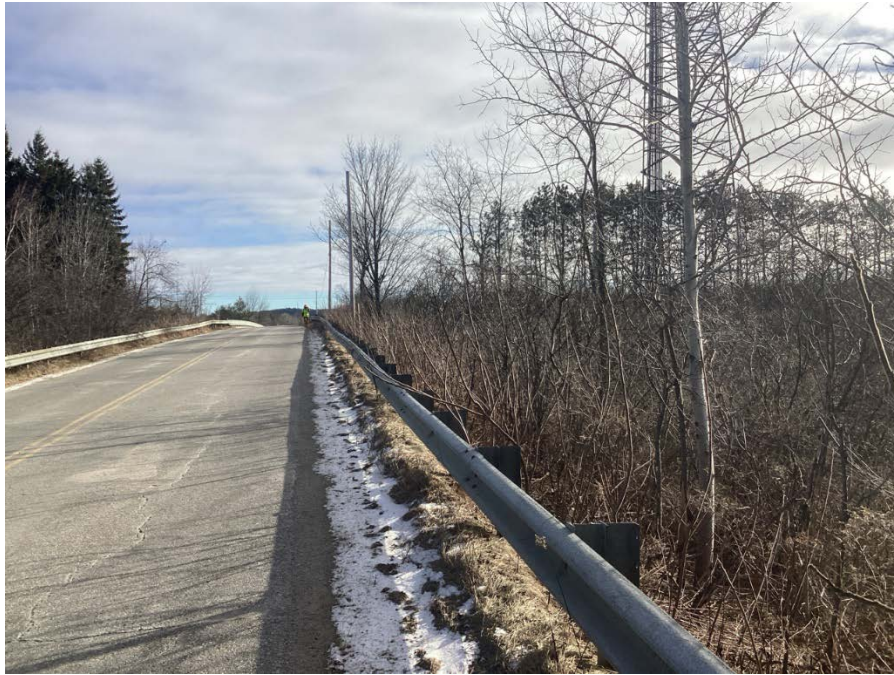
The road embankments of Town Farm Road are shrub- and sapling-dominated habitats and include species such as staghorn sumac, European barberry (*Berberis vulgaris*), nanny-berry (*Viburnum lentago*), and quaking aspen (*Populus tremuloides*) and milkweed habitat is largely limited to the edges of the roadway and small and discrete gaps amongst the denser shrub and sapling growth along the road.

Photo 3. Town Farm Road shoulder habitat along western approach. Stantec. January 10, 2025.

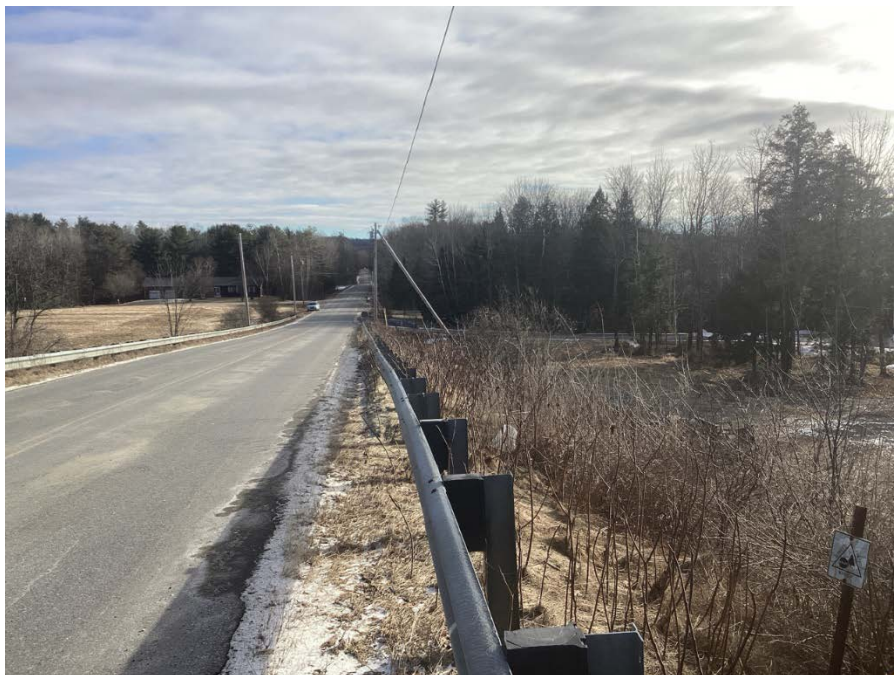
Photo 4. Town Farm Road shoulder habitat along eastern approach. Stantec. January 10, 2025.

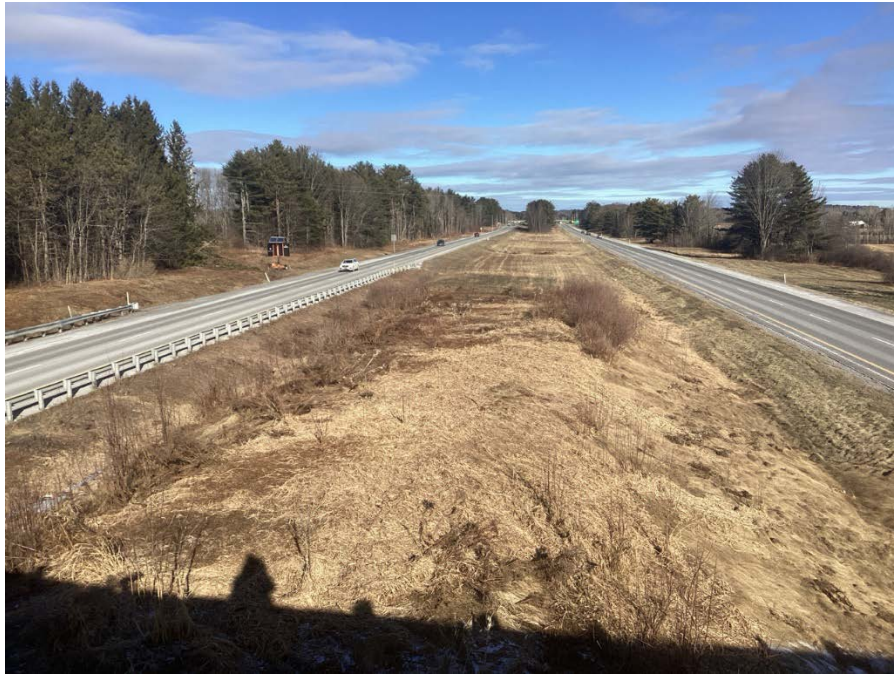
The Project area includes potentially suitable monarch habitat along the open roadway embankments and I-95 median. Common milkweed (*Asclepias syriaca*) was observed within the open upland habitats of the I-95 median. Approximately 8 to 10 remnant plants were observed within the Project to the north of the bridge location in the median with 5 to 8 additional plants scattered along the road shoulders and open habitats within the Project. The associated habitat consists of maintained early successional meadow and shrubland habitat and includes common associates such as Canadian goldenrod (*Solidago canadensis*), red fescue (*Festuca rubra*), Kentucky blue grass (*Poa pratensis*), staghorn sumac (*Rhus hirta*), setose blackberry (*Rubus setosus*), Morrow's honeysuckle (*Lonicera morrowii*), common red raspberry (*Rubus idaeus*), and yellow bristle grass (*Setaria pumila*).

Photo 5. Common milkweed habitat in I-95 median north of bridge. Stantec. January 10, 2025.

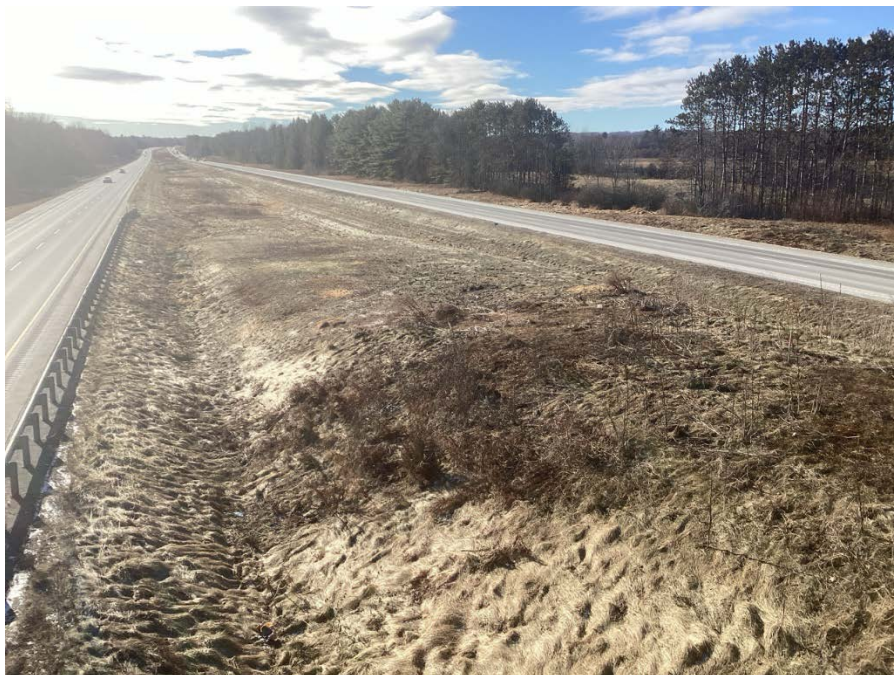
Photo 6. Common milkweed habitat in I-95 median south of bridge. Stantec. January 10, 2025.

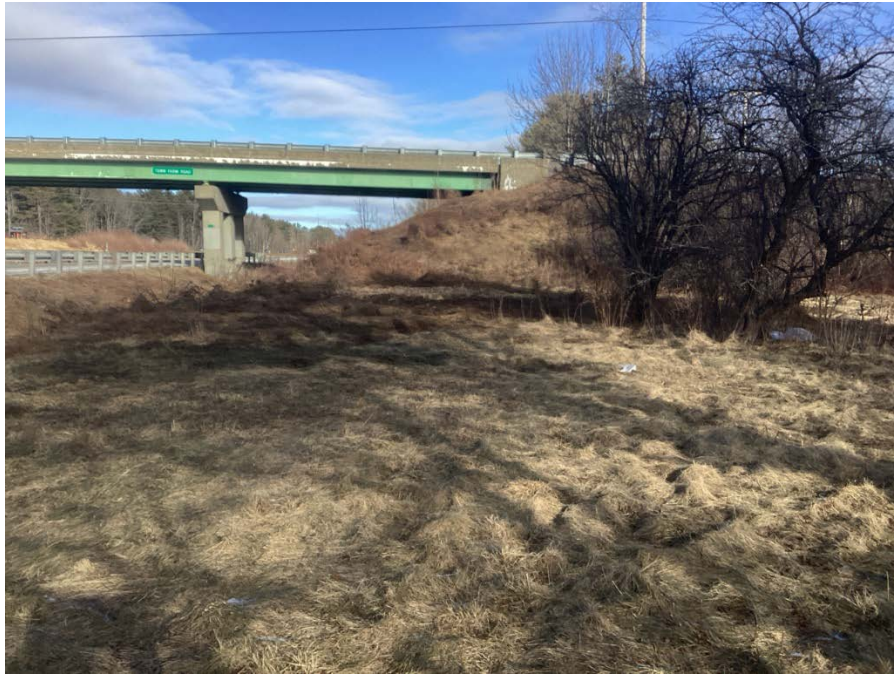
Open field and meadow habitat areas beyond the edge of the I-95 pavement are maintained periodically through mowing by MaineDOT as well as the abutting landowners. Frequent mowing largely limits the potential for common milkweed establishment and for monarch larvae to complete their life cycle. Steeper road embankments and the median appear to receive less mowing frequency than other areas within the Project area and may provide more viable habitat for monarch larvae development.

Photo 7. Town Farm Road bridge meadow habitat along I-95, view to the north. Stantec.
January 10, 2025.

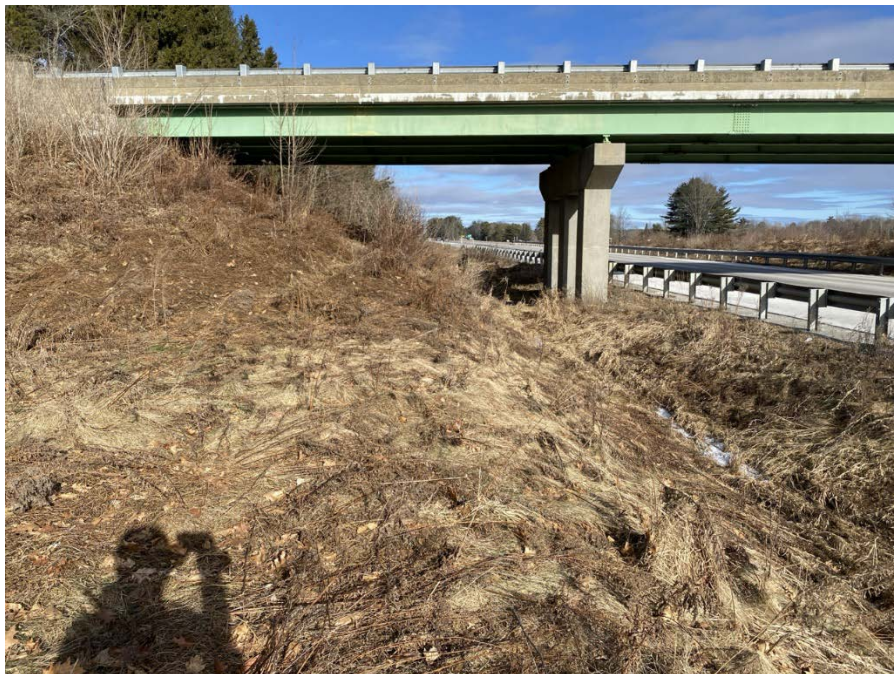
Photo 8. Town Farm Road bridge meadow habitat along I-95, view to the north. Stantec.
January 10, 2025.

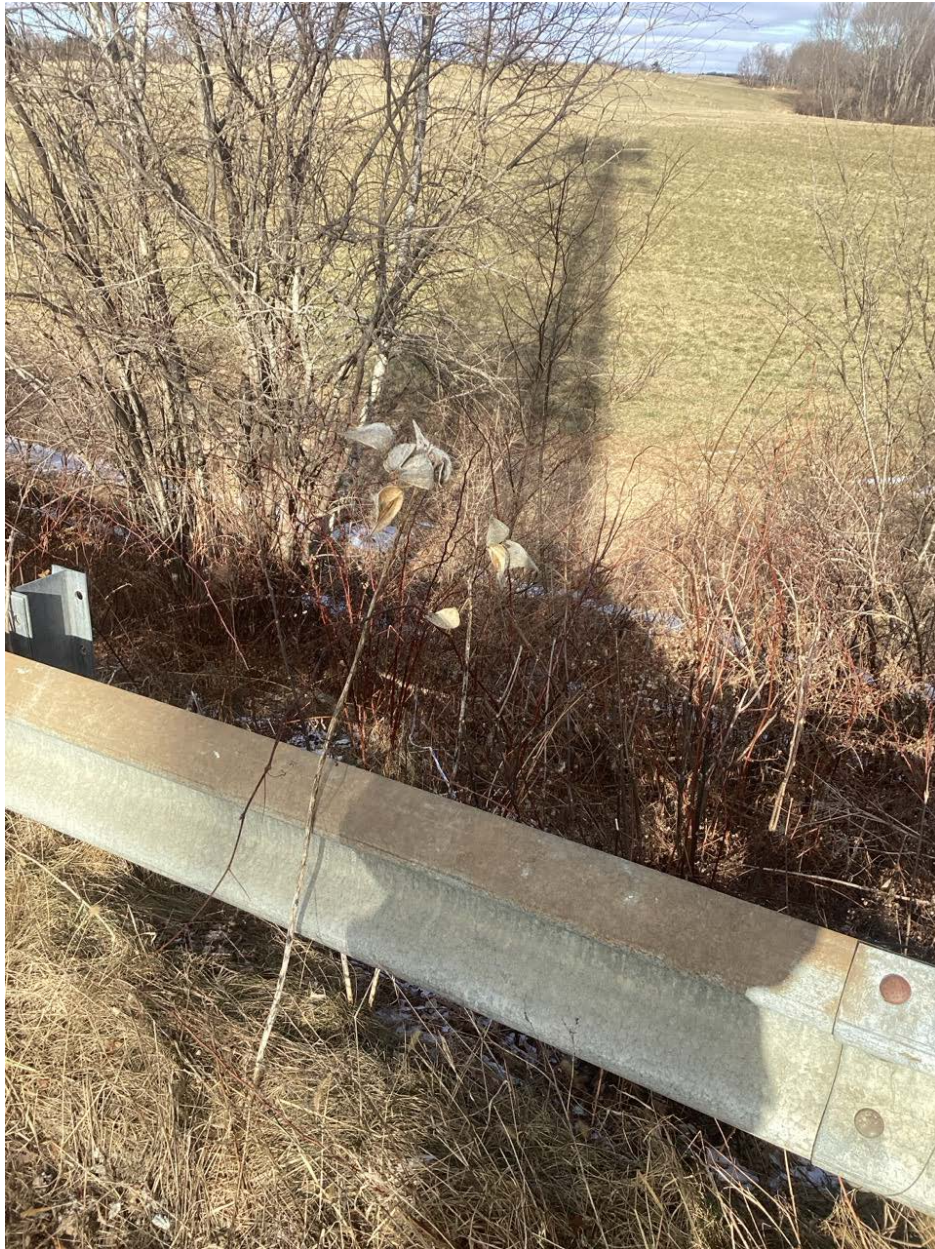
Photo 9. Common milkweed remnant along Town Farm Road shoulder. Stantec. January 10, 2025.

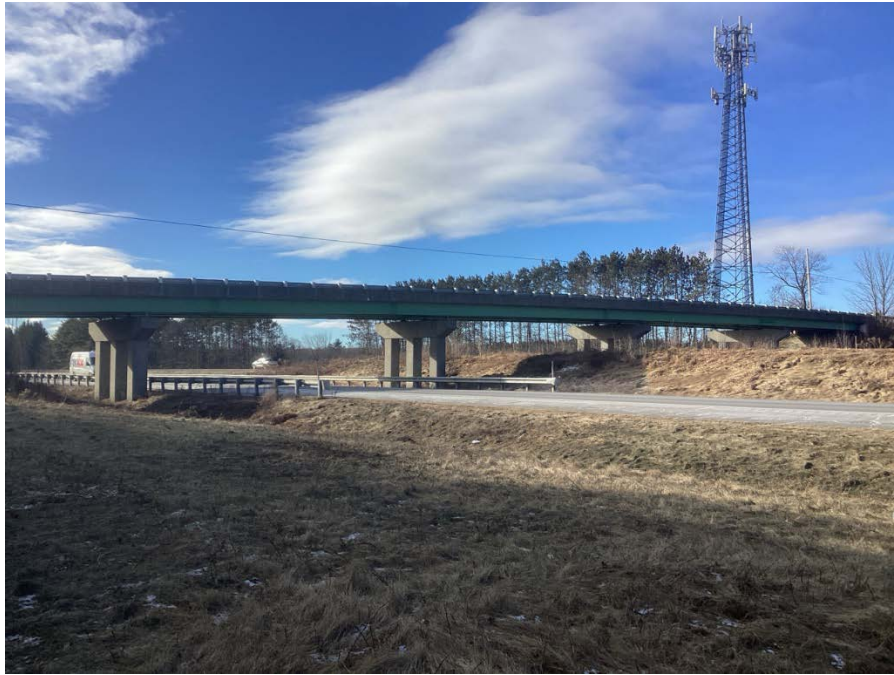
Photo 10. Town Farm Road bridge, view to the southeast. Stantec. January 10, 2025.
