Trafton Road Bridge (BR 5812) over Interstate 95 Wetland and Watercourse Delineation and Monarch Butterfly Habitat Assessment Report

Waterville, Maine
WIN 26152.00

Prepared for:
Maine Department of Transportation

February 28, 2025

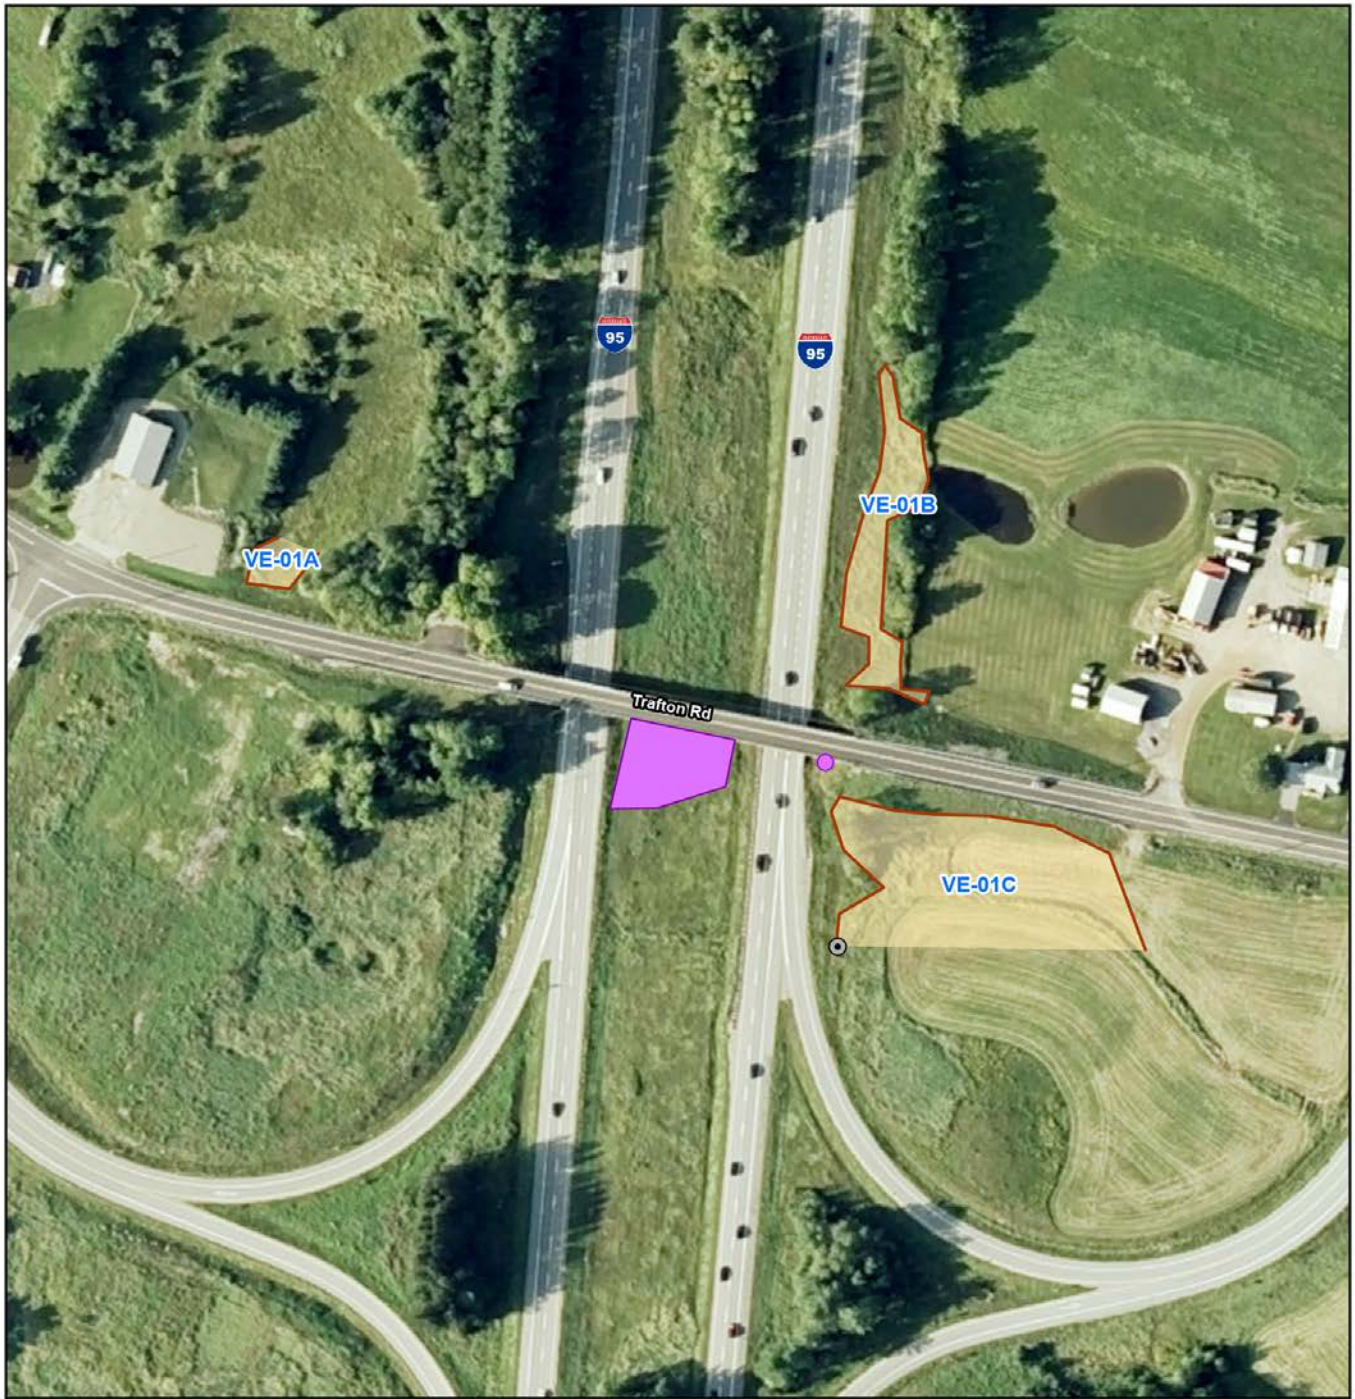
Figure No.
1

Title
**Wetland and Watercourse Delineation
and Milkweed Survey Map**

A total of 3 wetlands were delineated within the Project area (Figure 1). No streams, other potential Waters of the United States, or PVPs were observed. Representative photographs are provided in Appendix A and Standard MaineDOT Information / F&V Forms are provided in Appendix B. Table 1 summarizes the delineated wetlands.

Representative habitat photographs are provided in Appendix A and the locations of observed milkweed are indicated on Figure 1.

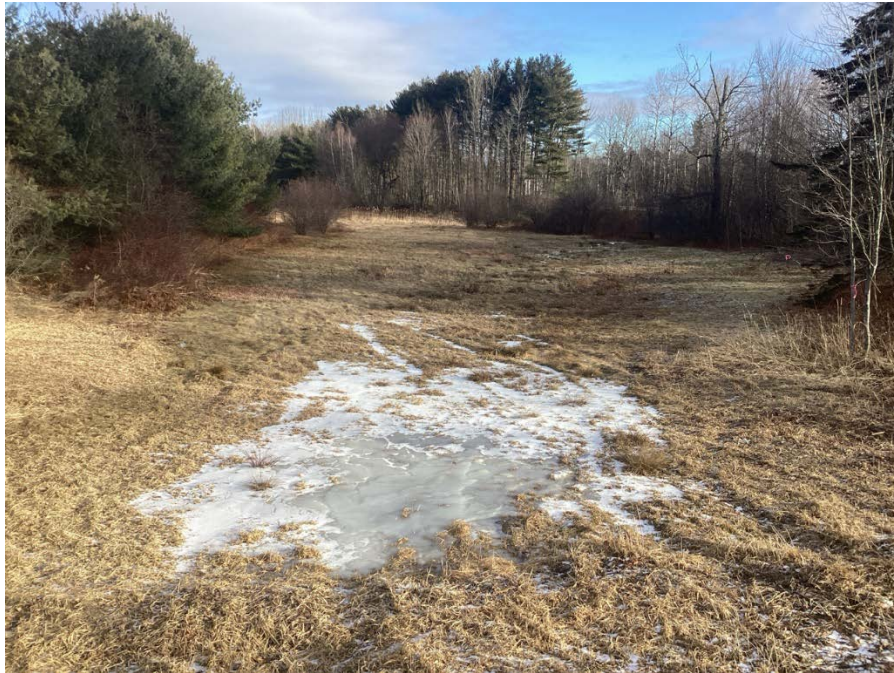
Photo 1. Wetland VE-01A. Stantec. January 10, 2025.

9. Wetland description including a soil description: Mowed wetland swale at toe of road embankment and continuing northerly off-site. Surface water present Soil: Frozen – not assessed at time of delineation. USDA NRCS soil mapped as Scio very fine sandy loam

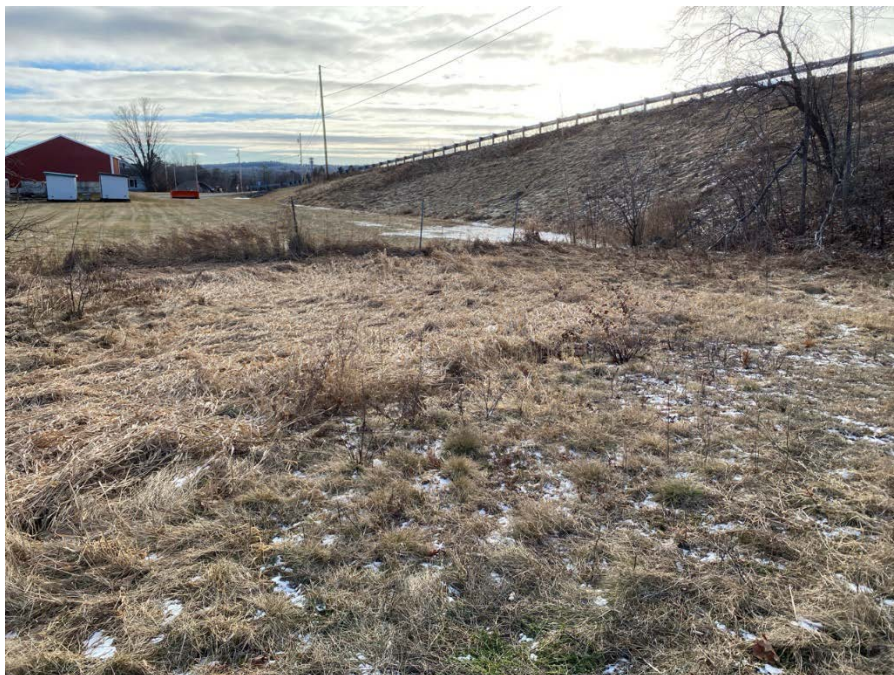
Photo 2. Wetland VE-01B. Stantec. January 10, 2025.

9. Wetland description including a soil description: Roadside wetland swale flowing into off-site farm pond Soil: Frozen along– not assessed at time of delineation. USDA NRCS soil mapped as Scantic silt loam

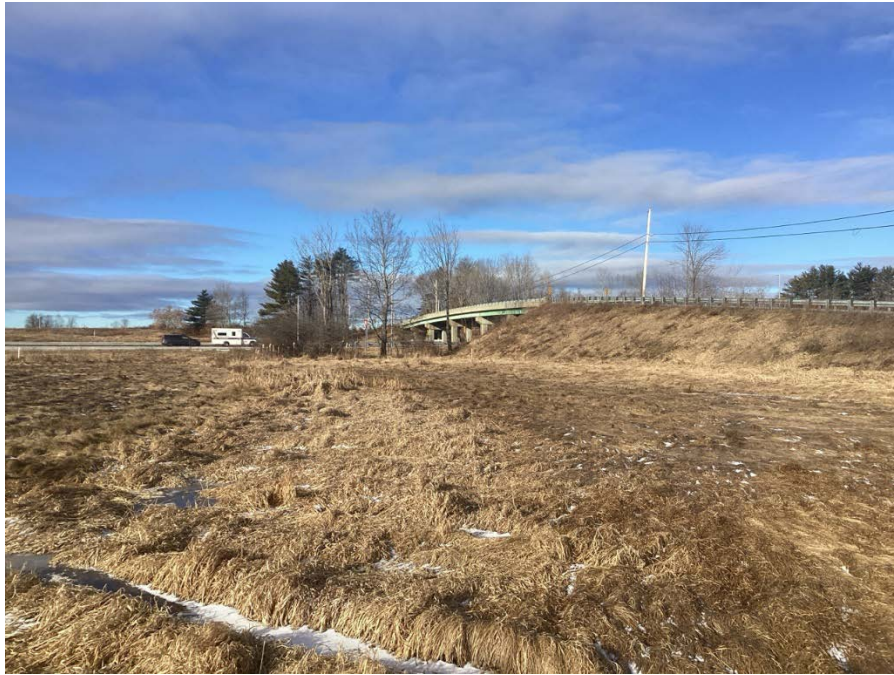
Photo 3. Wetland VE-01C. Stantec. January 10, 2025.

9. Wetland description including a soil description: Mowed wetland field at toe of road embankment and continuing southerly off-site via vegetated swale. Surface water present in flowing swale Soil: Frozen along edges – not assessed at time of delineation; interior depleted silty clay. USDA NRCS soil mapped as Scantic silt loam

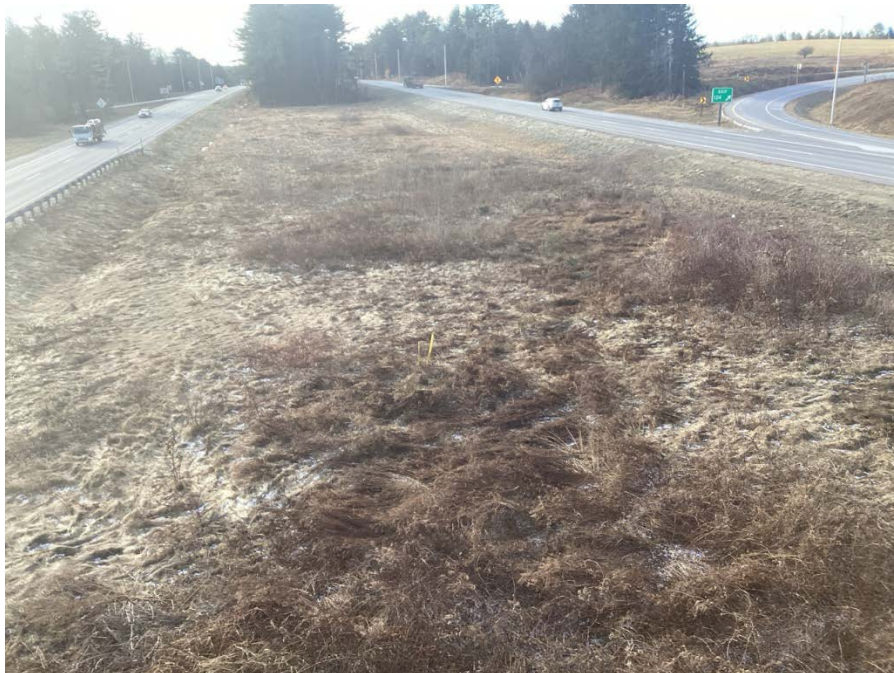
Photo 4. Common milkweed habitat in median south of Trafton Road. Stantec. January 10, 2025.

The Project area includes potentially suitable monarch habitat along the open roadway embankments and I-95 median. Common milkweed (*Asclepias syriaca*) was observed within the open upland habitats of the I-95 median. Approximately 25 remnant plants were observed within the Project to the south of the bridge location in the median with a single plant located at the eastern abutment. The associated habitat consists of maintained early successional meadow and shrubland habitat and includes common associates such as Canadian goldenrod (*Solidago canadensis*), common wormwood (*Artemisia vulgaris*), red fescue (*Festuca rubra*), reed canary grass (*Phalaris arundinacea*), Kentucky blue grass (*Poa pratensis*), wrinkle-leaf goldenrod (*Solidago rugosa*), and king's-cureall (*Oenothera biennis*).

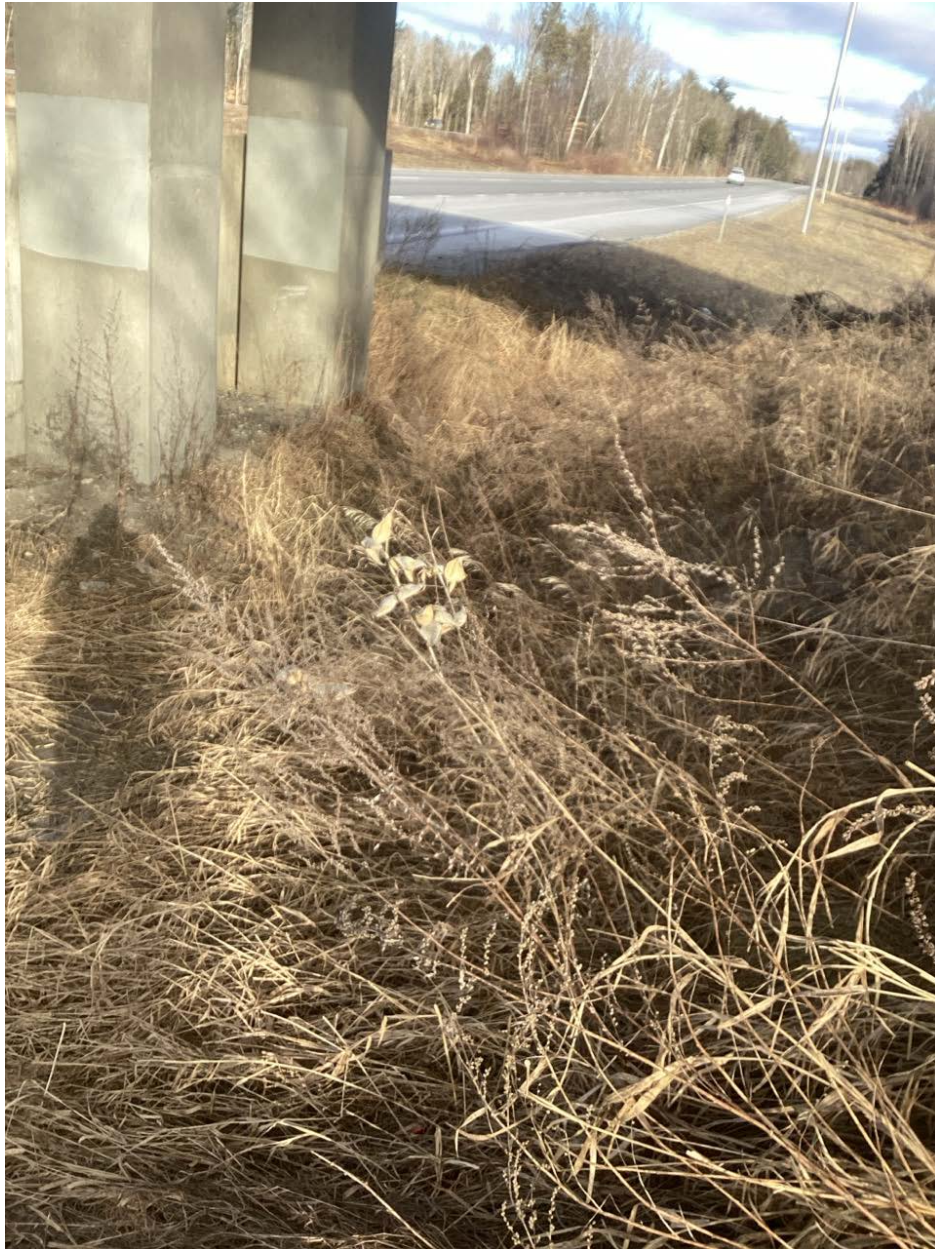
Photo 5. Common milkweed remnant at eastern bridge abutments. Stantec. January 10, 2025.

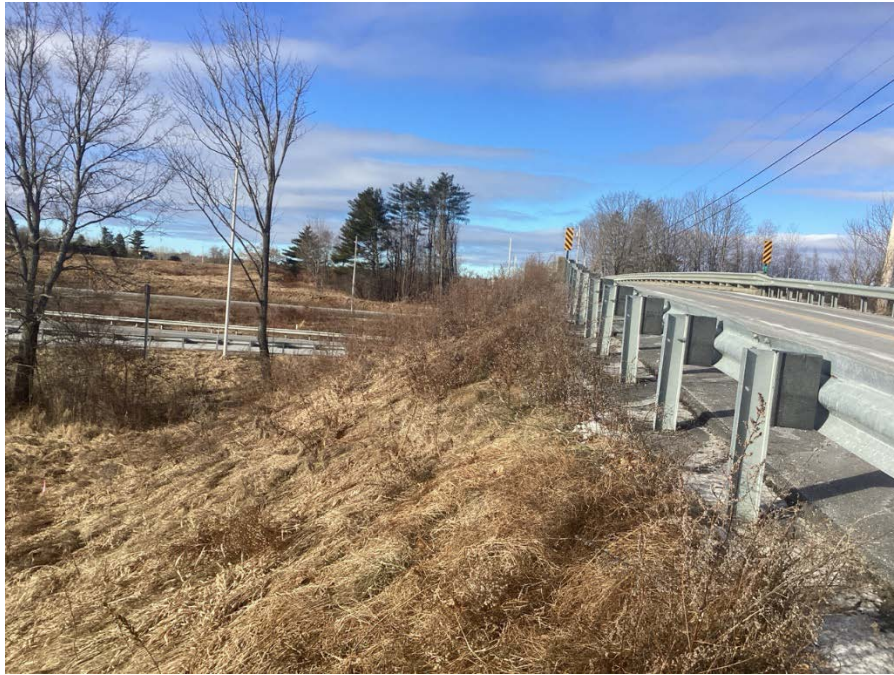
Photo 6. Representative Trafton Road shoulder habitat along eastern bridge approach. Stantec.
January 10, 2025.

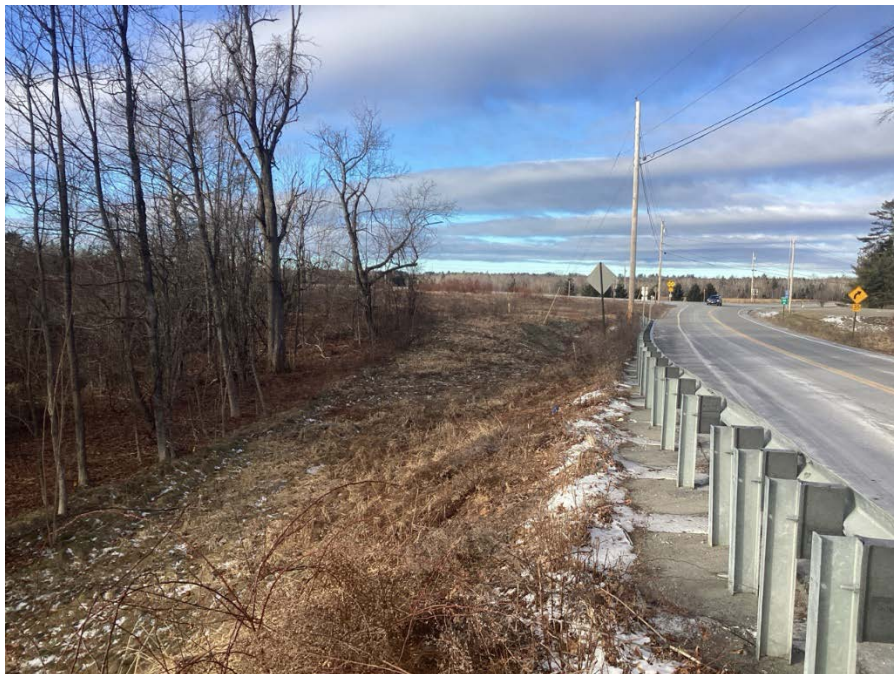
Photo 7. Representative Trafton Road shoulder habitat along western bridge approach. Stantec.
January 10, 2025.

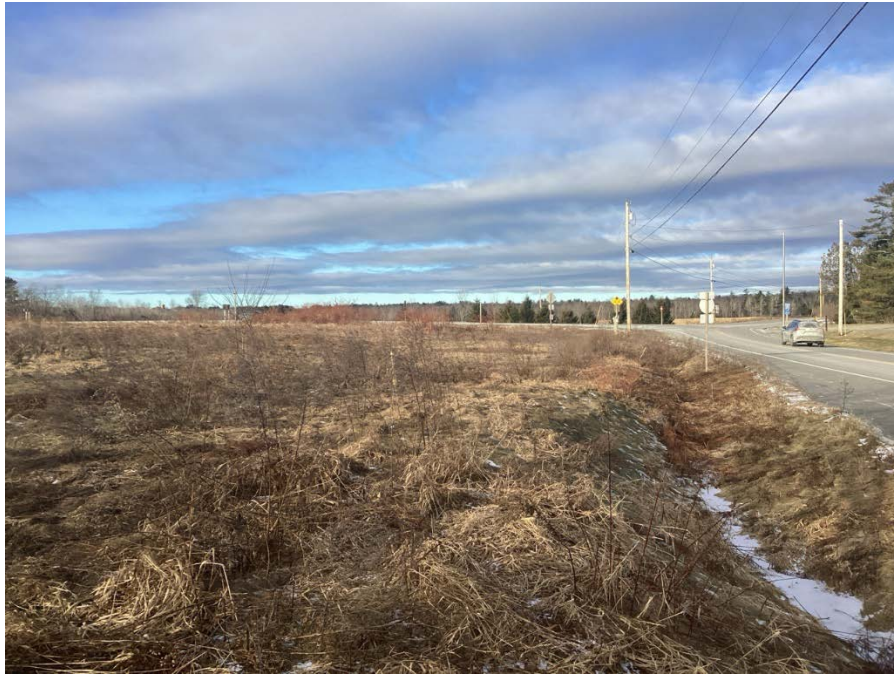
Photo 8. Early successional meadow and shrubland habitat along Trafton Road to west of bridge.
Stantec. January 10, 2025.
