Wetland Delineation Report

Sears Island Study Area

Searsport, Maine

January 2024

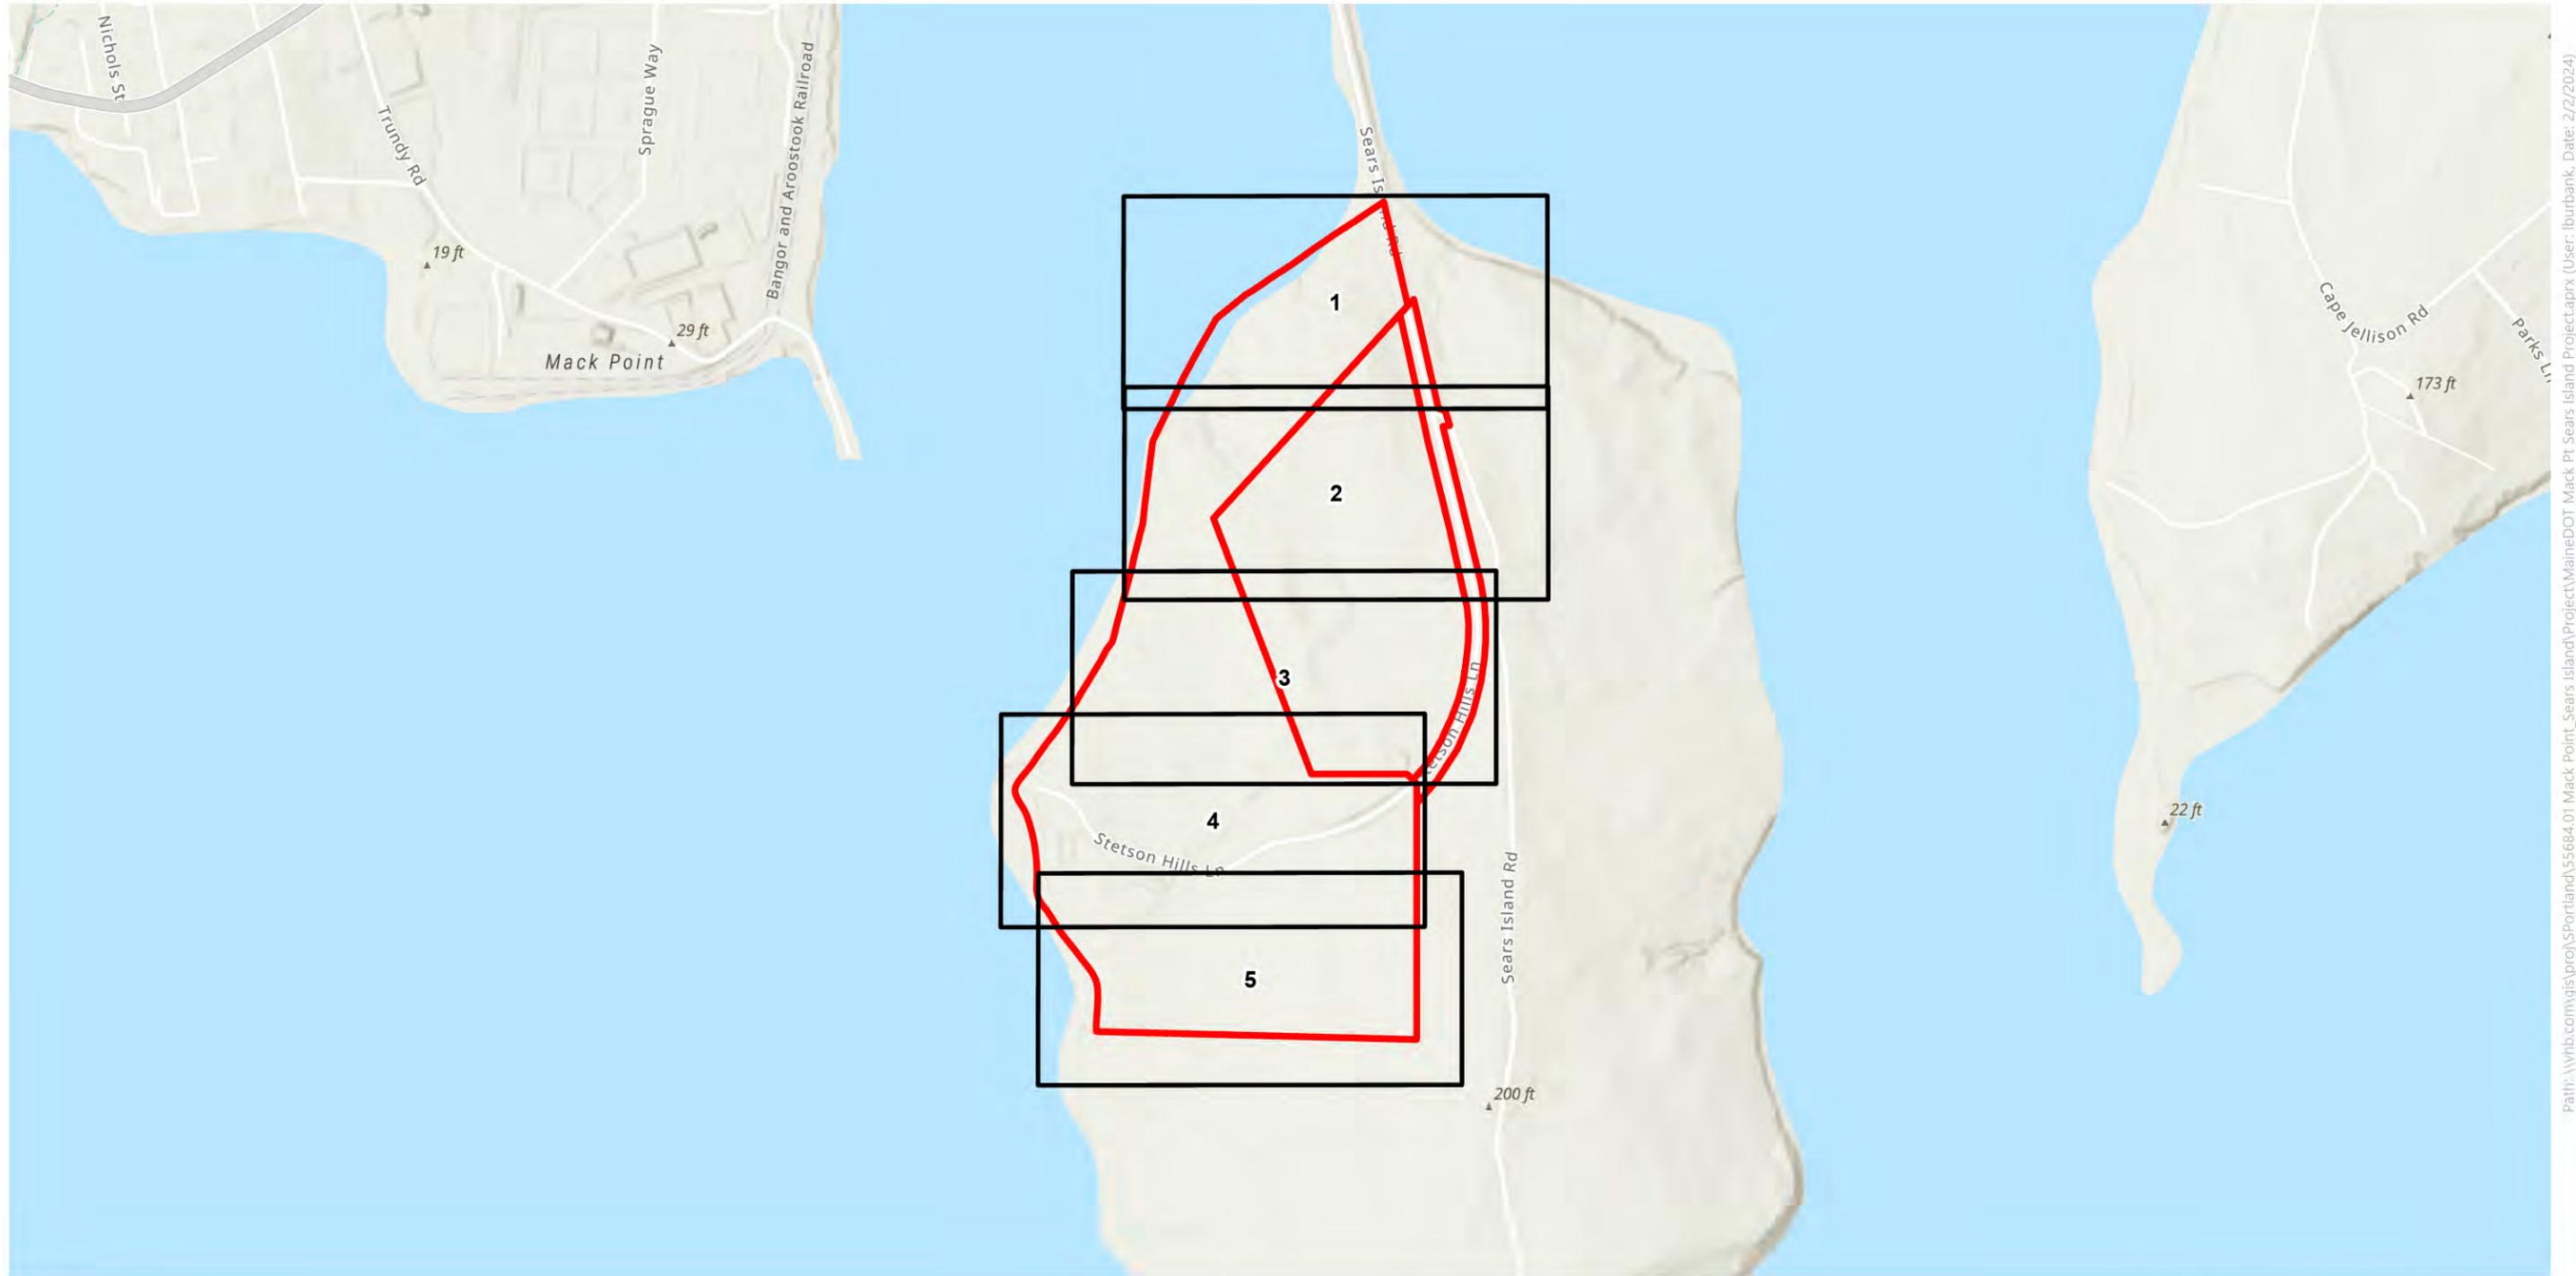
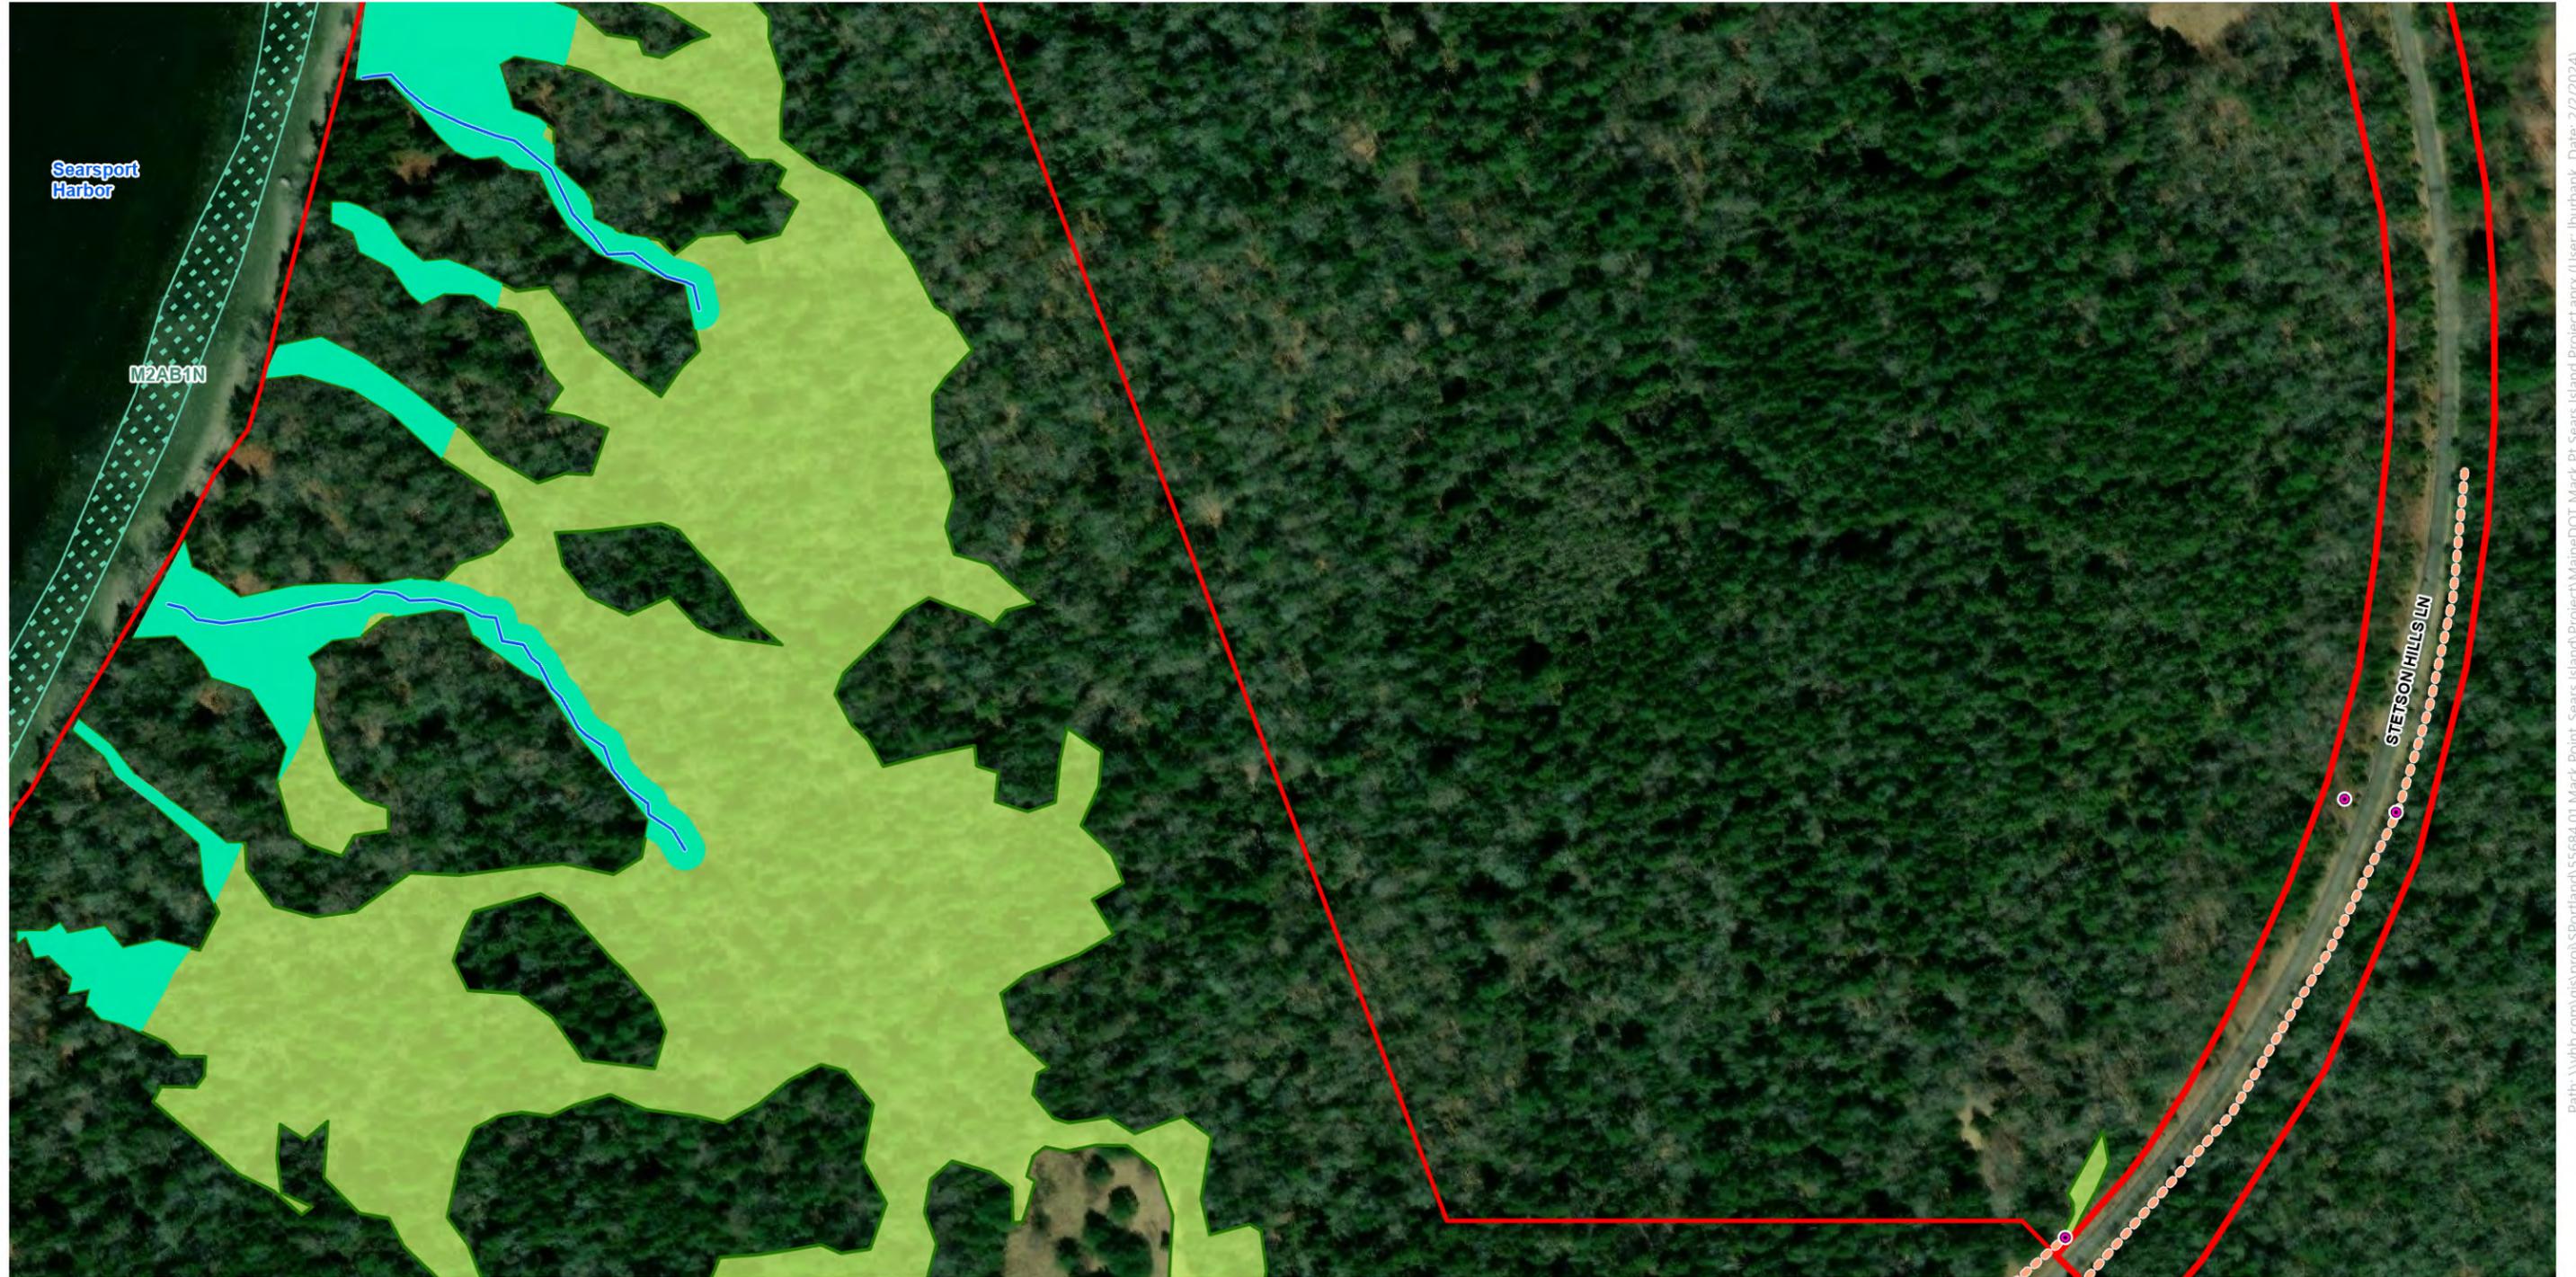
Figure 2: Natural Resources Map

- Culvert
- Constructed Ditch
- ▭ Study Area
- NWI - Mapped Estuarine and Marine Wetland
- MNAP - Mapped Sand Dunes
- Delineated Stream Centerline
- Delineated Wetland Edge
- ▭ Potential Vernal Pool
- ▭ Freshwater Vegetated Wetland
- ▭ Wetlands of Special Significance (WOSS)
- ▭ Stormwater Feature
- ▭ Wetland Restoration Area
- ▭ Wetlands Forming in Previously Disturbed Areas

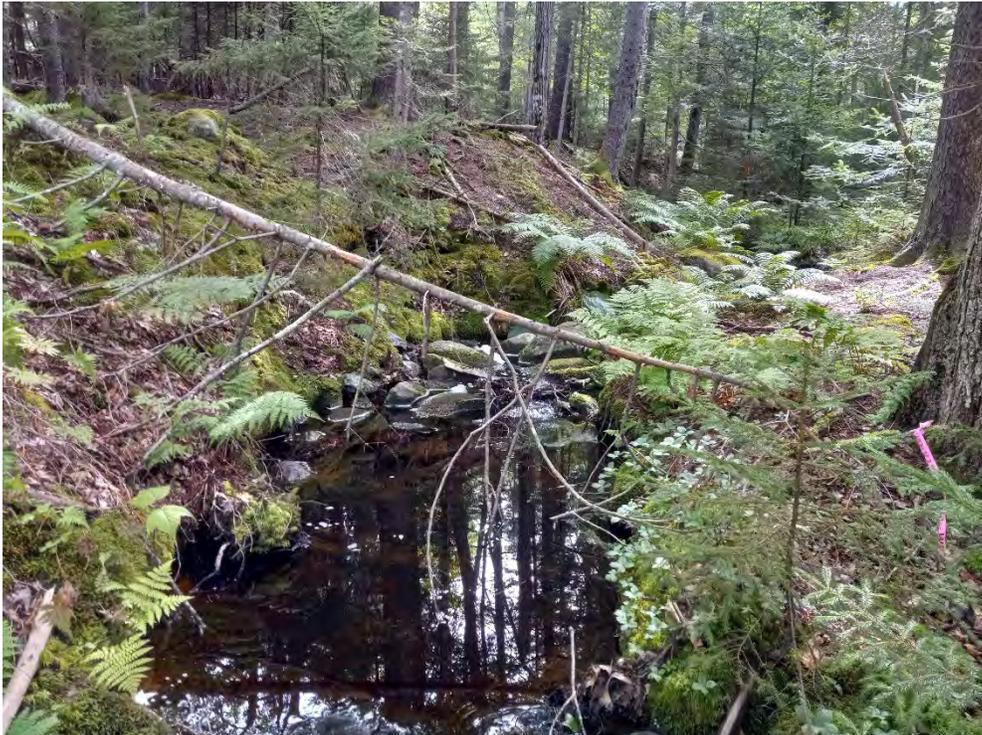
Photo No: 1	
Photo Date: 8-16-23	
Description: Perennial stream Perennial stream in northern portion of site where it enters the Study Area along its eastern boundary.

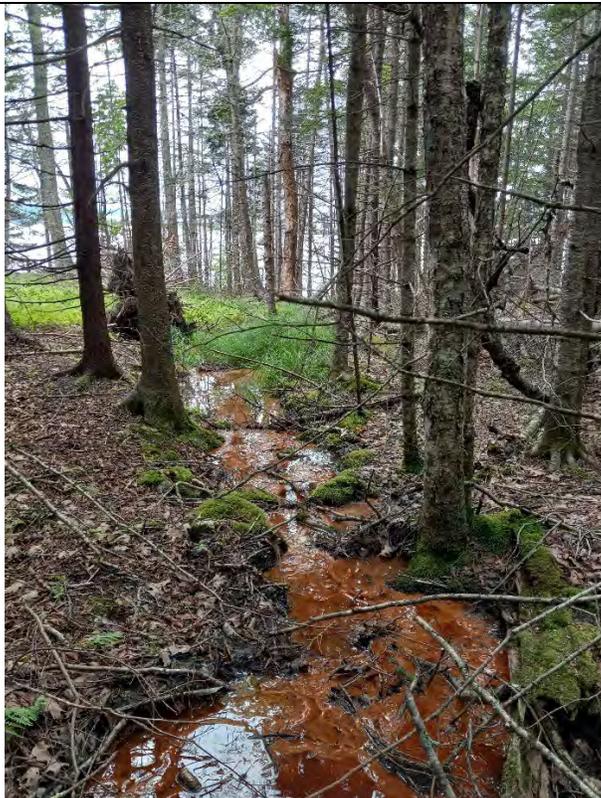
Photo No: 2	
Photo Date: 8-23-23	
Description: Intermittent stream Representative photo of intermittent stream in north-central portion of the study area where it flows west and exits the Study Area.

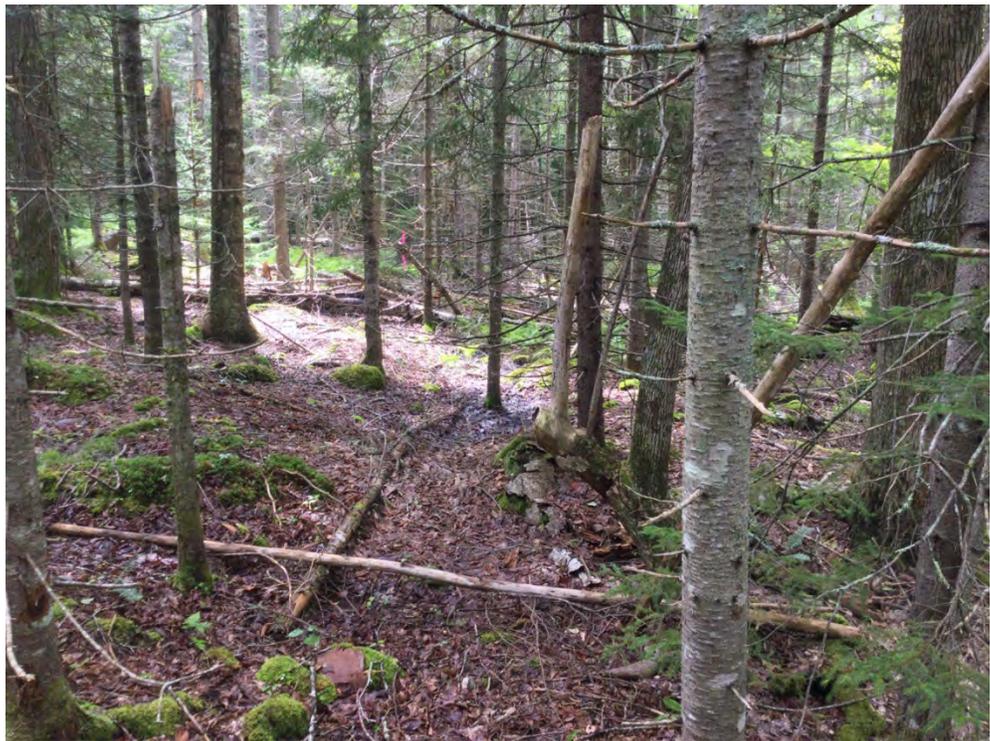
<p>Photo No: 3</p>

<p>Photo Date: 8-16-23</p>	
<p>Description: Wetland boundary</p> <p>Representative photo of wetland boundary line within southern portion of Study Area.</p>	
<p>Photo No: 4</p>

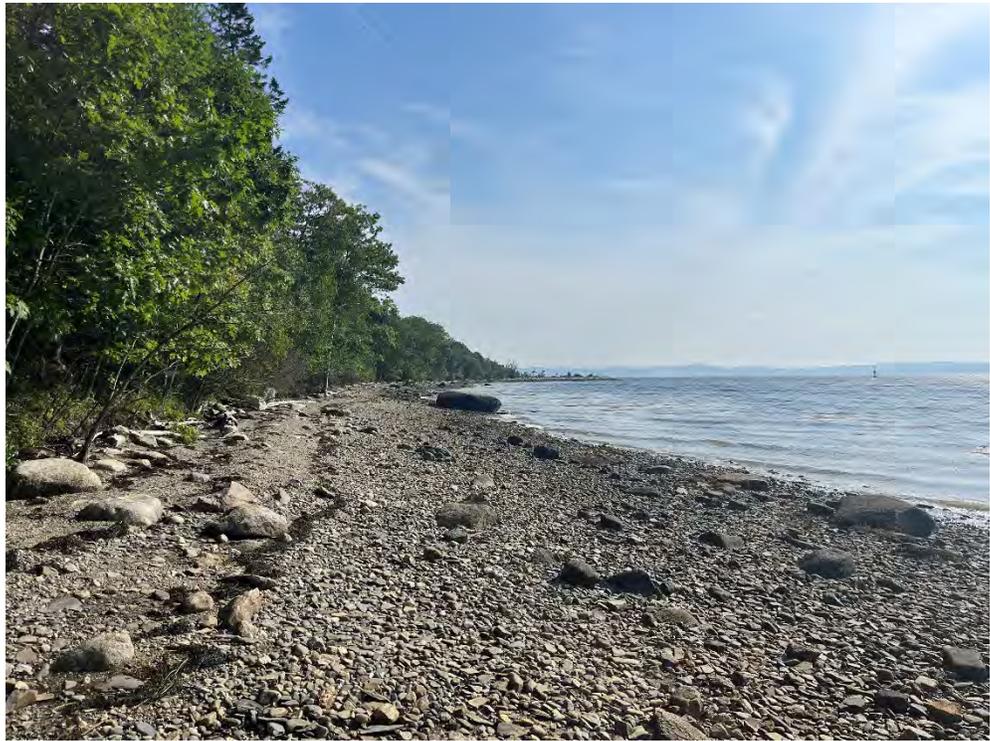
<p>Photo Date: 8-1-23</p>	
<p>Description: Western beach</p> <p>Representative photo of beach along western shore of Study Area looking south.</p>

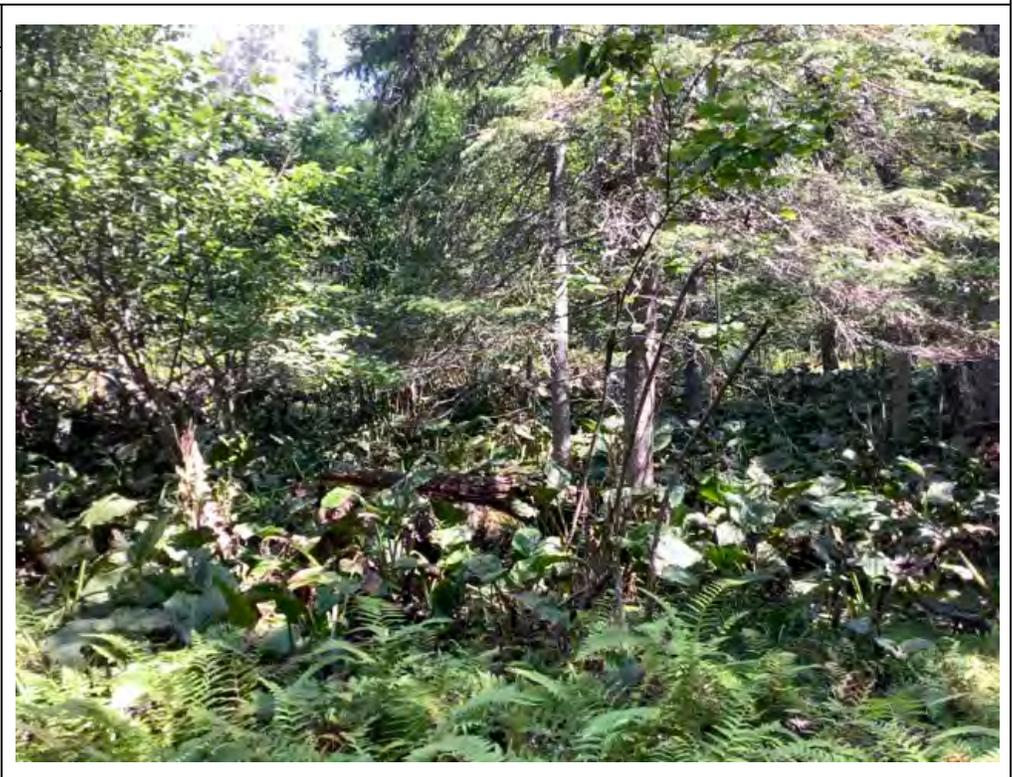
<p>Photo No: 5</p>

<p>Photo Date: 8-31-23</p>	
<p>Description: Forested wetland</p> <p>Representative photo of forested wetland within south-central portion of Study Area.</p>	
<p>Photo No: 6</p>

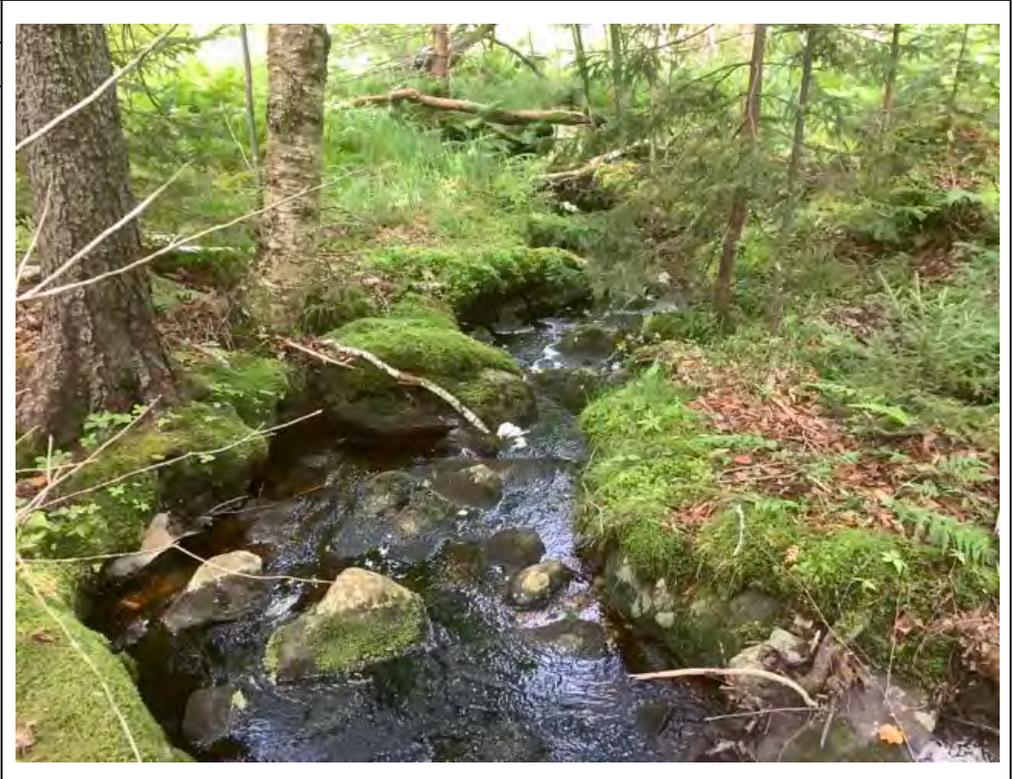
<p>Photo Date: 8-11-23</p>	
<p>Description: Perennial stream</p> <p>Representative photo of perennial stream which runs through the central portion of the Study Area.</p>

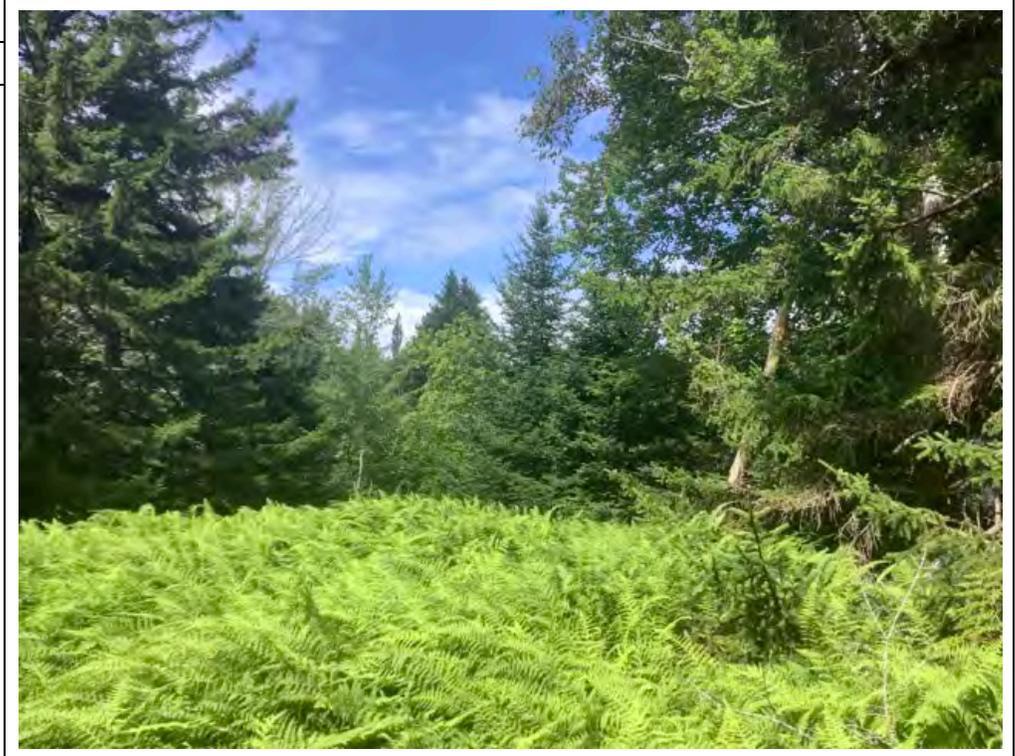
<p>Photo No: 7</p>	
<p>Photo Date: 8-11-23</p>	
<p>Description: Upland</p> <p>Representative photo of upland in the north-central portion of Study Area.</p>

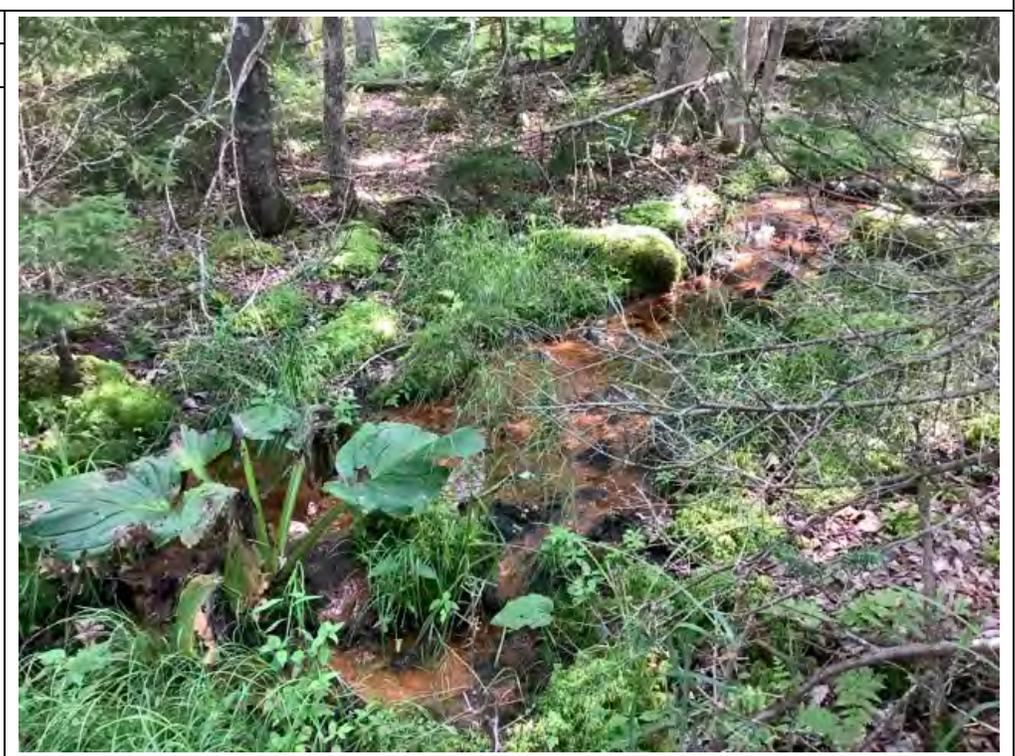
<p>Photo No: 8</p>	
<p>Photo Date: 8-3-23</p>	
<p>Description: Forested wetland</p> <p>Representative photo of forested wetland in southern portion of Study Area.</p>

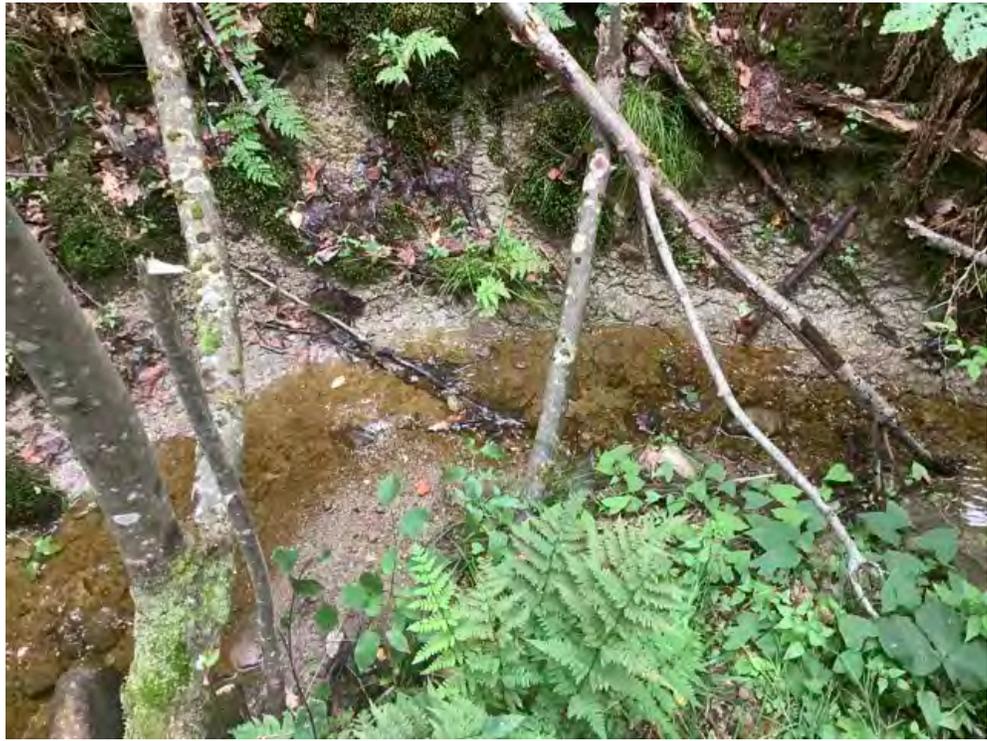
Photo No: 9

Photo Date: 8-16-23	
Description: Perennial stream Representative photo of perennial stream in the northern portion of the Study Area.	
Photo No: 10

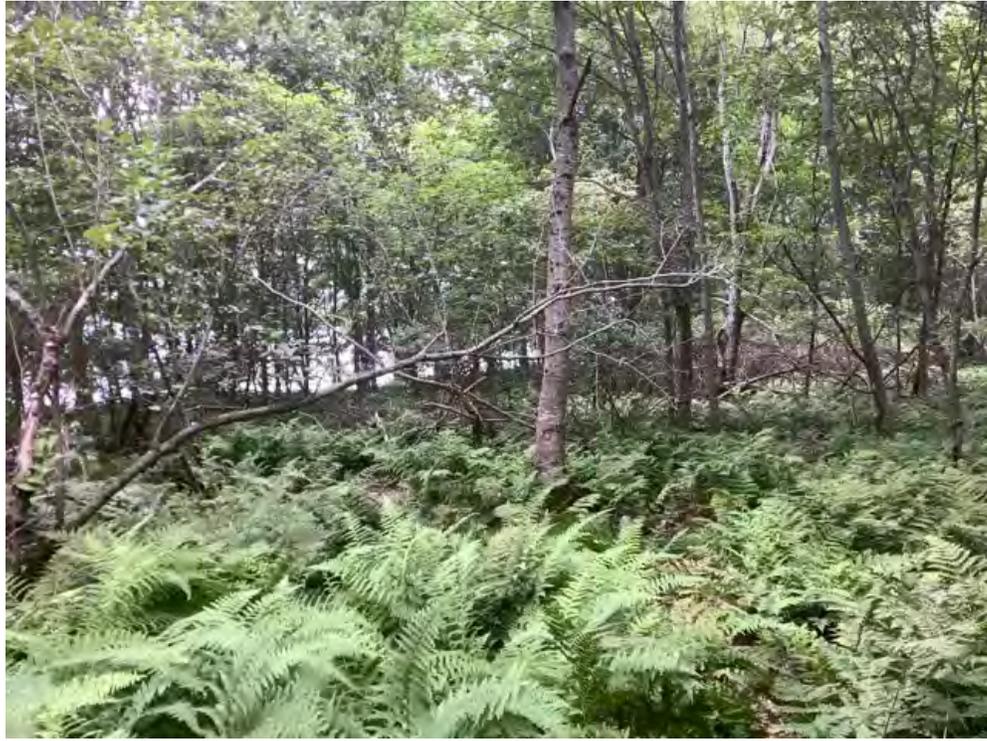
Photo Date: 8-17-23	
Description: Forested Representative photo of forested wetland in northwest portion of Study Area.

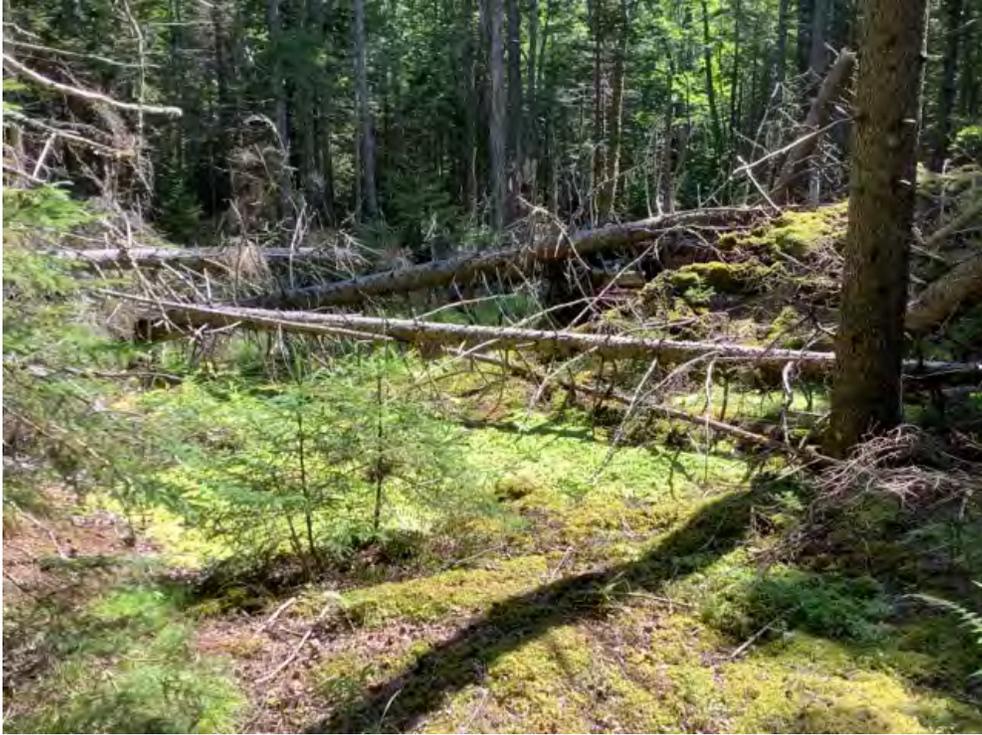
Photo No: 11	
Photo Date: 8-3-23	
Description: Forested wetland Representative photo of forested wetland in southeastern portion of the Study Area.

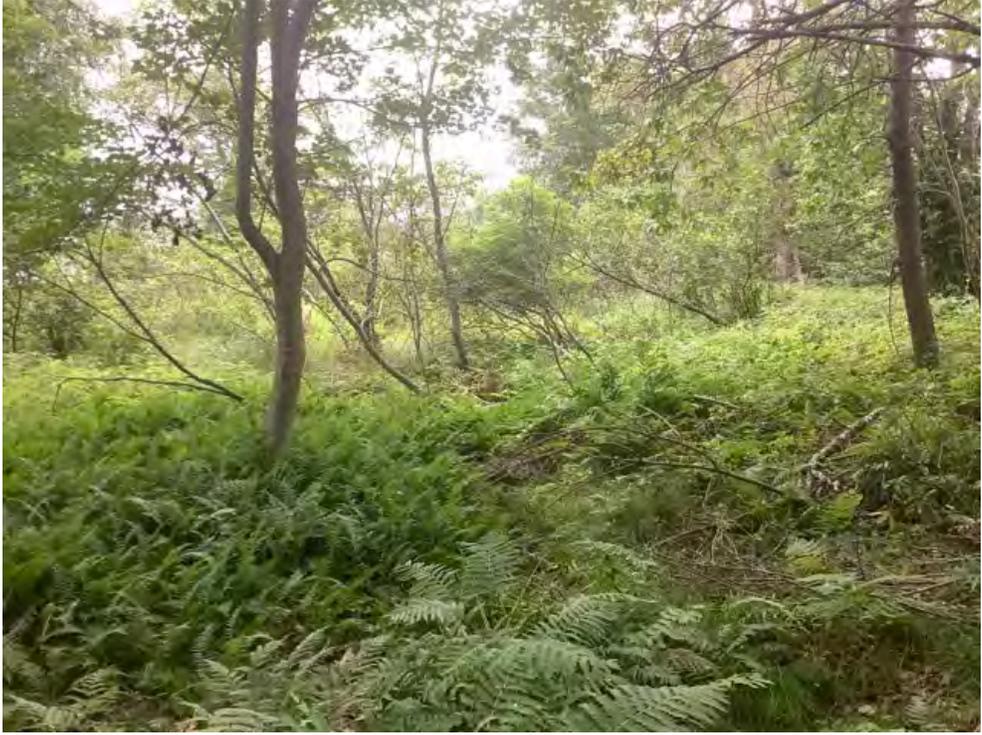
Photo No: 12	
Photo Date: 8-17-23	
Description: Forested wetland Representative photo of forested/scrub-shrub wetland in northern portion of the Study Area where perennial stream drains to beach.
