Hydrographic and Marine Geophysical
Site Characterization Surveys

Mack Point and Sears Island

Searsport, ME

Prepared for:
Stantec

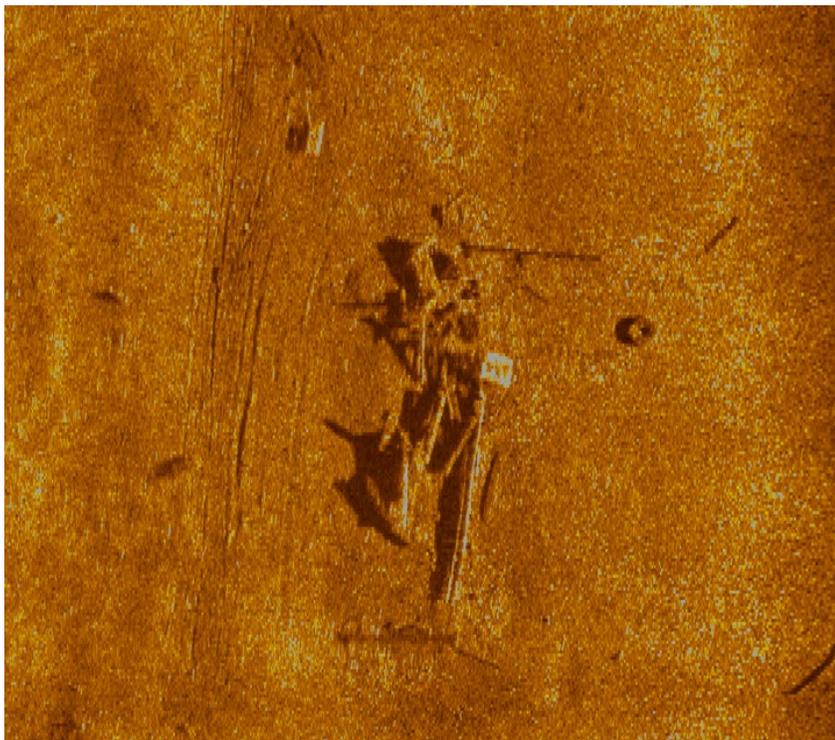
Figure 11. Target MP 19, Debris at Mack Point Near Sprague Terminal

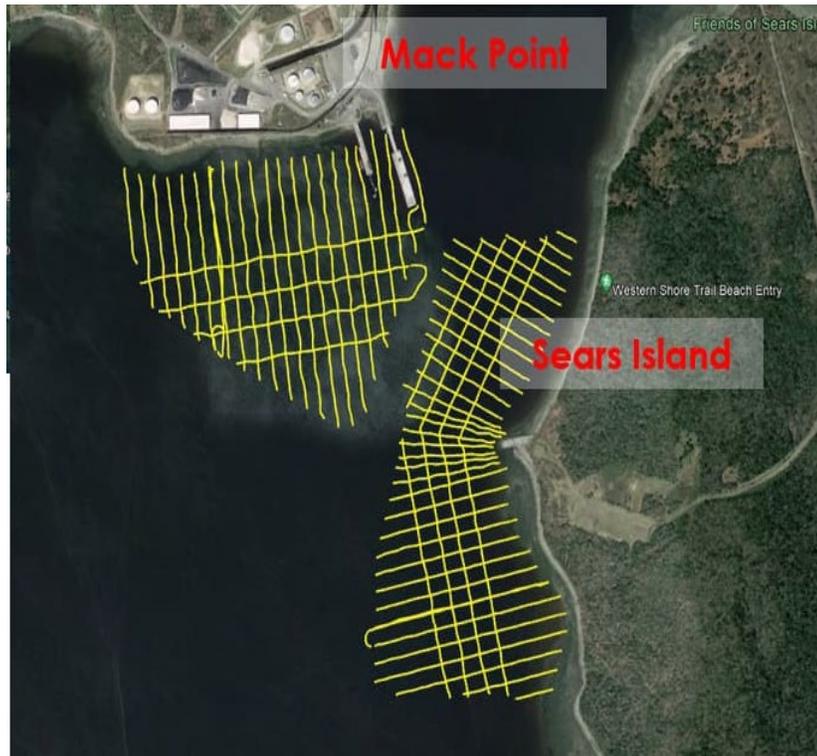
Figure 26. Sub-Bottom Profile Survey Transects

The Mack Point survey consisted of 23 transects oriented perpendicular to the shoreline in a N-S direction and 4 transects oriented parallel to shoreline (in a roughly E-W direction). Line spacing for the primary lines was approximately 150-ft and 300-ft for the cross lines (Figure 26). Transect length varied across the survey block.

The Sears Island survey consisted of 36 transects oriented perpendicular to the shoreline in a radiating fashion, changing from NW-SE in the north and WSW-ENE in the south (Figure 26). Cross tie information was provided by 5 transects oriented parallel to shoreline (bending from NE in the north to SE in the south). Line spacing for the primary lines was approximately 150-ft, although this narrowed around the rock jetty extending from the western shore of the island. The cross line spacing was approximately 200-ft. Transect length varied across the survey block.
