**PRELIMINARY GEOTECHNICAL REPORT
INTERSTATE 95
TRAFTON ROAD INTERCHANGE
WATERVILLE, MAINE
MaineDOT WIN 18129.10**

SchonewaldEA Project No. 15-001

Re: Preliminary Geotechnical Report
Proposed Trafton Road Interchange
Waterville, Maine
MaineDOT WIN 18129.10

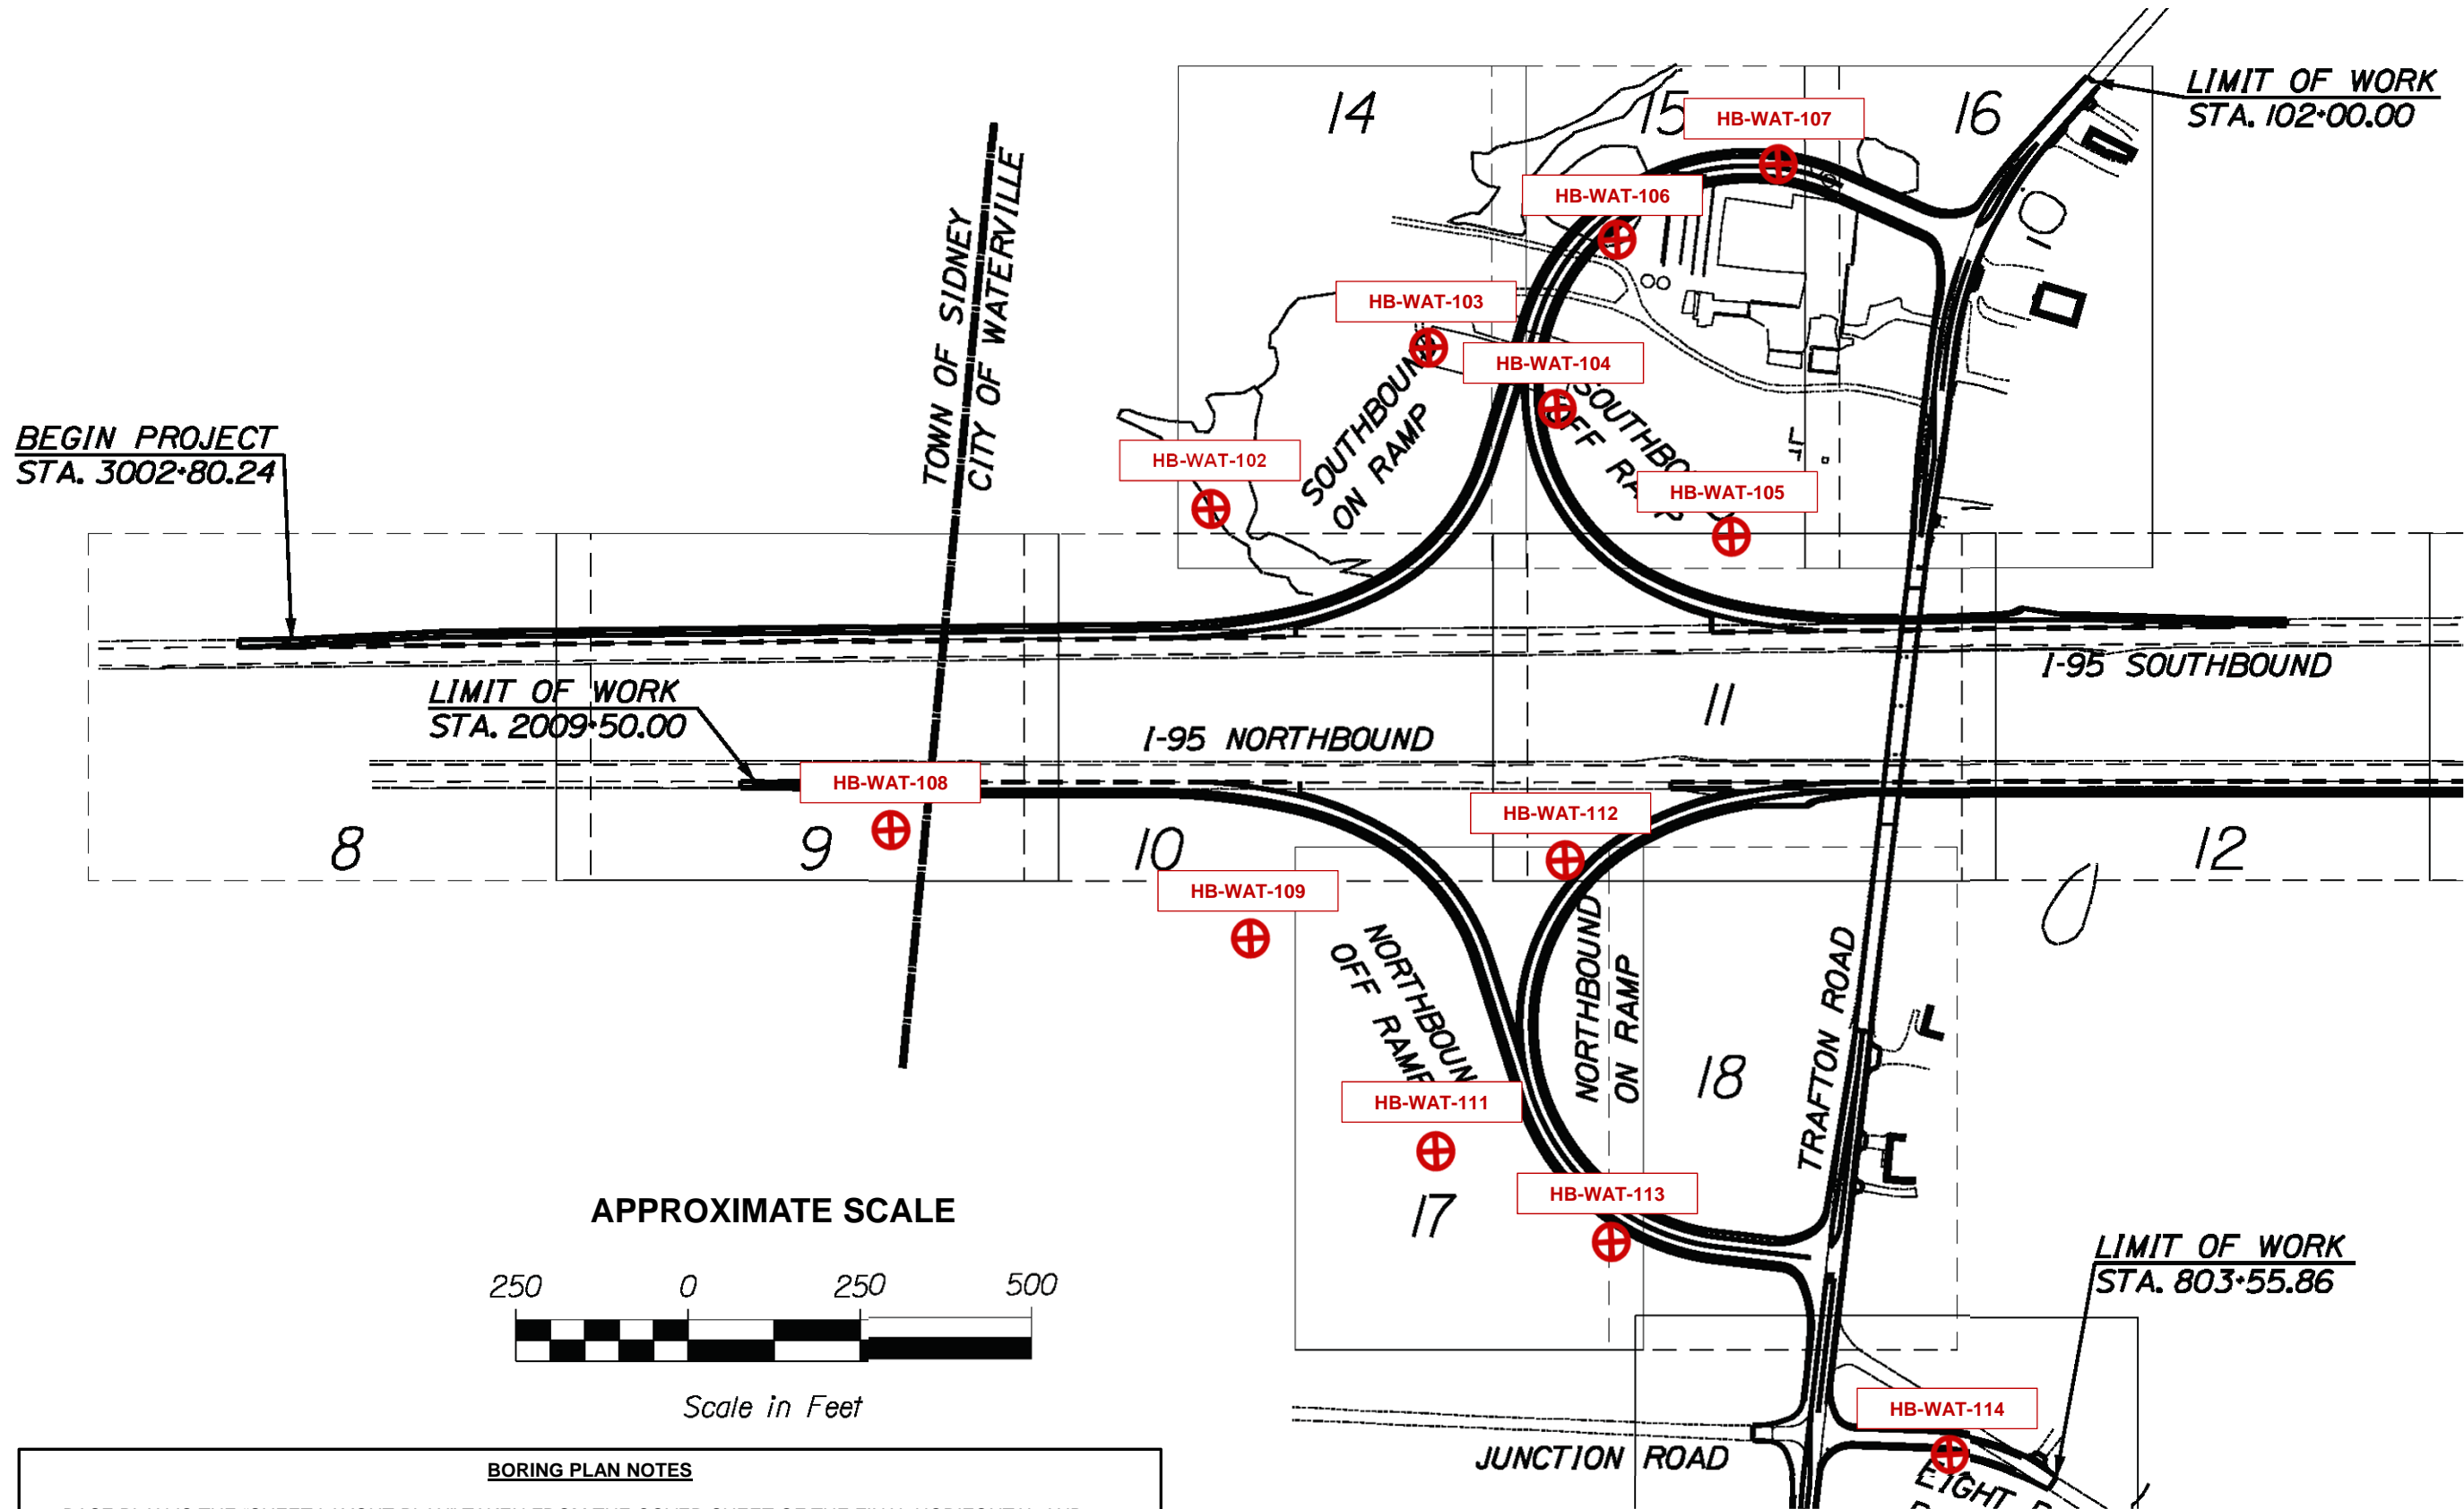
<p>SCHONEWALD ENGINEERING ASSOCIATES, INC.</p>	<p>PROJECT NO.: 15-001</p>
	<p>DATE: AUG. 2015</p>
<p>PROPOSED I-95 INTERCHANGE AT TRAFTON ROAD WATERVILLE, MAINE MAINE-DOT WIN 18129.10</p>	<p>DRAWN BY: IVS</p>
	<p>APPROX. SCALE: 1" = 250'</p>
<p>Sheet No.: 2</p>

The following table summarizes the test boring program. The approximate locations of the test borings are depicted on attached Figures - Sheet 2—Boring Location Plan. Geoplans depicting the locations of the test borings relative to the final HVAC alignments are also included with the attached figures.

SchonewaldEA retained New England Boring Contractors (NEBC) of Hermon, Maine to drill twelve test borings within the project area, designated HB-WAT-102 through -109 and HB-WAT-111 through -114. The approximate locations of the test borings are depicted on attached Figures - Sheet 2--Boring Location Plan. Geoplans depicting the locations of the test borings relative to the final HVAC alignments are also included with the attached figures.

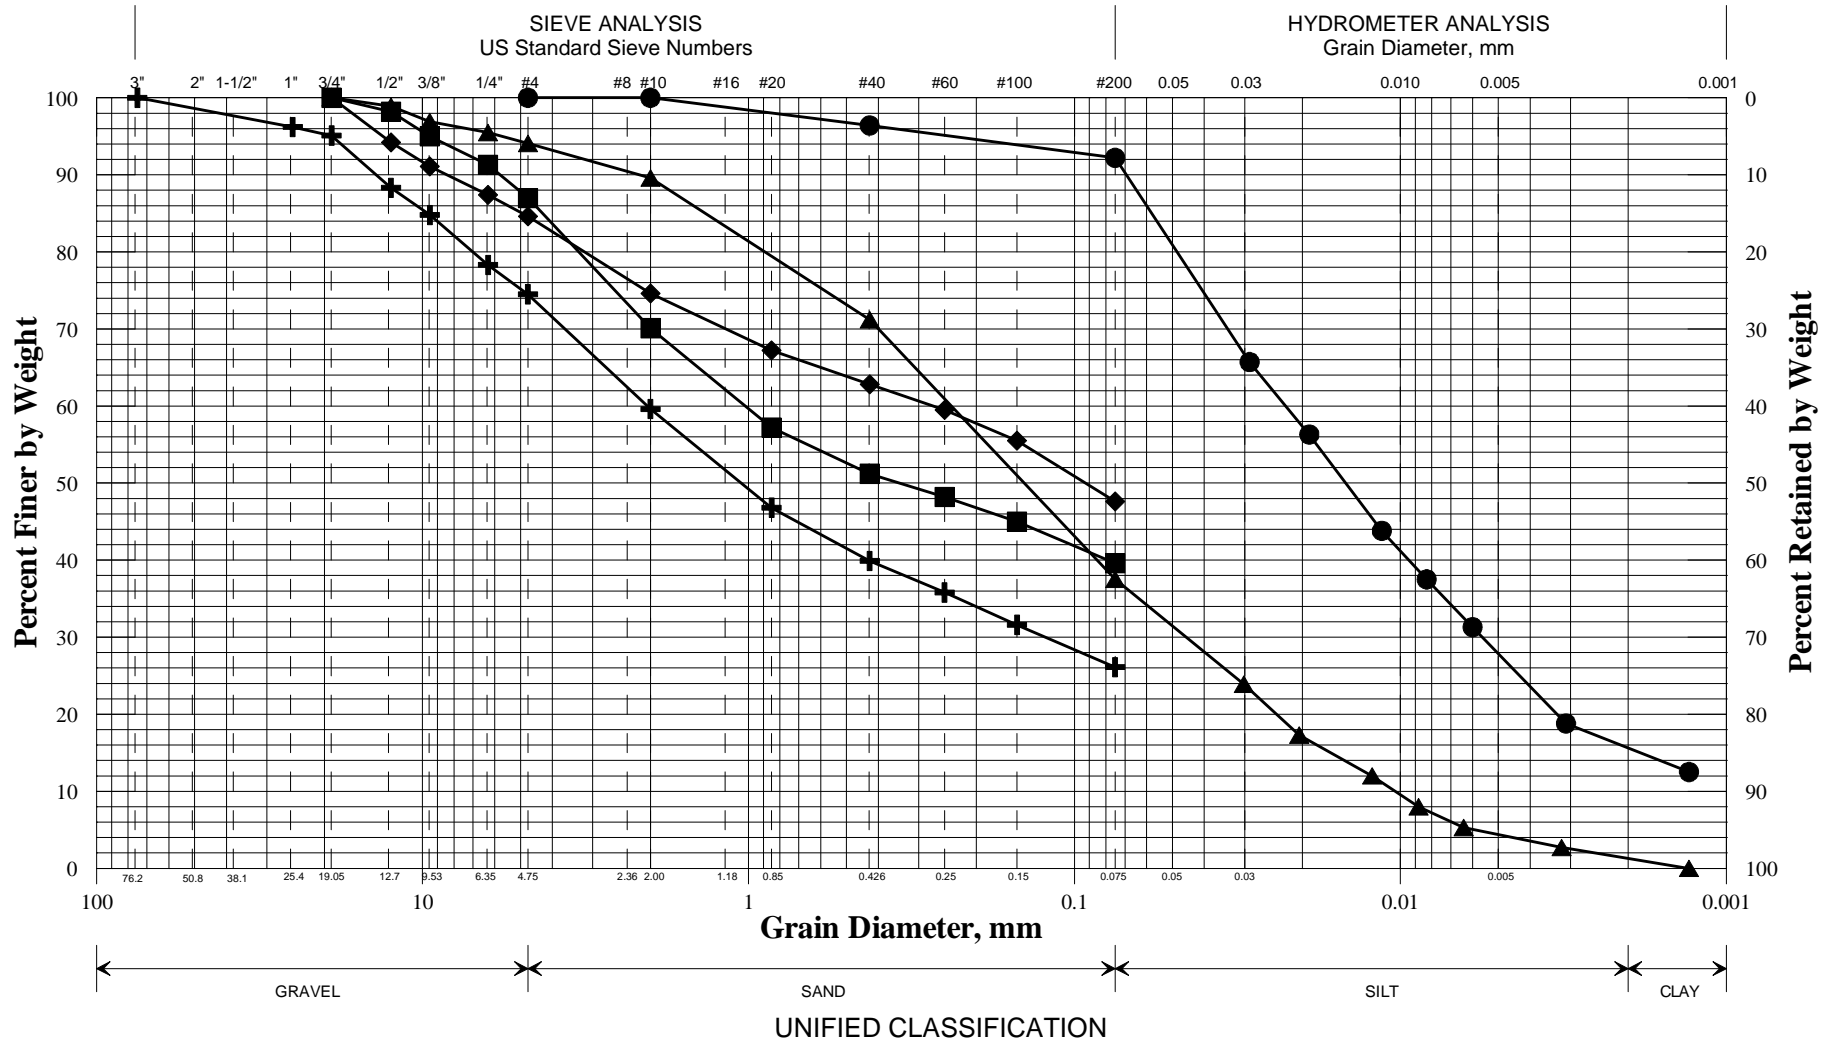
State of Maine Department of Transportation
GRAIN SIZE DISTRIBUTION CURVE

Boring/Sample No.	Station	Offset, ft	Depth, ft	Description	W, %	LL	PL	PI
+	HB-WAT-102/2D	514+01	141.8 LT	5.0-7.0	SAND, some silt, some gravel.	11.9			
◆	HB-WAT-104/1D	601+37	0.6 RT	2.0-4.0	Sandy SILT, little gravel.	11.8			
■	HB-WAT-105/2D	605+03	86.5 LT	5.0-7.0	Silty SAND, trace gravel.	8.1			
●	HB-WAT-106/2D	710+40	18.4 RT	5.0-7.0	SILT, little clay, trace sand.	24.7	23	22	1
▲	HB-WAT-106/3D	710+40	18.4 RT	10.0-12.0	Silty SAND, trace gravel, trace clay.	18.1			
×

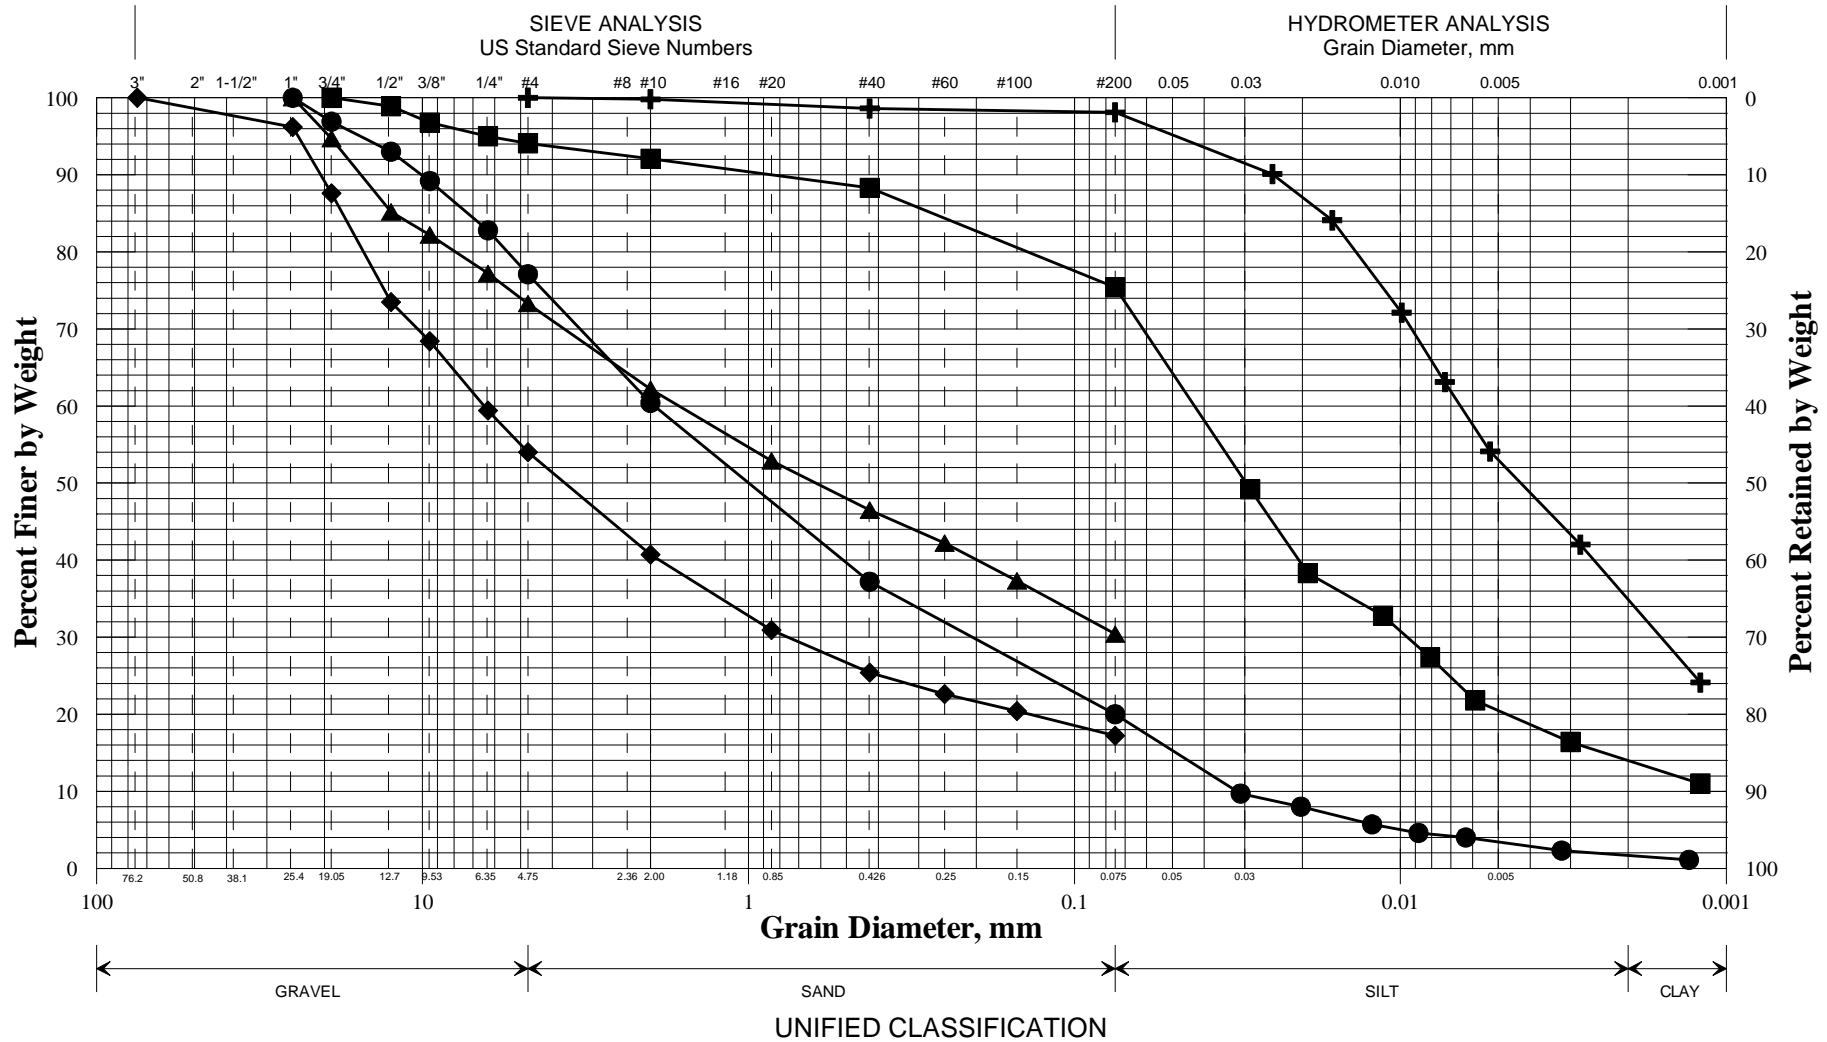
State of Maine Department of Transportation
GRAIN SIZE DISTRIBUTION CURVE

Boring/Sample No.	Station	Offset, ft	Depth, ft	Description	W, %	LL	PL	PI
+	HB-WAT-107/2D	704+15	4.6 RT	5.0-7.0	SILT, some clay, trace sand, trace gravel.	26.8	32	22	10
◆	HB-WAT-108/2D	202+17	107.0 RT	5.0-7.0	Sandy GRAVEL, little silt.	4.3			
■	HB-WAT-109/1D	207+84	229.5 RT	2.0-4.0	SILT, little sand, little clay, trace gravel.	19.3			NP
●	HB-WAT-109/2D	207+84	229.5 RT	5.0-7.0	SAND, some gravel, little silt, trace clay.	12.9			
▲	HB-WAT-111/2D	400+40.5	161.6 RT	5.0-7.0	SAND, some silt, some gravel.	11.7			
×

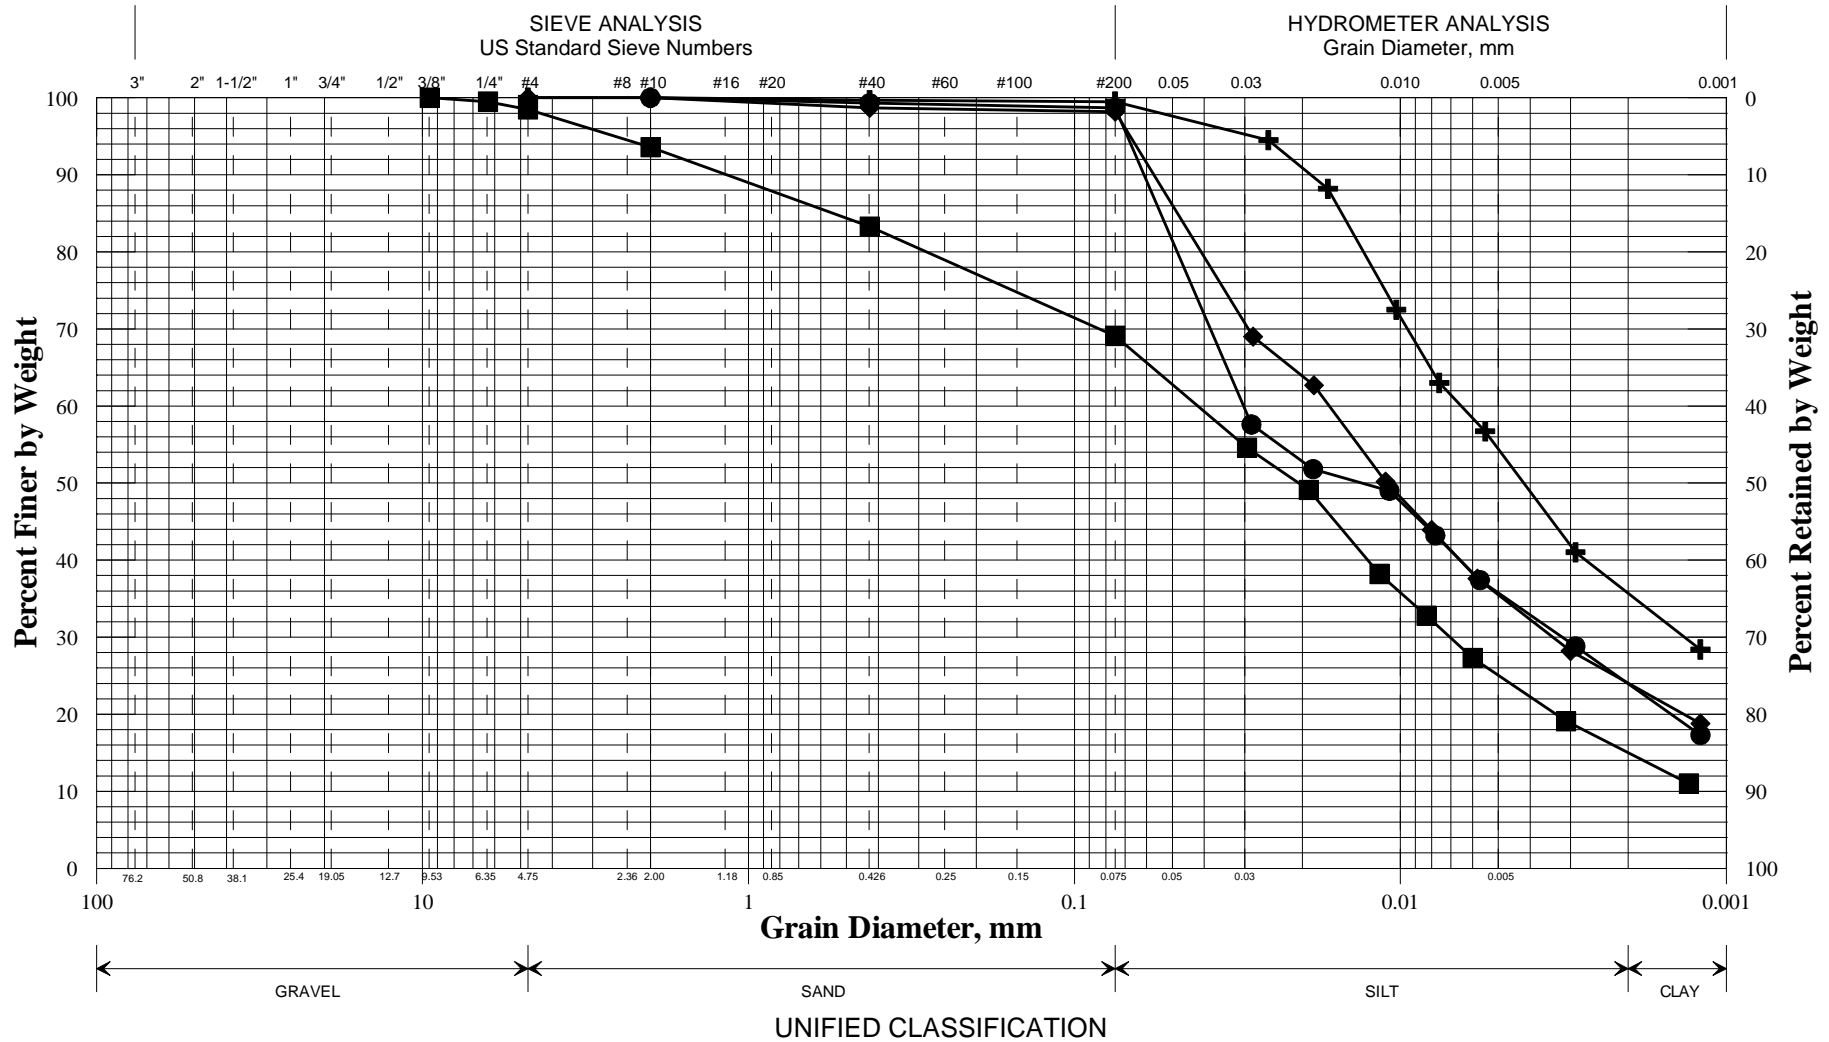
State of Maine Department of Transportation
GRAIN SIZE DISTRIBUTION CURVE

Boring/Sample No.	Station	Offset, ft	Depth, ft	Description	W, %	LL	PL	PI
+	HB-WAT-112/2D	303+11.5	39.2 LT	5.0-7.0	Clayey SILT, trace sand.	26.3	29	22	7
◆	HB-WAT-112/3D	303+11.5	39.2 LT	10.0-12.0	SILT, some clay, trace sand.	27.0	23	18	5
■	HB-WAT-113/2D	402+43	50.4 RT	5.0-7.0	SILT, some sand, little clay, trace gravel.	17.1			NP
●	HB-WAT-114/3D	802+20.5	16.8 RT	10.0-12.0	SILT, some clay, trace sand.	26.6	22	18	4
▲									
×

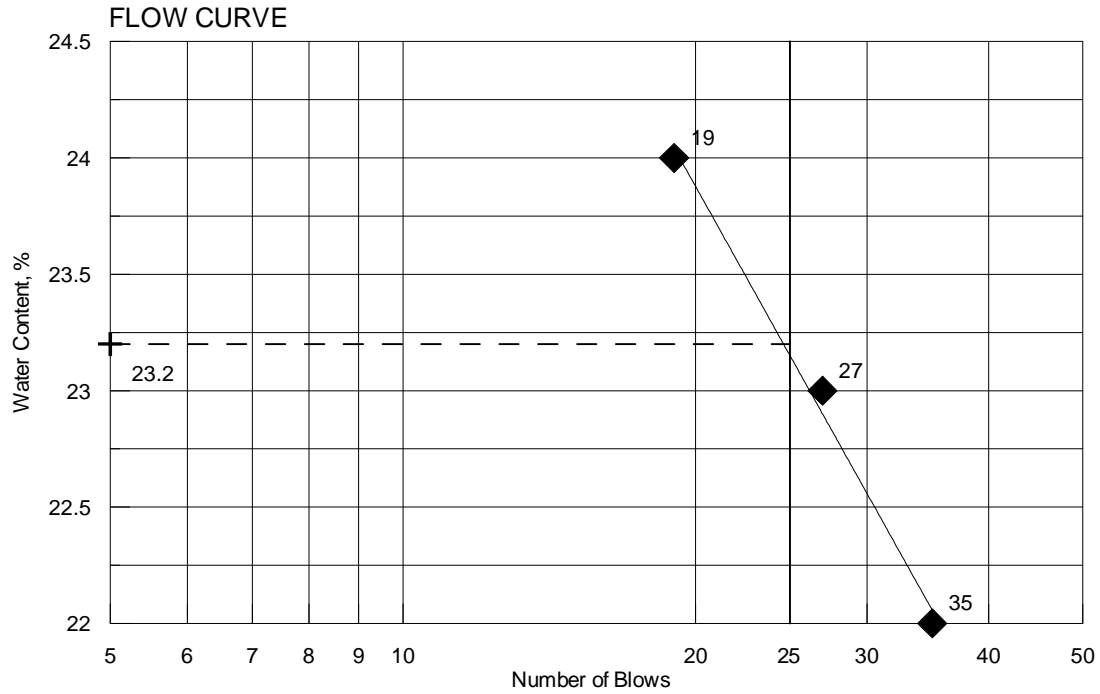
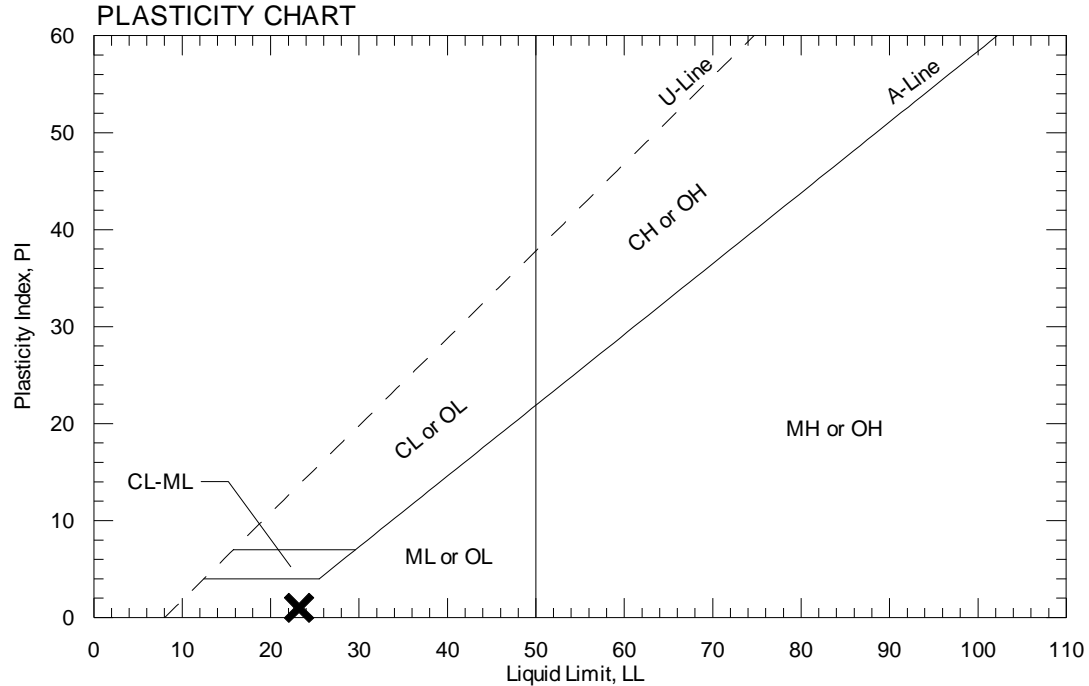
TOWN	Waterville	Reference No.	263404
WIN	018129.10	Water Content, %	24.7
Sampled	2/5/2015	Liquid Limit @ 25 blows (T 89), %	23
Boring No./Sample No.	HB-WAT-106/2D	Plastic Limit (T 90), %	22
Station	710+40	Plasticity Index (T 90), %	1
Depth	5.0-7.0	Tested By	BBURR

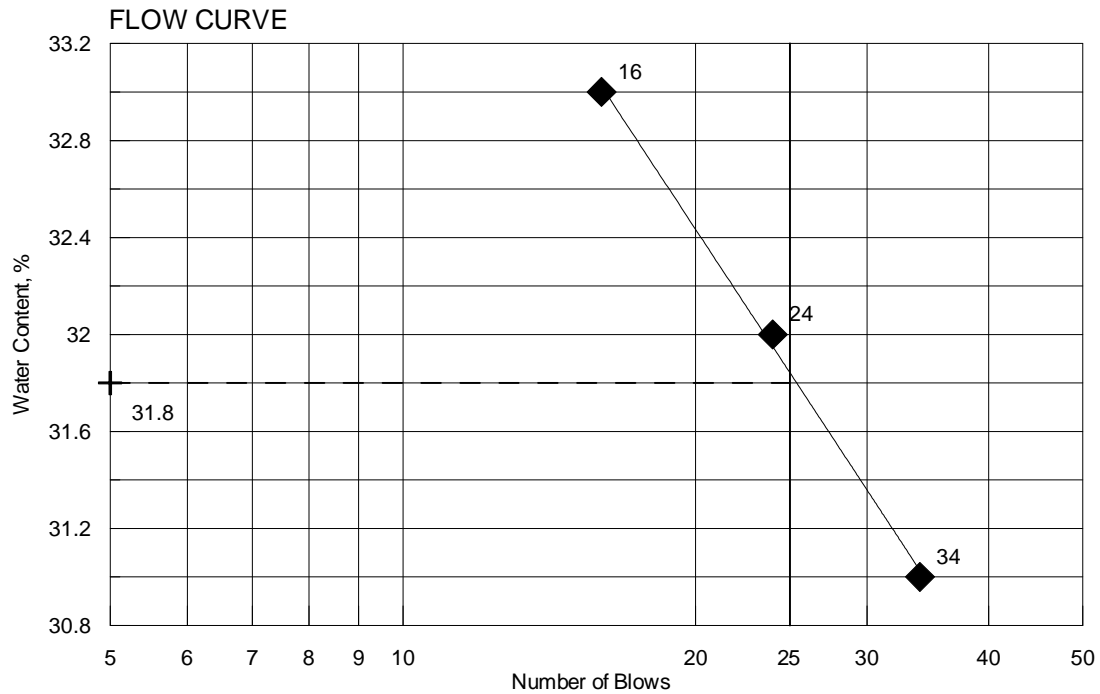
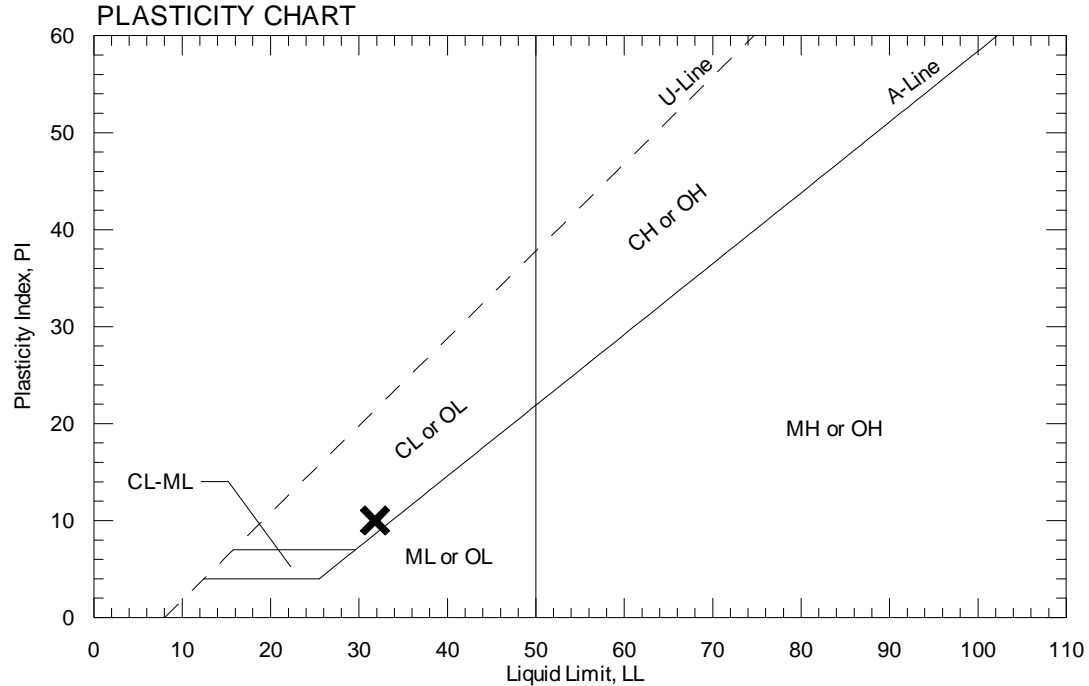
TOWN	Waterville	Reference No.	263406
WIN	018129.10	Water Content, %	26.8
Sampled	2/5/2015	Liquid Limit @ 25 blows (T 89), %	32
Boring No./Sample No.	HB-WAT-107/2D	Plastic Limit (T 90), %	22
Station	704+15	Plasticity Index (T 90), %	10
Depth	5.0-7.0	Tested By	BBURR

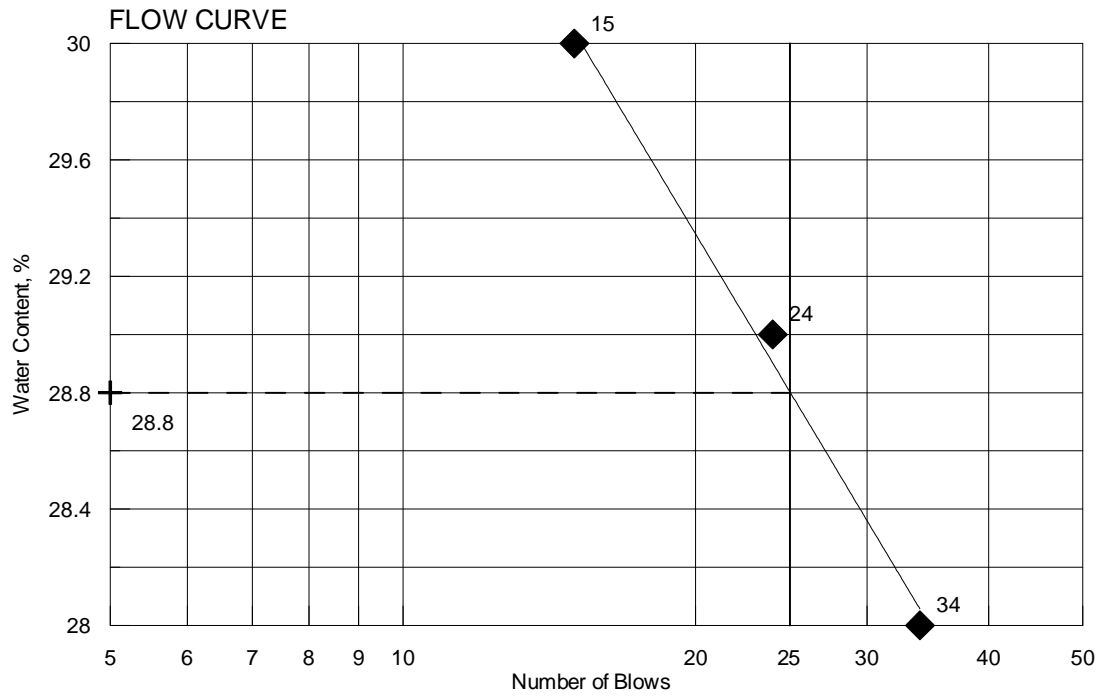
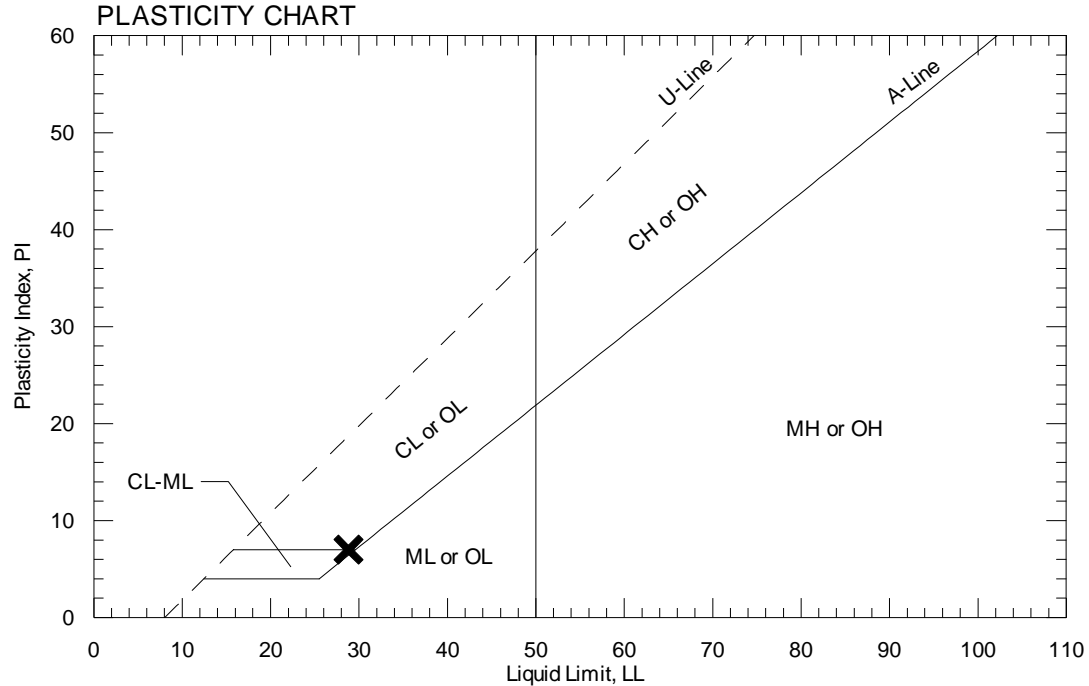
TOWN	Waterville	Reference No.	263411
WIN	018129.10	Water Content, %	26.3
Sampled	2/4/2015	Liquid Limit @ 25 blows (T 89), %	29
Boring No./Sample No.	HB-WAT-112/2D	Plastic Limit (T 90), %	22
Station	303+11.5	Plasticity Index (T 90), %	7
Depth	5.0-7.0	Tested By	BBURR

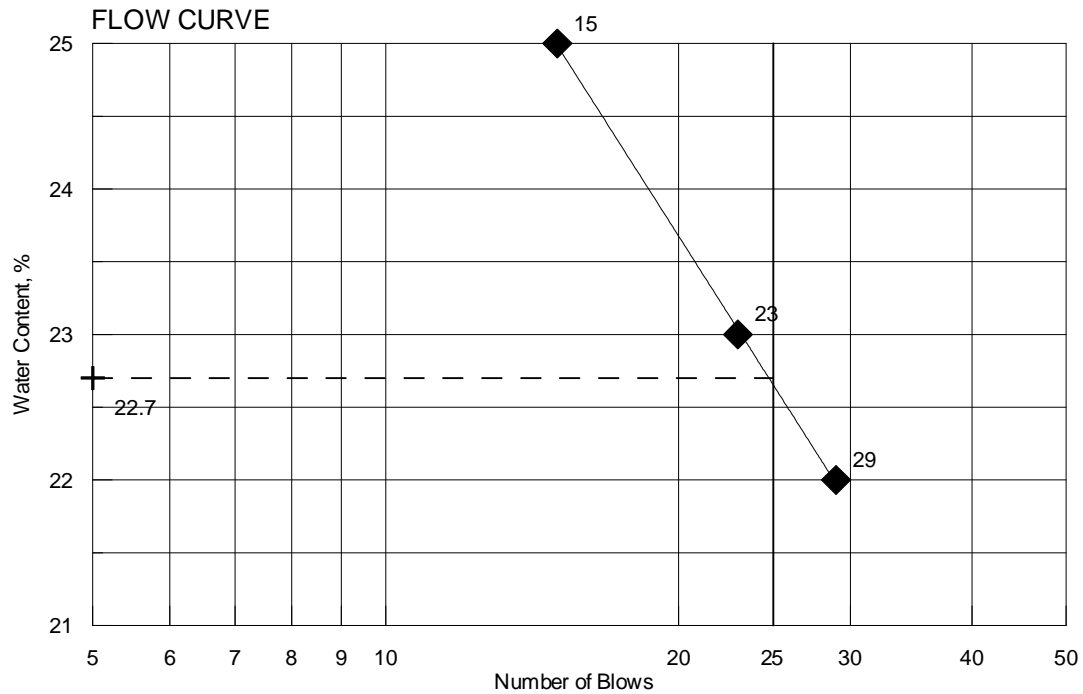
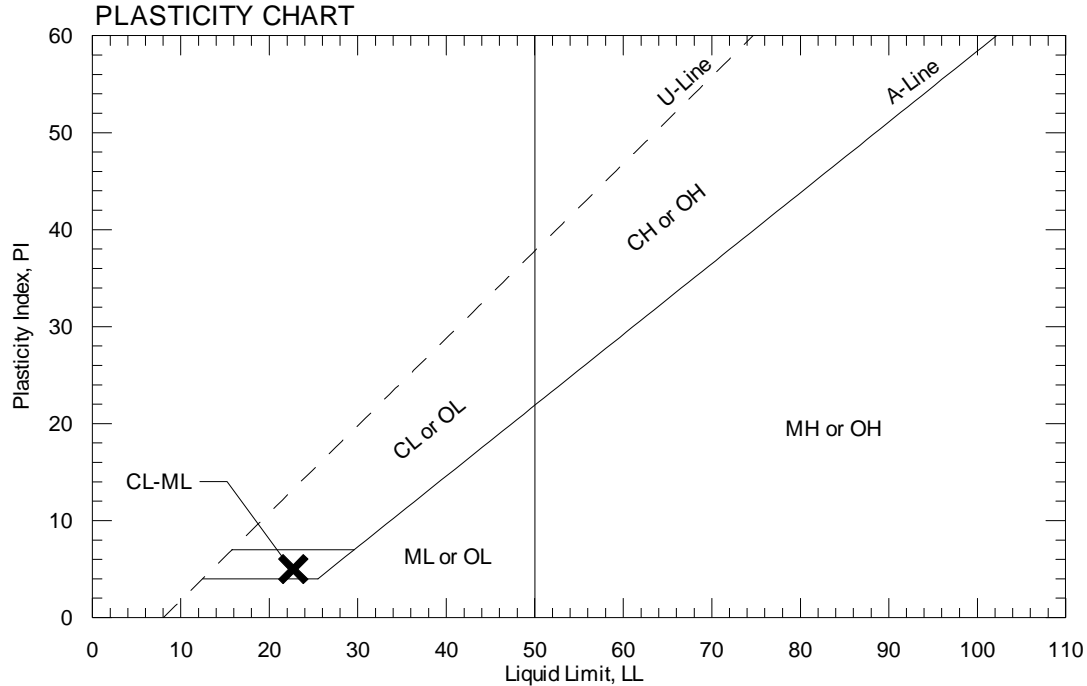
TOWN	Waterville	Reference No.	263412
WIN	018129.10	Water Content, %	27
Sampled	2/4/2015	Liquid Limit @ 25 blows (T 89), %	23
Boring No./Sample No.	HB-WAT-112/3D	Plastic Limit (T 90), %	18
Station	303+11.5	Plasticity Index (T 90), %	5
Depth	10.0-12.0	Tested By	BBURR

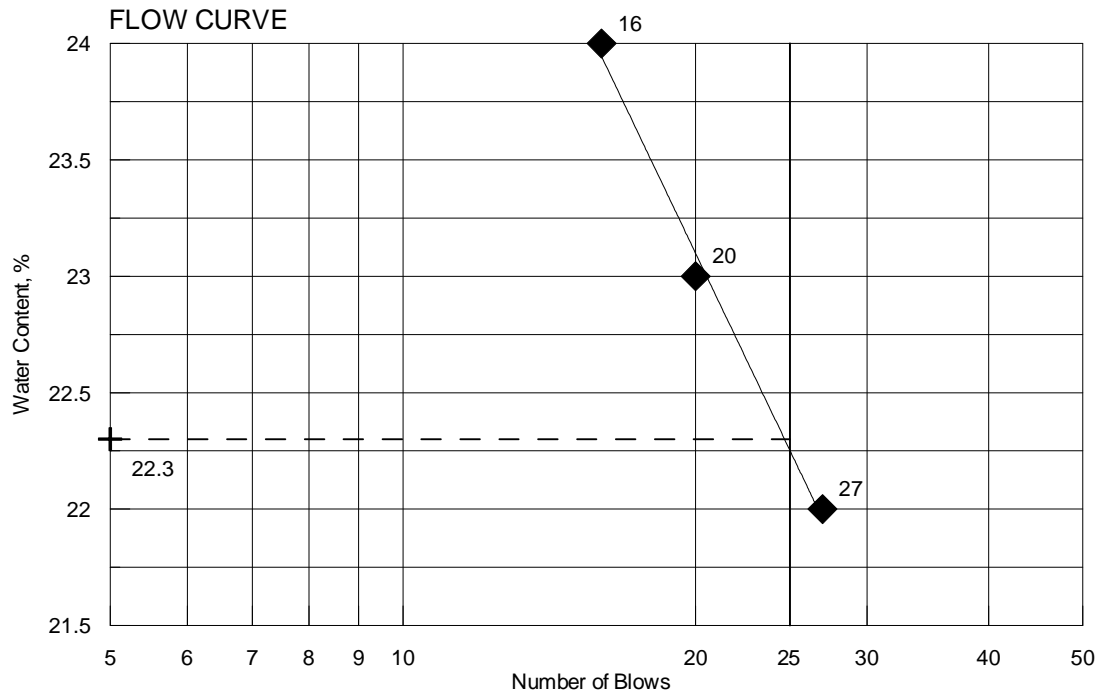
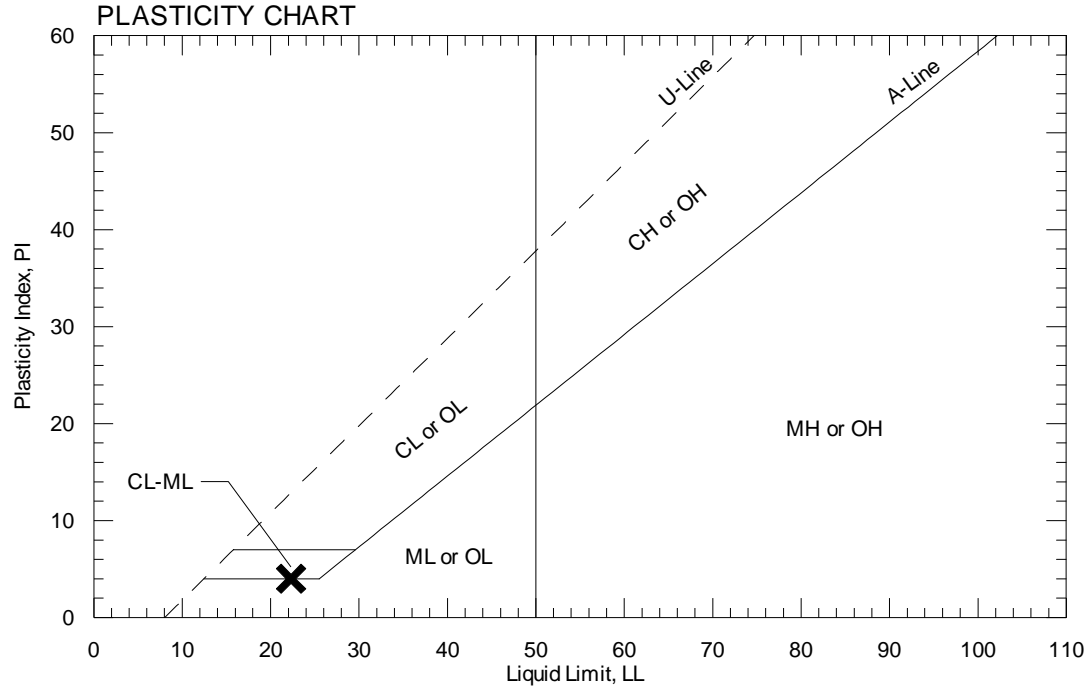
TOWN	Waterville	Reference No.	263414
WIN	018129.10	Water Content, %	26.6
Sampled	2/3/2015	Liquid Limit @ 25 blows (T 89), %	22
Boring No./Sample No.	HB-WAT-114/3D	Plastic Limit (T 90), %	18
Station	802+20.5	Plasticity Index (T 90), %	4
Depth	10.0-12.0	Tested By	BBURR
