# **GEOTECHNICAL DATA REPORT TRAFTON ROAD BRIDGE NO. 5812 OVER INTERSTATE 95 MAINE DOT WIN 29486.00 (LEGACY WIN 26152.00) SIDNEY, MAINE**

June 2025  
09.0026242.00

**Prepared for:**  
Maine Department of Transportation  
Augusta, Maine

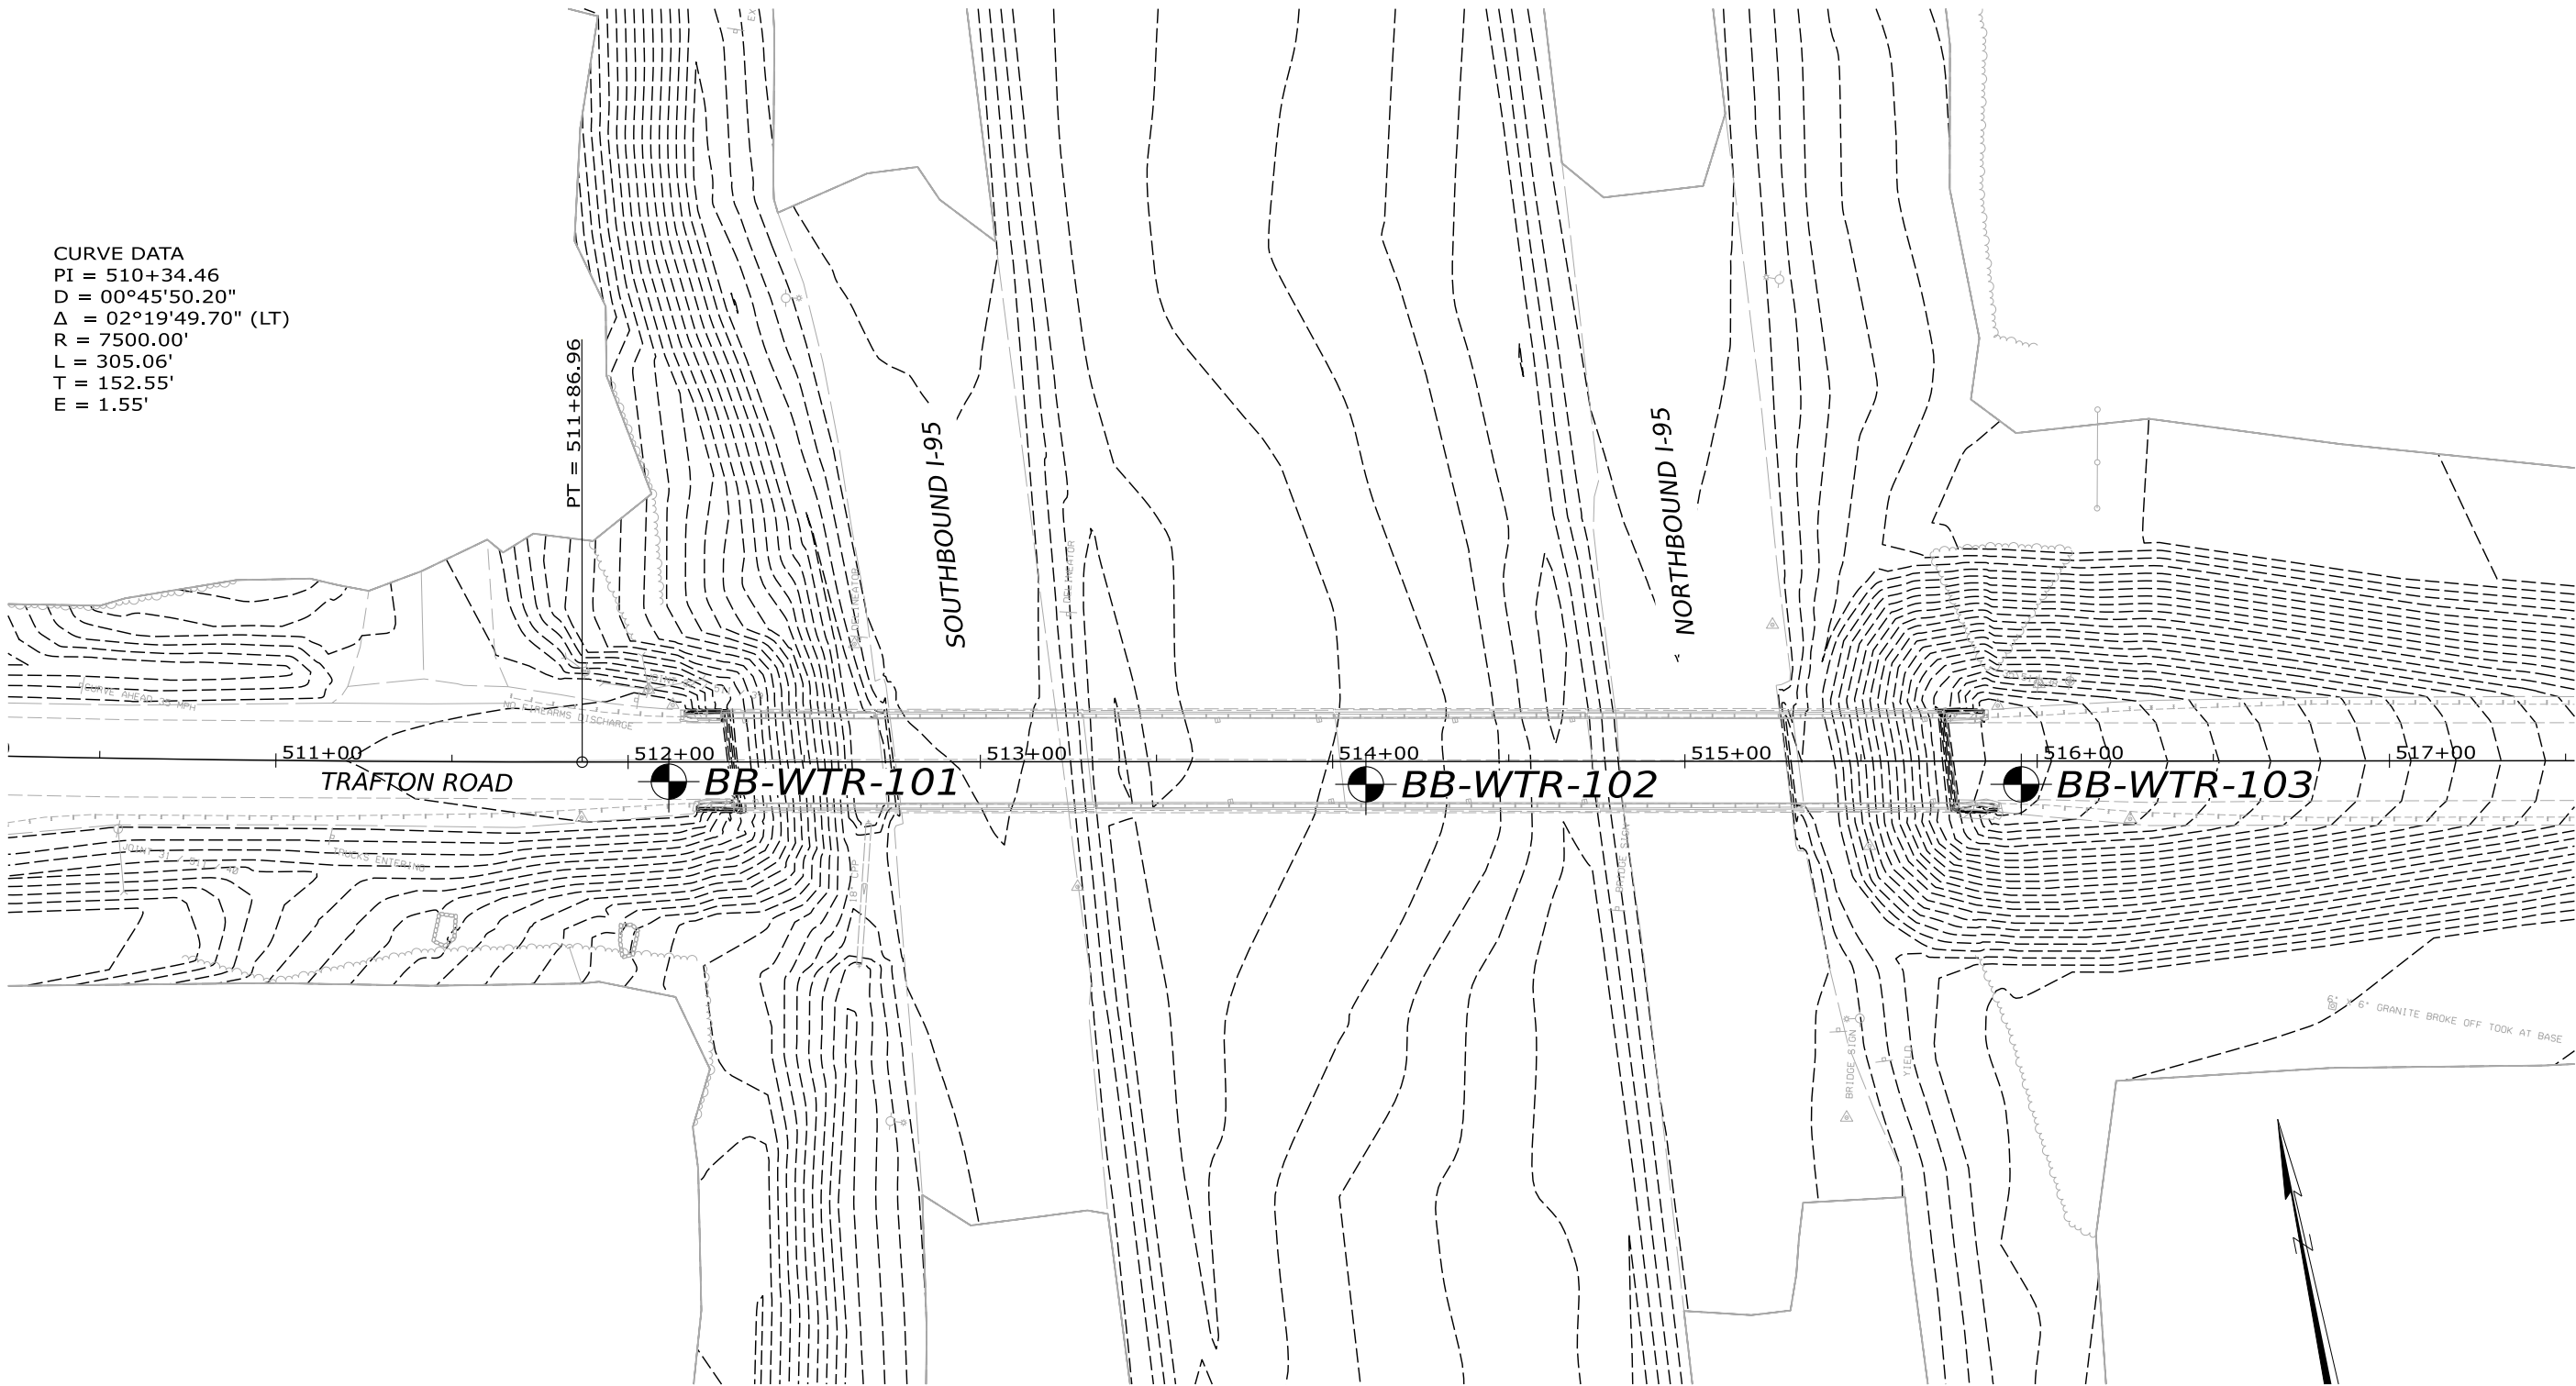
Location and designation of BB-WTR-100 series borings performed by New England Boring Contractors, LLC of Derry, NH and observed by GZA personnel between April 24 and 26, 2023.

GZA completed a subsurface exploration program consisting of three (3) test borings designated as BB-WTR-101 through BB-WTR-103. The locations and designations are shown on the attached **Boring Location Plan, Figure 2**. Borings BB-WTR-101 and -103 were completed about 15 feet behind the face of each abutment, and boring BB-WTR-102 was drilled through the bridge deck between Pier 3 and Pier 4. All three borings were drilled from Trafton Road. The as-drilled boring locations and elevations were surveyed by MaineDOT, provided to GZA and shown on the logs; the surveyed as-drilled locations are shown on **Figure 2**.

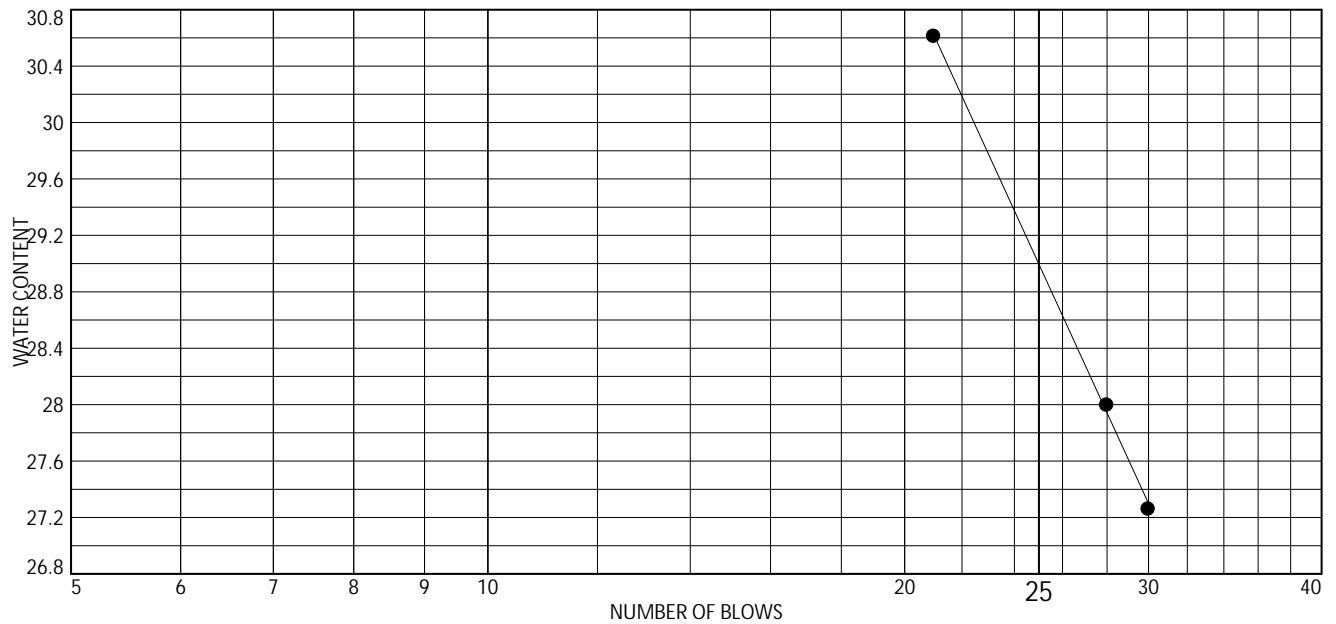
## LIQUID AND PLASTIC LIMITS TEST REPORT

MATERIAL DESCRIPTION	LL	PL	PI	%<#40	%<#200	USCS
Gray lean Clay	29	19	10

Project No. 90.0026186.00 Client: Stantec  
Project: Trafton Rd. Bridge  
Waterville, ME  
Source of Sample: BB-WTR Depth: 25-27'  
Sample Number: 103 / S6

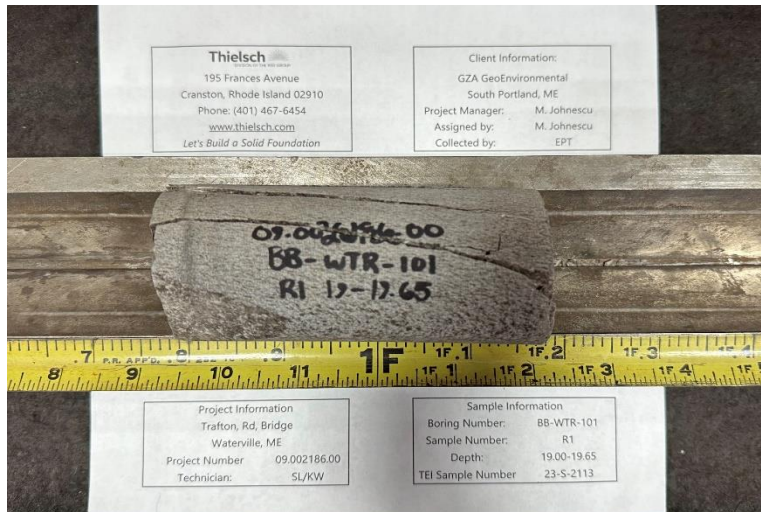
## ASTM D7012 Compressive Strength and Elastic Moduli of Intact Rock Core Specimens

Sample Information		Compressive Test Information	
Boring ID:	BB-WTR-101	Unit Weight (pcf):	168.1
Sample #:	R1	Failure Stress (psi):	15,834
Depth (ft):	19.00-19.65	Failure Mode:	Foliation
Tested Depth (ft):	19.1-19.5	Time to Failure (min)	13.02
Rock Type:	Grey Slate		
Features:	Broke along foliation		
Test Specimen Information		Elastic Moduli Test Information	
Diameter, D (in):	1.991	Poisson's Ratio @ 50%:	0.44
Length, L (in):	4.498	Strain %:	0.409
L:D Ratio:	2.26	E sec PSI @ 50%:	3.19E+06

**Testing Notes:** Minor break occurred at about 2500lb (803psi) may have caused high Poisson's ratio

SUMMARY OF BEDROCK STRENGTH TEST RESULTS						
Boring	Depth below Existing Ground (ft)	Depth below Top of Rock (ft)	Unconfined Compressive Strength (psi)	Secant Modulus @ 50% of Failure Stress (ksi)	Unit Weight (pcf)	Rock Type
BB-WTR-101	19.1 - 19.5	0.0 - 0.5	15,834	3,190	168.1	Phyllite
BB-WTR-102	10.4 - 10.8	2.6 - 3.0	12,194	3,620	169.3	Phyllite

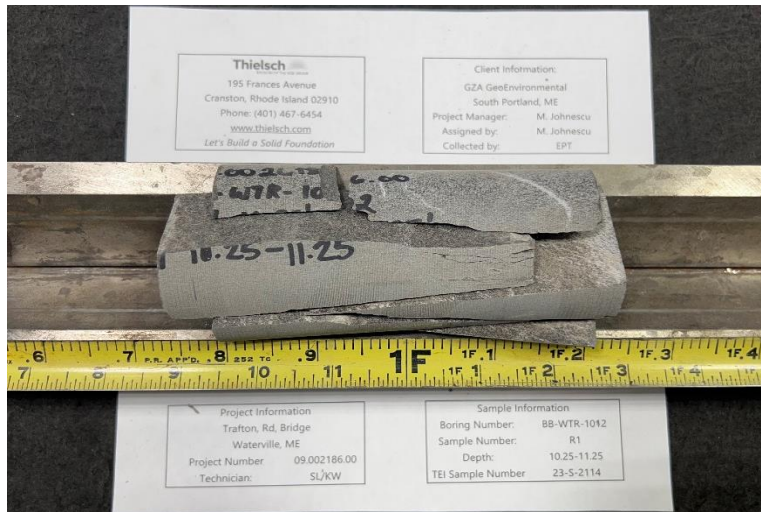
## ASTM D7012 Compressive Strength and Elastic Moduli of Intact Rock Core Specimens

Sample Information		Compressive Test Information	
Boring ID:	BB-WTR-102	Unit Weight (pcf):	169.3
Sample #:	R1	Failure Stress (psi):	12,194
Depth (ft):	10.25-11.25	Failure Mode:	Foliation
Tested Depth (ft):	10.4-10.75	Time to Failure (min)	8.03
Rock Type:	Grey Slate		
Features:	Broke along foliation		
Test Specimen Information		Elastic Moduli Test Information	
Diameter, D (in):	1.991	Poisson's Ratio @ 50%:	0.96
Length, L (in):	4.527	Strain %:	0.350
L:D Ratio:	2.27	E sec PSI @ 50%:	3.62E+06

**Testing Notes:** Early break along foliation may have caused high Poisson's Ratio

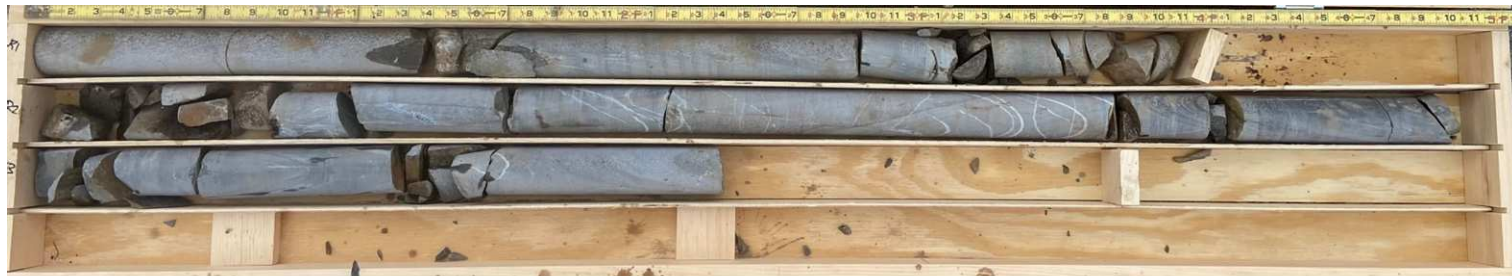
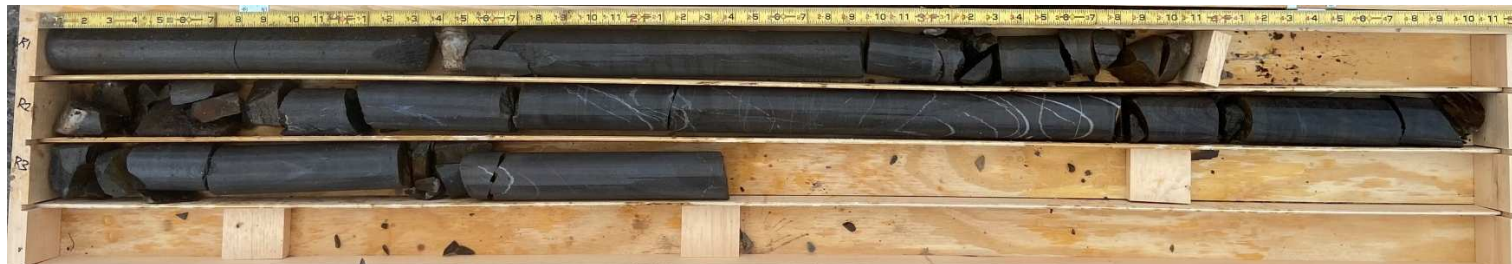
**Trafton Road Bridge No. 5812**  
**MaineDOT WIN 26152.00, Waterville, Maine**  
**Rock Core Photographs**

Boring No.	Run	Depth (ft)	Recovery (in)	Recovery (%)	RQD (in)	RQD (%)	Rock Type	Box Row
BB-WTR-101	R1	19.0 - 23.0	48	100	34	71	PHYLLITE	1
BB-WTR-101	R2	23.0 - 28.0	60	100	38	63	PHYLLITE	2
BB-WTR-101	R3	28.0 - 30.0	24	100	18	75	PHYLLITE	3

**Notes:** 1. Box row corresponds to the core box section in which the rock core sample is contained; Row 1=Top, Row 3=Bottom.  
2. Top photo is dry, bottom photo is wet.

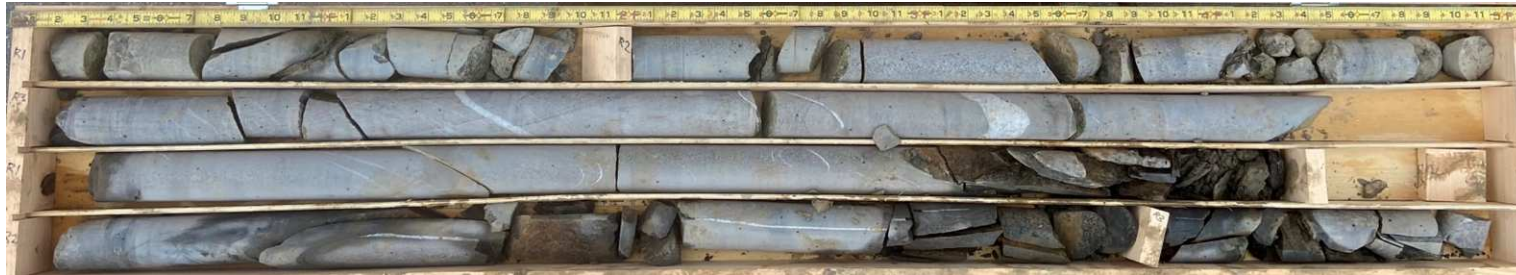
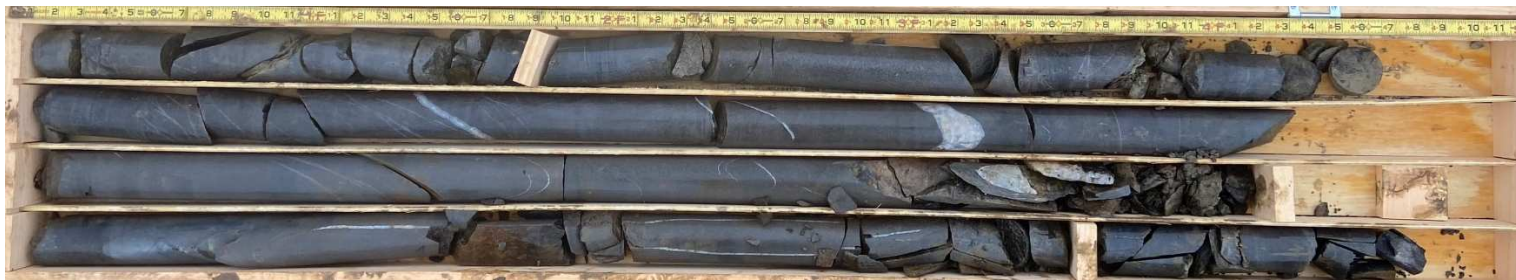
**Trafton Road Bridge No. 5812**  
**MaineDOT WIN 26152.00, Waterville, Maine**  
 Rock Core Photographs

Boring No.	Run	Depth (ft)	Recovery (in)	Recovery (%)	RQD (in)	RQD (%)	Rock Type	Box Row
BB-WTR-103	R1	39.0 - 41.0	20	83	4	17	PHYLLITE	1
BB-WTR-103	R2	41.0 - 44.0	32	89	18	50	PHYLLITE	1
BB-WTR-103	R3	44.0 - 49.0	52	87	47	78	PHYLLITE	2
BB-WTR-102	R1	8.4 - 12.9	48	89	33	61	PHYLLITE	3
BB-WTR-102	R2	12.9 - 16.4	42	100	19	45	PHYLLITE	4
BB-WTR-102	R3	16.4 - 17.4	12	100	0	0	PHYLLITE	4

**Notes:** 1. Box row corresponds to the core box section in which the rock core sample is contained; Row 1=Top, Row 4=Bottom.  
 2. Top photo is dry, bottom photo is wet.
