# Preliminary Geotechnical Data Report REV01

*Interstate 95 Bridges 1427 and 5800 over Stillwater Avenue, Bangor, Maine  
(WIN 027176.00)*

**Maine Department of Transportation**

**WSP USA, Inc.**

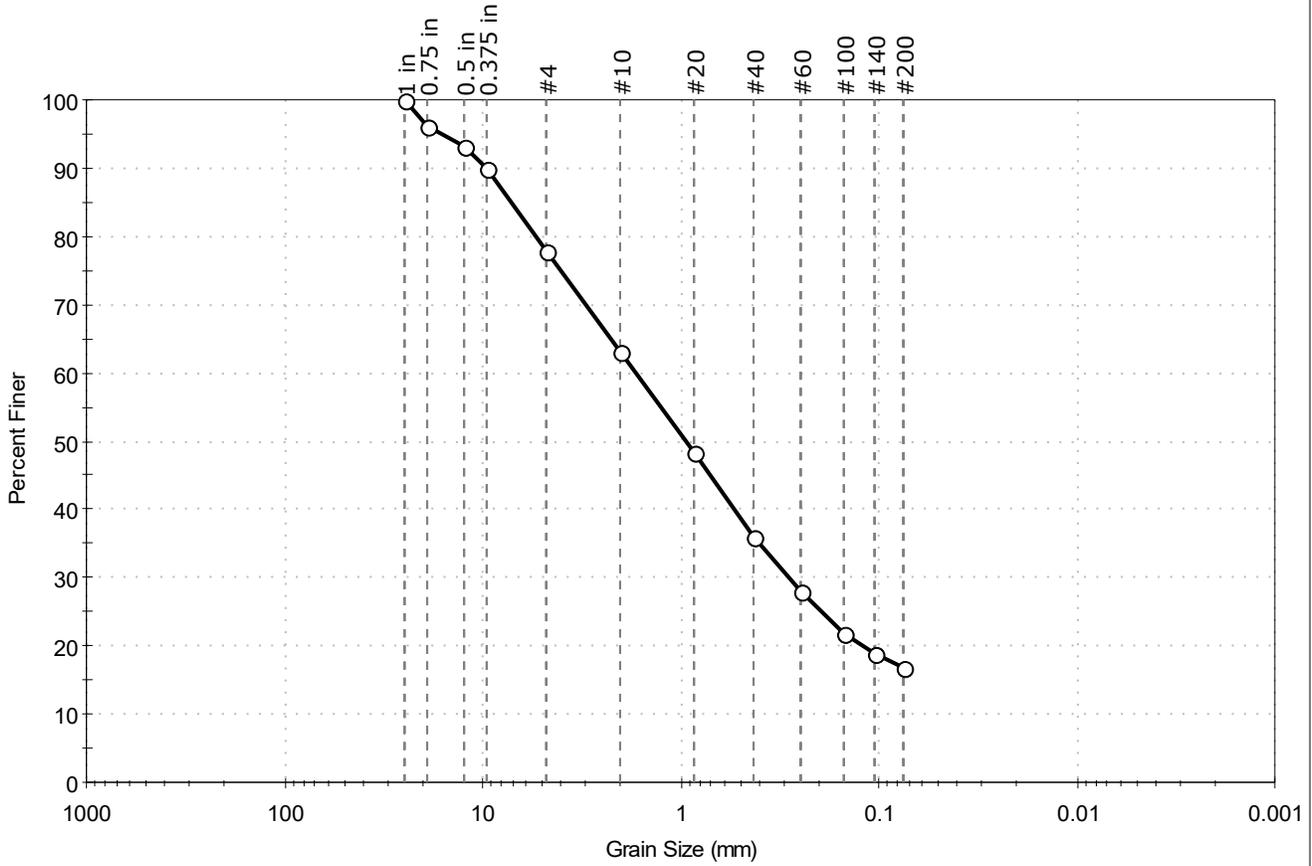
## Particle Size Analysis - ASTM D6913

% Cobble	% Gravel	% Sand	% Silt & Clay Size
—	22.0	61.2	16.8

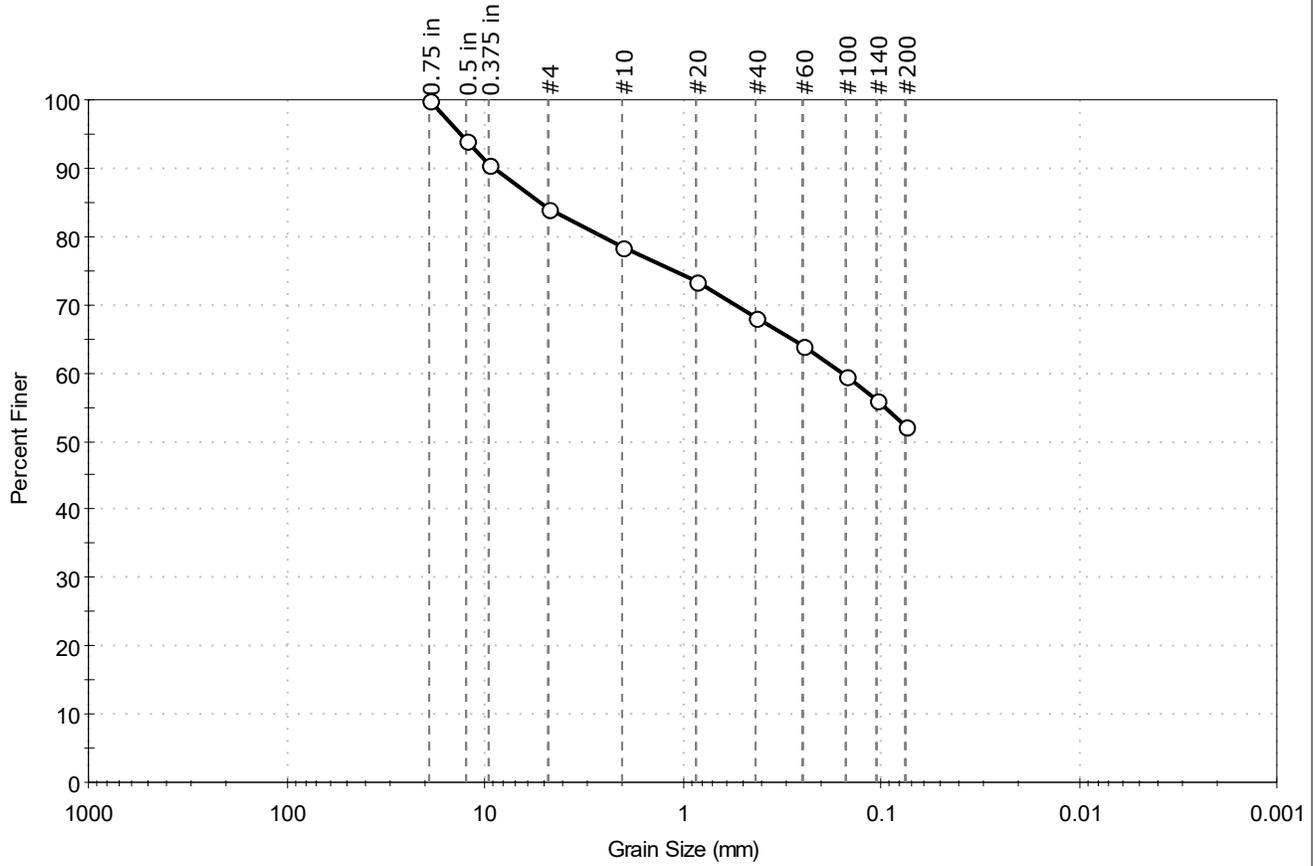
## Particle Size Analysis - ASTM D6913

% Cobble	% Gravel	% Sand	% Silt & Clay Size
—	15.8	32.0	52.2

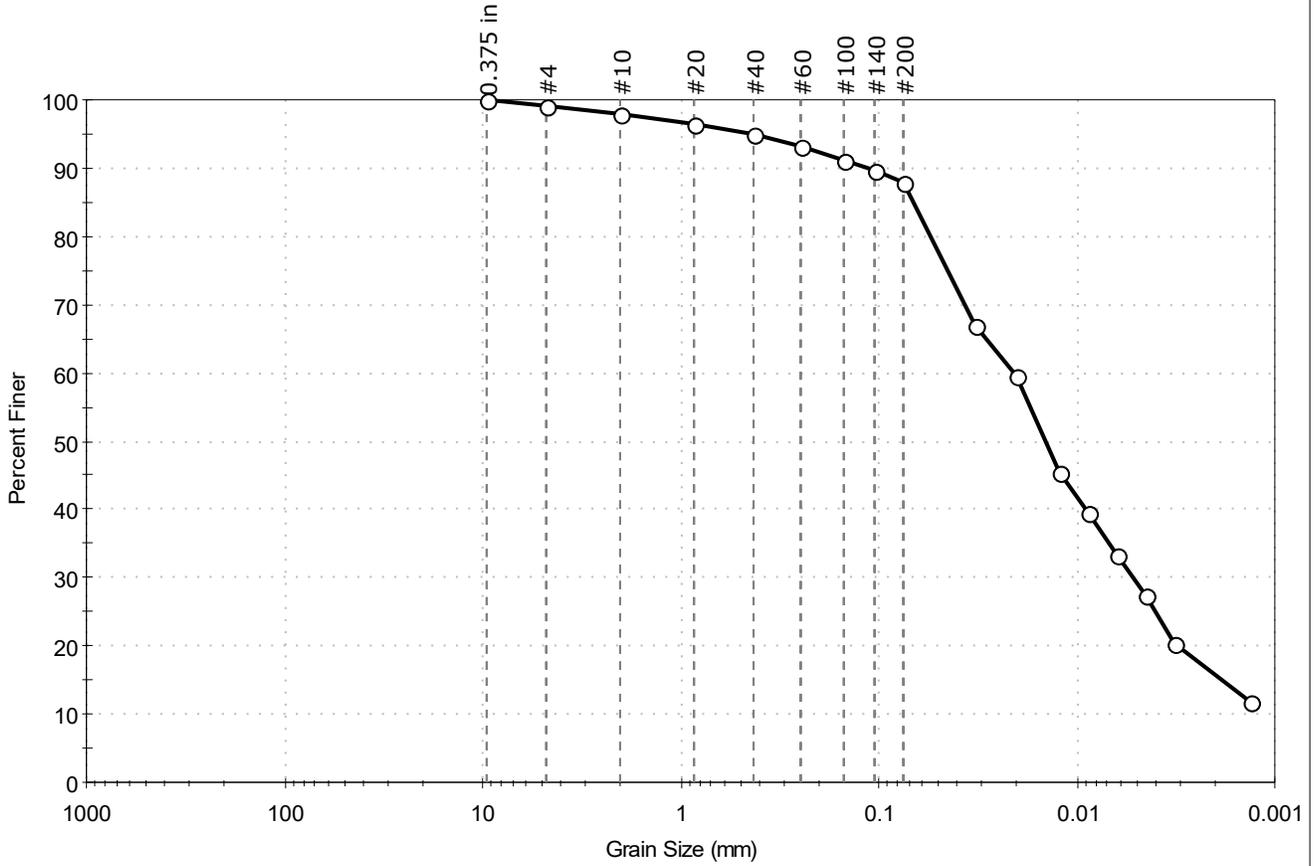
## Particle Size Analysis - ASTM D6913/D7928

% Cobble	% Gravel	% Sand	% Silt & Clay Size
—	1.0	11.2	87.8

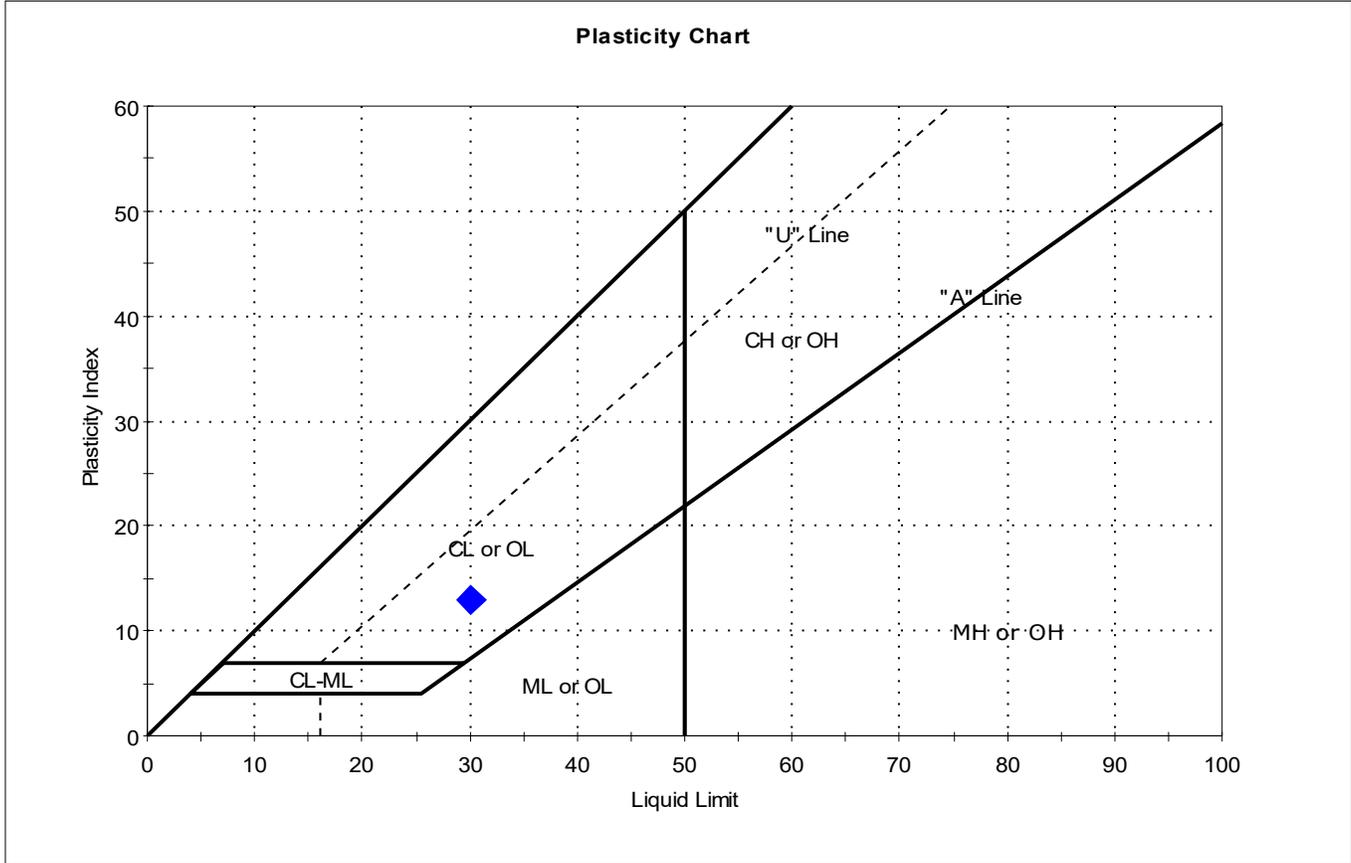
## Atterberg Limits - ASTM D4318

Symbol	Sample ID	Boring	Depth	Natural Moisture Content, %	Liquid Limit	Plastic Limit	Plasticity Index	Liquidity Index	Soil Classification
◆	6D	B-BSA-10	15-17 ft	25	30	17	13	0.6	Lean CLAY (CL)

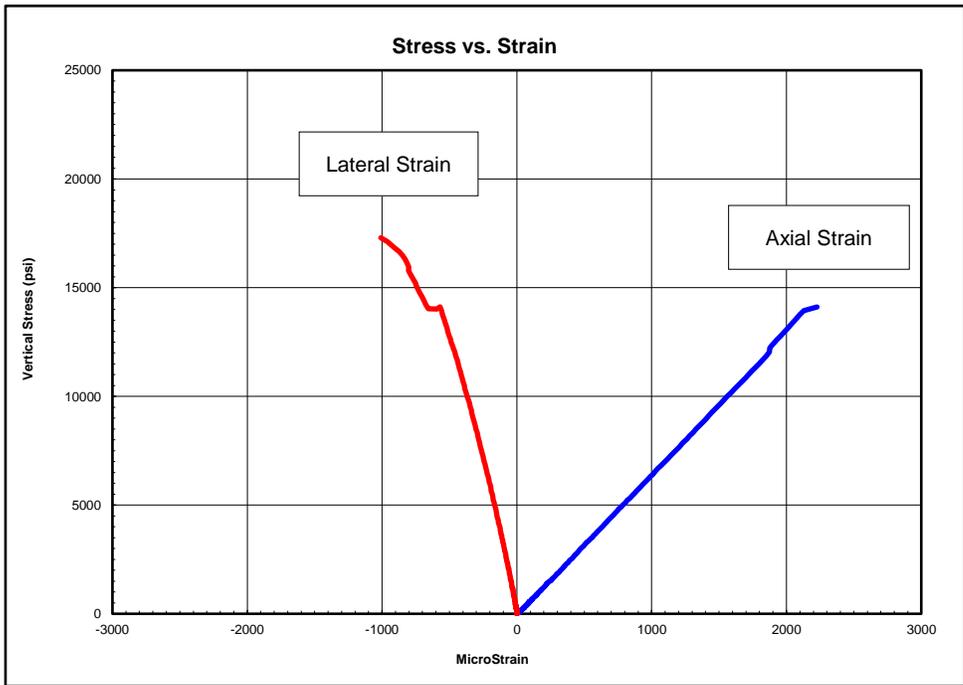
## Compressive Strength and Elastic Moduli of Rock by ASTM D7012 - Method D

Peak Compressive Stress: 17,296 psi

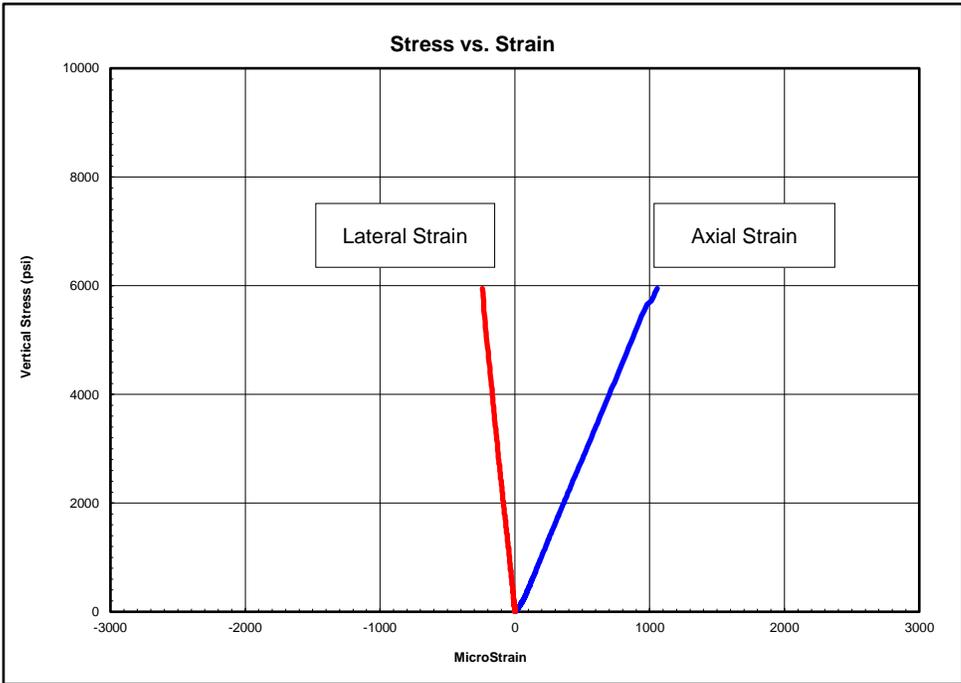
## Compressive Strength and Elastic Moduli of Rock by ASTM D7012 - Method D

Peak Compressive Stress: 5,948 psi
