Preliminary Geotechnical Data Report (REV02)

Kenduskeag Avenue Bridge No. 5798 over Interstate 95, Bangor, Maine (WIN 026095.00)

WIN 026095.00 / WSP US0025840.3905

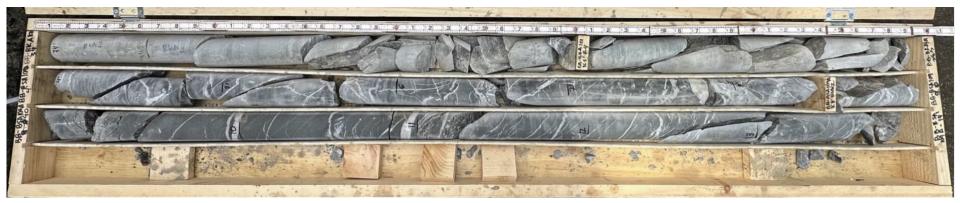
Depth Bel	ow Surface		Recovery				RQD				Date
Boring	Run	Feet		Feet		%	F	Feet		%	Rock Type	Box Row	Cored
BB-BKA-101	R3	34.5	- 36.5	2.0	- 2.0	100	0.3	-	2.0	17	Metawacke	Row 1	5/6/2024
DD-DKA-101	R4	36.5	- 38.5	2.0	- 2.0	100	0.0	-	2.0	0	Metawacke	Row 1	5/6/2024

"Box row" indicates the section of the box where the core is contained: 1 = top, 4 = bottom.
 Top of each core run is on the left and increases with depth to the right.

Up to 15 feet of rock core was collected in each boring using NX size (1-7/8-inch diameter) diamond tipped core barrels following either refusal of casing or failure to advance the split spoon sampler or roller bit. Rock core samples were placed in wooden boxes and transported to the WSP office. WSP recorded the lithology, Total Core Recovery (TCR), Rock Quality Designation (RQD), and coring rates for each core run which are provided in the boring logs in Appendix A. Photographs of all collected rock core are presented in Appendix B.

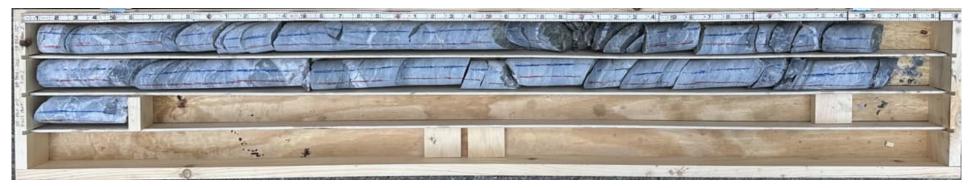
Depth Be	low Su	urface		Recovery			RQD						Date
Boring	Run	F	Feet		Feet		%		Feet		%	Rock Type	Box Row	Cored	
BB-BKA-102	R1	6.7	- 1	11.7	4.7	-	5.0	94	0.5	-	5.0	10	Metawacke	Row 1	8/1/2024
DD-DRA-102	R2	11.7	- 1	16.3	5.2	-	4.6	100	2.0	-	4.6	43	Metawacke	Row 2 & 3	8/1/2024

"Box row" indicates the section of the box where the core is contained: 1 = top, 4 = bottom.
 Top of each core run is on the left and increases with depth to the right.

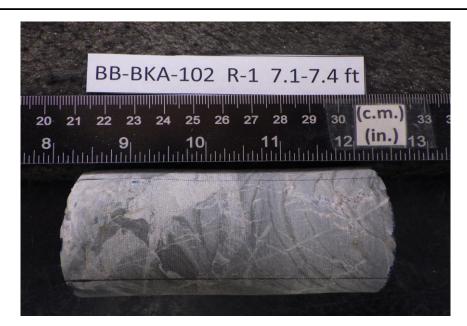
After cutting and grinding

Client:	WSP USA, Inc.						
Project Name:	MaineDOT I-95 Bridge Kenduskeag						
Project Location:	Bangor, ME						
GTX #:	319187						
Test Date:	8/27/2024						
Tested By:	gp						
Checked By:	smd						
Boring ID:	BB-BKA-102						
Sample ID:	R-1						
Depth, ft:	7.1-7.4
