Fire Safety Challenges of Tall Wood Buildings – Phase 2: Task 2 & 3 – Cross Laminated Timber Compartment Fire Tests

FINAL REPORT BY:

February 2018

Report number: FPRF-2018-01

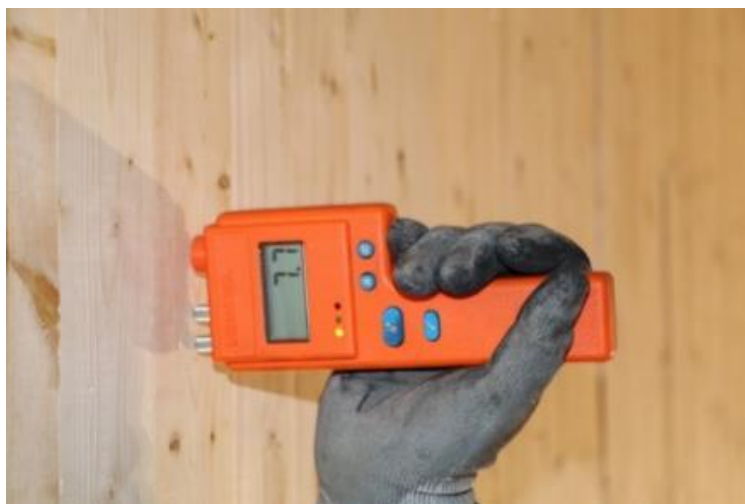
Figure 10. Measurement of panel moisture content using Delmhorst (BD-2100) meter.

Prior to fire testing the compartments, the moisture content of each wall was sampled using a handheld moisture meter (Figure 10). For Test 1-1 and Test 1-2, the measurements were made on the outside surface of the compartment after the gypsum board had been applied because there was no longer access to the inside surfaces. In Test 1-3 to Test 1-6, the measurements were made on the inside surfaces of the compartments shortly prior to installation of the gypsum board. Three measurements were made at random locations on each wall.

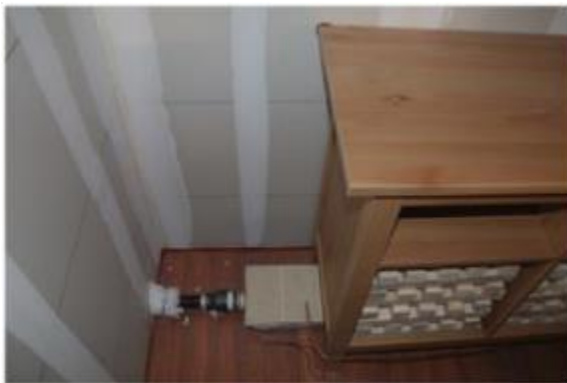
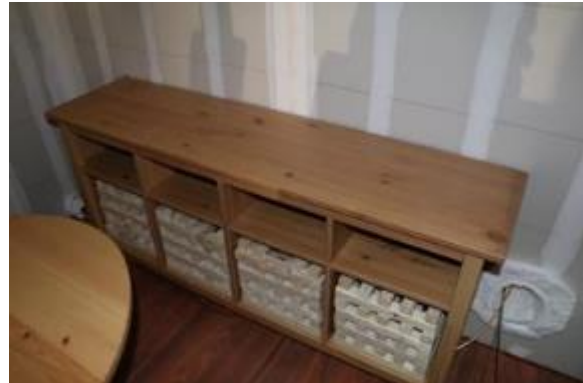
Figure 18. Photographs of (a) burner with copper tube for pilot flame and (b) the object of first ignition (console table with wood cribs).

A room corner ignition scenario was used in the CLT compartment fire tests. The ignition corner was formed by the adjacent W1 and W4 walls. The ignition source used was a natural gas diffusion burner (200 mm x 400 mm or 8 in. x 16 in.) placed in the corner partially under the shelving unit (console table). The natural gas flowed into a cavity below porous ceramic plates in the burner and then diffused upward. A small pilot flame was used to ignite the burner. The shelving unit (console table) was the first item ignited (Figure 18). A heat release rate of 50 kW (similar to a burning waste basket) from the burner was maintained until the total measured heat release rate from the compartment exceeded 1000 kW (due to ignited contents), at which time the burner was shut off. Four small wood cribs (85 MJ each) were placed in the console table to achieve a reliable ignition (Figure 18b). Two 'mock-up' tests of the ignition scenario were performed using a corner burn setup prior to the compartment test (Figure 19). The mock-up tests showed a reproducible fire growth and heat release sufficient to ignite neighboring contents in the compartment.

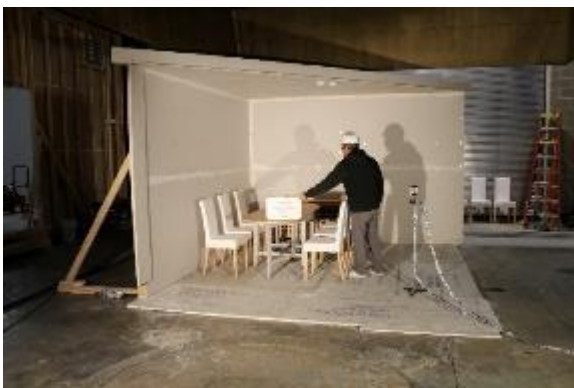
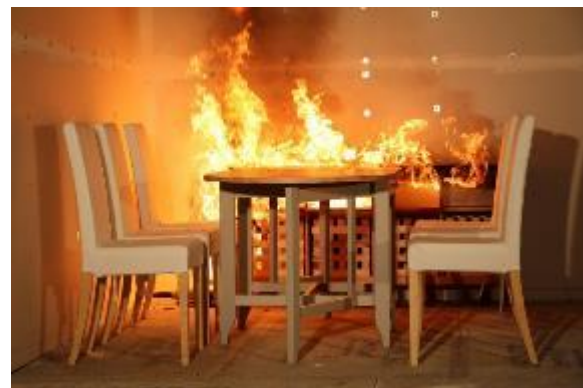
Figure 19. Photographs of (a) mock-up corner burn setup and (b) the object of first ignition catching fire.

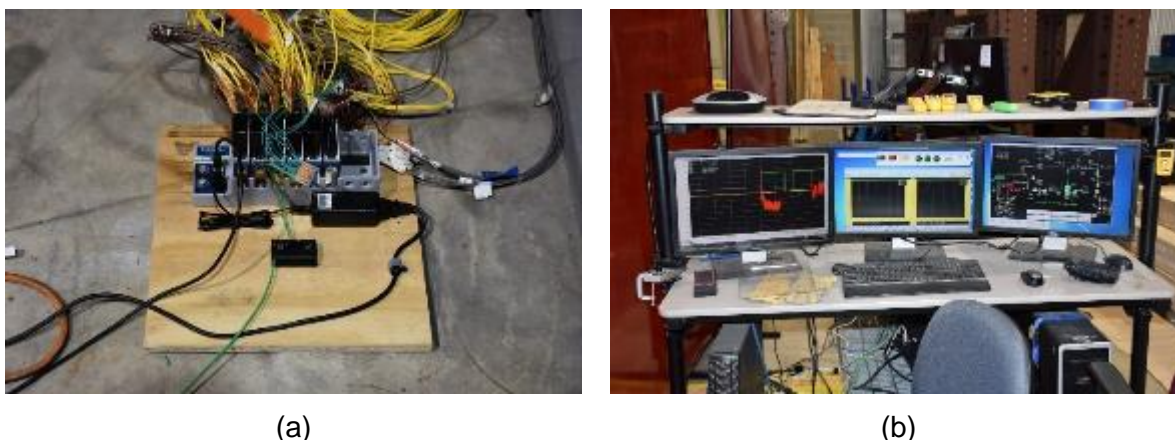
Figure 28. Photographs of (a) cDAQ-9188 chassis populated with I/O-modules and (b) setup used to control the NFRL calorimeter and data acquisition.

An in-house software developed in LabVIEW™ called MIDAS (Modular In situ Data Acquisition System) was used to allocate channels and control the data acquisition (Figure 28b). Each channel was sampled at 90 Hz and data were averaged and recorded at a rate of 1 Hz along with the standard deviations from the averaging process. The I/O-Modules had at least 16-bit precision, resulting in uncertainties from the DAQ that were orders of magnitude lower than those from other sources in all of the measurements reported here.

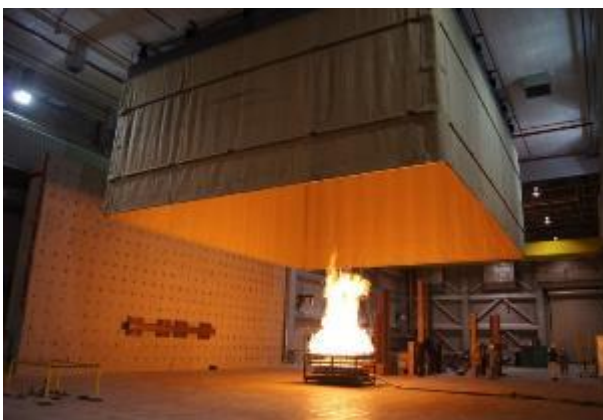
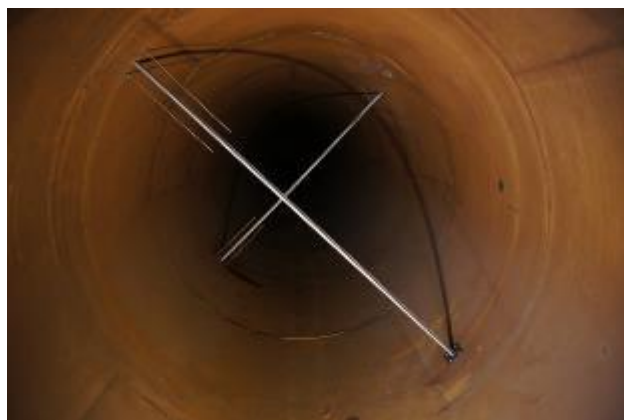
Figure 29. (a) 15-m exhaust hood with natural gas reference burner at 5 MW and (b) 2.42-m diameter calorimeter exhaust duct with averaging pitot tubes and temperature sensors (gas sample tube not shown).

The heat release rate measurement system was verified using a natural gas burner reference fire. The heat release rate of the reference fire had a measurement combined standard uncertainty of less than +/- 1%. Calorimeter verification tests were performed on 2 separate days at heat release rate values of 1 MW, 5 MW, 10 MW, 15 MW and 20 MW. The maximum relative difference between the measured heat release rate and reference fire was less than 4.5%. The relative standard deviation of the heat release rate varied from 6.5 % at 1 MW to 3 % at 20 MW for a steady reference fire over a period of 180 s. The combined standard relative uncertainty for the heat release rate measurements was determined to be 7.4 % for this set of experiments. This uncertainty estimate is valid for near steady state fires. Transient events (< 30 s) have larger uncertainty due to the effect of system response time. Additional time delays and smearing of heat release rate data related to transport of the combustion gases out of the test compartment are not quantified in this report.

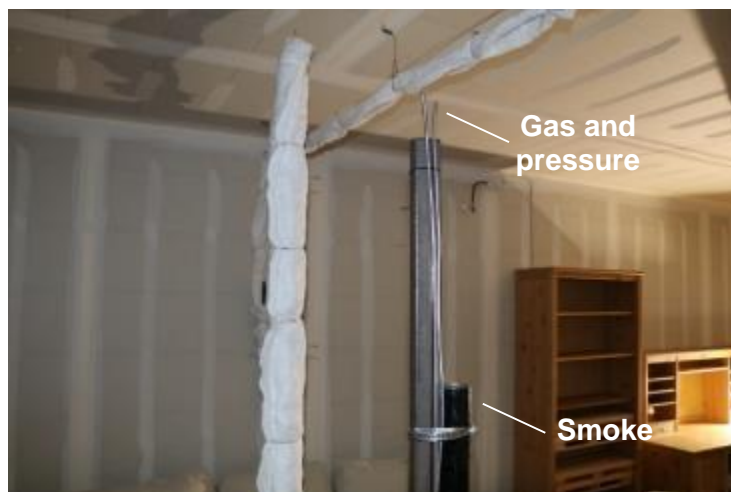
Figure 30. Photograph of stand with gas sampling tubes.

Gas samples inside the compartment were taken using metal tubes attached to a steel stand located at the centre of the room (Figure 20, Figure 21 and Figure 30). Samples for the gas analyzer and differential room pressure were drawn from two 6-mm (1/4 in) diameter stainless steel tubes with their opening 210 cm from the floor. Samples for the smoke meter were drawn from a 50-mm (2 in.) diameter steel pipe with an opening 160 cm from the floor.

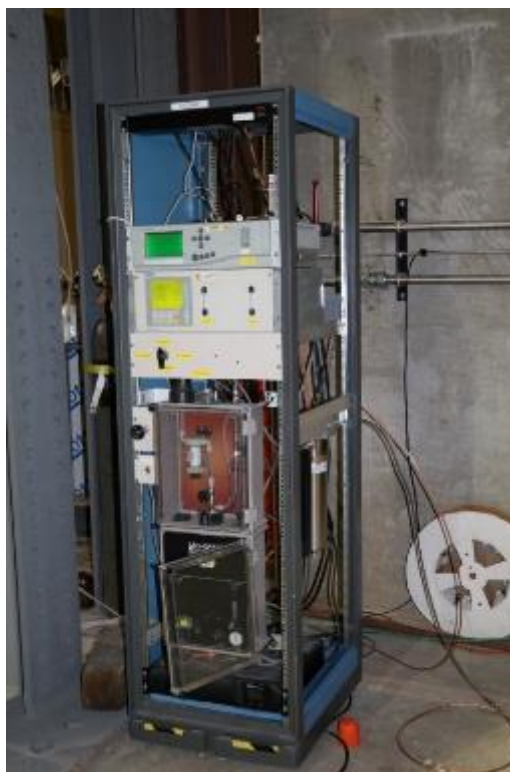
Figure 31. Photograph of gas analyzer rack.

Room gases were extracted and analyzed using the gas measurement rack shown in Figure 20, Figure 21 and Figure 30. A Permapure MiniGASS sample conditioning system was used to filter and dry the sample gas. The sample gas flow rate was set to 1 slpm for these tests. The delay time from the room inlet port to the gas rack was approximately 60 s. The oxygen was measured using a paramagnetic oxygen analyzer. Carbon dioxide and carbon monoxide were measured using a nondispersive infrared (NDIR) analyzer. The analyzers were calibrated prior to each test using calibrated zero and span gases. Nitrogen gas was used to zero each analyzer and room air was used to span the oxygen analyzer. Room air was assumed to have an oxygen concentration of 20.95% \pm 0.05 %. The carbon dioxide span gas consisted of 9.0% \pm 0.09% CO_2 in N_2 and the carbon monoxide span gas consisted of 4.0 % \pm 0.04% CO in N_2 . A high pressure air line was used to blow out the sample line during the test if the sample line became clogged by soot. The maximum range of the CO and CO_2 measurements was 20 %. This range was exceeded during several of the tests. There were other periods where gas sample data was invalid due to loss of sample flow and loss of sample tube support. The sample tube deformed and fell onto the room floor during several of the tests. The gas sample measurements were more reliable early in the tests. All gas measurements are reported on a dry basis.

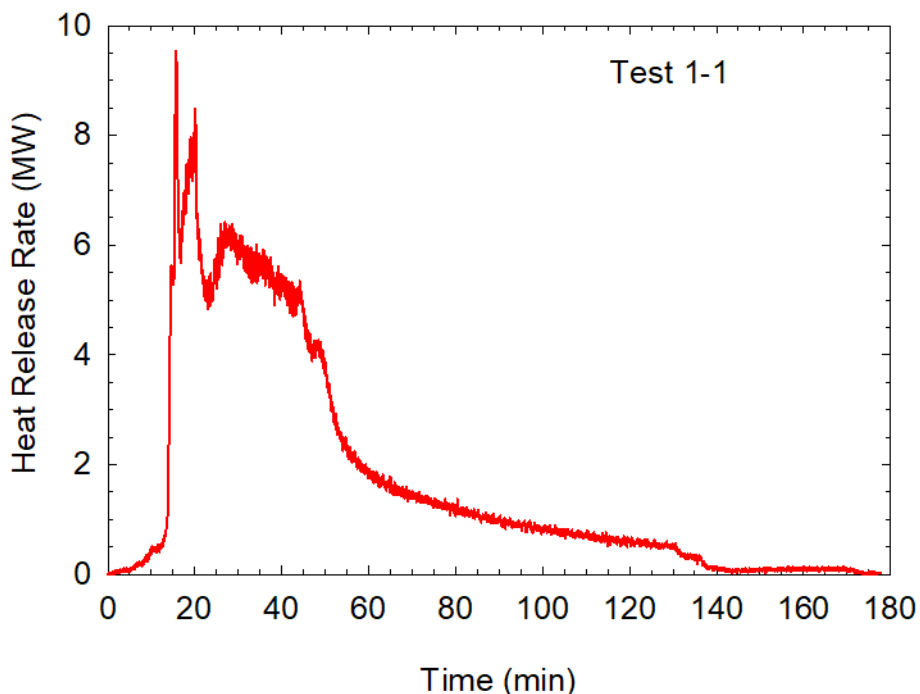
Figure 43. Heat release rate during Test 1-1 (test terminated at 134 min).

Figure 43 shows the heat release rate (HRR) during Test 1-1. The HRR was 9.5 MW at the initial peak right after the flashover and maintained above 5 MW until 45 min. As the fire decayed, the HRR reduced to 2 MW at 55 min and to 1 MW at 90 min. The test was terminated when HRR reduced to 0.3 MW at 134 min.

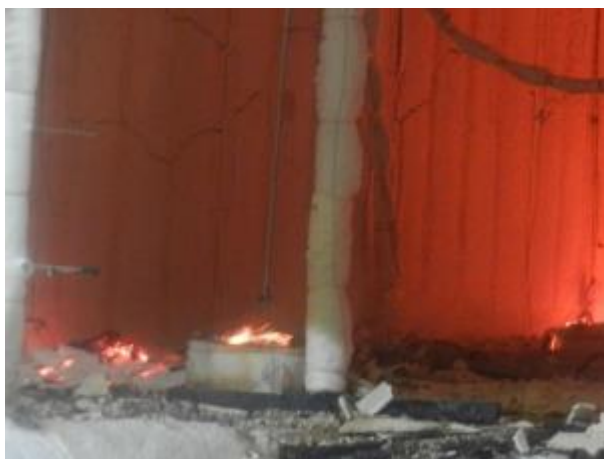
(a) CLT block near a TC Tree

Figure 53 shows the remaining thickness of the three small CLT blocks placed on the floor (only the top surface was exposed), each cut to half at the middle after Test 1-2. The char depth was 46 mm, 35 mm and 35 mm for the blocks placed at the front, middle and rear sections of the compartment, respectively.

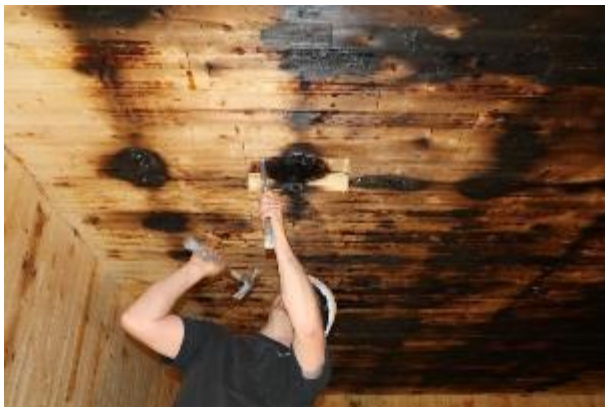
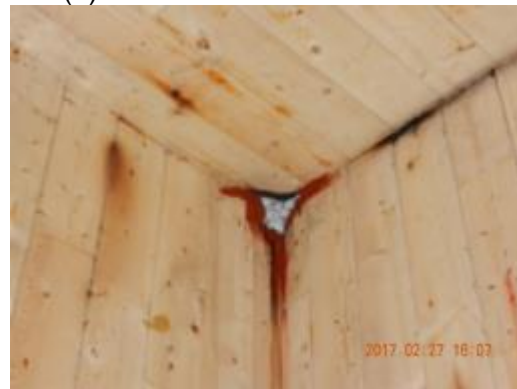
(a) char chiseled out

(c) plywood piece screwed in

(d) ceiling-W1-W4 corner spot filled

Figure 59. Repair of localized charring on ceiling after Test 1-2 before Test 1-3.

After Test 1-2, a cleanup operation was conducted in the CLT compartment #2 and all the remaining gypsum board was removed. The CLT compartment #2 was repaired, as shown in Figure 59. The deep charred spots between ceiling panels 11_006 and 11_007 and at the ceiling-W1-W4 corner joint were chiseled out. Plywood (0.3 m x 0.3 m) was screwed into the chiseled spot between panels 11_006 and 11_007. Fire caulking was used in repairing these two damaged spots. Ceramic fiber material was also filled into the ceiling-W1-W4 corner spot. Fire caulking was also used (only in this test) to seal limited CLT panel joints – between ceiling panels 11_006 and 11_007, between ceiling panels 11_007 and 11_008, and along the ceiling joint with the W1 wall.

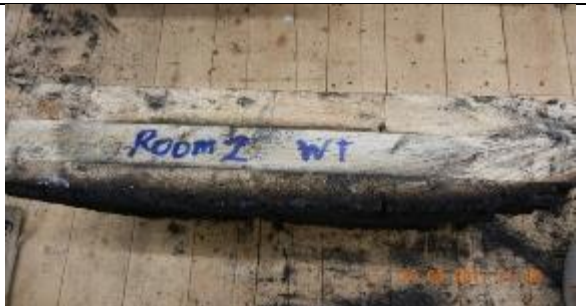
The photo in Table 8 shows the CLT sample that was cut from the W1 panel 10_018 where the embedded thermocouples were installed. The thickness of the char was 86 mm (remaining CLT thickness was 89 mm). This confirms the measurement of the char depth by the embedded thermocouples ($65 \text{ mm} < \text{char depth} < 90 \text{ mm}$).

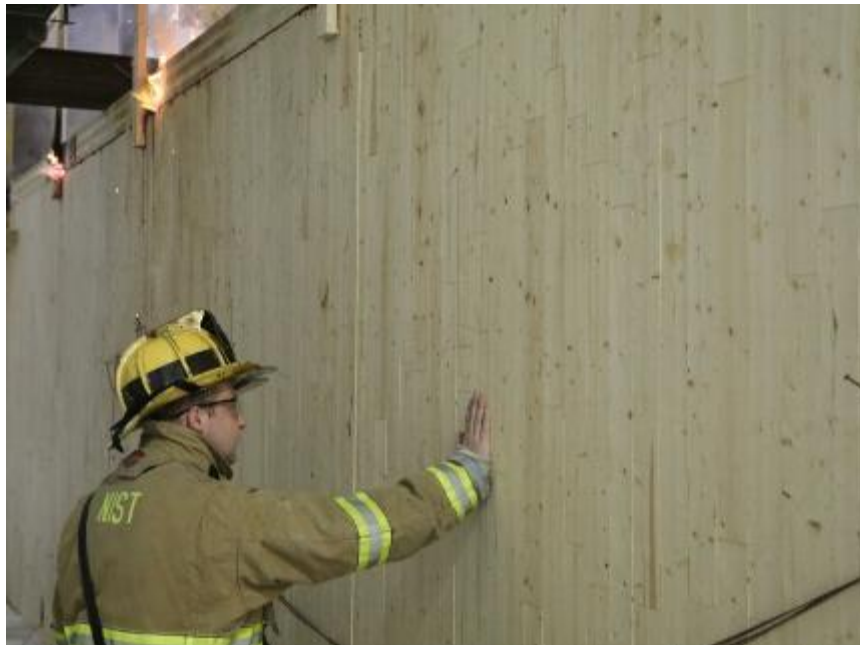
Figure 68. Exterior of the W1 wall at 198 min in Test 1-3.
