Route 1 Corridor DRAFT Transportation Feasibility Study

Wells, Maine

August 2024

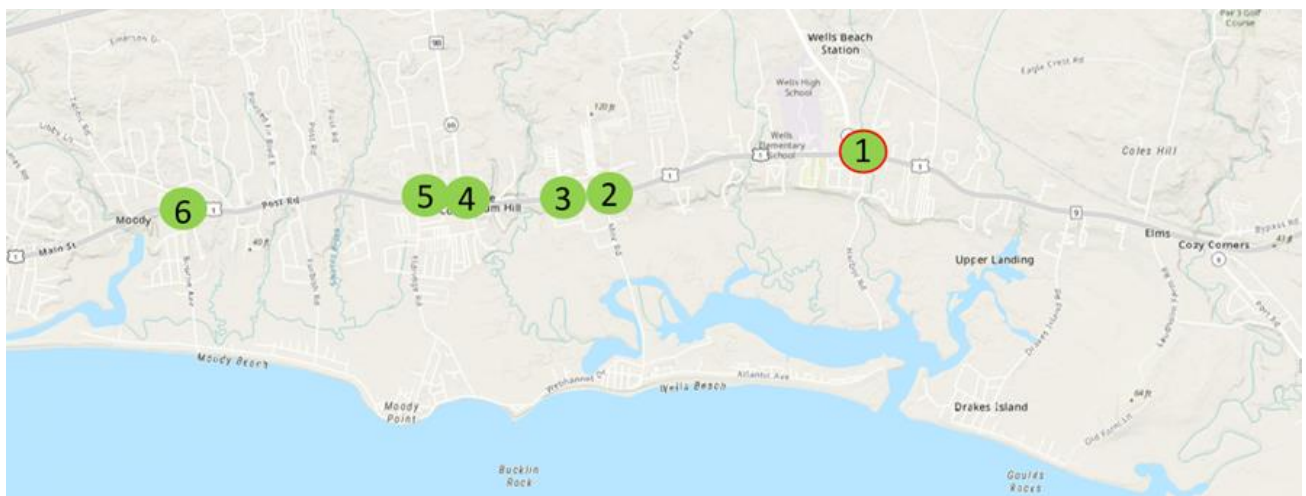
Figure 1: Map of study area.

The study area of the project includes several intersections on the Route 1 corridor in Wells, Maine including the focus intersections of:

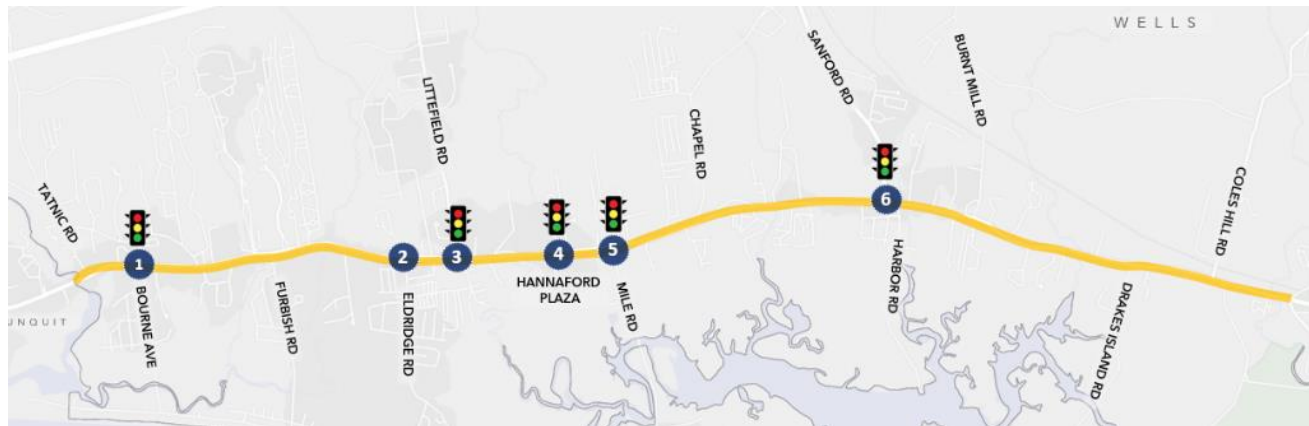
Figure 3: Study intersection locations.

Turning movement counts were conducted at the six focus study intersections on Wednesday, August 24, 2022, from 6 AM – 6 PM. Figure 3 depicts these locations, while Table 3 shows the AM and PM peak hourly volumes and pedestrian/bicycle counts for each location.

The study area includes US Route 1 (Route 1) from Bypass Road to the Ogunquit town line along with the focus intersections previously listed in Table 3 and previously shown in Figure 3.

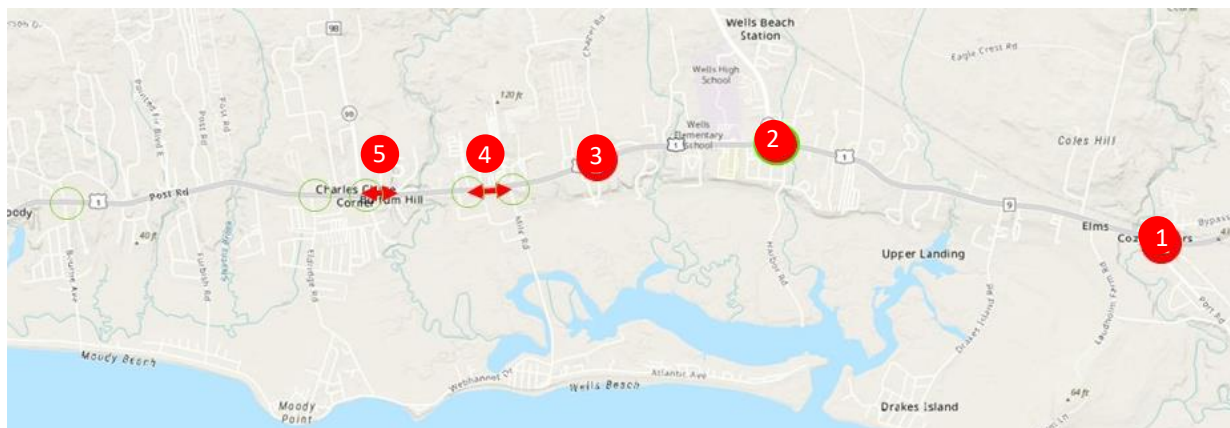
Figure 4: High crash location in the study area.

The RSA Team also focused on the following High Crash Locations (HCLs) shown in Figure 4:

1. *Intersection* – Route 1 (Post Road) / Route 9
2. *Intersection* – Route 1 / Harbor Road
3. *Intersection* – Route 1 / Chapel Road
4. *Segment* – Route 1 from Mile Road to Buzzell Road
5. *Segment* – Route 1 from Littlefield Road to Brown Lane

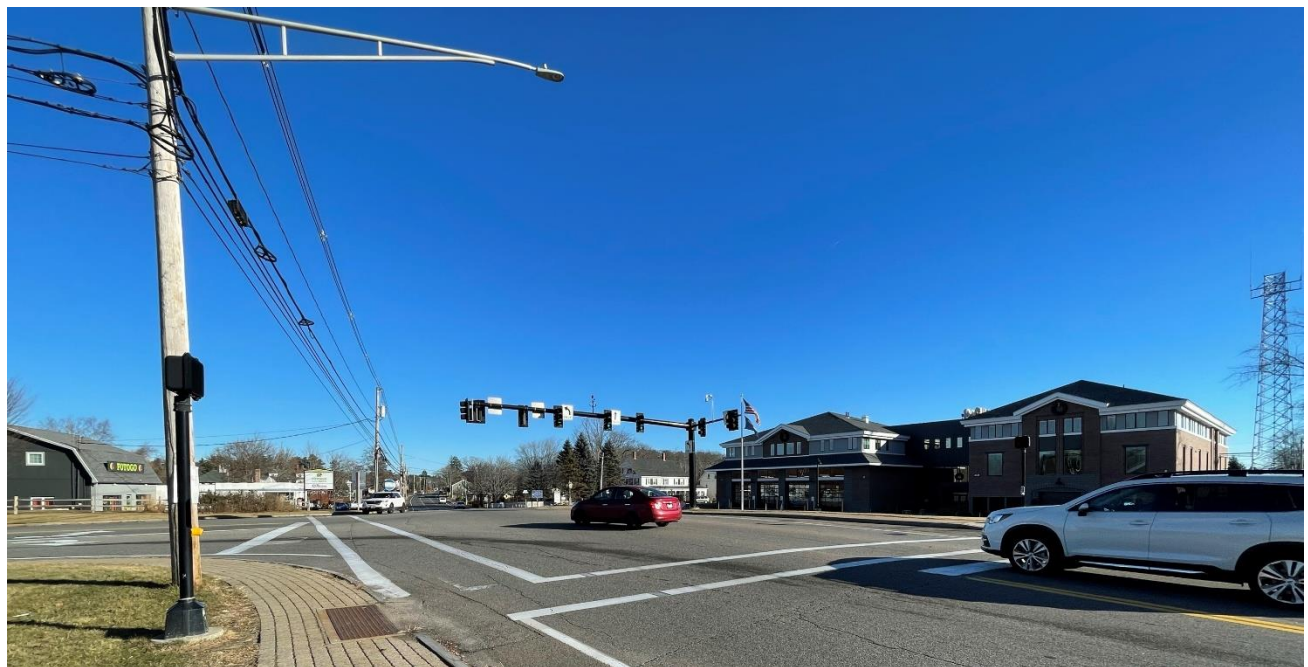
MaineDOT has implemented adaptive signals for two corridors in Augusta, two corridors in Waterville, and one corridor in Sanford. Adaptive signal technology is also operating in Wells, though not consistently very well. Upgrading the existing signal equipment in the study area would further expand the use of adaptive signals.

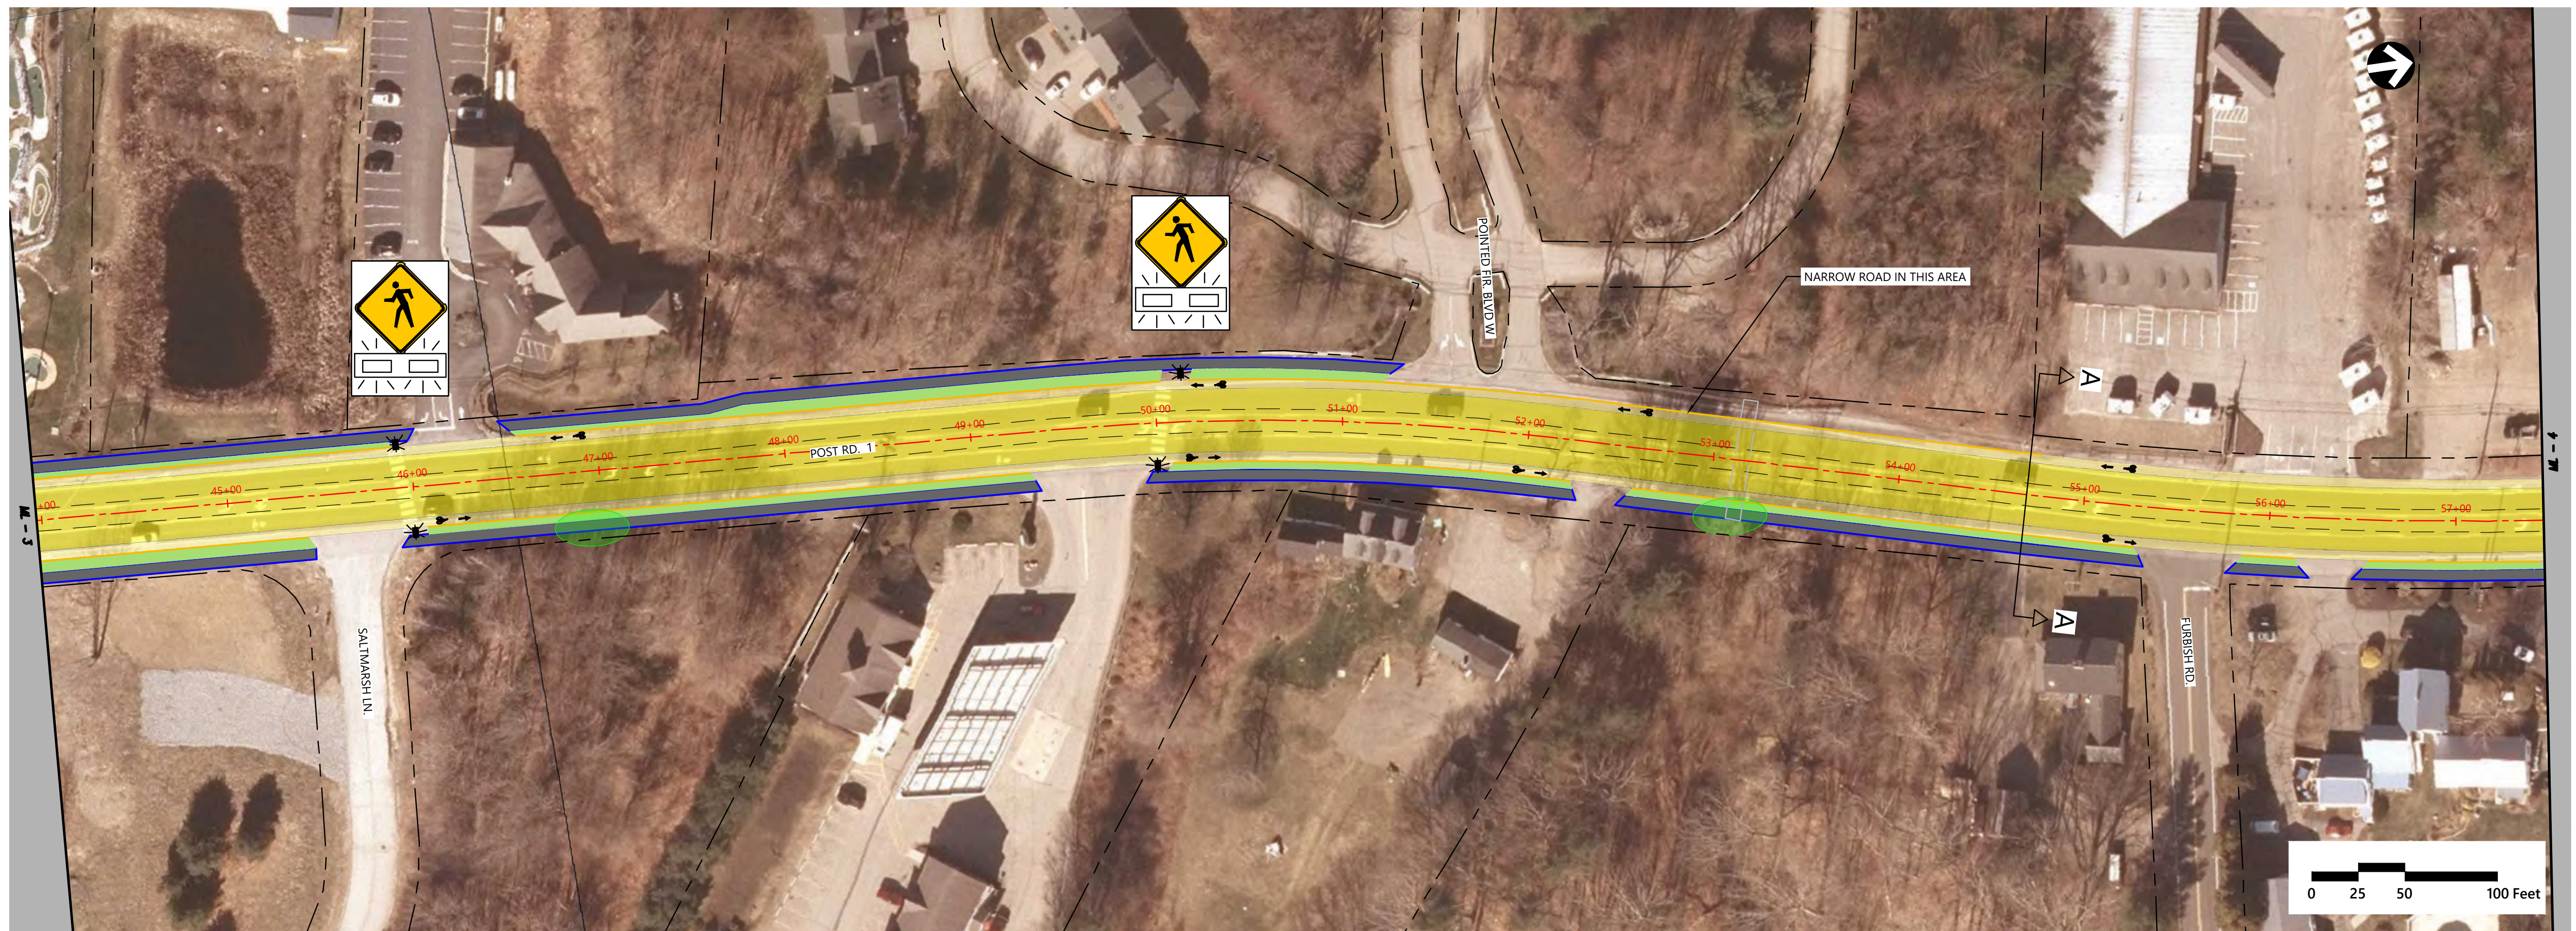
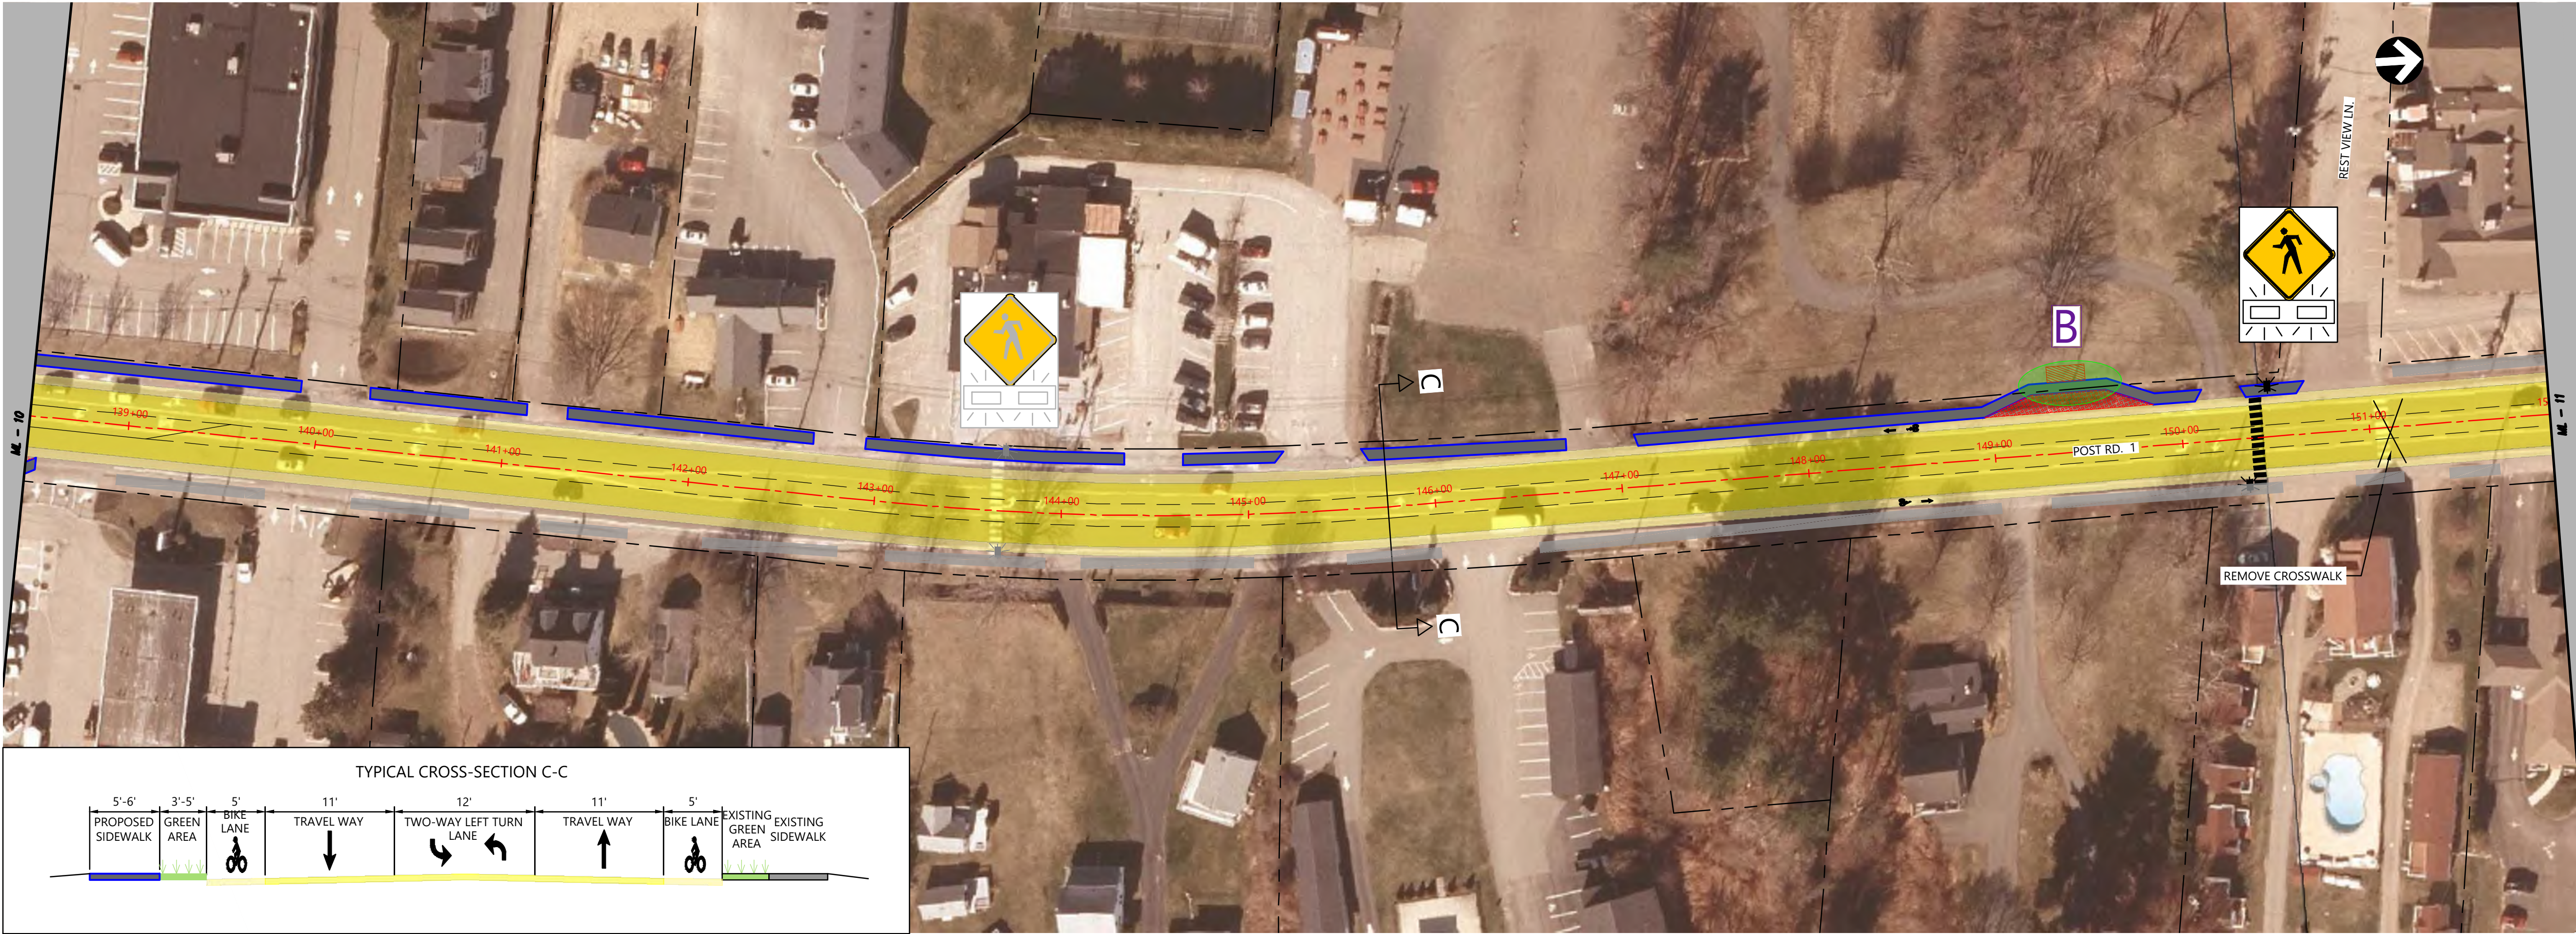
- RIGHT OF WAY
- PROPOSED EDGE OF PAVEMENT
- EXISTING BRIDGE
- EXISTING CULVERT
- EXISTING SIDEWALK
- PROPOSED SIDEWALK
- TRAVEL WAY
- BIKE LANE
- RAISED ISLAND
- GREEN AREA
- ELIGIBLE HISTORIC PROPERTY
- LISTED HISTORIC PROPERTY
- PROPOSED TRANSIT CENTER
- PROPOSED TRANSIT CUTOUT AND BUS SHELTER
- TOURIST INFORMATION CENTER
- EXISTING RECTANGULAR RAPID FLASHING BEACONS (RRFB)
- PROPOSED RECTANGULAR RAPID FLASHING BEACONS (RRFB)
- EXISTING TRAFFIC SIGNAL
- PROPOSED TRAFFIC SIGNAL
- PROPOSED CROSSWALK
- SIDEWALK IMPACT AREA

The preliminary recommendations are shown graphically on concept plans included in Appendix C. Note that these recommendations will be further refined once the project moves to the preliminary design phase including further consideration of comments received during the study process.
