Frank J. Wood Bridge: Summary of Alternatives

Prepared by T.Y. Lin International
March 10, 2017

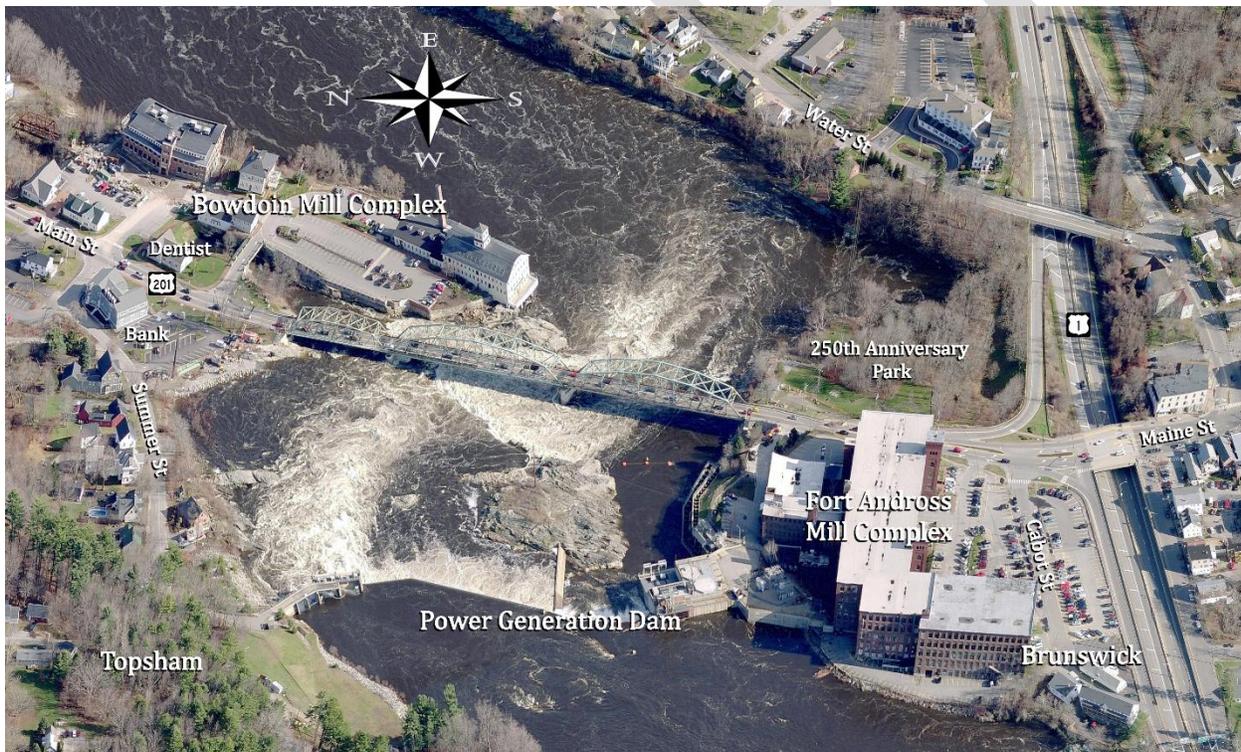
Figure 1: The Frank J. Wood Bridge spanning the Androscoggin River between Brunswick and Topsham

The Frank J. Wood Bridge is an 85-year-old, 805-foot-long, three span steel through-truss bridge with spans of 310'-310'-175'. It was rehabilitated most recently in 1985, 2006, and 2015. It is a “fracture critical” structure, indicating it is vulnerable to sudden collapse if certain components fail, in this case the truss diagonal and bottom chord members and their connections and the floor beams. Because of this designation, more detailed inspections are required. Detailed inspections by MaineDOT in 2012, June 2016 and August 2016 found many deteriorated areas. A load rating done by MaineDOT in 2013 and updated in August 2016 found some floor system members are no longer adequate for Maine’s legal loads. The bridge is now posted for 25 tons. There is corrosion and section loss in the steel floor system supporting the deck (the transverse cross beams, longitudinal stringers, and transverse floor beams). The floor system, bottom chords, and the concrete deck are currently in poor condition, and the bridge has a FHWA Sufficiency Rating of 25.4. Corrosion at the deteriorated areas is continuing and accelerating, and will do so until the bridge is rehabilitated comprehensively.

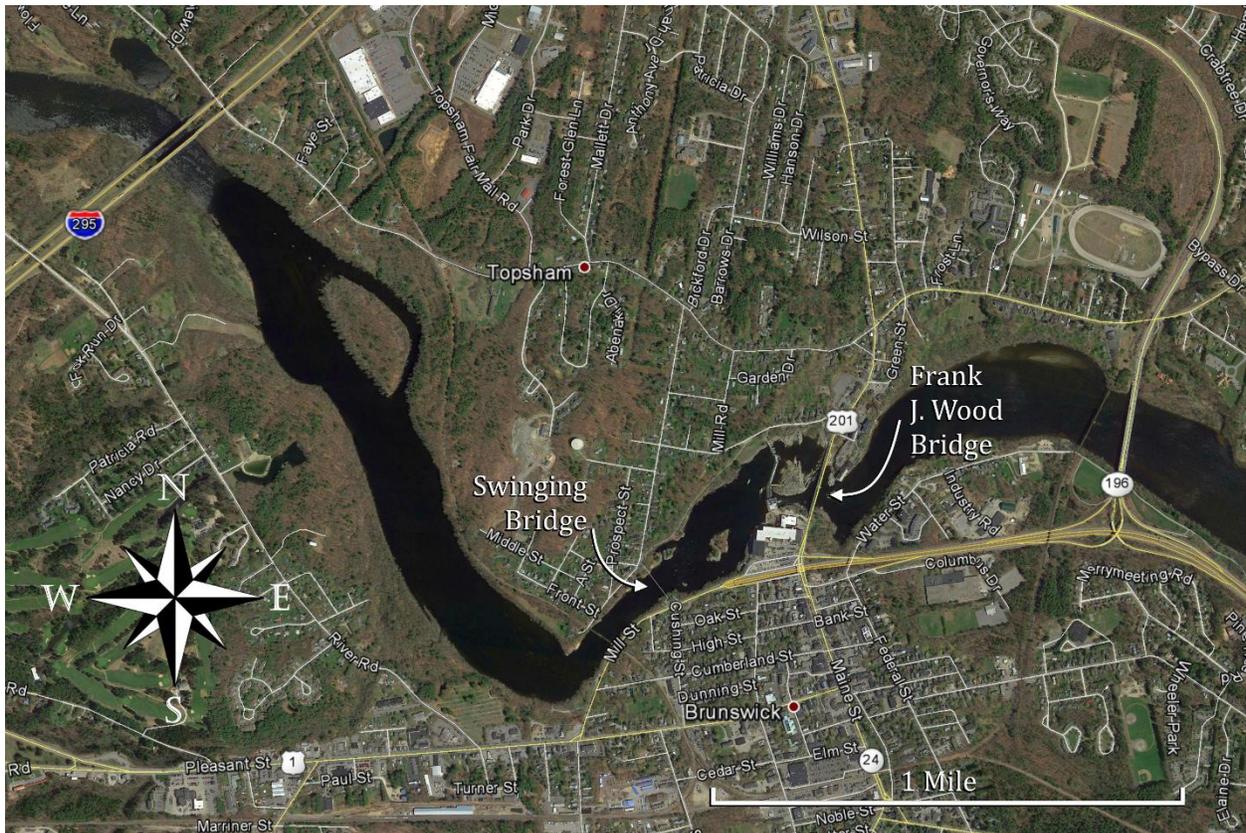
Figure 2: Androscoggin River crossings between Brunswick and Topsham

The Frank J. Wood is the central of three vehicular crossings of the Androscoggin River between Brunswick and Topsham. About 2 miles upstream, I-295 crosses the river; it has interchanges with U.S. 1 on the Brunswick side and ME 196 on the Topsham side. Less than 1 mile downstream, ME 196 (also known as the Coastal Connector) crosses the river. In addition to these vehicular crossings, the historic Swinging Bridge is a pedestrian crossing of the river about ½ mile upstream of the Frank J. Wood Bridge. Figure 2 shows all of these crossings.

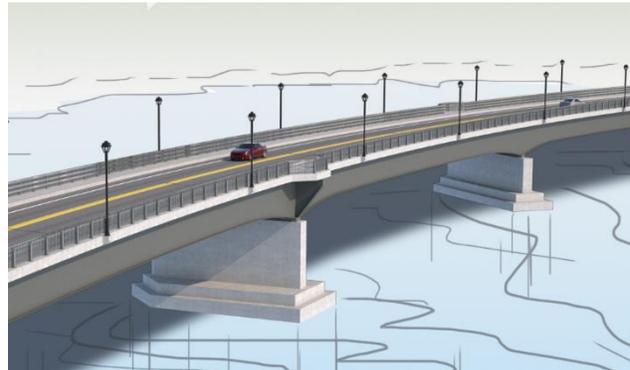
Figure 4: Artist's rendering of a steel girder bridge

A new bridge would be a multi-span steel girder bridge, with 4 or 5 spans. A steel girder bridge is considerably less expensive in Maine than alternative bridge types for this range of spans. To increase the life span of the new structure, the concrete deck would likely be reinforced with corrosion-resistant rebar and the steel girders would be metalized. Metalization of the girders will protect them from corrosion due to spray from the turbulent river beneath the bridge. The new bridge would have concrete wall abutments and solid shaft piers, all founded on the shallow bedrock at this site. New concrete bridge decks with high-performance membrane waterproofing and corrosion-resistant reinforcing bar are expected to last the service life of the new bridge or 100 years.

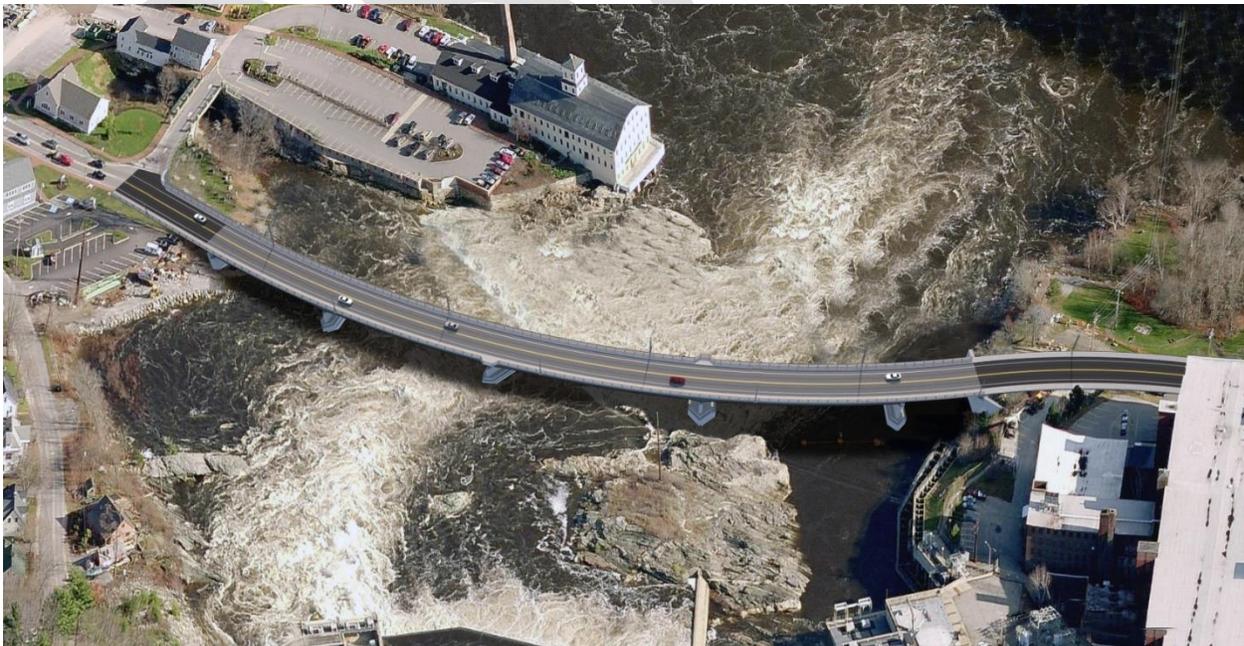
Figure 6: A Possible Curved Upstream Bridge

Alternative 2 is a new 835 ft, five span, steel girder bridge on a curved upstream alignment. A curved bridge reduces the length of approach roadway construction and reduces right of way impacts to abutting properties when compared to using a straight bridge in the same upstream location. This bridge alternative would have a short southern span to better align the spans to bridge the Brookfield power station outflow channel with a minimum of impact. The remaining four spans would be continuous haunched steel girder spans with a concrete deck. The span arrangement and number of piers would be selected to minimize footprint impact within the channel and within the FERC Boundary and to maximize the efficiency of steel girder superstructure. In addition, the existing hydraulic clearance over the river would be maintained as a minimum. To avoid an unacceptable rise in flood elevations along the Topsham bank of the river adjacent to the Bowdoin Mill area, Pier 3 would be skewed at 35 degrees to better align with the flow and the North Pier of the existing bridge would be retained.

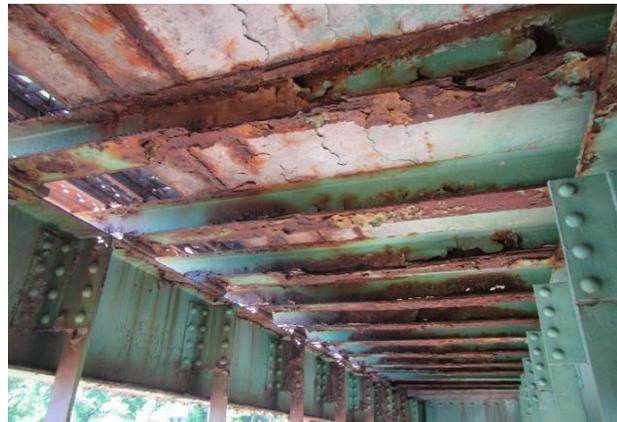
Figure 8: Deteriorated crossbeams & deck

1. Replace the existing bridge deck (including crossbeams) with a new reinforced concrete bridge deck. The existing concrete-filled steel grid deck is in poor condition and the supporting transverse crossbeams are badly deteriorated (See Figure 8).
2. Repair the top of steel sidewalk support brackets. The top of each bracket is non-existent now due to corrosion or other past modifications. This requires replacing the sidewalk concrete deck as well.

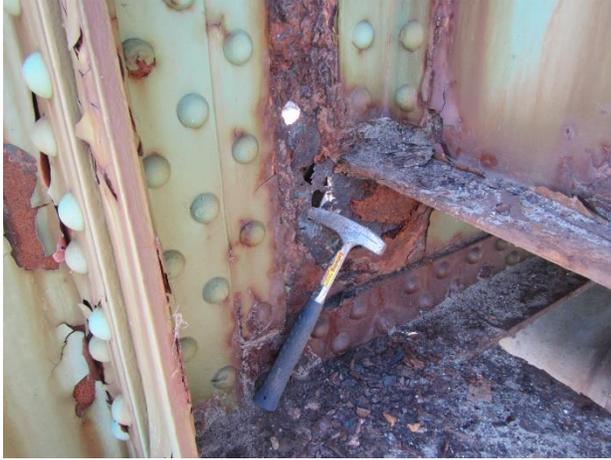
Figure 9: Hole in floor beam

3. Replace the bridge joints. Although these were replaced in 2015, replacement of the existing deck will require these to be replaced.
4. Replace the entire steel floor system, including the longitudinal stringer beams and transverse floor beams. The new floor system would be composite with the new deck. The floor system is heavily deteriorated and is below load carrying standards (see Figures 9 and 10).

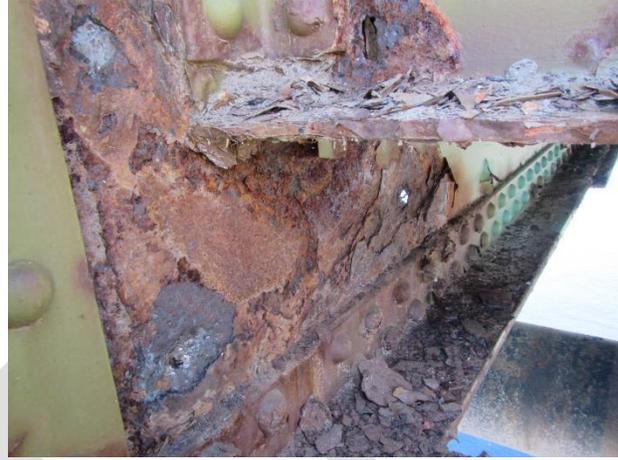
Figure 10: Deteriorated floor beam

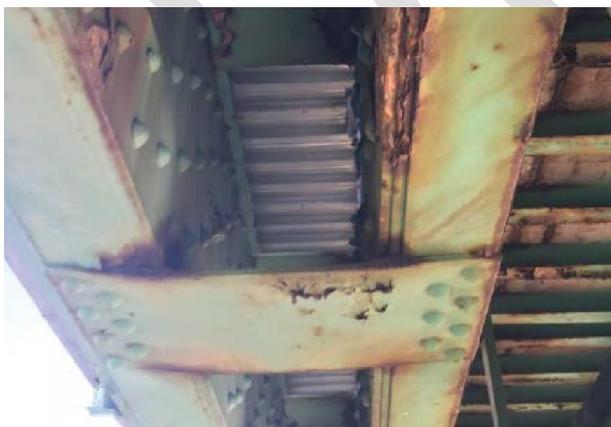
Figure 12: Bottom chord lattice plate bowing
on this structure is expected to cost about \$4,000,000.

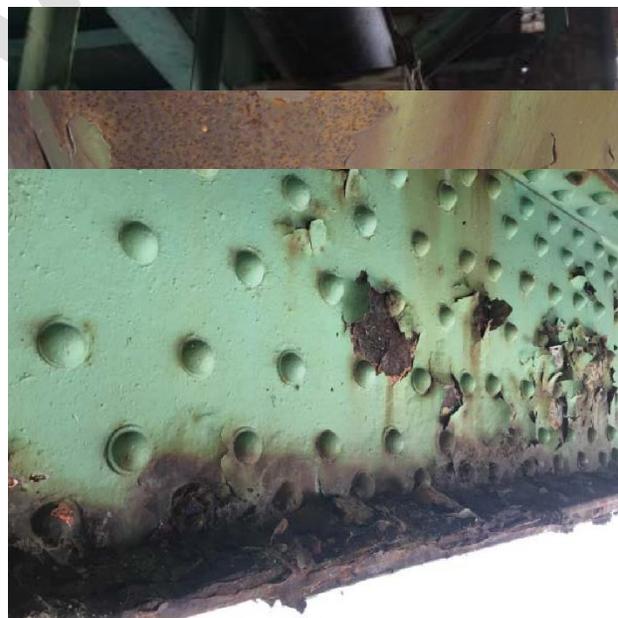
Figure 11: Bottom chord bottom flange corrosion

5. Replace the bottom flange angles of the bottom chord of the main trusses due to corrosion and distortion from pack rust, as seen in Figure 11. It is anticipated this work could be done one angle at a time without shoring while the deck is off the bridge.
6. Replace the lattice plates of the bottom chord, which are severely bowed due to pack rust. See Figure 12.
7. Remove the welded steel plates attached to truss vertical members. These are fatigue sensitive details on fracture critical members. Remediate these locations using cover plates. See Figure 13.
8. Paint the entire steel superstructure, including all above and below deck components. Doing a comprehensive paint job

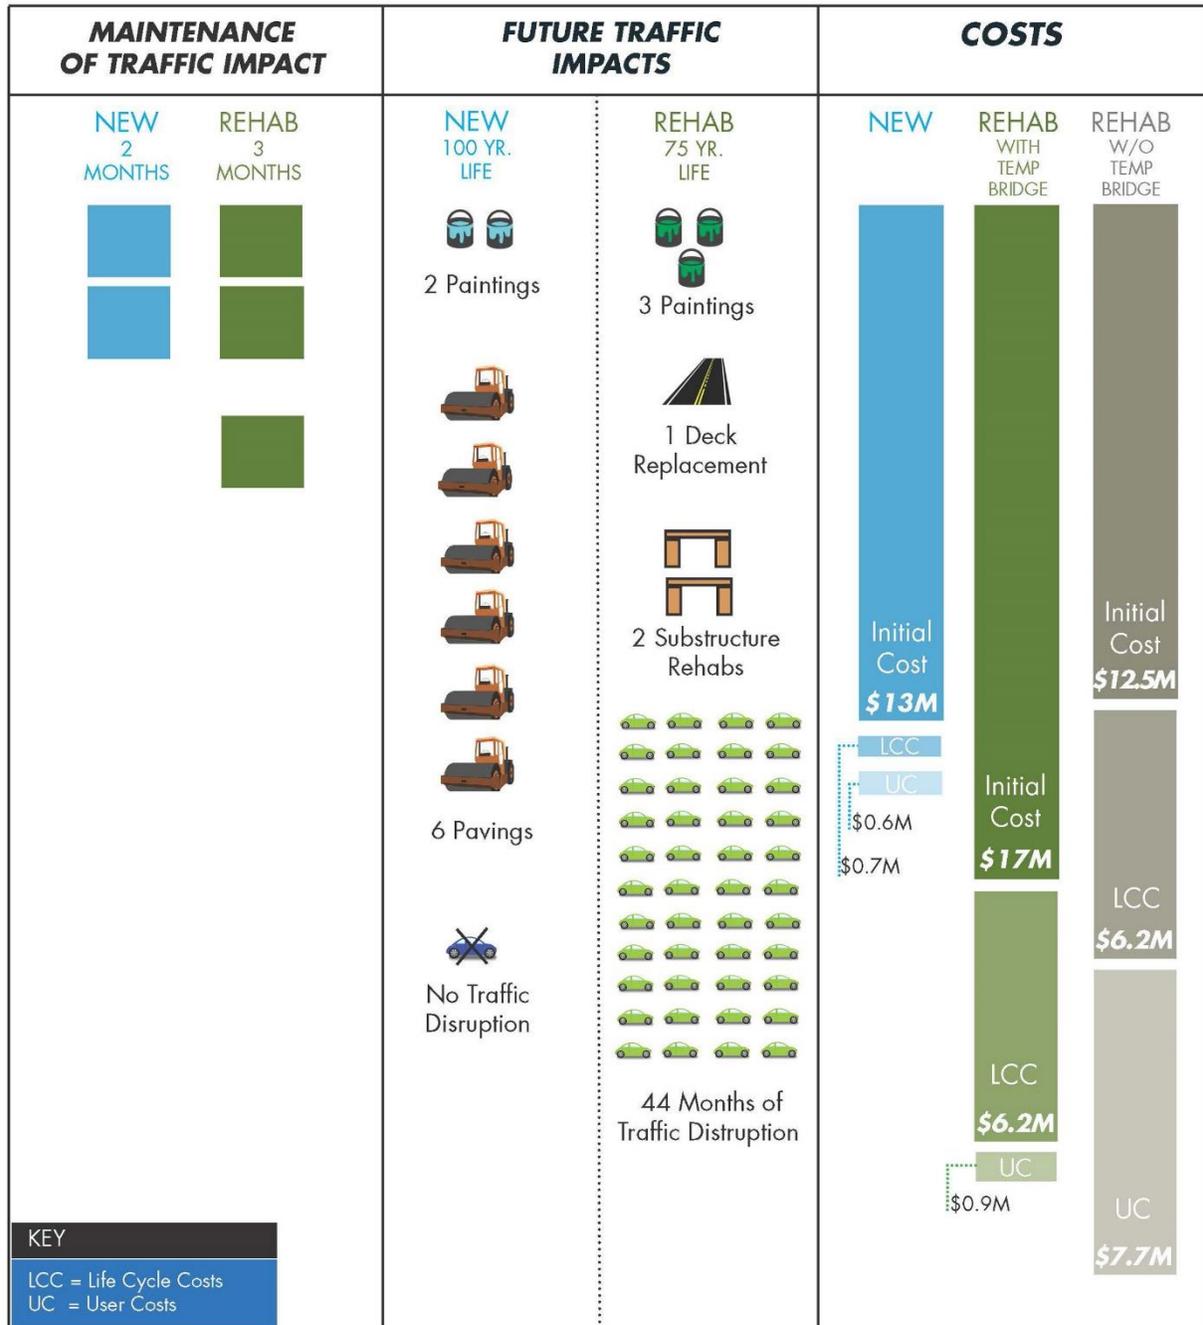
The graphic below compares Alternative 2 (the low cost replacement or new option) and Alternative 4 (the rehab option with two sidewalks). Three main areas are contrasted: maintenance of traffic during construction, future rehabilitation and maintenance, and total costs.
