Frank J. Wood Bridge Public Meeting

Environmental Assessment and Draft
Section 4(f) Evaluation

March 28, 2018

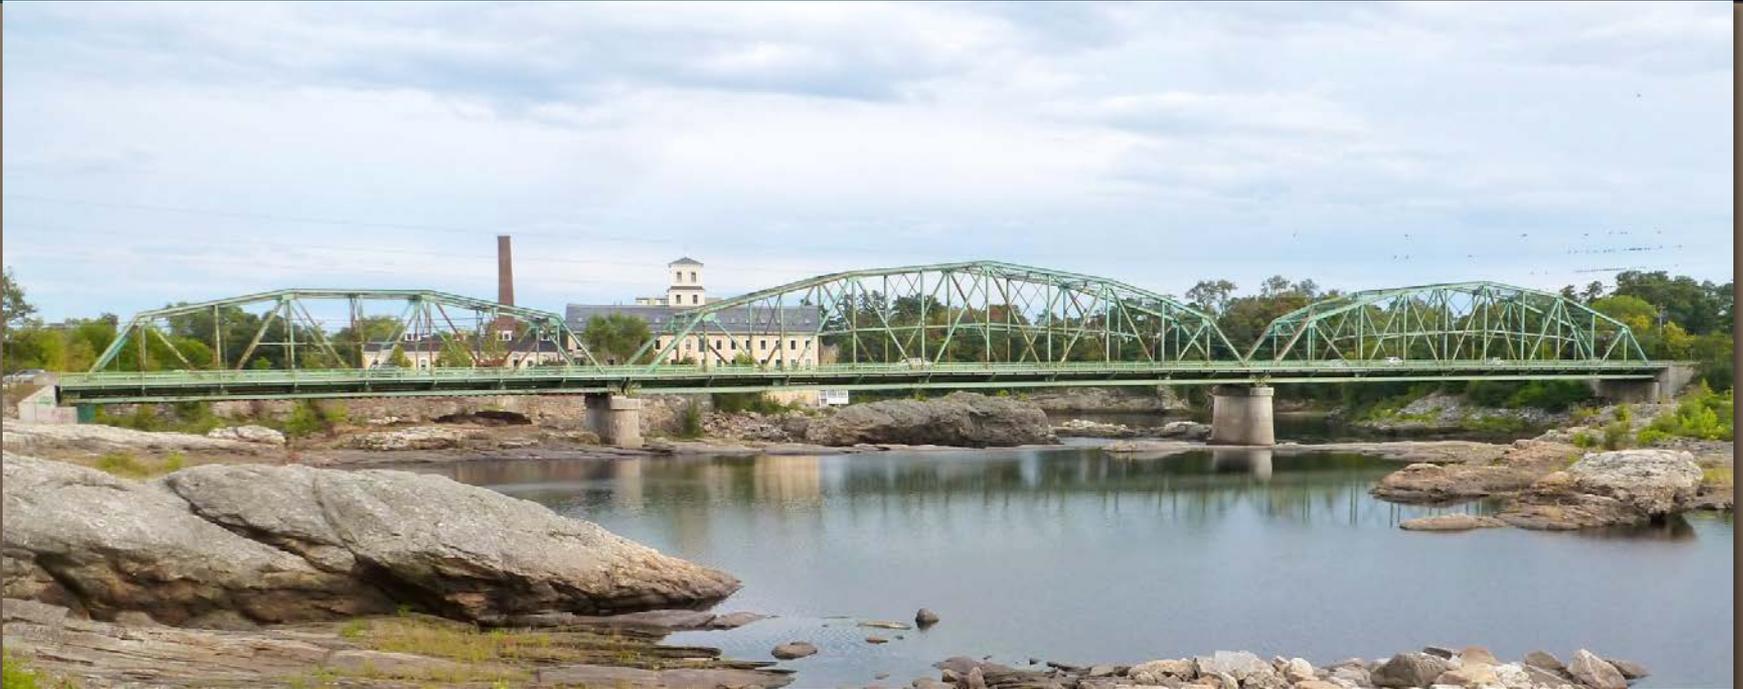
Frank J. Wood Bridge

- 805 ft, three-span steel truss
- Annual Average Daily Traffic Appx. 19,000 vpd
- Built in 1931 (87 yrs old)
- Appx. 9 bridges at this site since 1795

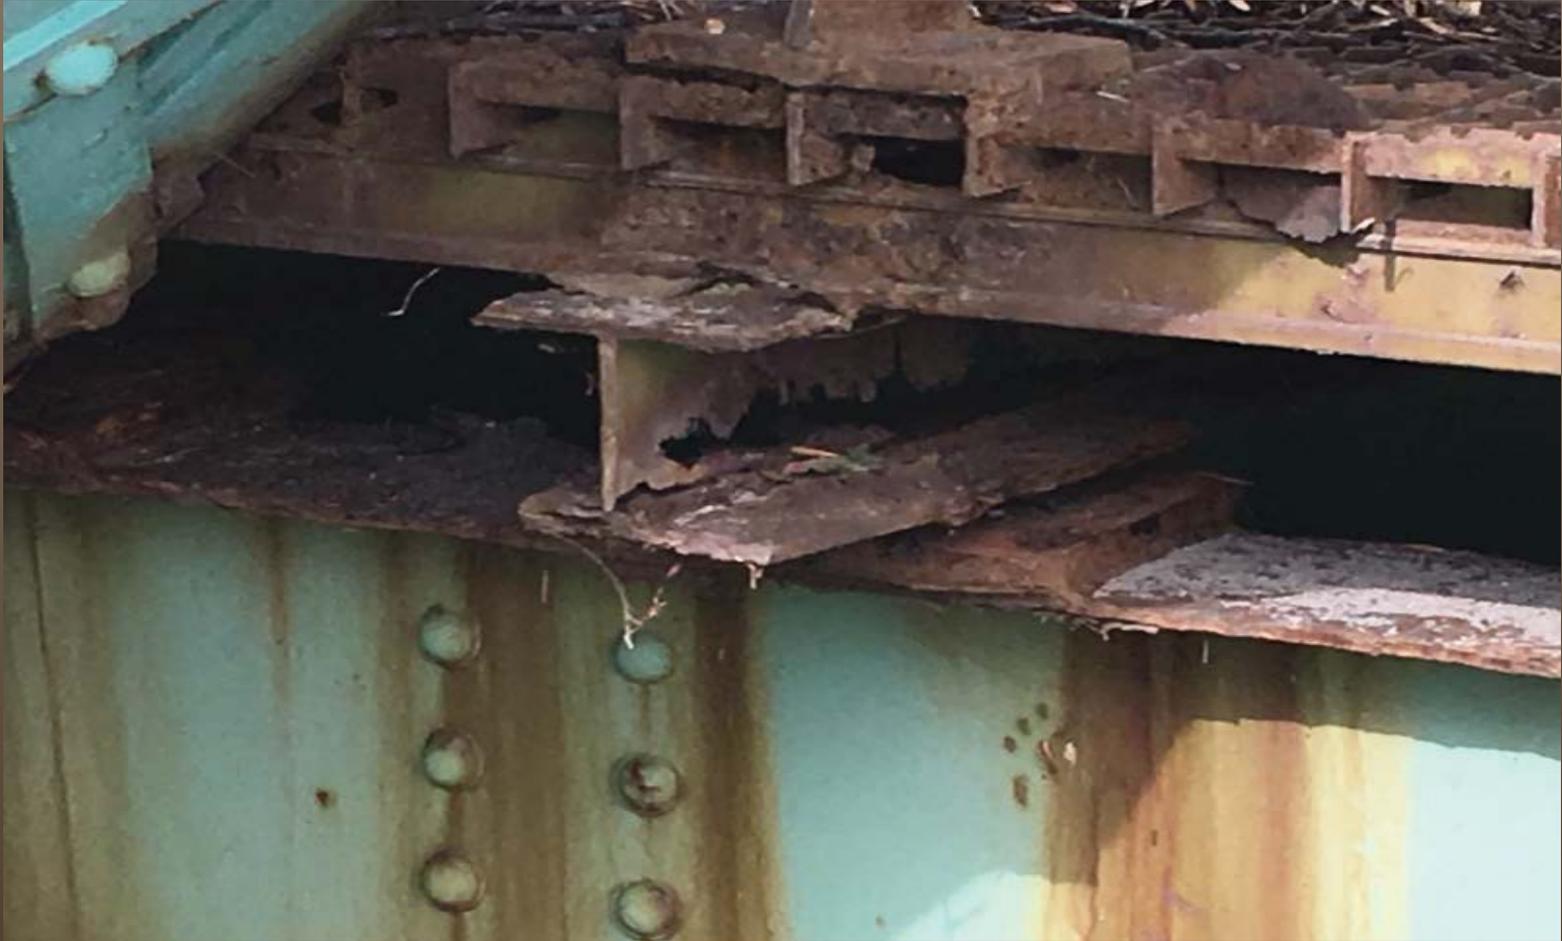
Severe Corrosion at Cross Beam

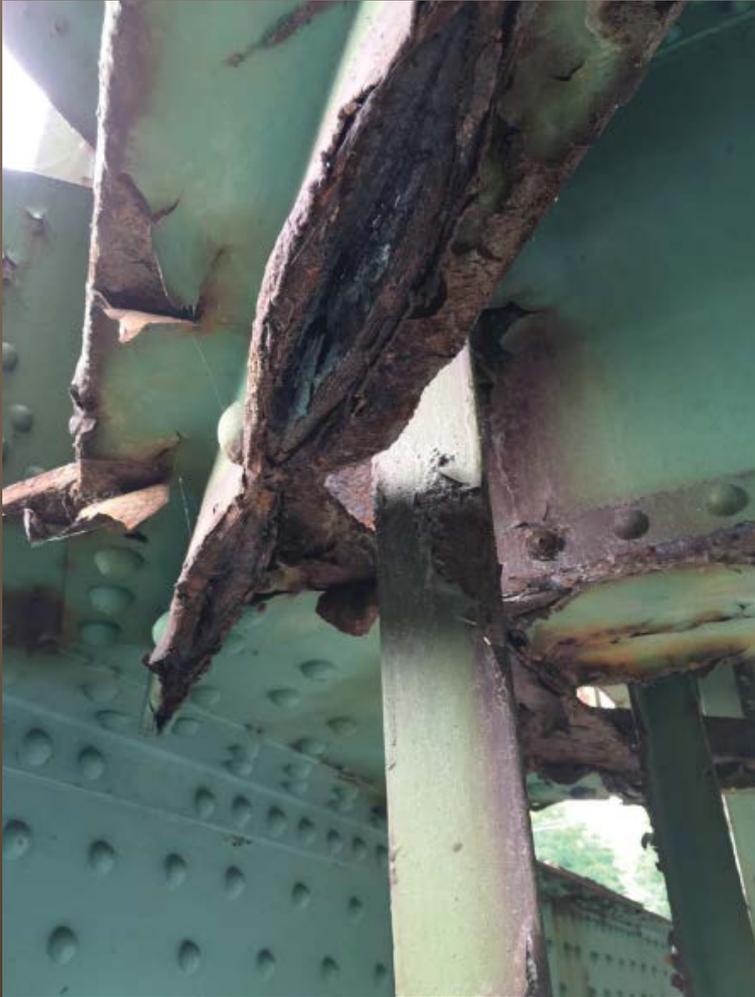
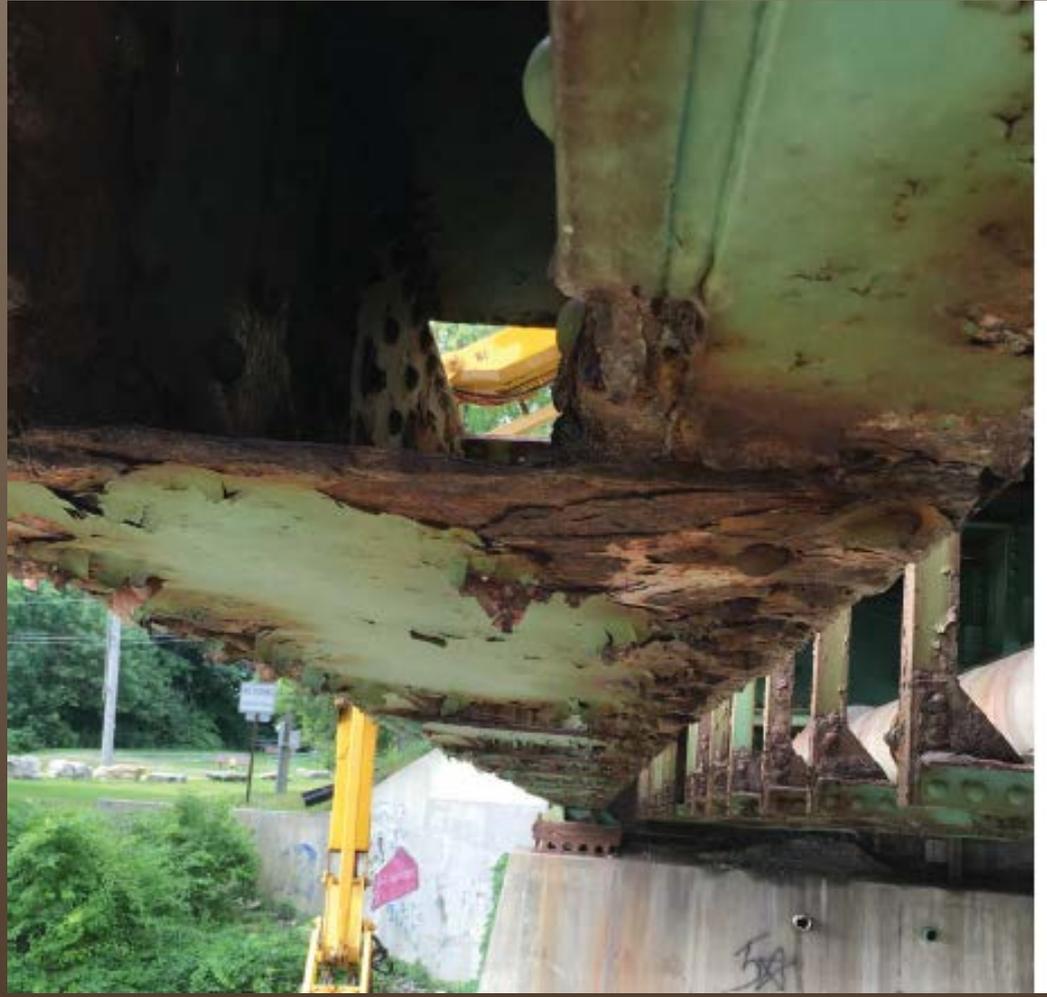
Pack Rust in Bracing and Bottom Chord

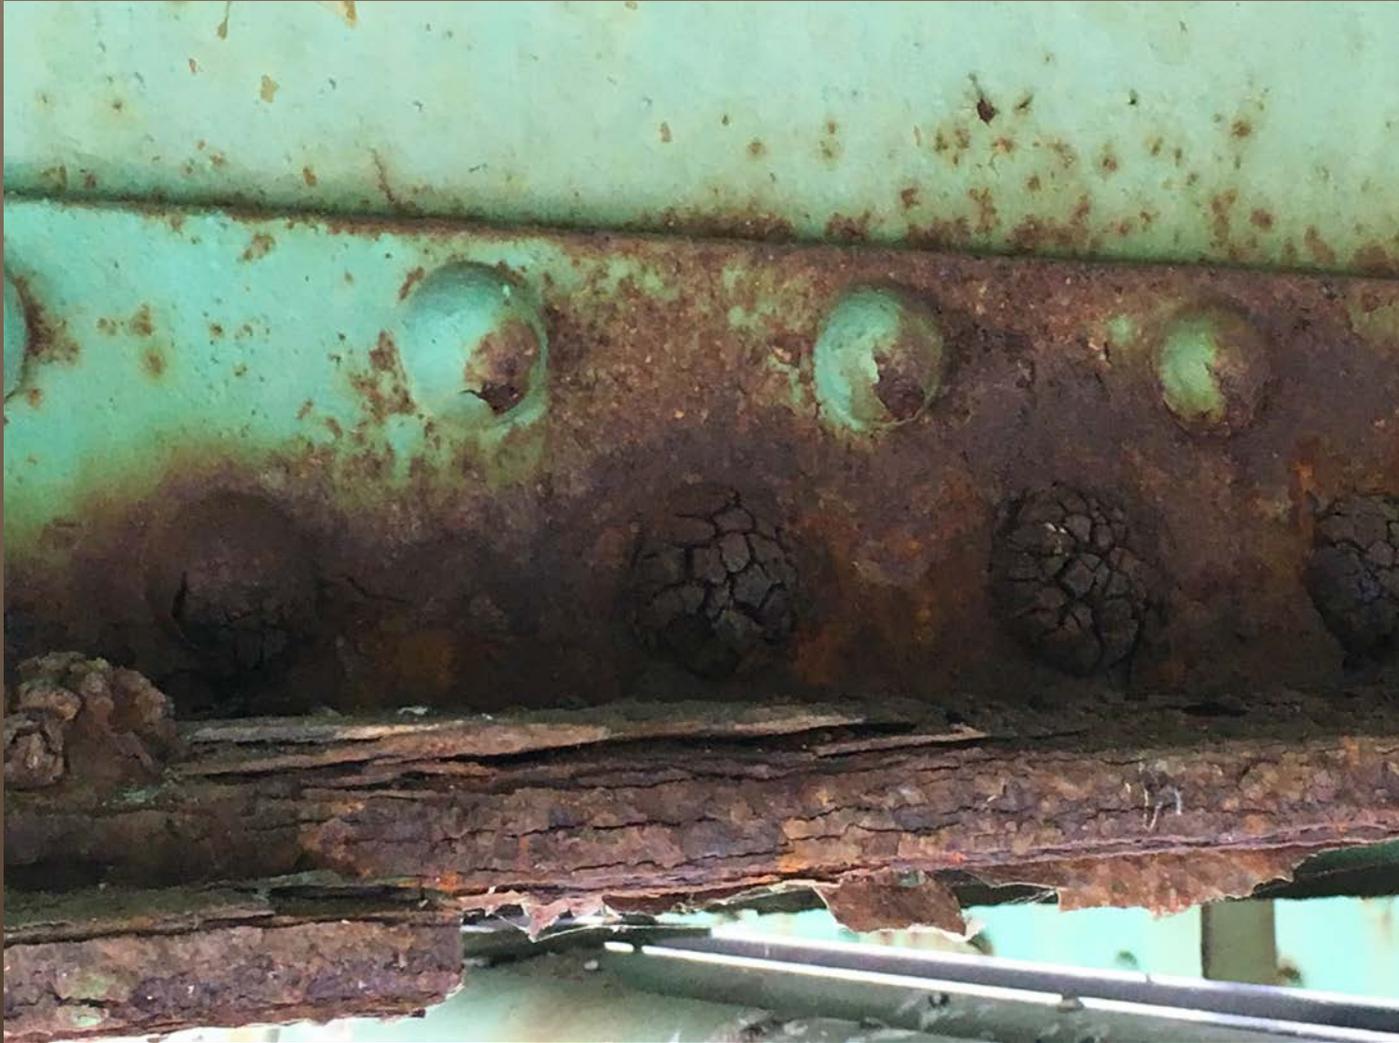
Severely Corroded Rivets

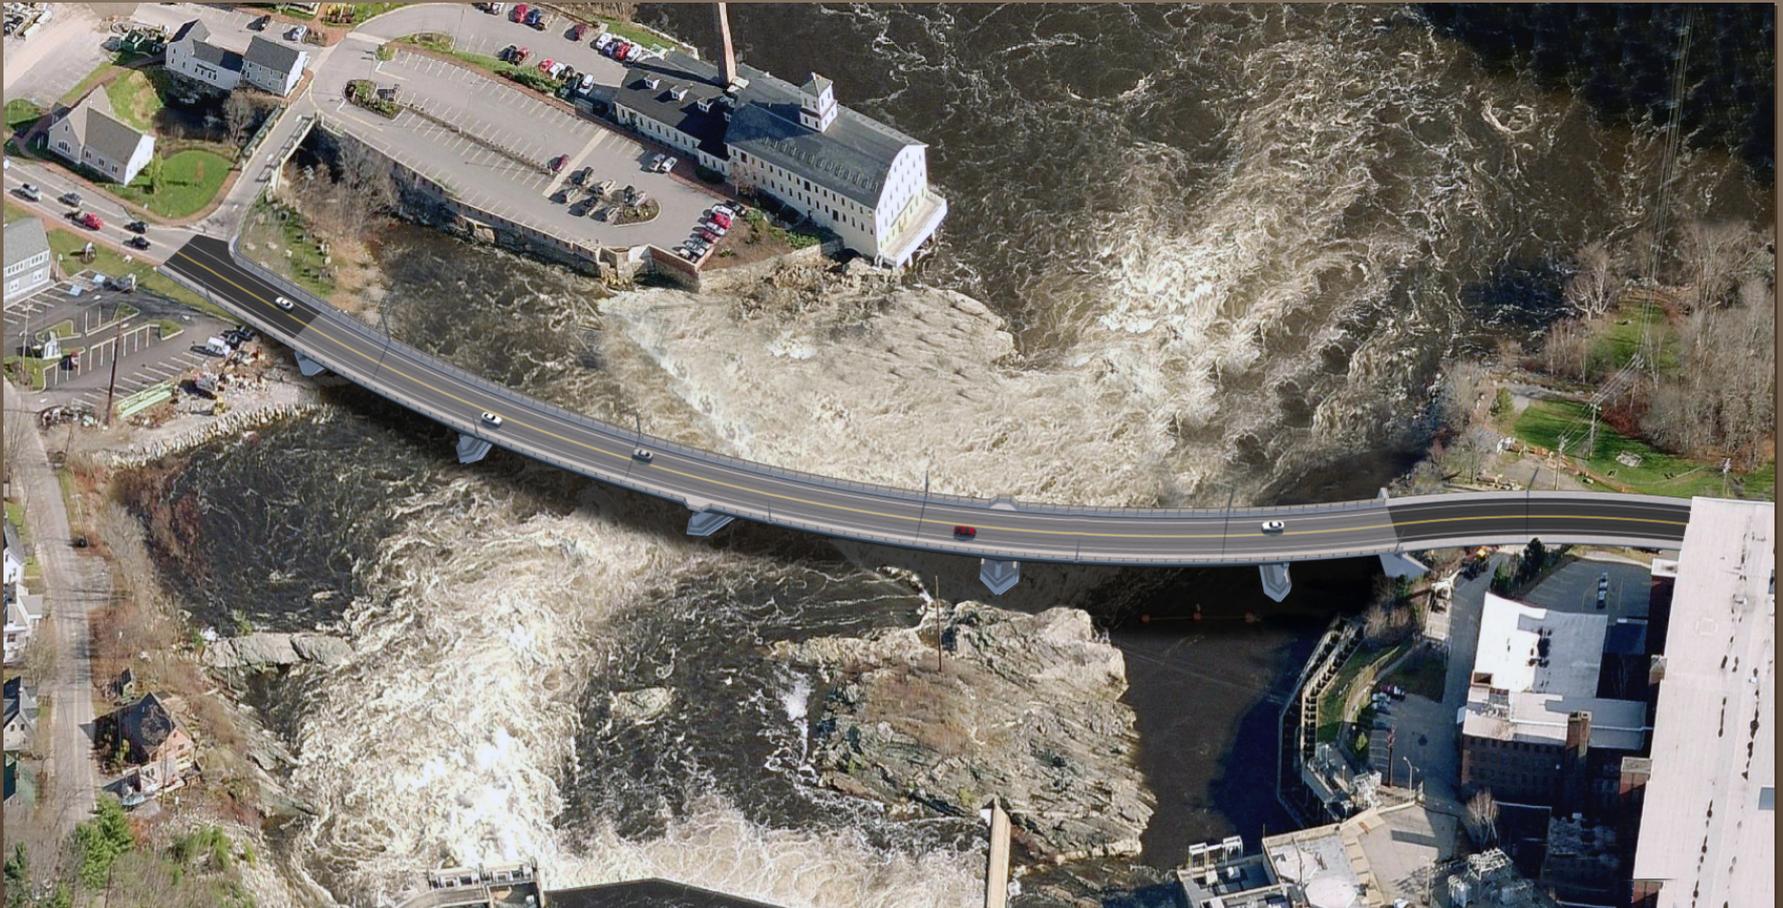
Rendering of Curved Upstream Bridge

Alt. 2 - New Bridge on Curved Upstream Alignment
