Supplemental Supporting Information for a Finding of Effect

Project: Milo 22627.00 Scope: Bridge Replacement

Finding of Effect: Adverse Effect

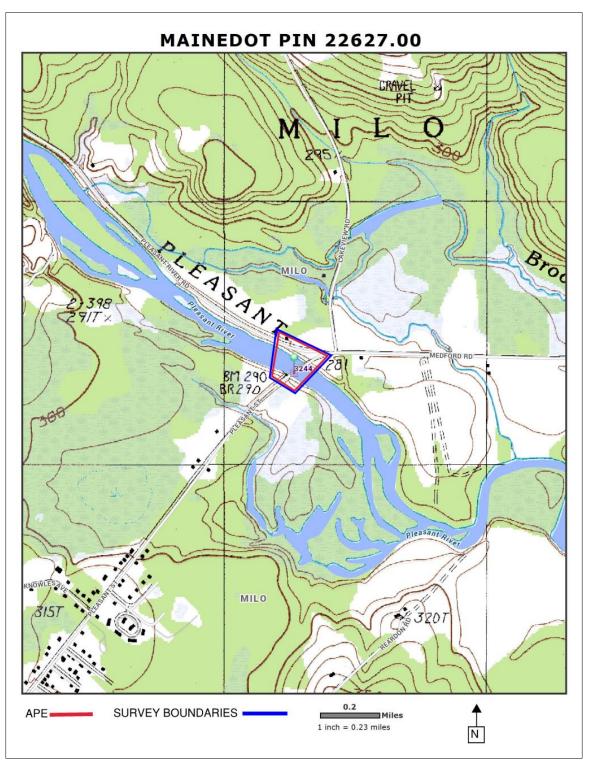
Figure 1. Milo 22627.00 Area of Potential Effect

The proposed project is located in Milo. The map below shows the APE.

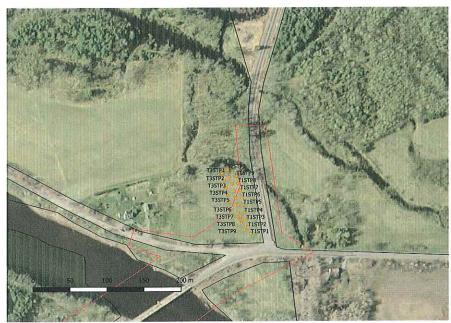
Figure 2. Location of STPS in Bouchard alfalfa field.

Andre and Theresa Bouchard own 125 acres of farmland between Pleasant River Road and Lakeview Road at the northwest corner of the bridge. The proposed APE extends into the Bouchard's alfalfa field where a 2011 archaeological survey conducted by Dr. Gary Shaffer of the NRCS identified fragments of 19th-century ceramic wares, but no pre-contact Native American artifacts during surface inspection (Shaffer and Spiess 2011). We excavated 29 shovel tests pits on three linear transects and recovered a waterworn piece of Kineo rhyolite in deep plow zone soils and in association with 19th- and 20th-century historic materials (Figure 2) Unworked Kineo rhyolite cobbles and broken 'flakes' are present along the river bank and in the cobble/pebble fraction of outwash sediments identified in several tests. Beneath plowzone soils are about 20 to 40cm of yellow brown fine sandy loam on outwash sand and gravel. No further archaeology is recommended.

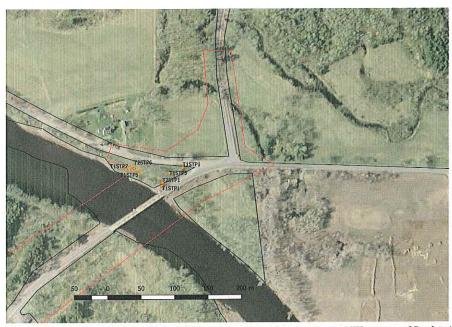
Figure 3. Location of GPS recorded STPS on Dana Perkins property, NW corner of Bridge #3244

During Phase I survey we excavated three linear transects of shovel tests on the river bank between the abutments and another about 35m from the break in slope at the intersection of Pleasant River Road and Pleasant Street (Figure 3). The latter transect found deep fill deposits emplaced during

1936 bridge construction. The remaining transects identified calcined bone and a waterworn Kineo rhyolite retouched flake or biface preform in plow zone soils with historic artifacts. Bracketing tests around the find yielded no additional pre-contact material, suggesting that it may have been washed in by flood waters. Shovel tests placed around the 2017 STP yielding the possible worked cobble, identified a mix of natural cobble lag and cobble fill eroding from the abutment. No other unequivocal pre-contact artifacts were recovered. The worked cobble may represent an entirely eroded archaeological site or perhaps it arrived in a load of fill from another location. No additional archaeology is recommended.

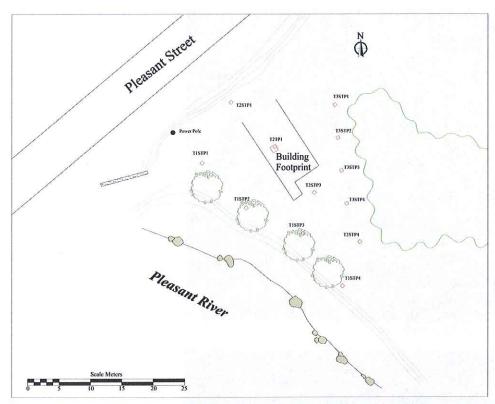
Figure 4. Location of shovel tests and building footprint on Dana Perkins house lot parcel, northeast corner of bridge #3244

Subsurface testing of the Perkins property was conducted with 12 shovel test pits and a one-meter-square test unit distributed on three transects (Figure 4). This work failed to identify pre-contact Native American artifacts, but it did confirm the presence of an historic structure that probably predated the publication of the 1947 Schoodic Topographic map. Nails and spikes recovered from the shovel test were of the wire variety and the insulation of wool. Copious amounts of plaster would suggest the building may have been more substantial than a barn or storage shed. The structure was at least 14m by 6m in plan, based on the dimensions of the rectangular depression where the majority of the artifacts were recovered. No additional archaeology is recommended.

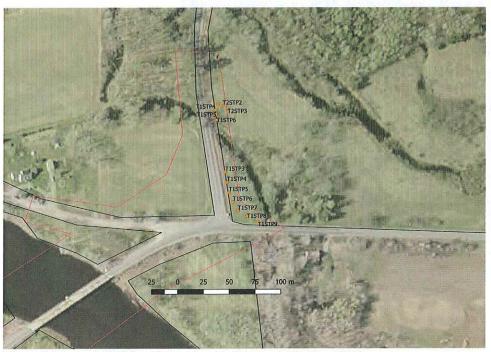
Figure 5. Location of STPS on Ritter property, NE corner of Bridge #3244

We excavated three transects of shovel tests at 5m intervals on the Ritter property (Figure 5). The first transect tests the area between Lakeview Road and the meander. Transects 2 and 3 test the road side and field overlooking the north side of the meander. These tests did not yield pre-contact Native American artifacts, but two deeply buried organic samples from the north side of the meander may be useful for directly dating the formation of the flood plain. No additional archaeology is necessary within the APE on the Ritter property.

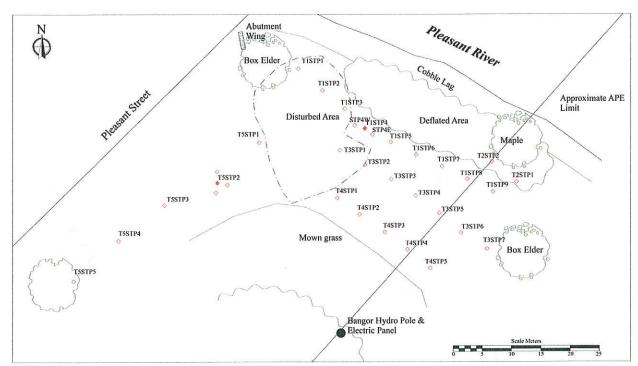
Figure 6. Location of STPS on Dana Perkins property, SE corner of Bridge #3244

Four transects of shovel tests were arrayed roughly parallel with the river bank at 5m intervals (Figure 6). Most of the shovel tests revealed about 50cm of Holocene alluvium on top of coarse sand or gravelly outwash. Several shovel tests in the western corner of the parcel below the bridge approach identified very disturbed deposits, culminating in the discovery of a buried manhole cover in test T3STP1. Upon obtaining an electronic copy of the 1936 bridge plans, we learned that there was a preexisting sewer line extending from the Perkins property to the bridge approach of the 19th-century alignment. Outside of the disturbed area a single flake was recovered from test T1STP4. Bracketing tests placed around the unit did not yield further evidence of pre-contact use of the immediate river bank.

A fifth transect of 5 STPS was used to test and elevated landform at the base of the toe slope of the bridge approach. Test T5STP2 produced a complete stemmed biface of Kineo rhyolite that is believed to be either Terminal Archaic or Ceramic Period in age, based on stem morphology. Three bracketing tests placed at 2m intervals around the unit did not yield additional pre-contact artifacts. No further testing within the project APE is recommended for the Perkins property.

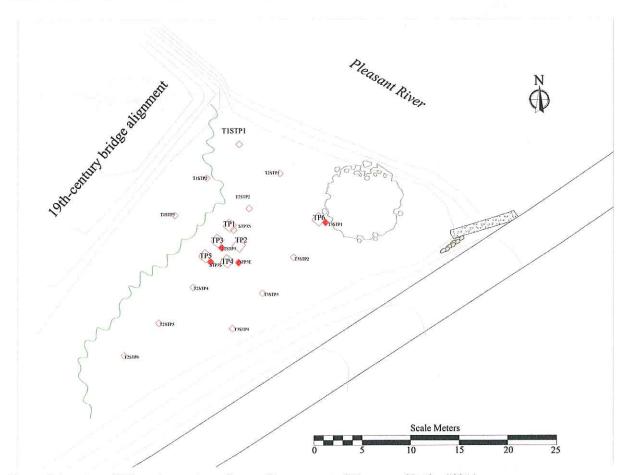
Figure 7. Location of STPs and test units on State or Town property, SW corner of Bridge #3244.

Three transects of shovel tests were arrayed at 5m intervals between the two bridge approaches (Figure 7). Soil profiles revealed fill and plowzone soils with historic artifacts to about 40cmbs, followed by about 20cm of yellow brown B-horizon soil and gravelly outwash. Two shovel tests produced flaked-stone biface preforms and flakes. Two of three bracketing tests placed around unit T2STP3 were also positive for pre-contact artifacts. The site was assigned the number 107.20 in the State Survey.

During Phase II testing six one-meter-square units were placed adjacent to the Phase I shovel tests yielding pre-contact artifacts. These yielded a small number of Kineo rhyolite and quartz flakes in plow zone soils, but did not reveal potential features, temporally diagnostic artifacts, or artifact concentrations. Site 107.20 is not NR eligible under any context of the State Plan. No further archaeology is necessary.

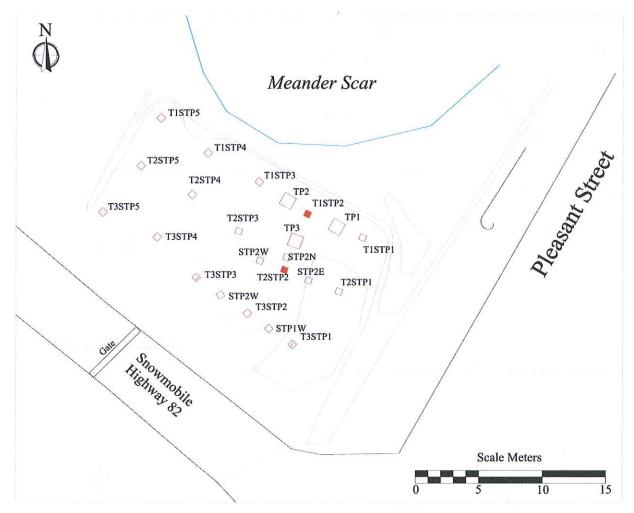
Figure 8. Location of STPS and test units on Sheila Kuchinski property, SW corner of Bridge #3244

We excavated three shovel test pits within 10m of the road edge along the break in slope of the meander scar (Figure 8). Soil profiles revealed a thin A-horizon soil with associated albic, about 10cm of yellow brown fine sandy loam, beneath which is gravelly outwash and or till. Shovel tests 2 (T1STP2) and 3 (T2STP2), yielded a couple Kineo rhyolite flakes and 19th-century ceramics from the interface of the Albic and B-horizon soils. The site is assigned 107.19 in the State Survey.

During Phase II testing we excavated three transects of shovel tests at 5m intervals, three one-meter squares, and several bracketing shovel tests. Phase I shovel tests 1 and 2 were incorporated into Transect 1. None of the additional STPS on T1 yielded pre-contact artifacts, though the two one-meter-square test units each produced a couple of weathered flakes in albic soil. Shovel tests on T2 yielded a couple of possible flakes, while from T3 tests we recovered a few 19th-century ceramics, brick fragments, bottle caps, and the like. The historic artifacts do not represent a potentially significant archaeological site. Testing of site 107.19 did not identify temporally diagnostic stone tools or ceramics or reveal features yielding calcined bone, charred botanical remains, or any other material. Site 107.19 is not NR eligible under any context of the State Plan. No further archaeology is necessary.

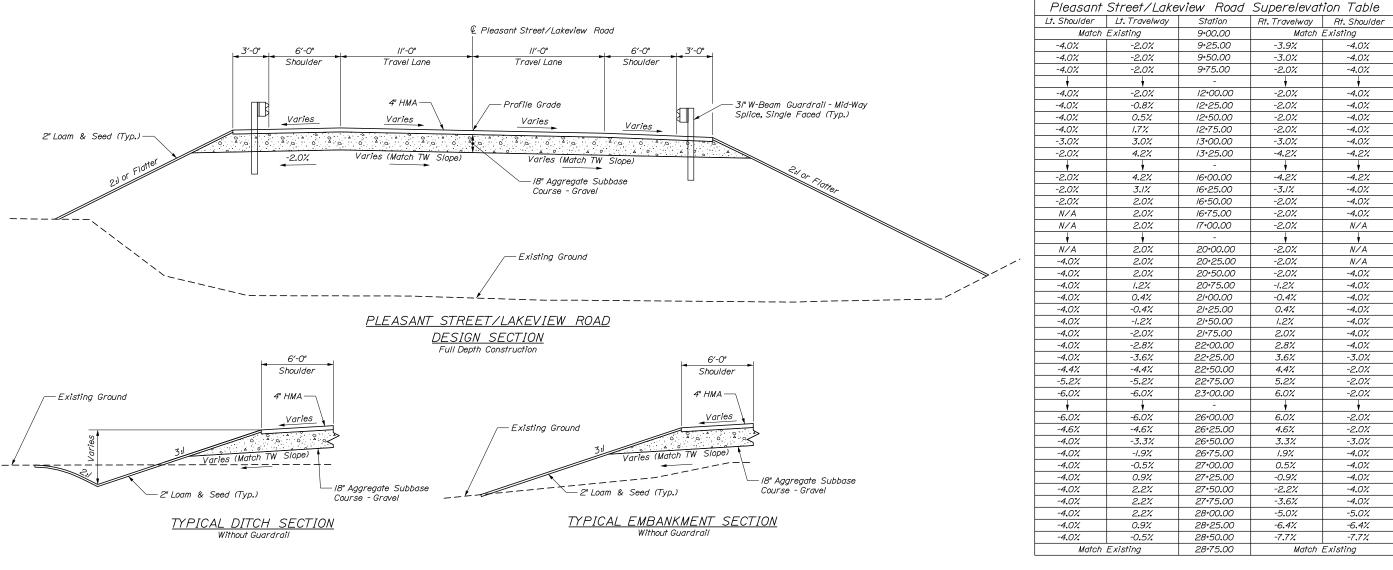
PLEASANT STREET/LAKEVIEW ROAD

DESIGN SECTION Shoulder Construction With Variable Depth Mill, Shim & 2" Overlay

0.4	, a . a . a . a . a . a . a .	, ,,, 0,,,,,,,,,
Match	Existing	9+00.00	Match E	xisting
-4.0%	-2.0%	9+25.00	-3.9%	-4.0%
-4.0%	-2.0%	9+50.00	-3.0%	-4.0%
-4.0%	-2.0%	9+75.00	-2.0%	-4.0%
+	+	-	+	+
-4.0%	-2.0%	12+00.00	-2.0%	-4.0%
-4.0%	-0.8%	12+25.00	-2.0%	-4.0%
-4.0%	0.5%	12+50.00	-2.0%	-4.0%
-4.0%	1.7%	12+75.00	-2.0%	-4.0%
-3.0%	3.0%	13+00.00	-3.0%	-4.0%
-2.0%	4.2%	13+25.00	-4.2%	-4.2%
	<u> </u>	-	→	—
-2.0%	4.2%	16+00.00	-4.2%	-4.2%
-2.0%	3.1%	<i>16+25.00</i>	-3.1%	-4.0%
-2.0%	2.0%	16+50.00	-2.0%	-4.0%
N/A	2.0%	16+75.00	-2.0%	-4.0%
N/A	2.0%	17+00.00	-2.0%	N/A

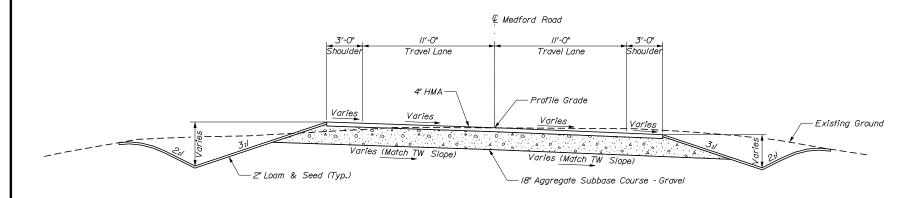
MEDFORD ROAD DESIGN TYPICAL SECTION

PLEASANT RIVER ROAD DESIGN SECTION

FIELD ENTRANCE DESIGN SECTION

Medford Ro	ad Superele	evation Table	9
Lt. Shoulder	Lt. Travelway	Station	Rt. Travelway	Rt. Shoulder
Match	Existing	103+50.00	Match	Existing
-2.4%	-2.4%	103+75.00	-4.1%	-4.1%
-1.0%	-1.0%	104+00.00	-4.1%	-4.1%
0.4%	0.4%	104+25.00	-4.1%	-4.1%
1.8%	1.8%	104+50.00	-4.1%	-4.1%
3.2%	3.2%	104+75.00	-4.1%	-4.1%
4.6%	4.6%	105+00.00	-4.6%	-4.6%
+	*	-	+	+
4.6%	4.6%	106+00.00	-4.6%	-4.6%
3.5%	3.5%	106+25.00	-3.5%	-3.5%

Pleasant River Road					
Supe	Superelevation Table				
Lt. Travelway	Station	Rt. Travelway			
Match Existing	201+50.00	Match Existing			
-2.0%	201+75.00	-2.0%			
V	-	†			
-2.0%	203+25.00	-2.0%			
-2.0%	203+50.00	0.0%			
-2.0%	203+75.00	2.0%			
-3.4%	204+00.00	3.8%
