Attachment E

Natural Resources Assessments, Mack Point & Sears Island

Hydrographic and Marine Geophysical Site Characterization Surveys

Mack Point and Sears Island

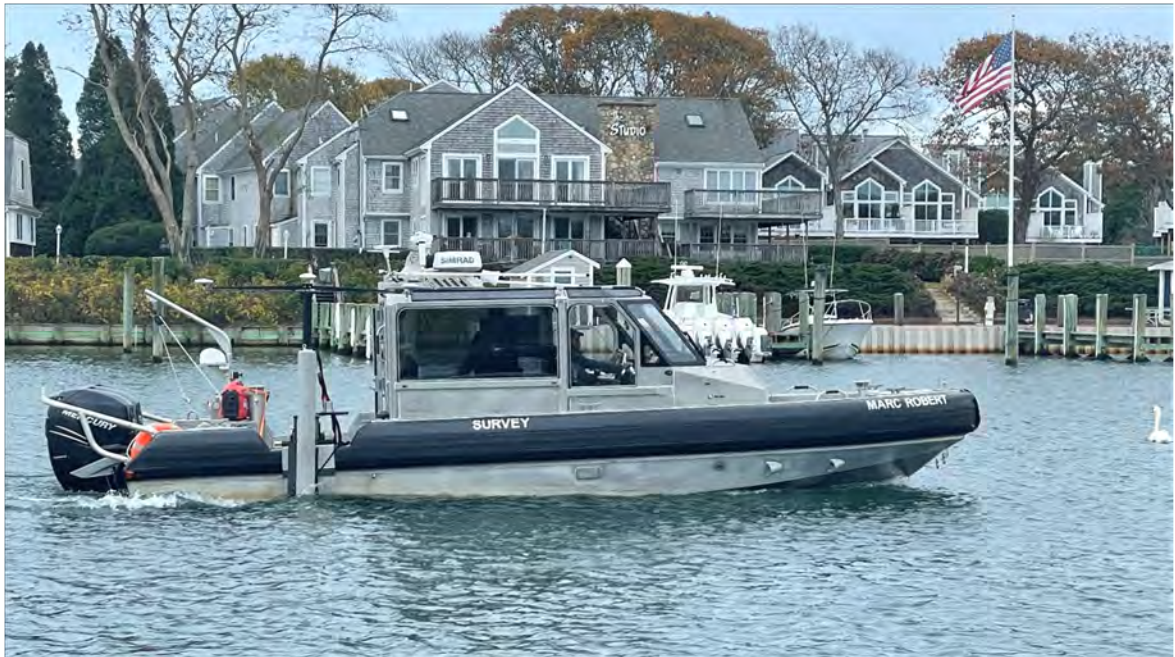
Figure 2. Survey Vessel Marc Robert

Survey Vessel: *Marc Robert*, Steele Associates' 29-ft aluminum hull, twin engine vessel

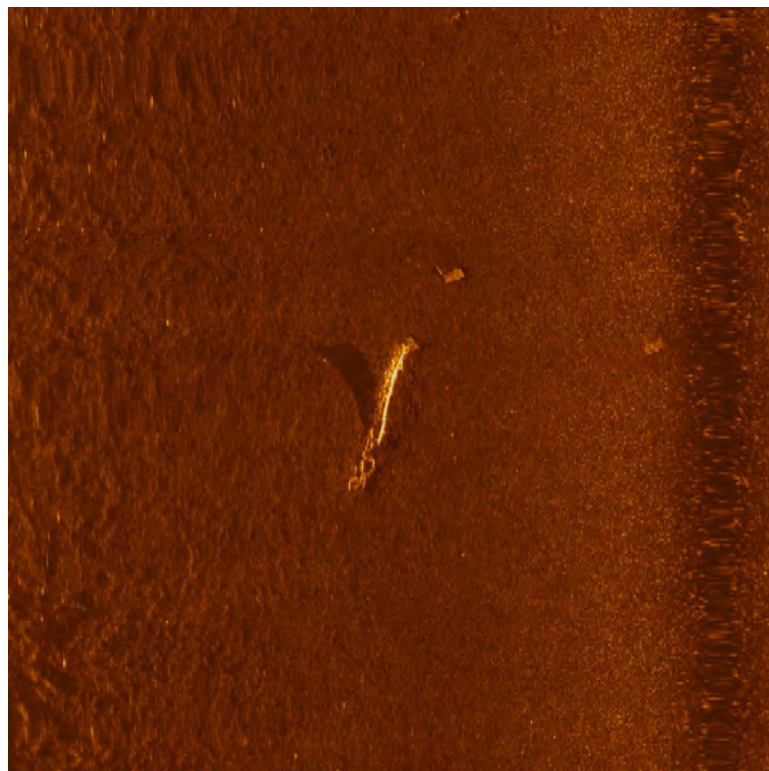
Figure 19. Side-Scan Sonar Target MP 13 / Magnetometer Target MP 11M: Debris and cable

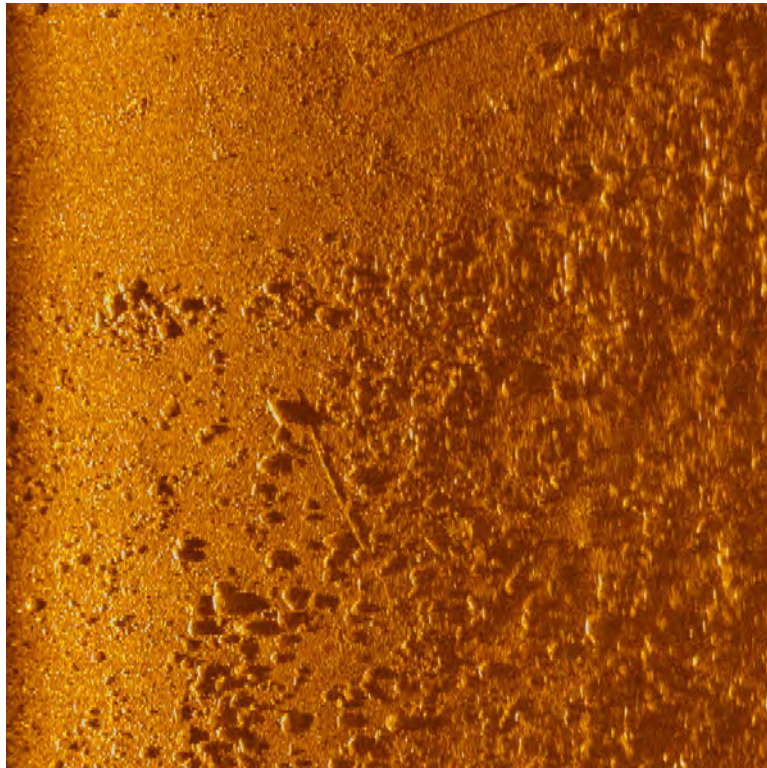
Figure 22. Side-Scan Sonar Target MP 16 / Magnetometer Target MP 02M & 03M: Apparent pipe

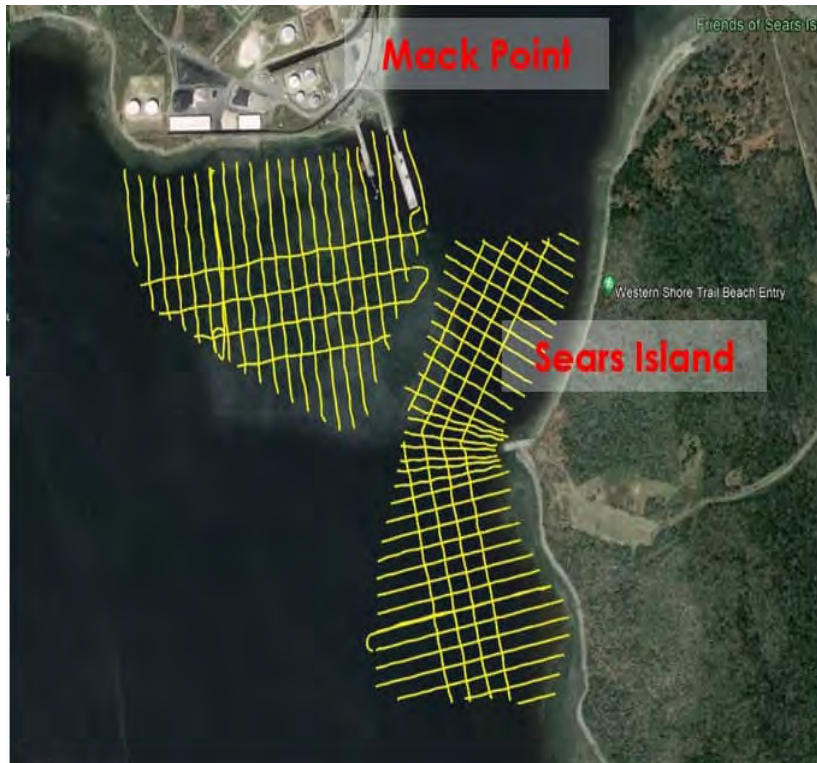
Figure 26. Sub-Bottom Profile Survey Transects

The Mack Point survey consisted of 23 transects oriented perpendicular to the shoreline in a N-S direction and 4 transects oriented parallel to shoreline (in a roughly E-W direction). Line spacing for the primary lines was approximately 150-ft and 300-ft for the cross lines (Figure 26). Transect length varied across the survey block.

The Sears Island survey consisted of 36 transects oriented perpendicular to the shoreline in a radiating fashion, changing from NW-SE in the north and WSW-ENE in the south (Figure 26). Cross tie information was provided by 5 transects oriented parallel to shoreline (bending from NE in the north to SE in the south). Line spacing for the primary lines was approximately 150-ft, although this narrowed around the rock jetty extending from the western shore of the island. The cross line spacing was approximately 200-ft. Transect length varied across the survey block.

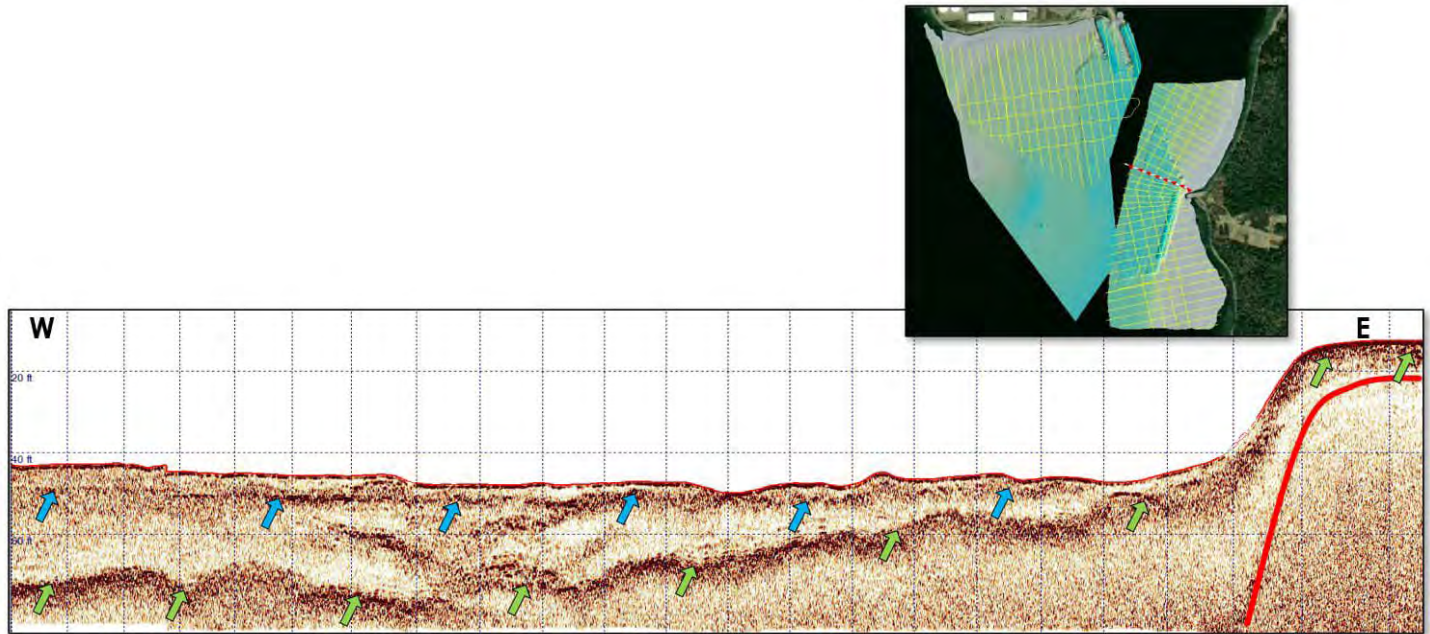
Figure 36. Reflectors showing the base of the unconsolidated sediment unit (blue arrows) and “basement” reflector (green arrows) observed across the Mack Point survey area. Seabed multiple shown by red line.

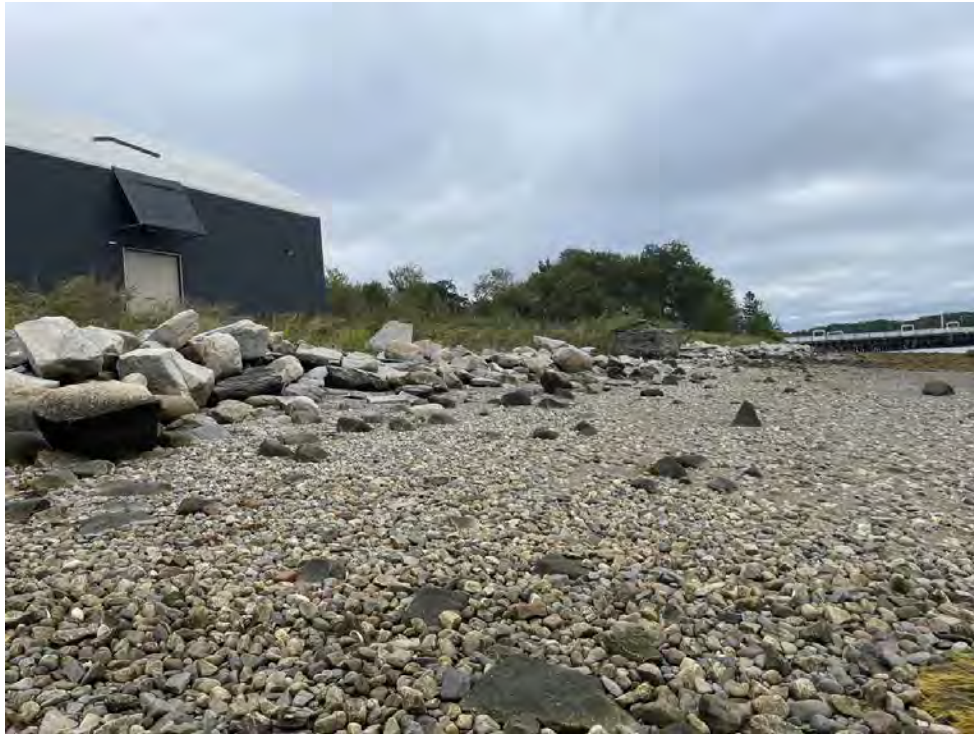
Photo 1. High intertidal characterized by rip rap consisting of boulder sized granite and coarse sand and gravel with scattered cobble and boulders. Mack Point. September 2023.

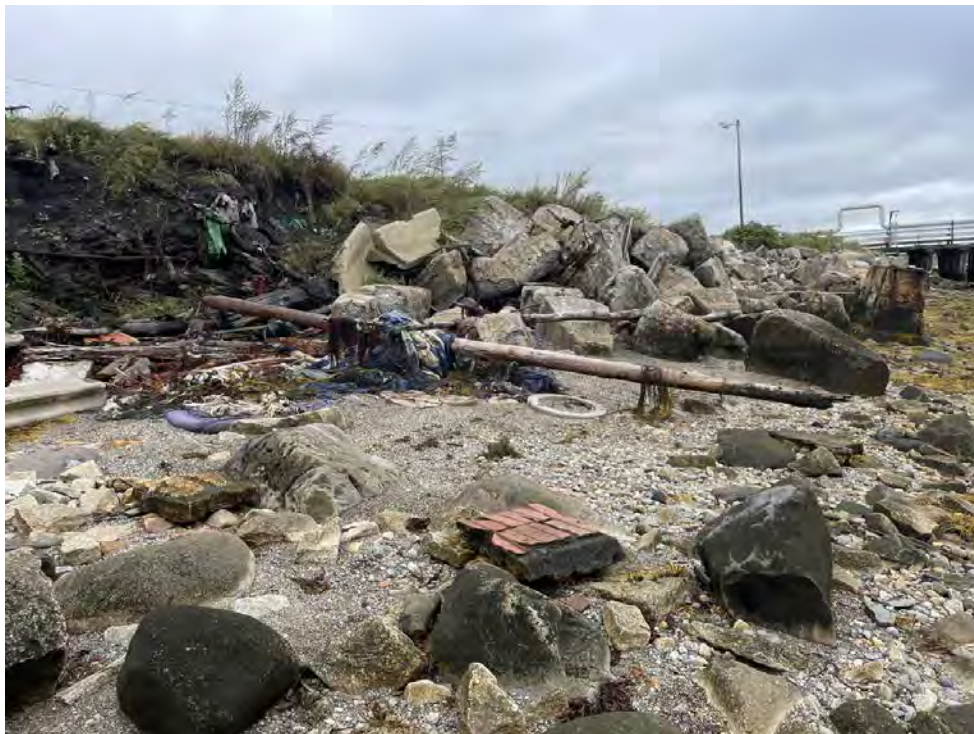
Photo 2. Fill material including metal debris in the high intertidal. Mack Point. September 2023.

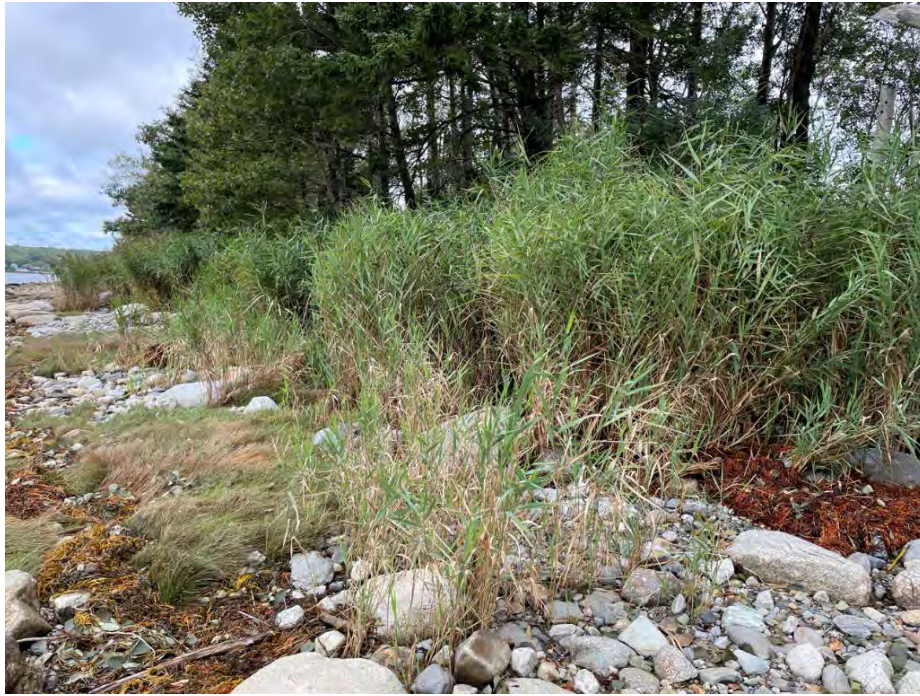
Photo 3. Invasive common reed and high salt marsh vegetation in the western portion of the high intertidal. Mack Point. September 2023.

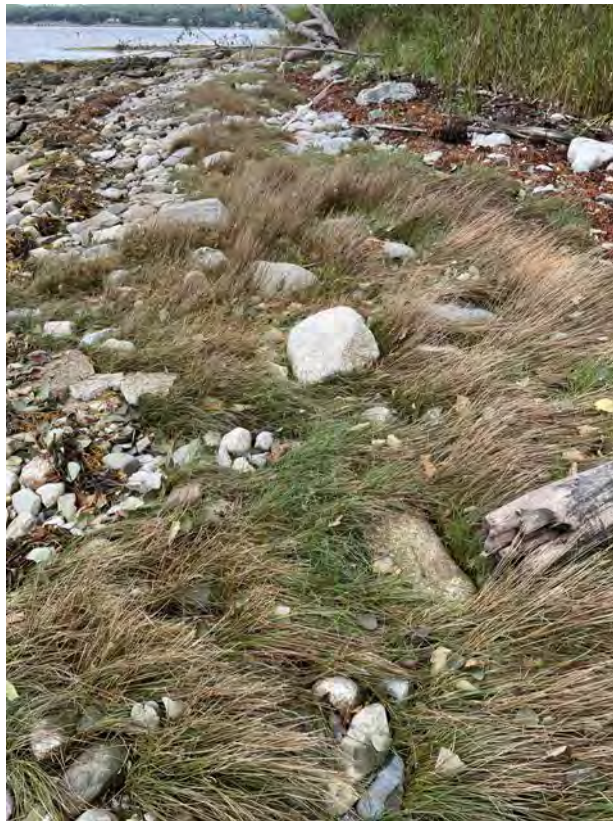
Photo 4. High salt marsh in the western portion of the high intertidal includes patches of saltmeadow cordgrass, Baltic rush, and seaside plantain. Mack Point. September 2023.

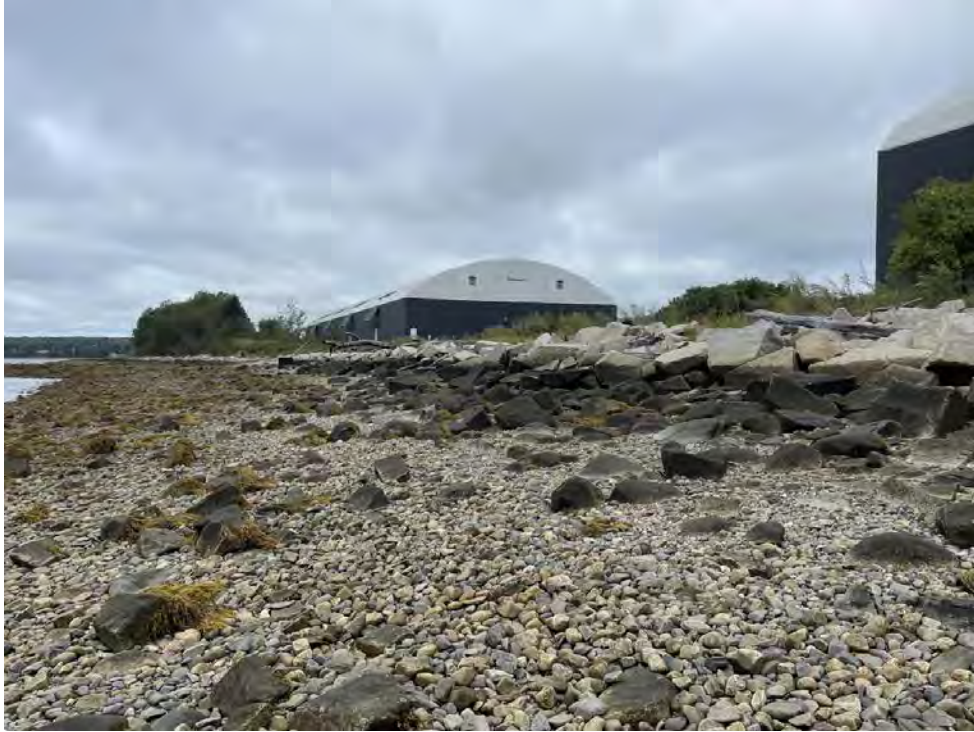
Photo 5. Coarse sand, gravel, and cobble substrate with boulders in the mid and high intertidal. Mack Point. September 2023.

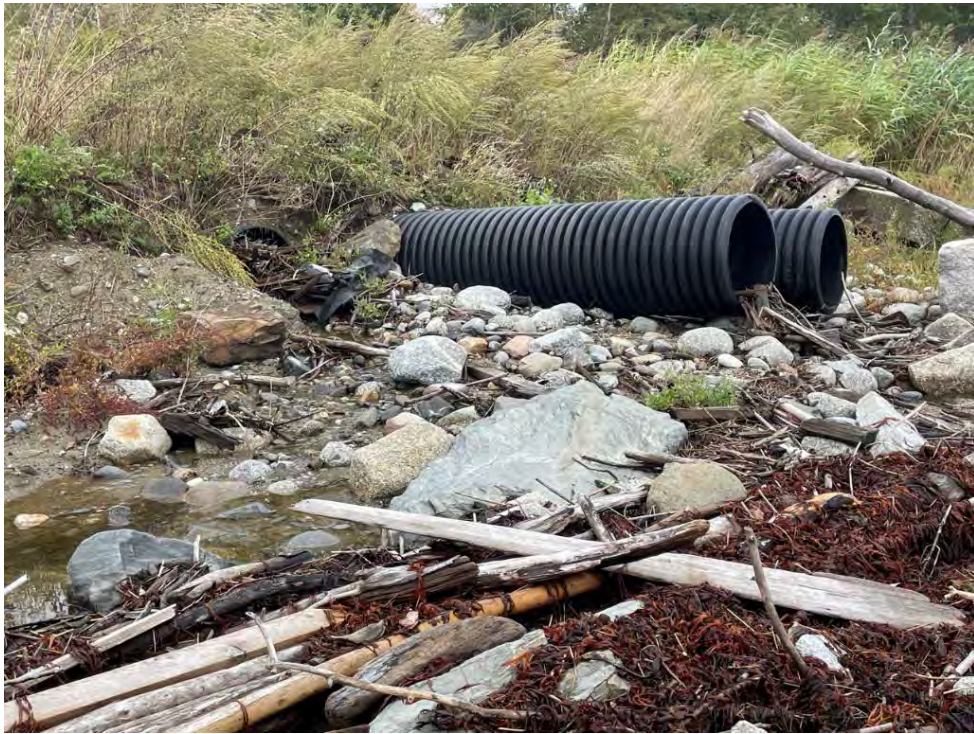
Photo 6. Outfall in the high intertidal. Mack Point. September 2023.

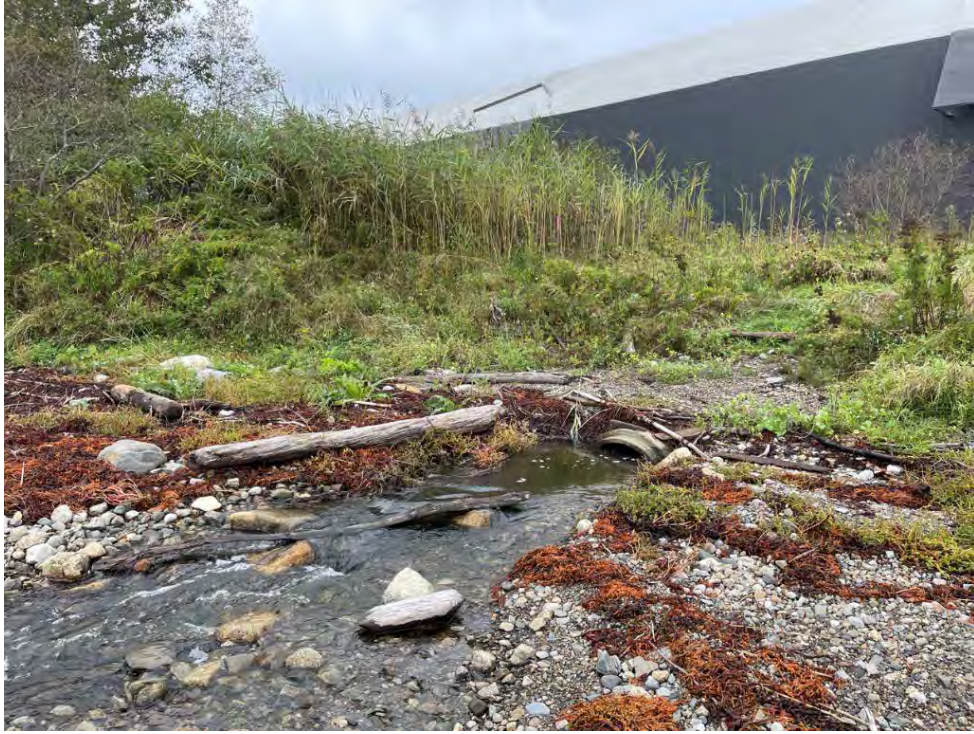
Photo 7. Outfall in the high intertidal. Mack Point. September 2023.

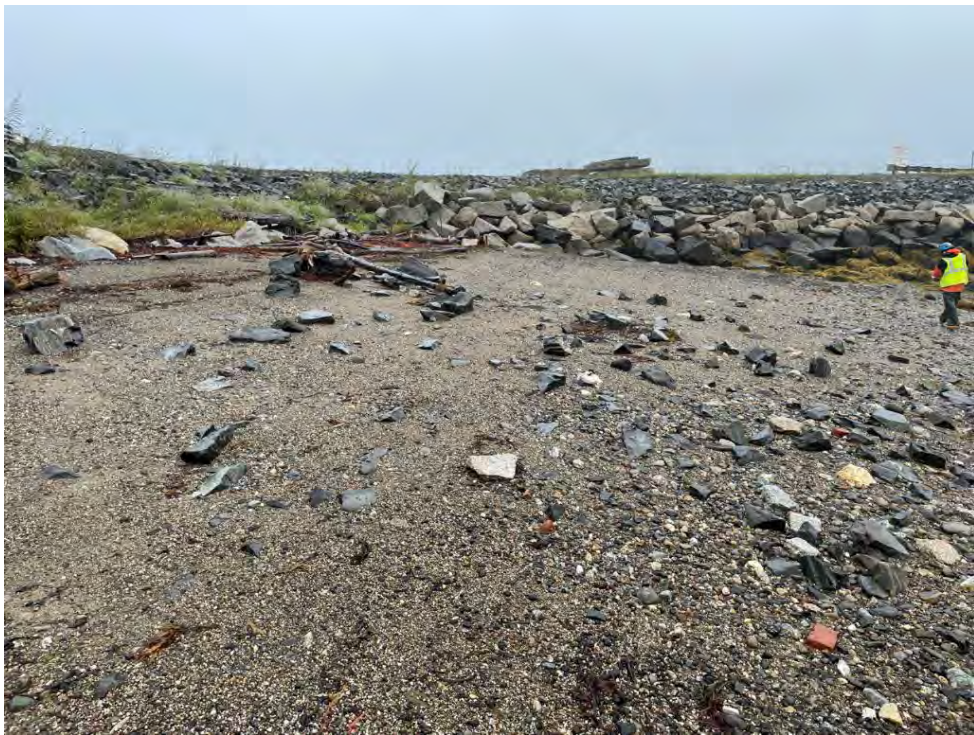
Photo 8. High intertidal between the piers at the Sprague Terminal characterized by rip rap, coarse sand, and gravel with scattered cobble. Mack Point. September 2023.

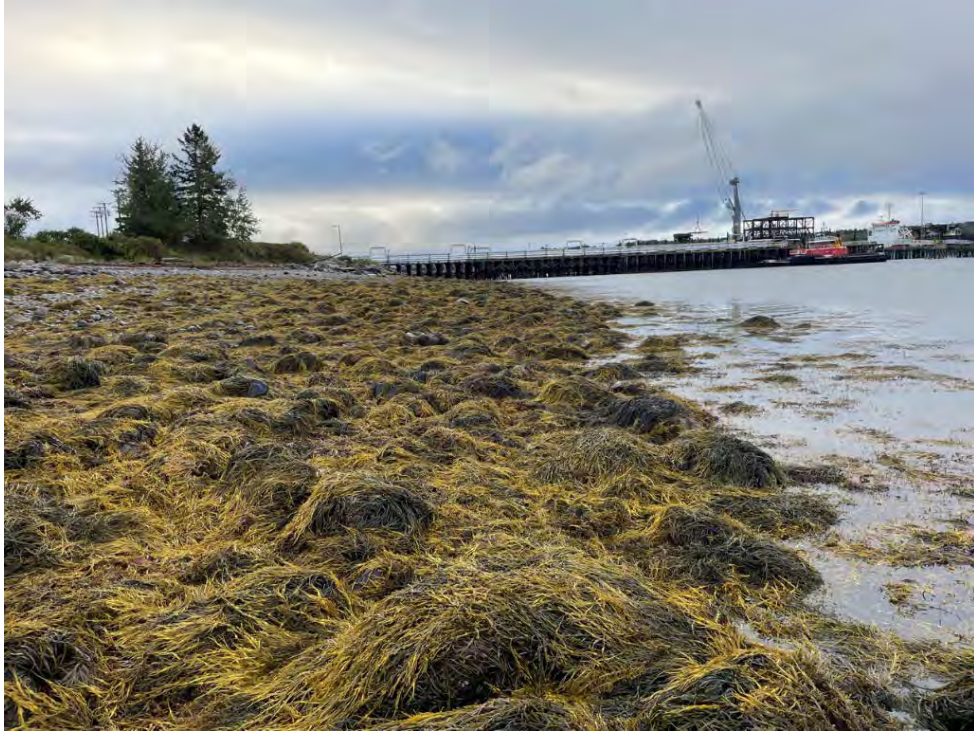
The mid intertidal at Mack Point is primarily mixed coarse and fines (boulder and cobble substrate with scattered gravel, sand, and silt). Macroalgae is abundant in this substrate type and consists of knotted wrack (*Ascophyllum nodosum*) and rockweed (*Fucus vesiculosus*) (Appendix C: Photo 9). The remnants of a former pier consisting of boulder and cobble is present in the central portion of the Survey Area (Appendix C: Photo 10). This feature has created a depositional area to the west dominated by mixed coarse and fines (coarse sand and gravel grading to more cobble and boulder to the west) (Appendix C: Photo 11). Macroalgae is scattered to common in this substrate type without the larger cobble and boulders to attach to. The mid intertidal survey area between the two piers is primarily mixed coarse and fines (coarse sand and gravel) (Appendix C: Photo 12). Excavation of survey quadrats revealed marine clay approximately 4 inches below the sediment surface in some areas. The boulders and cobble in this tidal zone are mostly embedded in the gravel, sand, and silt below. Soft-shell clams (*Mya arenaria*) were documented as occasional within the mid intertidal during excavation of quadrats (Appendix C: Photo 13; Figure 3). At the western edge of the potential project footprint, a tide pool with approximately 3 to 5 inches of water was observed. The tide pool contained several mummichogs (*Fundulus heteroclitus*) and one clam worm (*Alitta succinea*) (Figure 2).

Photo 9. Mid intertidal with abundant macroalgae, knotted wrack and rockweed, on the boulder and cobble substrate. Mack Point. September 2023.

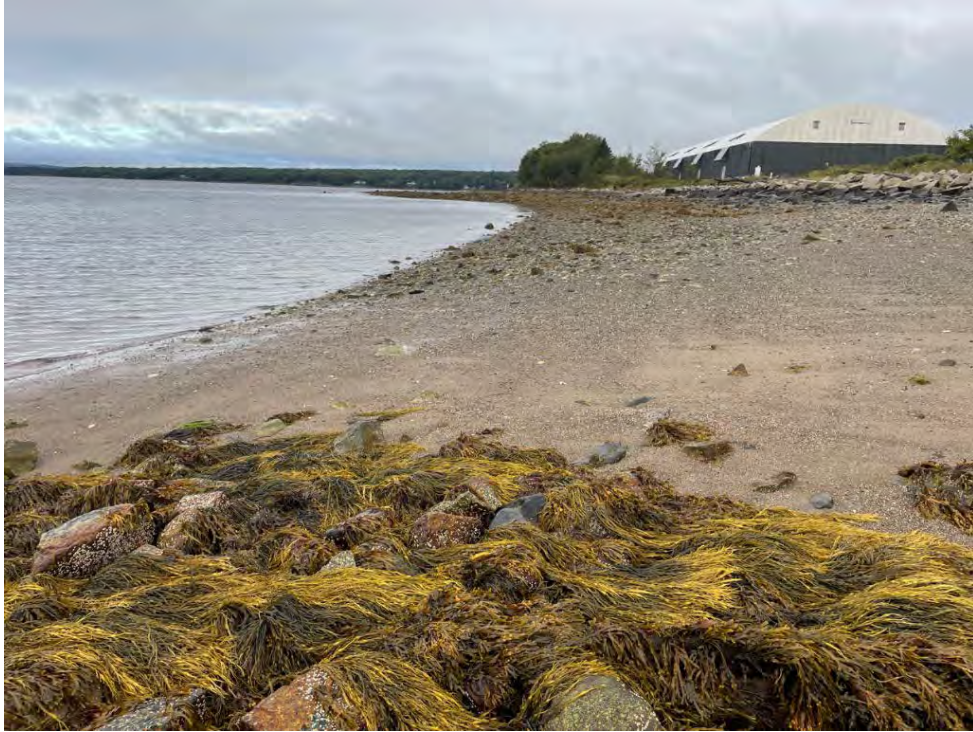
Photo 11. Depositional area in the mid and low intertidal to the west of remnant pier, dominated by coarse sand and gravel, grading to cobbles and boulders to the west. Mack Point. September 2023.

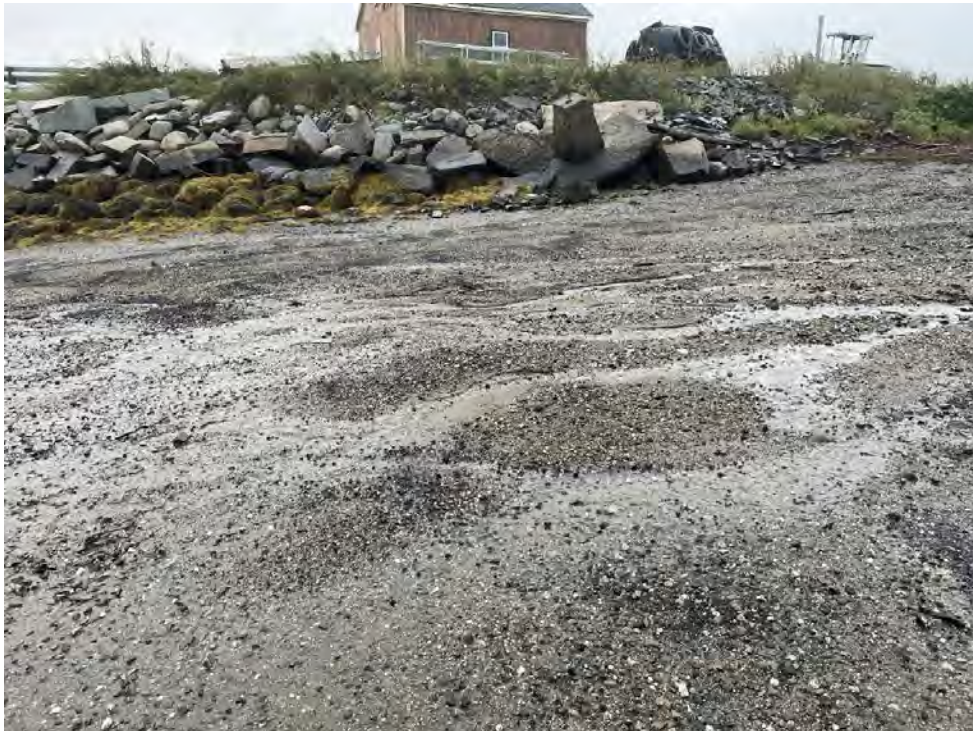
Photo 12. Mid intertidal between the piers at the Sprague Terminal with a substrate of primarily coarse sand and gravel. Mack Point. September 2023.

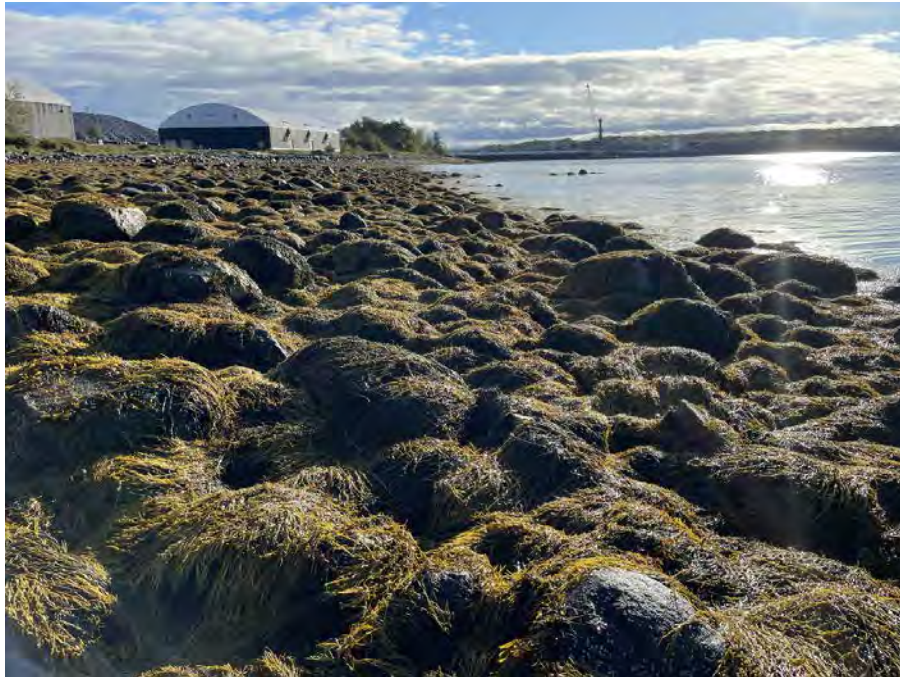
The low intertidal at Mack Point is dominated by mixed coarse and fines (boulder, and cobble substrate) with abundant macroalgae (knotted wrack and rockweed) (Appendix C: Photo 14). The exception to this larger grained substrate is the depositional area west of the former pier, which is dominated by gravel and coarse sand (Appendix C: Photo 10). Macroalgae is scattered in these finer grained substrates. The low intertidal survey area between the two piers is primarily mixed coarse and fines (coarse sand and gravel)

Photo 14. Low and mid intertidal at dominated by boulder and cobble substrate with abundant macroalgae (knotted wrack and rockweed). Mack Point. September 2023.

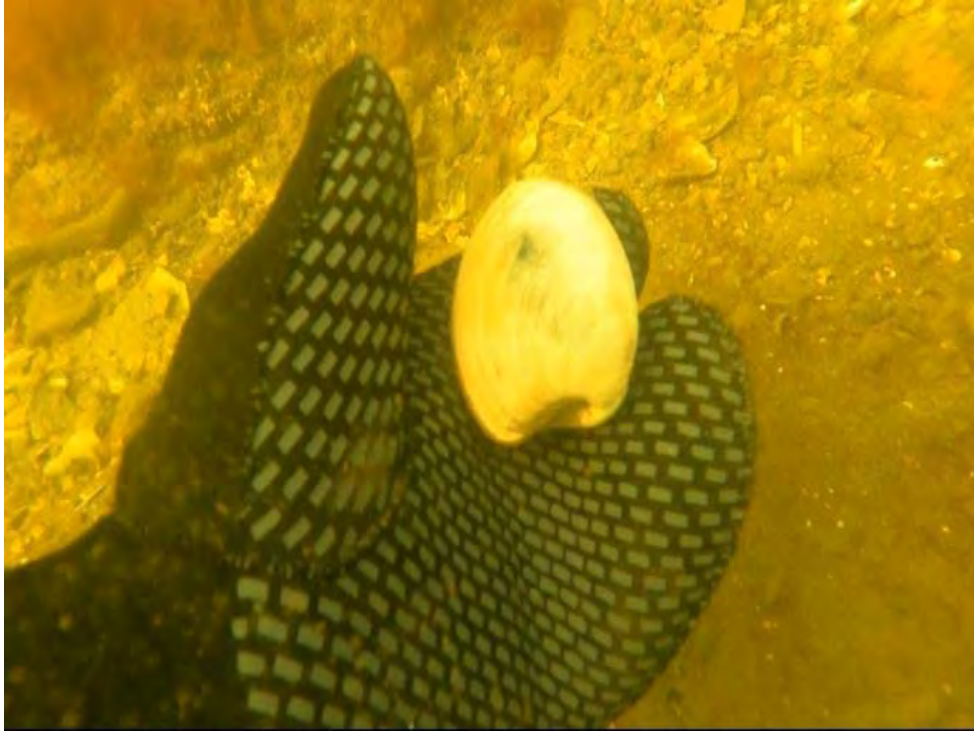
The shallow subtidal substrates were surveyed using SCUBA during the eelgrass and lobster and urchin surveys (Stantec 2024a,b). The mixed coarse substrate consisting of boulder and cobble observed in the low intertidal extends into the subtidal to approximately -10 feet mean lower low water (MLLW) before grading to unconsolidated sediments consisting of sandy silt in deeper water. Green sea urchins are abundant in the subtidal zone on hard substrate and have grazed most macroalgae off the cobble and boulders (Appendix C: Photos 17 and 18; Stantec 2024b). Crustose coralline alga (*Corallinales*) is common on these hard surfaces (Appendix C: Photo 19). Green crabs (*Carcinus maenas*) were abundant in this boulder and cobble substrate type and American lobsters were occasional, during the September 2023 eelgrass survey (Appendix C: Photos 20 and 21). One lobster was observed in boulder and cobble habitat in the subtidal during the November 5, 2023, survey. Divers observed lobster burrows that were not visibly occupied during the survey (Stantec 2024b). The subtidal area surrounding the remnant pier was unconsolidated sediments, sandy silt substrate. The shallow subtidal here had abundant sand dollars (*Echinarachnius parma*) and occasional surf clams (*Spisula solidissima*) and ocean quahog (*Arctica islandica*) (Appendix C: Photos 22—24).

Photo 24. Ocean quahog in the shallow subtidal. Mack Point. September 2023.

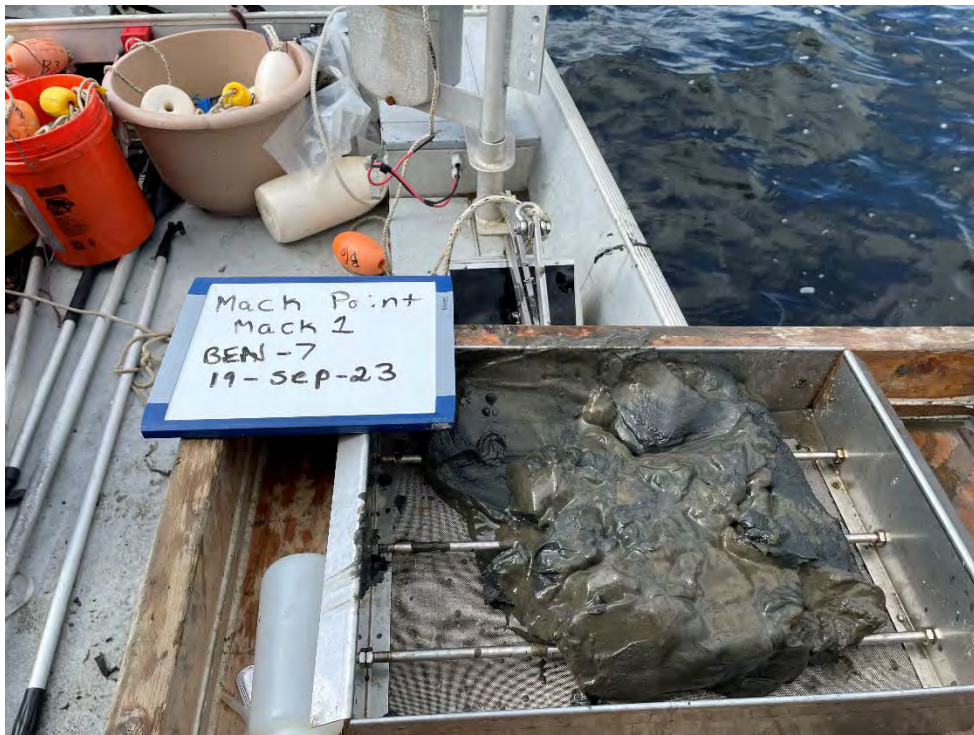
On September 19, 2023, Stantec collected five grab samples from subtidal areas with unconsolidated sediments (Figure 2). The sediments in the five grab samples consisted of silt and fine sand (Appendix C: Photos 25—29). Macroinvertebrate samples from the sediment grabs were sent for sorting, enumeration, and speciation to Haley and Ward. Identified species, total number of individuals, individuals per meter squared, species richness (number of species), species evenness (a description of the relative abundance across species in a sample), Shannon-Weiner Index, and functional groups present for each sample per the methods in Ward (1999a) are presented in Appendix E.

Photo 25. Mack Point Benthic Sample 1. September 2023.

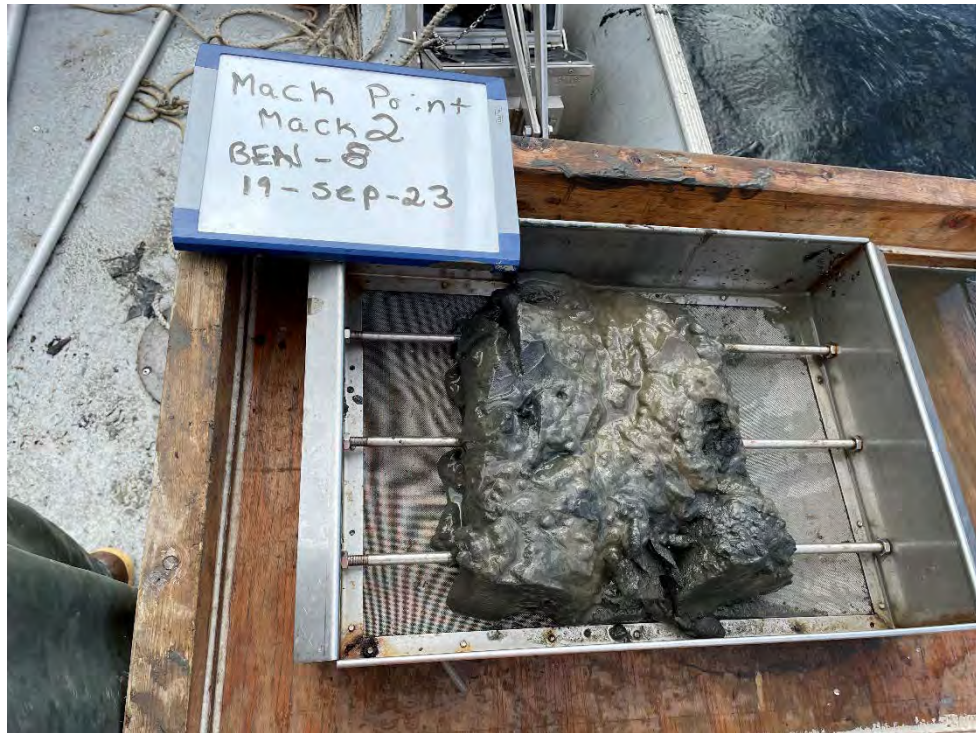
Photo 26. Mack Point Benthic Sample 2. September 2023.

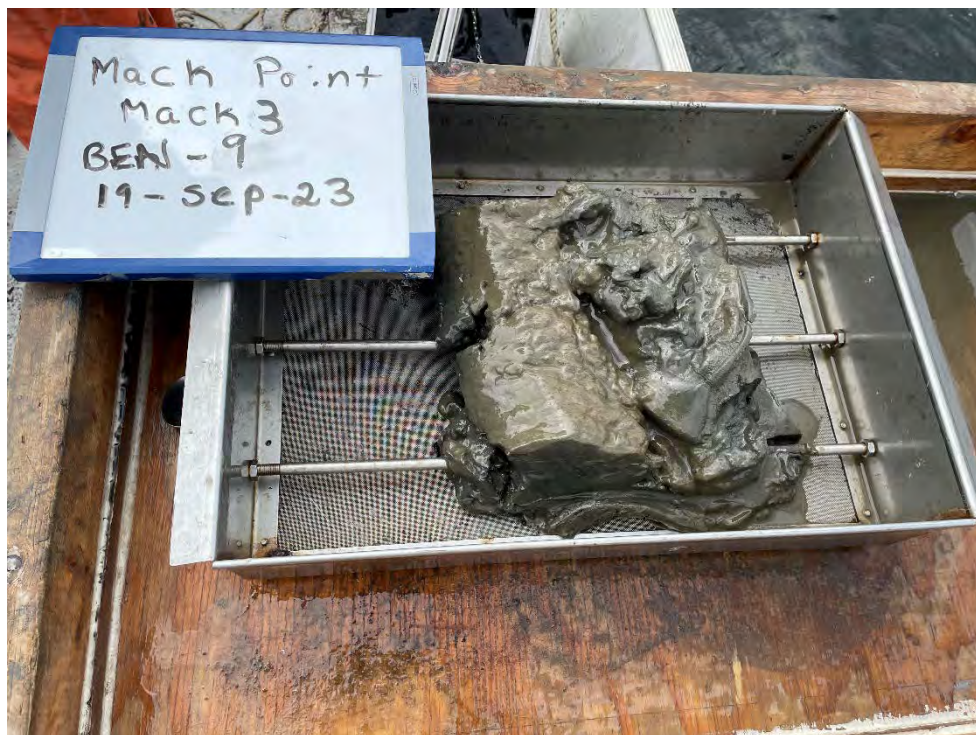
Photo 27. Mack Point Benthic Sample 3. September 2023.

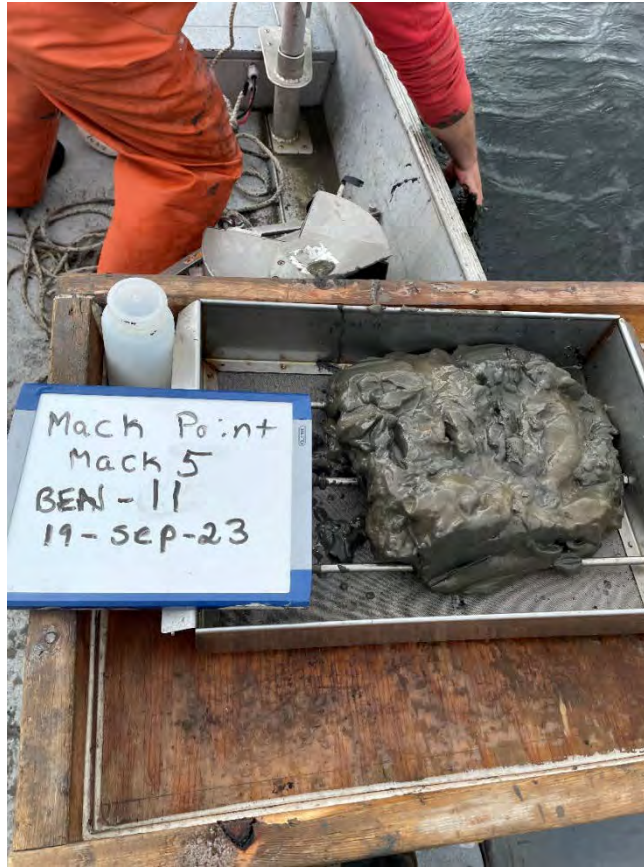
Photo 29. Mack Point Benthic Sample 5. September 2023.

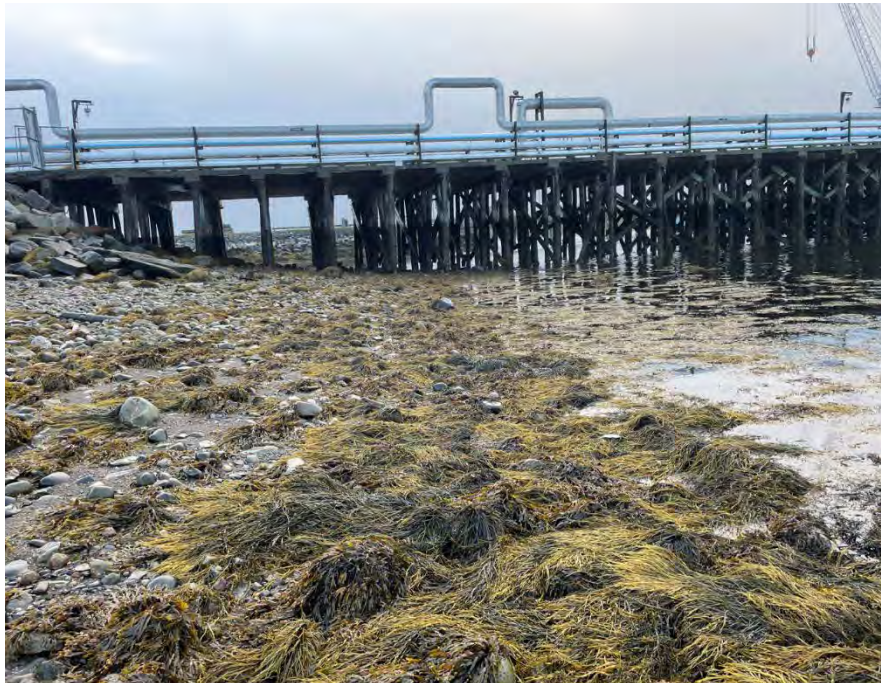
The Project will impact approximately 30 acres of intertidal and subtidal habitat for a sheet pile in-fill pier and approximately 5 acres of subtidal habitat for construction of heavy lift wharf, and approximately 24 acres of subtidal habitat will be dredged (Figure 1). The onshore portion of the site consists of approximately of a 140-acre marine terminal owned by Sprague Energy, with approximately 2,060 linear feet of undeveloped water frontage. The terminal contains two piers, a 560-foot by 100-foot dry cargo pier and a 2,500-foot-long liquid cargo Pier (Appendix C: Photo 30). Water depths within the Project Area range from the intertidal to approximately -51 feet MLLW.

Photo 30. Liquid cargo pier, Sprague Terminal. Mack Point. September 2023.

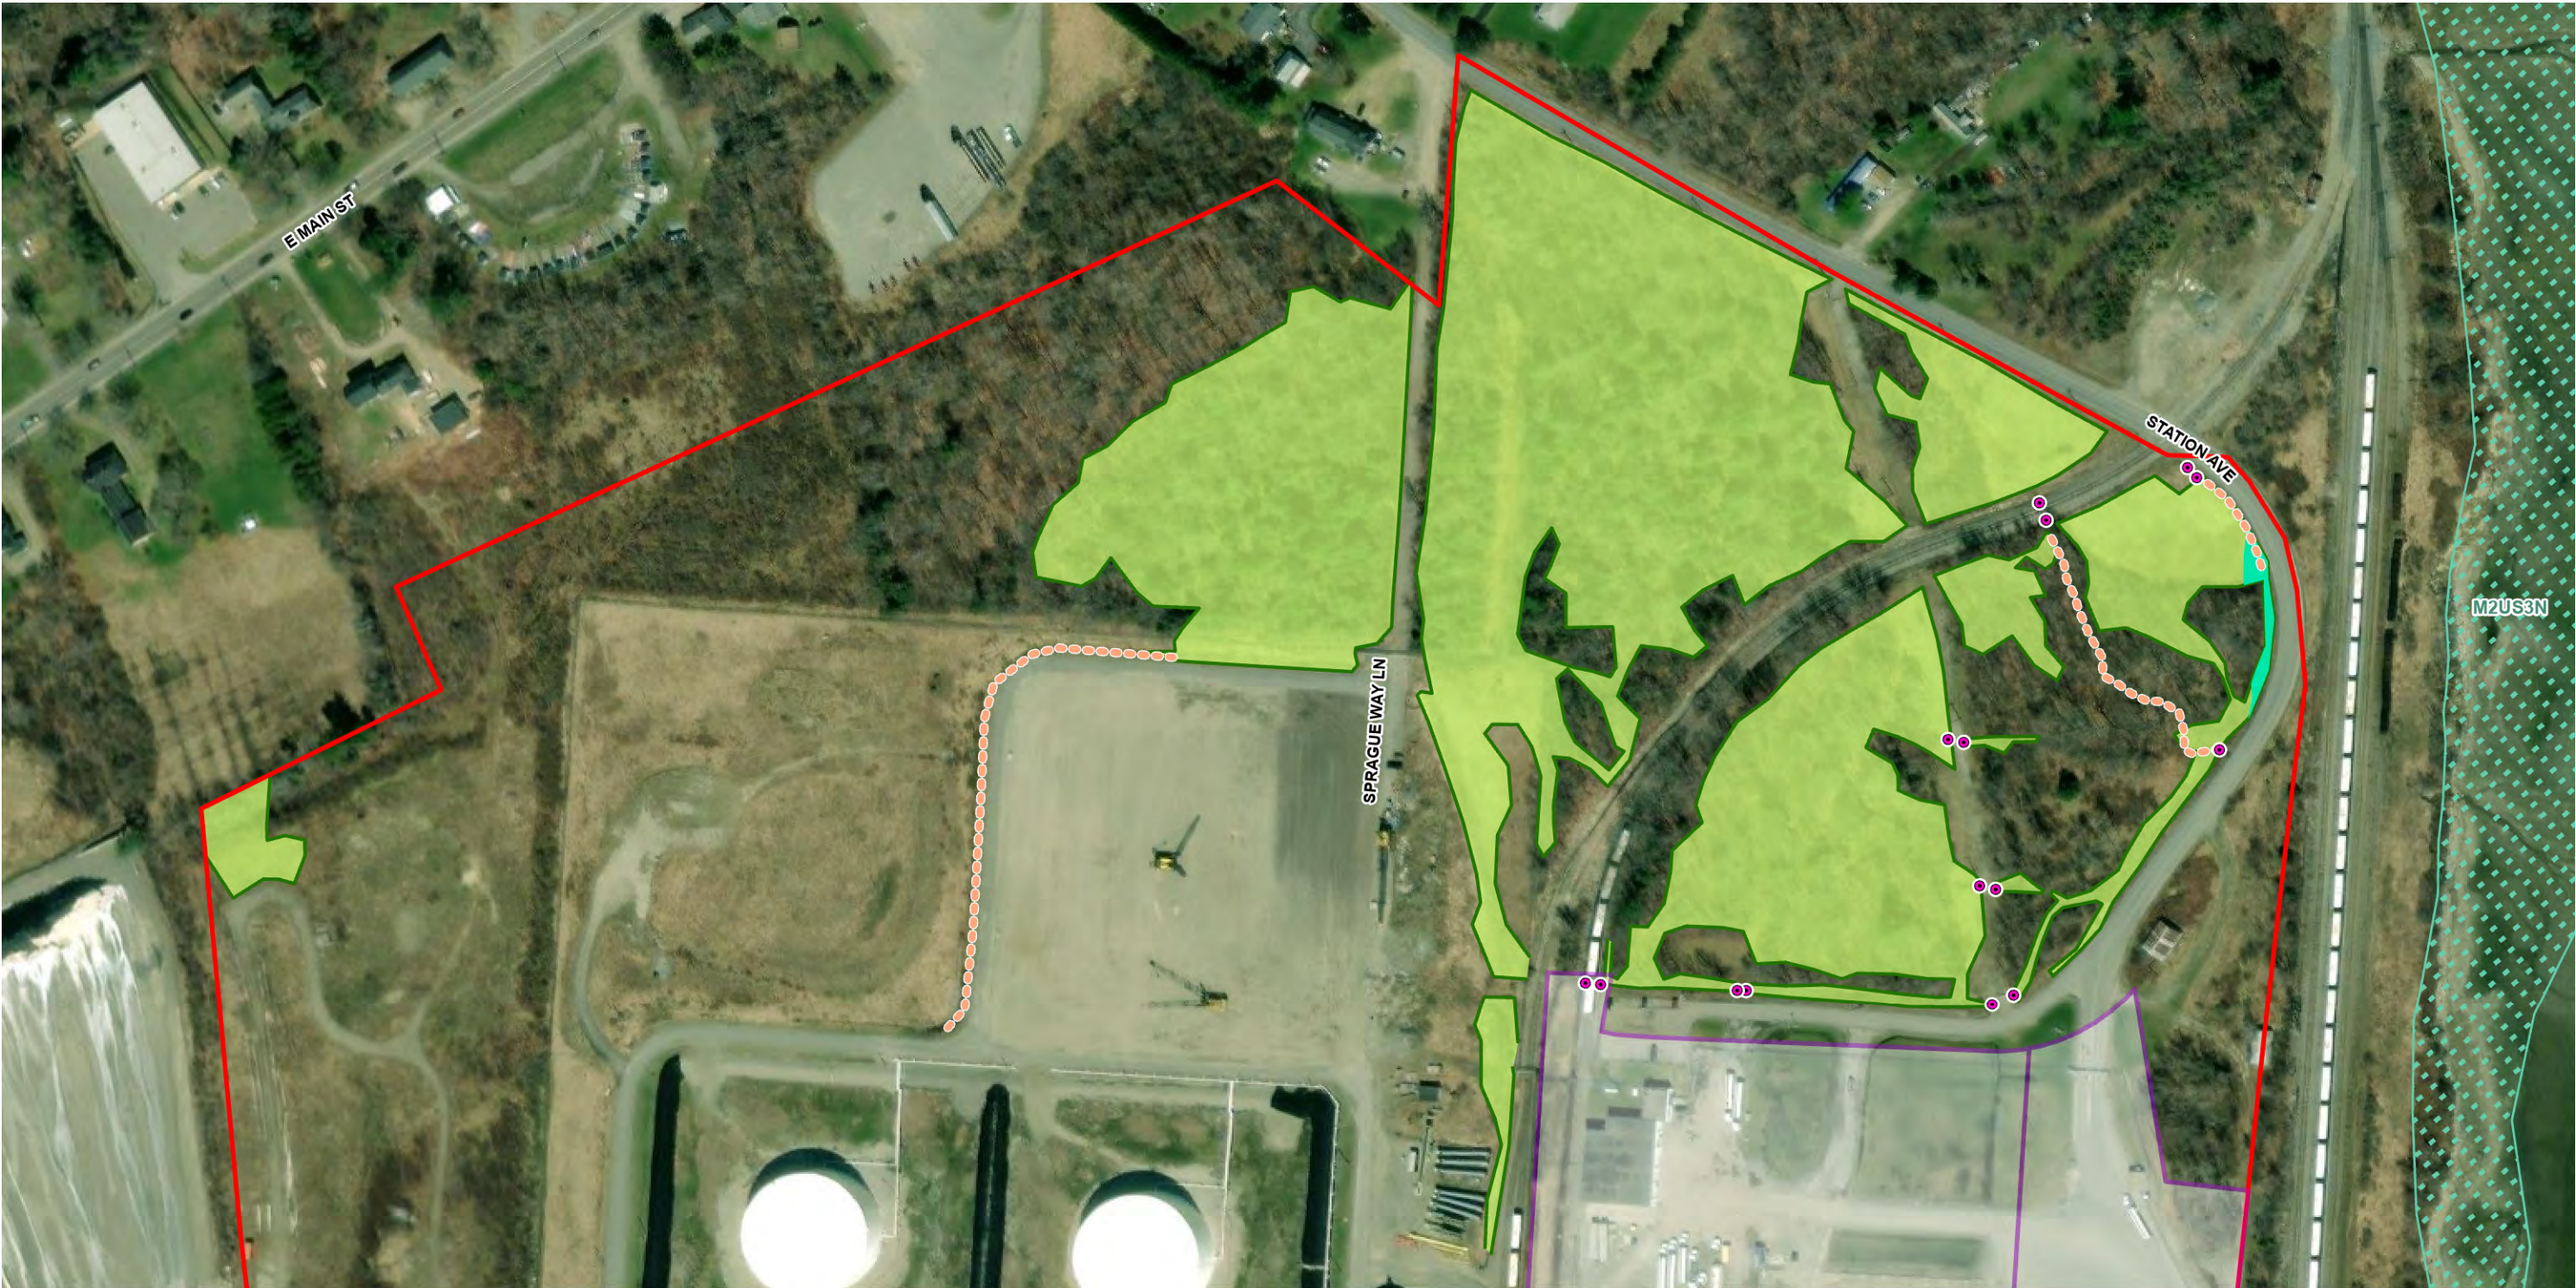
Figure 2: Natural Resources Map

Mack Point Study Area | Searsport, ME

VHB delineated one potential vernal pool (PVP) during the field effort. It is also within the undeveloped, forested area west and outside of the port terminal facility limits and is shown on the Natural Resources Maps in Appendix 2 (see Sheet 2 of 3). This PVP was observed in September and past the state-recommended period for vernal pool surveys. As such it was not possible for a determination to be made regarding if this pool should be classified as a significant vernal pool under NRPA. A determination on the PVP's status as significant or not-significant under state regulations would require a site visit during the spring and during the state-recommended period for vernal pool surveys within central Maine (April 25 – May 25).
