Attachment E

Natural Resources Assessments, Mack Point & Sears Island

Hydrographic and Marine Geophysical Site Characterization Surveys

Mack Point and Sears Island

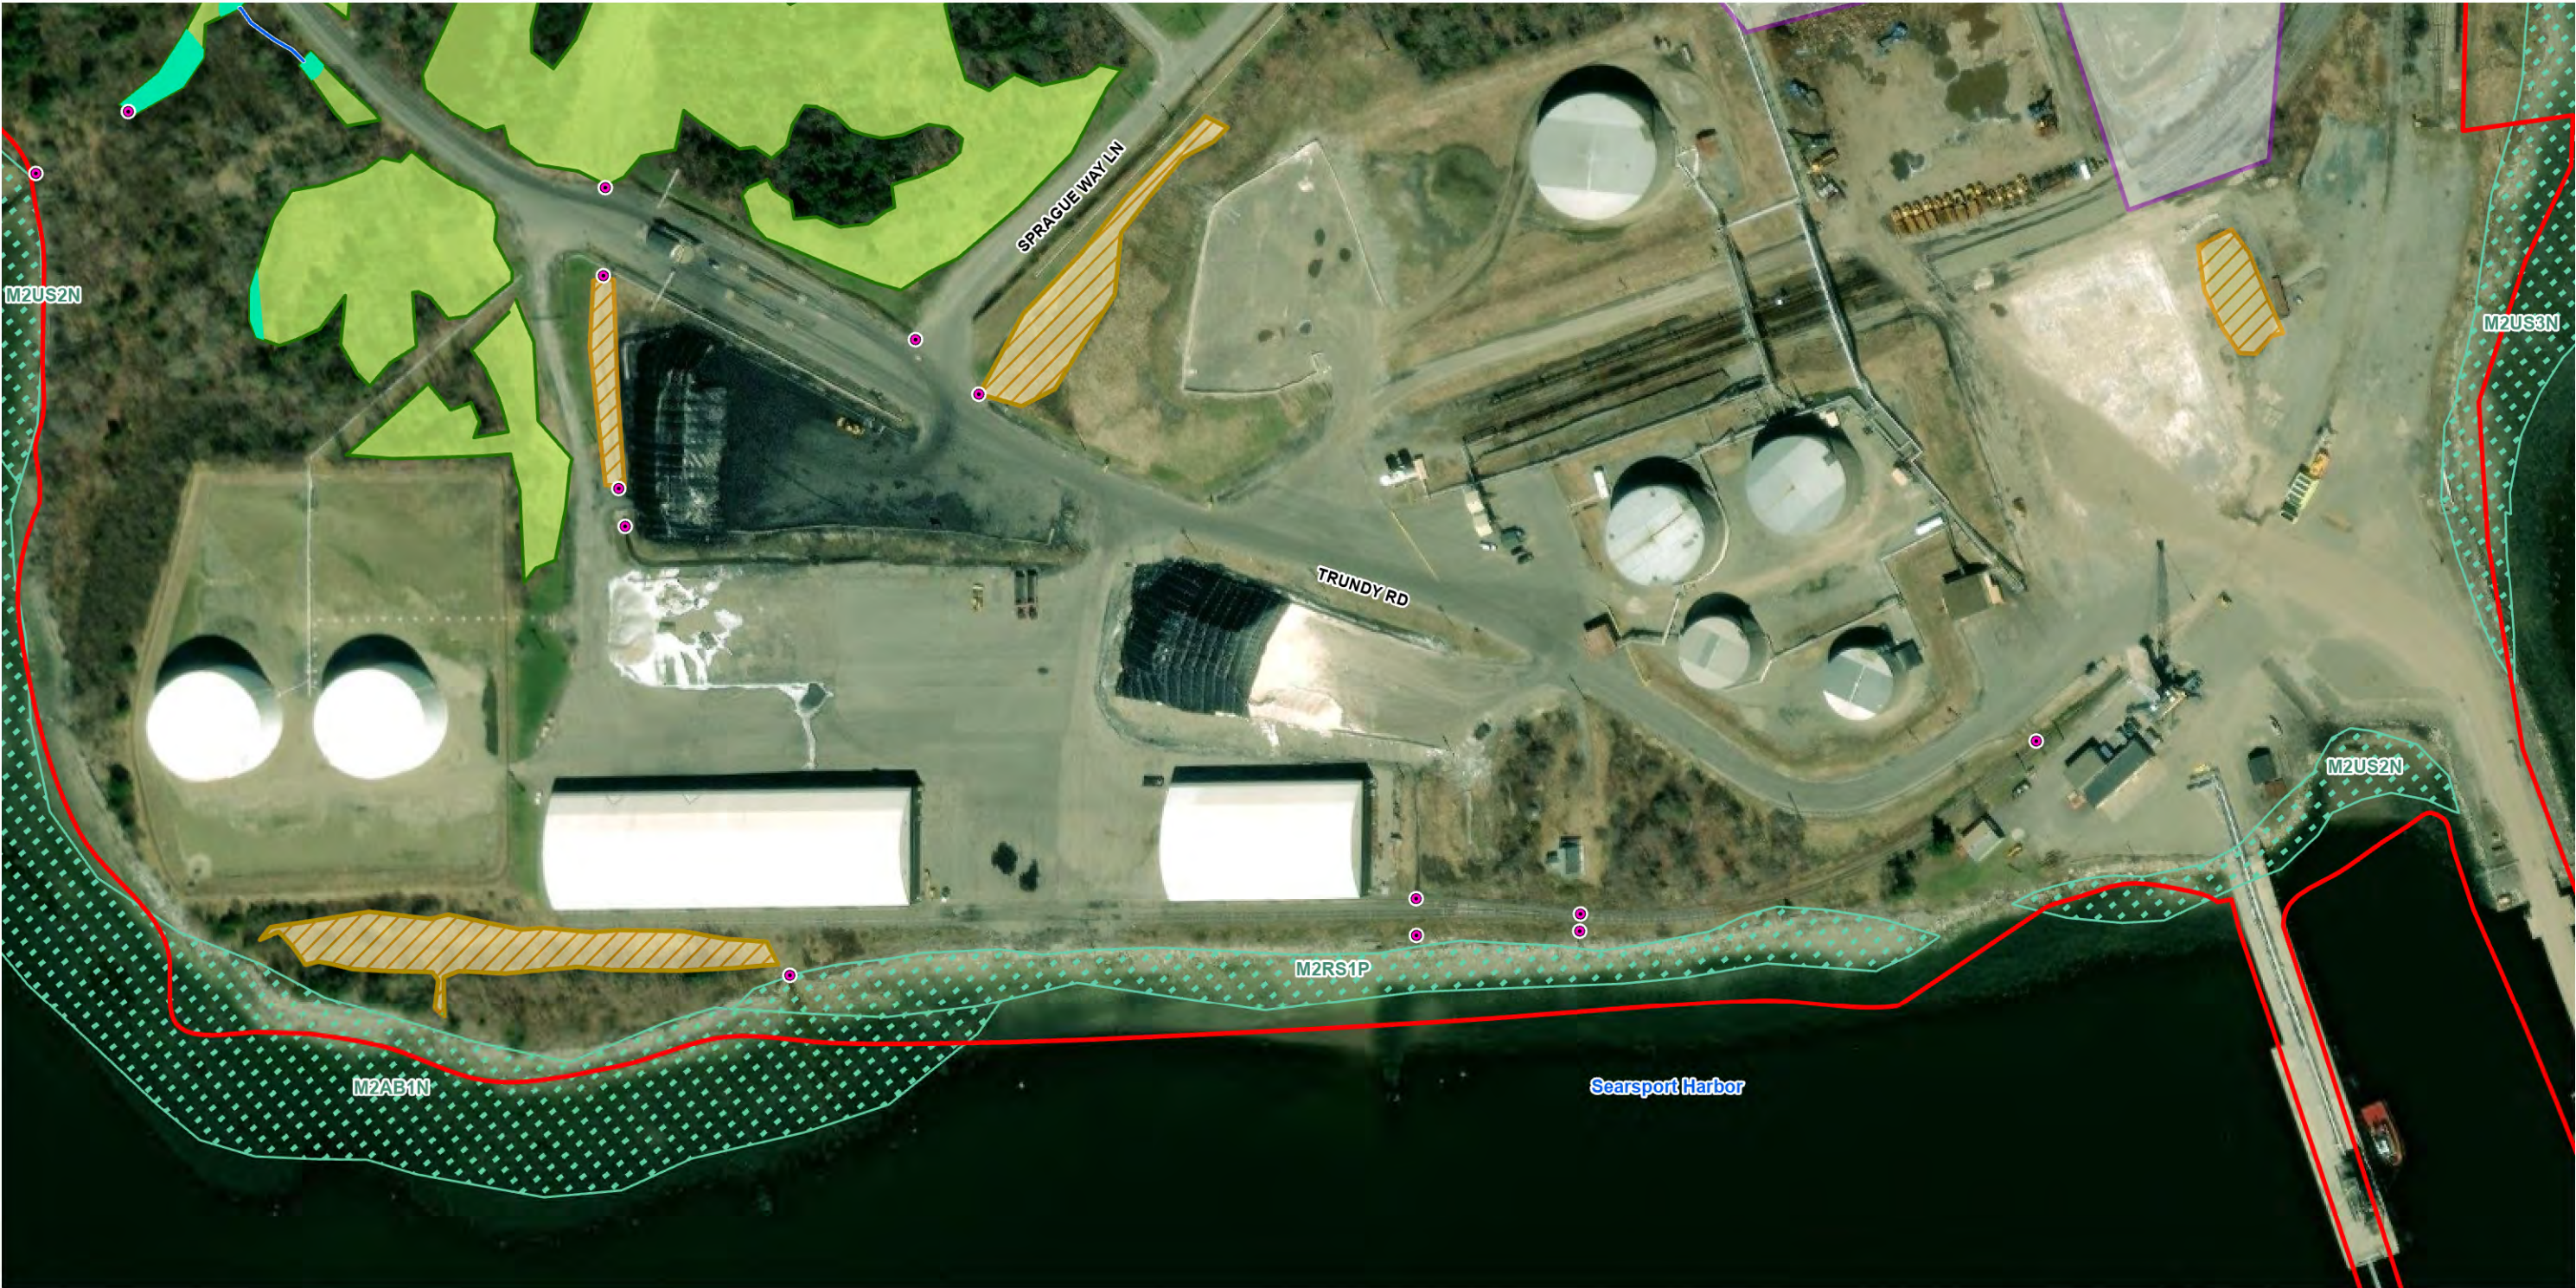
Figure 2: Natural Resources Map

Wetland Resources Delineated by VHB in August/September 2023

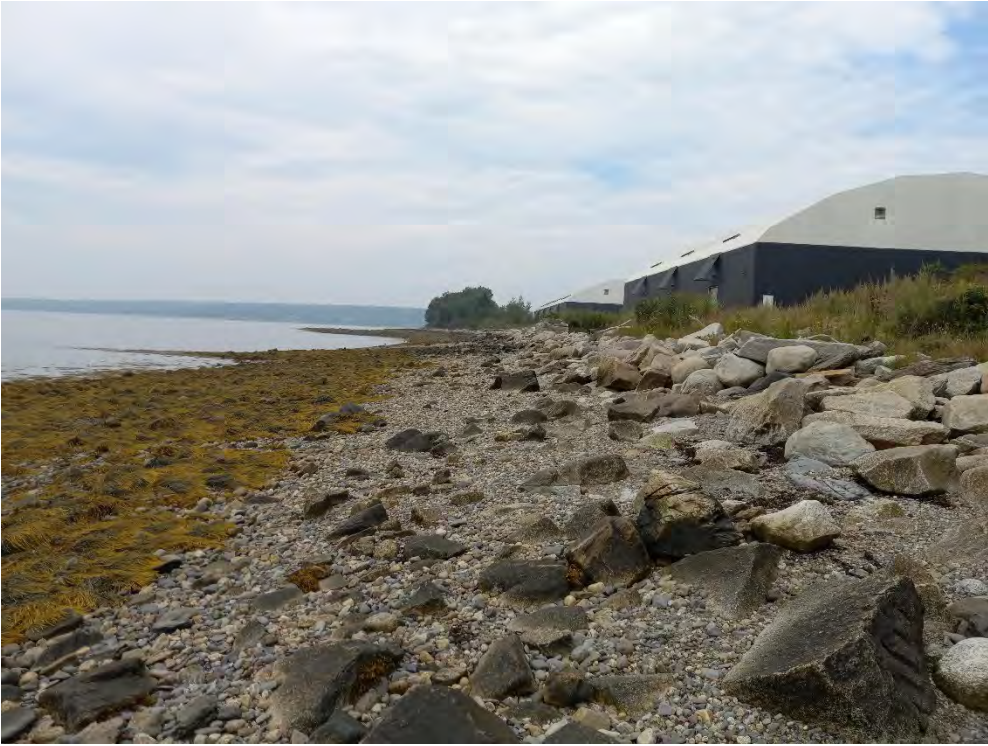
Photo No: 1	
Photo Date: 9-9-23	
Description: SW shore Representative photo of southwestern shore within Study Area. This photo includes coastal wetland area below MHHW.

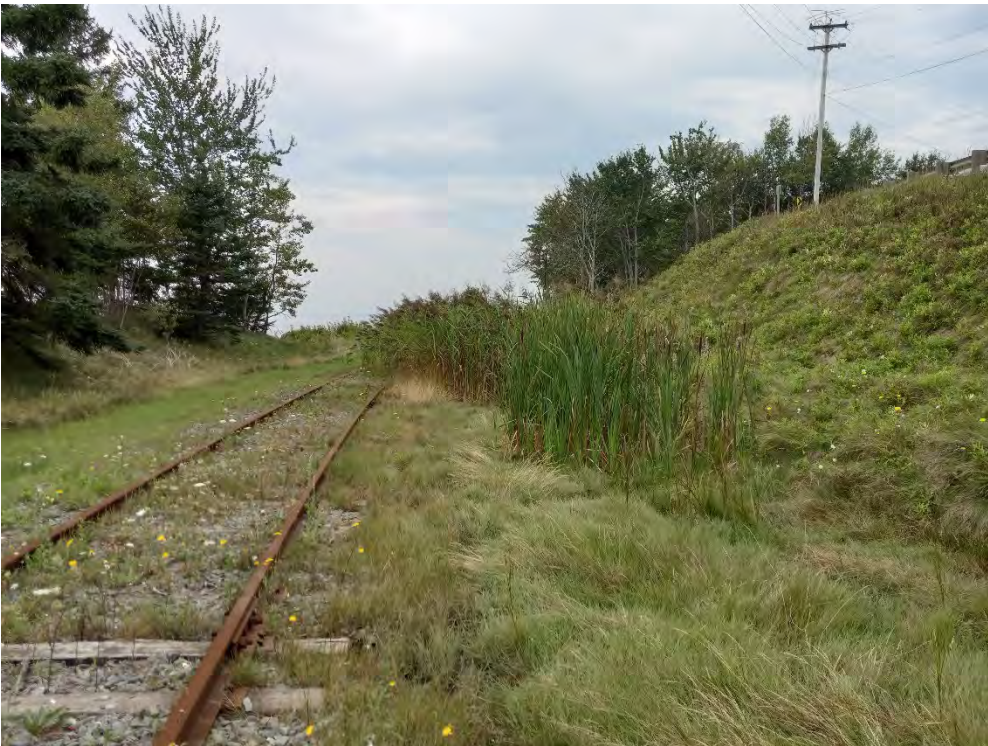
A photograph of a coastal wetland area. The foreground is filled with a dense field of yellow-green marsh grasses. To the right, a rocky shoreline with large, dark, angular rocks leads down to the water. In the background, a large, white, curved-roof building is visible on a slight rise, and the ocean extends to the horizon under a cloudy sky.
Photo No: 2	
Photo Date: 9-9-23	
Description: Rail Corridor Photo of historic rail corridor where it bisects southern portion of Study Area.

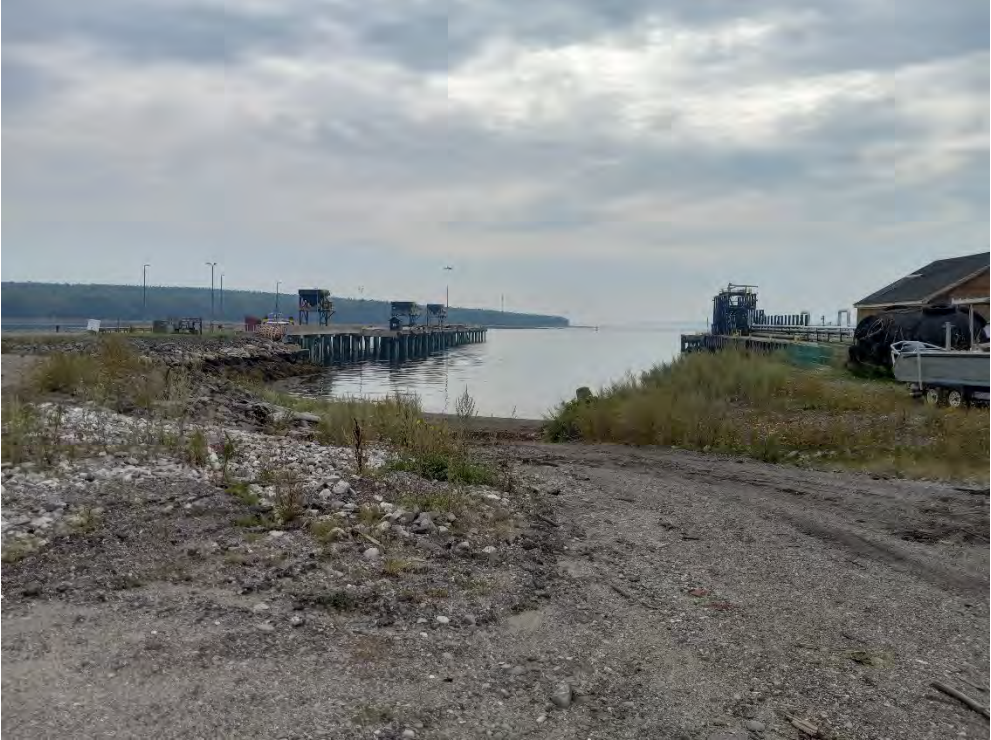
Photo No: 3	
Photo Date: 9-9-23	
Description: SE Shore/Pier Representative photo of southeastern shore of Study Area and pier area within port terminal facility.

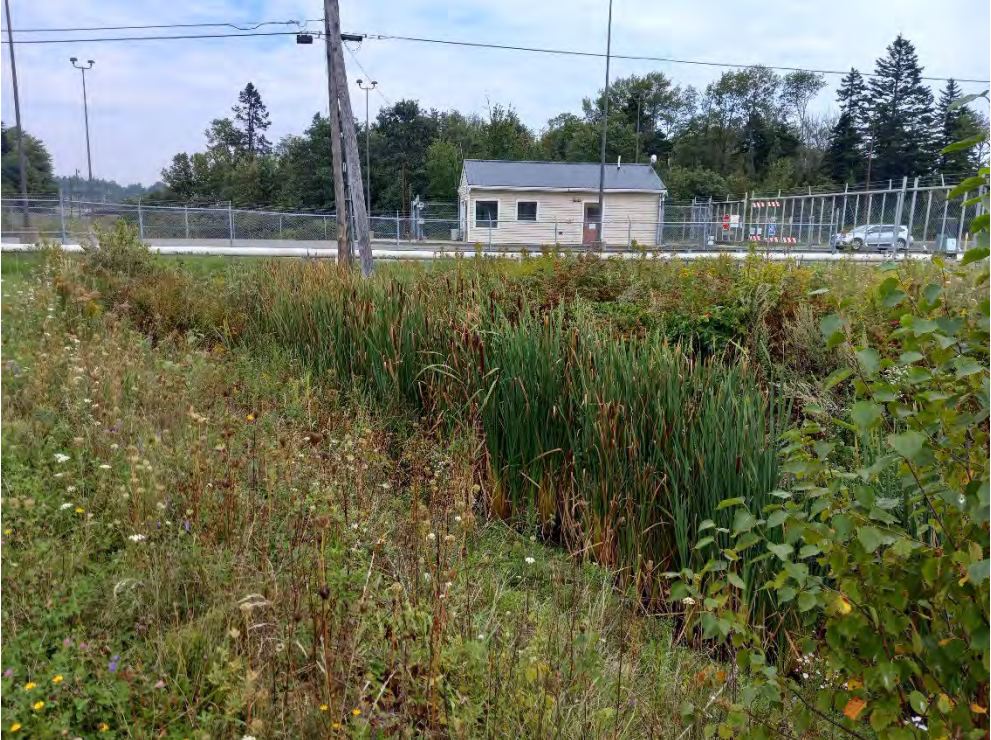
A wide-angle photograph showing a gravelly, unpaved shoreline in the foreground. In the middle ground, a long pier extends into a body of water under a cloudy sky. To the right, there are some industrial structures and a building.
Photo No: 4	
Photo Date: 9-9-23	
Description: SW Ditch View of stormwater ditch along entry area to Sprague port terminal.

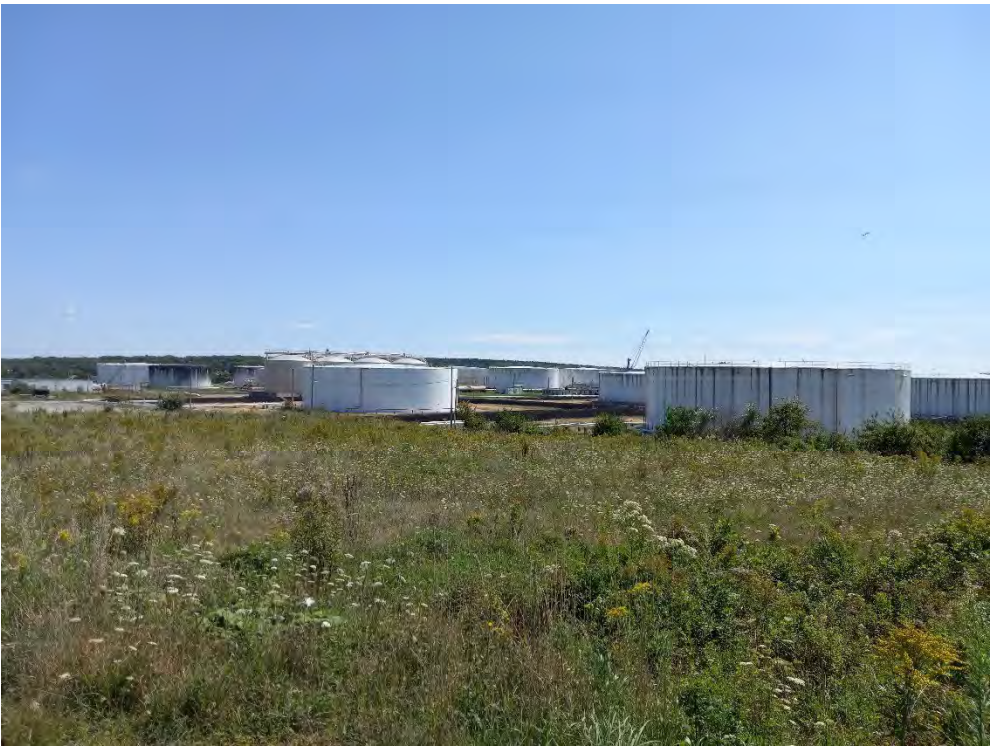
Photo No: 5

A wide-angle photograph showing a large industrial facility with several large, white, cylindrical storage tanks in the background. The foreground is filled with tall, green and yellow wildflowers and grasses. The sky is clear and blue.
Photo Date: 8-31-23	
<p>Description: NW port terminal</p> <p>Representative photo of large upland region in northwestern portion of Sprague port facility. Shows oil and natural gas tanks to the southeast.</p>	
Photo No: 6

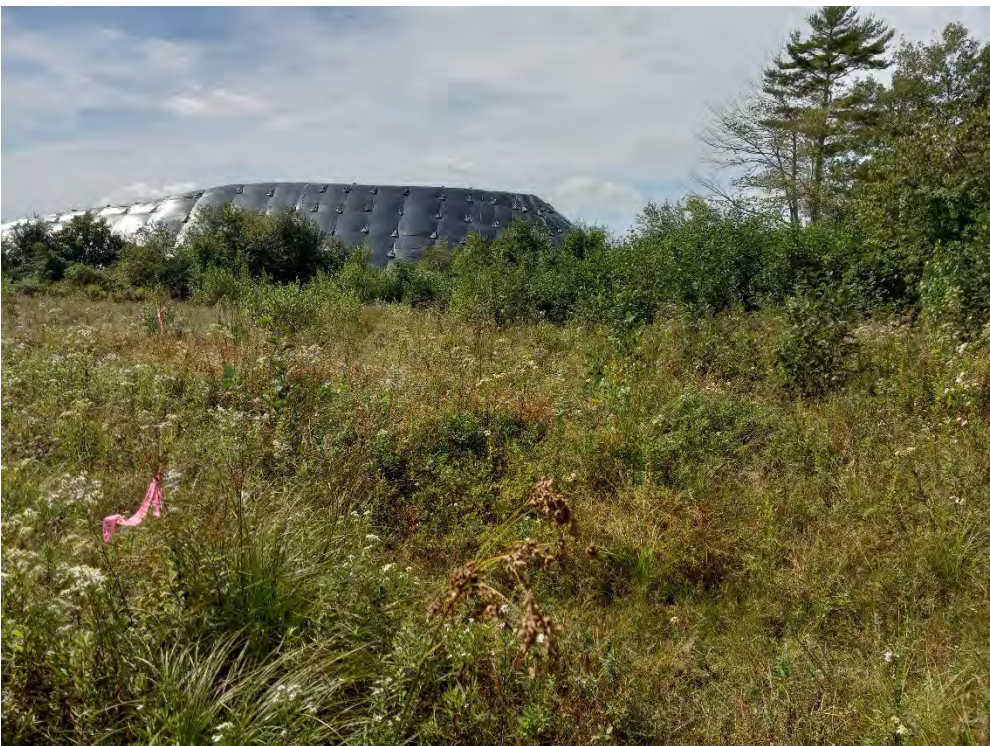
A photograph of a wetland area. In the foreground, there is dense, tall grass and weeds. In the background, a large, dark, dome-shaped structure, possibly a storage tank or a building, is visible behind a line of trees. The sky is overcast.
Photo Date: 9-15-23	
<p>Description: Small wetland</p> <p>Photo of small wetland in northwest corner of Study Area outside of terminal facility, adjacent to external salt facility.</p>

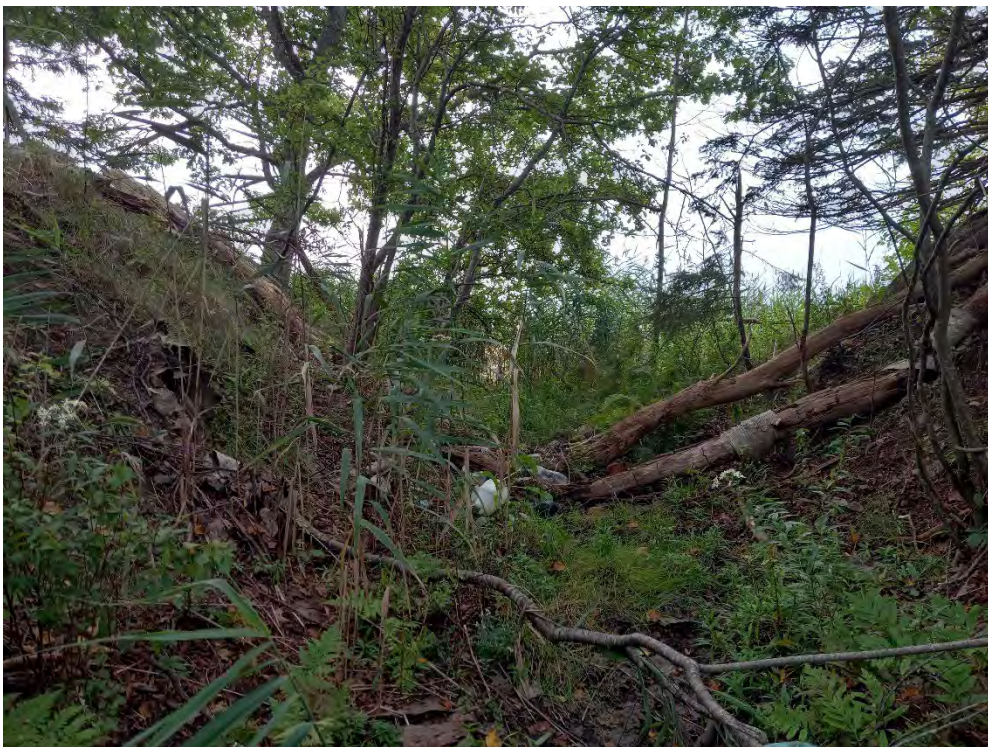
Photo No: 7

Photo Date: 9-9-23	
Description: outlet	
View of apparently constructed outlet in between berm sections, where stormwater feature in southwestern portion of Study Area drains to coastal area to the south.	
Photo No: 8

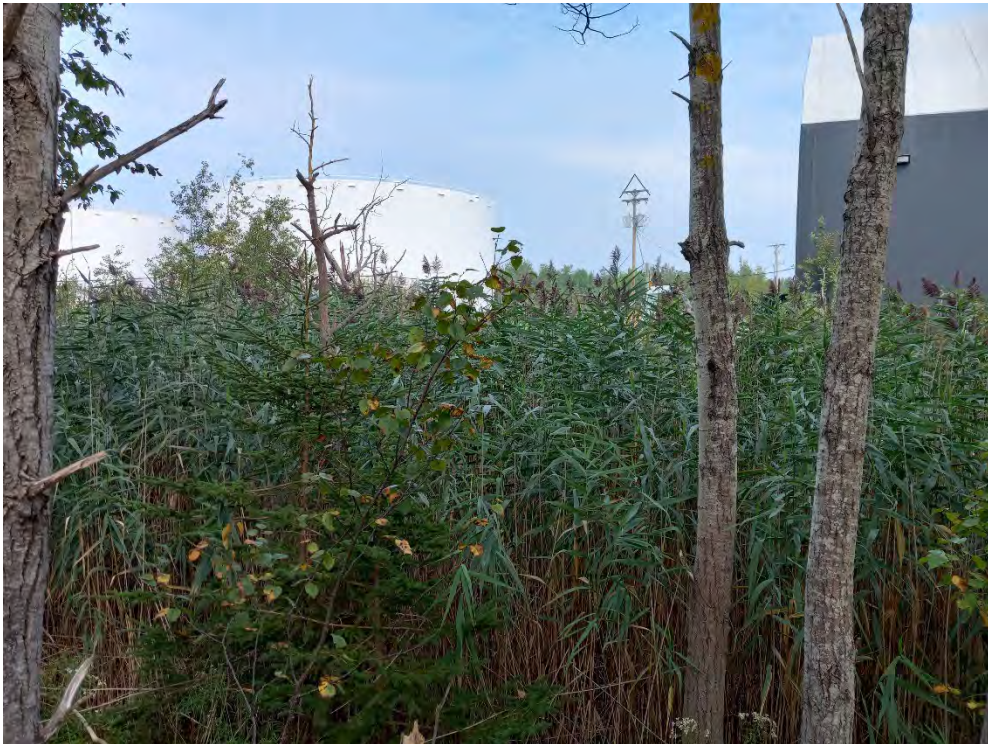
Photo Date: 9-15-23	
Description: SW Feature	
Representative view of stormwater feature in southwestern portion of property. This area consists of a thick stand of <i>Phragmites</i> and the drainage is dictated largely by a significantly sized berm along the southern edge.

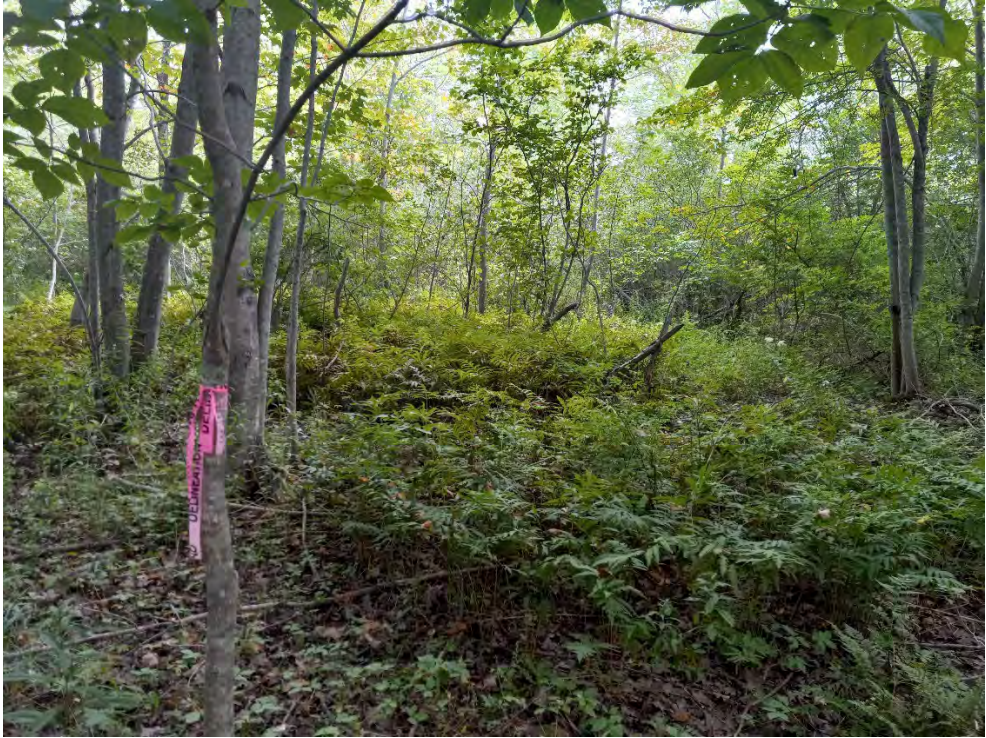
Photo No: 9	
Photo Date: 9-9-23	
Description: Forested wetland Representative photo of forested wetland in northern extent of Study Area outside of the port terminal facility.

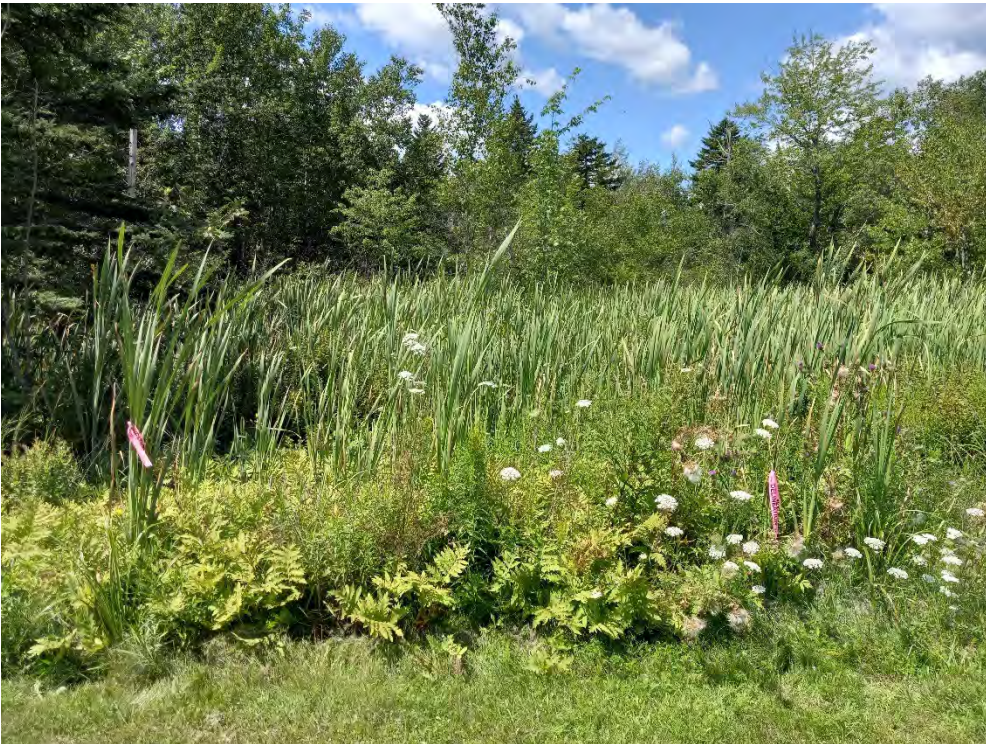
Photo No: 10	
Photo Date: 9-2-23	
Description: Wetland Area Representative photo of emergent wetland on eastern edge of Sprague port terminal facility.

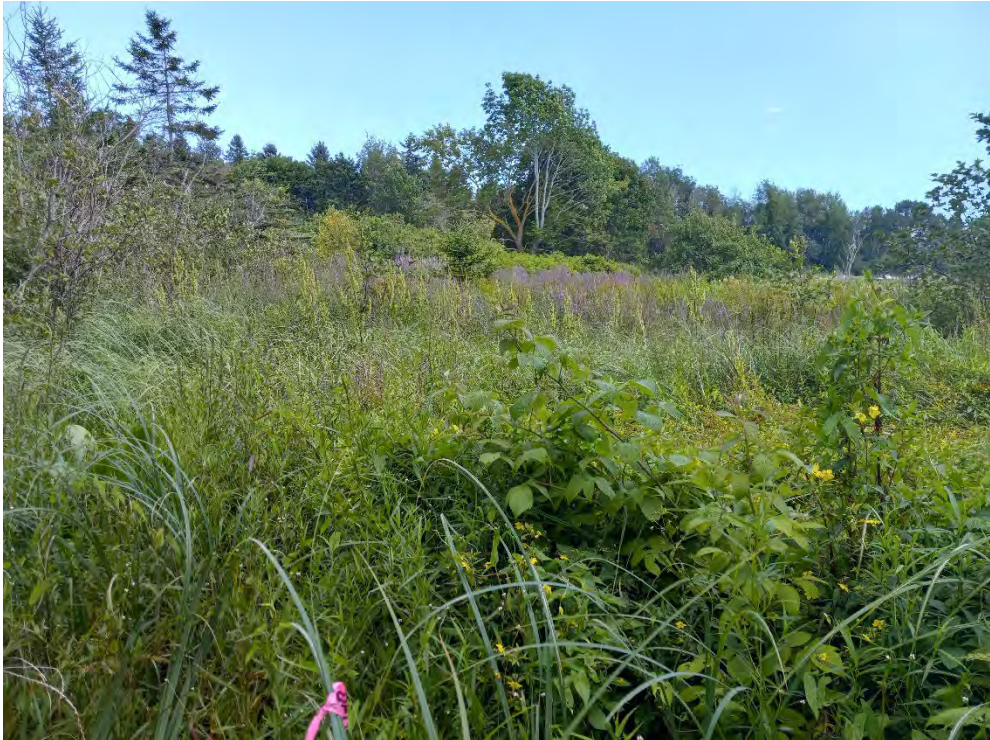
Photo No: 11

Photo Date: 8-2-23	
Description: Emergent wetland Representative photo of emergent wetland outside port facility limits on the southwestern portion of the Study Area.	
Photo No: 12

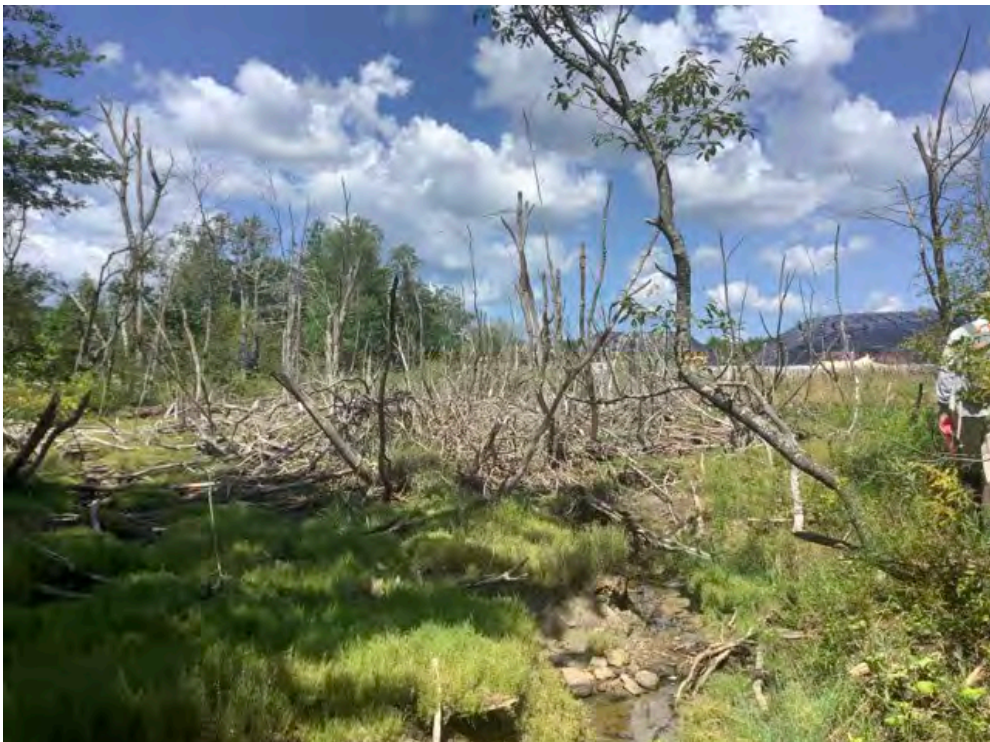
Photo Date: 8-24-23	
Description: Wetland Representative photo of wetland just below the salt facility on the northwestern portion of the Study Area which drains into the forested area along the western edge of the Study Area.

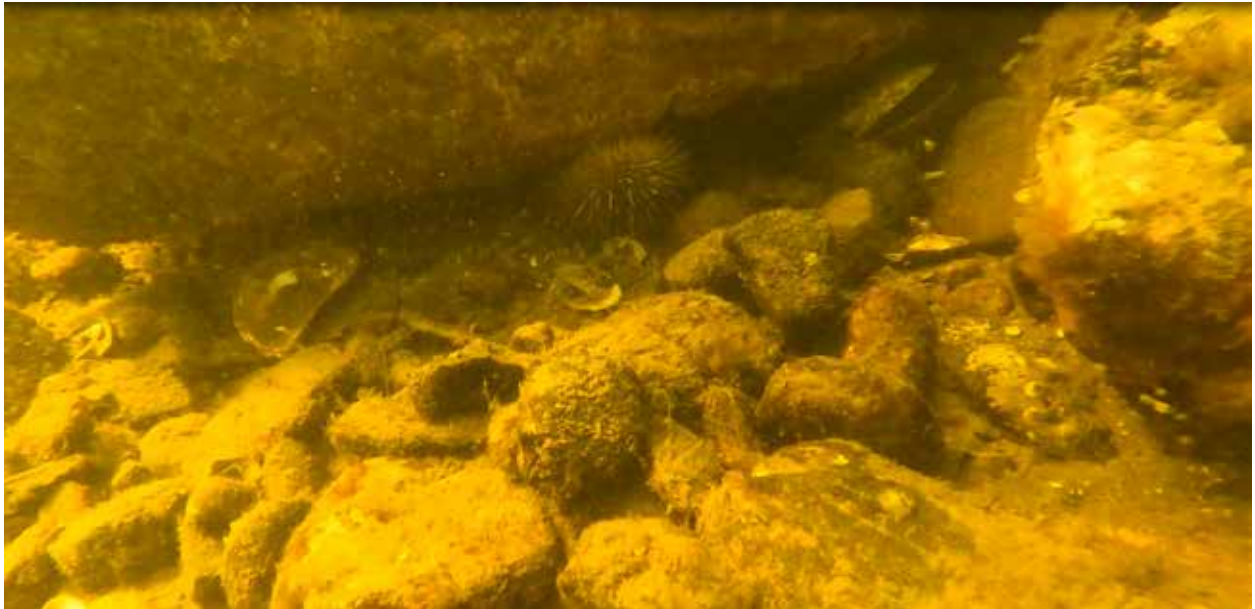
Photo 1. Cobble with gravel and sand with scattered boulders in the shallow subtidal with a green sea urchin at Mack Point. September 2023.

In the shallow subtidal, the substrate was primarily cobble with gravel and sand with scattered boulders (Photos 1 and 2). The substrate graded from the shallow subtidal to fine sandy silt and with scattered gravel, cobble, and boulders (Photo 3). The remnants of an old pier present in the intertidal extended into the subtidal and the rubble of the pier was observed by divers during the survey. Mapping of substrate types within the survey area based on the side-scan imagery is detailed in the Steele survey report.

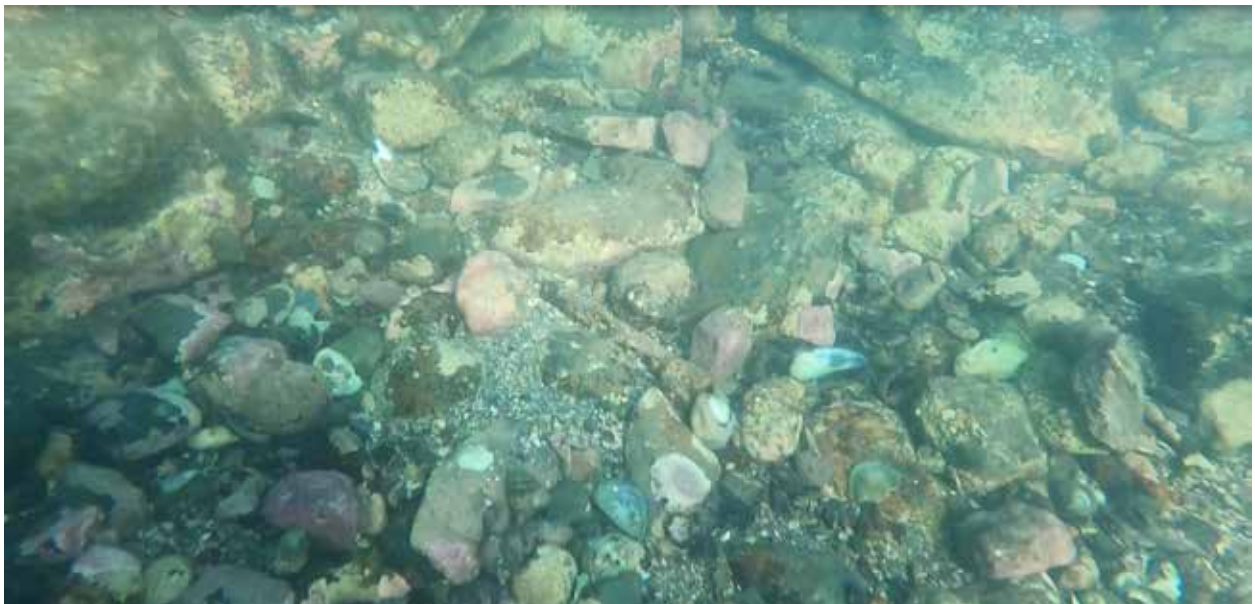
Photo 2. Cobble with gravel and sand with scattered boulders at Mack Point. September 2023.

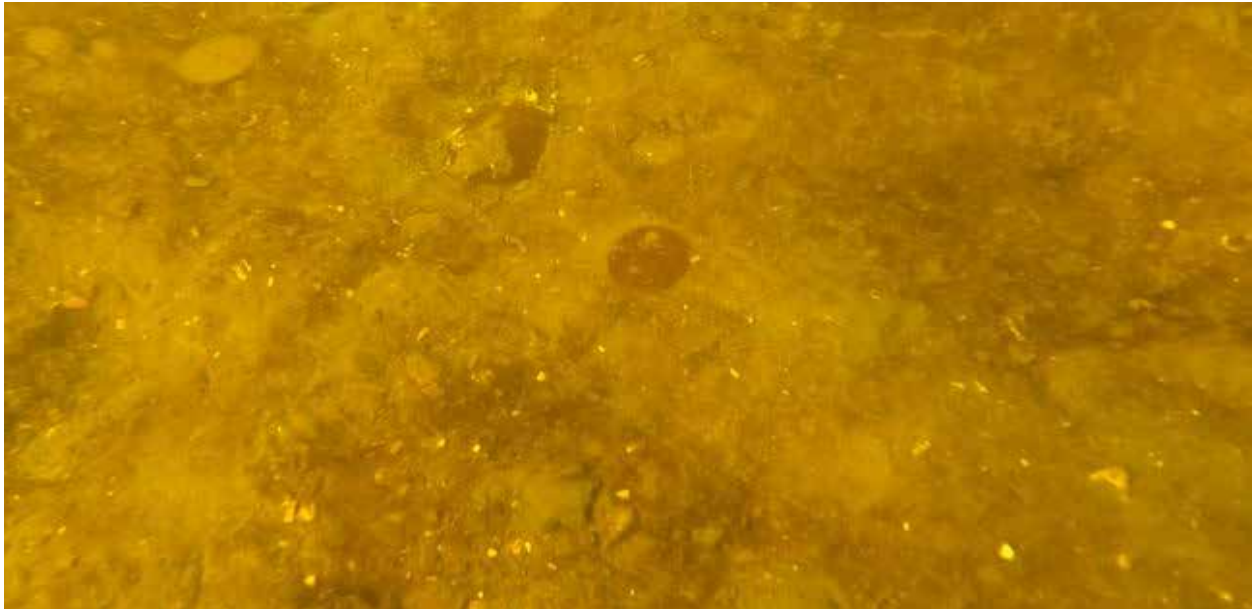
Photo 3. Sandy silt substrate in the shallow subtidal with sand dollars at Mack Point. September 2023.

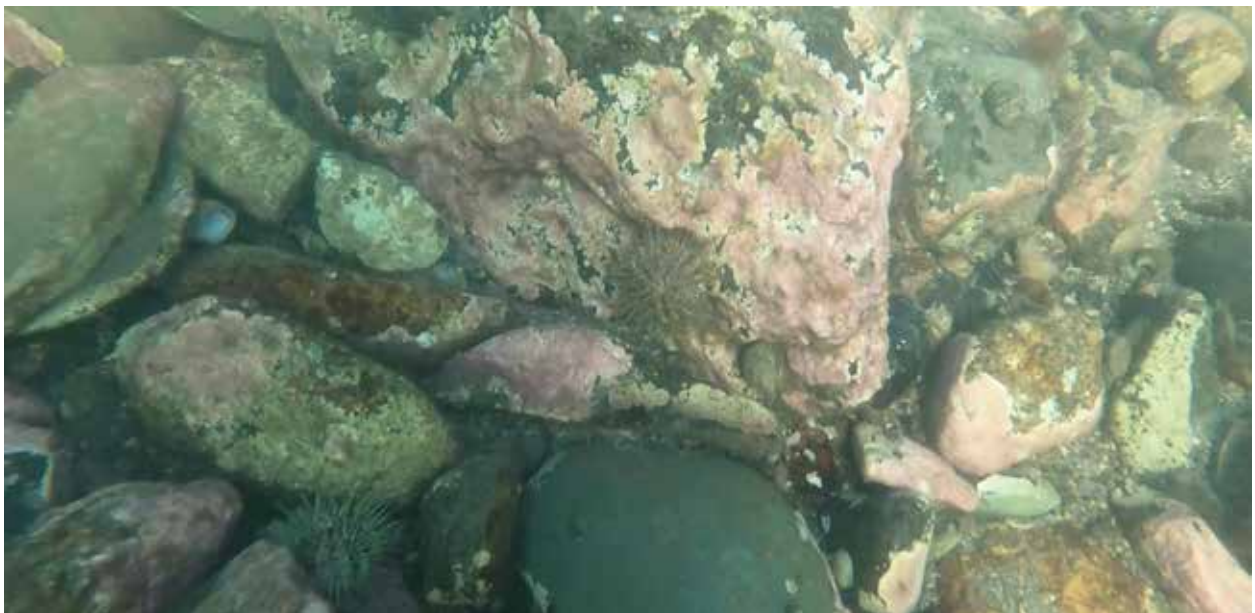
Photo 6. Boulders and cobble with crustose coralline algae due to urchin grazing at Mack Point. September 2023.

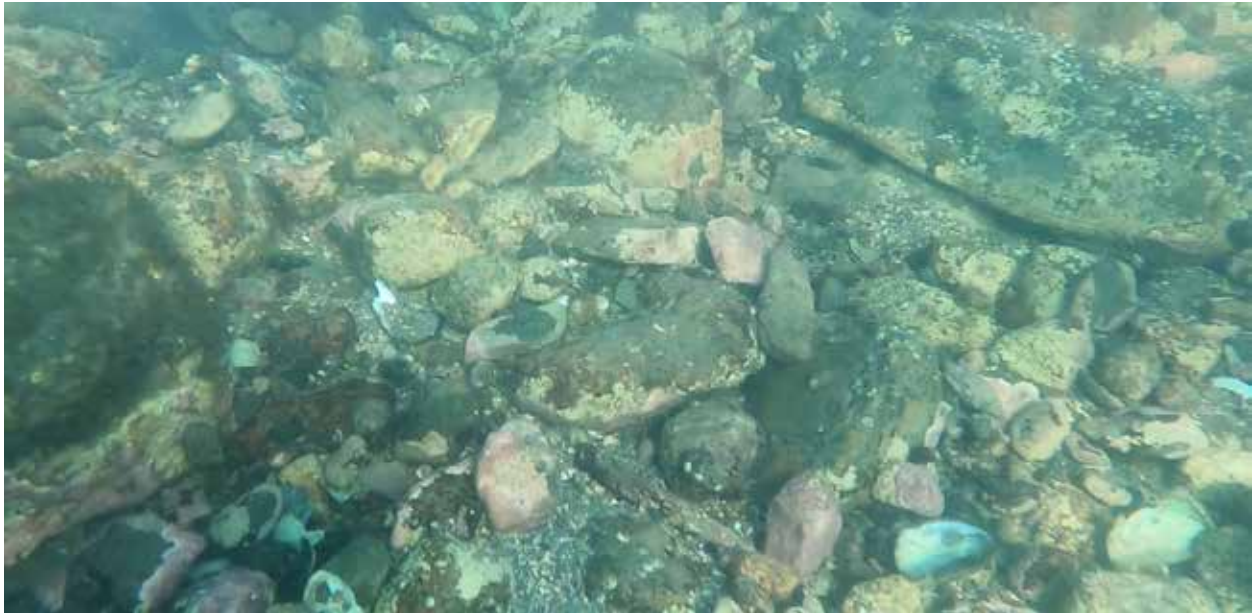
Photo 7. Boulders and cobble with crustose coralline algae due to urchin grazing at Mack Point. September 2023.

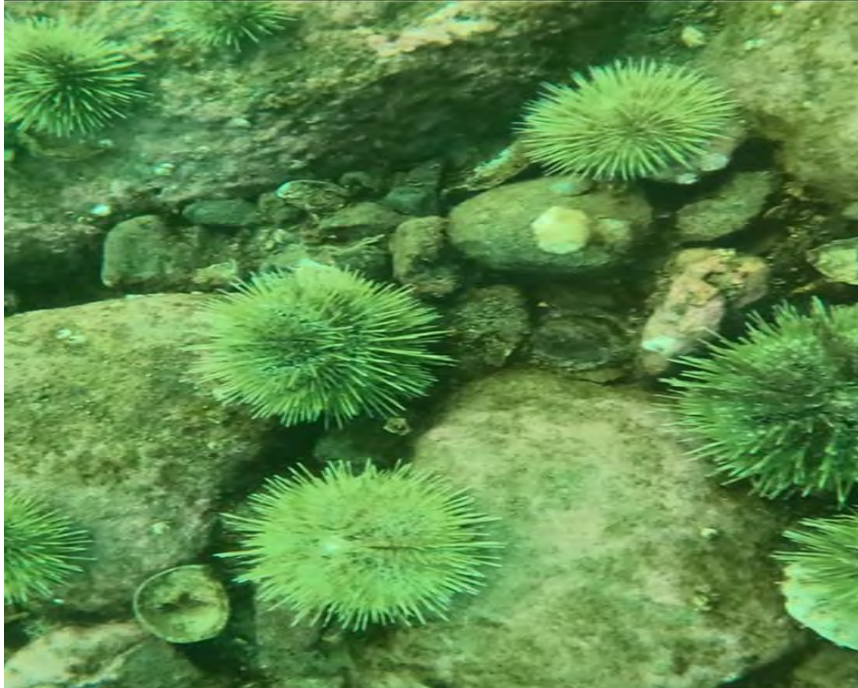
Photo 3. Abundant green sea urchins are in the shallow subtidal zone at Mack Point. November 2023.

A total of 3,996 urchins were observed in the Mack Point Survey Area. Urchins were only observed on Transect 1 in boulder and cobble habitat (Table 1; Photos 2 and 3). The remaining transects lacked hard bottom urchin habitat. The urchin density (2.1 urchins per square meter) on cobble and boulder substrate in the Survey Area has resulted in heavy browsing pressure on algae in the subtidal, with algae in these areas being primarily limited to crustose coralline algae (Photos 4 and 5).

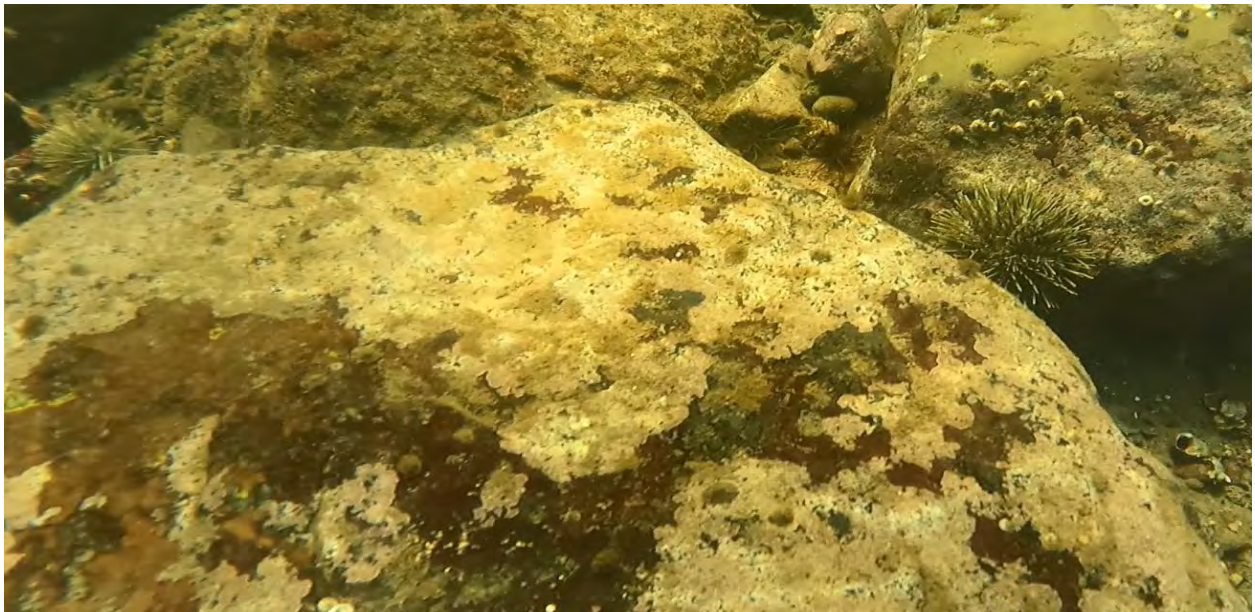
Photo 4. Boulders with crustose coralline algae due to urchin grazing. Mack Point. December 2023.

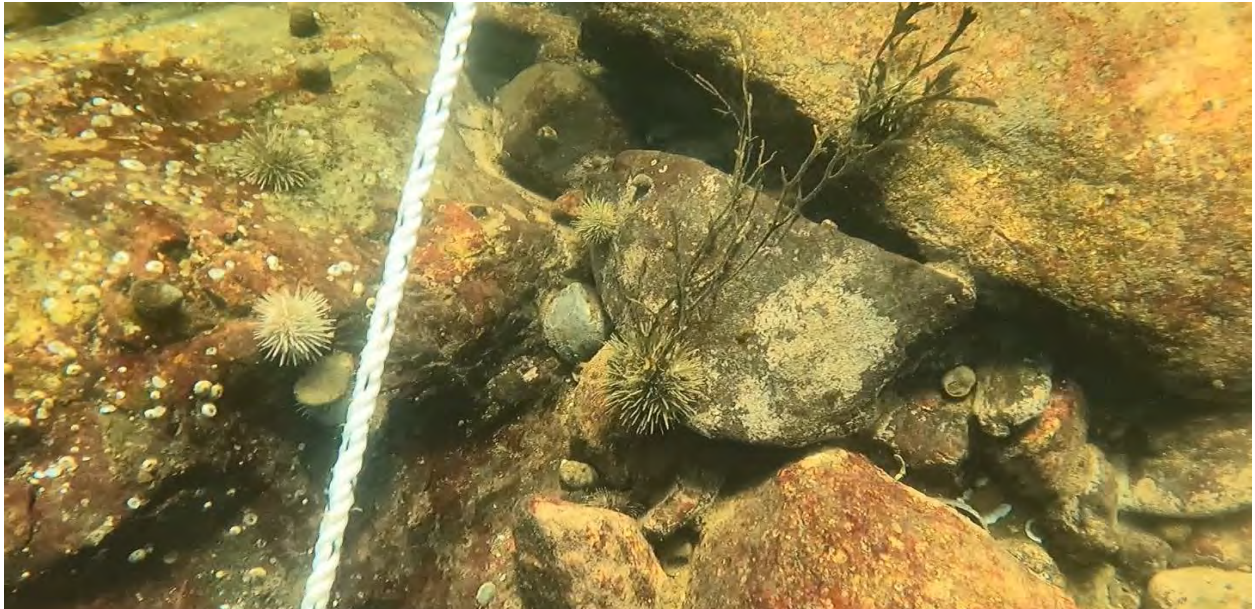
Photo 5. Boulders and cobble with crustose coralline algae due to urchin grazing. December 2023.

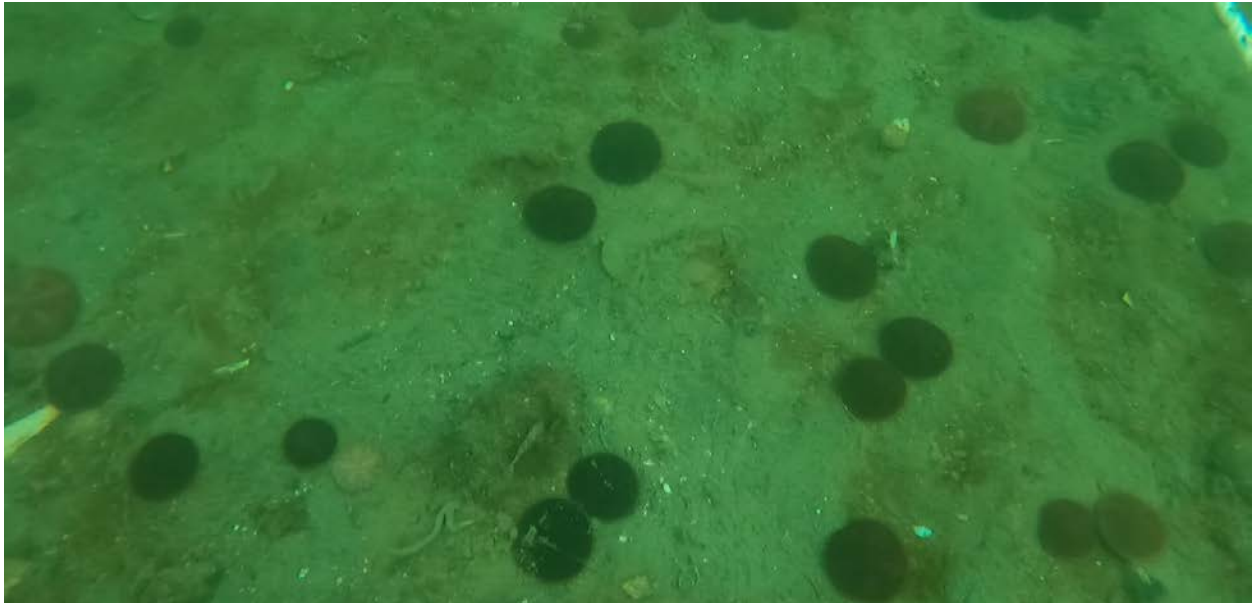
Photo 9. Sandy silt substrate in the shallow subtidal with sand dollars at Mack Point. November 2023

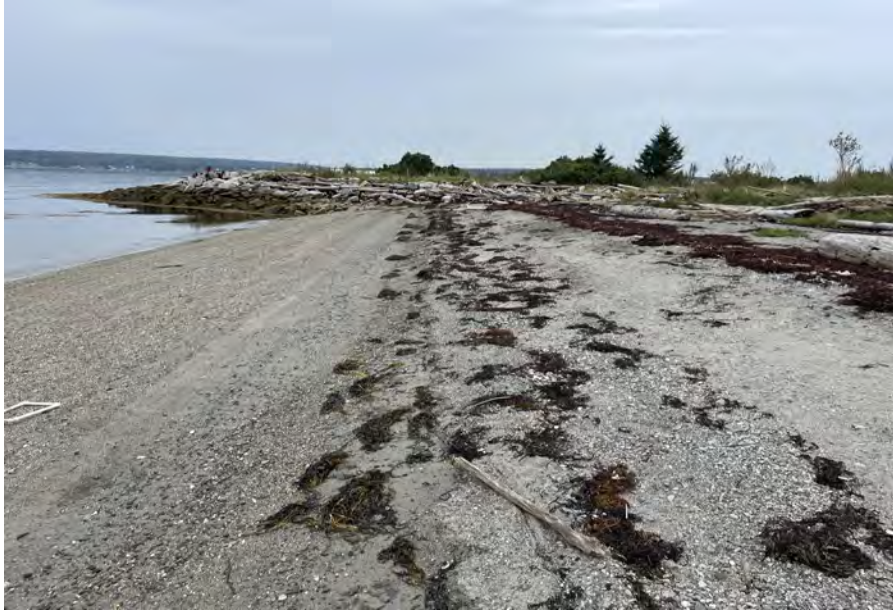
Photo 1. Depositional area to the south of the riprap jetty at Sears Island. September 2023.

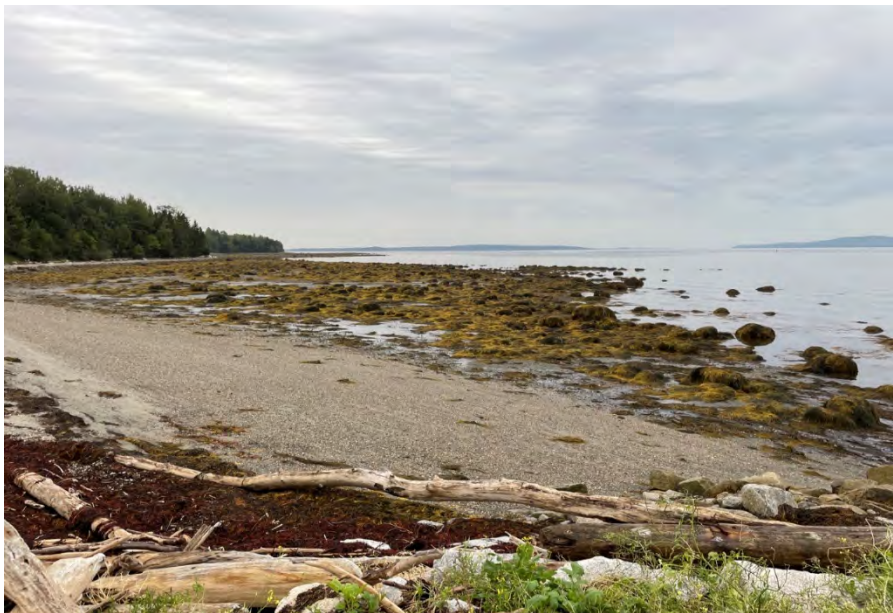
Photo 2. Depositional area to the south of the riprap jetty at Sears Island with boulder and cobble substrate in background. September 2023.

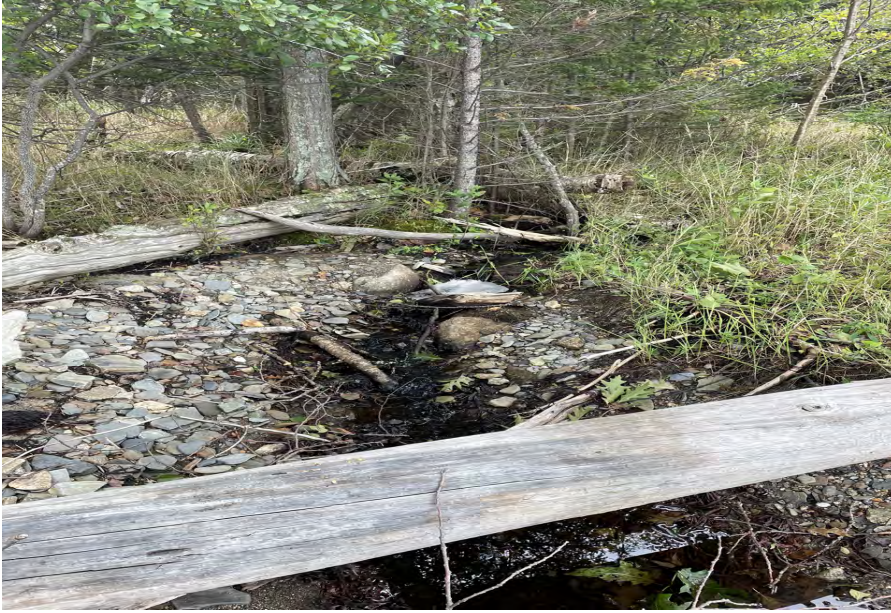
Photo 3. Freshwater seep from the forested wetland habitat at Sears Island draining into high intertidal. September 2023.

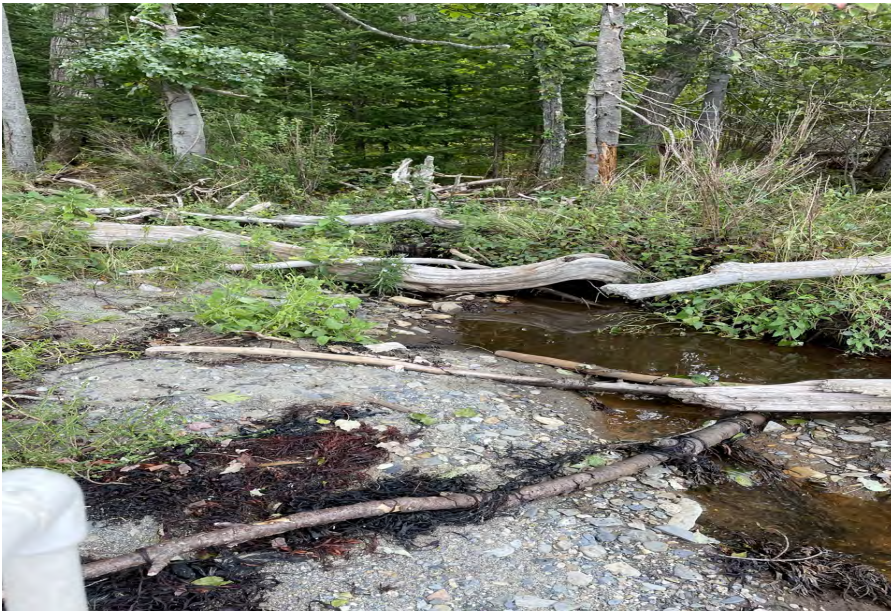
Photo 4. Freshwater seep from the forested wetland habitat at Sears Island draining into high intertidal. September 2023.

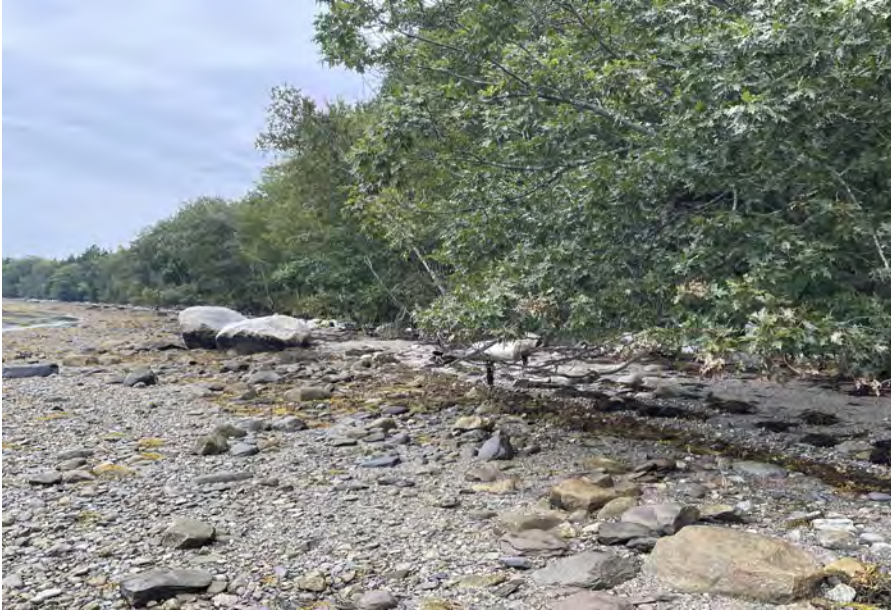
Photo 7. Coarse sand and gravel with scattered cobble in the high intertidal at Sears Island north of jetty. September 2023.
